Re: Monthly Report Summary #11 for the Valley-Ivyglen 115-kV Substation (VIG) Project

CPUC Site Inspection Reports
June 9 and 22, 2021

Valley – Ivyglen Subtransmission Project CPUC Site Inspection Form

Project:	Valley – Ivyglen Project	Date:	June 9, 2021
Project Proponent:	Southern California Edison (SCE)	Report #:	VS023
Lead Agency:	California Public Utilities Commission (CPUC)	Monitor(s):	Vincent Semonsen
CPUC PM:	Patricia Kelly, Energy Division	AM/PM Weather:	Partly cloudy and mild with a slight breeze
CPUC-CM (WSP):	Chuck Cleeves	Start/End time:	0600 to 0930
Project NTP(s):	Notice to Proceed (NTP-1), NTP-2, and NTP-3.

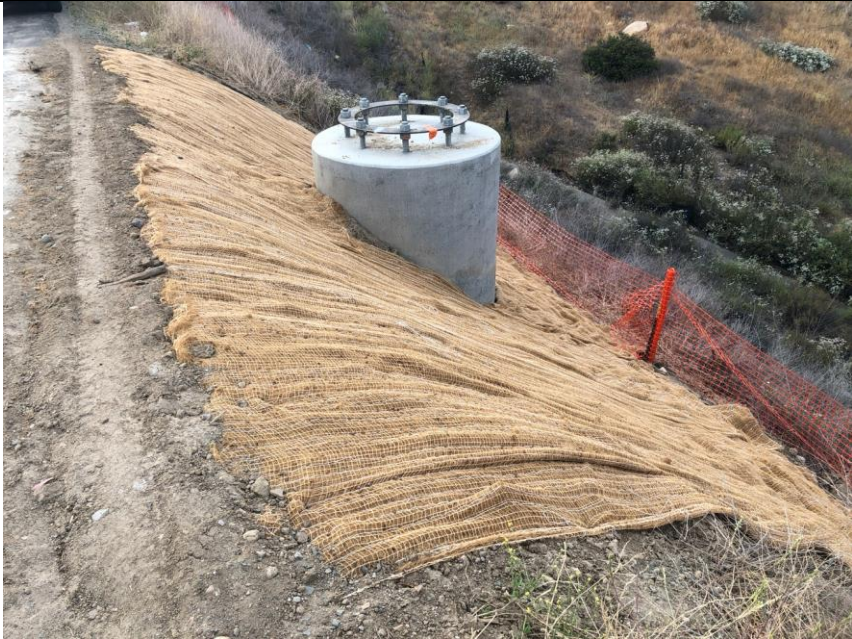
The EI and I made our first stop along DePalma Road to inspect TSPs 553 and 549 (Photo 1). Restoration was completed around the pole foundations, including the removal of excess soil and the removal of the wooden barriers. The area was recontoured and covered with a coconut blanket. No seeding or hydraulic mulch was applied.

Photo 1 – Restoration work completed around TSP 549.
6/09/21	VIG Project

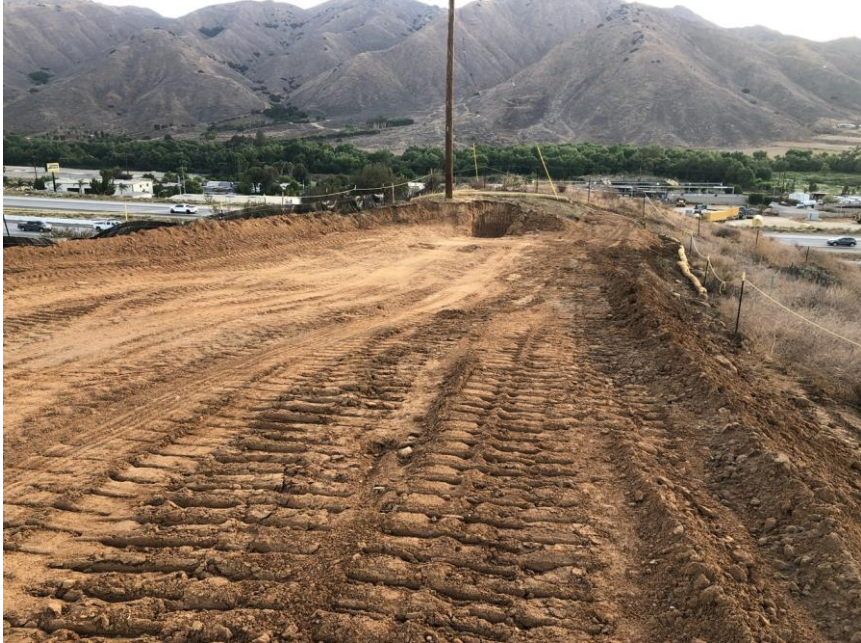
Our next stop was along Horsethief Canyon Road where several TSP foundations were being installed at the eastern end of a large open area. A long and dusty access road leads to TSP 530 where the pole site was graded in preparation for drilling the foundation hole (Photo 2). The TSP location required a 4-foot cut with excess soil spread out along the access road (Photo 3). Several hundred yards leading to the TSP 530 site were cleared and graded out to the disturbance limits (Photo 4). I questioned the EI about why this work had not been completed anywhere else along Horsethief Canyon Road. We discussed the need for additional dust control and watering the road before the end of the workday.

Photo 2 –Site preparation at TSP 530. Photo facing east.

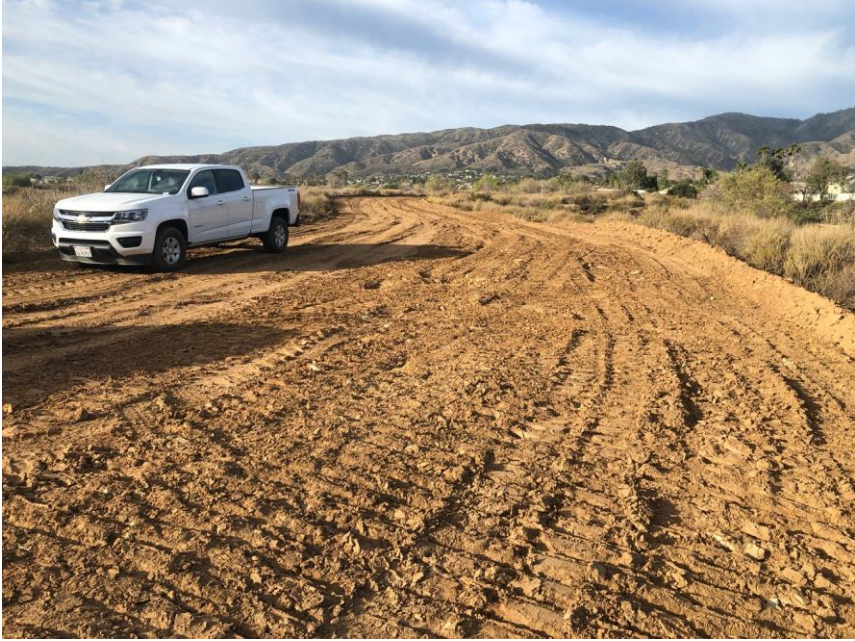
Photo 4 – Access road grading completed to TSP 530. Photo facing southwest.

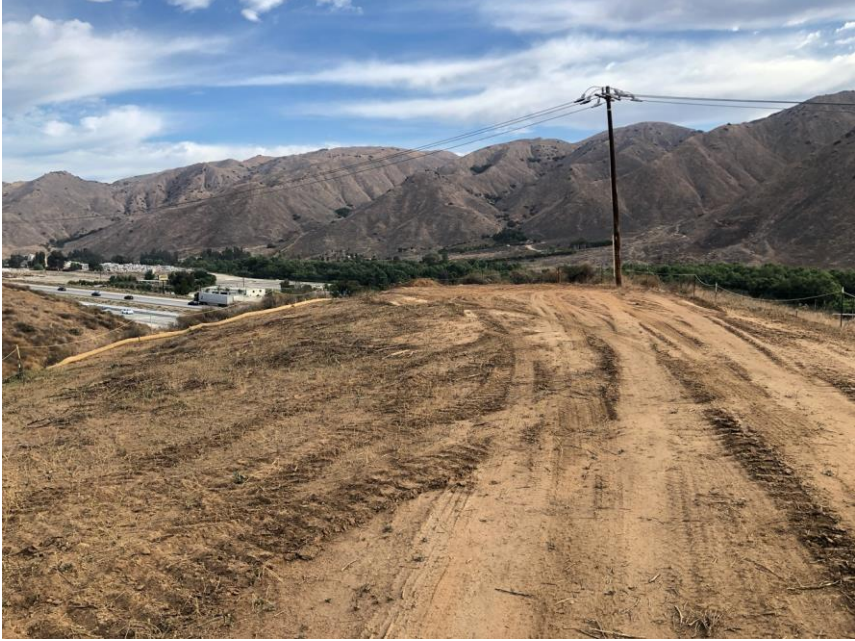
We traveled to TSP 529 located south of the TSP 530 location (Photo 5). The access road was very dusty.

Photo 5 – Graded construction area at TSP 529. Photo facing northeast.

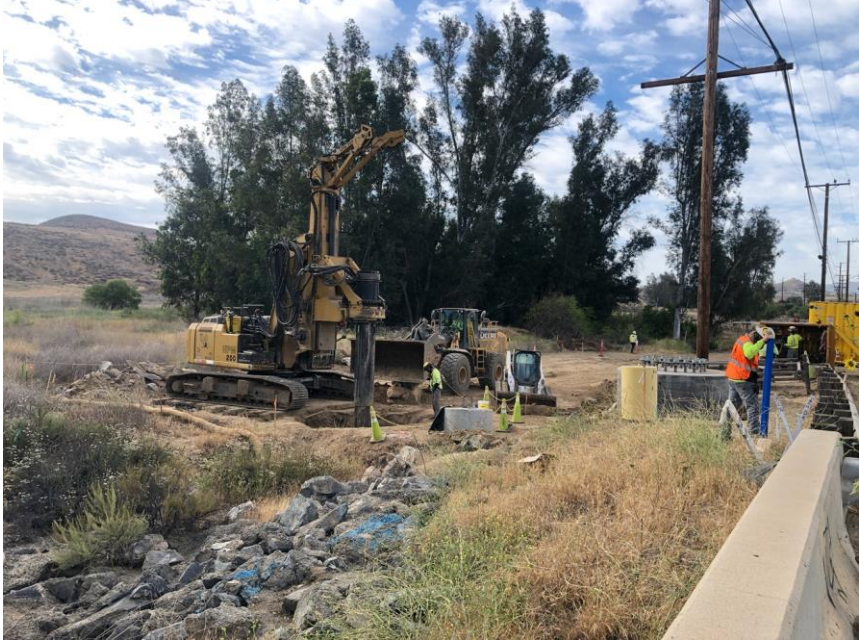
My final stop was along Lake Street where drilling crews were working on TSP 2161 (Photo 6). The area was very congested, especially during rush hour, so traffic control was in place. The site was near a dry creek corridor and a red-tailed hawk (*Buteo jamaicensis*) nest was in a nearby eucalyptus tree. The monitoring crew set up a 150-foot buffer around the nest and an avian biologist was onsite. The buffer was reduced from 150 to 130 feet, allowing the crews to access TSP 2161. One juvenile hawk had fledged but was still around the nest site. A large number of birds were seen and heard around the construction area, including Western kingbirds (*Tyrannus verticalis*), hooded oriole (*Icterus cucullatus*), house finch (*Haemorhous mexicanus*), Phainopepla, Nuttall's woodpecker (*Dryobates nuttallii*), and yellow warbler (*Setophaga petechia*). The site was dusty and the EI spoke to the crew about dust control (Photo 7). A water truck immediately watered the area.

Photo 6 – Drilling crew working at TSP 2161. Photo facing southwest.

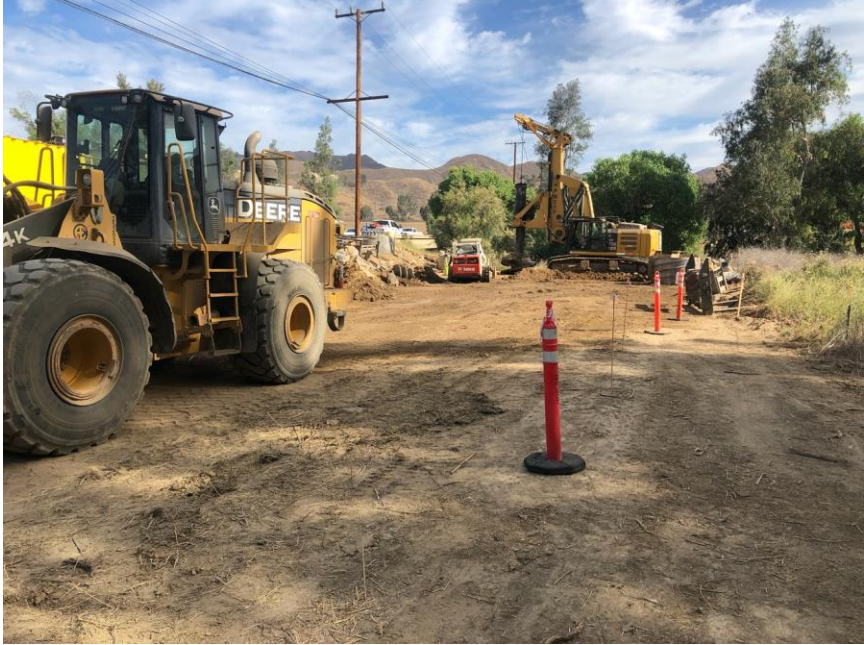
<p>Photo 7 – Work area around TSP 2161 with orange markers to delineate the nesting bird buffer zone. Photo facing east.</p>

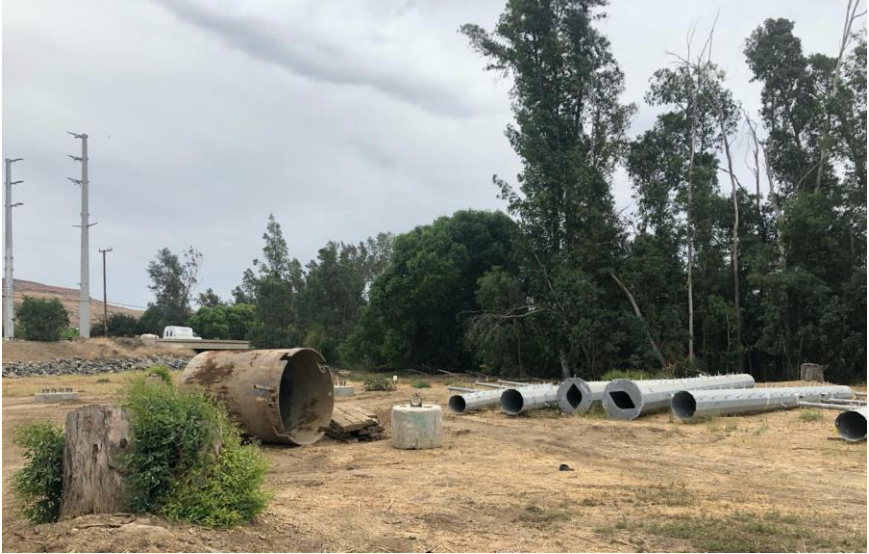
We traveled to an area west of Highway 15 and north of Lake Street where the Aldridge crew was working on TSP 4962165E (Photo 2). The final six TSPs were being completed in this area. Nesting bird surveys were regularly conducted near the work site within the vegetated environmentally sensitive area (ESA) (Photo 3). The vegetation was dominated by eucalyptus and does not provide the optimal bird nesting habitat. No nesting birds were documented. Equipment and additional poles were stockpiled in this area (Photo 4). Additional dust control was needed around the work site.

Photo 4 – Staging area along the transmission corridor. Photo facing southwest.

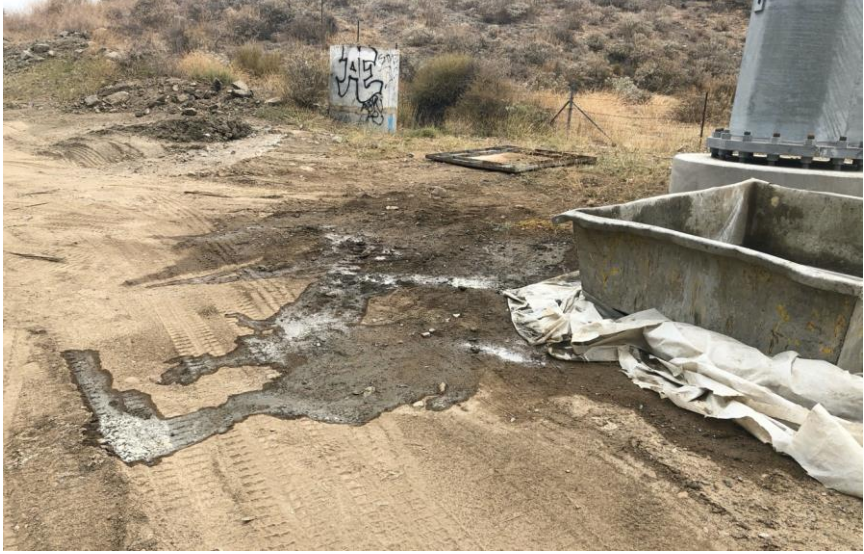
When we arrived at the drill site the crew had completed pouring most of the foundation (Photo 5). There were several concrete spills around the foundation hole and a crew member explained that the pour was wet due to the groundwater in the hole (Photo 6). The LEI said the spillage would be disposed of. The following morning, the LEI sent a photo of the area after it was cleaned. As we were leaving the site, the Aldridge crew was preparing to set the bolt cage in the fresh concrete (Photo 7).

Photo 6 – Several concrete spills around the foundation hole.

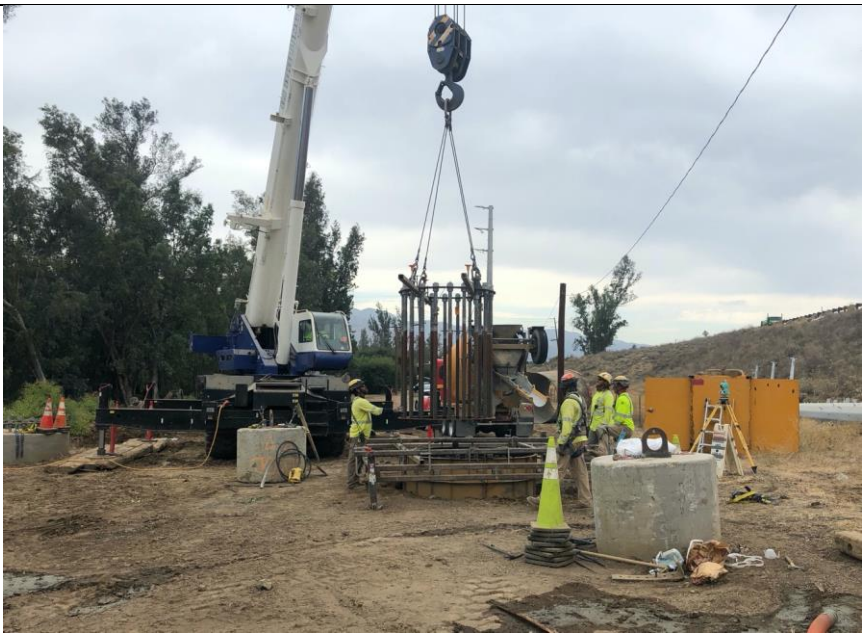
<p>Photo 7 – Crews lowering the bolt cage into the freshly poured concrete. Photo facing north.</p>

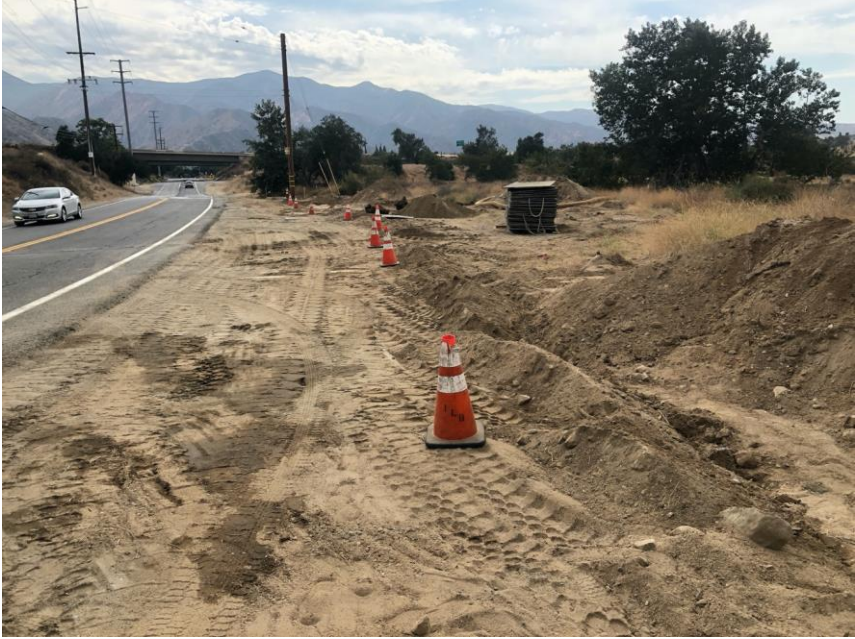
Our final stop was further north in segment 8 where an underground portion of conduit was being installed between vaults 2 and 3 (Photo 8). A portion of the trench near oak trees was left open, but was sealed with plywood and plastic (Photo 9). The oaks had been pruned earlier in the day under the supervision of an arborist and the trench work would be monitored by the arborist to properly seal and protect any oak roots.

Photo 8 – Underground conduit installation within segment 8. Photo facing west.
