Re: Monthly Report Summary #8 for the Valley-Ivyglen 115-kV Substation (VIG) Project

CPUC Site Inspection Reports
February 4 and 18, 2021

Valley – Ivyglen Subtransmission Project CPUC Site Inspection Form

Project:	Valley – Ivyglen Project	Date:	February 18, 2021
Project Proponent:	SCE	Report #:	VS016
Lead Agency:	California Public Utilities Commission	Monitor(s):	Vincent Semonsen
CPUC PM:	Patricia Kelly, Energy Division	AM/PM Weather:	Clear, cold and calm
CPUC-CM (WSP):	Chuck Cleeves	Start/End time:	0600 hrs – 1030 hrs
Project NTP(s):	NTP-1.

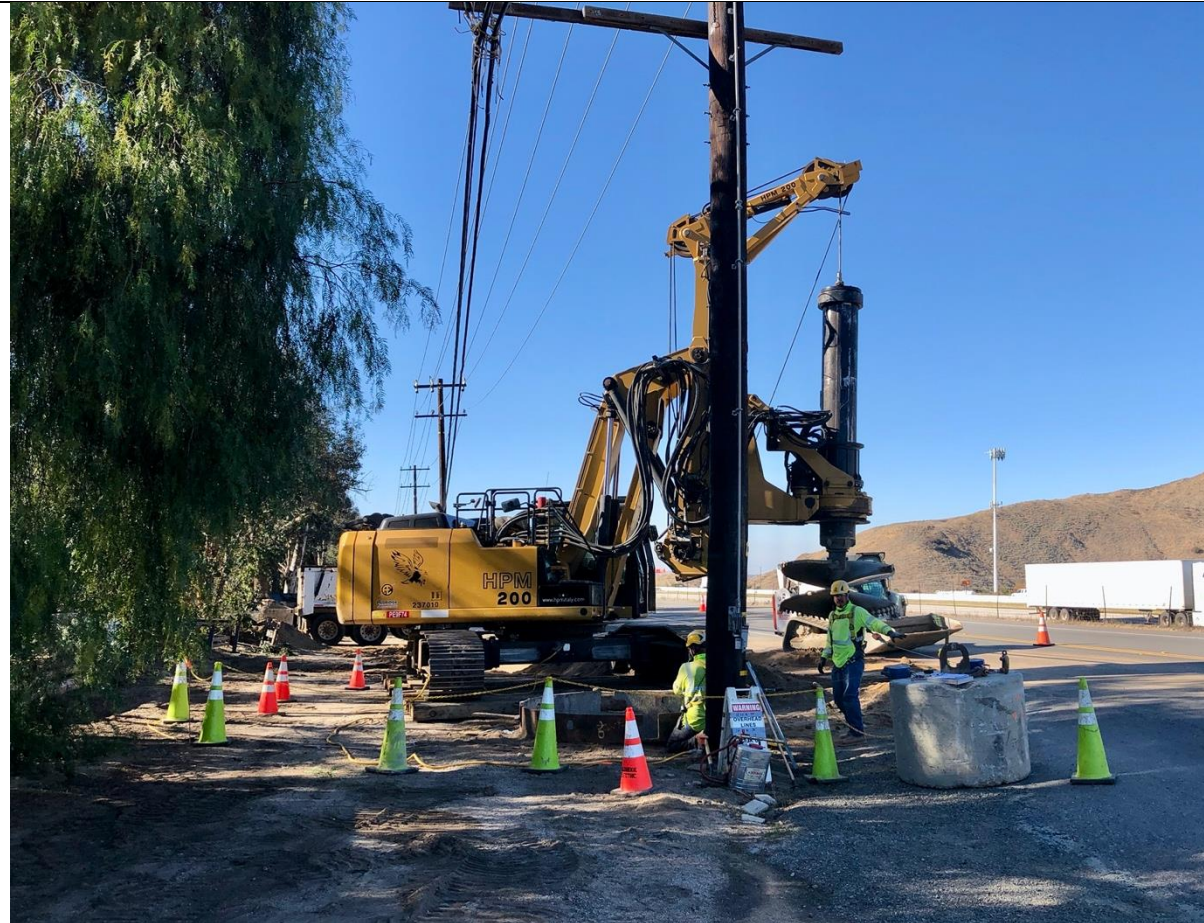
Photo 1 – Foundation drilling work underway at TSP 561. Photo facing northwest

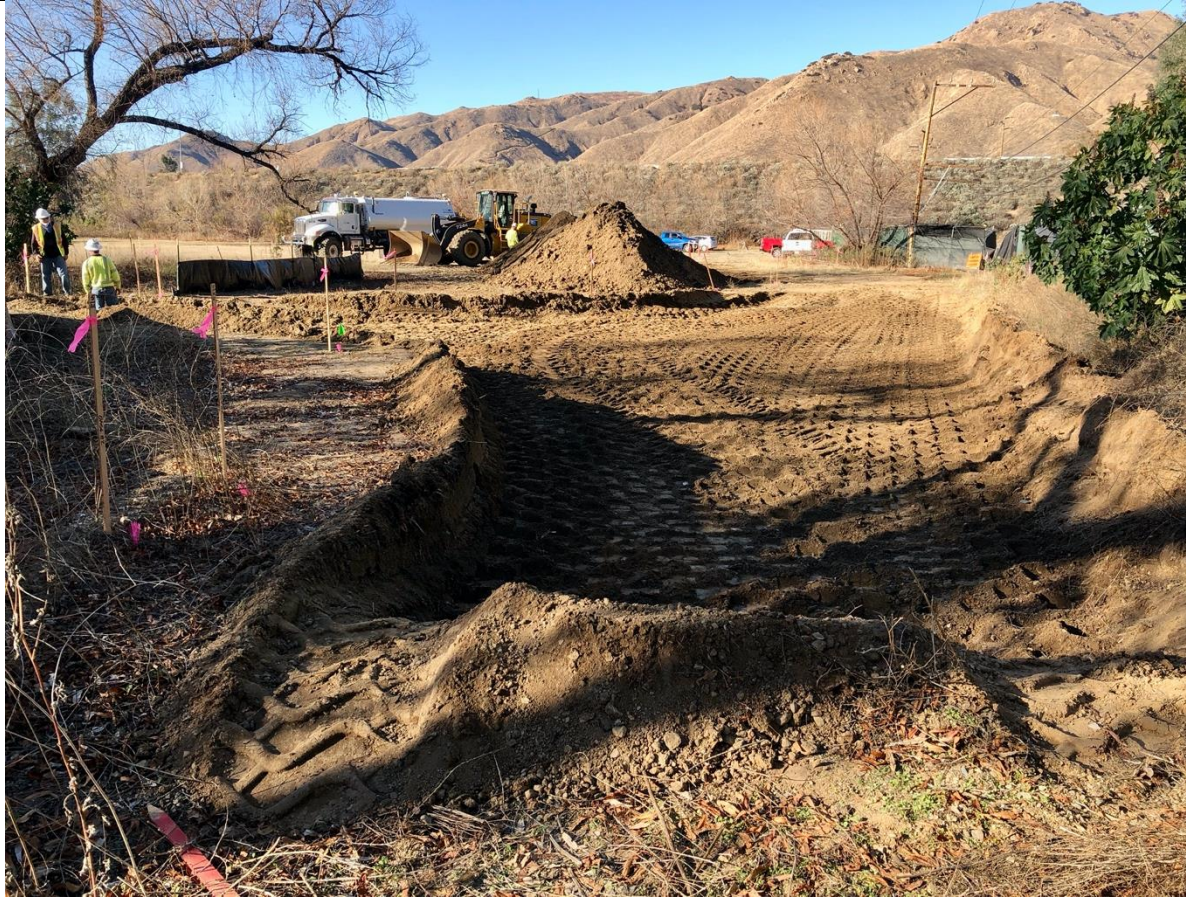
Photo 4 – Access
road enhancement
at TSP site 522.
BMPs are in place.
Photo facing
northeast

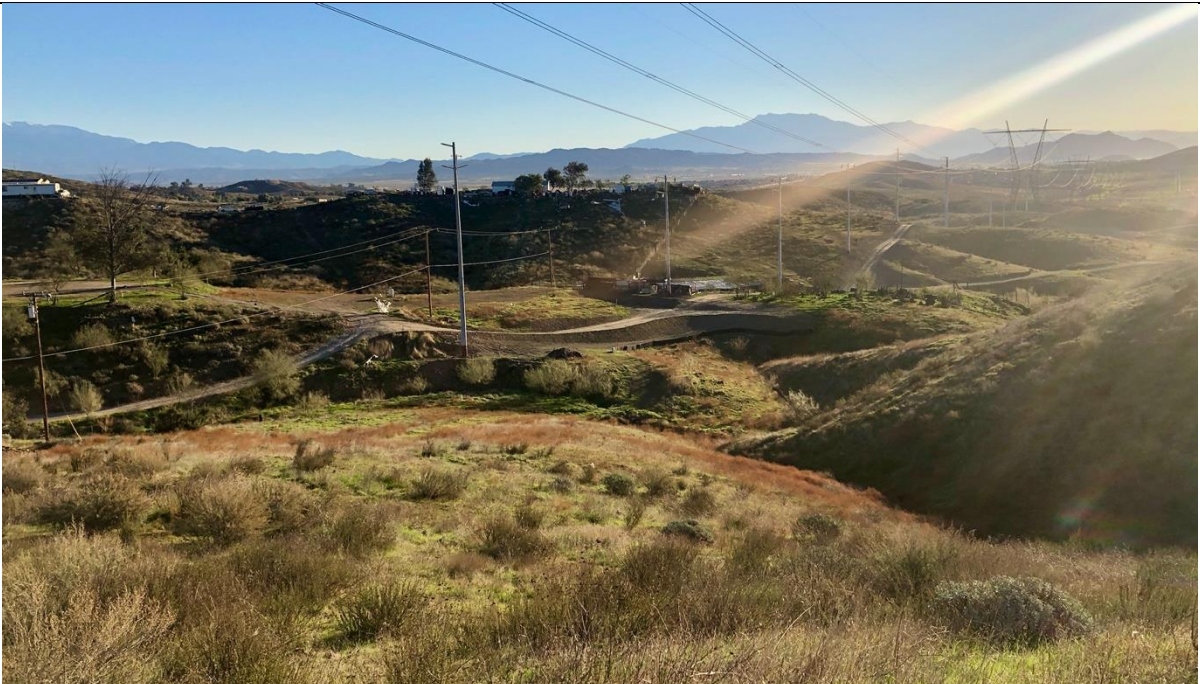
Photo 2 – Segment 1 Transmission corridor looking to the east from TSP 144. Photo facing east

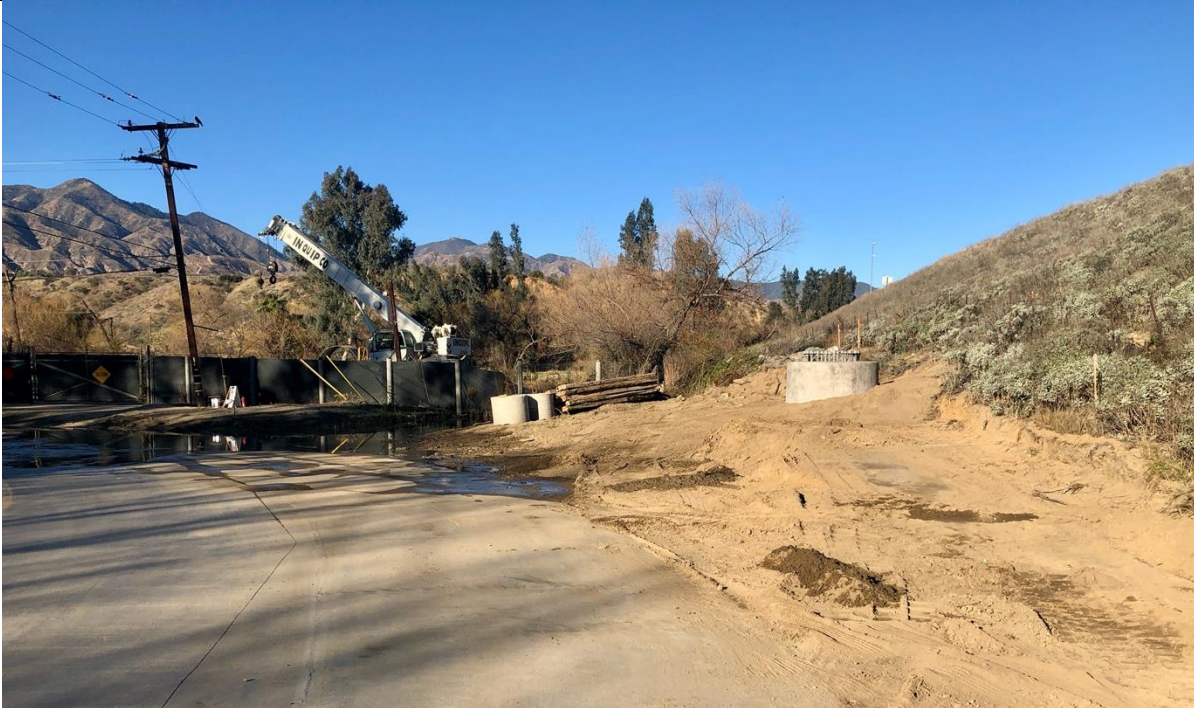
Photo 3 – The TSP 520 foundation has been drilled and poured. Photo facing northwest

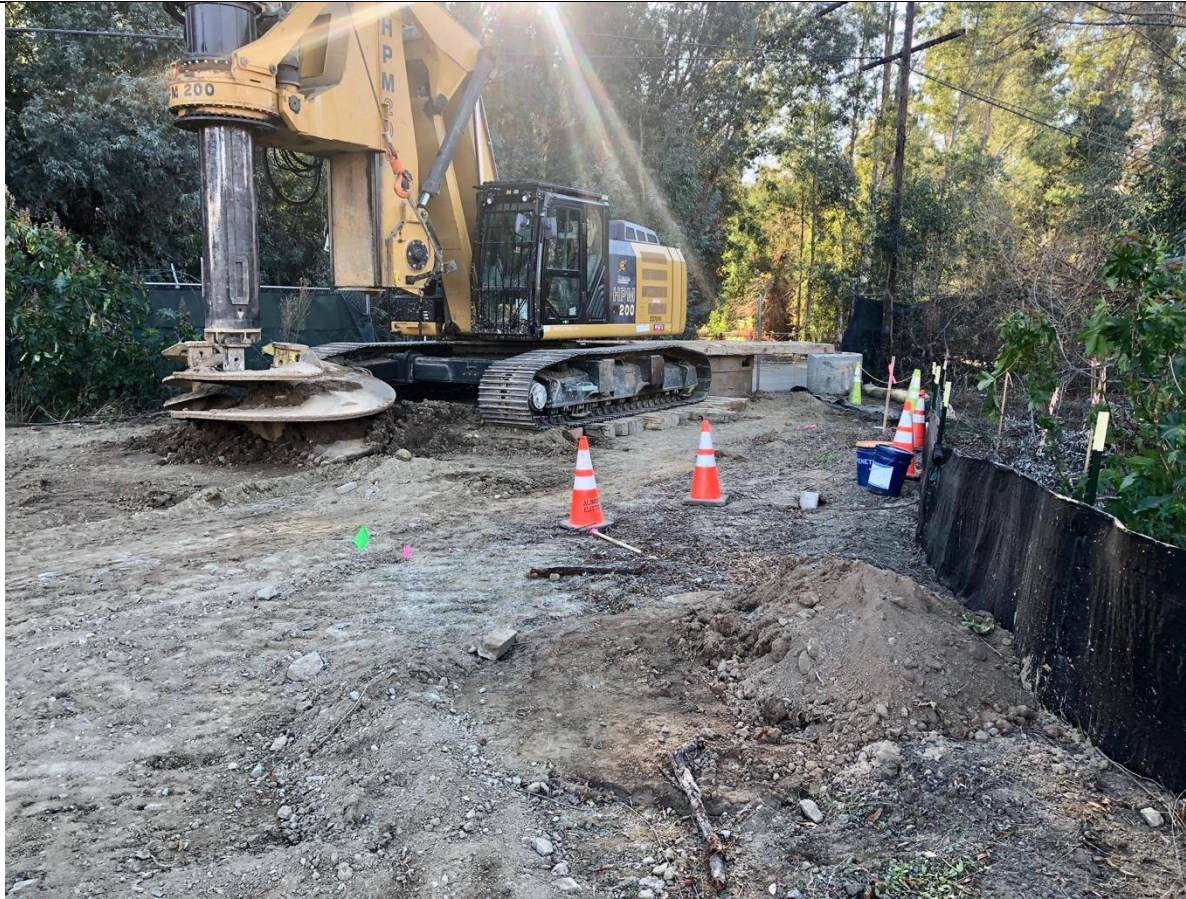
Photo 4 – Drilling equipment parked at TSP site 522. BMPs are in place. Photo facing southwest

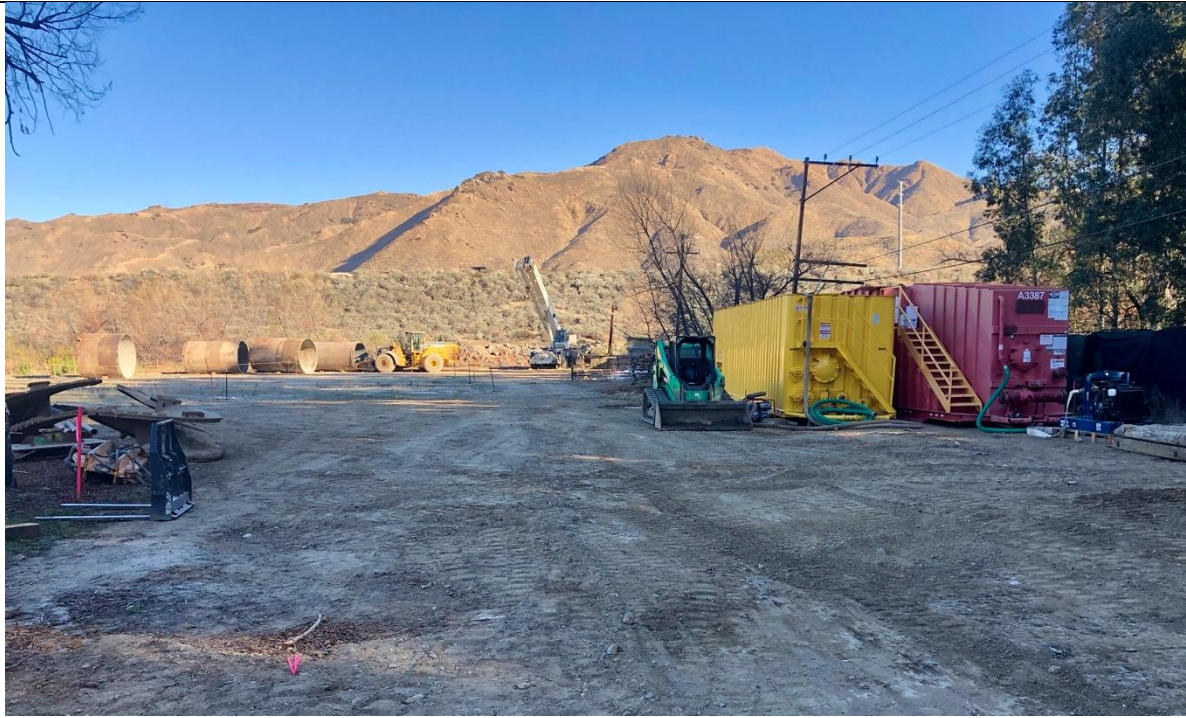
Photo 5 – Staging
area between TSPs
520 and 522. Photo
facing east

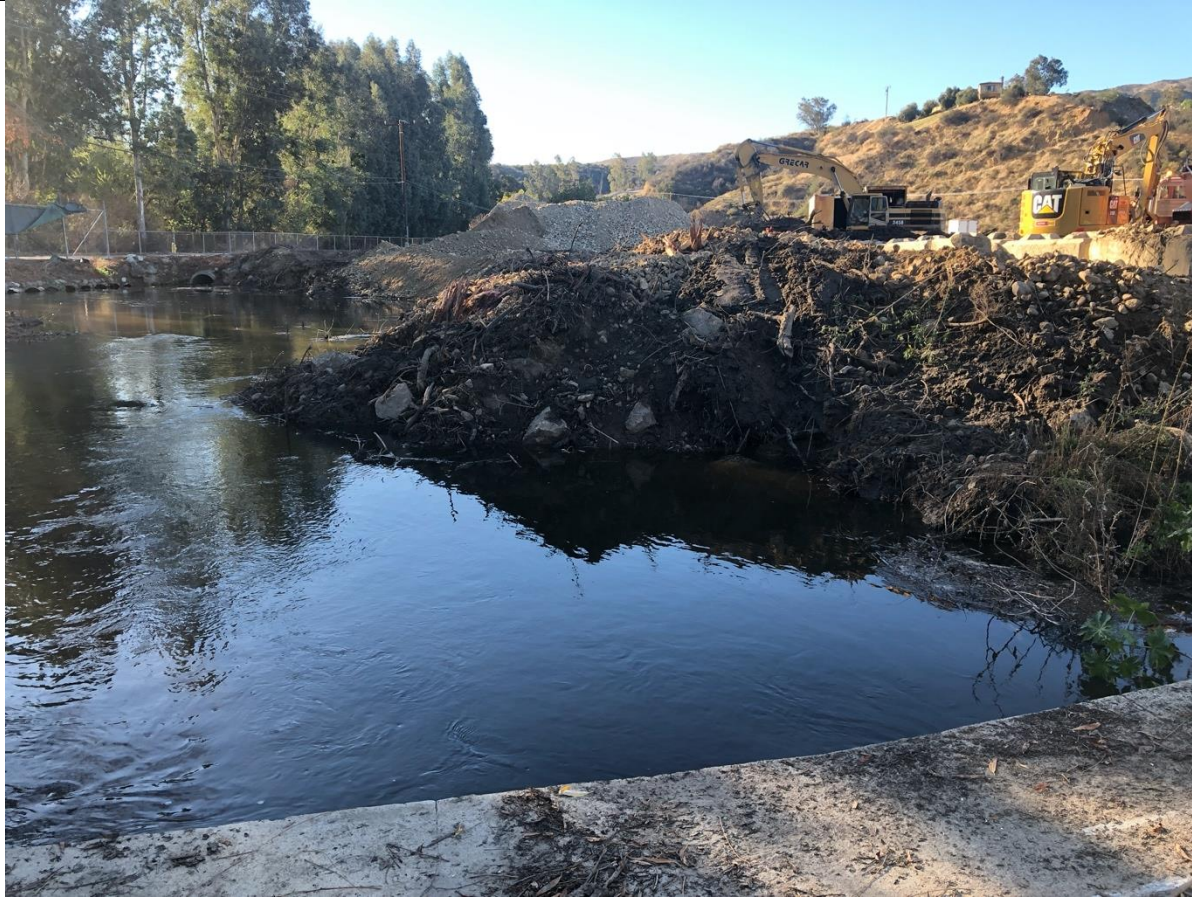
Photo 6 –
Unidentified crews
clearing vegetation
and dirt from
Temescal creek
across from TSP
520. Photo facing
southwest

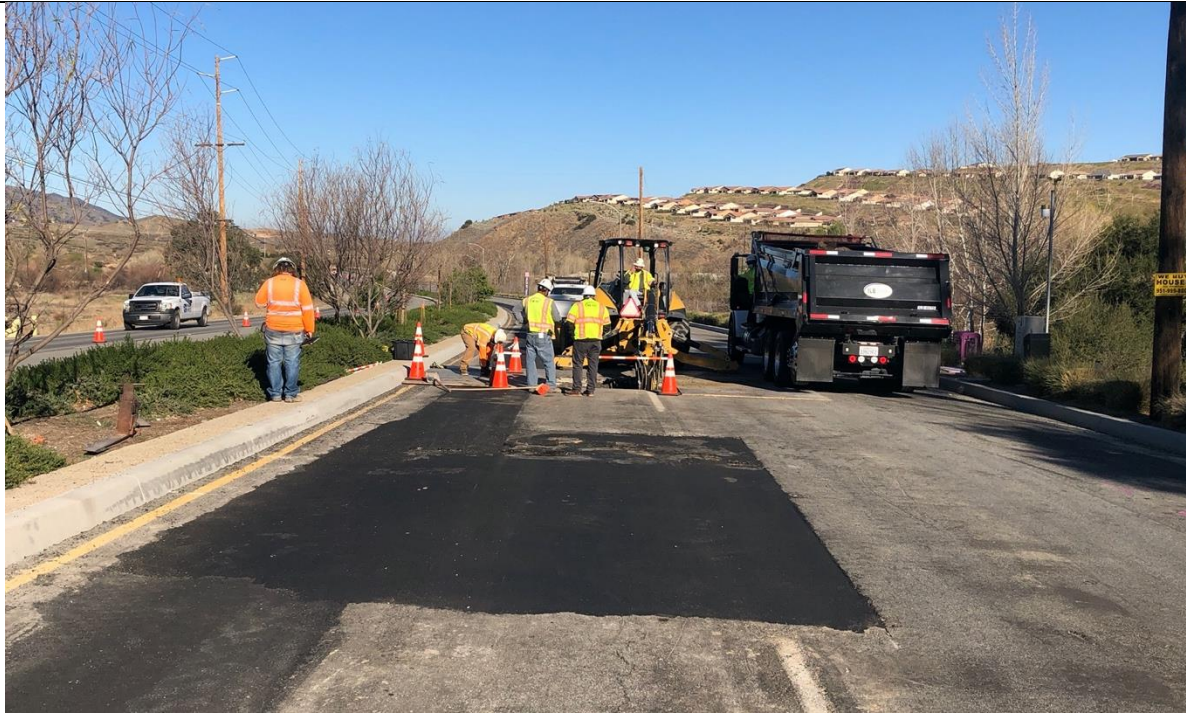
Photo 7 – Segment 8 underground installation within Temescal Canyon Road. Photo facing north

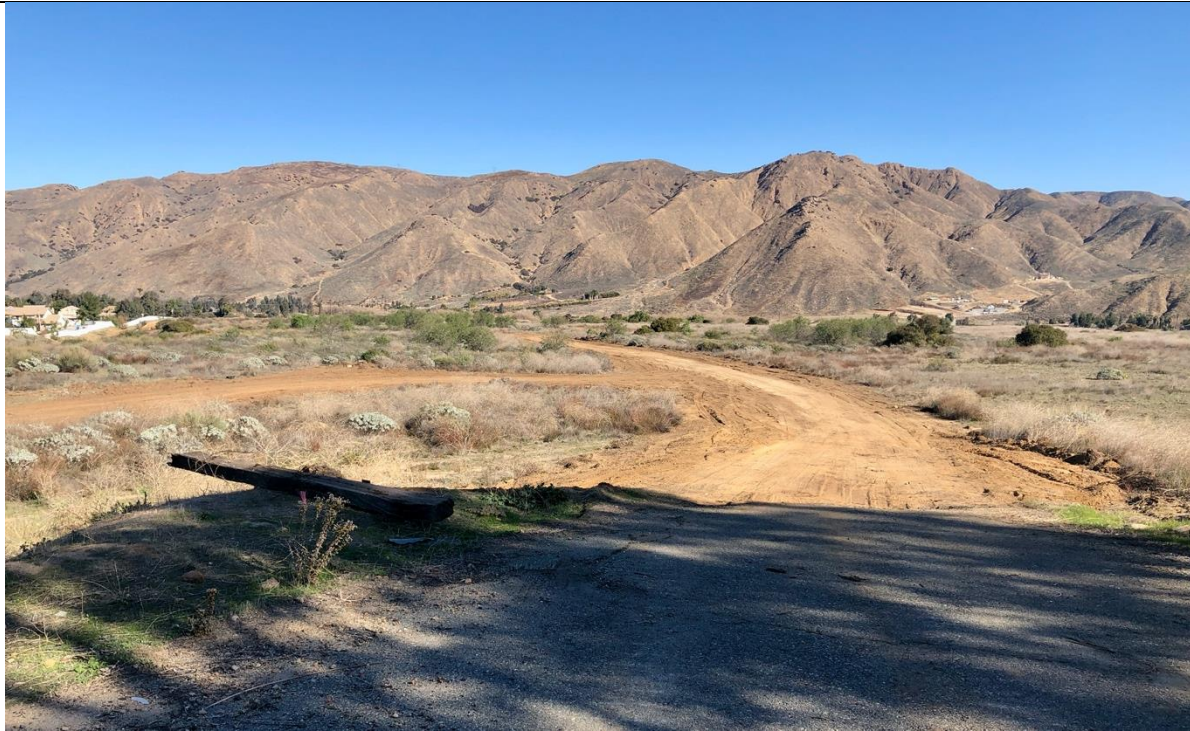
Photo 8 – Segment
6 access roads west
of Hwy 15. Photo
facing east
