**Re: Monthly Report Summary #13 for the Valley-Ivyglen 115-kV Substation (VIG) Project**

CPUC Site Inspection Reports  
August 12 and 13, and 18, 2021

## Valley – Ivyglen Subtransmission Project CPUC Site Inspection Form

<b>Project:</b>	Valley – Ivyglen Project	<b>Date:</b>	August 12 and 13, 2021
<b>Project Proponent:</b>	Southern California Edison (SCE)	<b>Report #:</b>	VS027
<b>Lead Agency:</b>	California Public Utilities Commission (CPUC)	<b>Monitor(s):</b>	Vincent Semonsen
<b>CPUC PM:</b>	Patricia Kelly, Energy Division	<b>AM/PM Weather:</b>	Clear and cool with a slight breeze
<b>CPUC-CM (WSP):</b>	Chuck Cleeves	<b>Start/End time:</b>	1700 to 1800 on August 12 0600 to 0930 on August 13
<b>Project NTP(s):</b>	Notice to Proceed (NTP-1), NTP-2, and NTP-3.

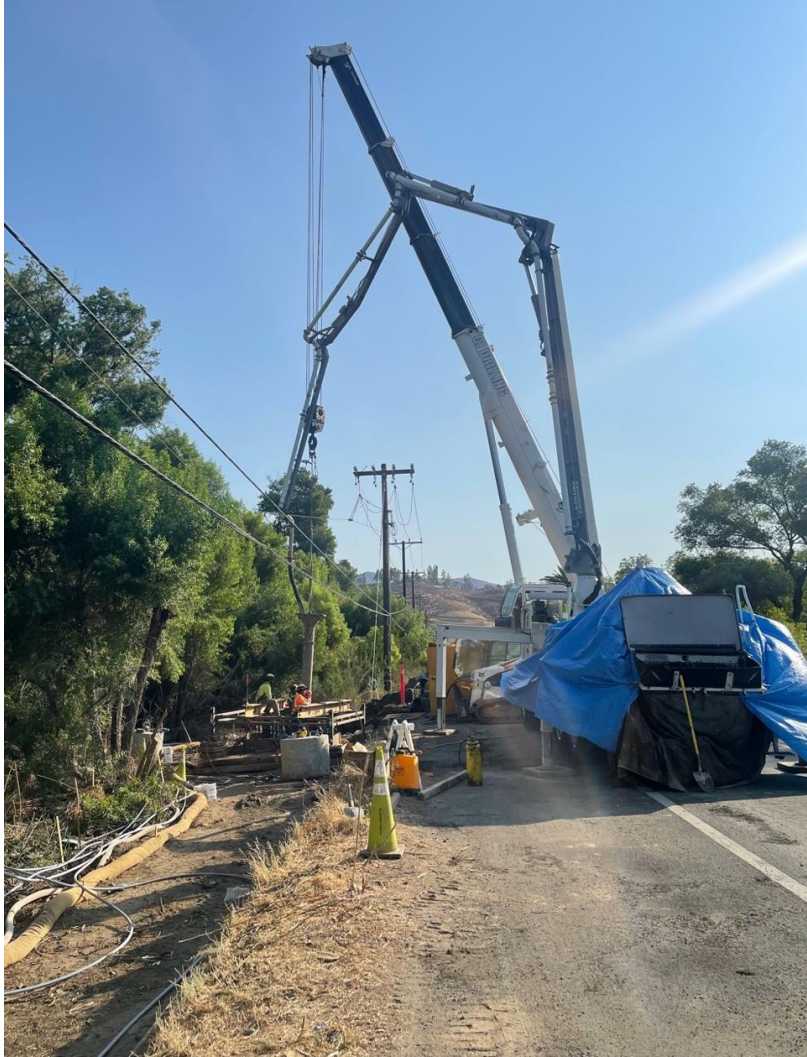
In the late afternoon on August 12, I was driving over the mountains on Highway 74 from San Juan Capistrano and the CPUC South Orange County Reliability Enhancement (SOCRE) project when I was caught in a traffic jam created by the VIG drilling operation at TSP 370. I stopped to inspect the work being completed within a riparian corridor at the intersection of Riverside Drive and Baker Street (Photo 1). The crew was pouring the TSP foundation with numerous slurry trucks (Photo 2). The work site was well contained with stakes and straw wattles in place at the construction limits. A concrete washout station had been set up down the road from the work site (Photo 3). As slurry was poured into the foundation hole, excess water was pumped to a nearby baker tank seen in Photo 3. A water pump had been set up along the roadway and another pump with a gas can were noted near the baker tank, though neither of them had secondary containment in place (Photos 4 and 5). I spoke to a foreman about the need for containment under the pumps, especially due to the proximity of a wetland. While I was onsite, I also noted several dust control issues. I mentioned the need for dust control to the same foreman. I spoke to the water truck driver about one dusty access roads and he planned to water that roadway.

Photo 1 – Pouring the TSP 370 foundation along Riverside Drive. Photo facing west.

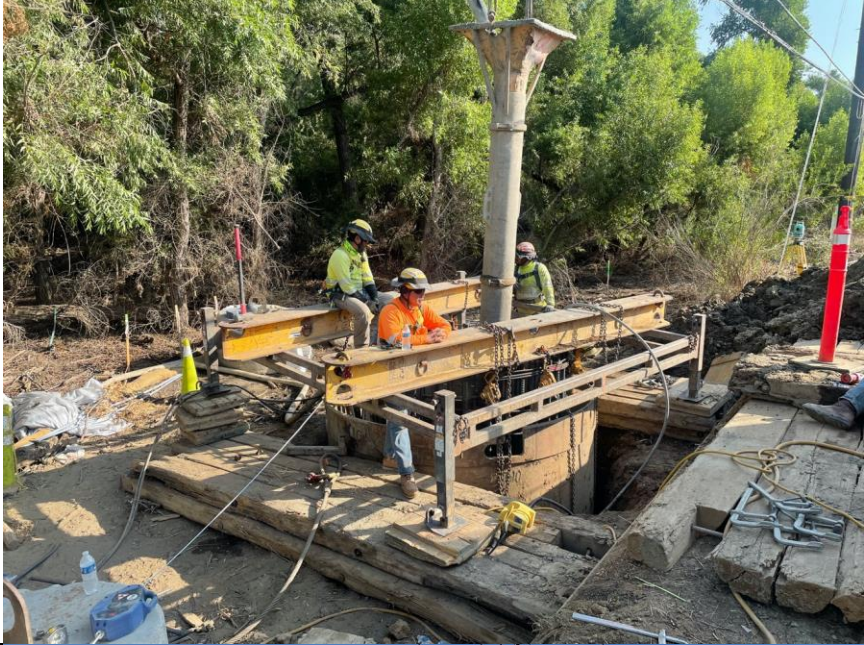
Photo 2 – Slurry being poured at TSP 370. Photo facing southwest.
8/12/21	VIG Project

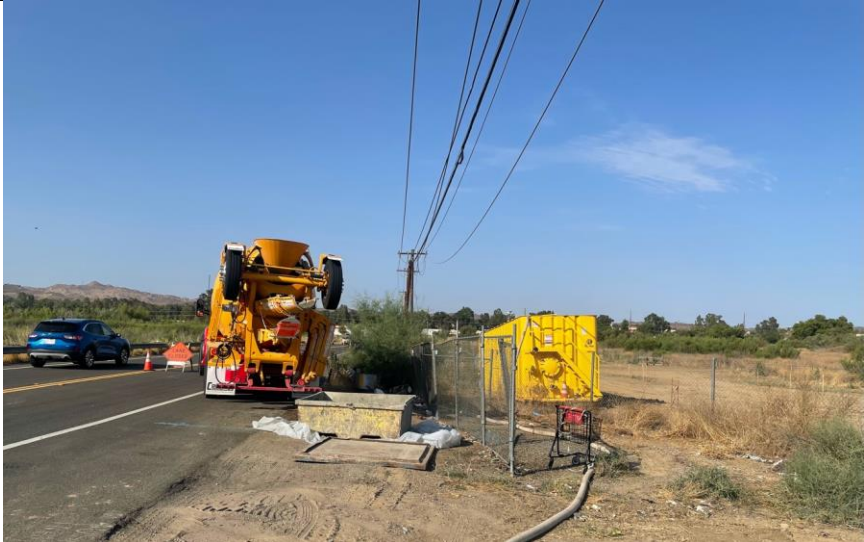
Photo 3 – Concrete washout station near a baker tank east of the TSP 370 work site. Photo facing east.

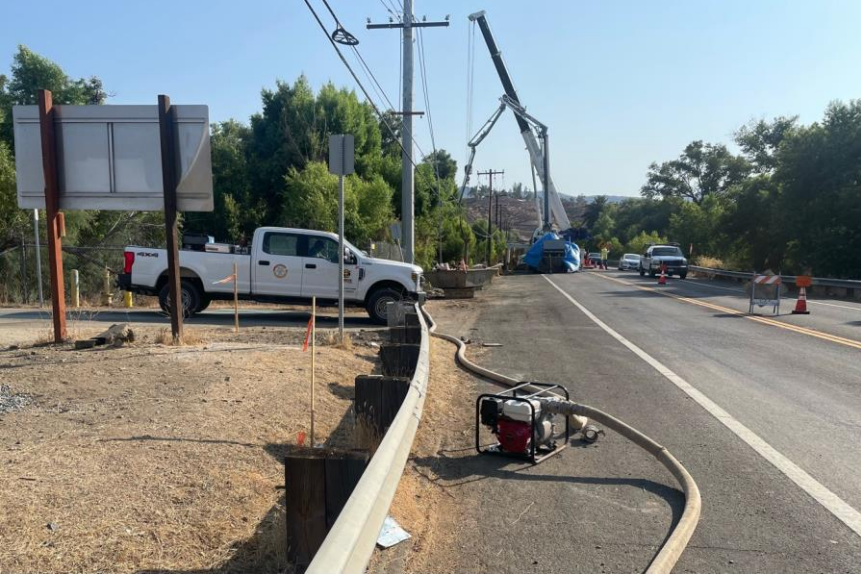
On the morning of August 13 I arrived onsite at 0600 and attended the morning tailboard meeting at the Concordia staging area. I spoke with the Lead Environmental Inspector (LEI) about the ongoing dust control issues and the need for secondary containment for the pumps at tubular steel pole (TSP) 370.

Photo 5 – Water pump in the roadway near TSP 370 without any secondary containment. Photo facing west.

Additional dust control measures need to be implemented throughout the site. Adequate secondary containment needs to be in

place around all equipment not in use.

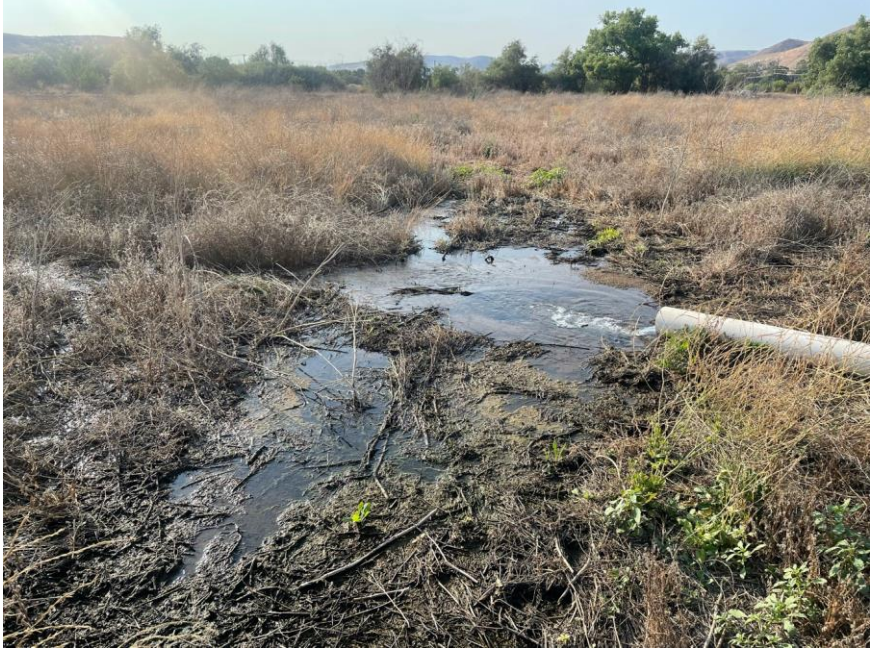
While driving from the area I stopped to inspect the dewatering outlet coming from the wells around TSP 358; the water appeared clear (Photo 6).

Photo 6 – Dewatering pipe. Photo facing north.

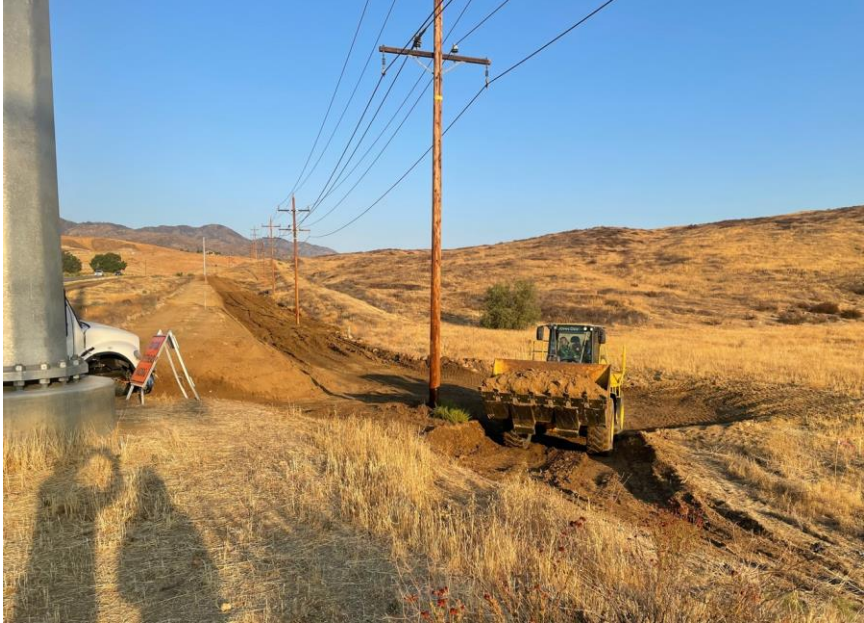
We began our site inspection at the segment 5 portion of the transmission corridor, along Nichols Street. Equipment was working near TSP 413 to create an access road where new poles would be installed (Photo 7). A botanical monitor was onsite due to the presence of sensitive plants that may need to be transplanted, and two paleontology monitors were overseeing the road work.

Photo 7 – New access road construction along Nichols Road near TSP 413. Photo facing northwest.

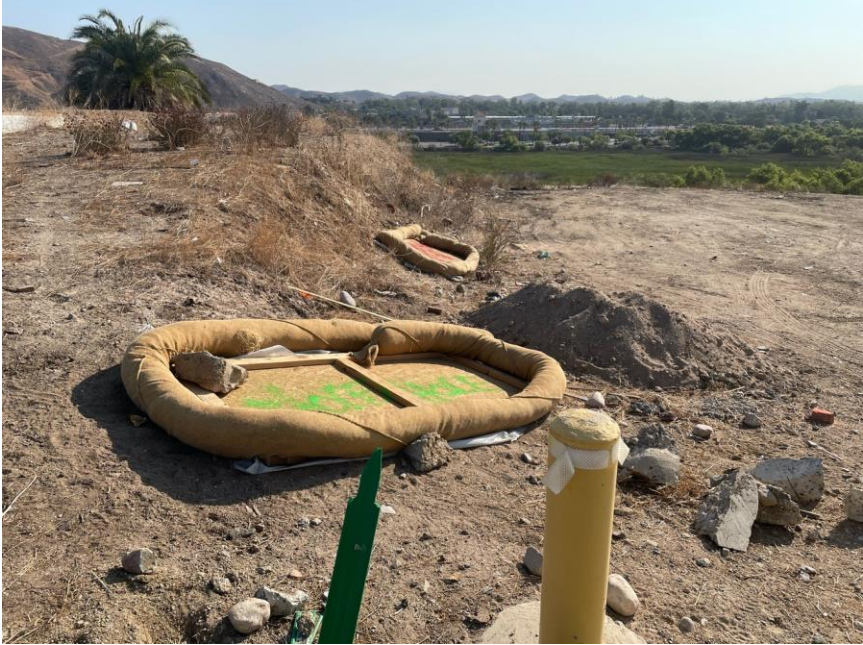
We drove south on Baker Street toward the TSP work along Riverside Drive. Wire stringing was being completed along Baker Street and lightweight steel poles (LSP) were staged nearby (Photo 8). Previously drilled holes for the LSPs were sealed with plastic, plywood, and straw wattles (Photo 9).

Photo 9 – Covered LSP foundation holes. Photo facing east.

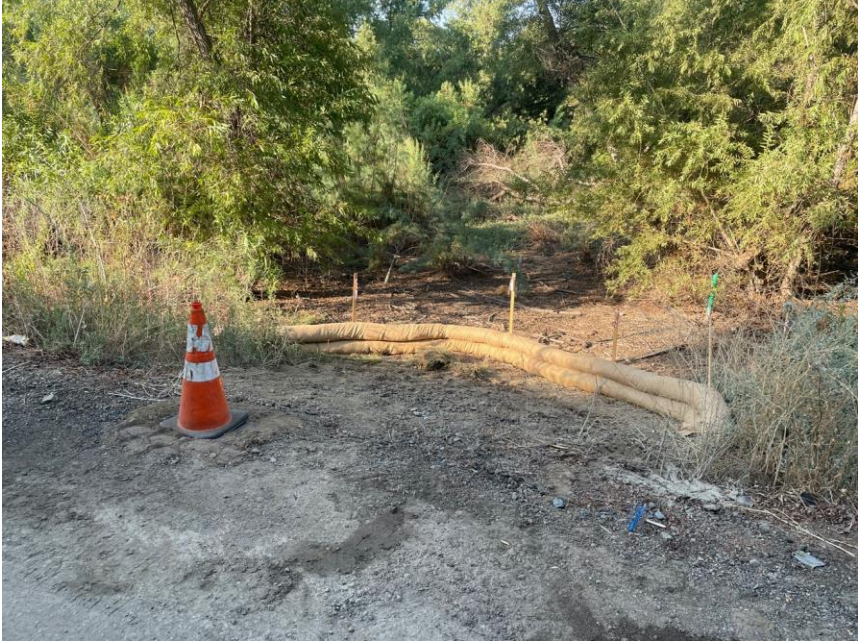
We drove by the staging area where equipment was set up for ongoing TSP drilling and pouring (Photo 10). TSP 376 located near the staging area was poured and crews were preparing to drill and pour TSP 372 (Photo 11). TSP 372 has a small impact area due to the surrounding sensitive habitat. Willows were trimmed along Baker Street between TSPs 370 and 372 with oversight provided by a biological monitor (Photo 12). While onsite, a male Least bell's vireo (*Vireo bellii pusillus*) was heard calling from the riparian corridor. No nesting activity was observed and none is expected for this time of year.

Photo 11- Staked work area around TSP 372. Photo facing west.

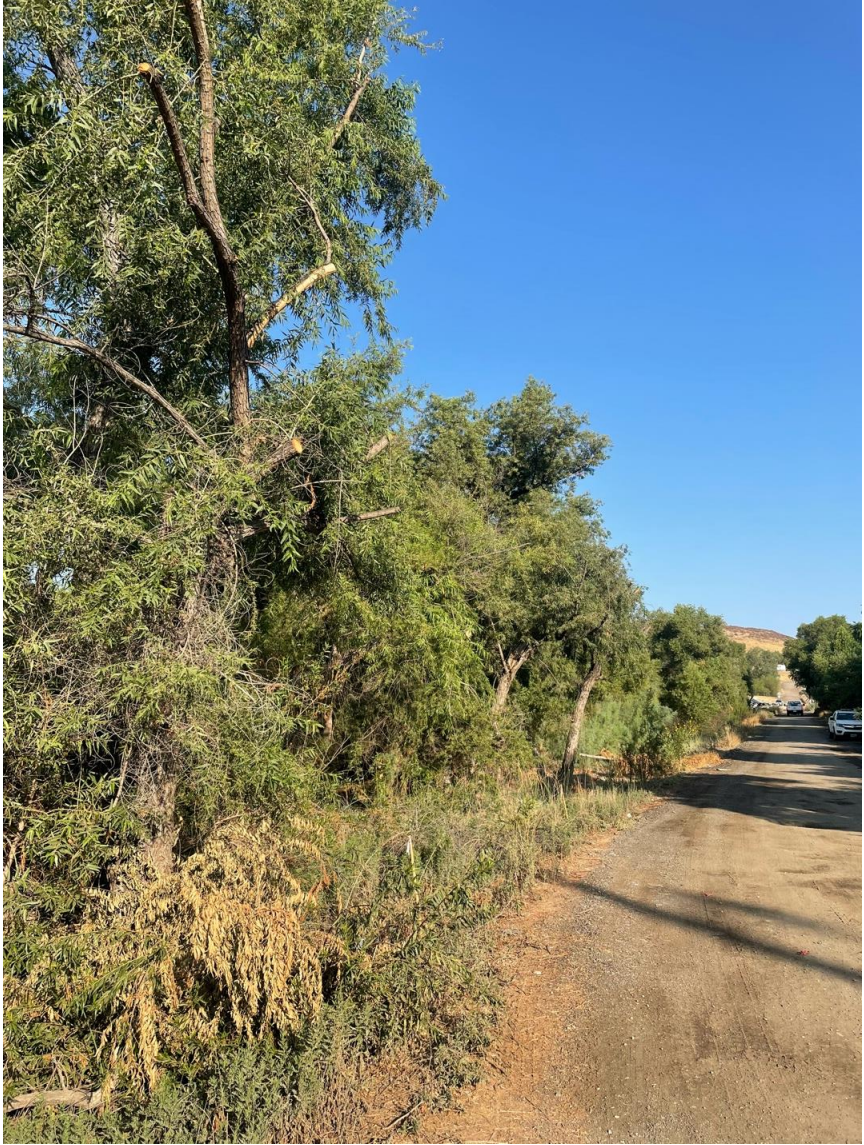
Photo 12 – Willows were trimmed along Baker Street between TSP 370 and 372. Photo facing north.

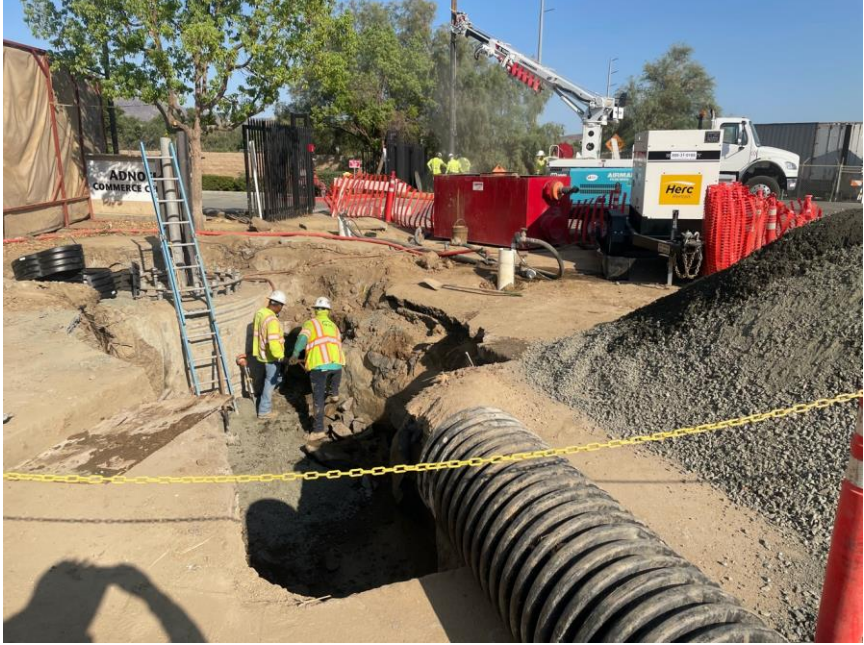
Our final stop was along segment 4 where crews had added slurry to the foundation hole at TSP 358 (Photo 14). A drainpipe was being installed to transport water from the dewatering wells and sound walls. The dewatering operation would be reinstalled around a vault south of the TSP.

Photo 14 – Final slurry work and drainpipe installation at TSP 358. Photo facing north.

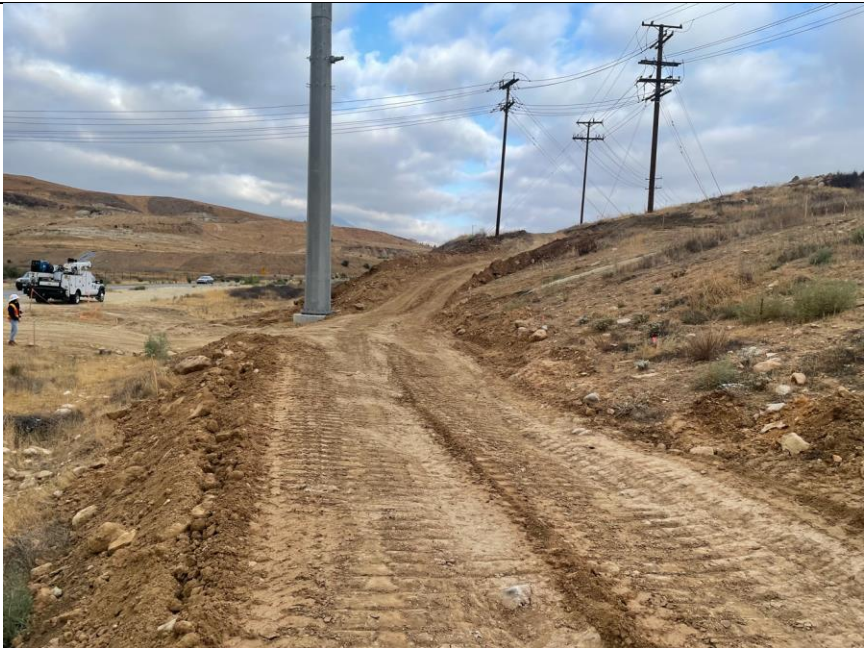
Our next stop was at TSP 421 located along the segment 5 portion of the transmission corridor where it parallels Nichols Road. Work on the access road continued with crews excavating and recompacting the road where it would parallel the new transmission corridor (Photo 3). After the completion of the road, lightweight steel poles (LSP) would be erected, and the existing wooden towers would be removed (Photo 4). The EI was onsite staking the sensitive areas, a botanical monitor was onsite to transplant sensitive plants, and a paleontology monitor was overseeing the grading. A water truck had watered the construction area prior grading and again during the earthwork.

Photo 3 – Access road work along Nichols Road. Photo facing north.

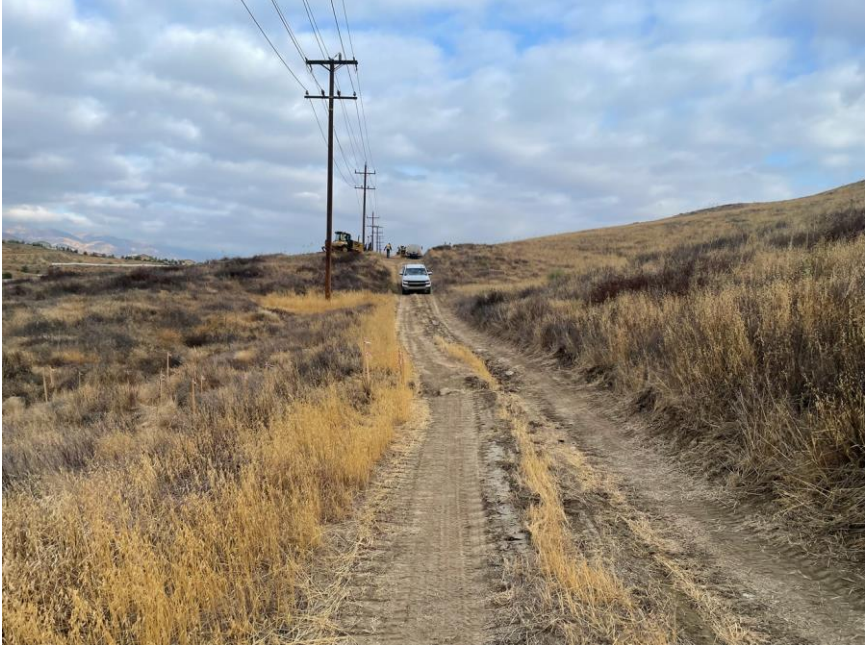
<p>Photo 4 – Access road work along Nichols Road. The wooden poles would be removed after the installation of the TSPs. Photo facing north.</p>

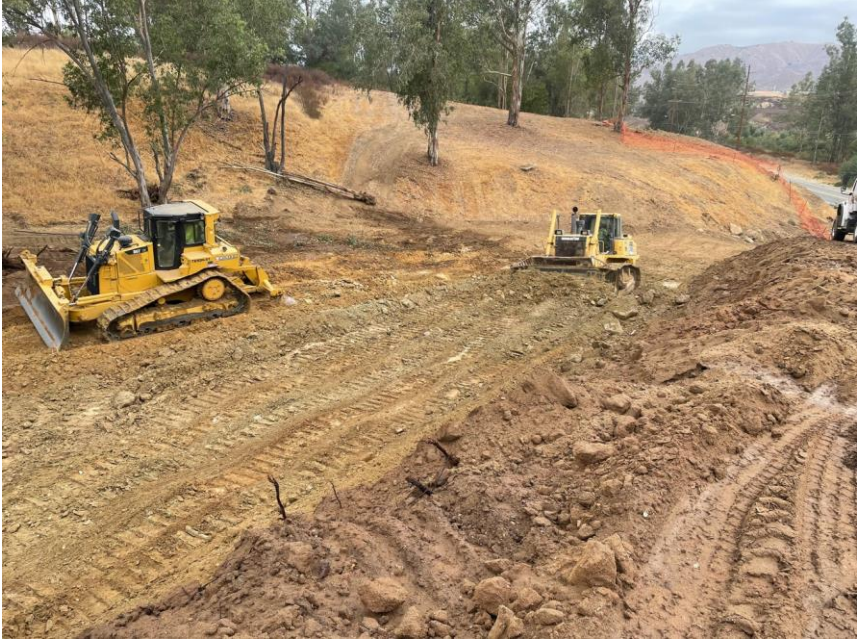
We drove north to Lake Street where project crews were removing soil along the roadway in preparation for a road expansion project. Several bulldozers, an excavator, a front loader, and water trucks were excavating soil and loading haul trucks (Photo 5). According to the LEI this work was being conducted under a new Notice to Proceed (NTP). Tubular steel poles (TSP) 453, 456, 454, and 455 were erected with LSPs to be installed later. Upgrades to the drainage swale were expected along Lake Street southwest of the work area (Photo 6). Additional best management practices (BMPs) would be installed at the base of steep slopes.

Photo 5 – Soil work along Lake Street. Photo facing northeast.
