Re: Monthly Report Summary #2 for the Valley-Ivyglen 115-kV Substation (VIG) Project

CPUC Site Inspection Reports
August 5, 13, and 27, 2020

Valley – Ivyglen Subtransmission Project CPUC Site Inspection Form

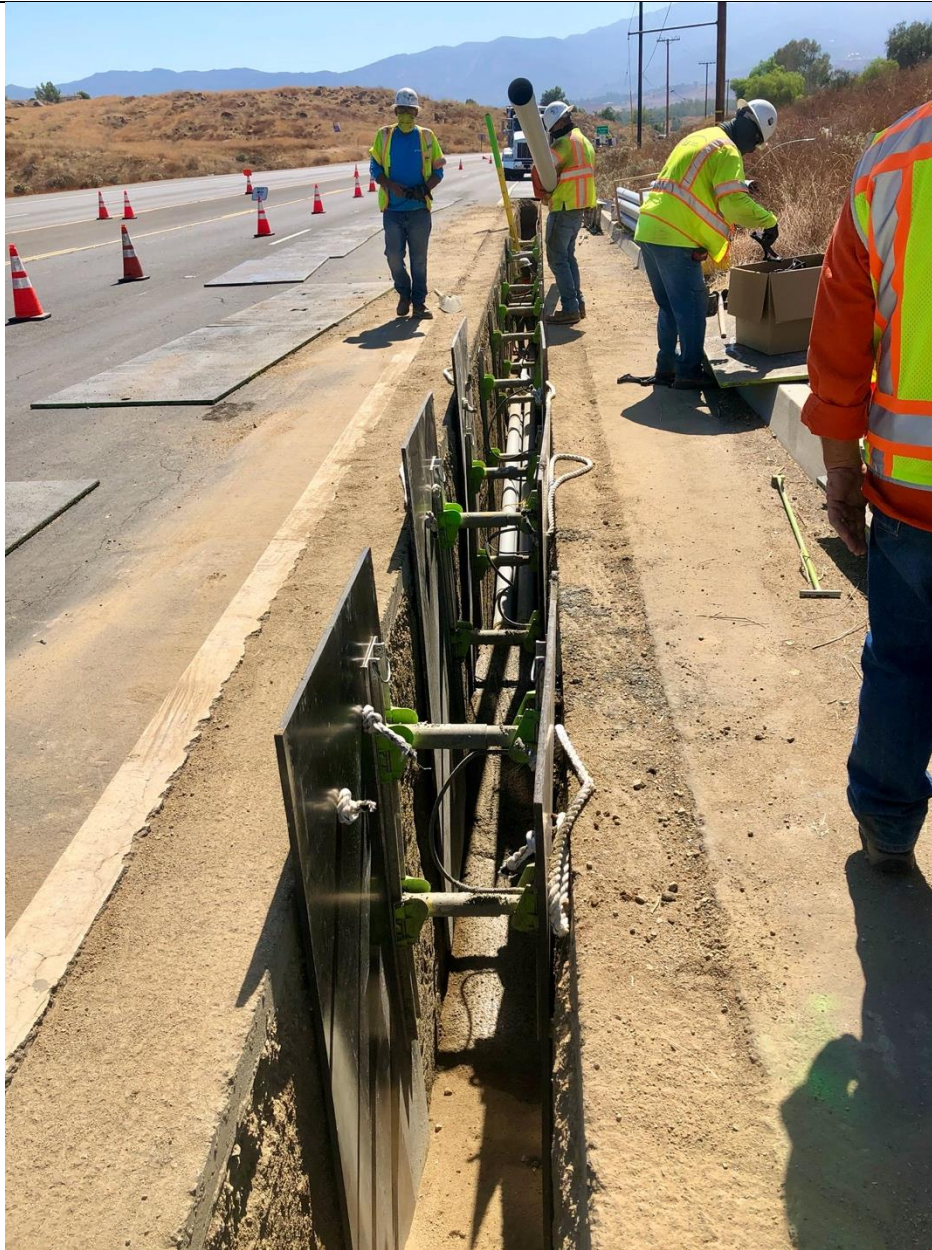
Photo 4 – Shored
conduit trench within
the road shoulder of
Highway 74. Photo
facing west

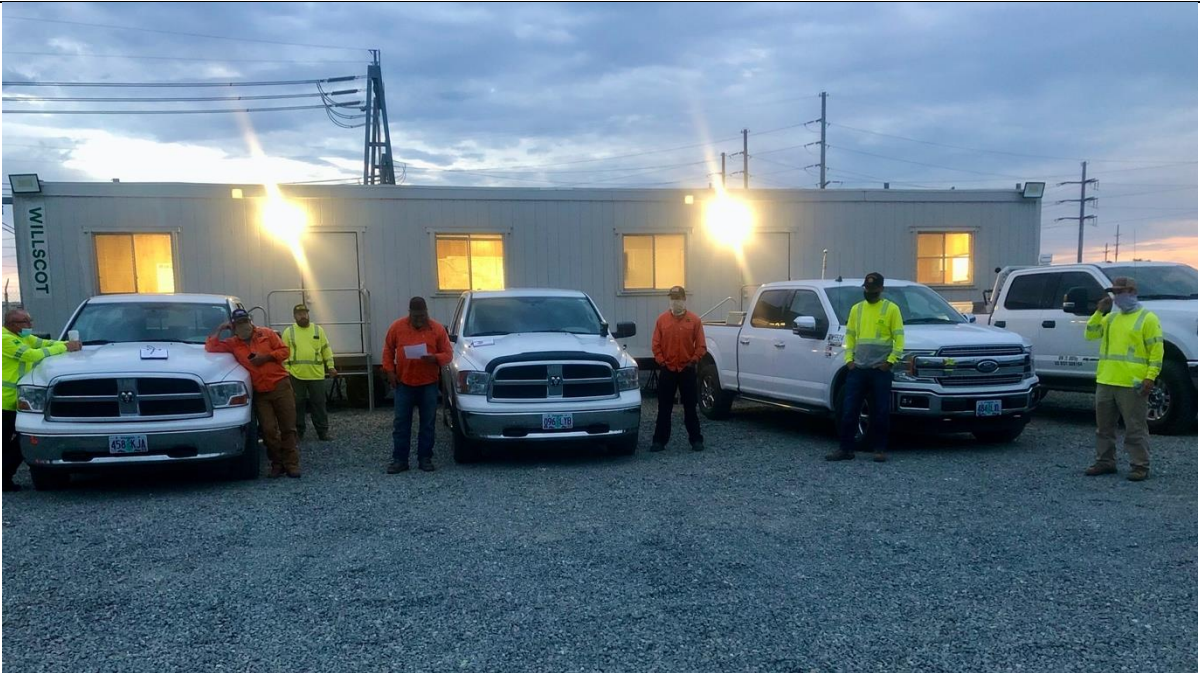
Photo 1 – 6 am Tailboard at the construction trailers. Photo facing east

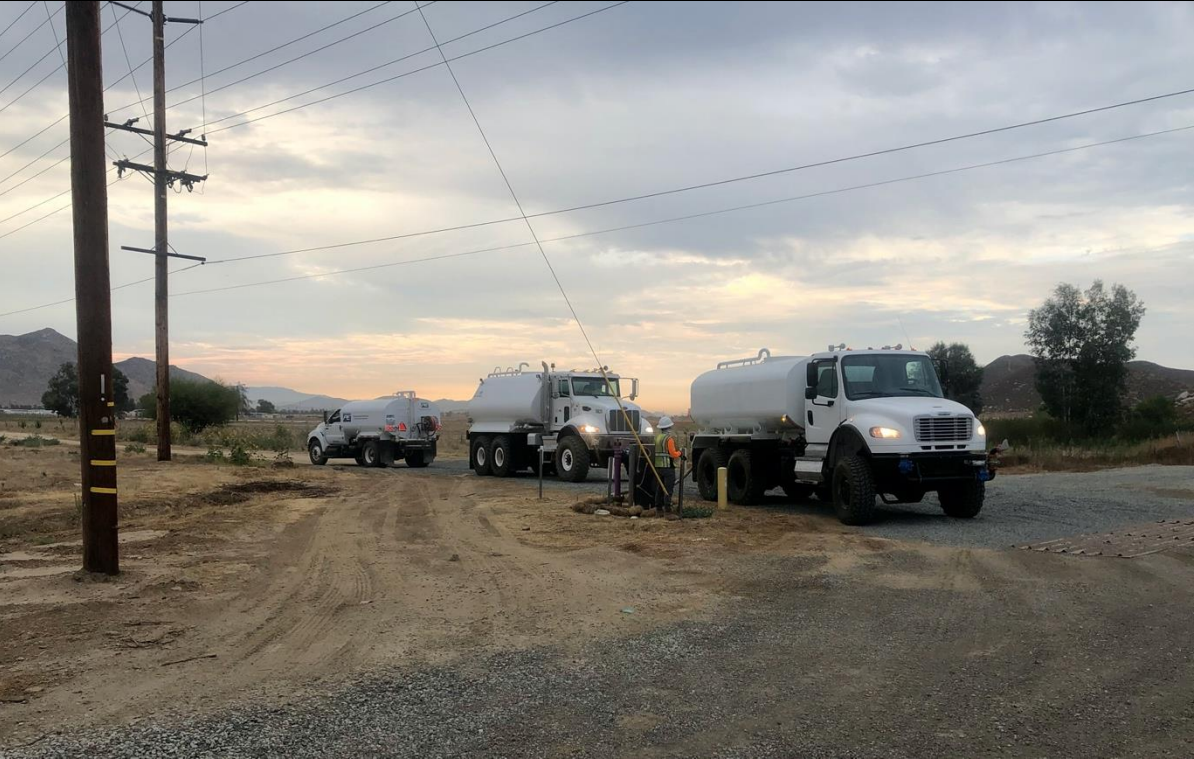
A photograph showing three white water trucks parked in a line on a dirt and gravel road. They are positioned at a reclaimed water hydrant. The scene is set in a rural area with utility poles on the left and hills in the background under a cloudy sky at dusk or dawn.	Photo 2 – Water trucks filling up at the reclaimed water hydrant. Photo facing southeast

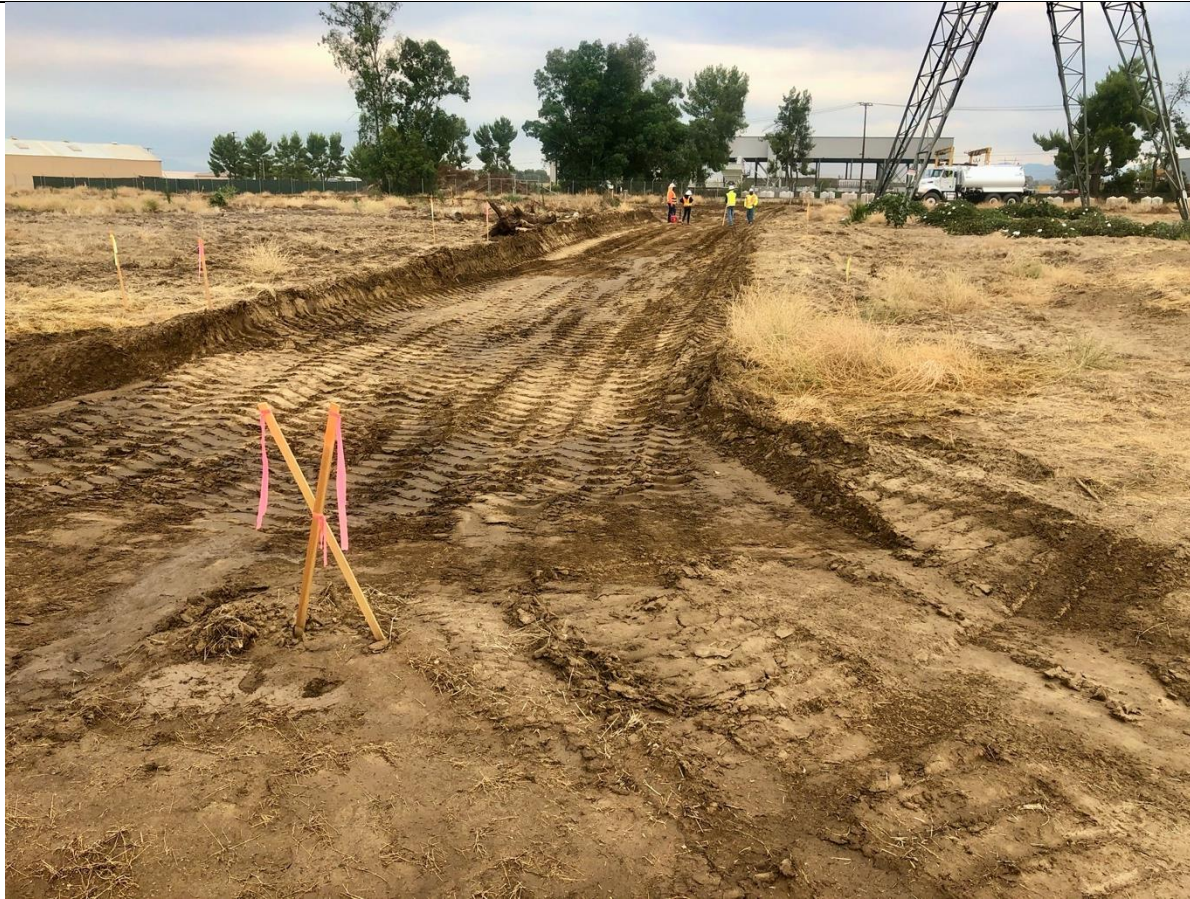
Photo 4 – Road
recompaction work.
Photo facing south

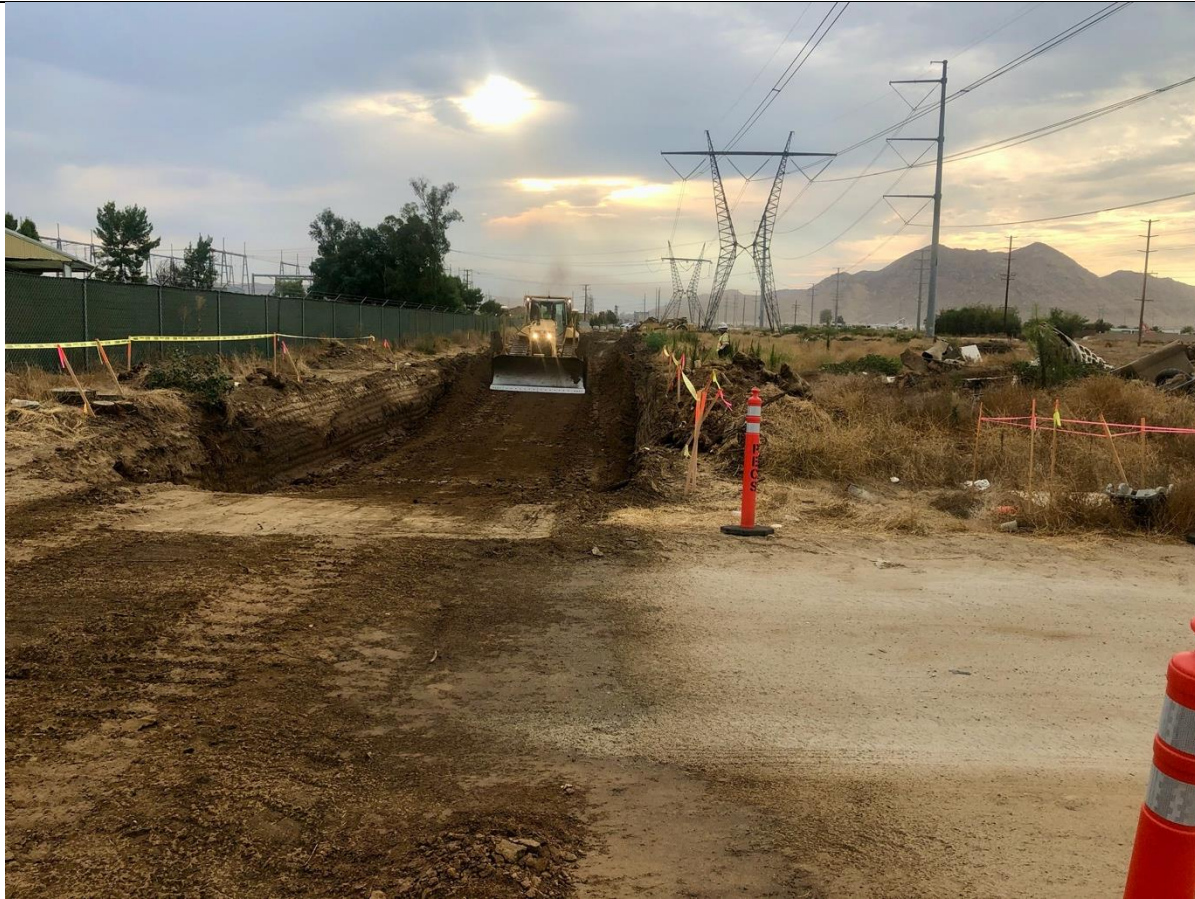
Photo 5 – A bulldozer digging out a gabion installation location. This work was monitored by the Paleo/Arch person. Photo facing east

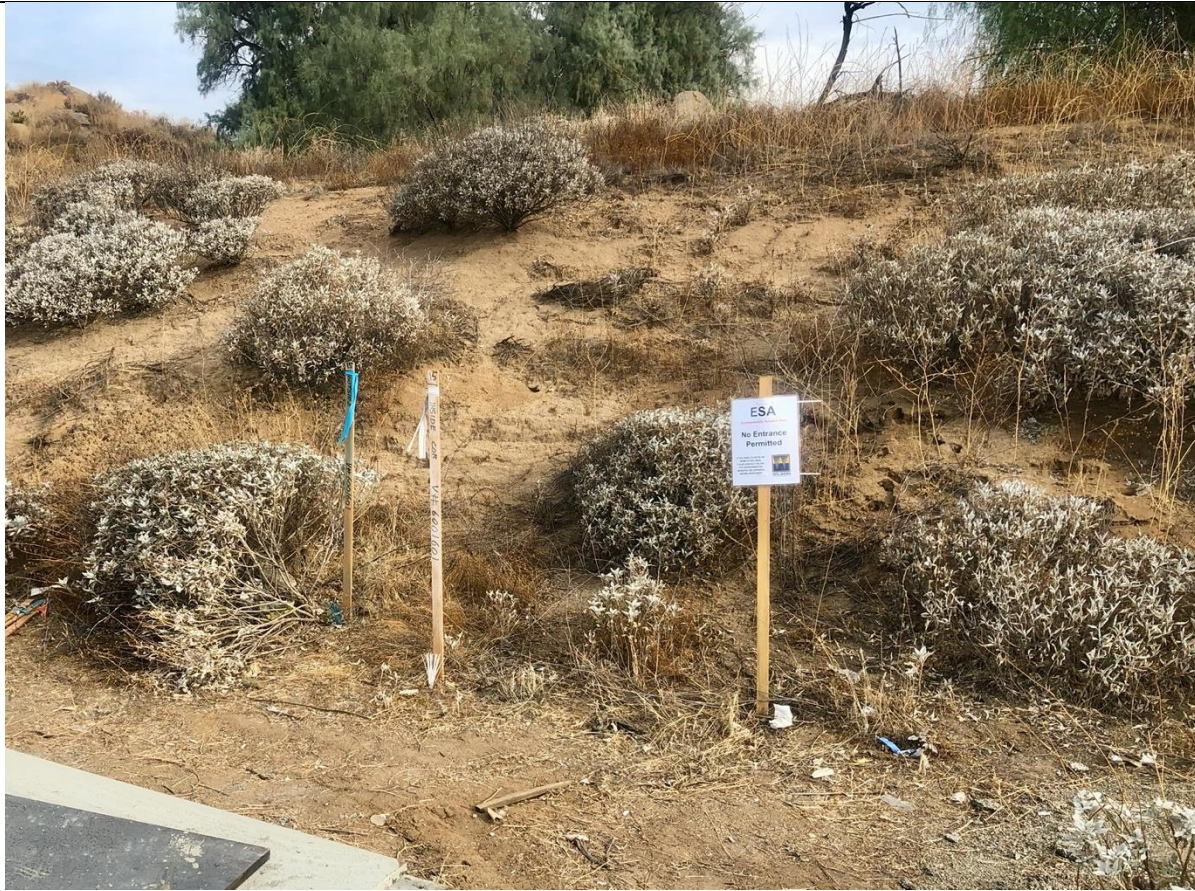
Photo 6 – ESA
signage along the
Segment 2
construction
corridor. Photo
facing north

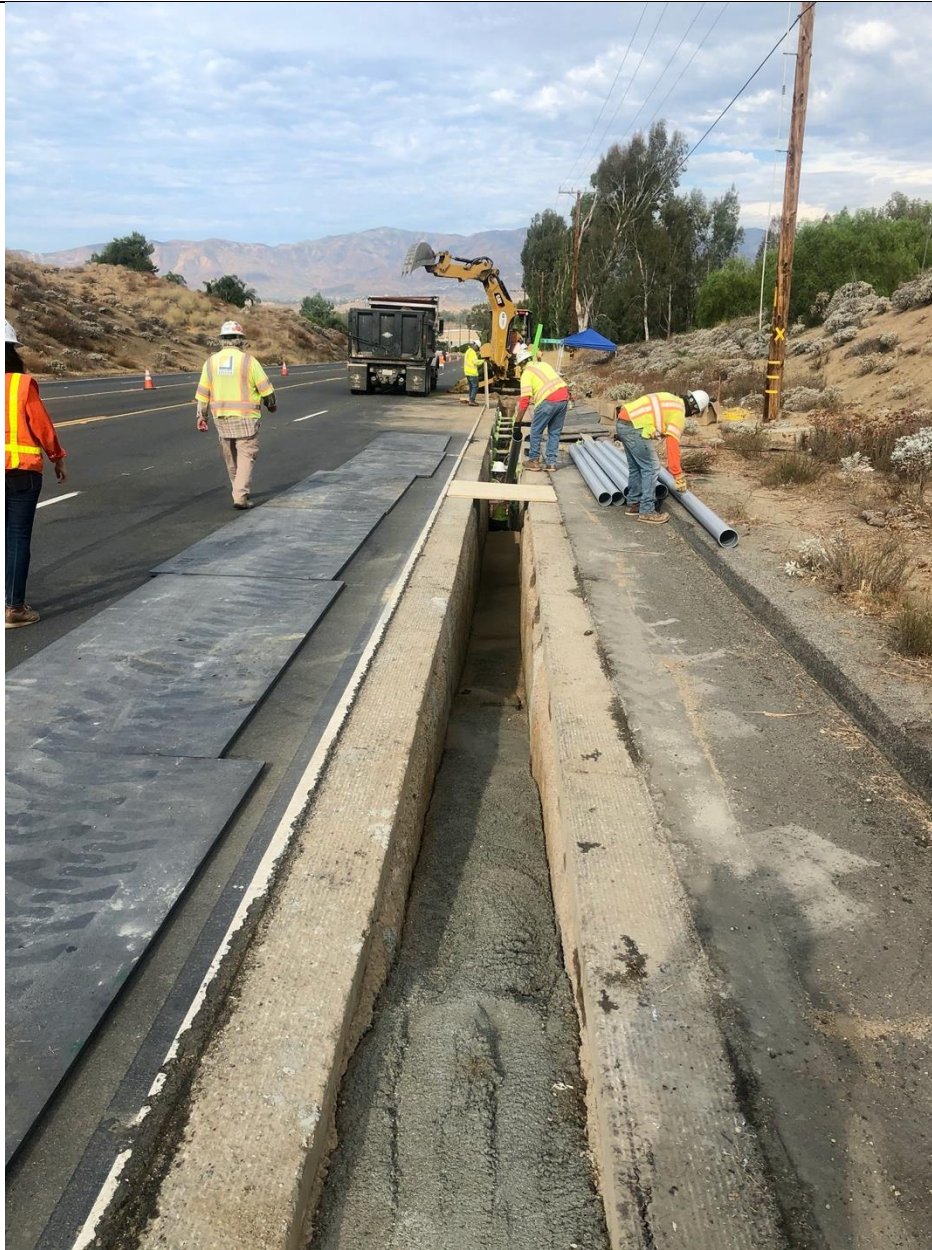
Photo 7 – Conduit installation crews working within Highway 74. Photo facing west

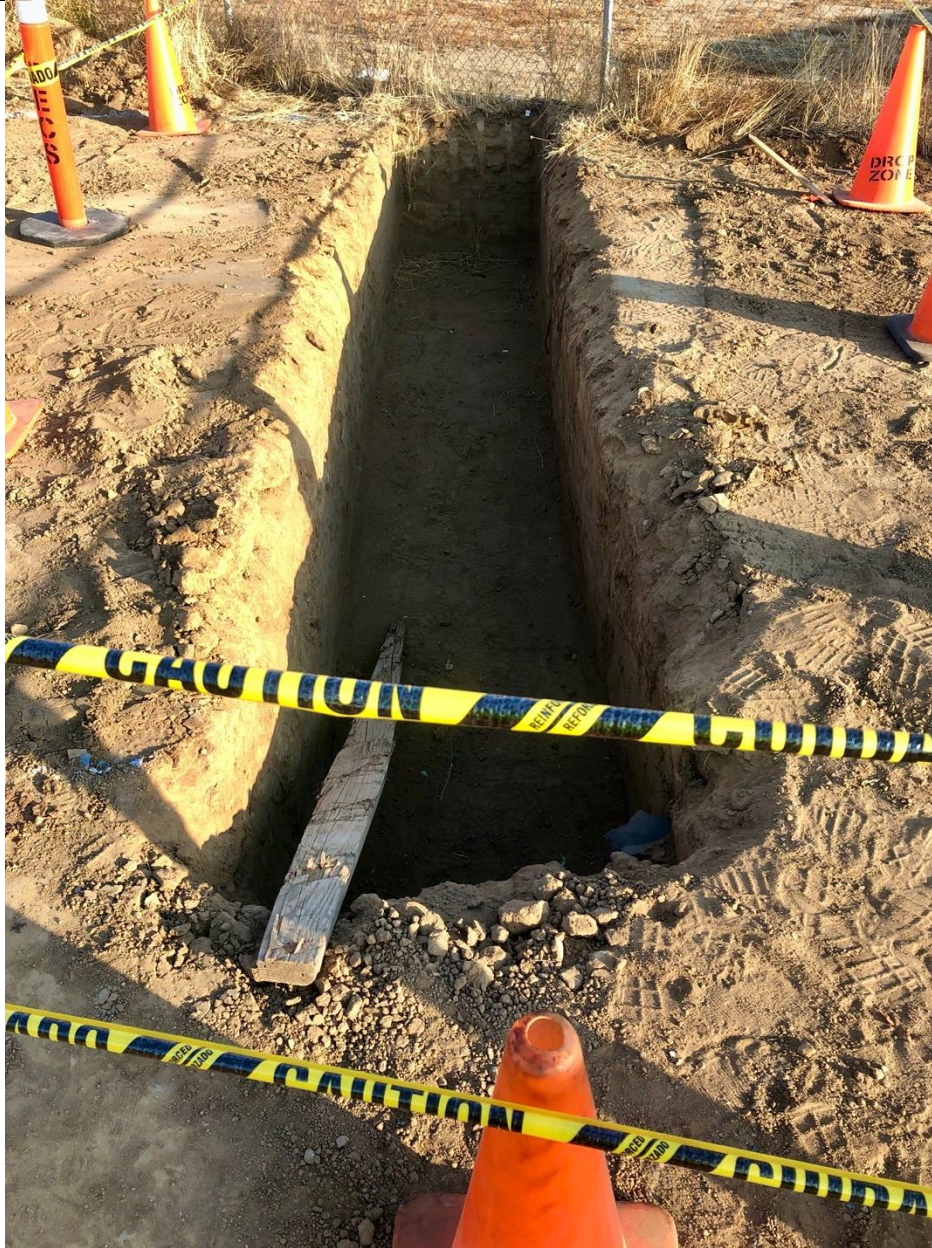
Photo 2 – An open
gabion trench with a
wooden climbing
structure.

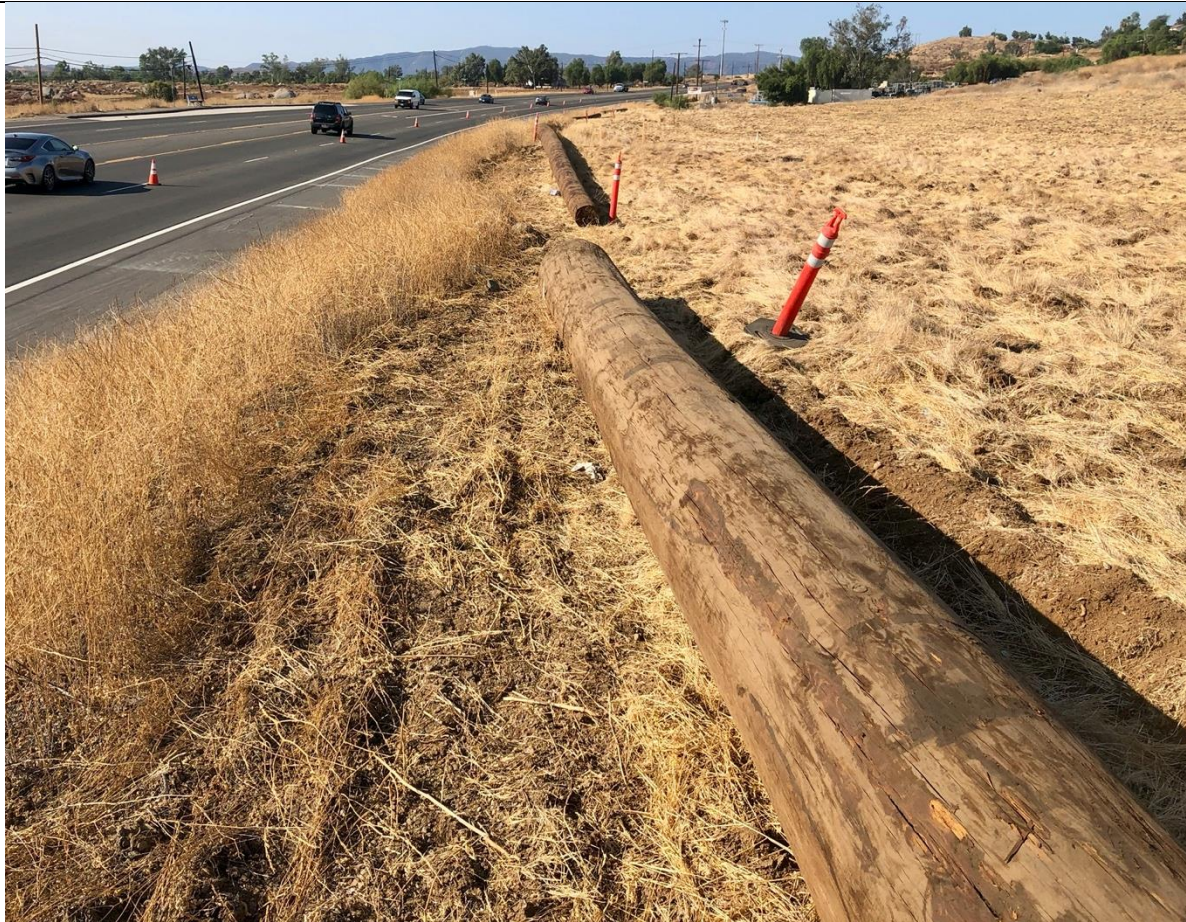
Photo 4 – Wooden poles placed along Highway 74 in Segment 2. Photo facing west

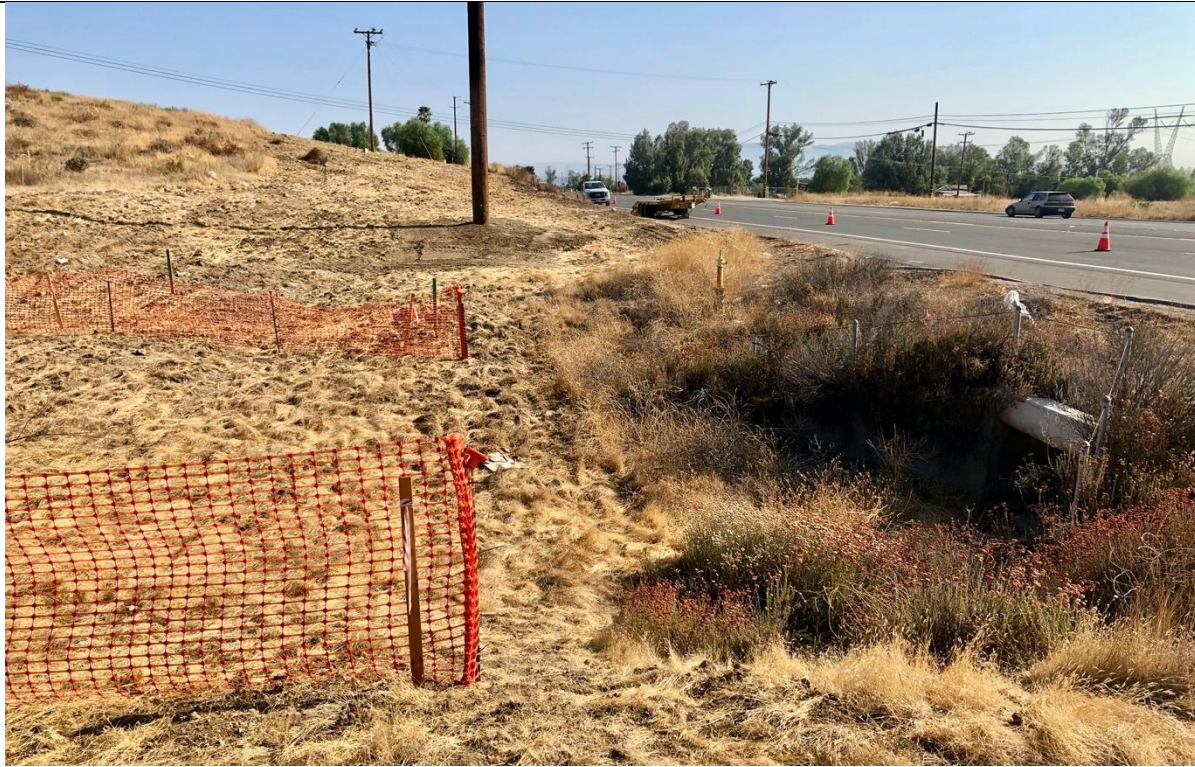
Photo 5 – A newly installed wooden pole and a small fenced off drainage. Photo facing east

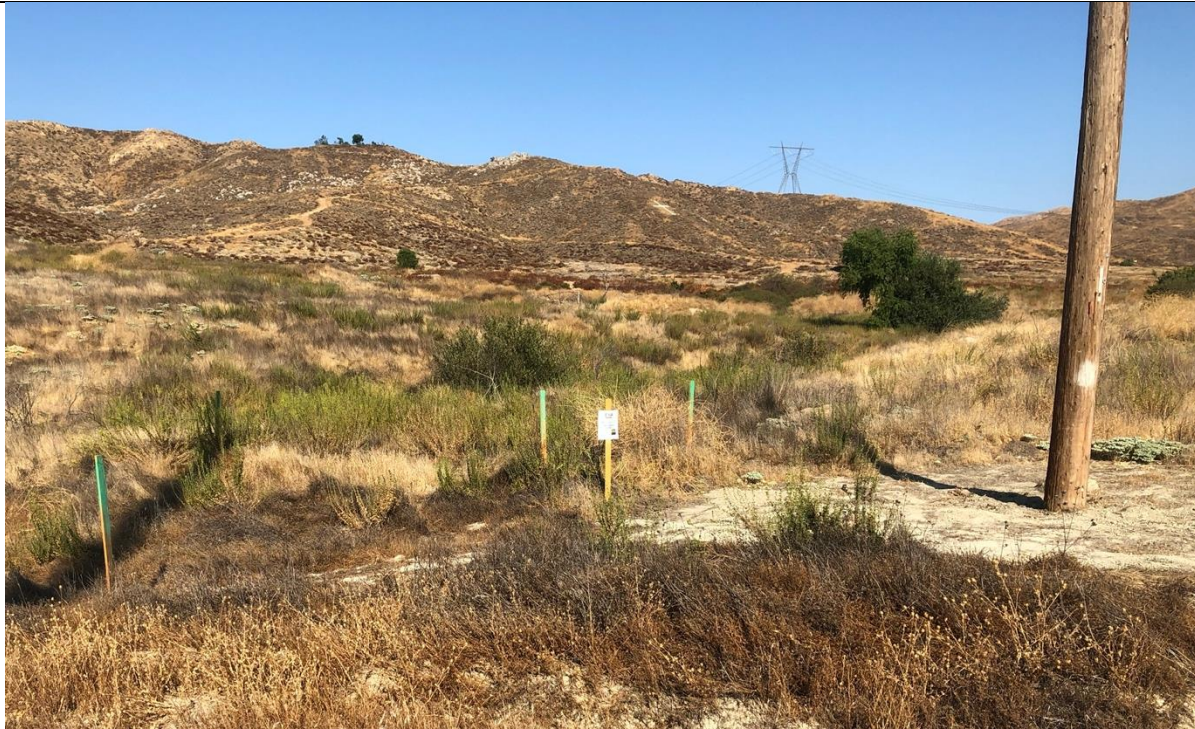
Photo 6 – ESA
signage along the
Segment 2
construction
corridor. Photo
facing north

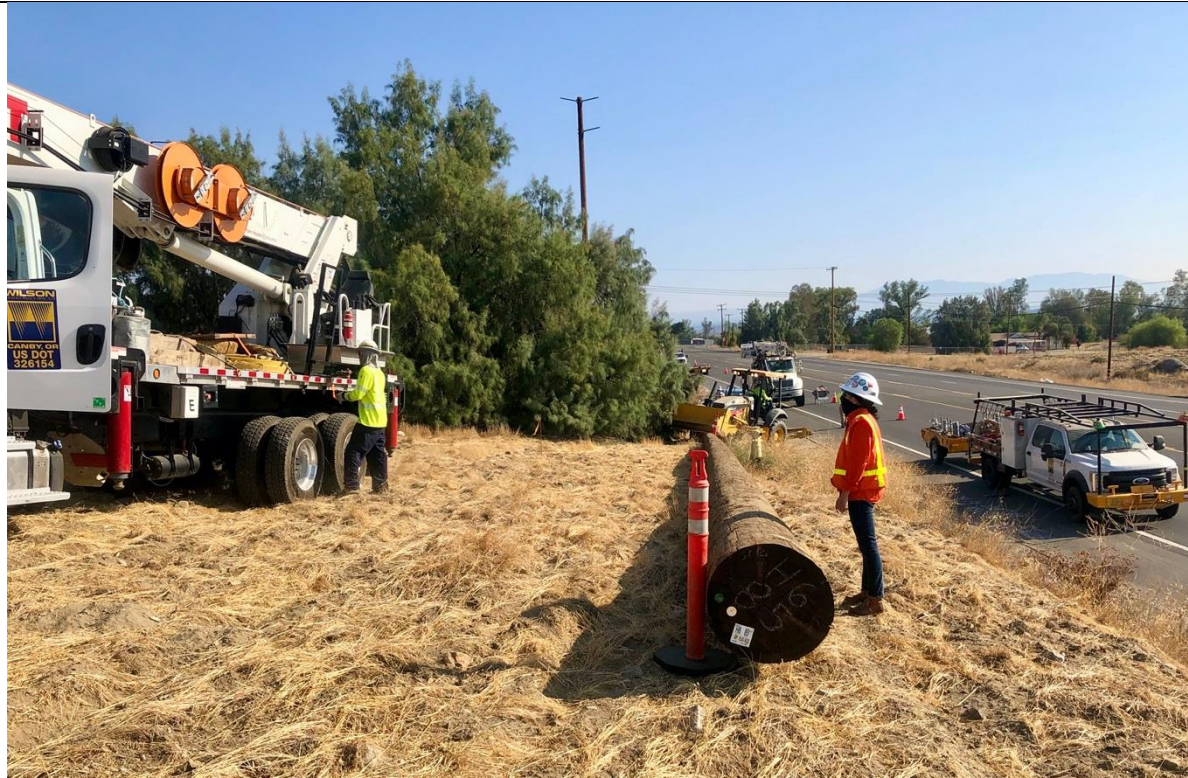
Photo 7 – Crews
setting up to drill and
install pole #171E.
Photo facing east

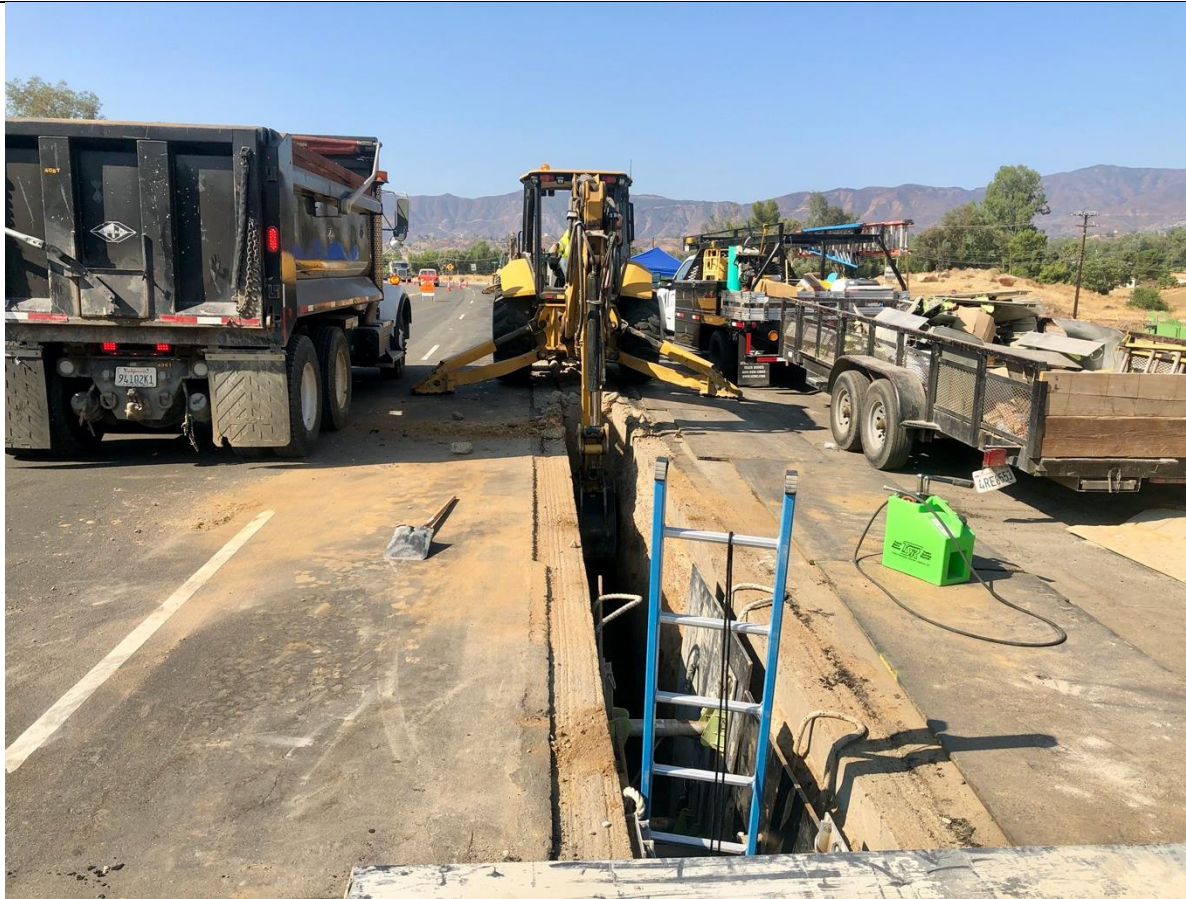
Photo 8 – Trenching
for the conduit
installation. Photo
facing west
