### **Re: Monthly Report Summary #5 for the Mesa 500-kV Substation Project**

CPUC Site Inspection Report  
February 6, 12, and 21, 2018

## Mesa 500-kV Substation Project CPUC Site Inspection Form

<b>Project:</b>	Mesa 500-kV Substation Project	<b>Date:</b>	February 6, 2018
<b>Project Proponent:</b>	Southern California Edison	<b>Report #:</b>	VS015
<b>Lead Agency:</b>	California Public Utilities Commission	<b>Monitor(s):</b>	Vince Semonsen
<b>CPUC PM:</b>	Lisa Orsaba, Energy Division	<b>AM/PM Weather:</b>	Hazy sunshine; cool with a slight breeze
<b>E &amp; E CM:</b>	Jenny Vick	<b>Start/End Time:</b>	1130 to 1330
<b>Project NTP(s):</b>	NTP-1, NTP-2

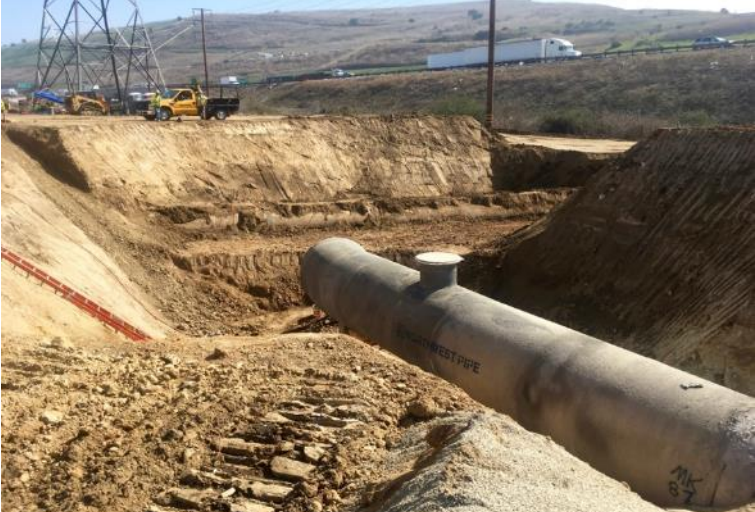
Photo 9 – Water line near the southern tie-in location. Photo facing southeast
2/6/18	Mesa Substation

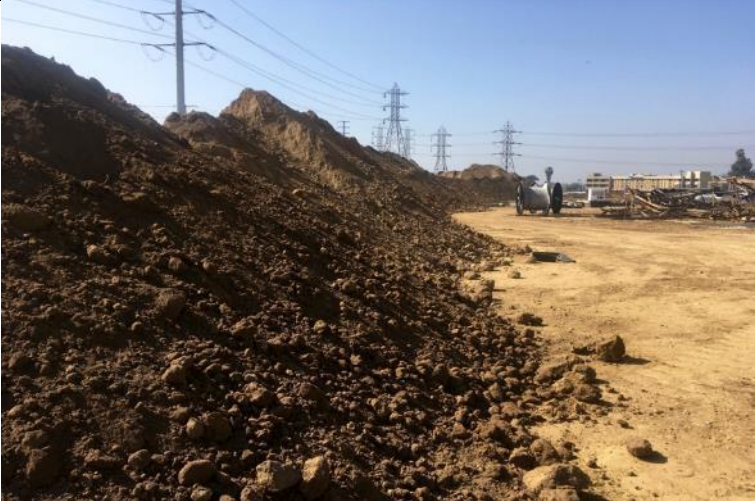
Photo 10 – Spoil piles from the water line trench. Photo facing west
2/6/18	Mesa Substation

Dust control on spoil piles  
Bird surveys and buffers will be important

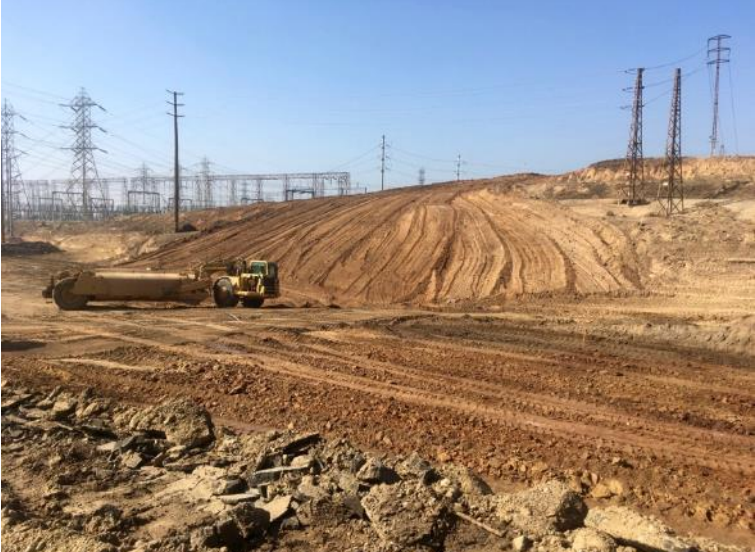
Photo 11 – Earthwork. Photo facing northwest

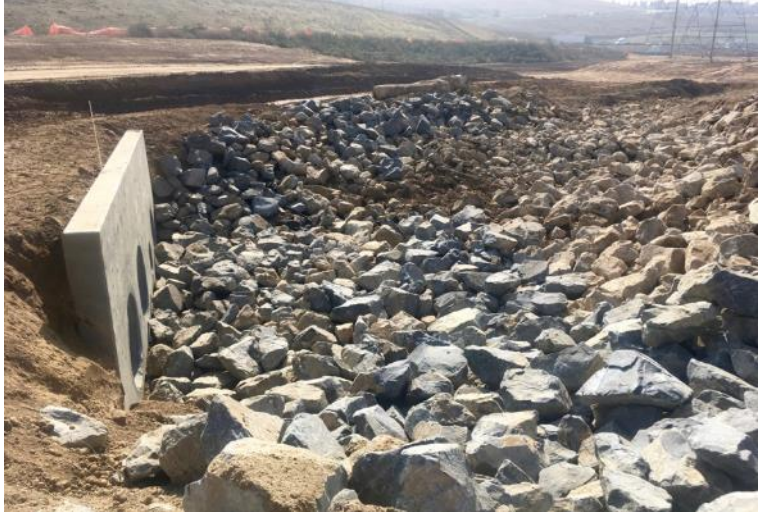
At the time of my site visit, the Market Place work appeared to be complete, with the storm drain headwall finished and the riprap installed (Photo 12). The restored slopes had also been stabilized with straw wattle best management practices (BMPs) (MM HY-1) (Photo 13). The straw wattles were plastic-lined, and this type of straw wattle can trap animals. Biological monitors noted the use of plastic-lined straw wattles in their Field Reporting Environmental Database (FRED) entries. Use of plastic-lined straw wattles is in conflict with SCE's Streambed Alteration Agreement Avoidance and Minimization Measure 2.28.

Photo 12 – Finished headwall for the storm drain. Photo facing southwest
2/6/18	Mesa Substation Market Place

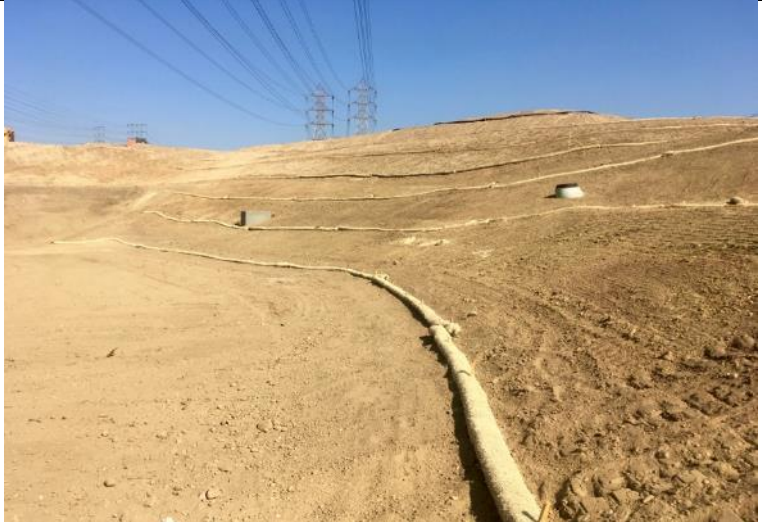
Photo 13 – Restored slopes with straw wattle BMPs installed. Photo facing east
2/6/18	Mesa Substation

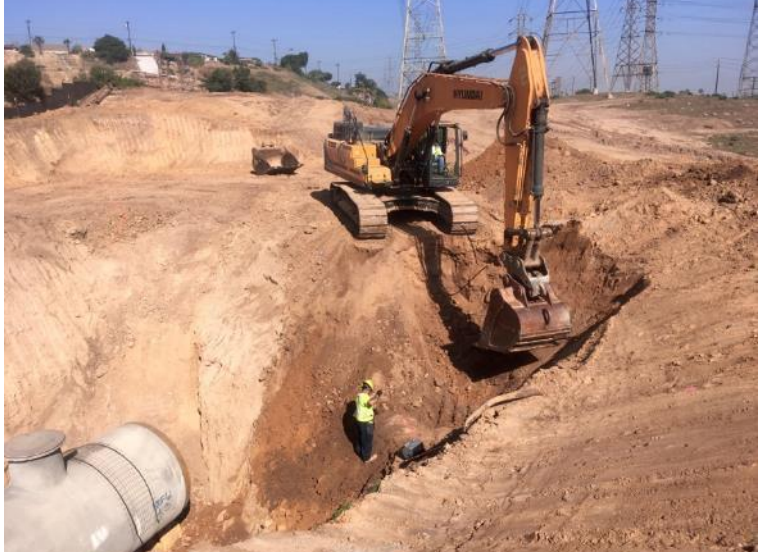
Kiewit work activities north of Potrero Grande Drive included an excavator exposing the old water line near the tie-in point (Photo 14) and backfilling of the water line (Photo 15). In the Kiewit yard, ESA buffer stakes had been placed around the tower with the red-tailed hawk nest (APM-BIO-06). I did not see either of the birds while I was onsite.

Photo 14 – Excavator exposing the old water line in preparation for tie-in work. Photo facing east

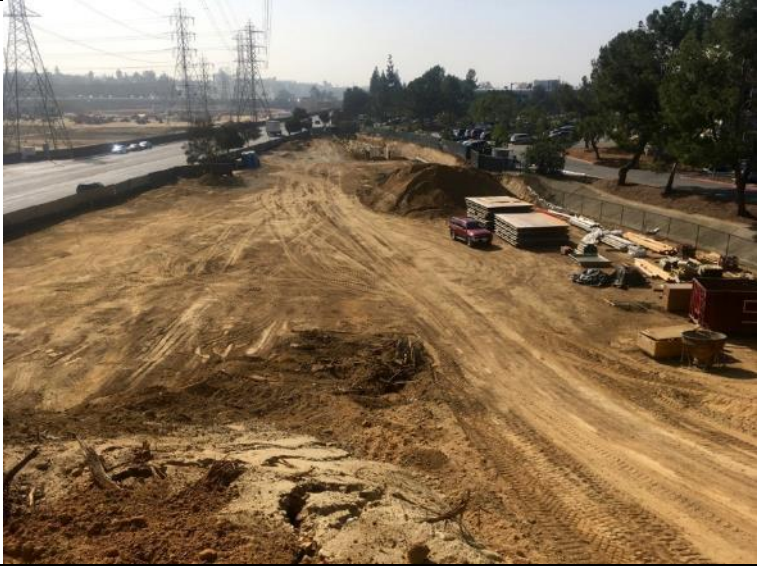
Photo 15 – Backfilling the water line near the exit hole north of Potrero Grande Drive. Photo facing west.

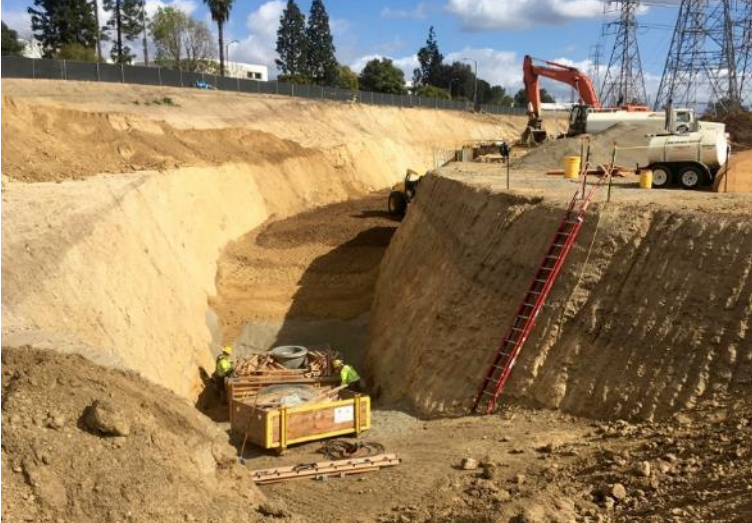
Photo 4 – Crews are stripping the forms off of the water line manhole.
2/12/18	Mesa Substation

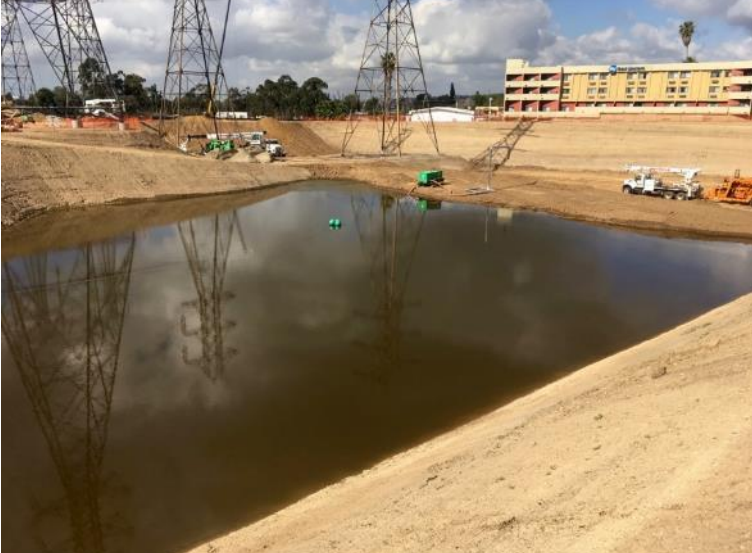
I walked to the retention basin at the west end of the Mesa Substation Project site (MM HY-3). The retention basin was nearly full and had a pump in place for filling water trucks (Photo 5). Numerous pieces of equipment were parked just east of the retention basin (Photo 6). I looked under a number of the machines and noted that drip pans were in place and there were no leaks. Extensive work was being conducted within the 16-kV switchrack area (Photo 7).

Photo 5 – The retention basin remains nearly full. Photo facing northwest.
2/12/18	Mesa Substation

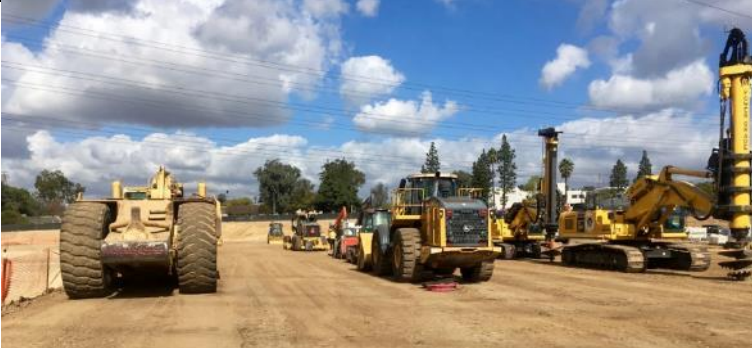
Photo 6 – Equipment parked just east of the retention basin. Photo facing north.

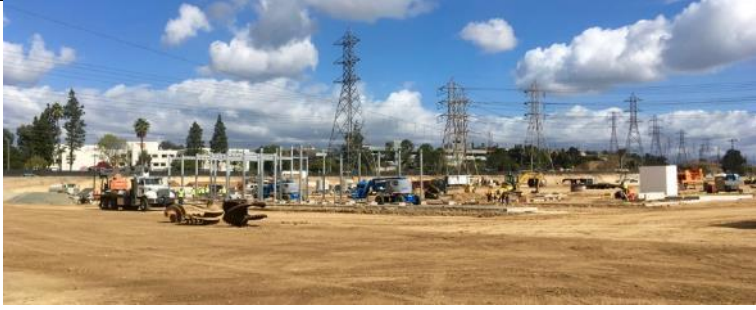
Photo 7 – Overview of the 16-kV switchrack construction. Photo facing north.
2/12/18	Mesa Substation

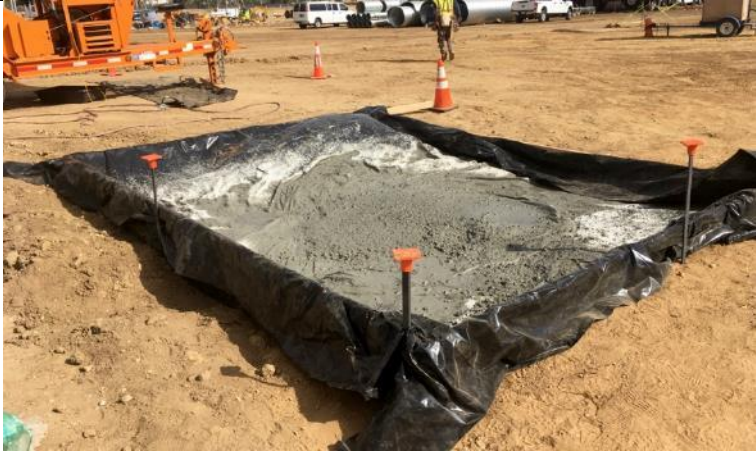
A crew was pouring the foundation for the perimeter fence (Photo 9), and there was a concrete washout in place near the work area (Photo 8). The crew was using two small gas-powered generators for the vibrating equipment that settles the concrete, and both generators were placed on pieces of black plastic that were located adjacent to the large offsite drainage ditch (Photo 10). The ditch was full of water (Photo 11) flowing from an operation that was draining the old water line (Photo 12). This work was being conducted in preparation for tying the old water line into the new water line (Photo 13). I was concerned with both the containment under the generators and their location next to the drainage ditch, so I called the Mesa Project Coordinator Pete Lubich (ULM Services, Inc.) who had the crew upgrade the containment and move the generators away from the ditch.

Photo 8 – Concrete washout area for pouring the perimeter wall.
2/12/18	Mesa Substation

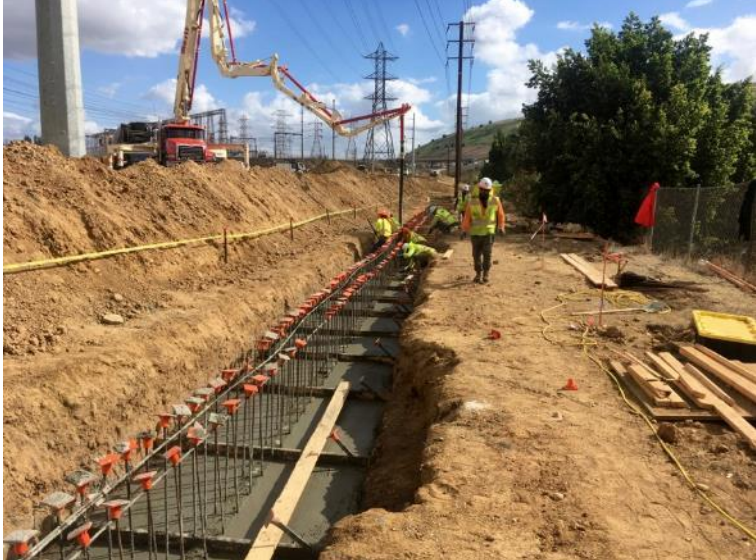
Photo 9 – Pouring the perimeter fence foundation. Photo facing east.

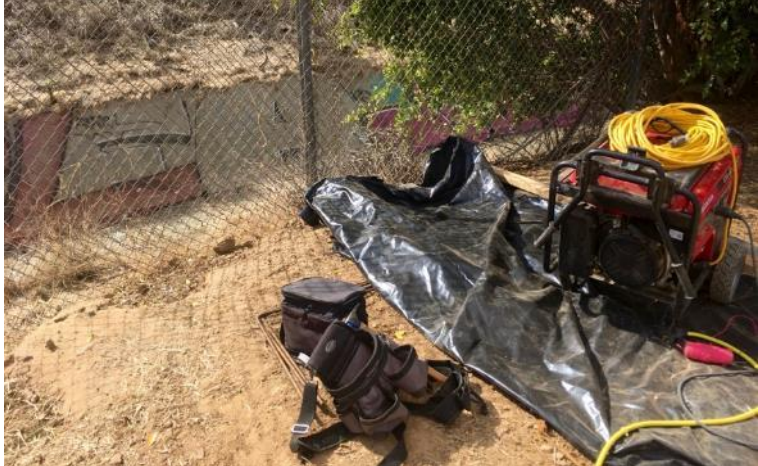
Photo 10 – Generators set up on plastic located next to the drainage ditch.
2/12/18	Mesa Substation

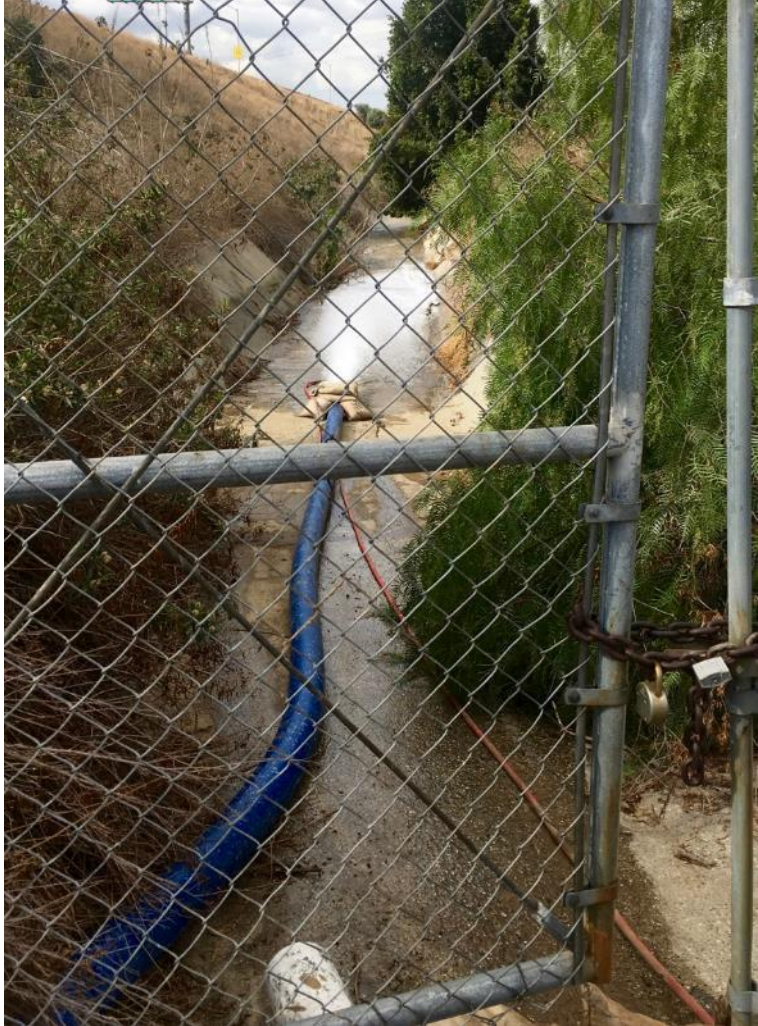
Photo 11 – Water being drained from the water line. Photo facing west

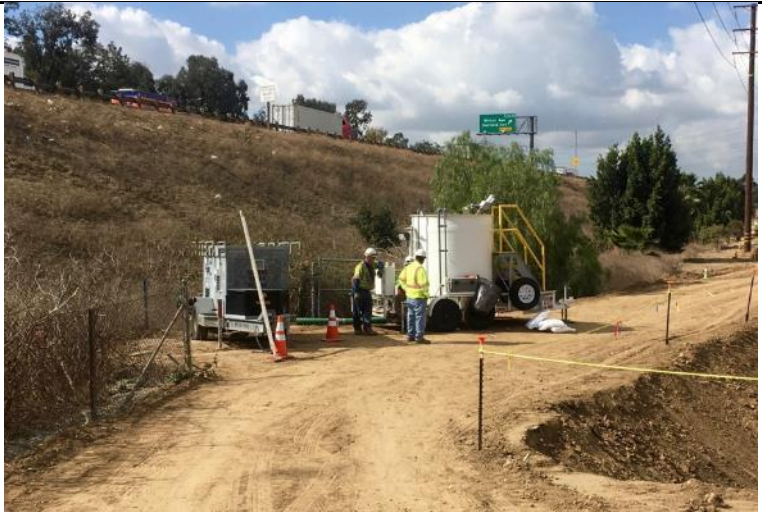
Photo 12 – Crew draining the old water line. Photo facing southwest
2/12/18	Mesa Substation

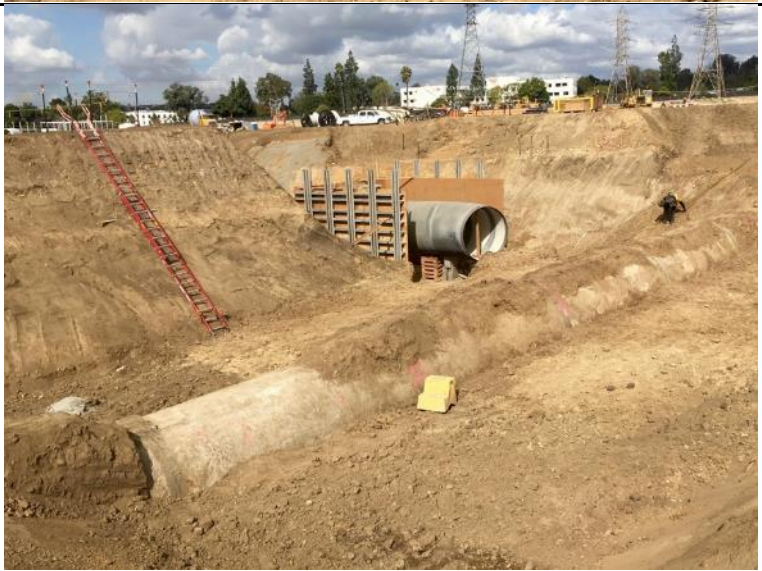
Photo 13 – New and old water line waiting to be tied in. Photo facing north.
2/12/18	Mesa Substation

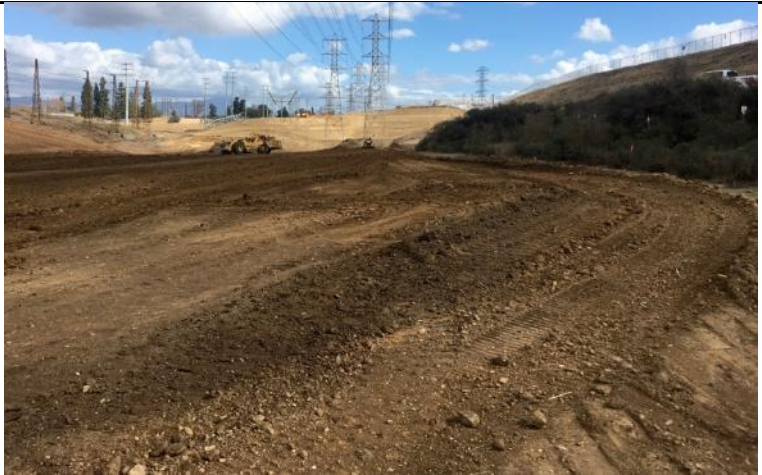
Earthwork was ongoing in the southeastern portion of the Mesa Project site near the Environmentally Sensitive Area (ESA); therefore, ICF biological monitor Matt Daniele (APM-BIO-03, APM-BIO-04, MM BR-2) was overseeing this aspect of the project (Photo 14).

Photo 14 – Earthwork near the ESA habitat. Photo facing east.

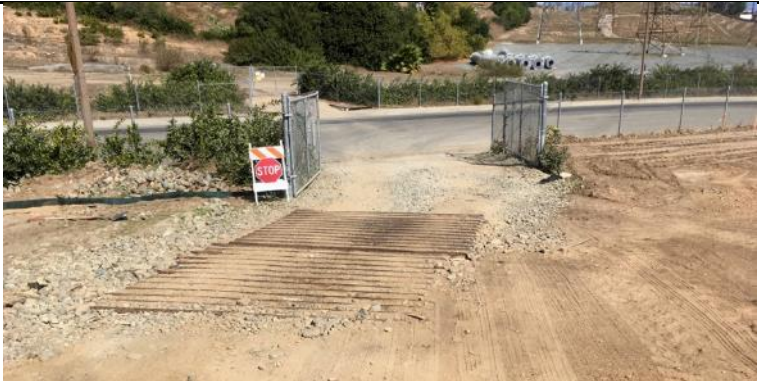
I walked across Potrero Grande Drive to observe the work activities. I noted a red-tailed hawk sitting on a nest built in a tower in the Kiewit yard (APM-BIO-06). The exit/entry best management practice (BMP) into the work area had rumble plates installed, but their placement allowed vehicles to easily avoid driving over them. Also, the rock around the plates needed improvements (Photo 15).

Photo 15 – The exit/entry BMP into the work area north of Potrero Grande Drive.
2/12/18	Mesa Substation

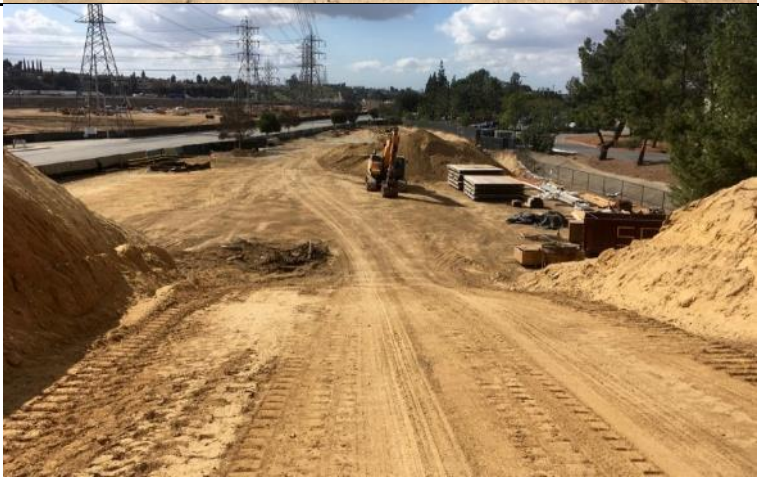
Crews were backfilling the water line north of Potrero Grande Drive (Photo 16). A pipeline crosses the new water line, but there is a suitable ramp into the hole (Photo 16).

Photo 16 – Backfilling the water line near the exit hole north of Potrero Grande Drive. Photo facing west.
2/12/18	Mesa Substation Project

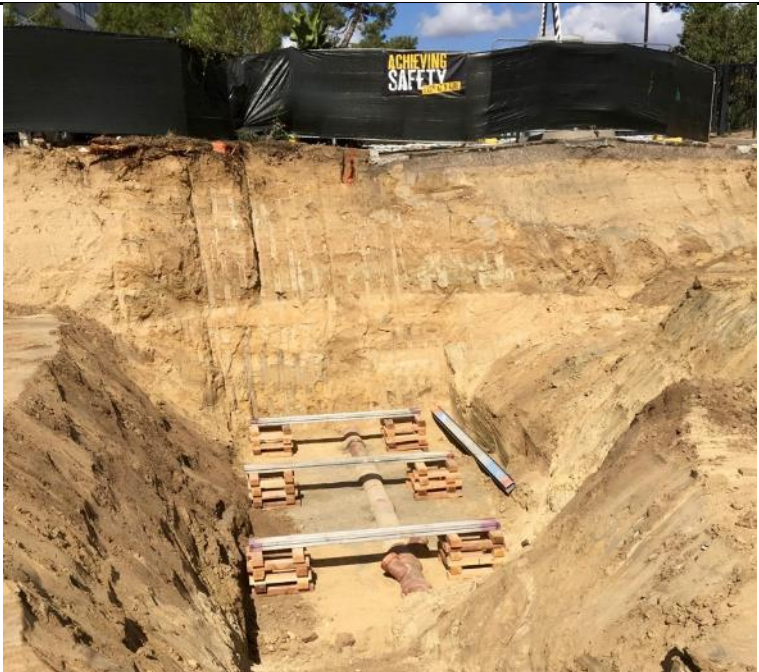
Photo 17 – Exposed pipe over the newly installed water line. Photo facing north.

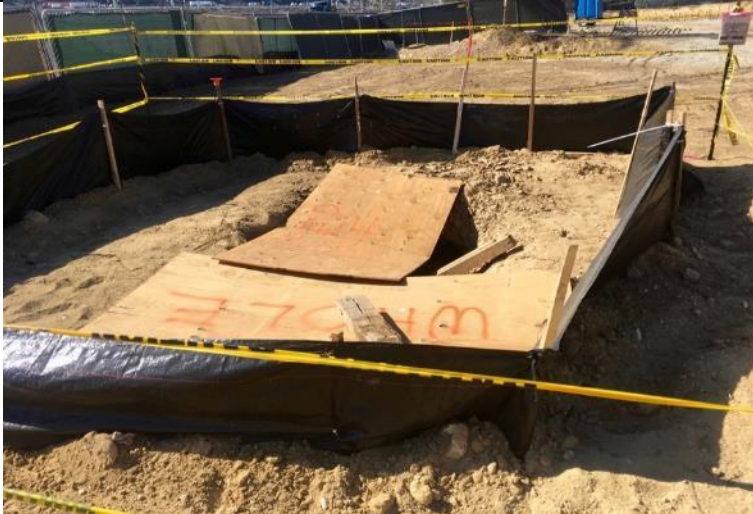
Photo 1 – Holes covered with plywood and surrounded by silt fence.
2/21/18	Mesa Substation – North of Potrero Grande Drive

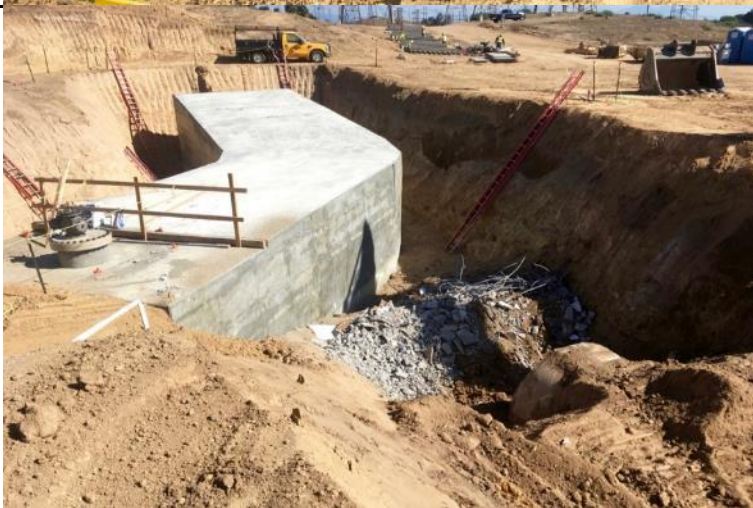
Photo 2 – Water line tie-in location. Photo facing east.
2/21/18	Mesa Substation – North of Potrero Grande Drive

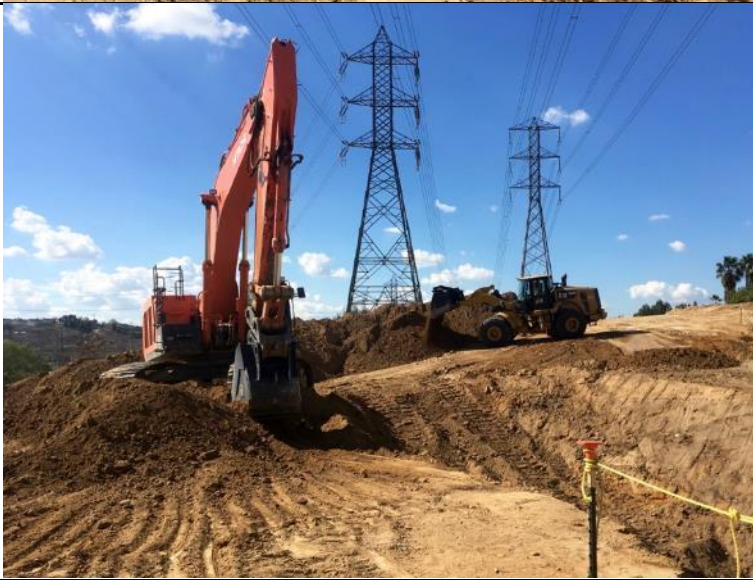
Photo 3 – Water line being backfilled near the tie-in. Photo facing southwest.

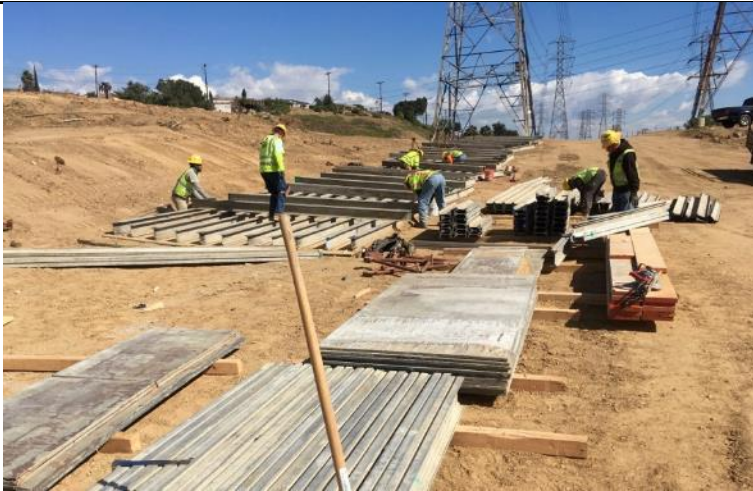
Photo 4 – Crews are stripping the forms off of the water line. Photo facing east.
2/21/18	Mesa Substation

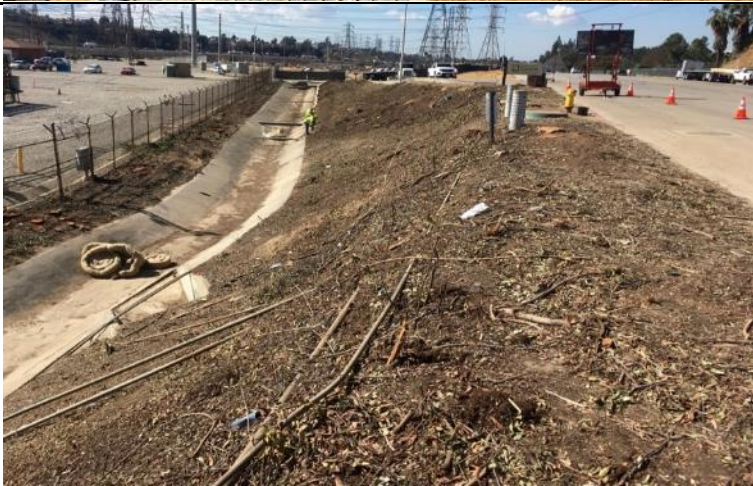
Photo 5 – BMP installation in a newly cleared area. Photo facing southwest.
2/21/18	Mesa Substation – Whittier Narrows

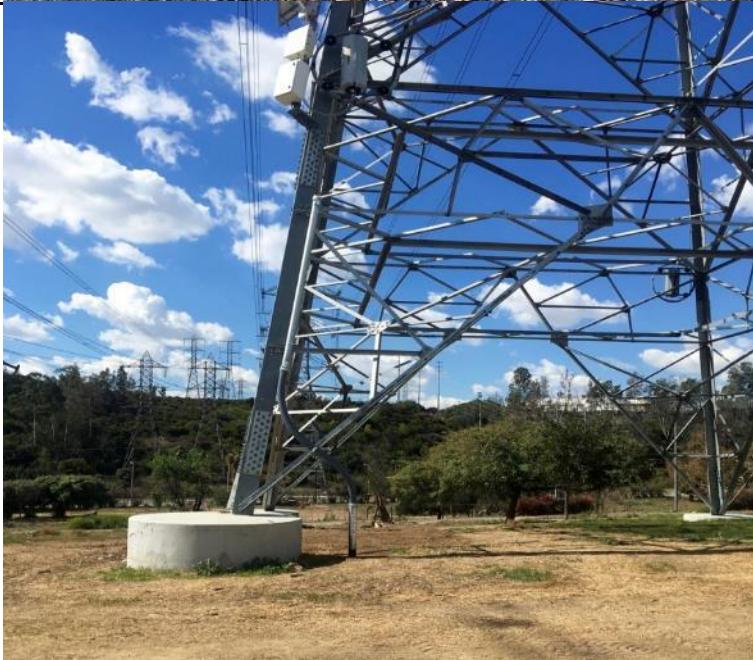
Photo 6 – Underground cable work.
