September 4, 2018

Re: Monthly Report Summary #10 for the Mesa 500-kV Substation Project

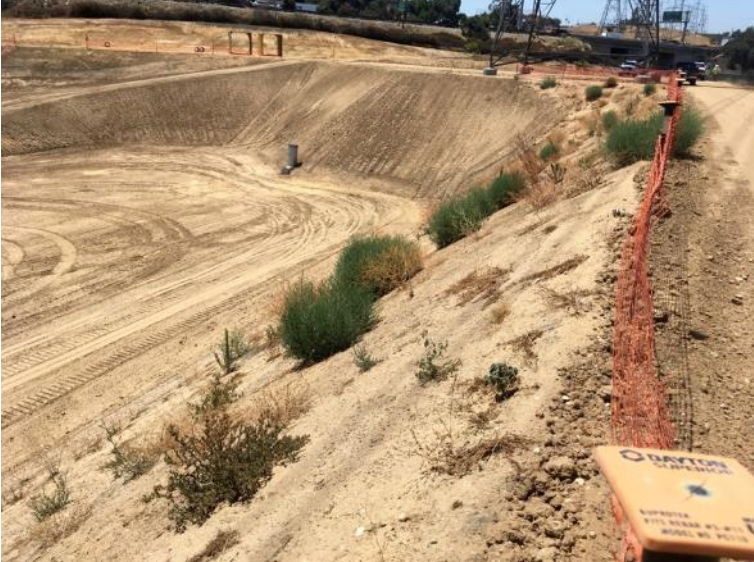
Weeds were growing on the banks of the detention basin. Some of the weeds were large Russian thistle (aka tumbleweed) (Photo 7). Removal of these weeds is recommended before they break off and begin to "tumble," or they will be spreading seed both onsite and offsite (MM BR-4).

<p>Photo 7 – Detention basin showing weeds growing on the banks. Photo facing southwest.</p>
7/13/18	Mesa Substation

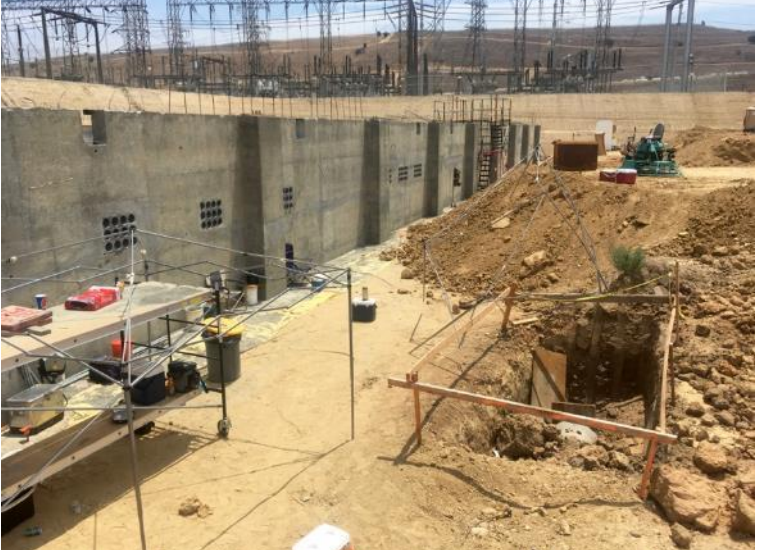
<p>Photo 2 – The Senior MEER storm drain inlet remains open; the pipe is capped and there is an exit ramp. Photo facing south.</p>
7/18/18	Mesa Substation

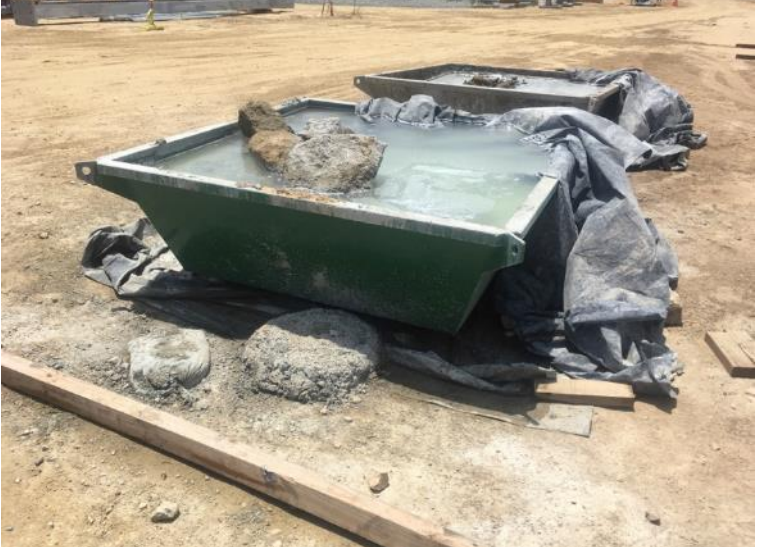
- July 18 and 23, 2018: On July 18, 2018, the CPUC Compliance Monitor observed two concrete washout bins near the northeast corner of the 66-kV switchrack area that were full and in disrepair. The Compliance Monitor also observed concrete washout on the ground near the bins. The bins were still in this condition during the subsequent site visit on July 23, 2018. The washout was cleaned up by the next site visit (July 31, 2018). This incident conflicts with: MM HY-1: Stormwater Pollution Prevention Plan, which requires project-related spills be cleaned up immediately; Avoidance and Minimization Measures (AMM) 2.34: Pollutants and Debris, which states no materials from construction, including concrete washings, shall be allowed to contaminate the soil; and AMM 2.35: Hazardous Substances, which requires concrete washings be prevented from contaminating the soil.

I observed two concrete washout bins near the northeast corner of the 66-kilovolt (kV) switchrack area. They were almost full and the coverings were in disrepair. It appeared that some washouts were being performed on the ground near these bins (Photo 3). I spoke with Power Grade foreman Willie Clark about the bins and he said the crews would be swapping the bins on the day of my site visit and the area would be cleaned up. Lead biological monitor Matt Daniele (ICF), avian biological monitor Wayne Woodroof (Noreas), and biological monitor Bob Huttar (Noreas) were onsite (MM BR-1, APM-BIO-03, MM BR-90). I spoke with Matt Daniele about the Mesa Substation Project, and I mentioned the concrete washout bins. He said he would follow up with Willie Clark.

<p>Photo 3 – Concrete washout bins near the 66-kV switchrack. They are full to overflowing and poorly covered; some washout appears to have been performed outside of the bins.</p>

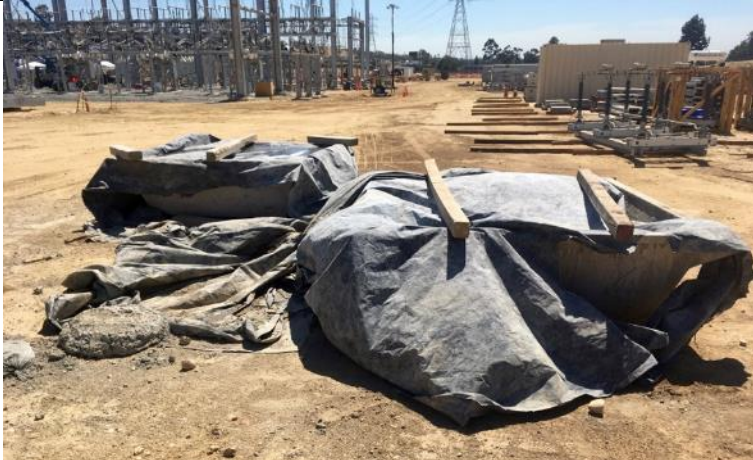
At the Senior Mechanical Electrical Equipment Room (MEER), the concrete floor had been poured and crews were using a crane to hoist steel girders into the building (Photo 1). I checked the concrete washout bins, which were nearly full and covered in plastic (Photos 3 and 5). The concrete spillage noted during my previous site visit had not been cleaned up. I pointed this out to lead biological monitor Matt Daniele (ICF) and also spoke to Mesa Project Coordinator Pete Lubich (ULM Services, Inc.) regarding the bins. Pete Lubich said he would pass on my concerns to the Power Grade foreman Willie Clark.

Photo 3 – Concrete washout bins near the 66-kV switchrack. The bins were replaced, but the spillage was not cleaned up.

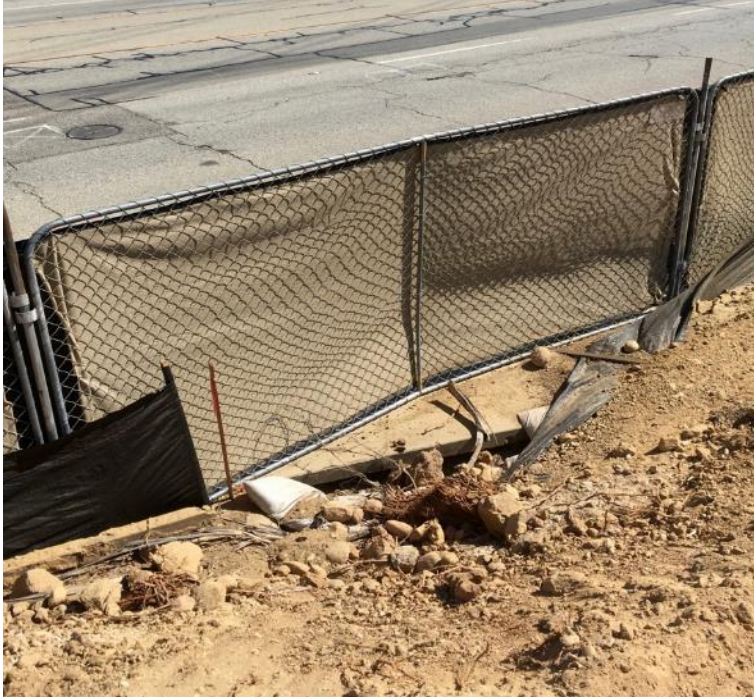
North of Potrero Grande Drive, finish grading was being conducted (Photo 11). I noted one of the street drains located near the HDD work area north of Potrero Grande Drive was nearly full of dirt and debris, and the silt fencing was down (Photo 12). This area should be evaluated by the Stormwater Pollution Prevention Plan (SWPPP) inspector and possibly regraded and stabilized before the next rain event (MM HY-1).

Photo 12 – Street drain onto Potrero Grande Drive needs some maintenance and BMPs.

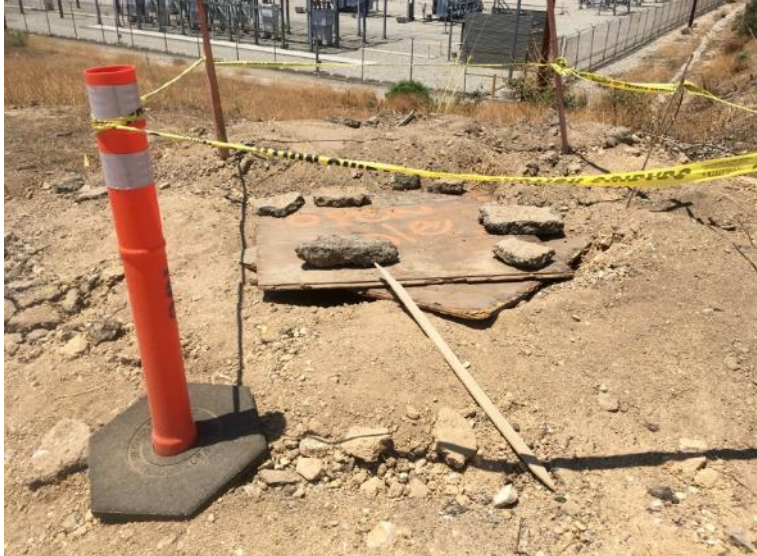
- July 31, 2018: The CPUC Compliance Monitor observed that the plywood over an excavation at the Mesa Operations Building site did not completely cover the excavation, such that small animals could fall into the hole. The cover was repositioned and the excavation was completely sealed later that day. This incident conflicts with MM BR-10, which states that excavations must be covered at the end of each day or completely fenced off at night in such a way that wildlife cannot become entrapped.

I noted a covered hole as I walked toward the Mesa Operation Building Site. The area had been cordoned off with markers and construction tape, and boards had been placed over the hole (Photo 14); however, the boards did not completely seal the hole, so animals could easily crawl under the boards and fall into the hole (MM BR-10). I called lead biological monitor Matt Daniele (ICF) and we looked at the site. Matt Daniele said he would make sure the hole was completely sealed before the end of the day. He said he would attempt to look into the hole to see if any animals had already fallen in. At the Mesa Operations Building Site, crews continued to install pipe/conduit (Photo 15). The crew expected to be pouring these trenches soon.

<p>Photo 14 – Covered hole near the east entrance to the Mesa Substation site; note the openings around the boards. Photo facing north.</p>
7/31/18	Mesa Substation
