January 13, 2020

Re: Monthly Report Summary #16 for the Mesa 500-kV Substation Project

This report provides a summary of the compliance monitoring activities that occurred during the period from **January 1 to 31, 2019**, for the Mesa 500-kilovolt (kV) Substation (Mesa Substation) Project in Los Angeles County, California. Compliance monitoring was performed to ensure that all project-related activities conducted by Southern California Edison (SCE) and their contractors comply with the requirements of the Final Environmental Impact Report (Final EIR) for the Mesa Substation Project, as adopted by the California Public Utilities Commission (CPUC) on February 9, 2017.

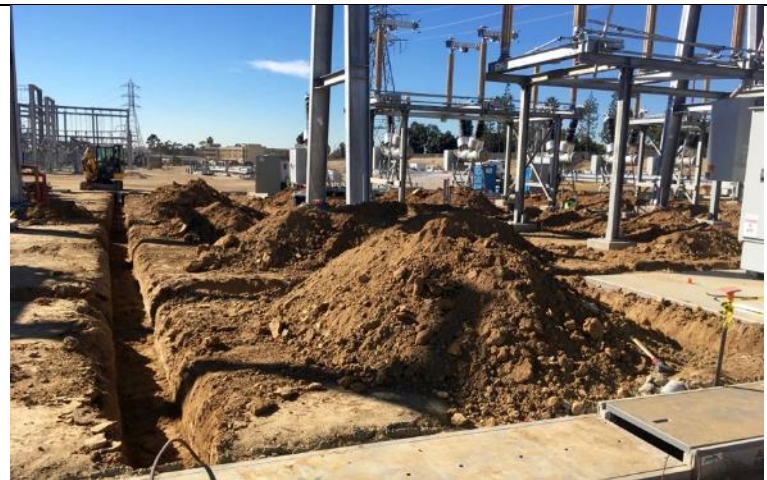
Trenching prior to installation of the copper grounding wire continued within the 220-kilovolt (kV) switchrack area – Photo 1. Most of the aboveground structure foundations have been poured in this area – Photo 2.

Photo 1 – Trenching for the grounding wire within the “disconnect” structures. Photo facing south.
1/3/19	Mesa Substation

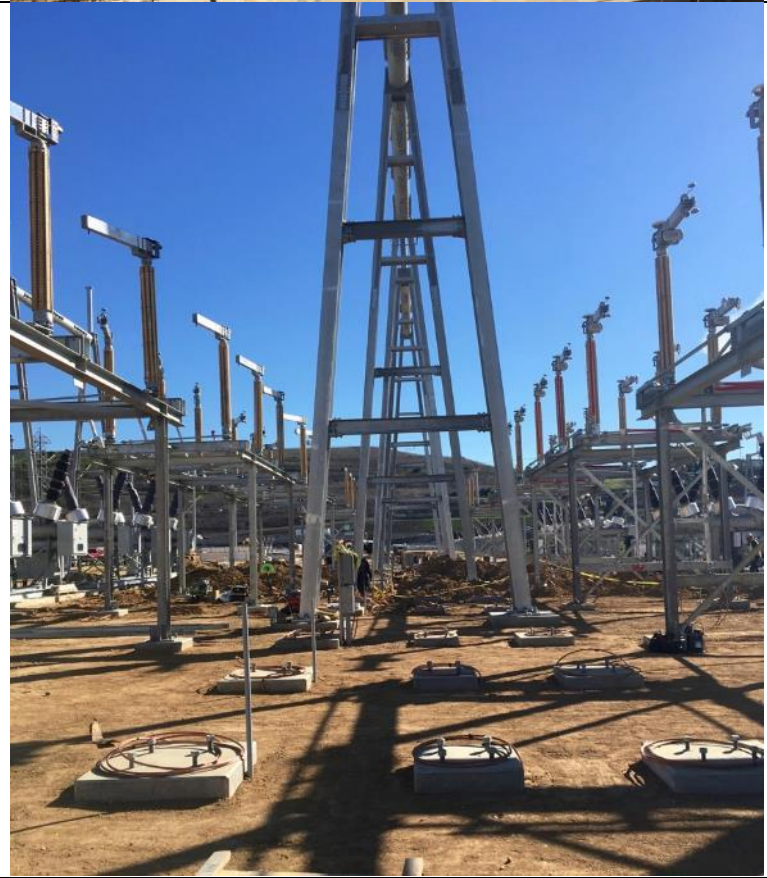
Photo 2 – Erection of structural supports within the 220-kV switchrack area. Photo facing south.

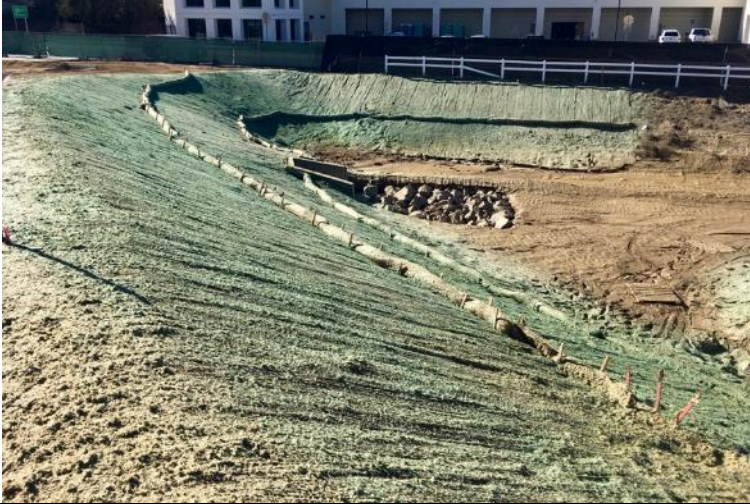
The small “triangular” detention basin had been repaired and re-hydrmulched – Photo 4. I noticed that the standpipe had been shortened by several feet; I spoke to the Power Grade foreman, Willie Clark, who confirmed that the standpipe had been shortened to address concerns regarding water ponding into the neighboring property.

Photo 4 – Hydroseeding at the small “triangular” detention basin. Photo facing west.
1/3/19	Mesa Substation

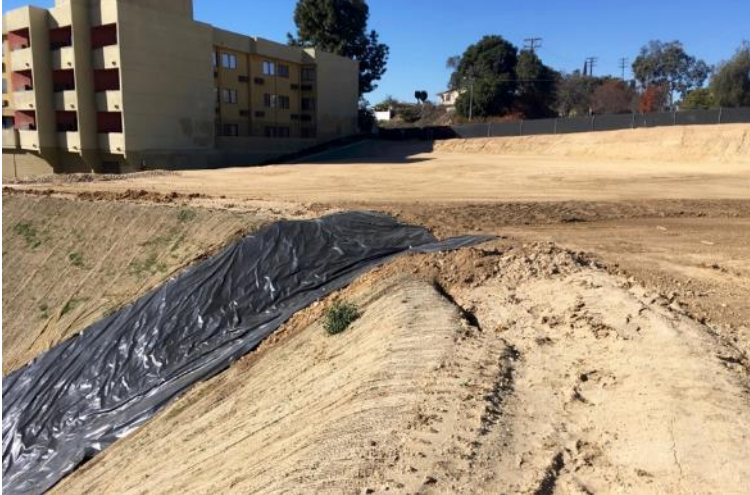
Crews had repaired some of the storm damage at the large detention basin and had re-lined the two sheet-flow entry points at the northeast and southeast corners of the basin, respectively – Photo 5. Crews had also re-sealed the base of the large standpipe with plastic – Photo 6.

Photo 5 –Plastic sheeting directing flows into the northeast corner of the detention basin. Photo facing north.

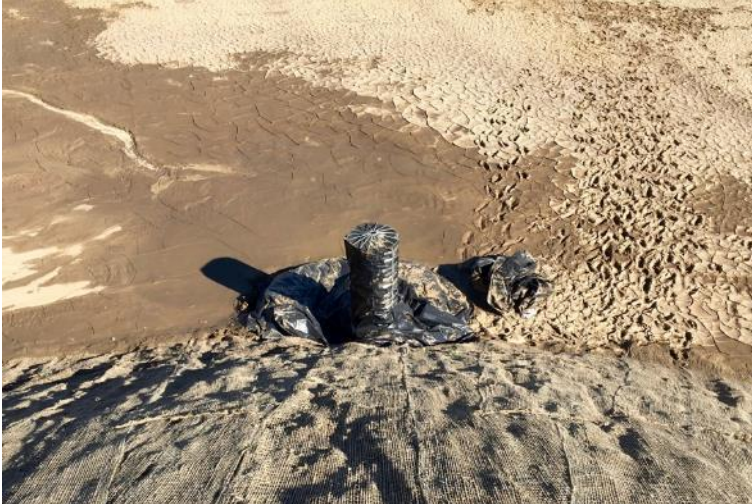
- On January 3, 2019, the CPUC Compliance Monitor noted that although SCE had re-sealed the standpipe in the large detention basin with plastic and installed gravel bags, this may not effectively retain water within the basin, as the plastic sheeting failed previously.

Photo 6 – Standpipe in the large detention basin re-covered with plastic sheeting.
1/3/19	Mesa Substation

SCE's solution of re-sealing the detention basin standpipe with plastic may likely be inadequate method because this solution was not effective in previous major rain events.

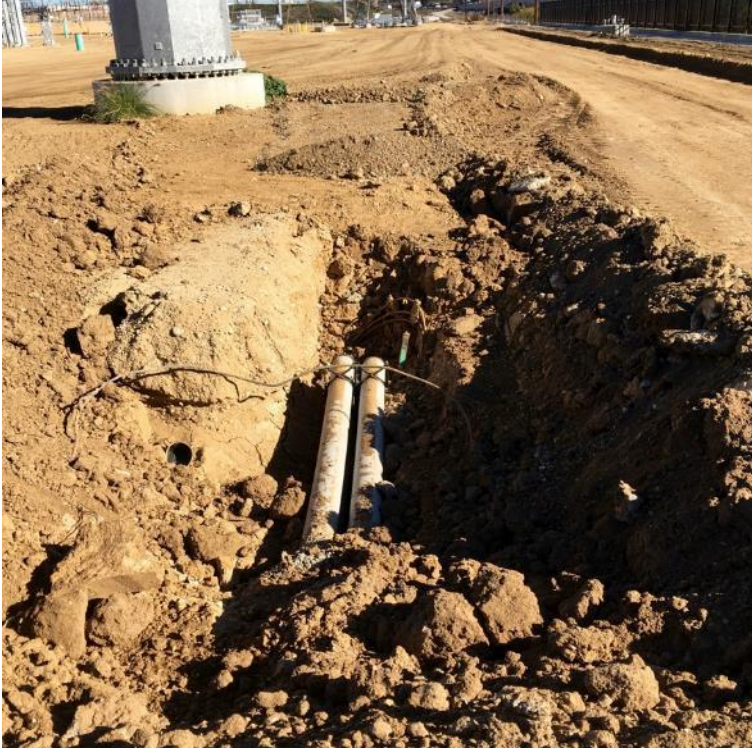
Several small areas of conduit trench remained open, though all of the conduit pipes were capped – Photo 9. Some of the conduit vaults were holding 4 to 5 feet of water, according to a crewmember. The water was being pumped from the conduit vaults – Photo 12. The pumped conduit vault water runs down the southern project area boundary until it reaches a small berm, which was built to redirect surface flow away from the boundary wall and into the large detention basin – Photo 10. The berm appeared to require repairs before the upcoming storms. Matt Daniele (ICF), Pete Lubich (ULM Services, Inc.), and I reviewed the site drainage path. I indicated where installation of additional berms would help redirect surface flows into the large detention basin. I contacted the Storm Water Pollution Prevention Plan (SWPPP) inspector, Lucy Cortez-Johnson (CASC), and we discussed the importance of ensuring that all surface flows are directed into the detention basin.

Photo 9 – Open conduit trench. Photo facing east.
1/3/19	Mesa Substation	 	Photo 10 – Small berm redirecting stormwater runoff. Photo facing west.
1/3/19	Mesa Substation	 	Photo 11 – Tower foundation installation; Biological monitoring being conducted by a qualified biologist. Photo facing east.

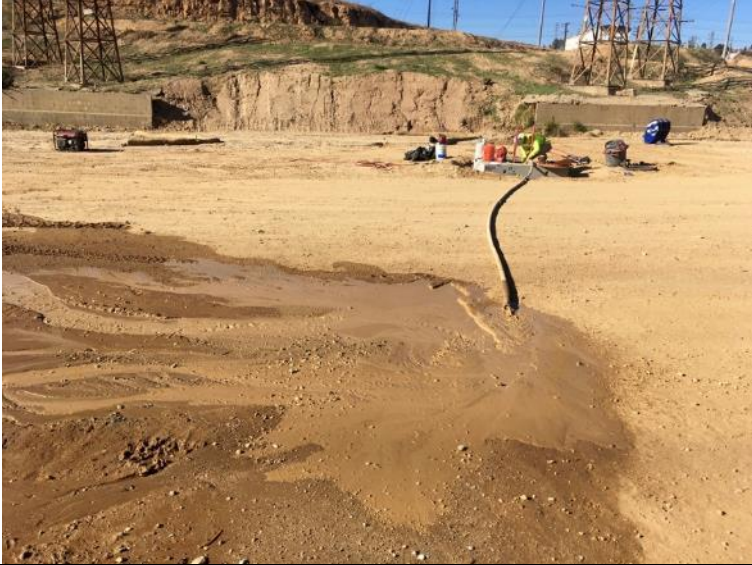
Photo 12 – Stormwater being pumped out from the conduit vaults. Photo facing north.
1/3/19	Mesa Substation

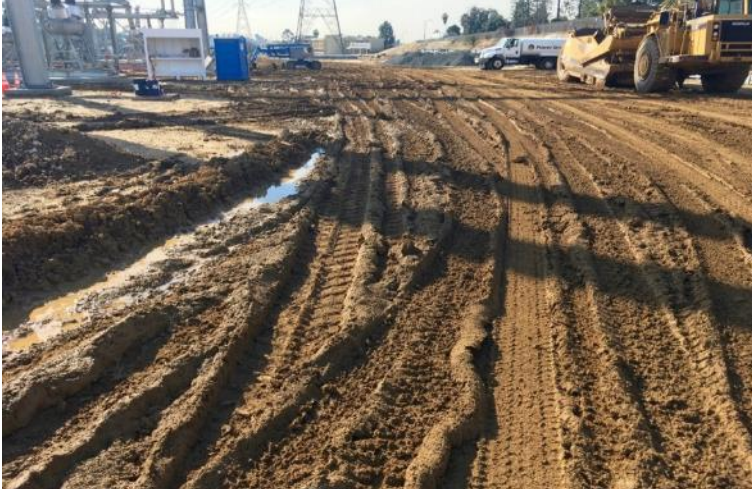
<p>Photo 2 – Muddy conditions onsite. Photo facing west.</p>
1/9/19	Mesa Substation

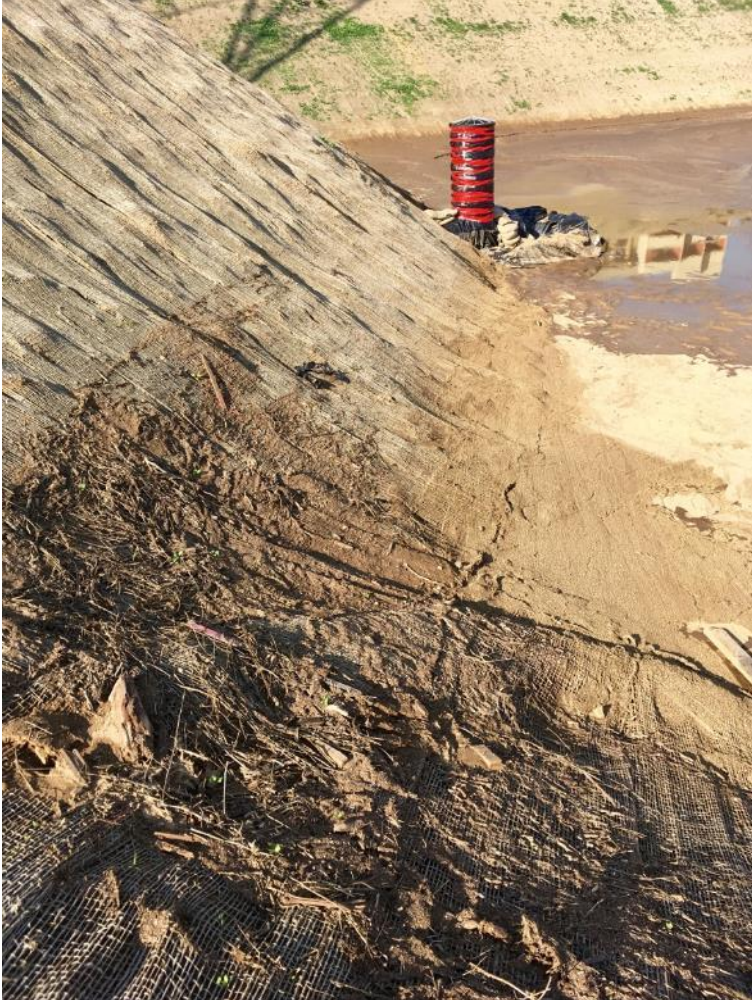
<p>Photo 6 – The standpipe in the large detention basin re-covered with plastic sheeting, and the sheeting has been duct taped around the pipe.</p>
1/9/19	Mesa Substation

Consider additional methods for preventing water from rapidly leaving the project site via the standpipe in the large detention basin- sealing the standpipe with plastic sheeting is not an adequate method because it repeatedly has failed to retain water.

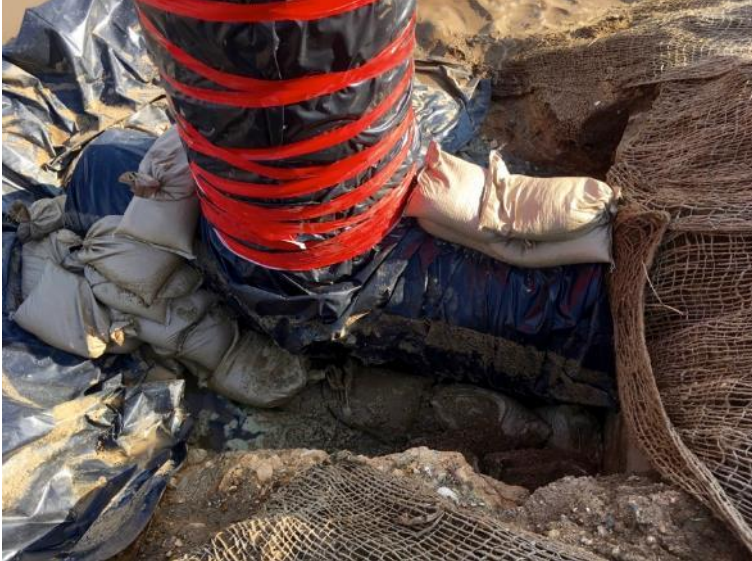
- On January 9, 2019, the CPUC Compliance Monitor observed watermark levels on the side of the large detention basin that indicated that water levels in the basin reached a depth of approximately three feet during recent rains. The plastic sheeting noted on January 3 was ruptured, and it appeared that water had flowed through the base of the standpipe at a rate at which sediment would not have likely been able to settle out from the water column before entering the public storm drain system.

Although the standpipe was resealed with plastic sheeting and surrounded with gravel bags at the base, there appeared to be no standing water in the large detention basin – Photo 4. Based on the sediment level visible along the banks of the detention basin, it appeared that water had filled the basin to a depth of approximately 3 feet before the plastic/gravel seal ruptured – Photo 6. The water appeared to have drained from the same location at the base of the standpipe where water had previously drained – Photo 7.

<p>Photo 7 – Area surrounding the base of the standpipe at the large detention basin, where water drained.</p>

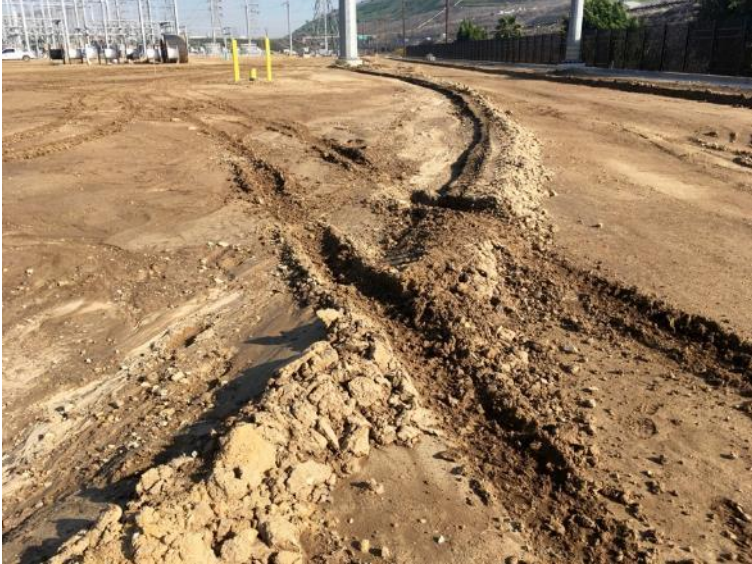
<p>Photo 9 – A vehicle had tracked through the new diversion berm, impeding stormwater flows. Photo facing east.</p>
1/9/19	Mesa Substation

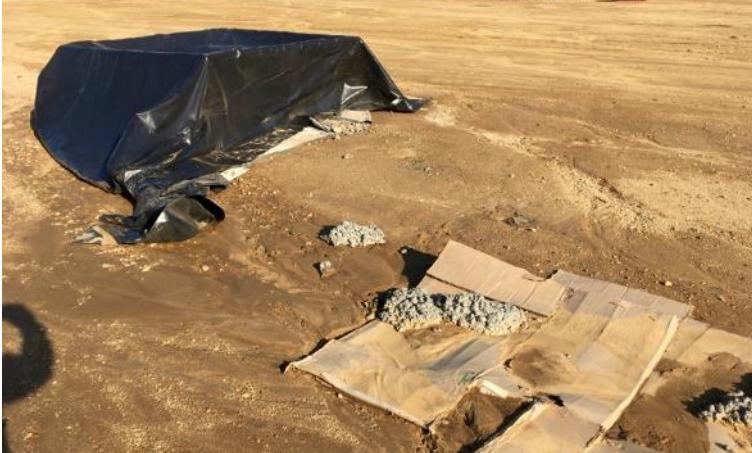
<p>Photo 15 – The concrete washout area needs cleanup/ maintenance.</p>
1/9/19	Mesa Substation

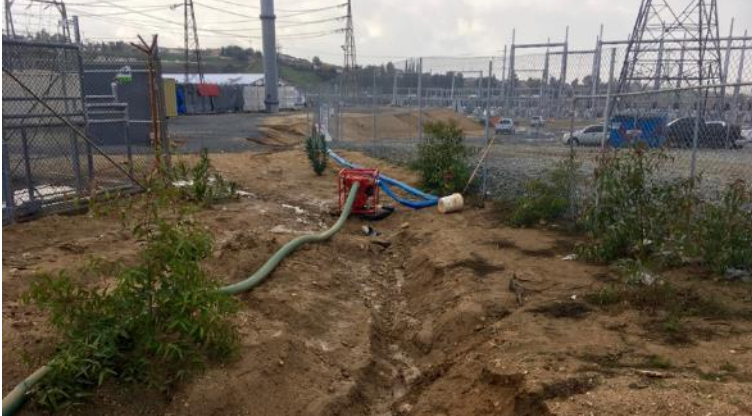
- On January 18, 2019, the CPUC Compliance Monitor observed a pump and gas canister staged near ponded water without secondary containment. He recommended that the equipment be removed from this area, and be placed in containment devices (such as drip pans).

<p>Photo 2 – Pump and a gas can located near an erosion channel. Photo facing west.</p>
1/18/19	Mesa Substation

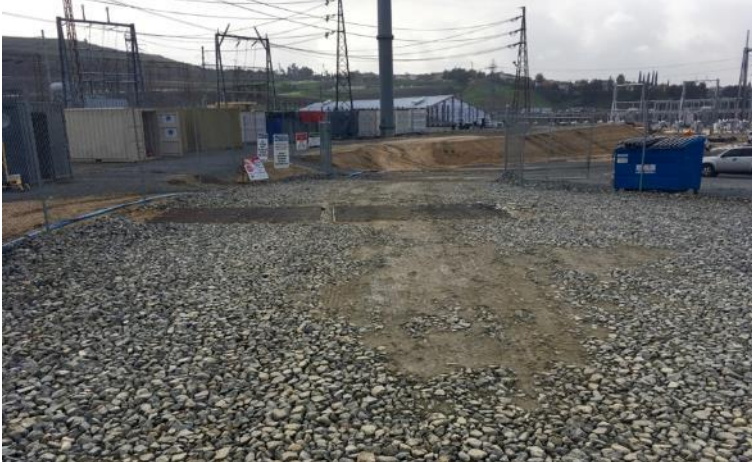
<p>Photo 3 – The main site entry/exit area requires sweeping to prevent trackout. Photo facing southwest.</p>

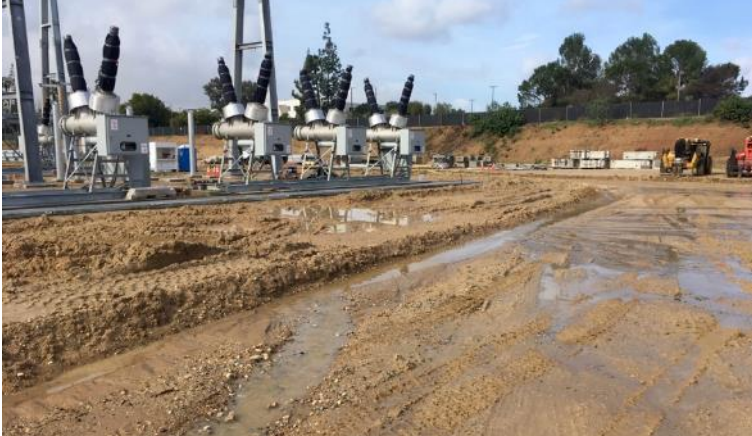
Photo 6 – Substantial mud and ponded water throughout the site. Photo facing north.

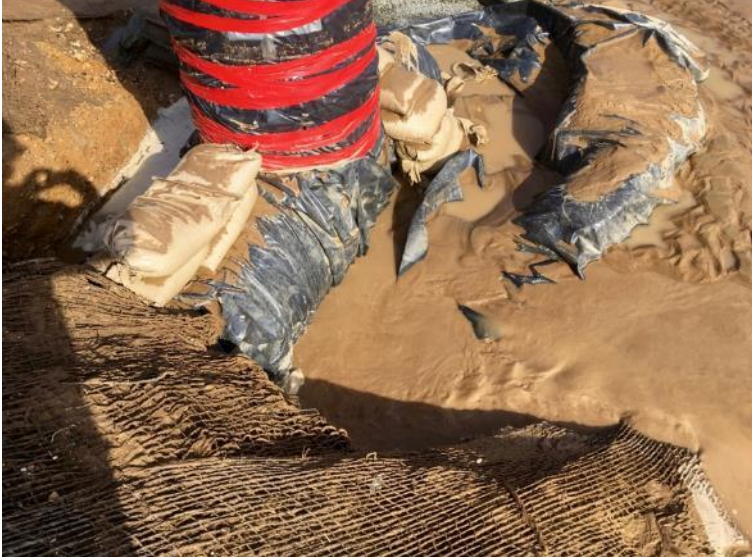
- On January 18, 2019, the CPUC Compliance Monitor observed that stormwater from a recent rain event was circumventing erosion control best management practices (BMPs), had eroded the soil at the base of the large detention basin standpipe, and had rapidly flowed from large detention basin into the public storm drain system. As a result, the basin is not functioning as a secondary containment system as required by the amended Spill Prevention, Control, and Countermeasure (SPCC) Plan; in the event of an oil spill onsite, oil would not be retained within this basin. Additionally, the stormwater flowing from the basin into the public storm drain system was visibly heavily sediment-laden, which does not fulfill the intent of Construction General Permit and Storm Water Pollution Prevention Plan (SWPPP) requirements. On numerous prior occasions, CPUC had notified SCE that the detention basin was an area of compliance concern. However, all attempted updates to the basin and standpipe did not adequately address the CPUC's SWPPP or SPCC Plan concerns. This incident was out of compliance with **MM HAZ-3: Spill Prevention, Control, and Countermeasure Plan**, **MM HY-1: Storm Water Pollution Prevention Plan**, and the **Construction General Permit Order No. 2009-0009-DWQ, as Amended by Order Nos. 2010-0014-DWQ and 2012-0006-DWQ**.

Photo 11 – Water exiting the large detention basin at the base of the standpipe.

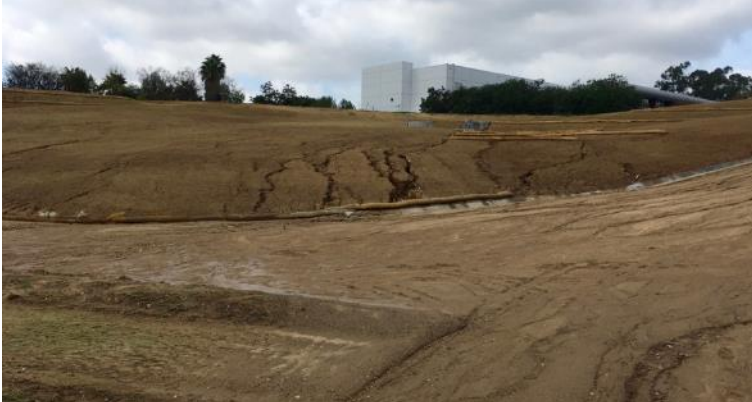
- On January 18, 2019, the CPUC Compliance Monitor observed numerous large erosion rills on the steeper slopes within the transmission corridor north of Potrero Grande Drive. He noted that these erosion rills should be repaired prior to upcoming storm events.

A photograph of a dirt area showing significant erosion. Deep, dark brown rills have formed in the soil, running across the frame. In the background, there are some trees and a large, light-colored building under a cloudy sky.	Photo 17 – Erosion rills within the telecommunications corridor North of Potrero Grande Drive. Photo facing north.

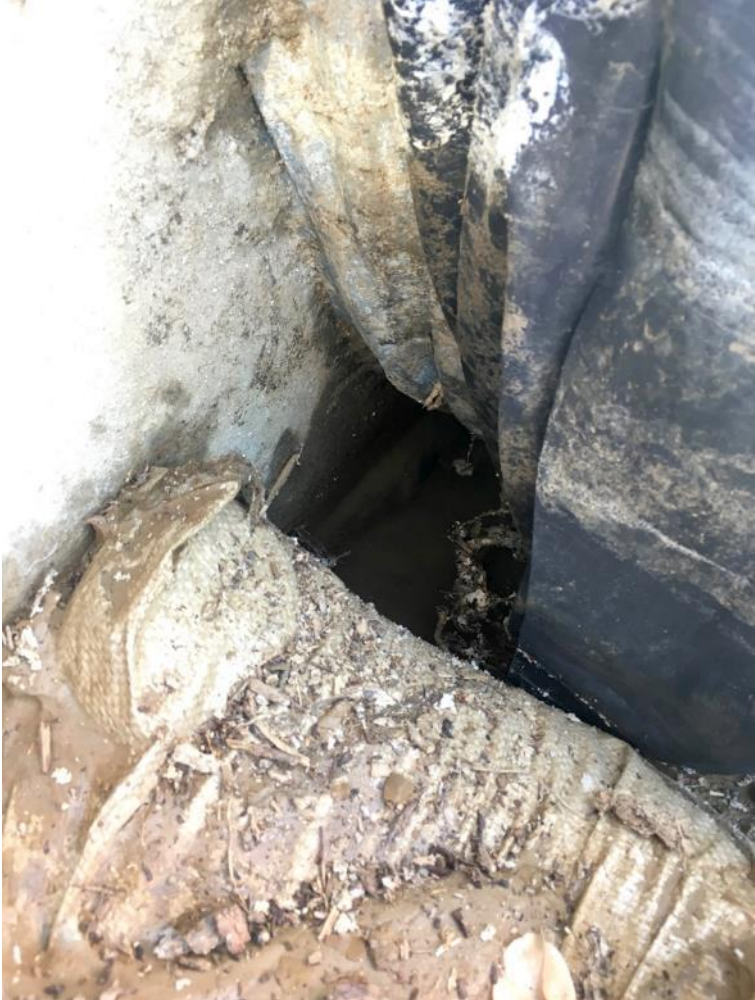
Photo 5 – The base of the standpipe inside of the large detention basin. Note the standing water is at a lower level than the culvert.

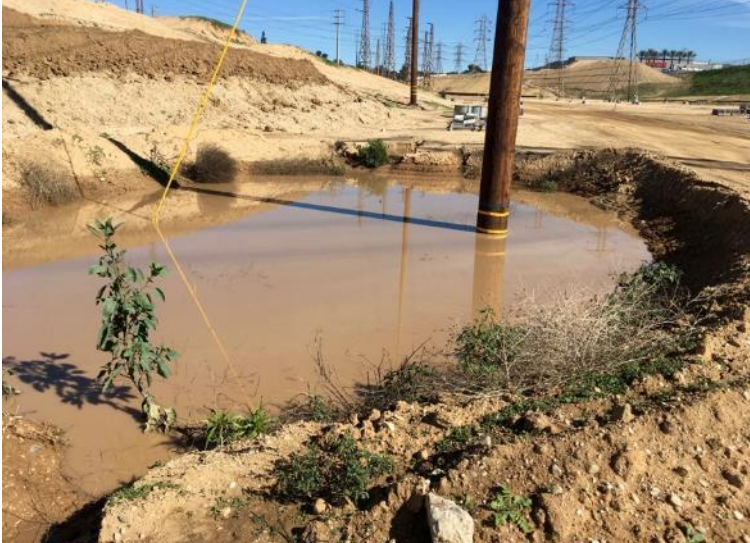
Photo 10 – Pounded/standing water onsite. Photo facing east.

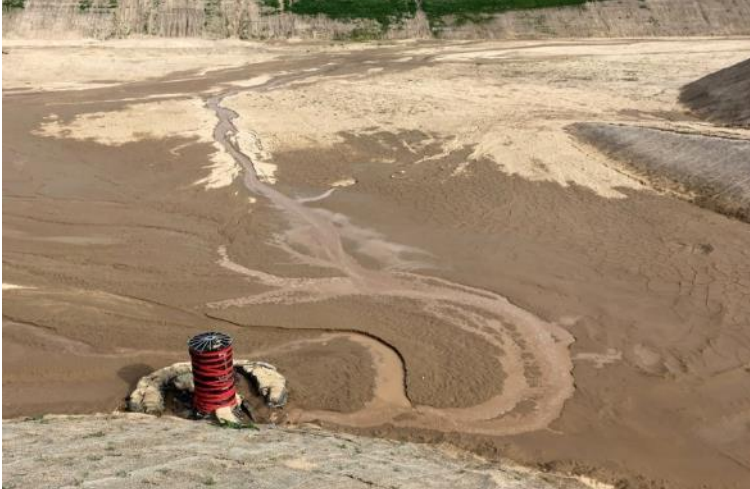
<p>Photo 5 – A small stream of water continues to flow through the large detention basin. However, the basin generally does not contain extensive ponded water. Photo facing east.</p>
1/28/19	Mesa Substation

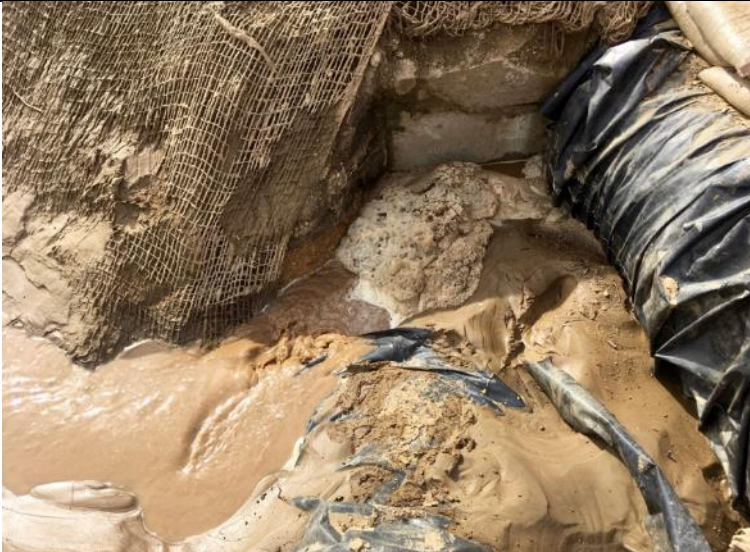
<p>Photo 6 – Water draining from the large detention basin at the base of the standpipe.</p>

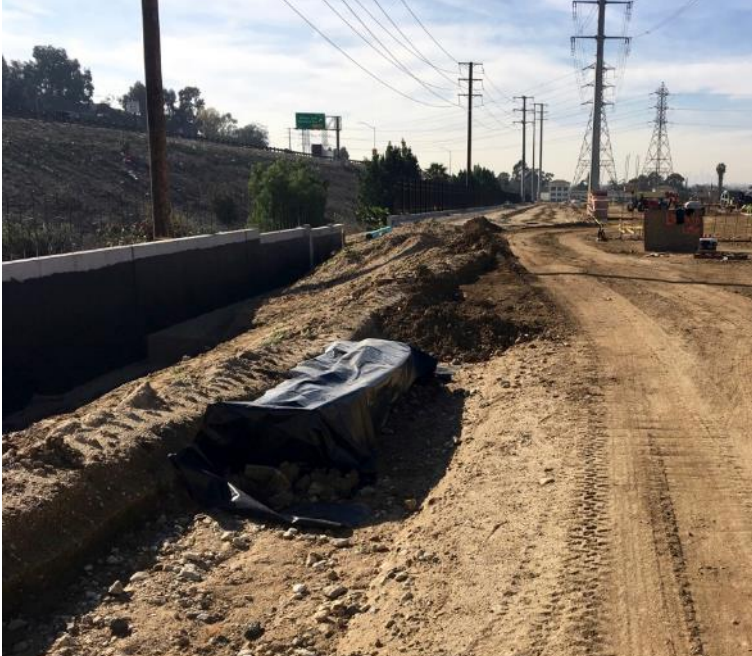
- On January 24, 2019, the CPUC Compliance Monitor observed dirt, mud, and debris accumulating in the concrete swale surrounding the project area.
- On January 28, 2019, the CPUC Compliance Monitor observed that a berm located along the southern portion of the project that directs rainwater runoff from the southern boundary wall and the smaller triangular basin and into the large detention basin has been compromised in numerous locations. Runoff water that should have been directed by this berm ran through materials that the CPUC Compliance Monitor observed stockpiled in the flow line.

<p>Photo 10 – Dirt and construction materials stockpiled in the rainwater runoff channel. Photo facing west.</p>
1/28/19	Mesa Substation
