Re: Monthly Report Summary #19 for the Mesa 500-kV Substation Project

Mesa 500–kV Substation Project CPUC Site Inspection Form

Project:	Mesa 500-kV Substation Project	Date:	April 3, 2019
Project Proponent:	Southern California Edison	Report #:	VS067
Lead Agency:	California Public Utilities Commission	Monitor(s):	Vince Semonsen
CPUC PM:	Connie Chen, Energy Division	AM/PM Weather:	Mostly cloudy and breezy with mild temperatures
E & E CM:	Silvia Yanez	Start/End Time:	1245 to 1445
Project NTP(s):	NTP-1, NTP-2

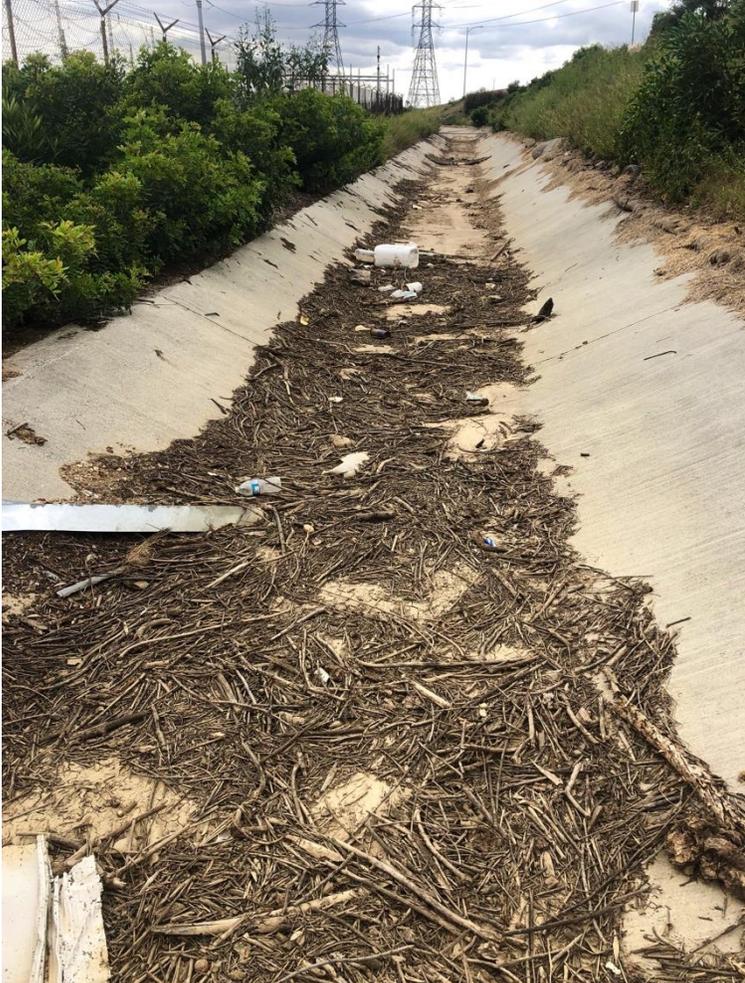
Photo 2 – Sediment and trash in the substation drainage channel. Photo facing west.

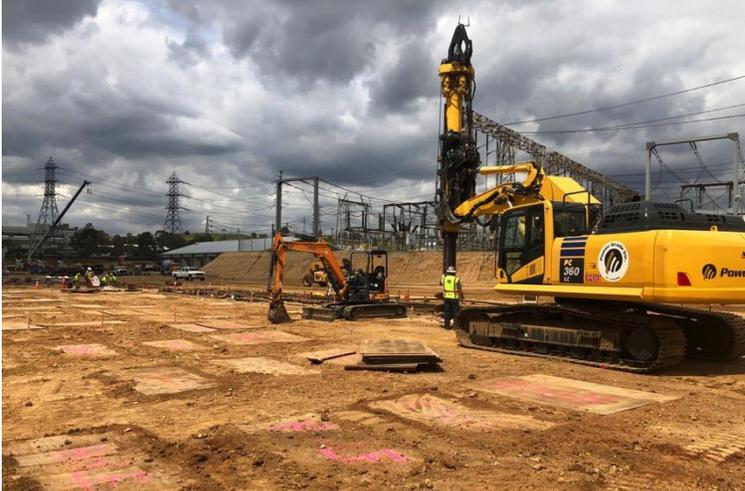
Crews were drilling foundations on the southeast end of the 220-kV switchrack area and were spreading gravel – Photos 7 & 8.

Photo 7 – Drilling foundation holes within the 220-kV switchrack area. Photo facing northeast.
4/03/19	Mesa Substation

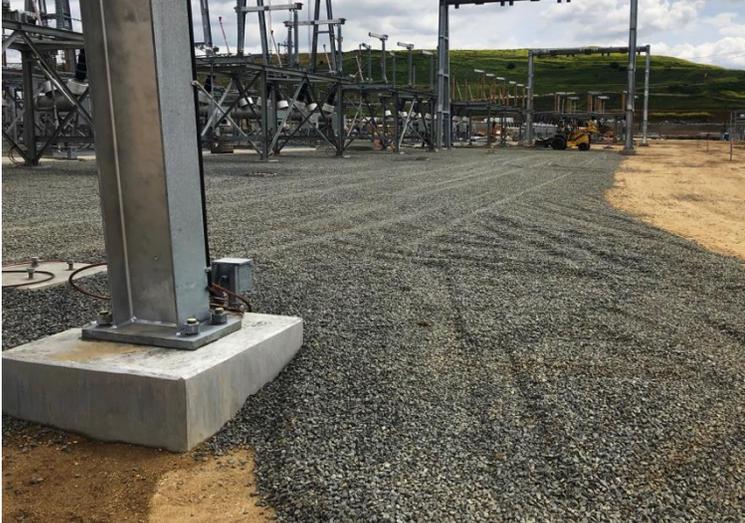
Photo 8 – Spreading gravel within the 220-kV switchrack area. Photo facing south.

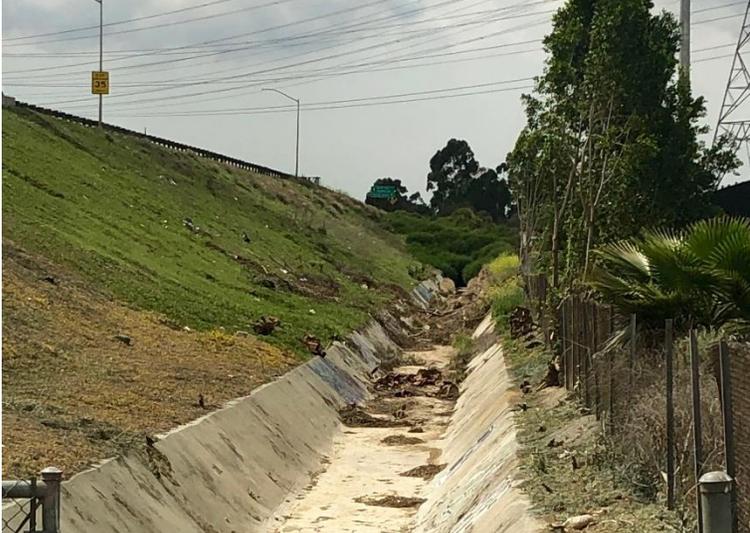
I inspected the Caltrans channel outside of the southern boundary wall and noted minimal changes since my last visit. A significant amount of project sediment and vegetation remained inside of the channel – Photo 14.

Photo 14 – Sediment and vegetative material in the Caltrans channel. Photo facing west.
4/03/19	Mesa Substation

- On April 3, 2019, the CPUC Compliance Monitor inspected the Caltrans concrete channel outside of the southern boundary wall and noted minimal changes since the last visit. A significant amount of project sediment and vegetation remained inside of the channel. The CPUC Compliance Monitor advised cleaning the channel.

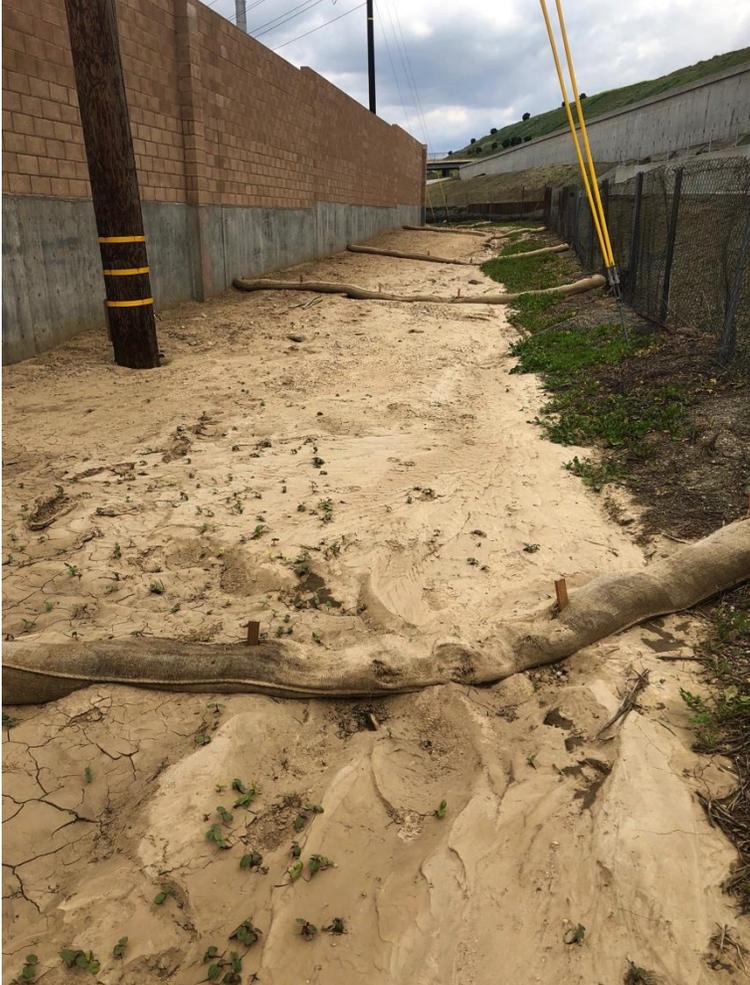
The straw wattles located outside of the southern boundary wall were not repaired – Photo 15.

Photo 15 – Undermined wattles outside of the southern boundary wall. Photo facing east.

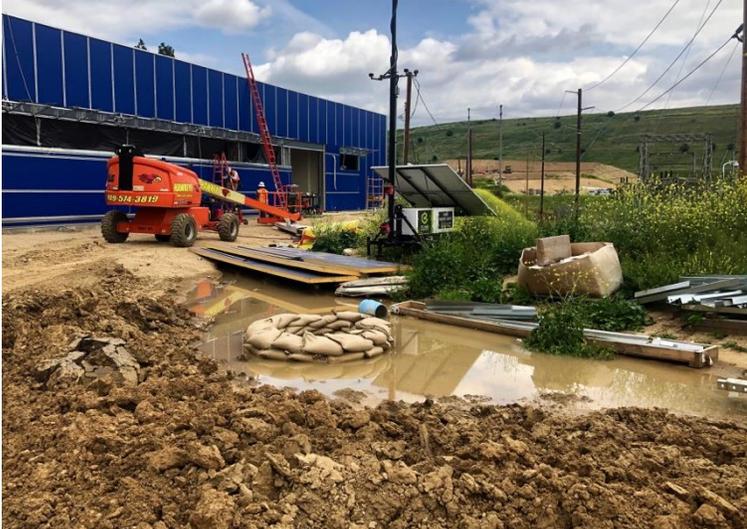
Photo 22 – Poned rainwater runoff near the Mesa Operations Building. Photo facing south.

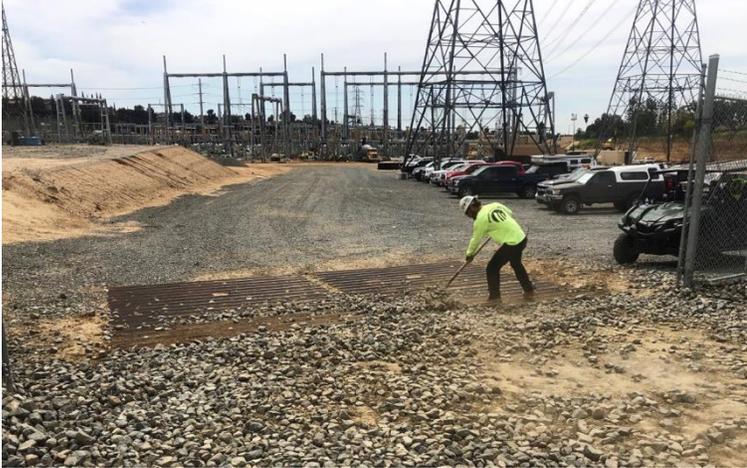
Photo 1 – Rumble plate being cleaned out. Photo facing west.
4/11/19	Mesa Substation

- On April 3, 11, and 18 2019, the CPUC Compliance Monitor observed the entry/exit rumble plates at the main entrance filled with rock. The CPUC Compliance Monitor recommended increasing the frequency of maintaining the rumble plates clean when safe to do so.

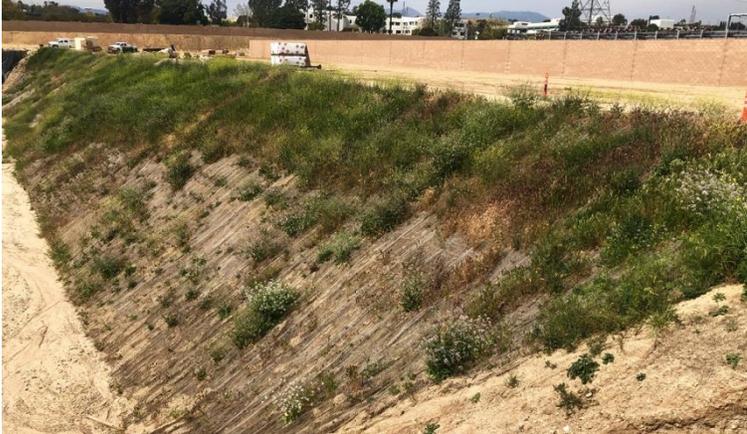
- On April 11, 2019, the CPUC Compliance Monitor noted a large quantity of significant vegetation growing on the slopes of the large detention basin, particularly weeds, such as black mustard, wild radish, and at least 3 species of thistle. The CPUC Compliance Monitor advised removing these weeds to minimize potential nesting habitat and to adhere with the Mesa Substation noxious weed control plan.

Photo 8 – Slopes at the large detention basin. Photo facing north.

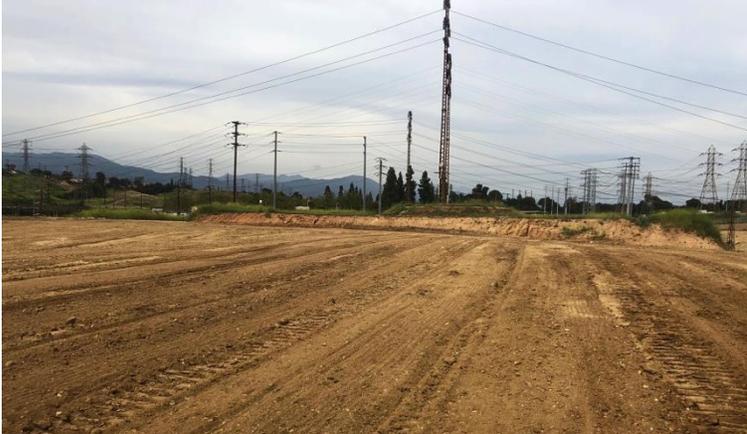
Excess soil from the project area was being transported to a location south of the existing substation – Photo 11. Currently, the soil transported to this location is moist; however, eventually, this area will need to be checked for potential dust control issues.

Photo 11 – Soil stockpile area east of the existing substation. Photo facing east.
4/11/19	Mesa Substation

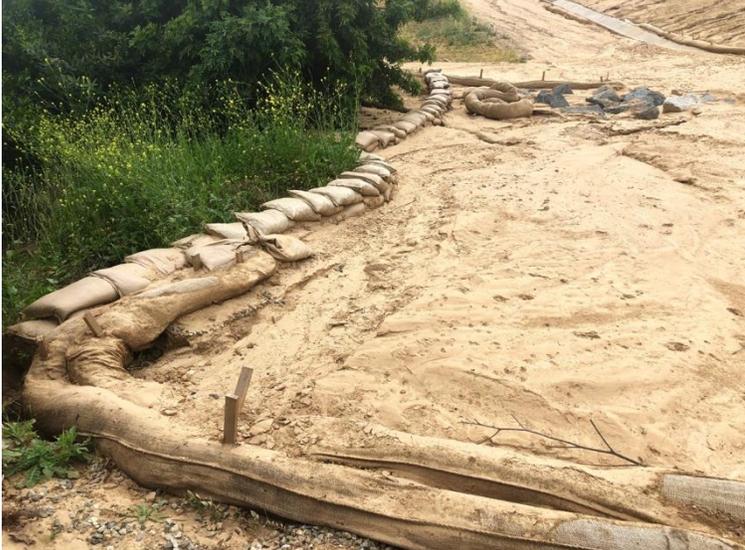
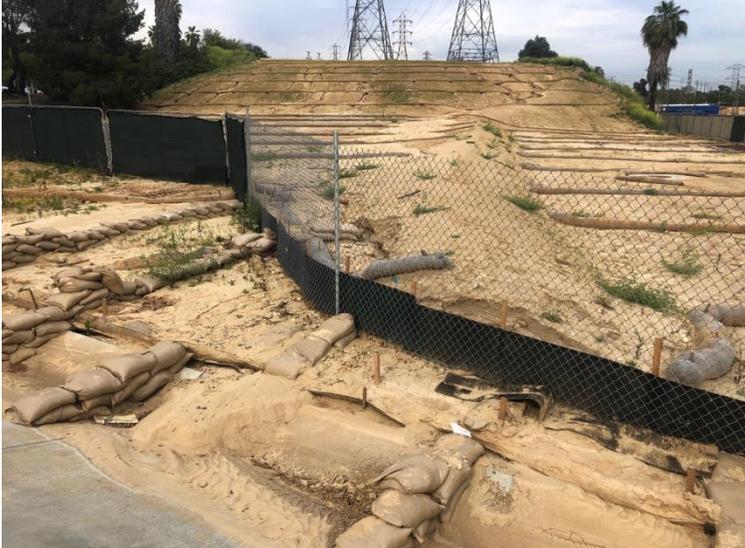
There were no signs of best management (BMP) repair work completed at the Transmission Corridor north of Potrero Grande Drive – Photos 15 & 16.

Photo 15 – BMPs north of Potrero Grande. Photo facing northwest.
4/11/19	Mesa Substation

Photo 16 – BMPs north of Potrero Grande. Photo facing east.

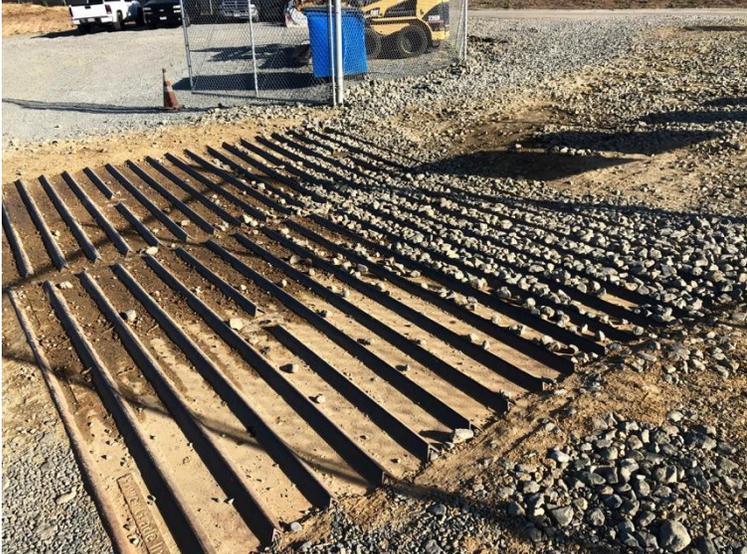
Photo 1 – Rumble plate once again filled with rock.
4/18/19	Mesa Substation

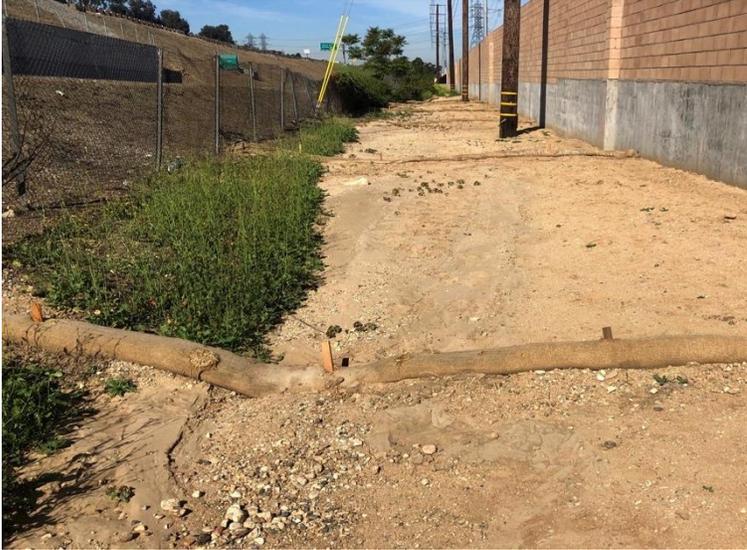
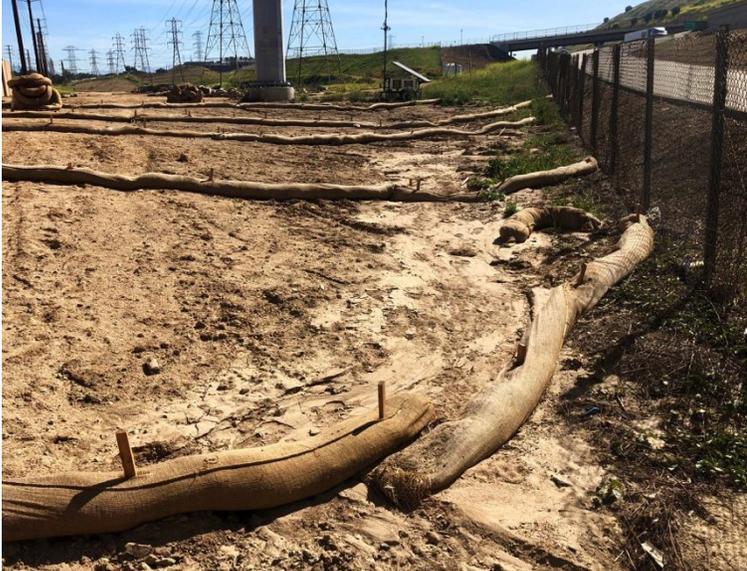
Some upgrades to best management practices (BMP) were completed outside of the southern boundary wall; however, most appeared to be in poor condition – Photos 11 & 12.

Photo 11 – BMPs installed outside of the southern boundary wall. Photo facing west.
4/18/19	Mesa Substation

Photo 12 – BMPs installed outside of the southern boundary wall. Photo facing east.

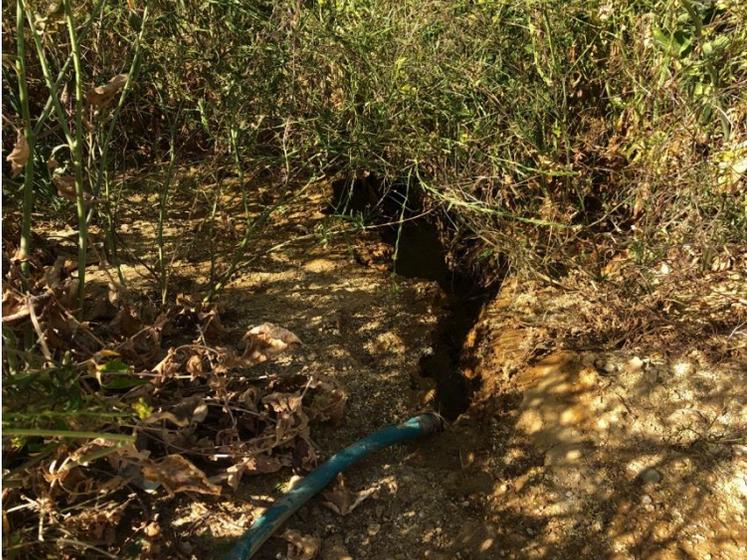
Photo 13 – Erosion rill on the western slope of the Mesa Operations Building construction area.
4/18/18	Mesa Substation
