## ecology and environment, inc.

### **Re: Monthly Report Summary #1 for the Mesa 500-kV Substation Project**

This report provides a summary of the compliance monitoring activities that occurred during the period from **September 29 to October 31, 2017**, for the Mesa 500-kV Substation (Mesa Substation) Project in Los Angeles County, California. Compliance monitoring was performed to ensure that all project-related activities conducted by Southern California Edison (SCE) and their contractors are in compliance with the requirements of the Final Environmental Impact Report (Final EIR) for Mesa, as adopted by the California Public Utilities Commission (CPUC) on February 9, 2017.

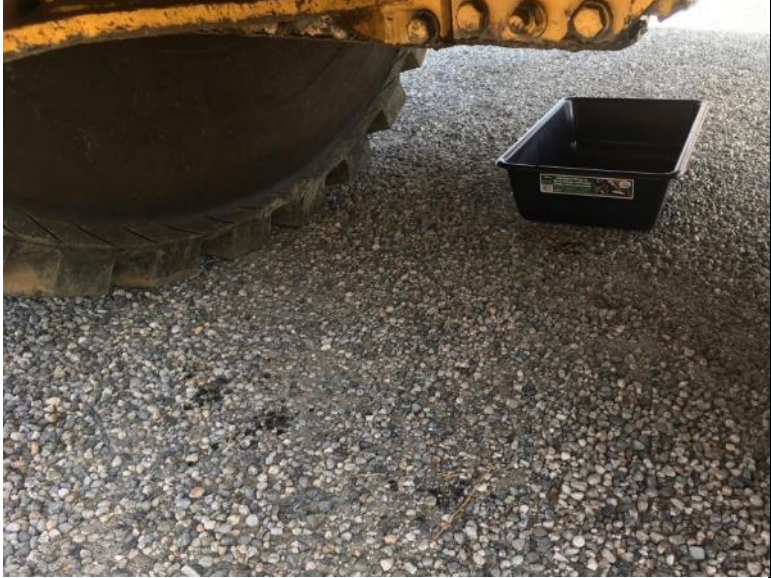
A number of large pieces of equipment were onsite and parked within the construction area (Photo 5). Drip pans had been placed under each piece of equipment but were not under portions of the engine that drip oil (Photo 6) (MM HZ-3). I noted several slow leaks of oil and/or hydraulic fluid coming from the equipment and dripping onto the gravel substrate. Later in the day, I attended another tailboard meeting and mentioned the inadequate placement and size of the drip pans. I briefly spoke with the SCE Environmental Project Manager Lori Rangel about the drip pans and the overall status of the Mesa Substation Project. I also spoke with Lucy Cortez-Johnson the Storm Water Pollution Prevention Plan (SWPPP) consultant (CASC Engineering and Consulting, Inc. [CASC]) and Klaus Wojak a SCE inspector, both of whom I had worked with on the Aliso Canyon Natural Substation Project.

Photo 6 – Drip pan underneath equipment. Note that the pan is not located under the drips.

Recommendation that they use larger drip pans under equipment.

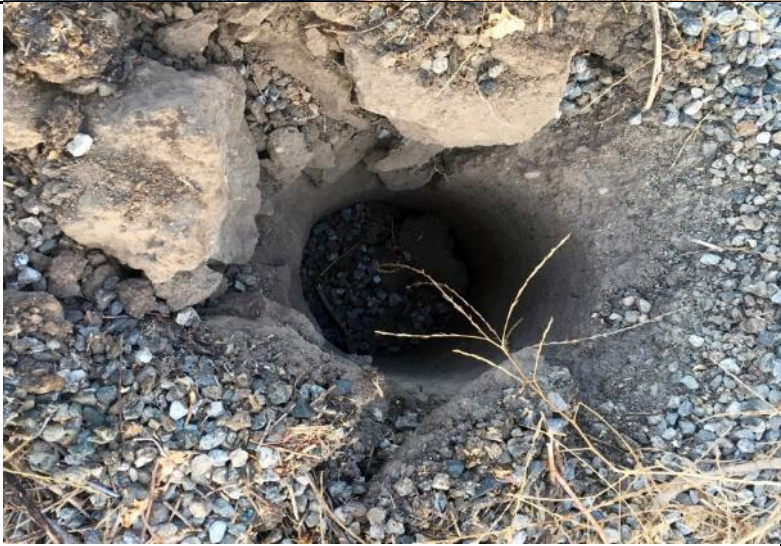
A crew was removing the old chain link fencing and had removed some of the concrete encased posts the day before. A number of the post holes remained and were not filled and were uncovered; they appeared to be approximately 12 inches in diameter and up to 2.5 feet deep (Photo 5). These holes can be pitfall traps for wildlife and safety hazards for crew members and project staff, therefore, the holes should be backfilled or covered at the end of each work day (MM BR-10). I mentioned the holes to the biological monitor Matt Daniele (ICF) and Power Grade Environmental Contact Craig Pernot; Matt Daniele told me later that the crew would backfill these holes before the end of the day.

Photo 5 – One of the many post holes left after the fence removal.
10-04-17	Mesa Substation

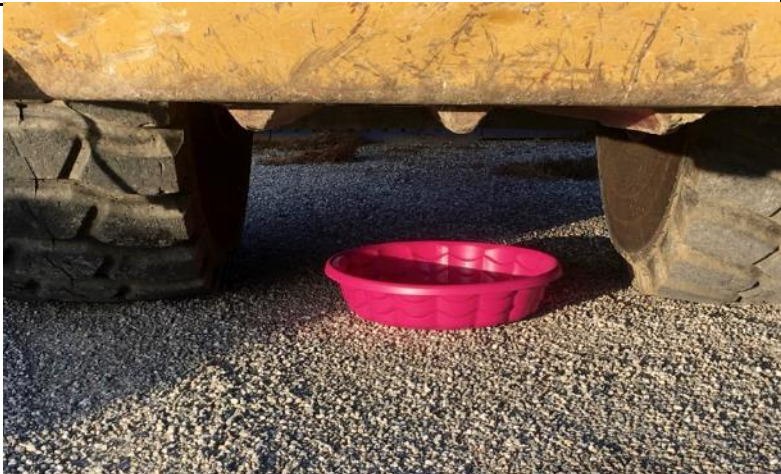
I walked to the equipment parked onsite and noted that additional and larger drip pans (kiddie pools) had been brought onsite and placed under the equipment (Photo 6) (MM HZ-3).

Photo 6 – New kiddie pool drip pans used in addition to the small black plastic drip pans.

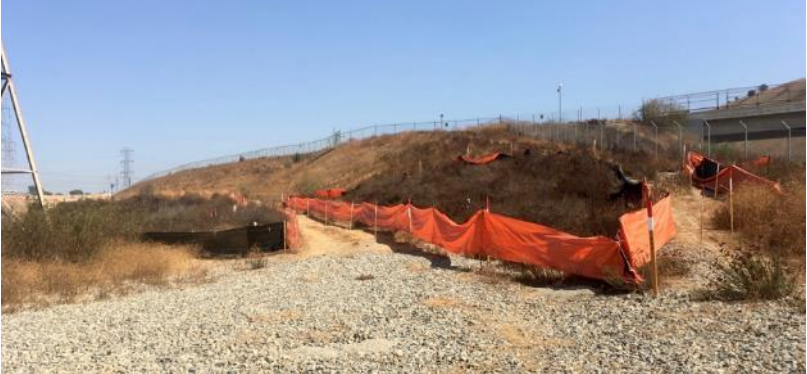
I walked by the Restricted Use Area located along the southeastern edge of the Mesa Substation site; this area supports coastal sage scrub (CSS) vegetation and had been cordoned off with orange silt fencing (APM BIO-01, MM BR-2) (Photo 6). Some portions of the area were lined with black silt fencing, but some of this fencing was in need of repair (Photo 7). It was unclear if the black silt fencing delineated any of the Restricted Use Area.

Photo 6 – Fencing around CSS sensitive habitat along the southeastern portion of the Mesa Substation site. Photo facing east

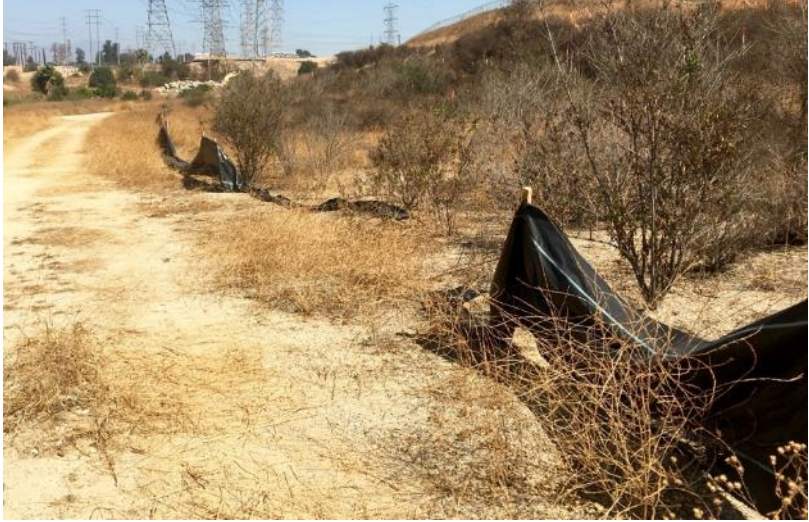
Photo 7 – Some of the exclusion fencing needs repair and replacement. Photo facing east
10-12-17	Mesa Substation

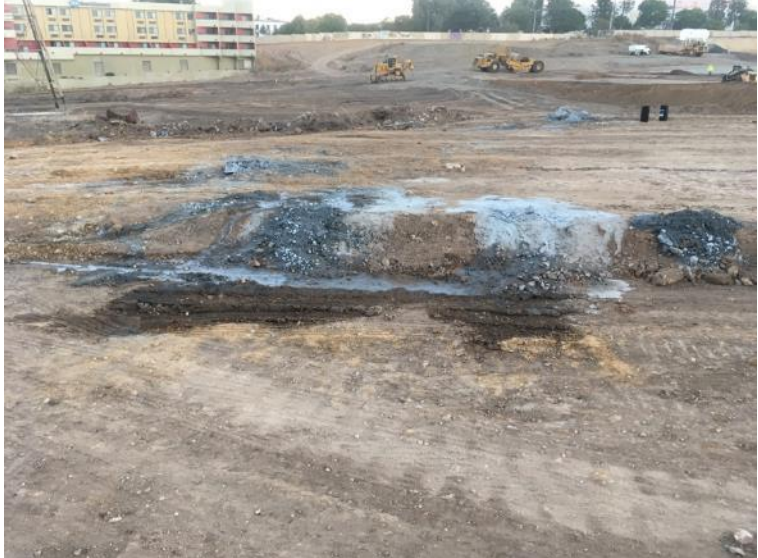
Photo 6 – Concrete washout spillage. Photo facing north.
10/24/17	Mesa Substation

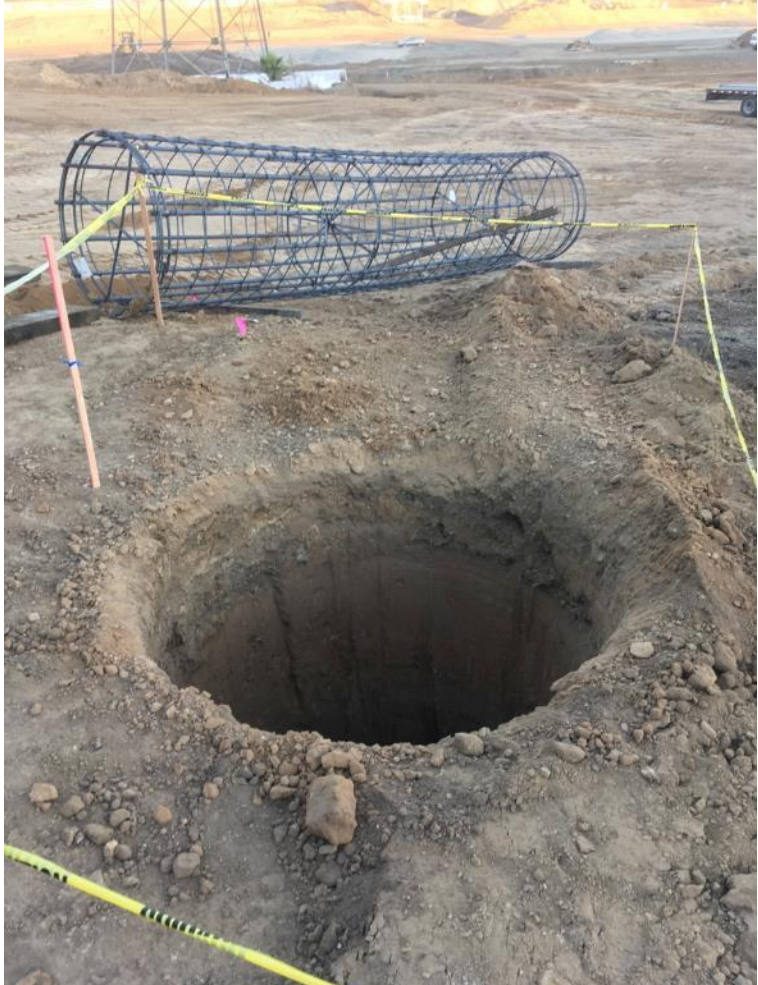
Photo 7 – Tubular steel pole (TSP) foundation cage with an open hole.

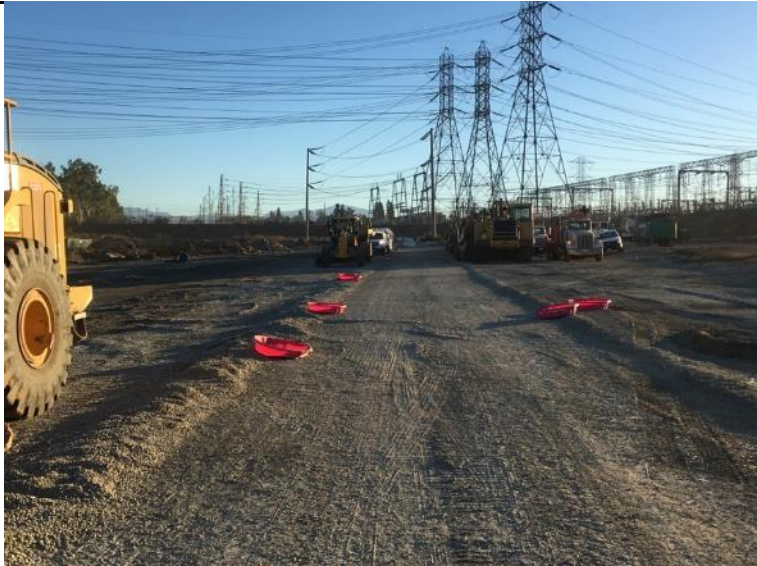
Photo 9 – Equipment parking area with kiddie pool drip pans.
