January 14, 2020

Re: Monthly Report Summary #21 for the Mesa 500-kV Substation Project

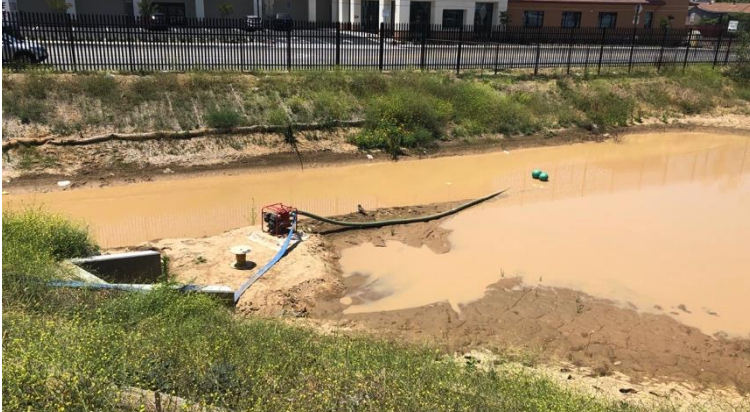
I arrived onsite at 1230 and noted that the concrete channel around the substation had been pumped out. Project Coordinator Pete Lubich (ULM Services, Inc.) said that the water would be used for dust suppression throughout the project site – Photo 1. The channel accumulated a significant amount of sediment, vegetative material, and trash, and should be cleaned out before the next rainy season. The Power Grade crew completed pumping water out of the catch basin that is located south of the existing substation – Photo 14. The crew was pumping water out of the “triangular” retention basin at the western end of the project site – Photo 9. The water pump placed in the triangular retention basin was not well contained; I notified Pete Lubich about this concern.

Photo 9 – Pumping captured rainwater out of the triangular retention basin. The water would be used for dust control. The pump is inadequately contained. Photo facing northwest.

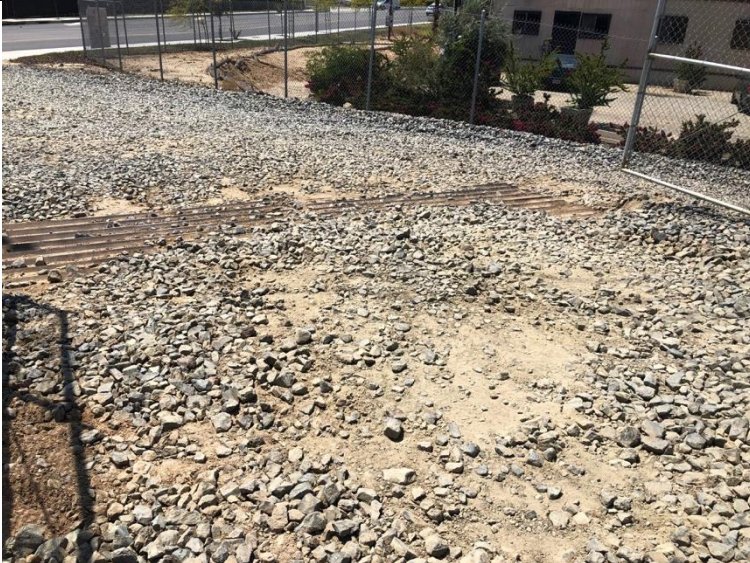
The trash previously noted along the entry fence had been removed. The rumble plates at the main project entry/exit appeared clean. However, the entry/exit best management practices (BMPs) east of Market Place Drive leading to the construction trailers and staging area needed upgrades – Photo 17. I notified Project Coordinator Pete Lubich (ULM Services, Inc.) about this concern.

Photo 17 – Exit/Entry BMP east of Market Place Drive needs maintenance. Photo facing northwest.
6/6/19	Mesa Substation

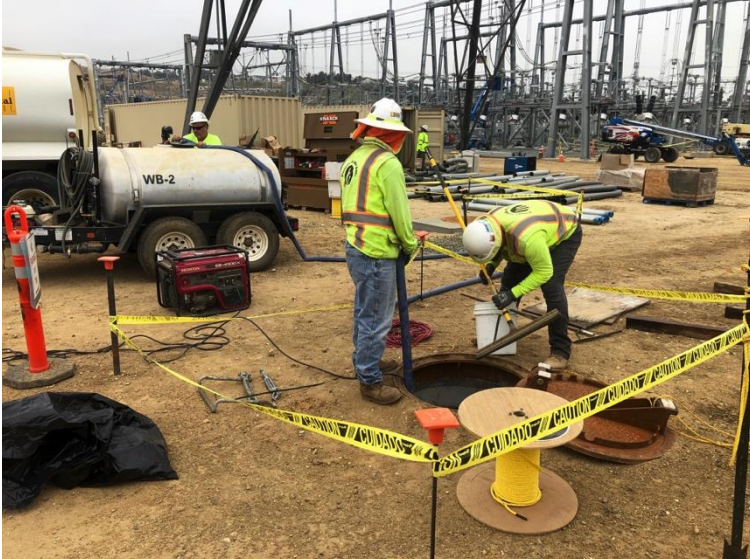
Photo 2 – Crew pumping out a conduit vault – note the lack of a drip pans under the generator. Photo facing south.
6/13/19	Mesa Substation

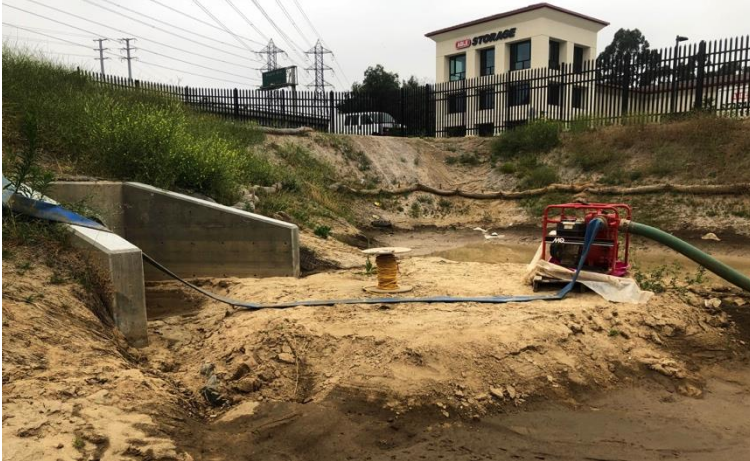
<p>Photo 11 – Pumping rainwater runoff out of the triangular retention basin. The pumped water would be used for dust control. The pump was contained with a small kiddie pool. Photo facing west.</p>
6/13/19	Mesa Substation

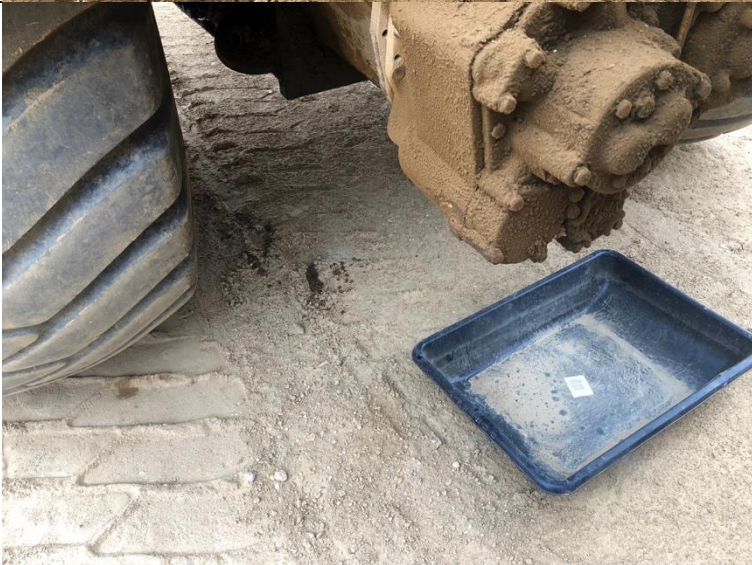
Photo 14 – Poorly placed drip pans – more than one pan is needed for this piece of equipment.
6/13/18	Mesa Substation

- On June 6, 13, 19, and 26 2019, the CPUC Compliance Monitor observed inadequate drip pan placement underneath parked equipment that was not being utilized. The CPUC Compliance Monitor recommended increasing the frequency of ensuring proper drip pan placement.

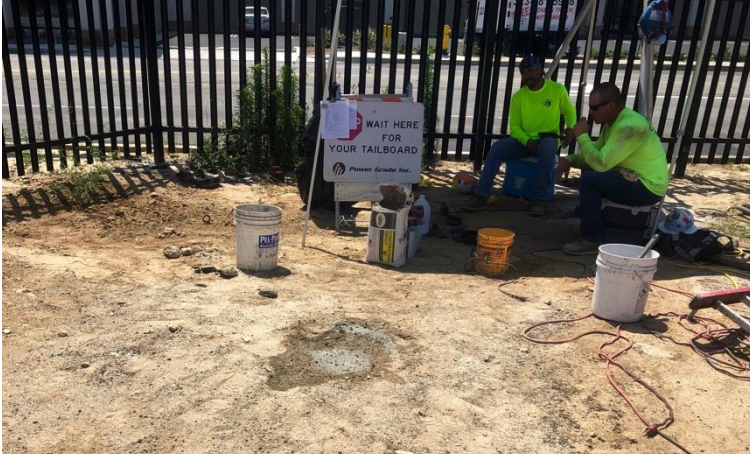
A small construction crew was working on the manhole covered access shaft to the stormwater drainage system at the far western portion of the site near East Markland Drive. I noted some small concrete washouts near the site – Photo 6 – and an inadequate containment system for their generator – Photo 7. Power Grade foreman Willie Clark came by and I pointed out both issues to him. He said they would lift the concrete and get better containment for the generator.

Photo 6 – A crew working on the storm drain system near E. Markland Drive – note the concrete washout on the ground. Photo facing west.

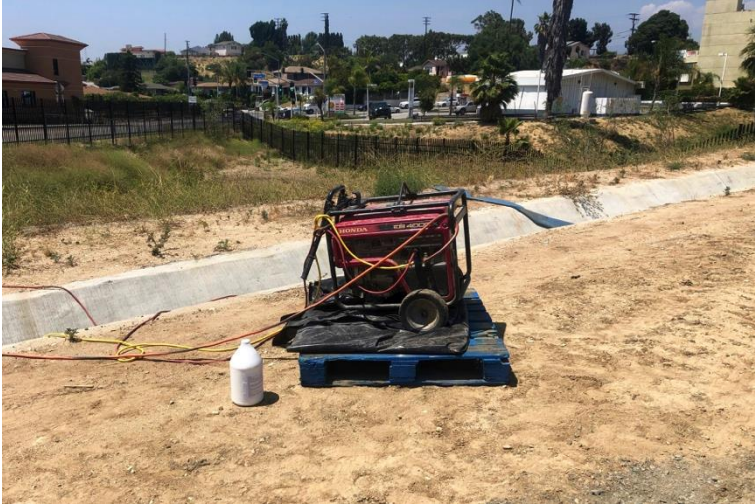
Photo 7 – Generator with an inadequate catch basin. Photo facing north.
6/19/19	Mesa Substation

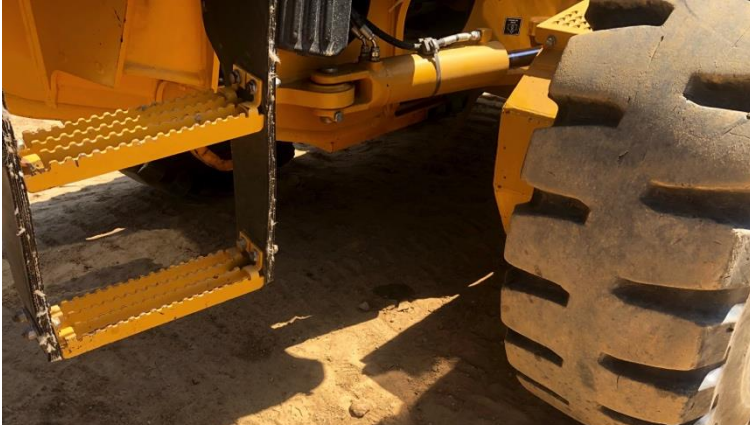
Proper drip pan placement under the parked equipment continued to be a issue – Photo 14. I recommended a larger, plastic-lined catchment basin to be installed for large equipment, such as scrapers.

Photo 14 – No drip pan in place.
6/19/18	Mesa Substation
