January 14, 2020

**Re: Monthly Report Summary #22 for the Mesa 500-kV Substation Project**

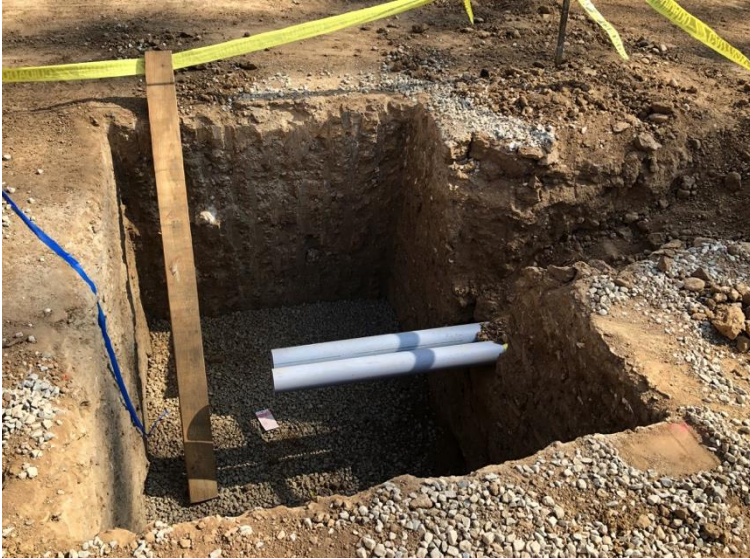
Photo 11 – Conduit vault work, note the board installed as a climbing structure.

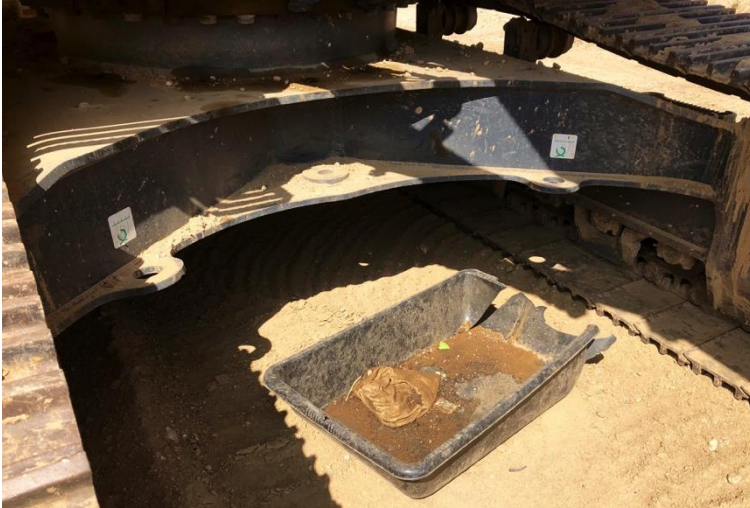
Drip pans were not properly placed underneath equipment – Photo 13. Some of the pans appeared to be in poor condition – Photo 14.

Photo 14 – Poorly placed and broken drip pan.
7/10/18	Mesa Substation

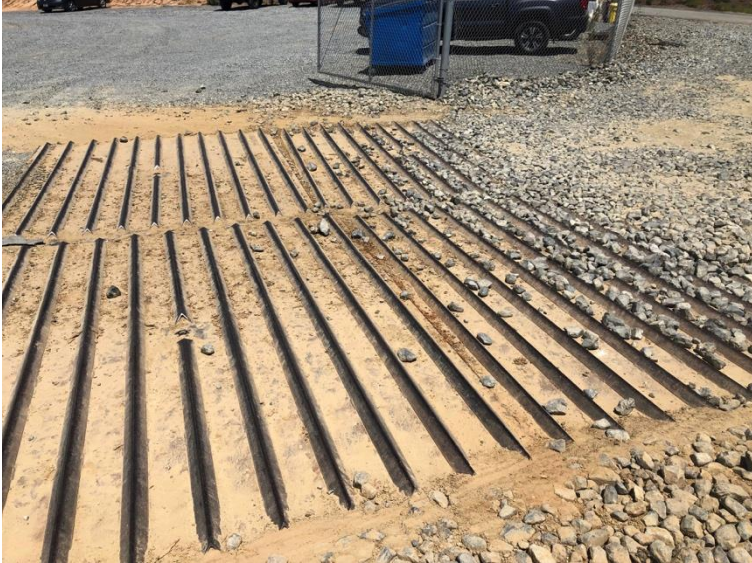
Photo 1 – Main project exit/entry needs cleaning.
7/17/19	Mesa Substation

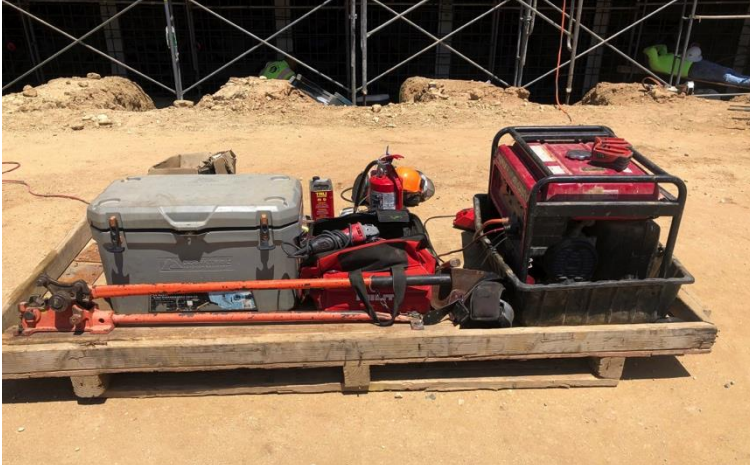
Construction work continued on the northern retaining wall. Crews continued applying the moisture barrier and rebar along the inside of the wall – Photo 3. Gas generators used for this work were well contained – Photo 4.

Photo 4 – Gas generator with excellent containment.
7/17/19	Mesa Substation

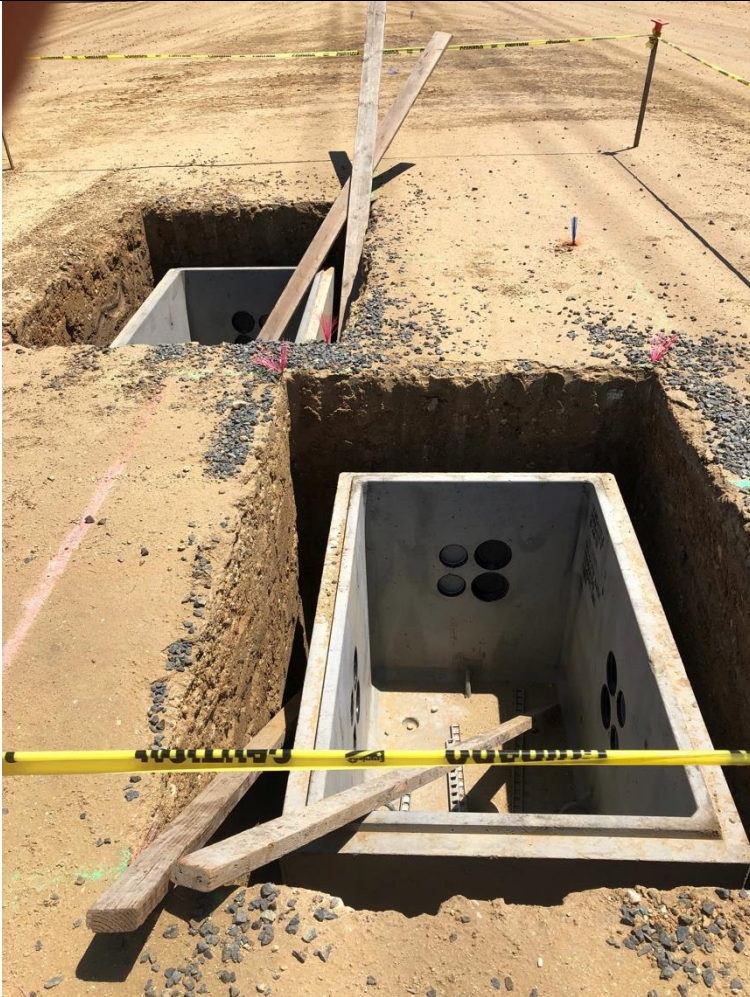
Plastic conduit pipe and conduit vaults were being installed at various locations throughout the project site – Photos 5, 6, & 11. Climbing structures were installed for trapped animals. I inspected one of the numerous trash bins onsite and noted that a large amount of wood and plastic conduit pipe had been thrown away – Photo 15. I spoke to Project Coordinator Pete Lubich (ULM Services, Inc.) about whether they were doing any recycling for that material and he responded that they were only recycling metal.

Photo 5 – Conduit vaults with climbing structures.

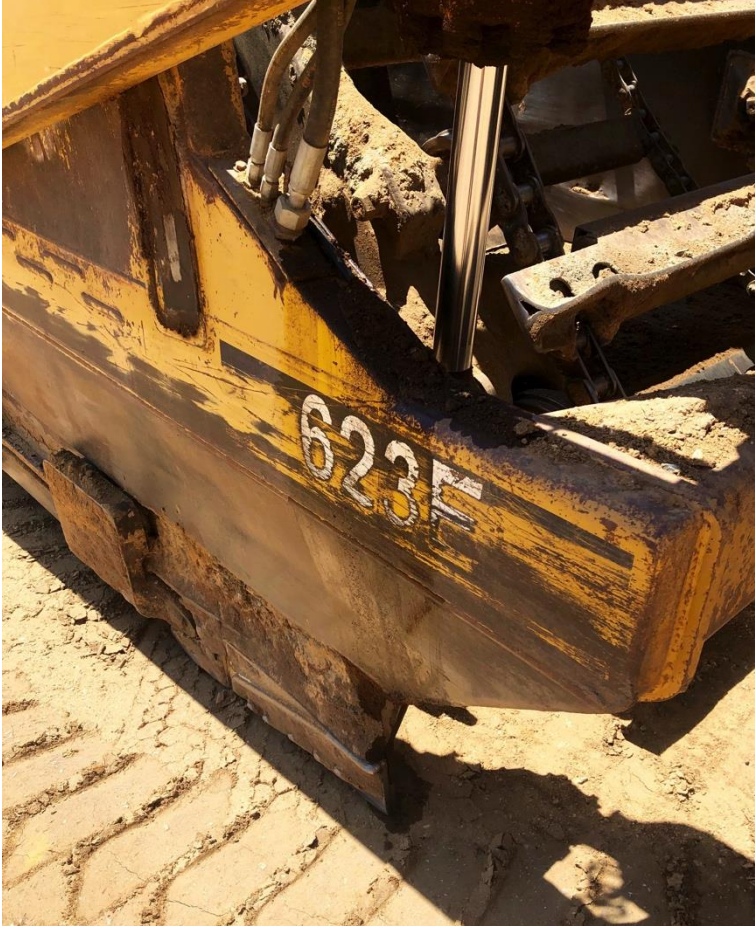
Photo 8 – Parked and leaking loader.
7/17/19	Mesa Substation

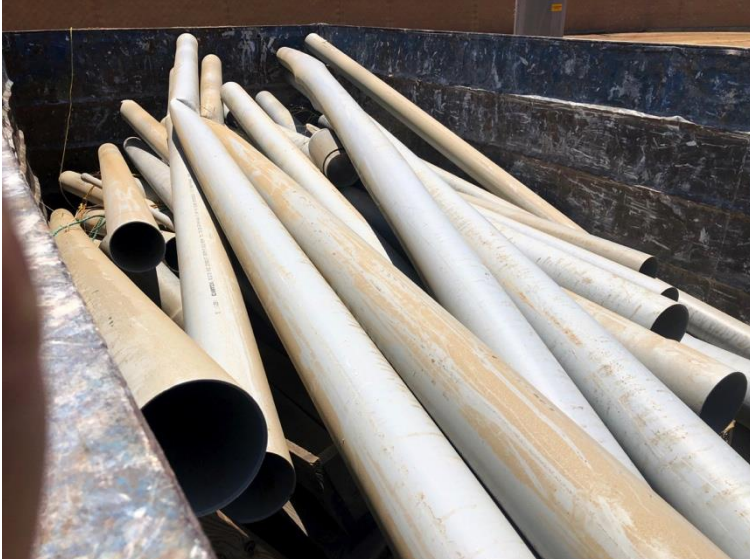
Photo 15 – Plastic conduit pipe in a trash bin.

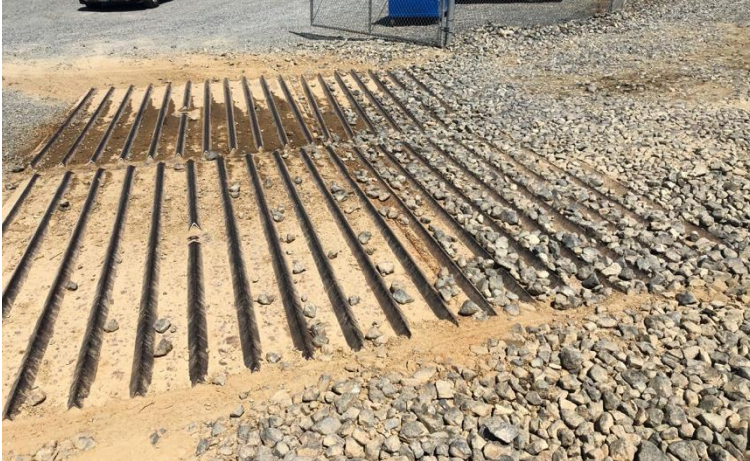
Photo 1 – Main project exit/entry needs cleaning.
7/24/19	Mesa Substation

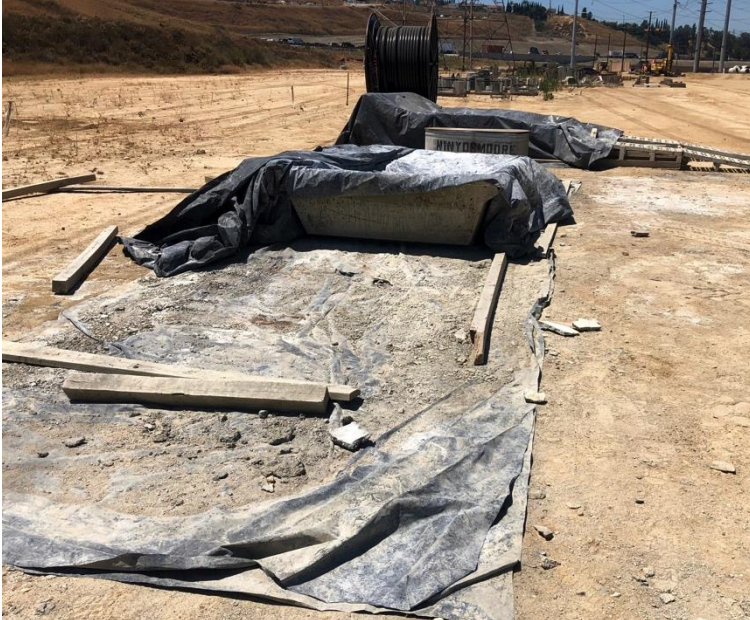
Photo 12 – Concrete washout area needs cleaning. Photo facing southwest.
7/24/19	Mesa Substation

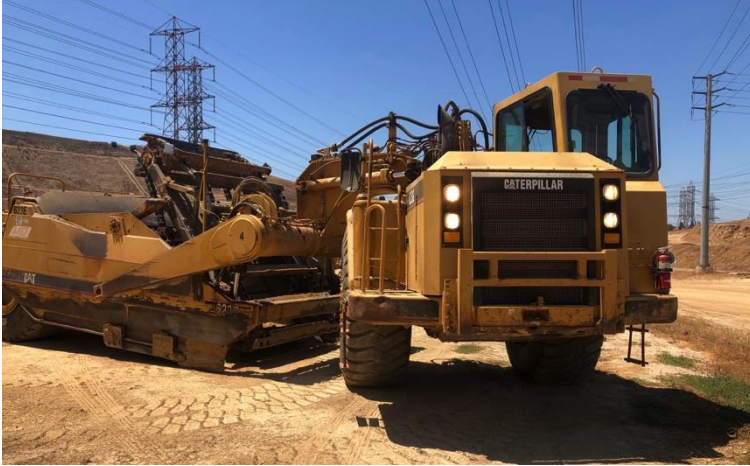
- On July 24, 2019, the CPUC Compliance Monitor noticed a loader parked near the Mesa Operations Building. The engine was running while not being operated and had no drip pans underneath. The Prava construction superintendent and contractor were notified. Further, the equipment remained idling for the remainder of his visit. The CPUC Compliance Monitor recommended that equipment not be left idling when not being operated.

Photo 13 – Parked & idling loader – no drip pans placed underneath.
7/24/18	Mesa Substation

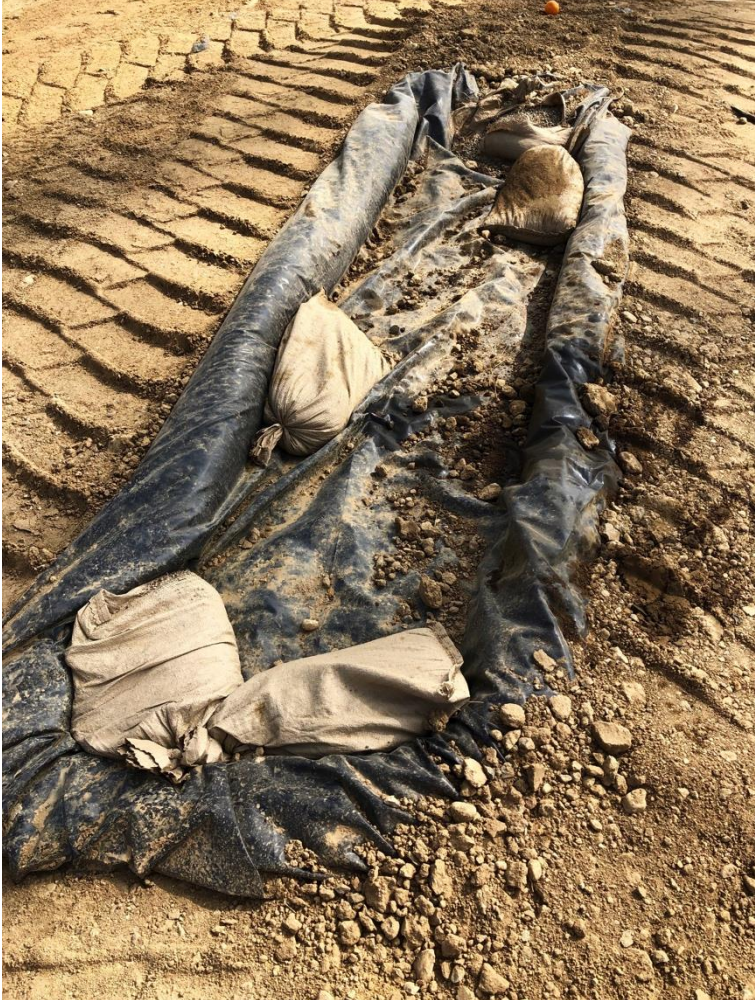
Photo 12 – Catch basin was not built wide enough to catch leaking fluids.
7/31/19	Mesa substation/ Mesa Operations Building
