January 15, 2020

**Re: Monthly Report Summary #25 for the Mesa 500-kV Substation Project**

This report provides a summary of the compliance monitoring activities that occurred during the period from **October 1 to 31, 2019**, for the Mesa 500-kilovolt (kV) Substation (Mesa Substation) Project in Los Angeles County, California. Compliance monitoring was performed to ensure that all project-related activities conducted by Southern California Edison (SCE) and their contractors comply with the requirements of the Final Environmental Impact Report (Final EIR) for the Mesa Substation Project, as adopted by the California Public Utilities Commission (CPUC) on February 9, 2017.

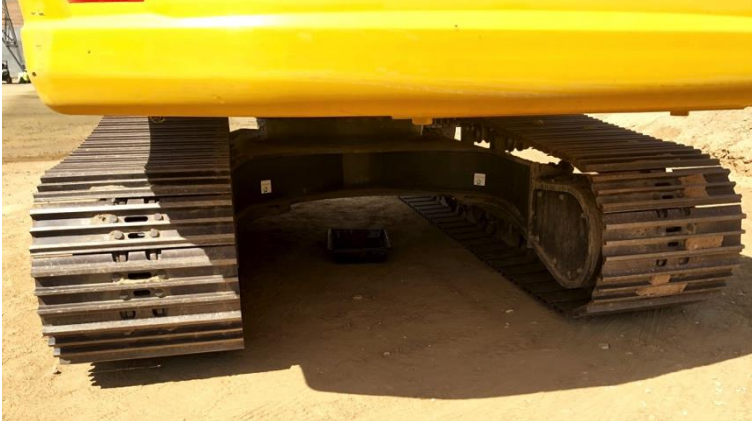
Drip pans under equipment remained an ongoing issue throughout the project site. A large drill rig was parked near the Senior Mechanical Electrical Equipment Room (MEER) building and had a small drip pan inadequately placed under the engine – Photo 2. A loader and other equipment were parked near the southern boundary of the project site, and they each had a small and poorly placed drip pan underneath. I could see liquid on the ground – Photo 12. Some pieces of equipment parked at the Mesa Operations Building had damaged drip pans – Photo 13 – or no drip pans at all. I discussed my concerns about the drip pans with Project Coordinator Pete Lubich (ULM Services, Inc.).

<p>Photo 2 – Inadequate drip pan placed under a big drill rig.</p>
10/03/19	Mesa Substation

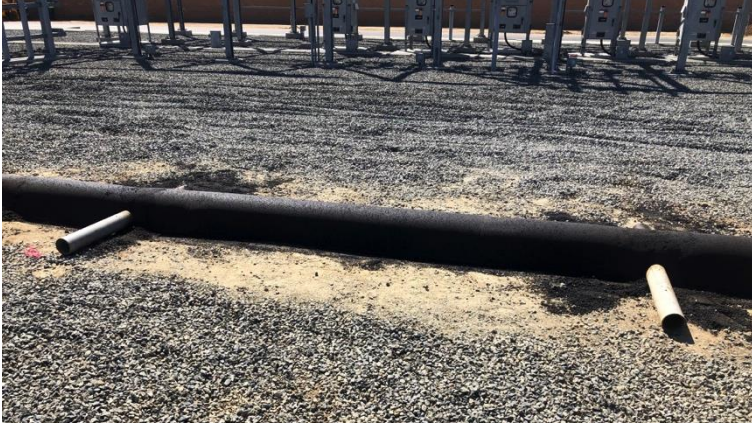
The temporary catch basin berm installed within the 16-kV switchrack area was replaced with an asphalt berm – Photo 7. Pipes were placed through the berm. Eventually, ball valves will be installed in the piping.

Photo 7 – New asphalt catch basin barrier within the 16-kV switchrack area. Photo facing west.
10/03/19	Mesa Substation

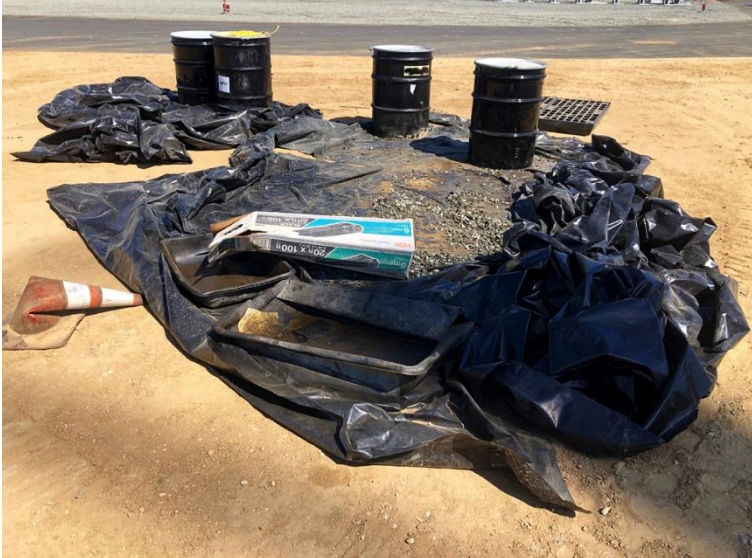
Photo 8 – Final cleanup of the hydraulic fluid spill.
10/03/19	Mesa Substation

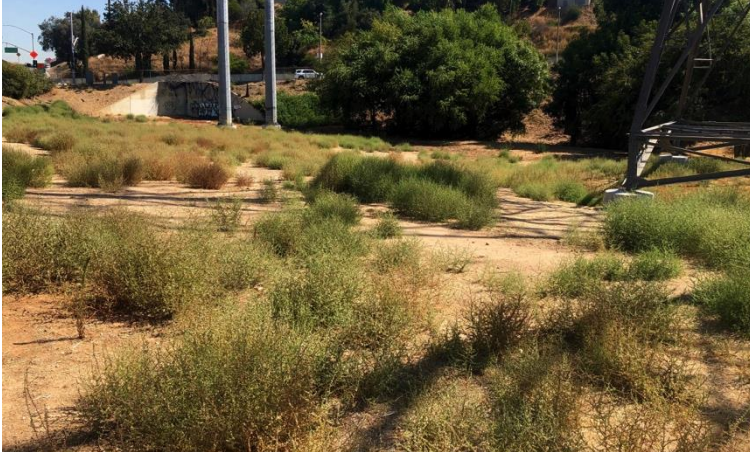
I arrived onsite at 1300 and notified Project Coordinator Pete Lubich (ULM Services, Inc.). While driving to the substation, I noted large amounts of Russian thistle growing in the Transmission Corridor south of Highway 60.

<p>Photo 1 – Russian thistle within the Transmission Corridor, located south of Highway 60. Photo facing southeast.</p>
10/08/19	Mesa Substation

- On October 8, 2019, the CPUC Compliance Monitor noted a significant amount of Russian thistle in the large detention basin. The Russian thistle was maturing and the CPUC Compliance Monitor recommended removal soon before they seed.

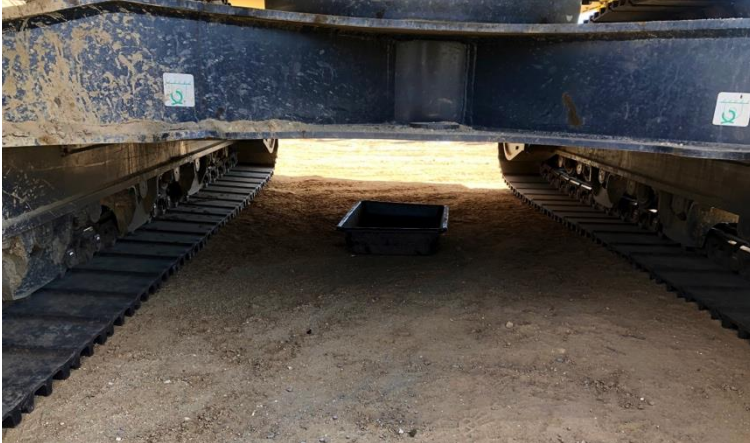
<p>Photo 2 – The same inadequate drip pan placed under the drill rig parked near the Senior MEER.</p>
10/08/19	Mesa Substation

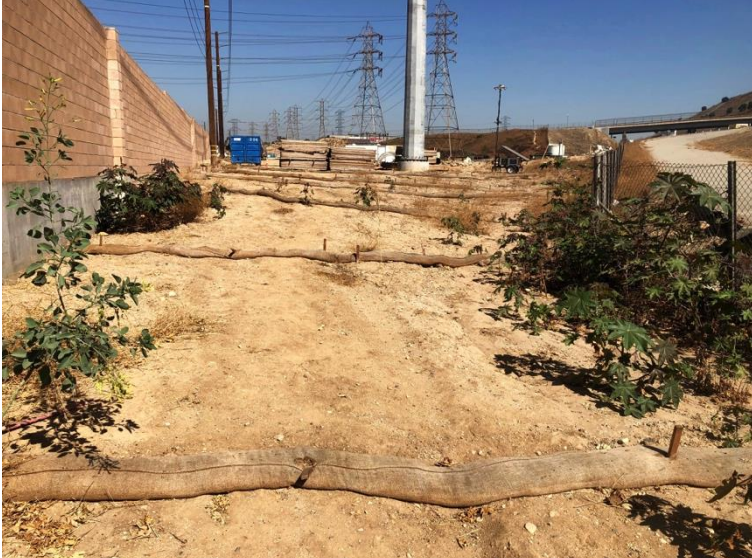
Photo 9 – Old BMPs along the outside of the southern boundary wall. Photo facing east.
10/08/19	Mesa Substation

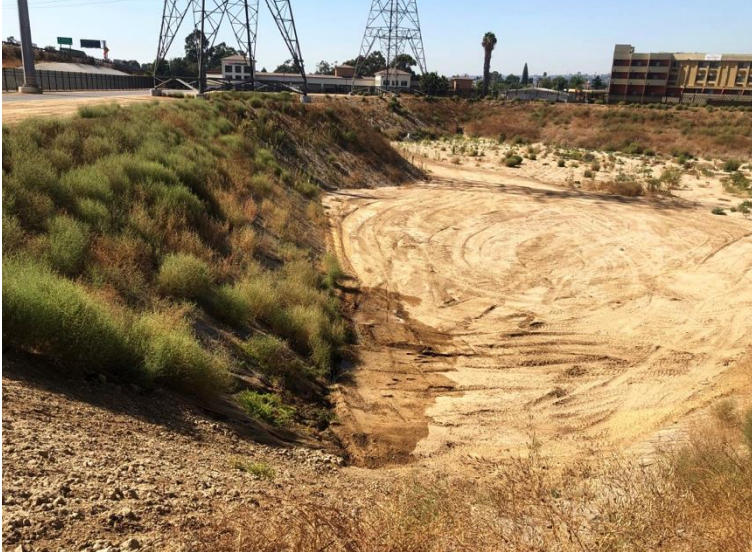
Photo 10 –Russian thistle and the water seep at the large detention basin Photo facing west.

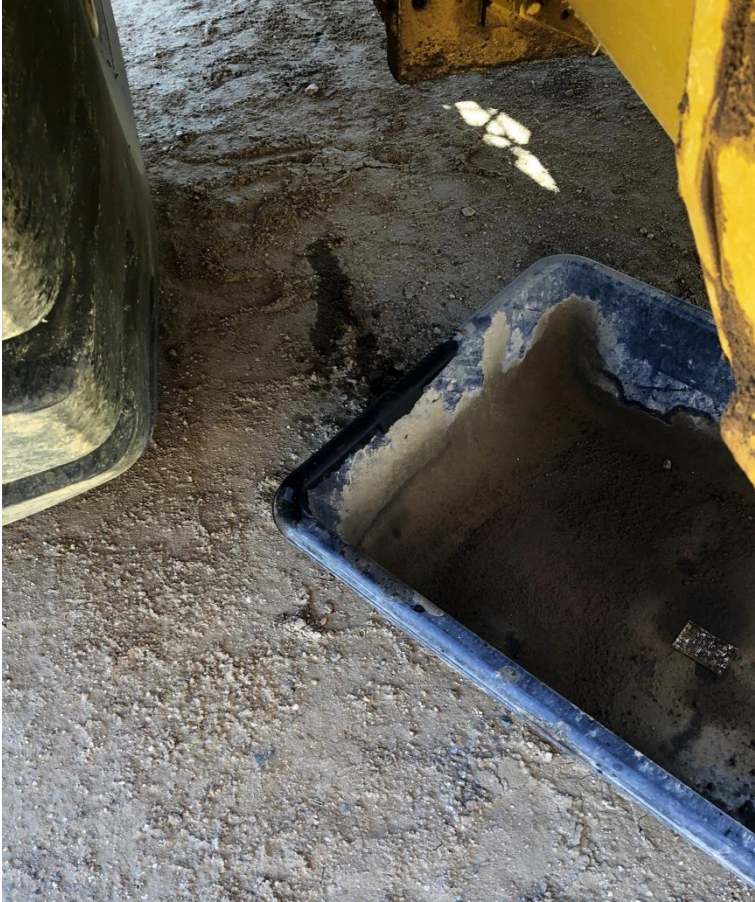
Photo 11 – Poorly placed drip pan.
10/08/19	Mesa Substation

I walked through the large equipment parking area and noted damaged drip pans laying around, equipment without drip pans, and equipment with inadequate drip pans – Photo 11. Not a single piece of equipment was adequately contained.

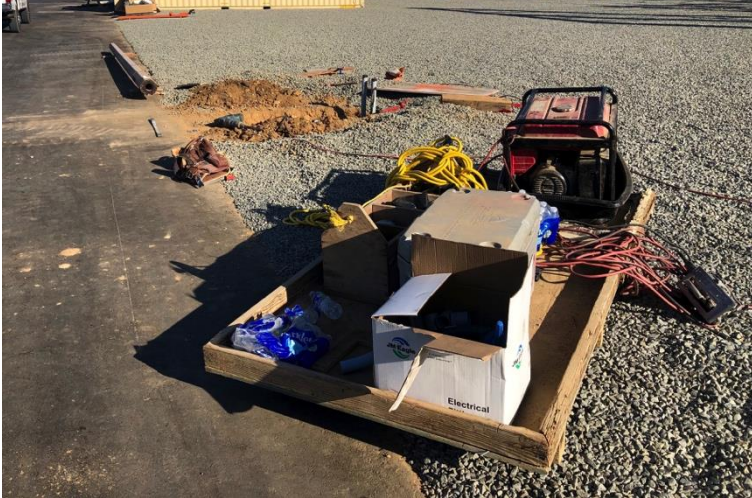
<p>Photo 7 – Light pole installation along the paved road – note the well-contained gas generator.</p>
10/16/19	Mesa Substation

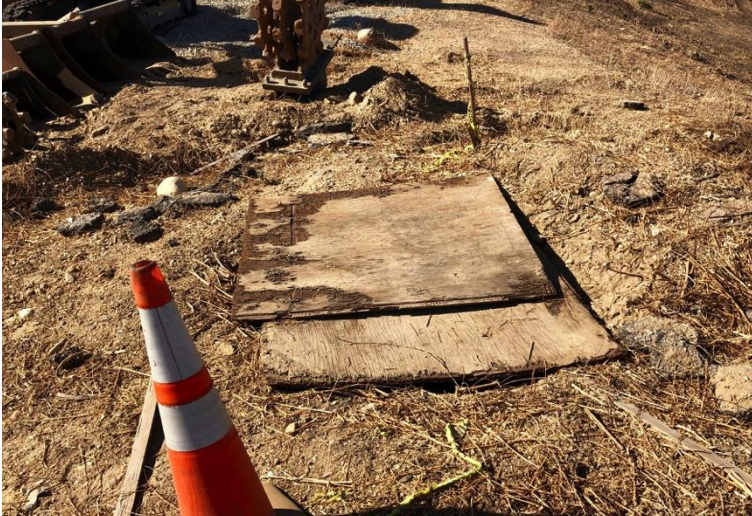
- On October 16, 2019, the CPUC Compliance Monitor noted an excavated hole partially covered with plywood and empty around the edges. The CPUC Compliance Monitor explained to personnel onsite the importance of sealing up the edges, in order to prevent small animal entrapment.
- On October 30, 2019, the CPUC Compliance Monitor noted a construction work area with significant dust blowing west across Markland Drive. The CPUC Compliance Monitor spoke to the operator and recommended getting a water truck to spray that work area to suppress dust

Photo 14 – Covered hole needed to be sealed around the boards.

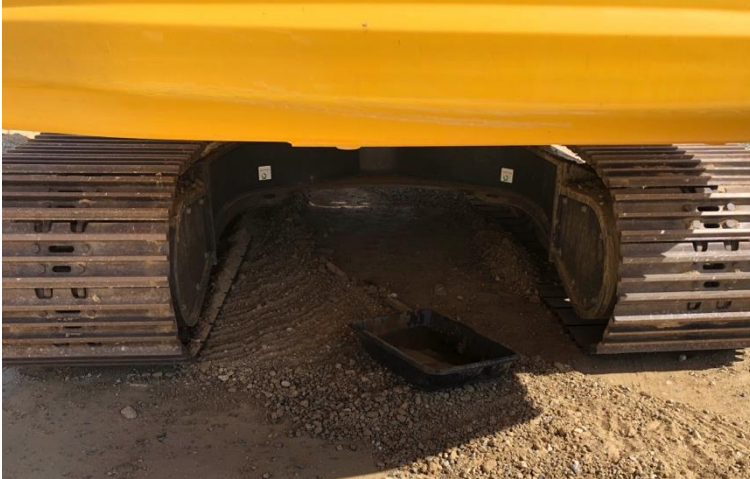
<p>Photo 2 – Inadequate drip containment under parked equipment.</p>
10/30/19	Mesa Substation
