February 23, 2021

Re: Monthly Report Summary #29 for the Mesa 500-kV Substation Project

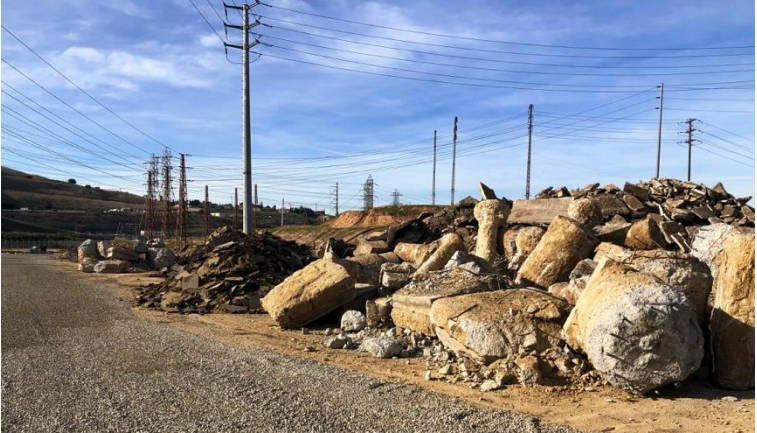
Photo 3 – Stockpiled material from the old substation. Photo facing southwest.

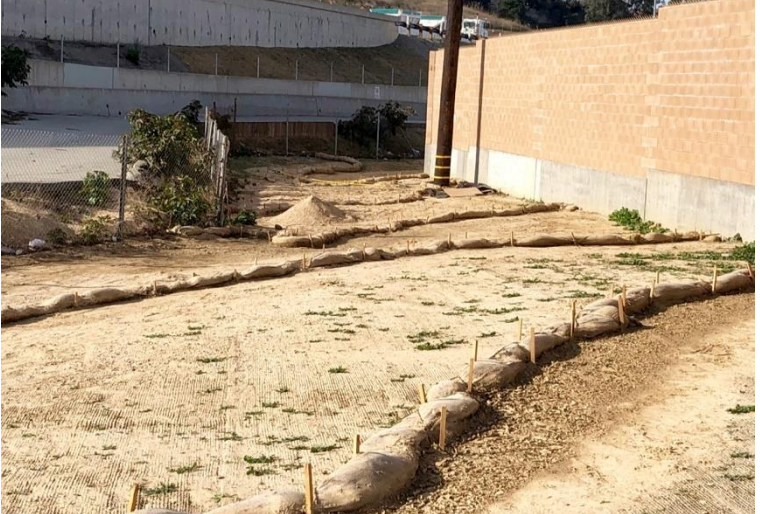
Photo 7 – BMPs along the outside of the southern boundary wall – note the pile of captured sediment needing to be removed. Photo facing southwest.
2/05/20	Mesa Substation

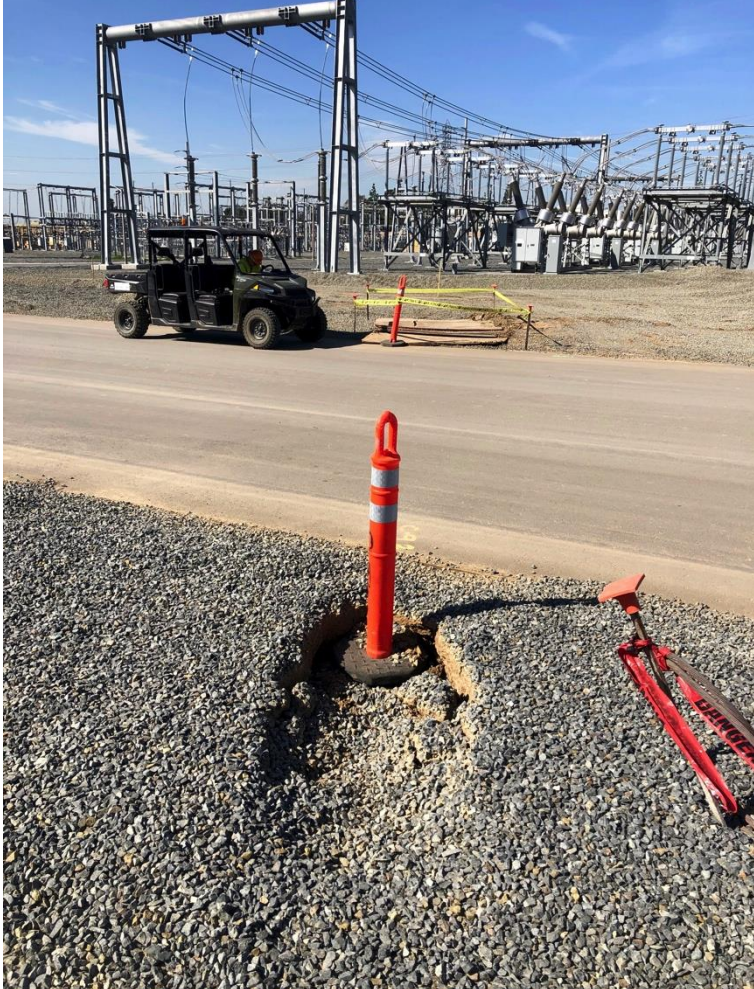
Photo 8 – Sink hole over a trench line near the southern portion of the 66- and 220-kV rack areas. Photo facing north

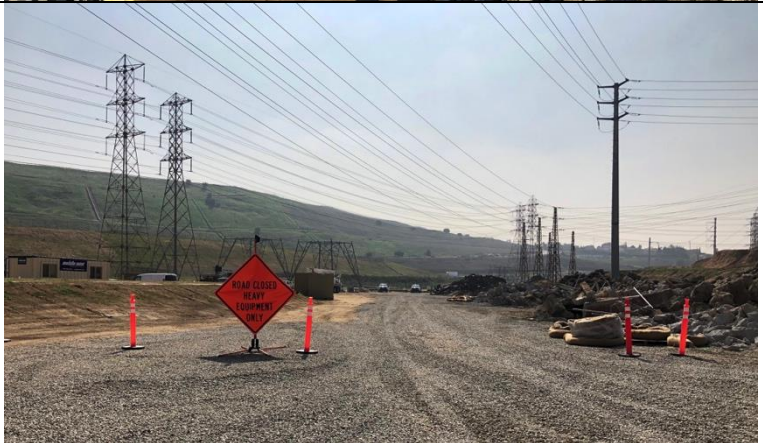
Mr. Daniele accompanied me on a site visit through the substation. We entered through the eastern entrance and noted signage excluding heavy equipment from traveling down the southern access road (Photo 3). Mr. Daniele said this was due to the discovery of a coastal California gnatcatcher (*Polioptila californica*) nest found in the Environmentally Sensitive Area (ESA) vegetation along the southern edge of the construction site. The avian biologist has established a 300-foot buffer around the nest site (Photo 4). Some tower construction was being performed just outside of the buffer. They were hoping to obtain a buffer reduction down to 200 feet as this would allow vehicles to utilize the access road.

Photo 3 – Road closure signage because of the nesting coastal California gnatcatchers. Photo facing southwest.

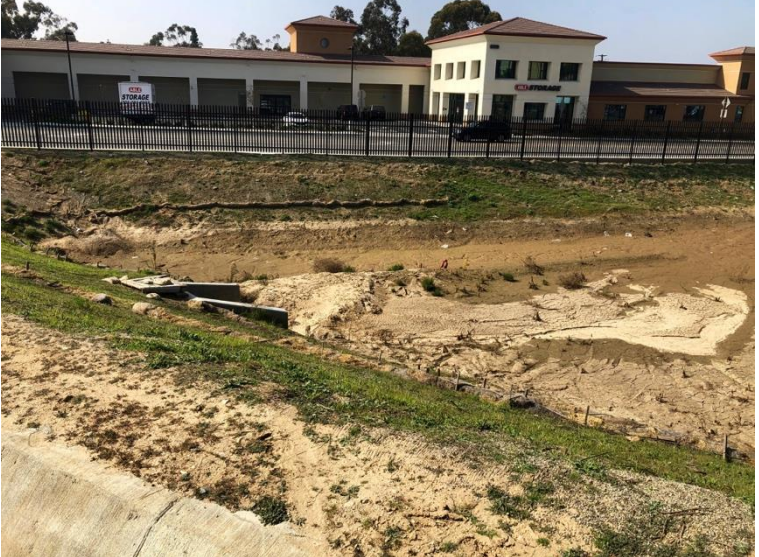
Photo 5 – The small triangular detention basin is dry and remains full of sediment. Photo facing west.
2/19/20	Mesa Substation

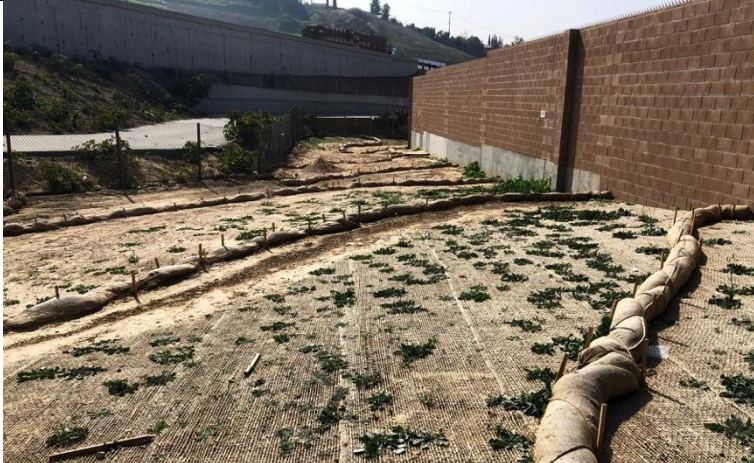
<p>Photo 8 – No upgrades to the BMPs have been completed along the outside of the southern boundary wall. Photo facing southwest.</p>
2/19/20	Mesa Substation

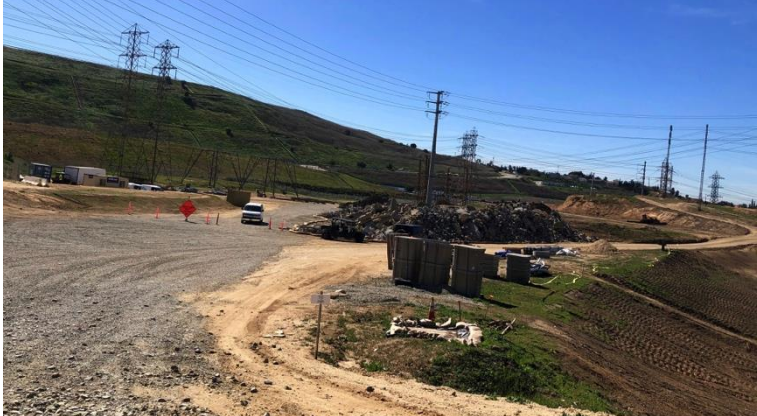
Construction materials from the Phase 3 grading operation continued to be stockpiled over in the southeastern portion of the project site (Photo 1). The access road through this area remains partially blocked because of the coastal California gnatcatcher (*Polioptila californica*) nest found in the Environmentally Sensitive Area (ESA) vegetation along the southern edge of the construction site (Photo 2). Mr. Daniele said they were continuing to wait on buffer reduction approvals. According to Mr. Daniele, the birds were continuing to build their nest.

Photo 1 – Stockpiled materials and partially blocked access road along the southern portion of the project. Photo facing southwest.
2/26/20	Mesa Substation

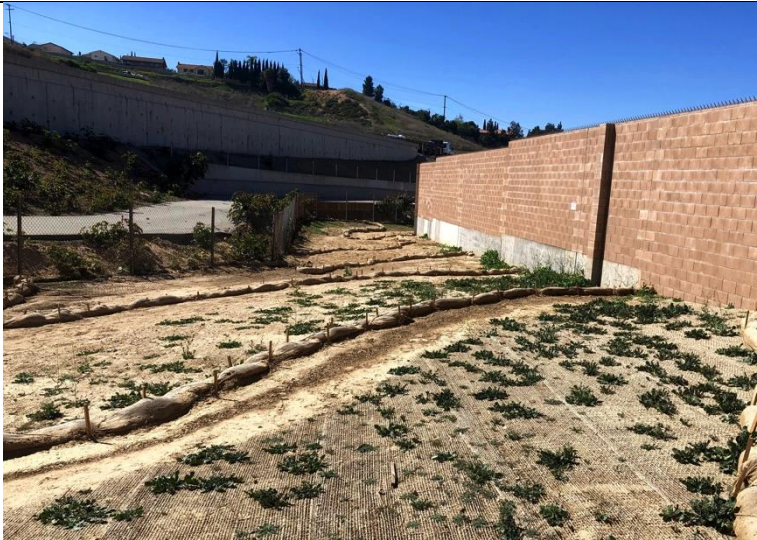
Photo 6 – No upgrades to the BMPs have been completed along the outside of the southern boundary wall. Photo facing southwest.
