February 23, 2021

Connie Chen
Project Manager
California Public Utilities Commission
505 Van Ness Avenue
San Francisco, CA 94102

Re: Monthly Report Summary #30 for the Mesa 500-kV Substation Project

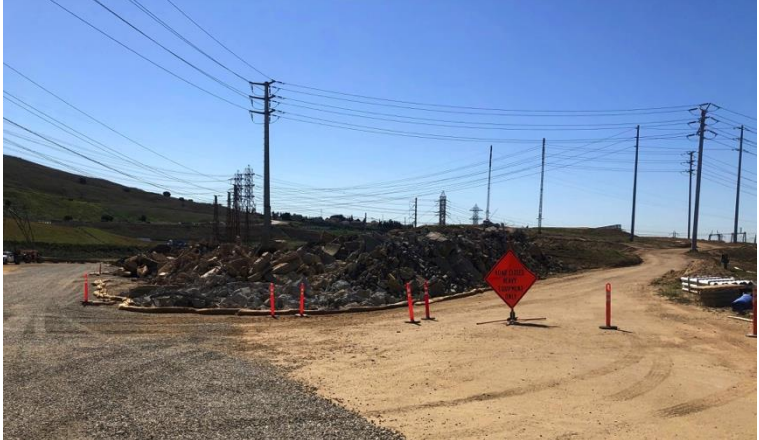
Photo 1 – Stockpiled materials and partially blocked access road along the southern portion of the project. Photo facing southwest.
3/03/20	Mesa Substation

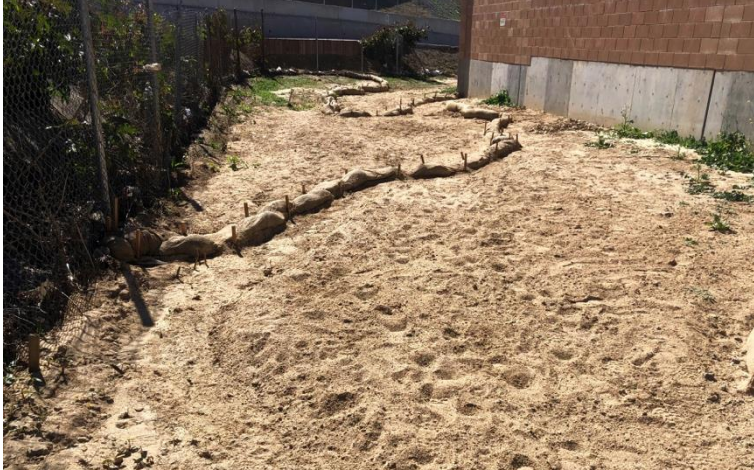
Photo 6 – Captured sediment remains in and around the straw wattles. Photo facing southwest.

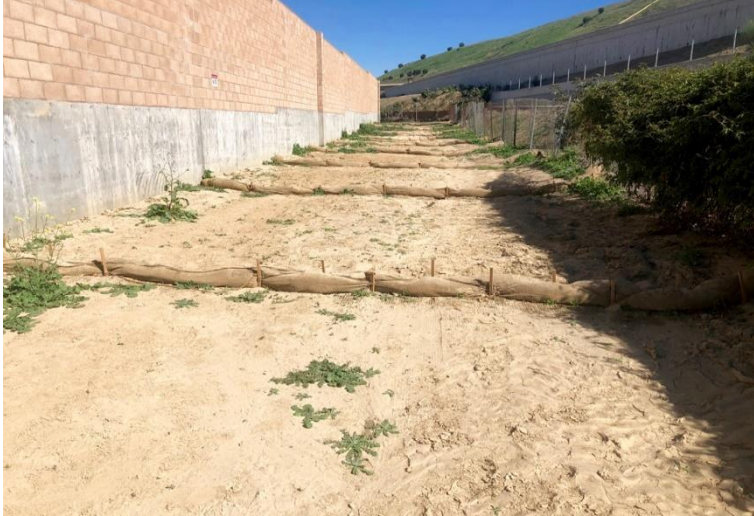
Photo 7 – Degraded straw wattles along the outside of the southern boundary wall. Photo facing east.
3/03/20	Mesa Substation

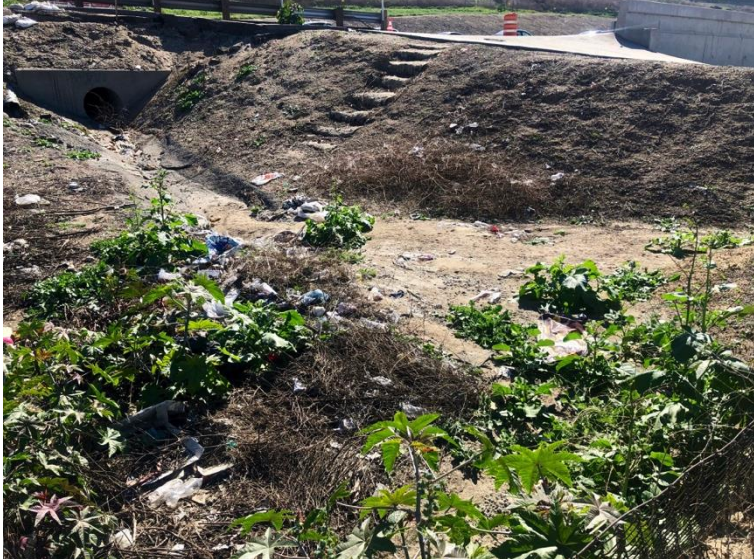
I observed a drain opening coming off Highway 60 (Photo 8). Some of this water appears to have been diverted into the project site by an accumulation of weeds, trash, and sediment. This could be easily fixed and was documented in an earlier report.

Photo 8 – Drain channel coming from Highway 60. Photo facing south.
3/03/20	Mesa Substation

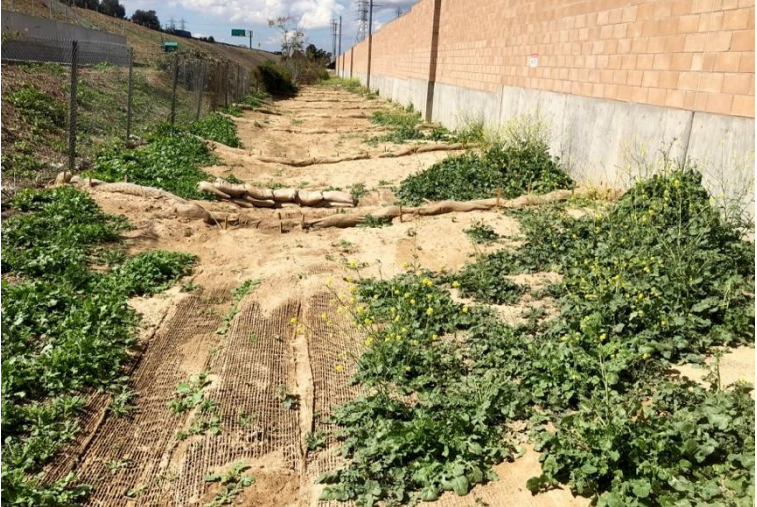
I walked the length of the BMP area outside of the southern boundary wall, noting that there had been no maintenance or upgrades to any of the BMPs (Photo 5). At the concrete-lined California Department of Transportation (CalTrans) channel just downstream of the BMP area, accumulated sediment was observed in the lower portion of the channel but not in the top half (Photo 6).

Photo 5 – BMPs along the outside of the southern boundary wall. Photo facing west.
3/11/20	Mesa Substation

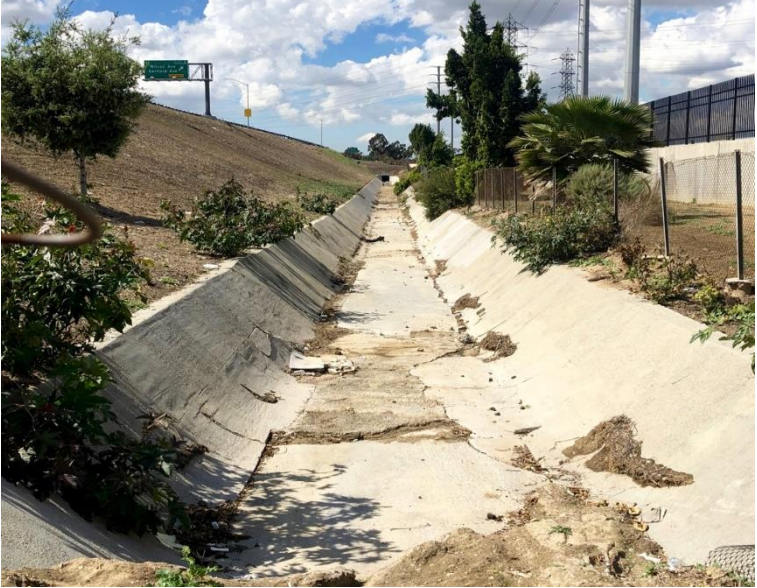
Photo 6 – CalTrans channel outside of the southern boundary wall. Photo facing west.

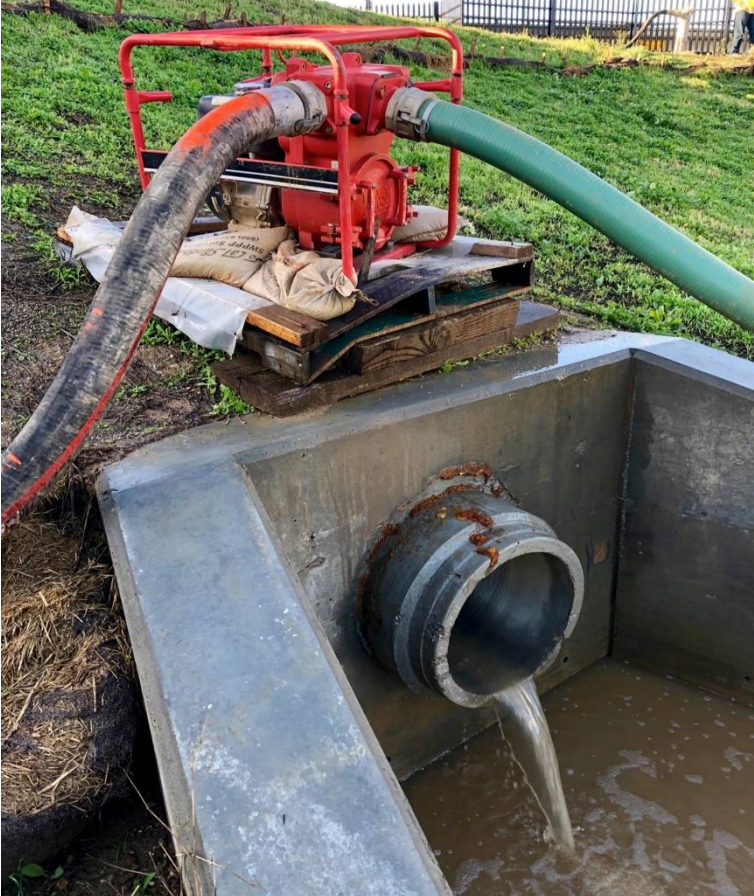
A crew was also pumping out the small triangular detention basin using a large water pump located just over the intake culvert (Photo 3). The drip pan under this pump was in poor condition and needed to be fixed or replaced; I passed this information on to Inspector Morales and Mr. Daniele. Water continued to enter this basin via several drainage ditches; the water was being pumped into the large retention basin with BMPs in place to reduce erosion (Photo 4).

<p>Photo 3 – Drain outlet into the small detention basin. Water pump being used to move water into the large retention basin. Note the inadequate drip pan under the pump. Photo facing south.</p>
3/23/20	Mesa Substation

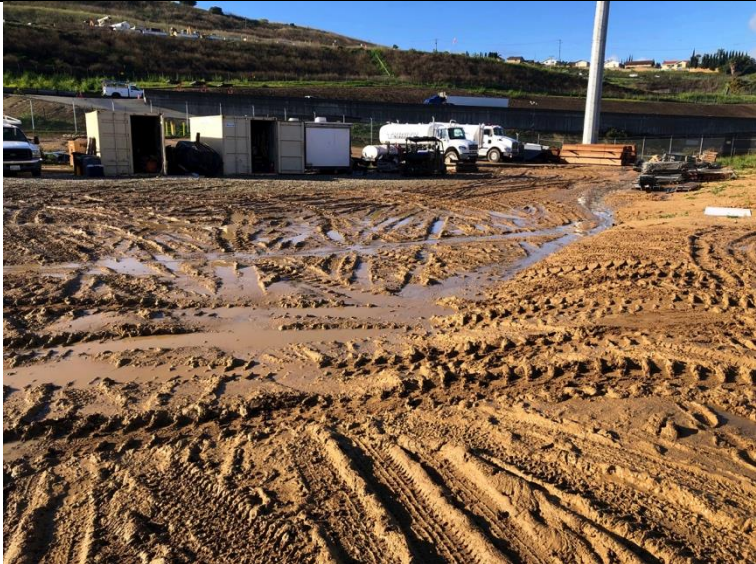
Photo 7 – Muddy area located just upslope of the southern boundary wall BMP drainage. Photo facing southwest.

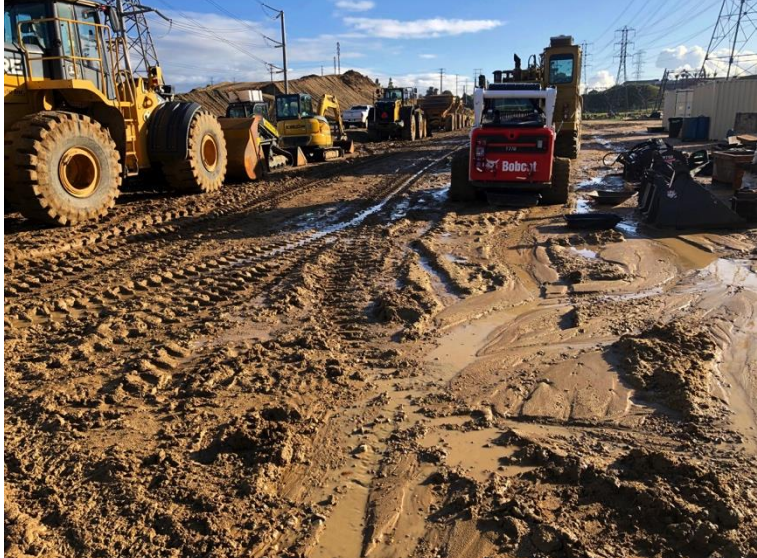
<p>Photo 8 – Muddy area surrounding the parked equipment, rainwater runoff flows through this area and to the BMP channel outside of the southern boundary wall. Photo facing east.</p>
3/23/20	Mesa Substation

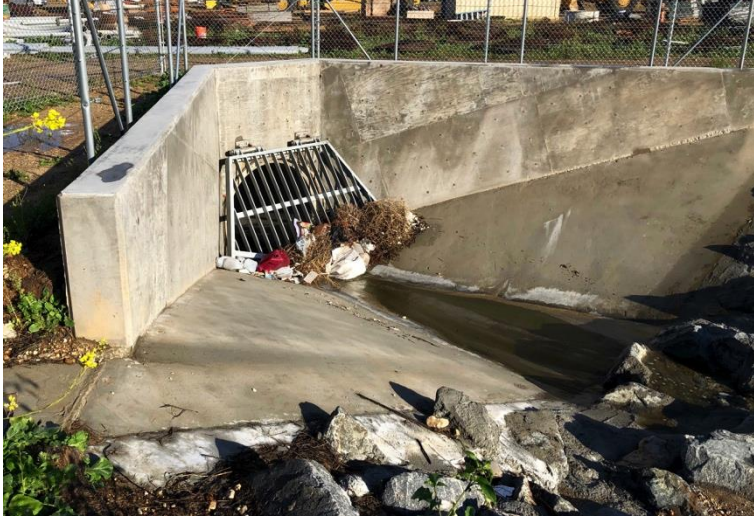
Photo 12 – Culvert inlet capturing Highway 60 runoff and directing it through the project site and into the public drainage system. Photo facing north.
3/23/20	Mesa Substation

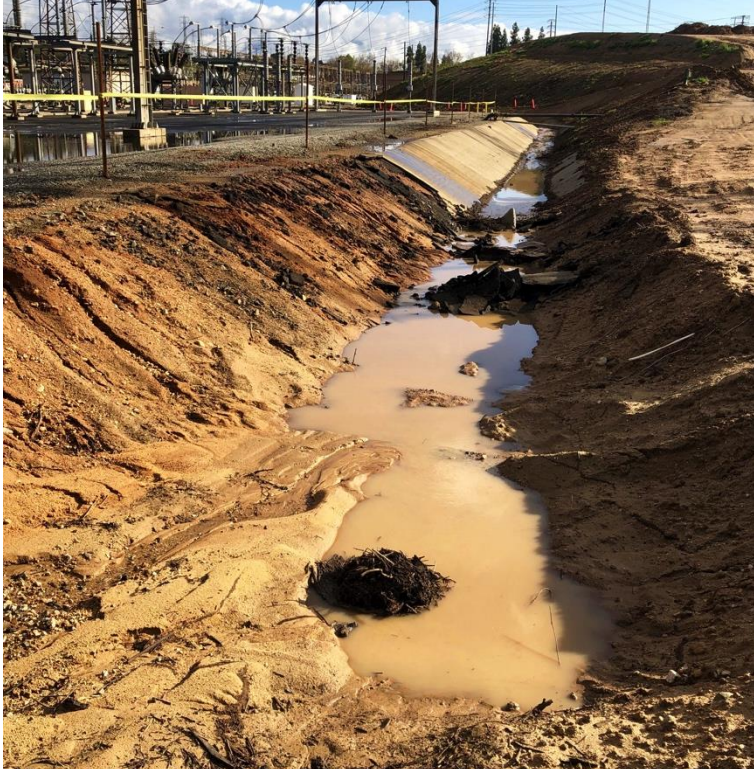
Rainwater runoff was observed flowing down the drainage channel surrounding the old substation and entering a standpipe at the western end of the channel (Photo 14). This standpipe connected to drainpipe that runs offsite. Previously, this standpipe

<p>Photo 14 – Drainage channel for the old substation. Rainwater runoff is flowing down the channel and into the standpipe; the standpipe opening is covered with vegetation. Photo facing east.</p>
3/23/20	Mesa Substation

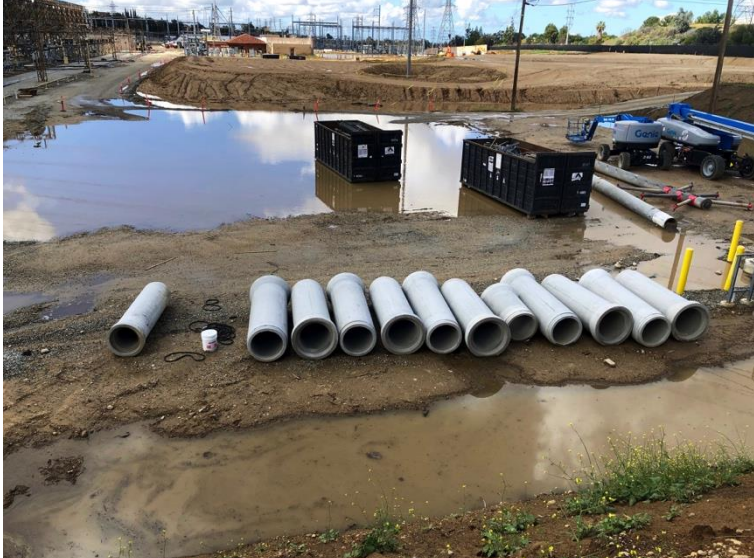
<p>Photo 15 – Poned areas below and to the west of the Mesa Operations Building; this water flows south, then west, in the old drainage channel. Photo facing west.</p>

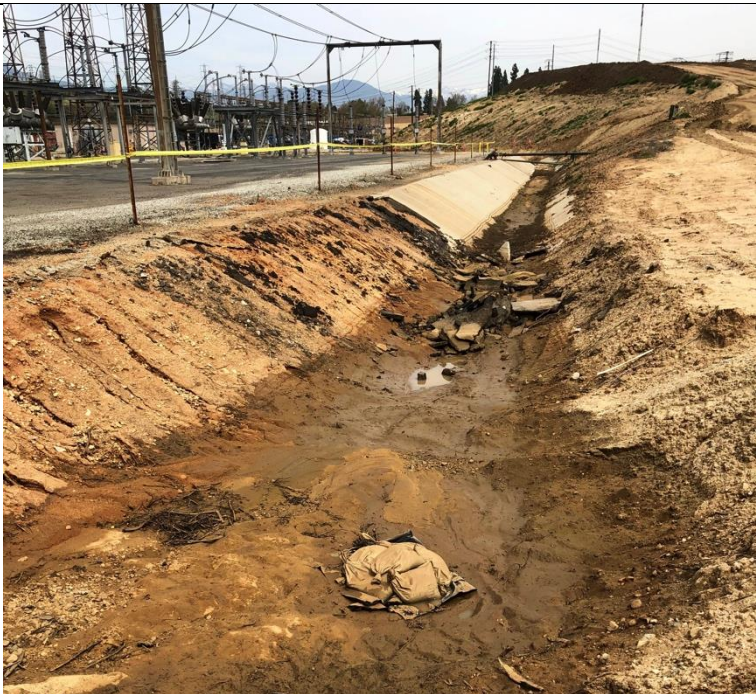
Photo 12 – Drain outlet has now been plugged with filter fabric and gravel bags. Photo facing north.
3/31/20	Mesa Substation

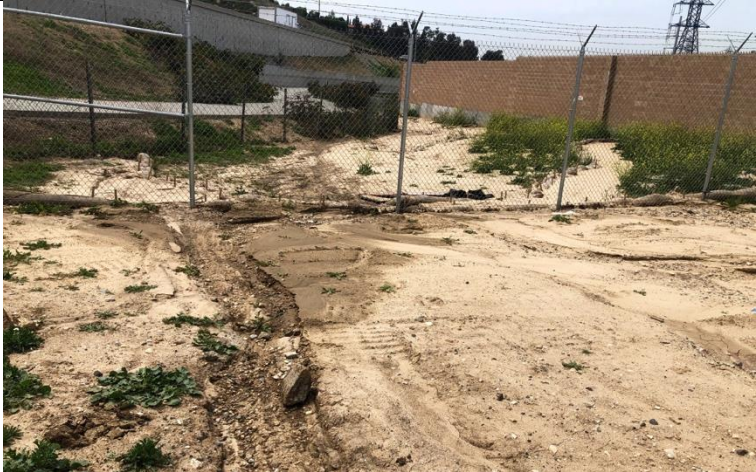
Photo 13 – No BMP work has been completed in the area south of the southern boundary wall. Photo facing southwest.
3/31/20	Mesa Substation
