February 23, 2021

Re: Monthly Report Summary #31 for the Mesa 500-kV Substation Project

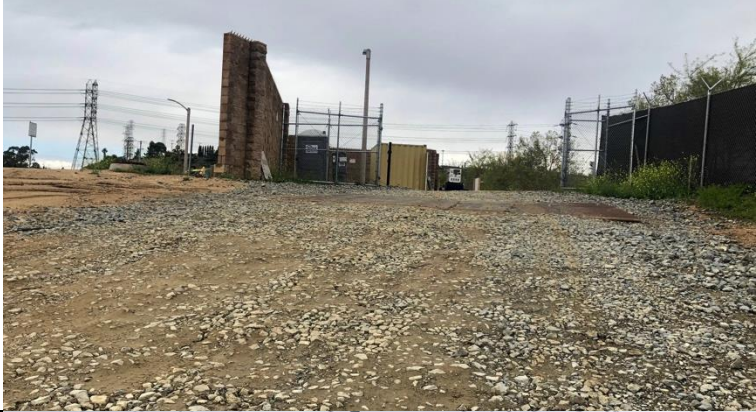
We entered the site through the eastern entrance, and I noted that the exit and entry BMPs required maintenance (Photo 1). The rock placed on either side of the rumble plates was filled with mud and needed to be cleaned. SCE did not have street sweepers working to clean the public roadways and I emphasized the importance of preventing track out.

Photo 1 – The rocky portion of the exit and entry BMP at the eastern entrance to the project was packed with mud and not functioning. Photo facing north.
4/07/20	Mesa Substation

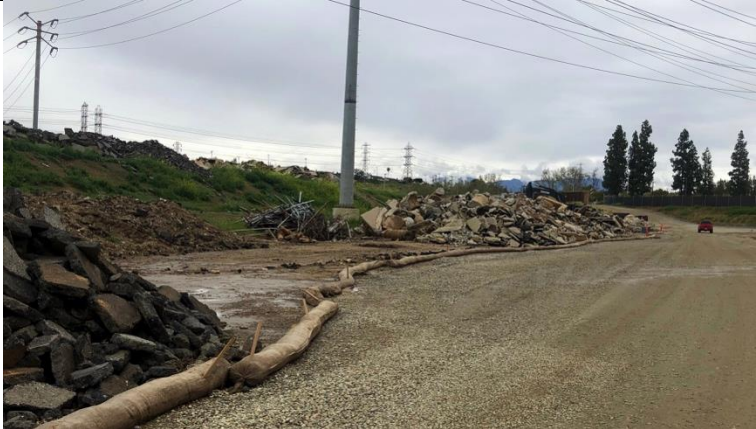
I observed the SWPPP inspector onsite and she noted the project rain gauge had registered 1.25 inches of rain. Conditions were wet and muddy so only a few crews were working. The stockpiled concrete and asphalt remained in the southeastern portion of the project site (Photo 2).

Photo 2 – Demolished construction materials with straw wattles around them. Photo facing northeast.
4/07/20	Mesa Substation

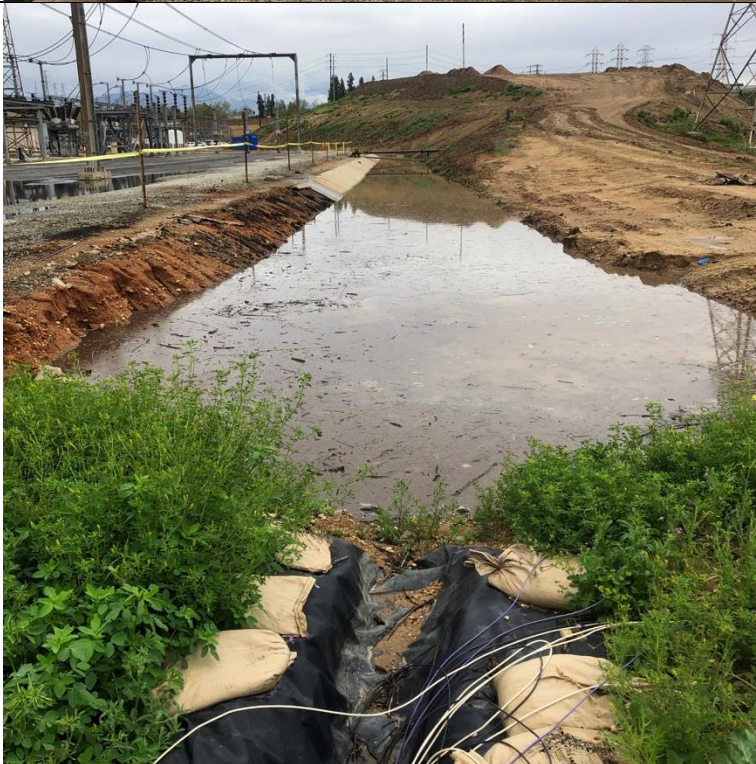
I checked the drainage channel surrounding the existing substation and observed that the drain inlet remained blocked and was nearly full of rainwater (Photo 3). The captured water did not appear to have spilled over into the new rack areas.

Photo 3 – Rainwater runoff in the existing drainage channel around the substation. Photo facing east.

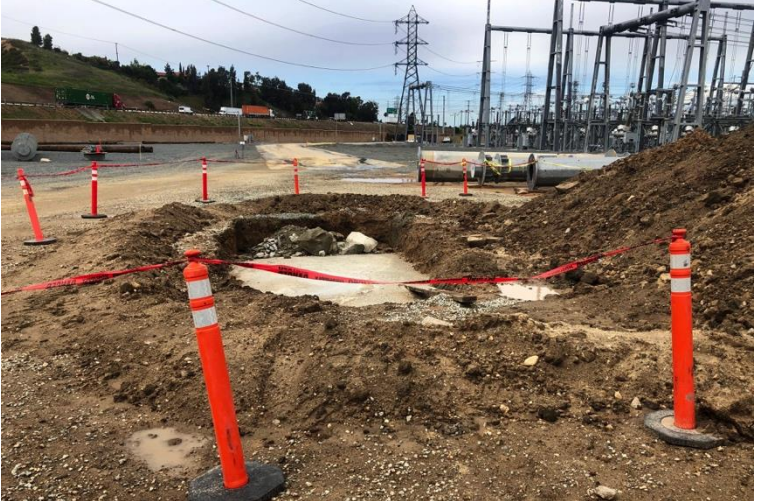
Excavation work had been performed near the southwestern corner of the existing substation. According to Mr. Lubich, a crew had removed an existing tower foundation and the hole had been partially filled with slurry (Photo 4).

The area where the equipment was parked was very muddy (Photo 5), and I noted no secondary containment devices under the equipment (Photo 6). I asked Mr. Lubich about this and he said that drip pans were not used during rain events because they fill with water or could get washed away. I had previously discussed this with Mr. Daniele, the Lead Environmental Monitor, and we agreed it was best not to use secondary containment during rain events.

Photo 4 – Existing tower foundation removal work. Photo facing west.
4/07/20	Mesa Substation	 	Photo 5 – Mud present in the vehicle parking area. Photo facing east.

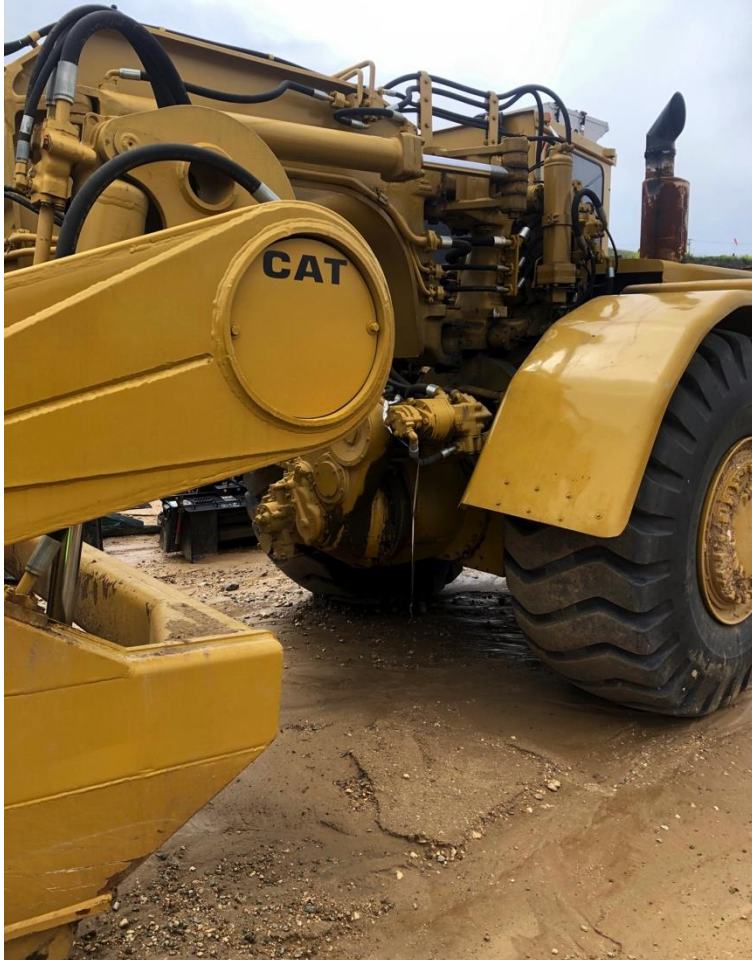
A close-up photograph of a yellow CAT wheel loader. The machine is parked on a dirt and gravel surface. The front loader bucket is visible on the left, with the 'CAT' logo clearly marked on its side. The large, treaded tire of the rear axle is prominent on the right. The background shows a clear sky and some distant structures.	Photo 6 – Parked equipment without secondary containment.
4/07/20	Mesa Substation

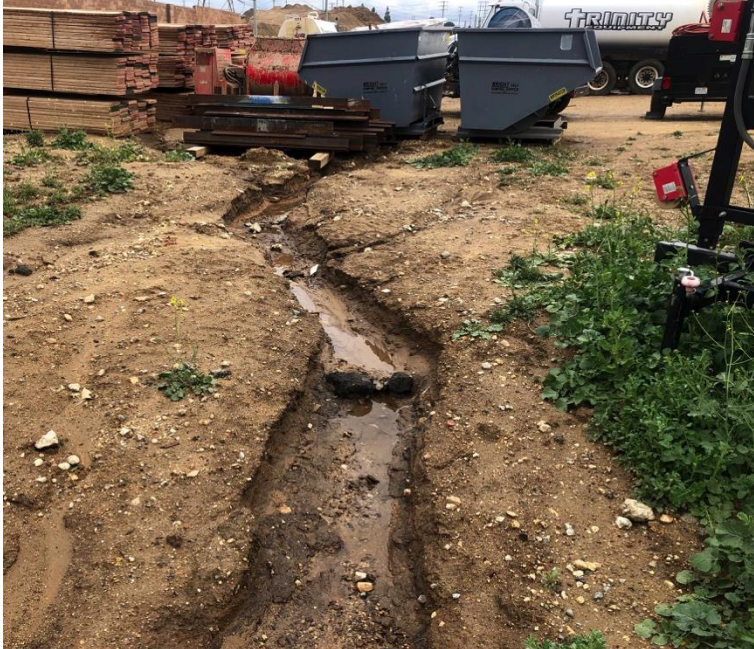
<p>Photo 8 – Rainwater runoff exiting the site through the materials staging area, leading to erosion. Photo facing east.</p>
4/07/20	Mesa Substation	 	<p>Photo 9 – No BMP maintenance or upgrades were present in the area south of the southern boundary wall. Photo facing southwest.</p>

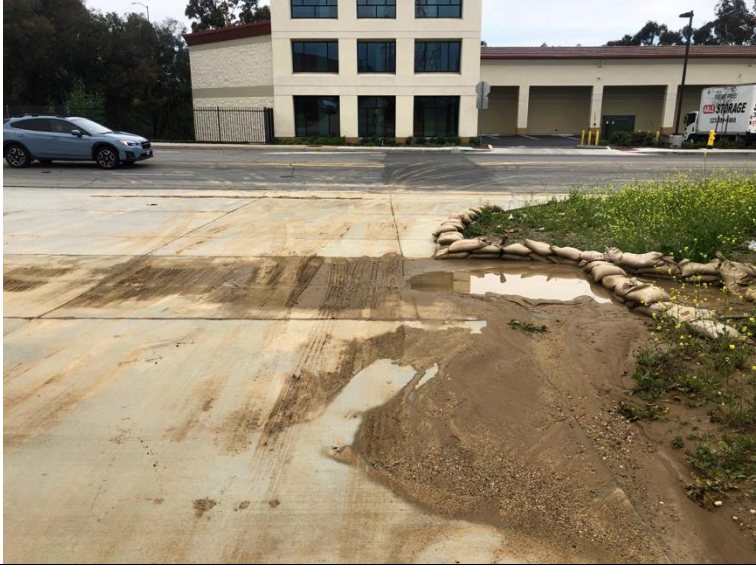
The western gate was open and muddy sediment was on the pavement being tracked out onto the public roads (Photo 11). I pointed this out to the SWPPP inspector. I observed Biology Monitor Wayne Woodroof onsite checking for nesting birds. He observed several mourning doves (*Zenaida macroura*) beginning to nest in the new rack areas.

Photo 11 – Muddy conditions at the western project entrance. Photo facing west.
4/07/20	Mesa Substation

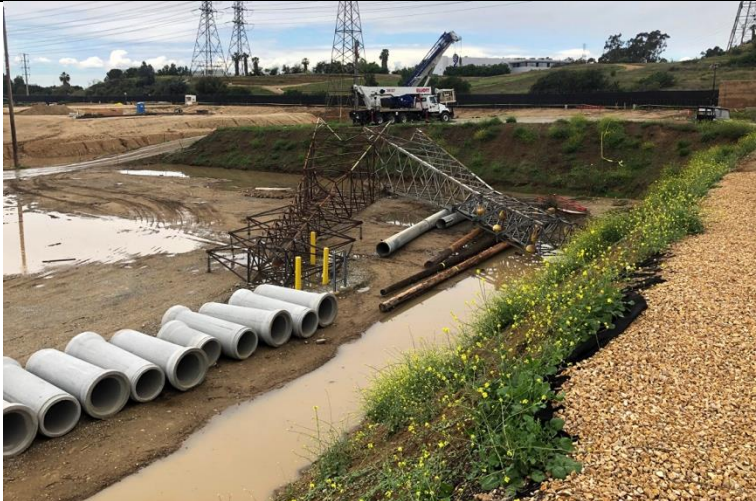
Existing lattice steel towers were stockpiled in the area west of the Mesa Operations Building (Photo 12). Ponded water was noted in the same area (Photo 13). Crews were working within the existing substation, dismantling the equipment.

Photo 12 – Existing lattice steel towers stockpiled onsite. Photo facing north.

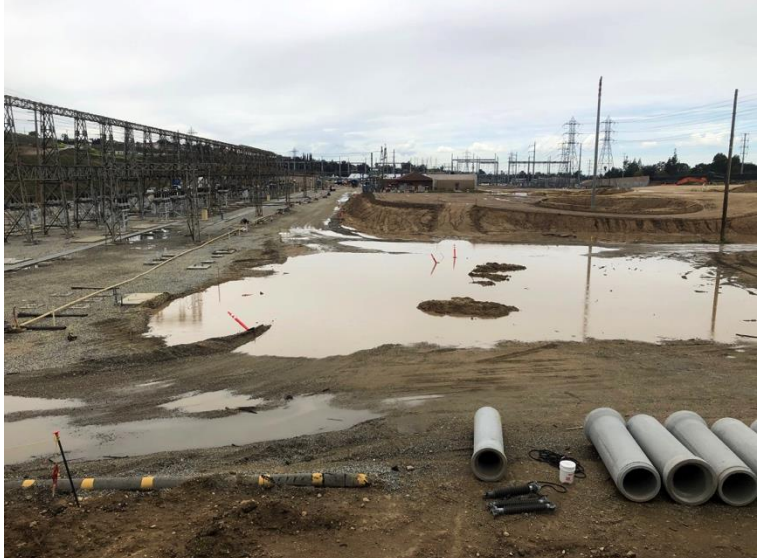
Photo 13 – Ponded water near the Phase 3 grading area. Photo facing west.
4/07/20	Mesa Substation

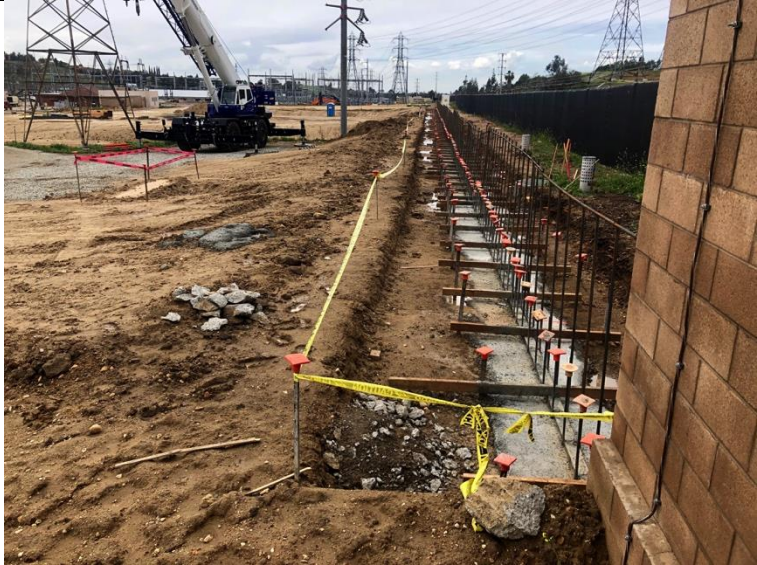
Work on the foundation for the northern boundary wall continued with rebar installation and concrete pouring (Photo 14). Some concrete was spilled on the ground and required cleaned up. I mentioned this to Mr. Lubich.

Photo 14 – Work on the northern boundary wall foundation. Photo facing west.

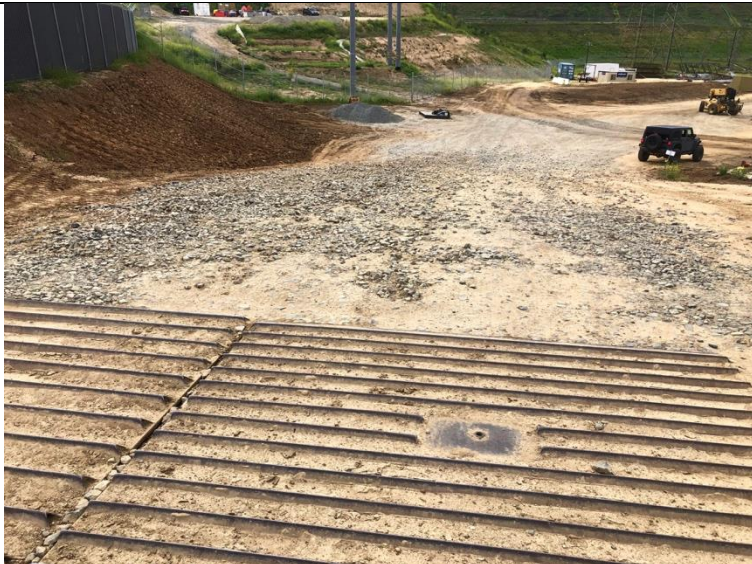
I arrived onsite at 1000 hours and met with Matt Daniele who escorted me into the project site where Pete Lubich took over. Upon entering the site, I noted the exit and entry BMPs again needed maintenance (Photo 1). Mr. Lubich indicated some upgrades to the BMPs had been completed since my last site visit, but the recent storms again filled the rock with mud.

Photo 1 – The rocky portion of the exit and entry BMP at the eastern entrance to the project was packed with mud and not functioning. Photo facing south.
4/17/20	Mesa Substation

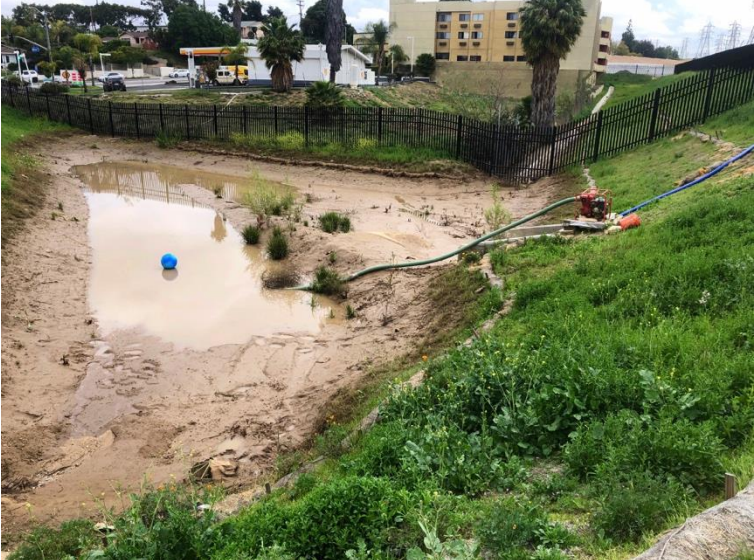
The triangular detention basin appeared to be filled with water, but was being pumped into the large retention basin (Photo 9). The secondary containment under the water pump in the retention basin was in poor condition and needed to be replaced (Photo 10). I mentioned this to Mr. Lubich and Mr. Daniele via text at the end of the day.

Photo 9 – Triangular basin with pumping equipment. Photo facing east.
4/17/20	Mesa Substation

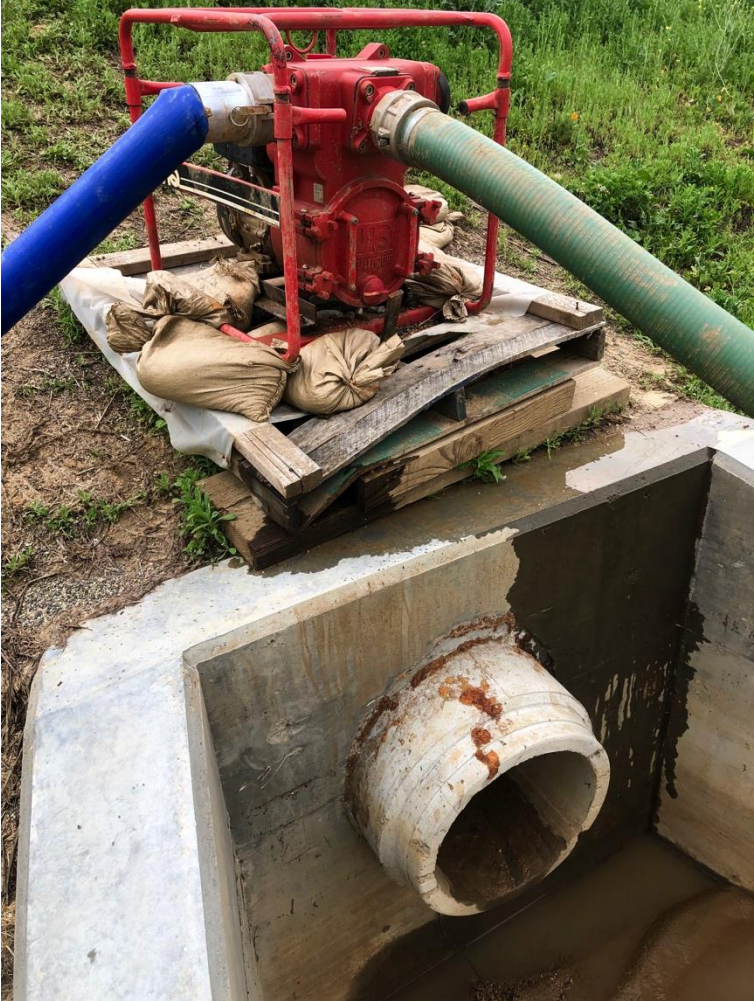
Photo 10 – Water pump in the triangular basin with a broken secondary containment structure.

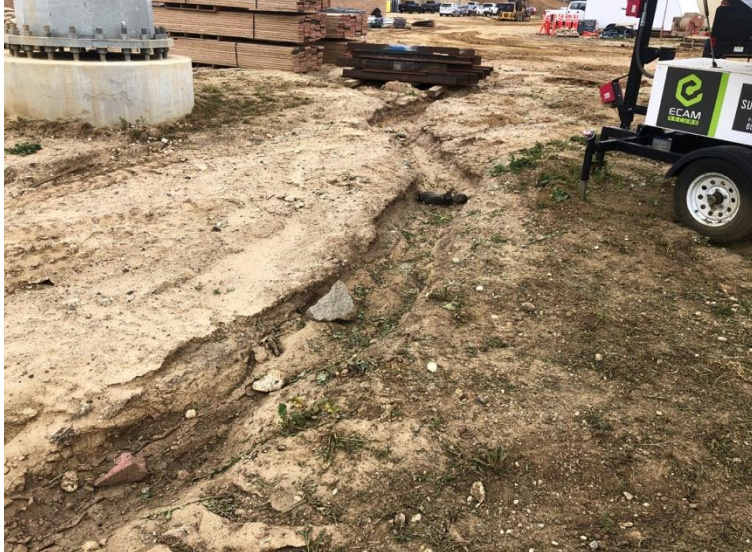
Photo 13 – Erosion rills where water was draining from the project site. Photo facing east.

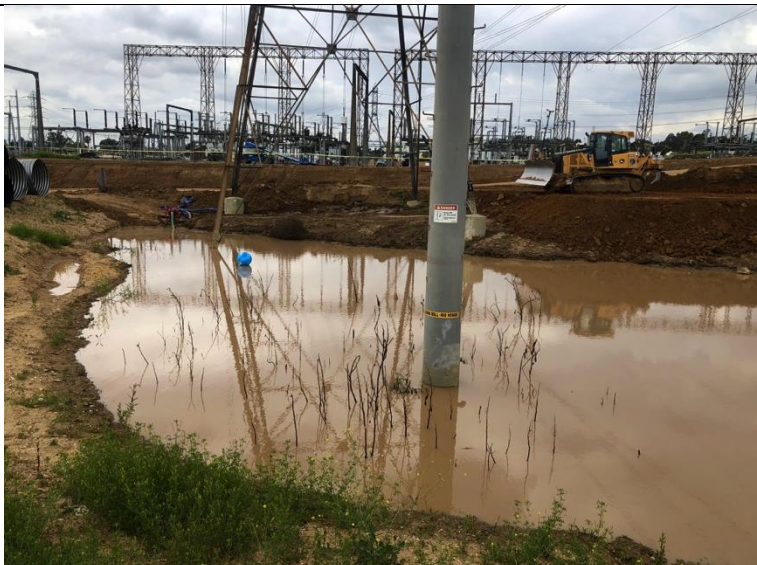
Rainwater runoff filled a catch basin under one of the lattice steel towers (Photo 14); according to Mr. Lubich, it was being pumped into water trucks for use throughout the project. The water pump was leaking oil and the drip pan was in poor condition (Photo 15). I pointed this out to Mr. Lubich. The drainage channel surrounding the existing substation was full of muddy rainwater runoff (Photo 16).

Photo 14 – Pondered rainwater runoff south of the existing substation. Photo facing north.
4/17/20	Mesa Substation

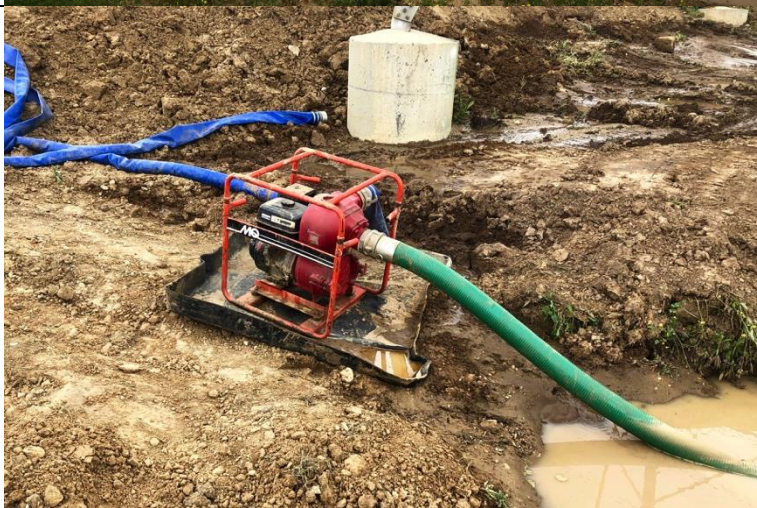
Photo 15 – Water pump with a broken drip pan.
4/17/20	Mesa Substation

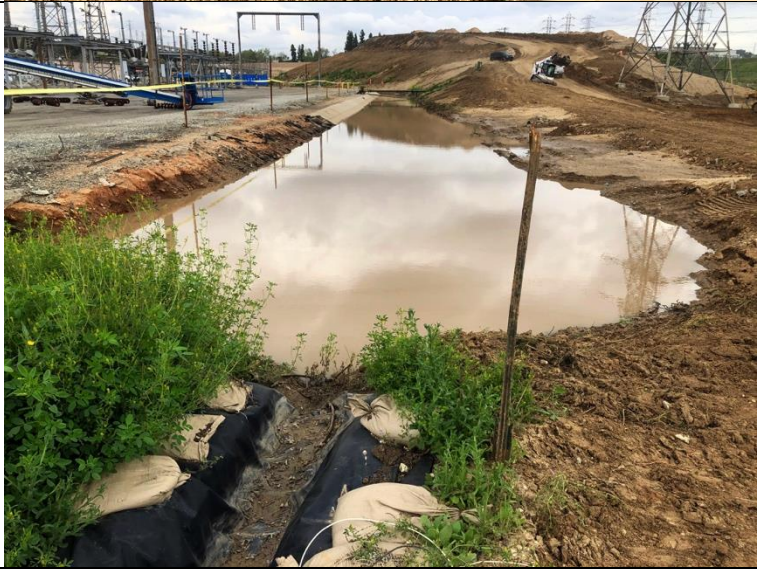
Photo 16 – Rainwater runoff in the existing substation drainage channel. Photo facing east.

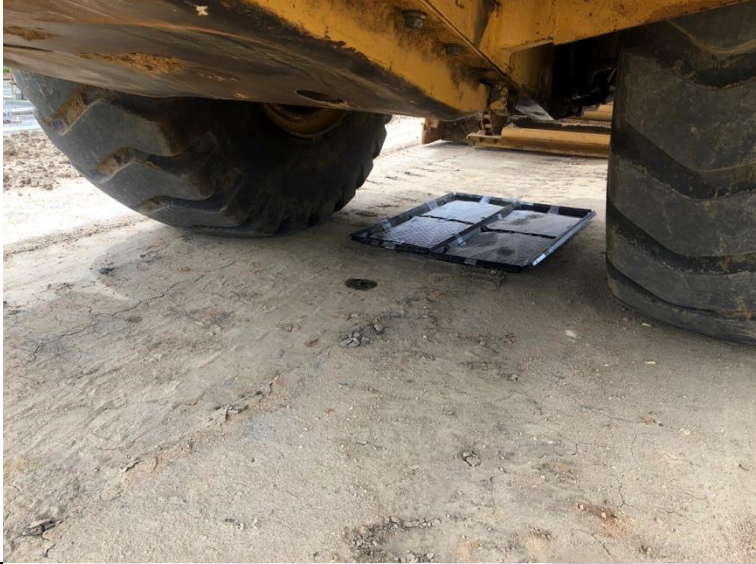
Work continued on the foundation for the northern boundary wall (Photo 17). Phase 3 grading work continued along with installation of the new stormwater drainage pipe system (Photo 18). One of the parked scrapers had several drip pans underneath it and they were not catching the dripping fluid (Photo 19). Both Mr. Daniele and I spoke to the construction crews numerous times about the need for additional secondary containment, especially under the larger pieces of equipment.

Photo 19 – Drip pan under a large scraper to contain an oil leak.
4/17/20	Mesa Substation	 	Photo 20 – Equipment being dismantled within the existing substation. Photo facing southwest.
4/17/20	Mesa Substation

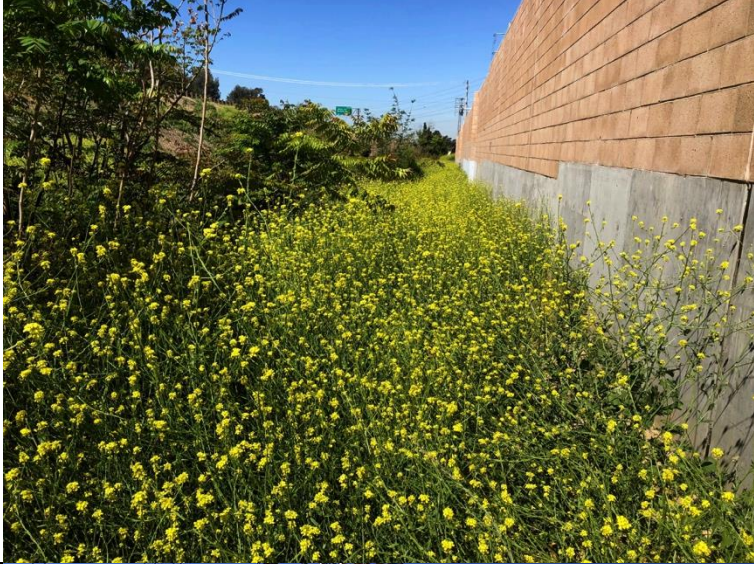
Photo 8 – Black mustard and castor bean plants growing outside of the southern boundary wall. Photo facing west.
4/24/20	Mesa Substation

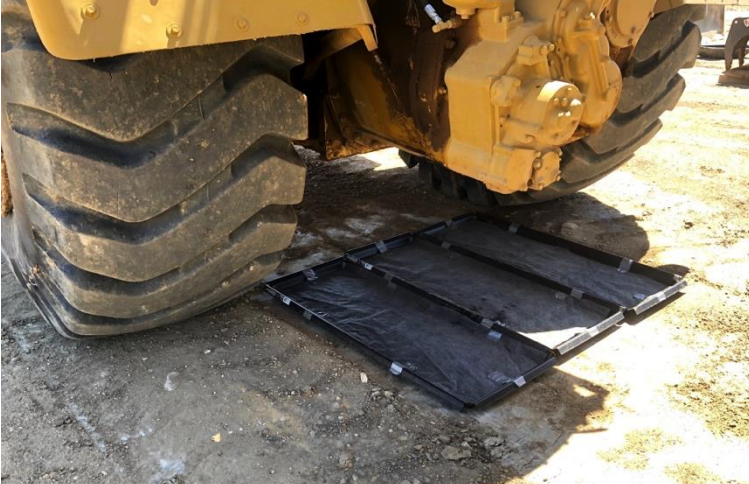
Photo 14 – Inadequate secondary containment under parked equipment.
4/24/20	Mesa Substation
