March 3, 2021

Re: Monthly Report Summary #34 for the Mesa 500-kV Substation Project

ATTACHMENT 1

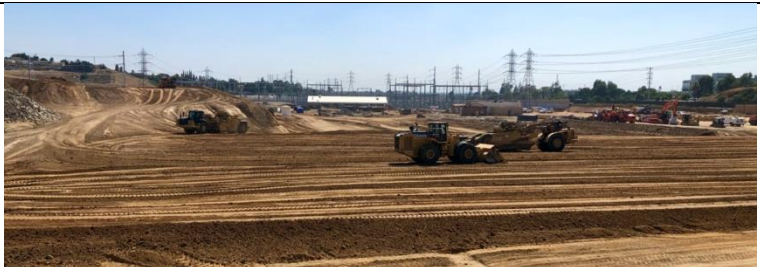
Upon entering the site through the eastern entrance, I noted the ongoing earthwork in the area west of the new Mesa Operations Building (Photo 1). The soil was being delivered from the large hill south of this location.

Photo 1 – Earthwork near the Mesa Operations Building. Photo facing west.

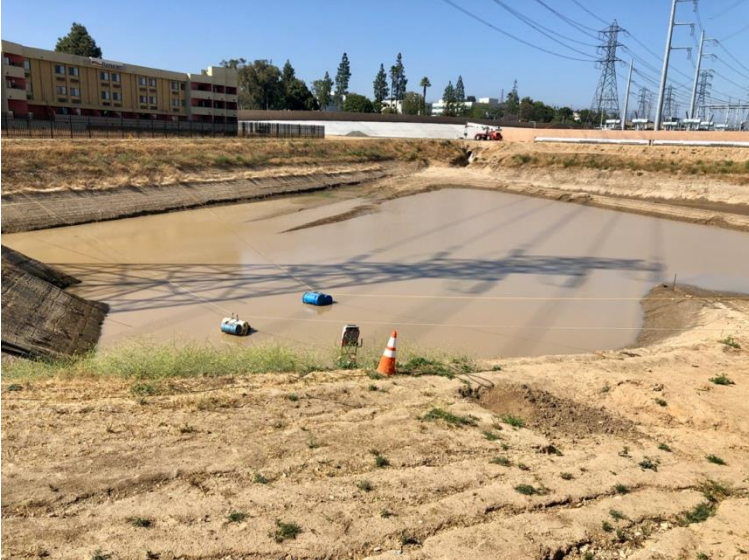
Photo 2 – Water levels in the retention basin. Photo facing northeast.
7/01/20	Mesa Substation

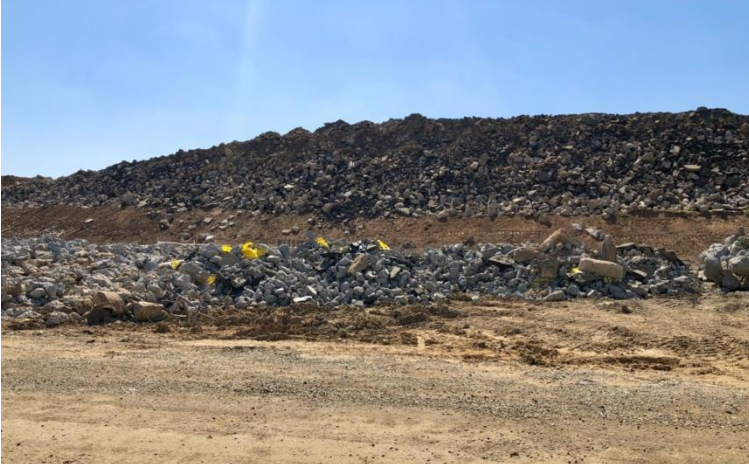
Photo 3 – Concrete and asphalt debris piles. Photo facing north.
7/01/20	Mesa Substation

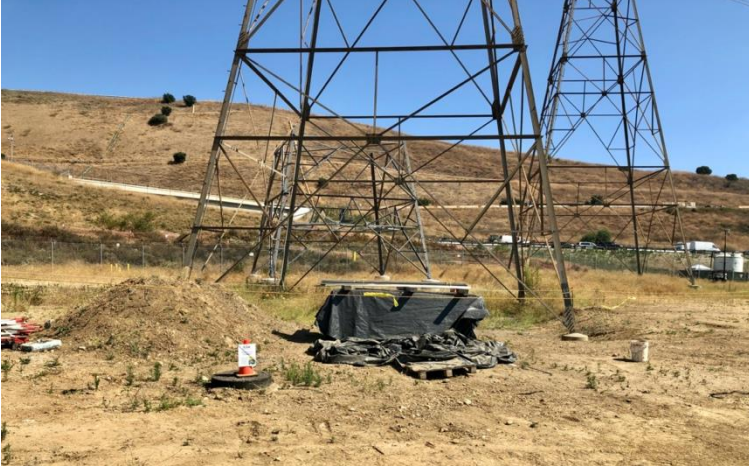
I spoke with Avian Biologist Wayne Woodroof about the nesting bird issues. Approval was received to reduce the coastal California gnatcatcher (*Poliophtila californica*) nest buffer to 200 feet (Photo 4), which allowed work on the southern boundary wall to continue (Photo 5). A mourning dove (*Zenaida macroura*) nest was observed on top of a haul truck tire. We discussed the need for earthen ramps on the trenches wherever possible.

Photo 4 – Coastal California gnatcatcher buffer. Photo facing south.

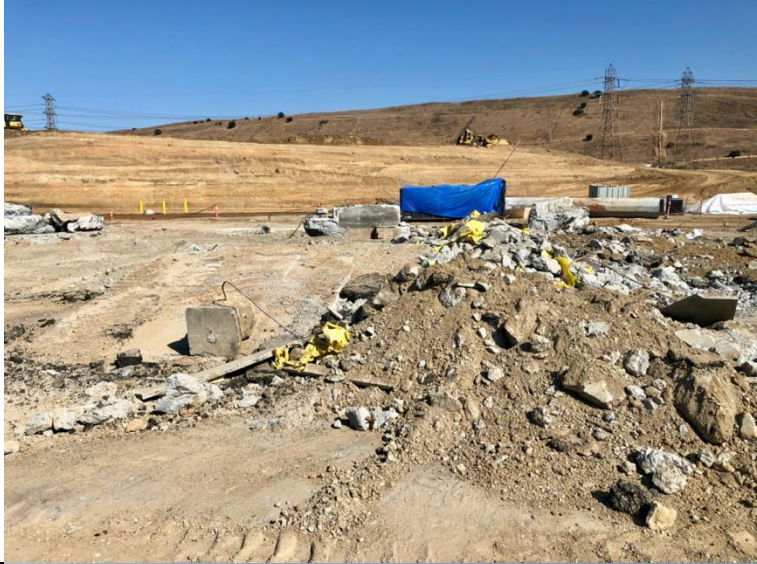
Within the Phase 3 grading area, work was being performed on the northern wall (Photo 7), the demolition of buildings and foundations continued (Photos 8 and 9), and conduit installation was underway (Photo 10). The conduit trench had an earthen ramp at one end.

Photo 8 – Foundation removal work. Photo facing south.
7/01/20	Mesa Substation

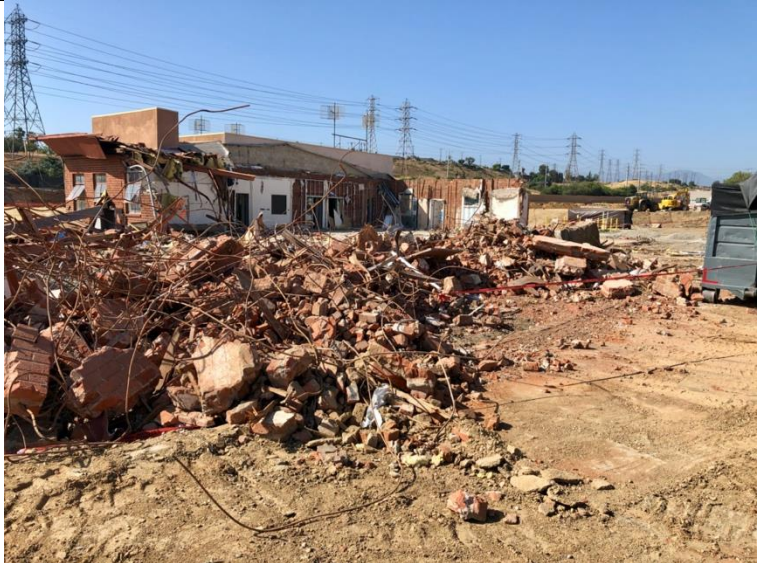
Photo 9 – Demolition of the various buildings. Photo facing north.

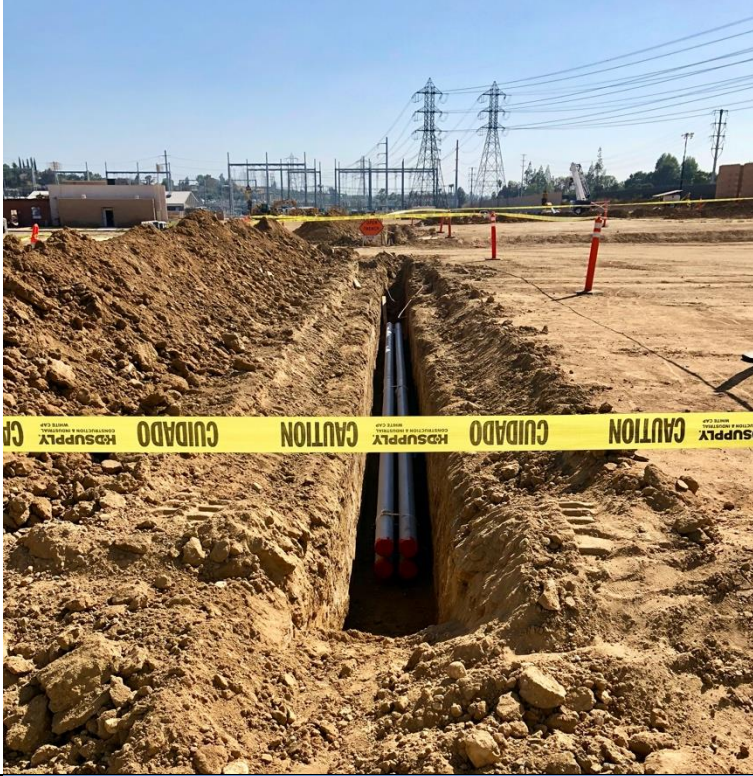
Photo 10 – Conduit trench with sloped exit ramp. Photo facing west.
7/01/20	Mesa Substation

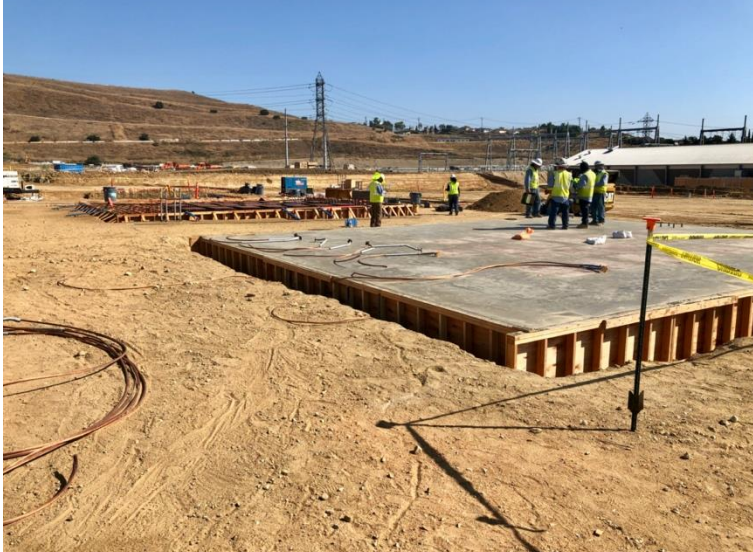
The Phase 4 work was underway building the transformer foundations (Photo 11).

Photo 11 – Phase 4 transformer foundation work. Photo facing south.

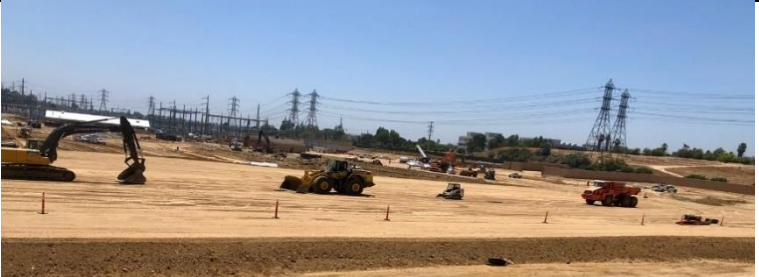
Photo 1 – Earthwork near the Mesa Operations Building to regrade. Photo facing northwest.

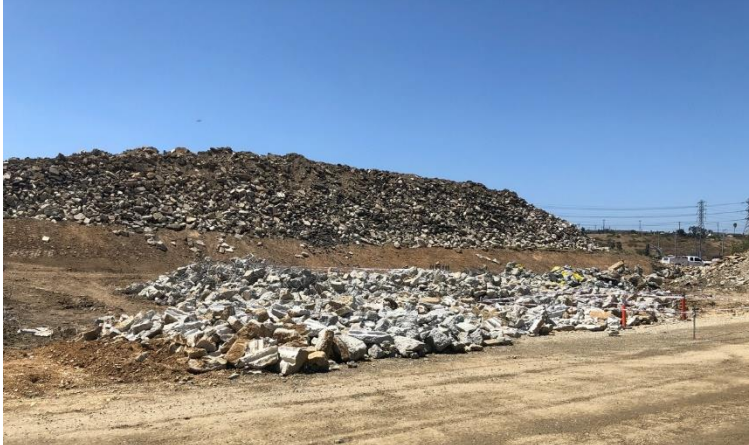
Photo 2 – Concrete and asphalt debris piles. Photo facing north.
7/07/20	Mesa Substation

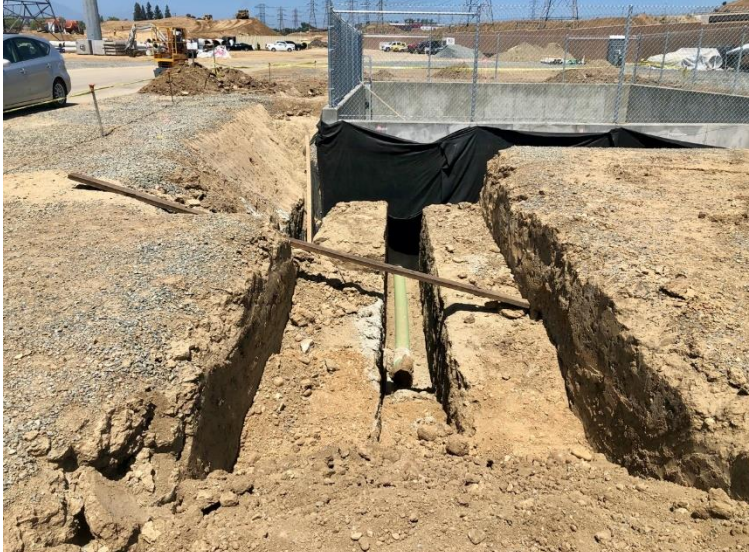
Photo 3 – Transformer catch basin. Photo facing east.
7/07/20	Mesa Substation

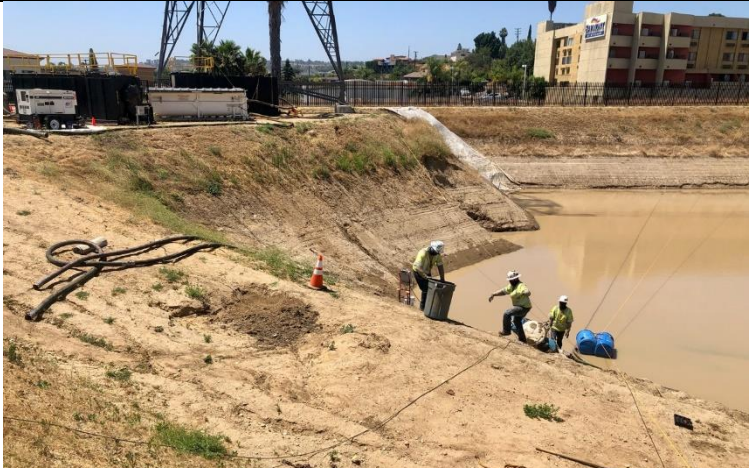
Photo 4 – Water levels in the retention basin. Photo facing north.

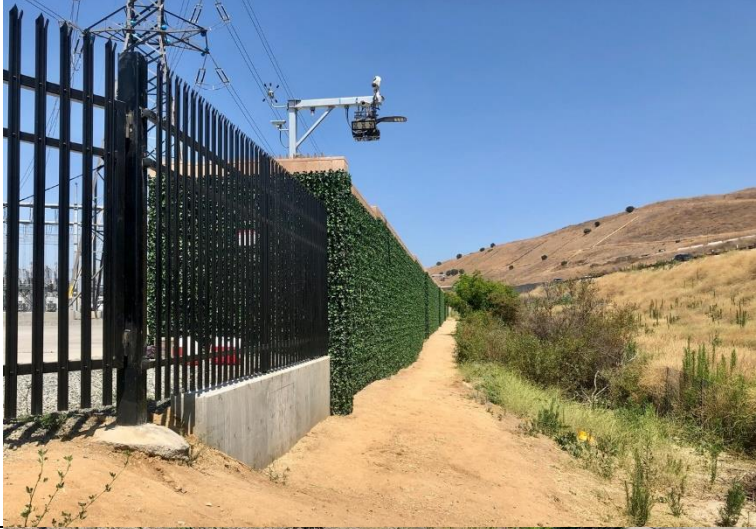
Photo 5 – Southern wall construction and the addition of artificial ivy. Photo facing east.
7/07/20	Mesa Substation

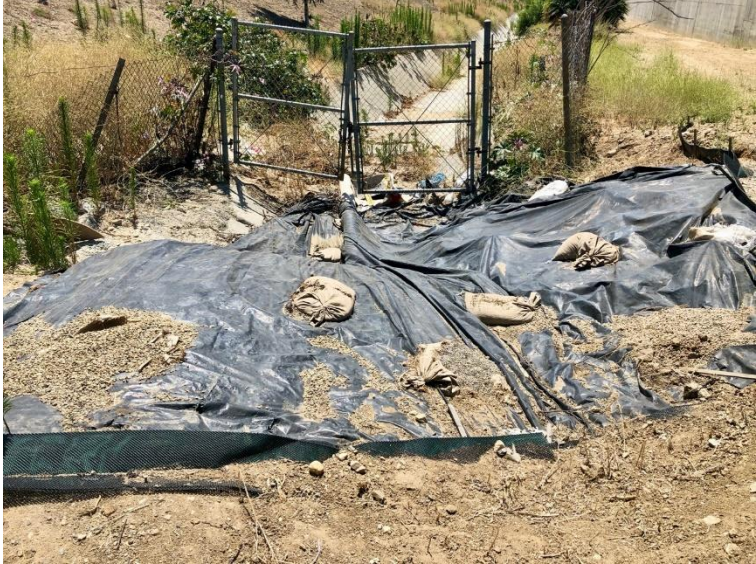
Photo 6 – Existing BMPs at the entrance to the Caltrans channel. Photo facing west.
7/07/20	Mesa Substation

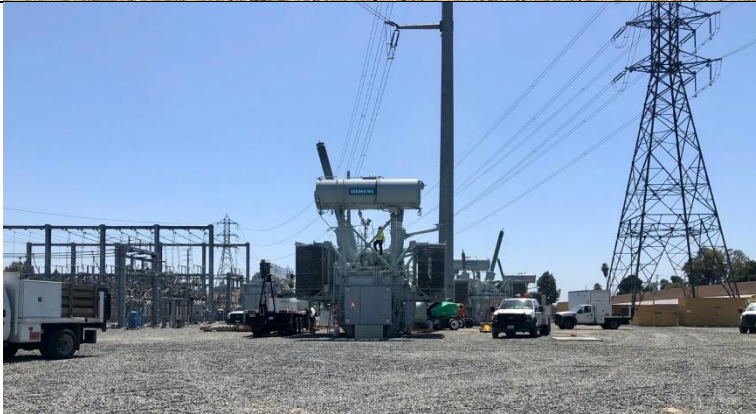
Photo 7 – Transformer assembly within the 66-kV rack area. Photo facing west.

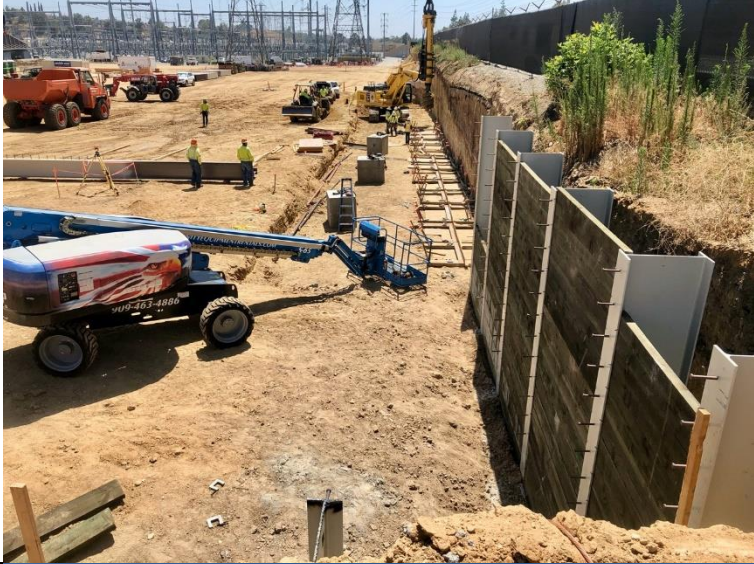
Within the Phase 3 grading area, work continued on the northern wall with drilling and installation of the I-beams (Photo 8). The open holes were adequately covered. Demolition of buildings and foundations was ongoing, but had slowed due to waiting for a determination on how to dispose of the contaminated materials (Photo 9). Soil work continued (Photo 10), as well as the installation of the stormwater drainage pipe system (Photo 11).

Photo 8 – Work on the northern boundary wall. Photo facing west.
7/07/20	Mesa Substation

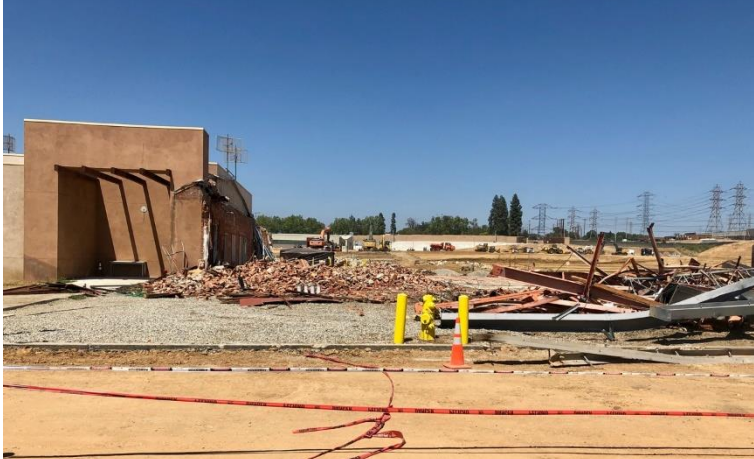
Photo 9 – Demolition of the various buildings continued. Photo facing east.
7/07/20	Mesa Substation

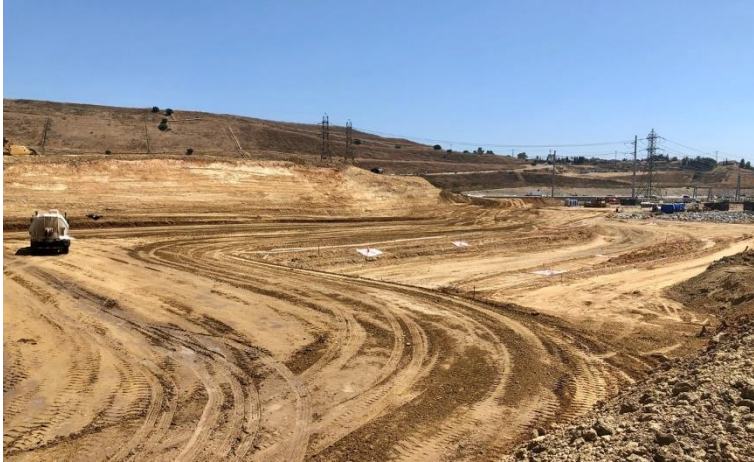
Photo 10 – Soil work continued in the Phase 3 area. Photo facing south.

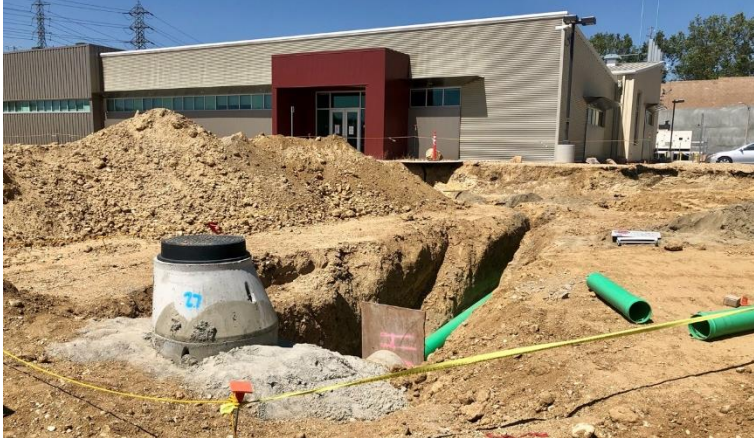
Photo 11 – Storm drain installation by the Mesa Operations Building. Photo facing east.
7/07/20	Mesa Substation

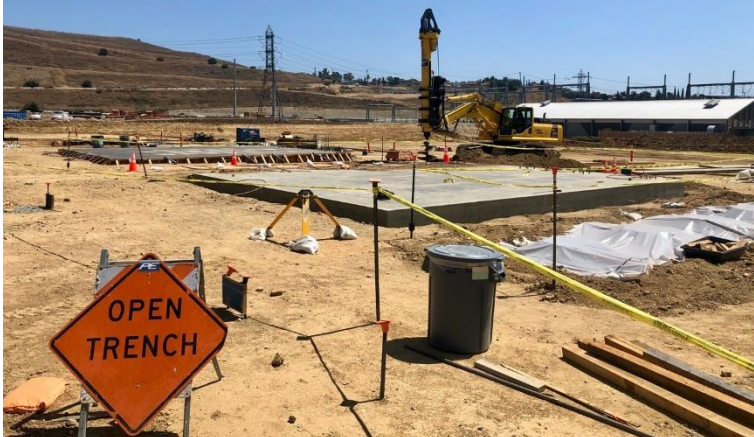
The Phase 4 work completed by Professional Electrical Construction Services was focused on the installation of the transformer foundations (Photo 12). They had installed secondary containment pans under their equipment (Photo 13).

Photo 12 - Phase 4 transformer foundation work. Photo facing southwest.
7/07/20	Mesa Substation

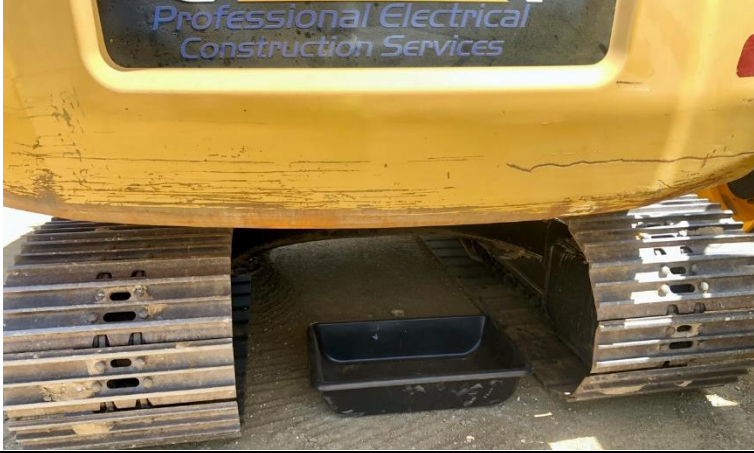
Photo 13 – Professional Electrical Construction Services equipment with drip pans in place.

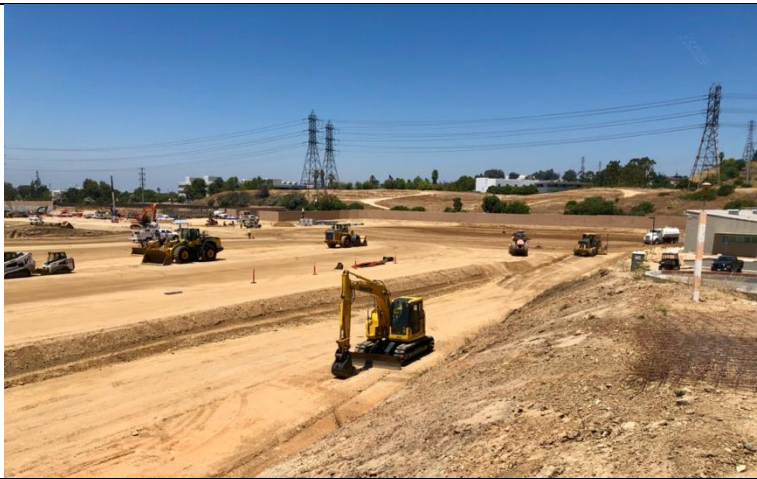
Photo 1 – Earthwork near the Mesa Operations Building. Photo facing northwest.

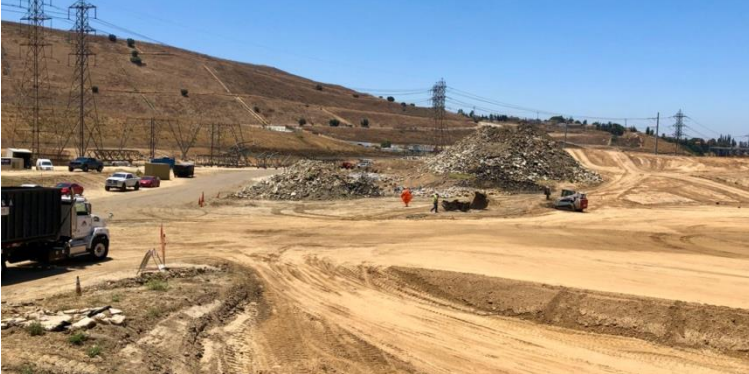
Photo 2 – Concrete and asphalt debris piles. Photo facing south.
7/15/20	Mesa Substation

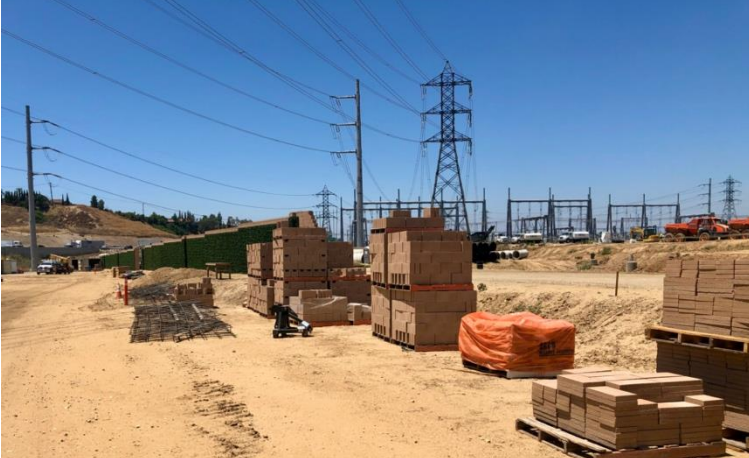
Photo 3 – Work on the southern boundary wall. Photo facing west.
7/15/20	Mesa Substation	 	Photo 4 – Soil work continued in the Phase 3 area. Photo facing northeast.

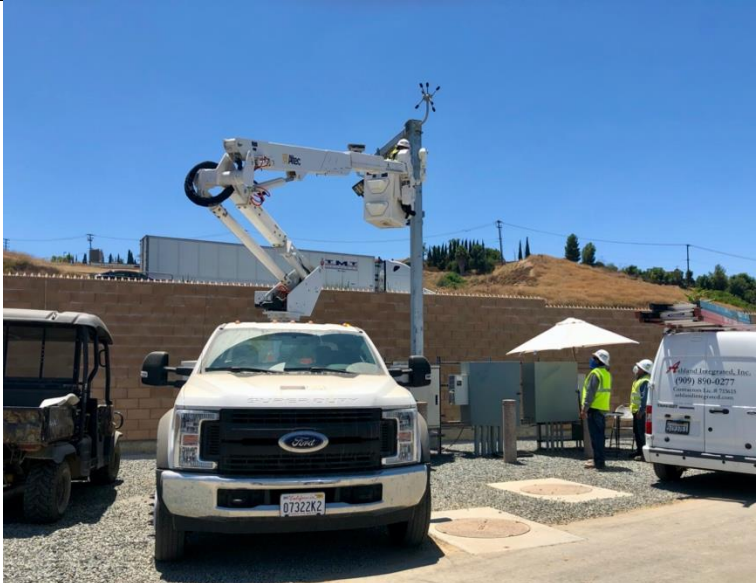
Photo 5 – Work continued on the security towers. Photo facing south.
7/15/20	Mesa Substation

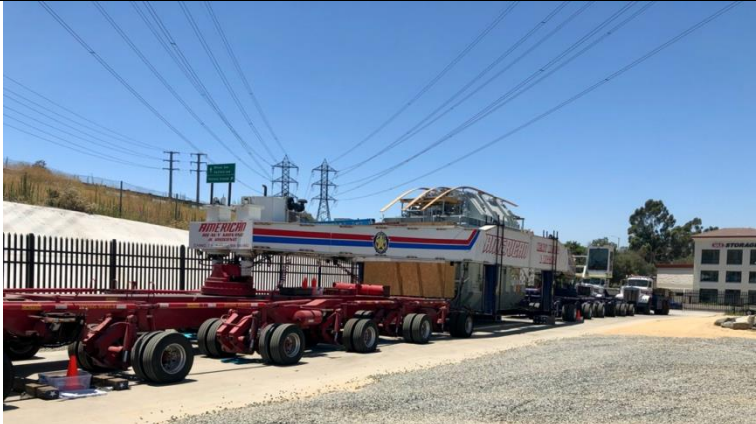
Photo 6 – Another transformer was delivered to the site. Photo facing west.
7/15/20	Mesa Substation

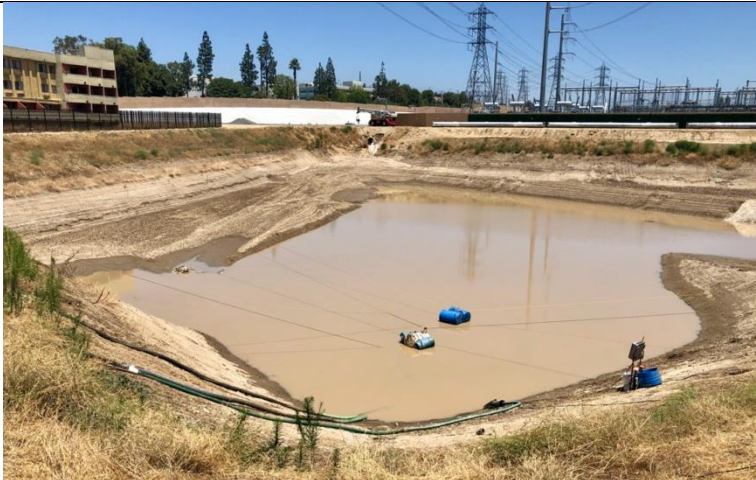
Dewatering continued with the limited water remaining in the retention basin (Photo 7). The lower water level had created muddy conditions, so the flow rate decreased (Photo 8).

Photo 7 – Water levels in the retention basin had decreased. Photo facing northeast.

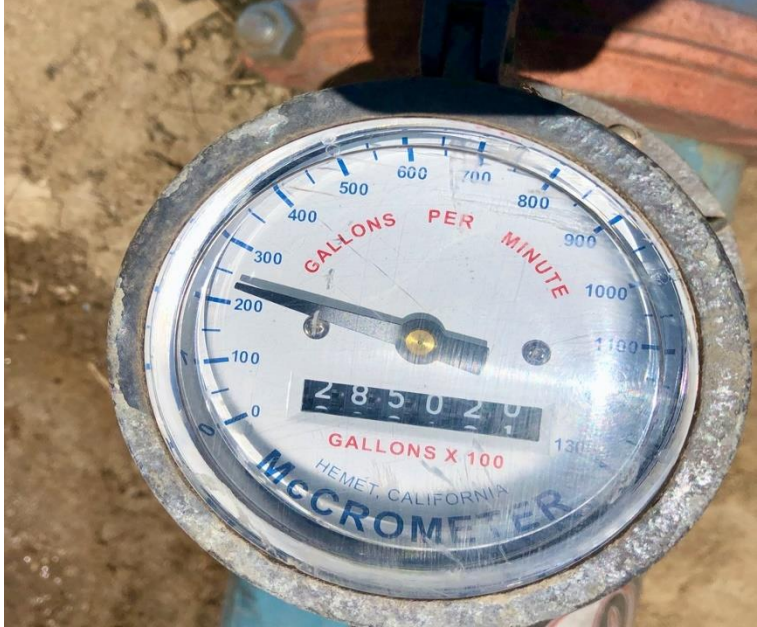
Photo 8 – Flow meter on the dewatering and desilting system.
7/15/20	Mesa Substation

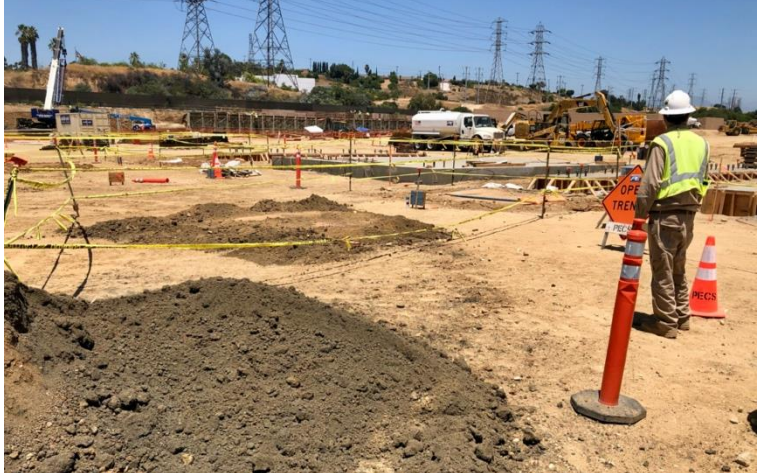
Several foundation holes had been drilled around the new Phase 4 transformer foundations (Photo 9). The holes were covered up. Another transformer foundation was poured (Photo 10). Three locations had cement washout performed on the soil (Photo 11). The biological monitor, Mr. Woodroof, and I reported this to one of the project coordinators.

Photo 9 – Drilling operation near the new transformer foundations. Photo facing north.
7/15/20	Mesa Substation

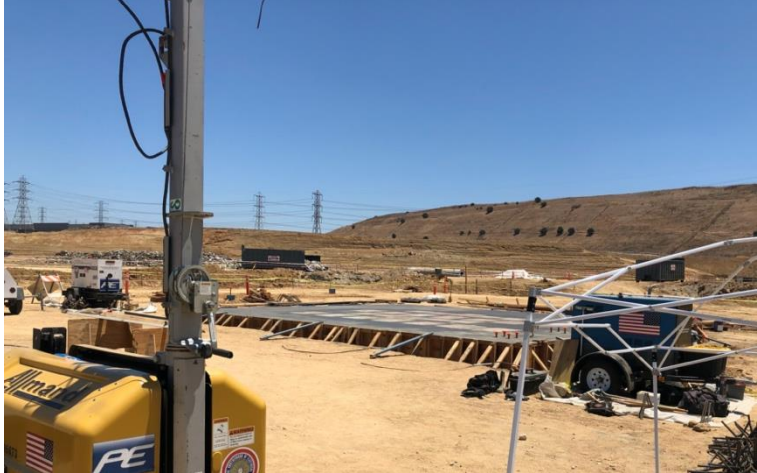
Photo 10 – Phase 4 transformer foundation work. Photo facing southeast.

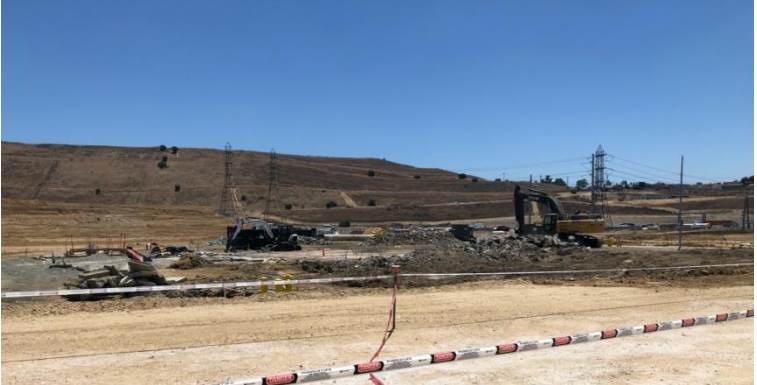
Other Phase 3 work included the construction of the northern boundary wall (Photo 12), the demolition of buildings and existing foundations (Photo 13), and the installation of the stormwater drainage pipe system (Photo 14).

Photo 13 – Demolition continued on the existing buildings. Photo facing south.
7/15/20	Mesa Substation

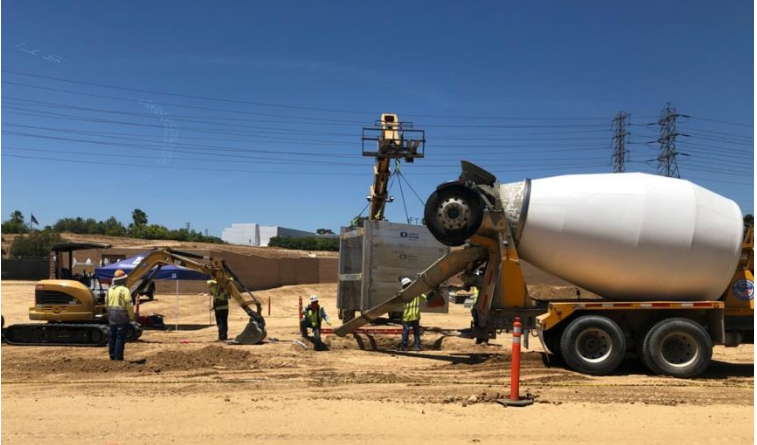
Photo 14 – Concrete pouring for the storm drain system. Photo facing north.

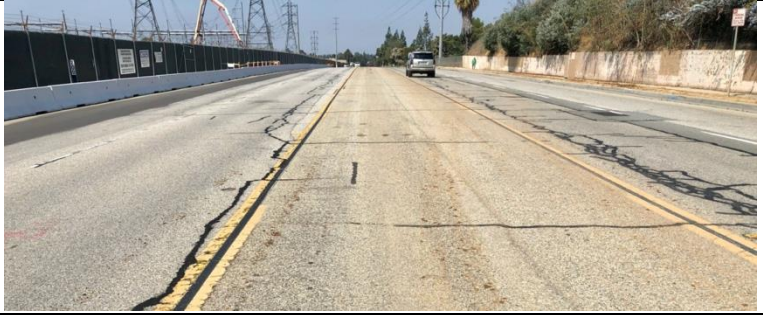
- On July 10, 2020, SCE received a Level 1 Non-Compliance regarding muddy trackout onto Market Place Drive and Potrero Grande Drive. Copies of street sweeping logs were requested for the period of June 1, 2020, to July 10, 2020, including the contact information for the company that performed the cleaning. BMP issues were previously noted by SCE at the project entrance/exit, including a need for sediment control maintenance. Trackout onto the roadway was noted as early as April 9, 2020. To address the issue, a street sweeping was performed from 0700 to 1700 hours on weekdays to clean the road. On July 20, 2020, nighttime powerwashing was conducted on Market Place Drive to remove the mud.

As I drove up Potrero Grande Drive to the Mesa Substation site, I noted a street sweeper cleaning the roadway and observed muddy trackout in the road (Photo 1). The new northern entrance to the substation was open and the entry and exit BMPs had been installed (Photo 2). I arrived at 1030 hours and contacted Pete Lubich and Matt Daniele to inform them I was onsite and mentioned the trackout I observed in the roadway.

Photo 1 – Muddy trackout on Potrero Grande Drive. Photo facing west.

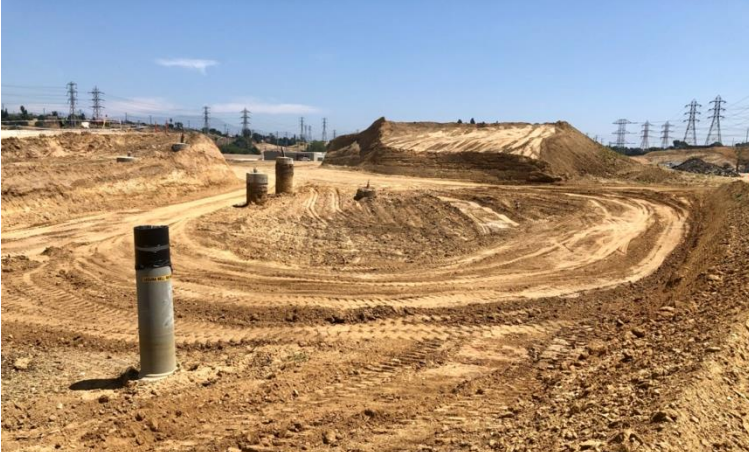
Equipment, including scrapers and bulldozers, continued to move soil from the large hill into the Phase 3 grading area (Photo 5). Soon the existing tower foundations would be removed.

Photo 5 – Soil being moved from the large hill into the Phase 3 grading area. Photo facing east.
7/21/20	Mesa Substation

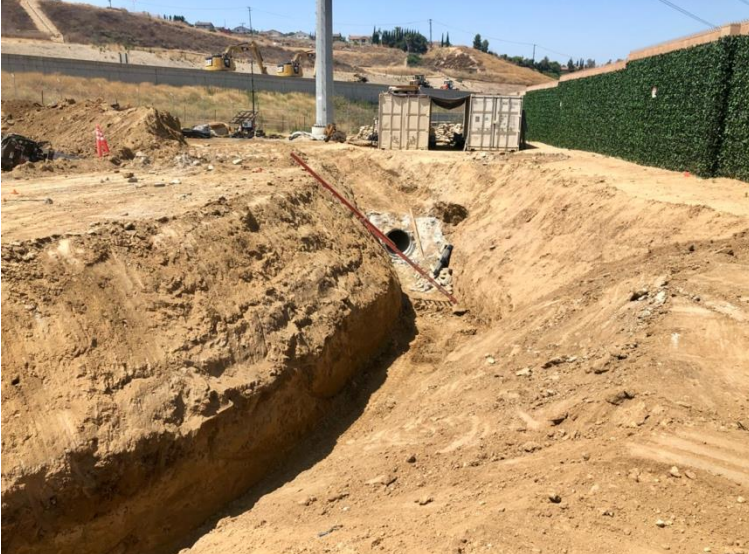
Photo 6 – Storm drain trenching south of the southern boundary wall. Photo facing southwest.
7/21/20	Mesa Substation

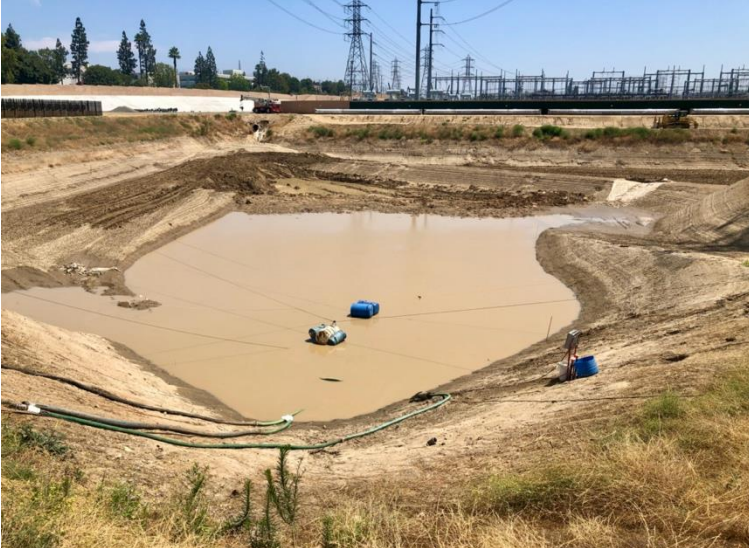
Photo 7 – Water levels in the retention basin were low. Photo facing northeast.

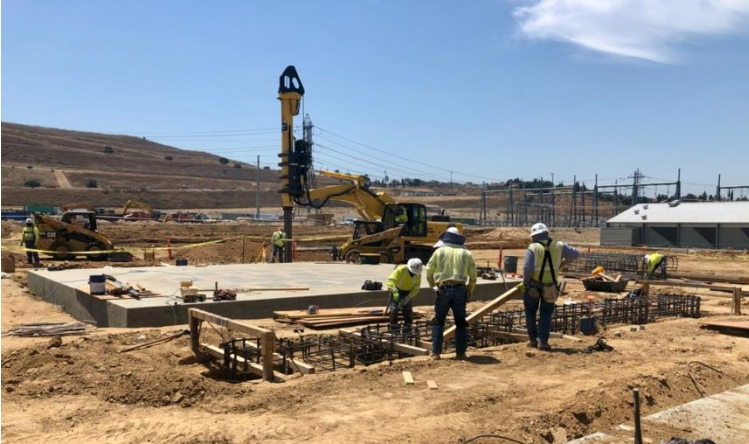
Phase 4 work included forming and pouring the transformer foundations and associated fire walls (Photo 8). Concrete trucks were washing out in the designated locations (Photo 9).

Photo 8 – Drilling operation and form pouring near the new 500-kV transformer foundations. Photo facing south.
7/21/20	Mesa Substation

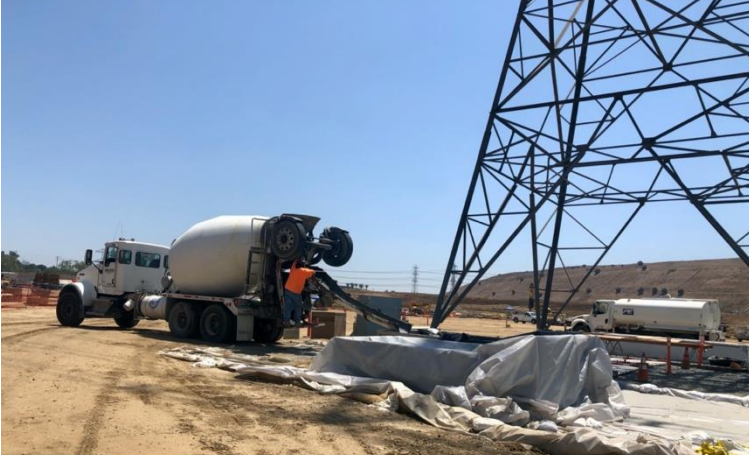
Photo 9 – Concrete washout station being utilized. Photo facing east.
7/21/20	Mesa Substation

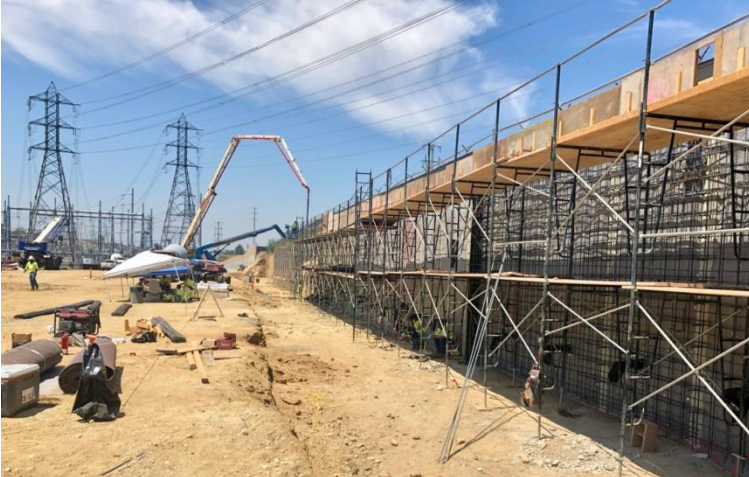
Within the Phase 3 work area, a large crew was working on the northern boundary wall installing rebar (Photo 10) and pouring slurry behind the new wall (Photo 11). Demolition of the existing foundations continued (Photo 12) along with trenching work for the new stormwater drainage pipe system (Photo 13).

Photo 10 – Work on the northern boundary wall. Photo facing west.

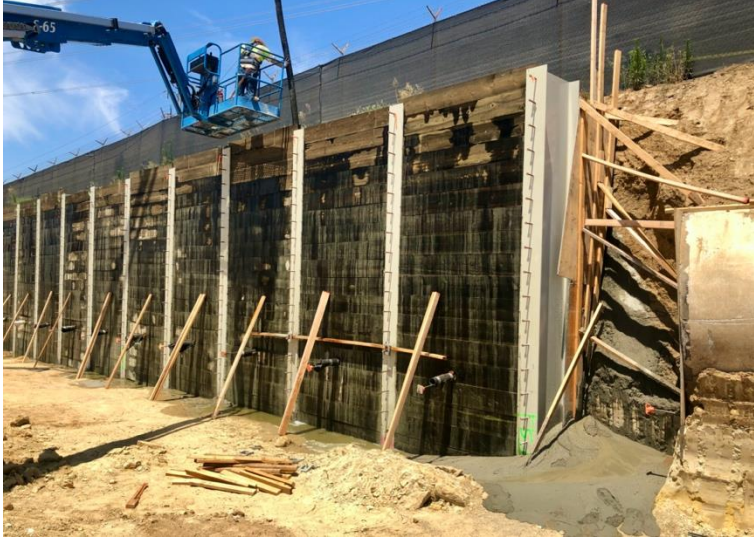
Photo 11 – Pouring slurry behind the northern boundary wall. Photo facing northwest.
7/21/20	Mesa Substation

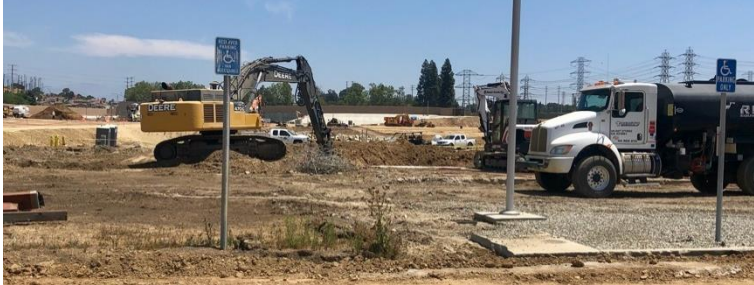
Photo 12 – Foundation demolition continued within the Phase 3 grading area. Photo facing east.
7/21/20	Mesa Substation

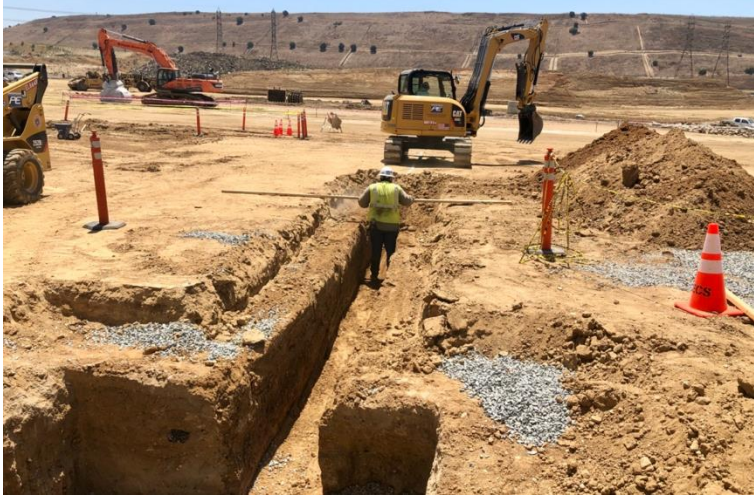
Photo 13 – Storm drain trenching. Photo facing south.
