March 8, 2021

Re: Monthly Report Summary #35 for the Mesa 500-kV Substation Project

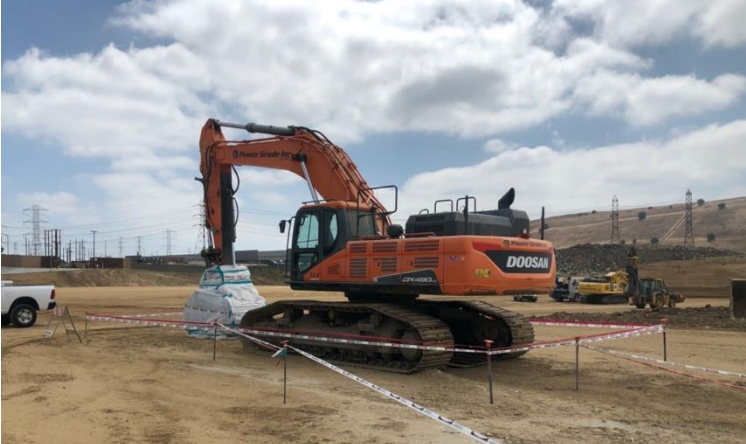
One of Mr. Lubich's crew, Duane Cave, met me onsite and explained the ongoing work activities. Clean-up of the asbestos-contaminated material and equipment remained to be performed (Photos 4 and 5). According to Duane, they continued to wait for clearance to transport the material offsite. Clearance was received to excavate soil and foundations from within a portion of the existing substation. The soil was being delivered to rebuild the new retention basins.

Photo 4 – Contaminated excavator. Photo facing southeast.
8/05/20	Mesa Substation

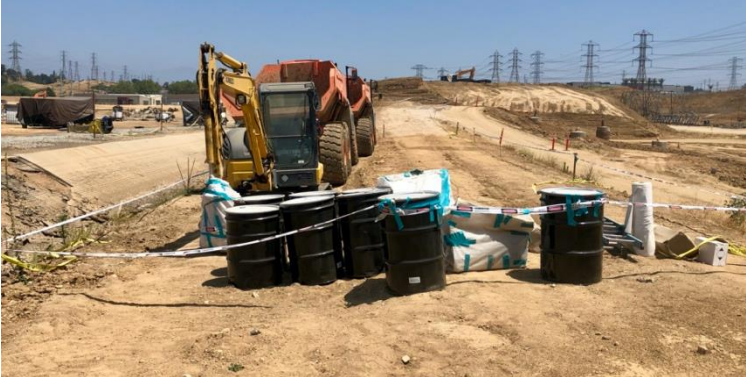
Photo 5 – Taped off area with contaminated material and equipment. Photo facing east.
8/05/20	Mesa Substation

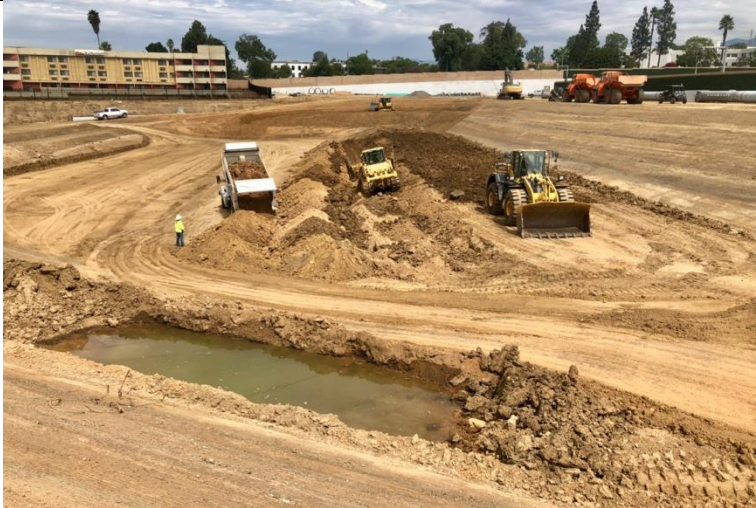
Power Grade continued to work on Phase 3, including the construction of the northern boundary wall. While I was onsite, a large crew was spraying a portion of the wall with shotcrete (Photo 6) and installing rebar (Photo 7). I briefly spoke to Craig Pernot about the Power Grade construction activities. Their crews continued to excavate the soil and existing foundations in the southwestern corner of the existing substation (Photo 8) and hauling this soil to the existing retention basin (Photo 9). The soil was being compacted into the portion of the basin that will become a bioswale. A pool of water was contained in the southern portion of the basin but the source was unclear.

Photo 9 – Reworking the existing retention basin. Pounded water was observed nearby from an unknown source. Photo facing north.
8/13/20	Mesa Substation

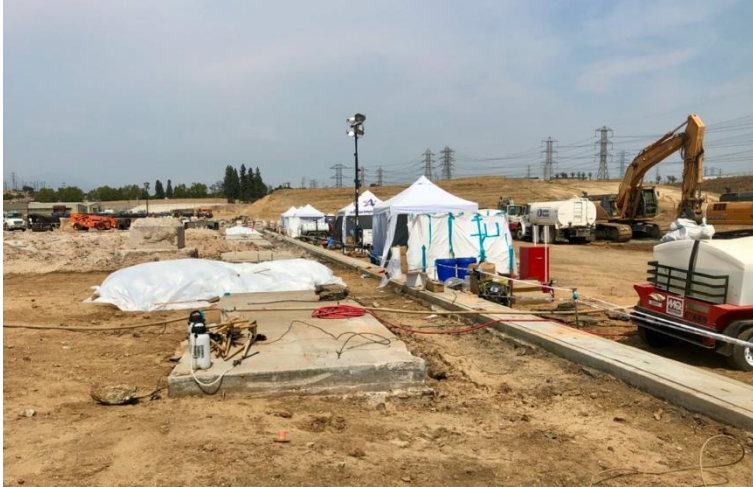
Photo 5 – Taped off area with contaminated material and equipment. Photo facing east.
8/19/20	Mesa Substation

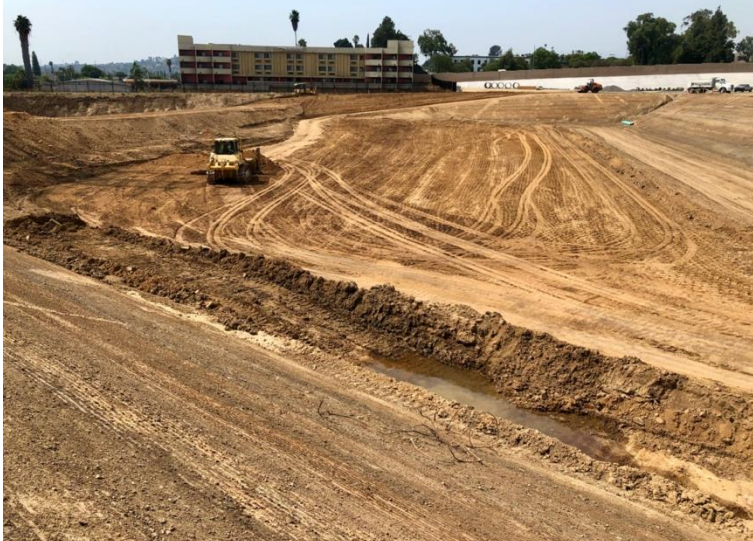
Photo 6 – Reworking the existing retention basin. Pondered water was present from an unknown source. Photo facing north.

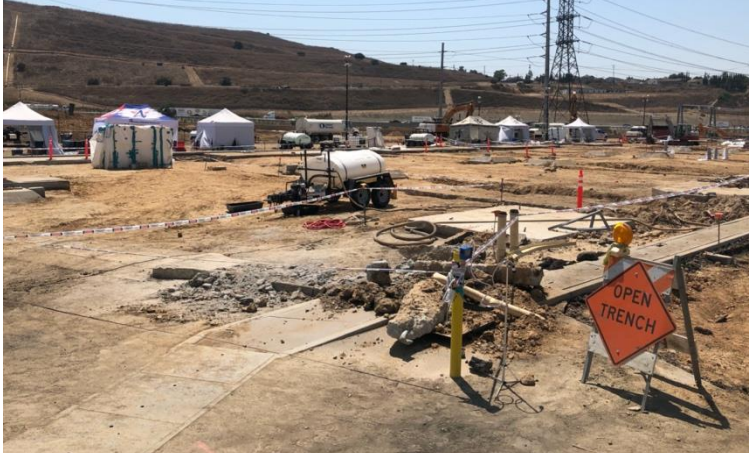
A portion of the Phase 3 grading area remained cordoned off due to contamination by hazardous materials (Photo 4). Crews were removing the material by hand during night shifts over the weekends.

Photo 4 – Taped off area with contaminated material and equipment. Photo facing southwest.
8/27/20	Mesa Substation	 	Photo 5 – Compacting soil into the existing detention basin. Photo facing north.
8/27/20	Mesa Substation
