March 15, 2021

Re: Monthly Report Summary #36 for the Mesa 500-kV Substation Project

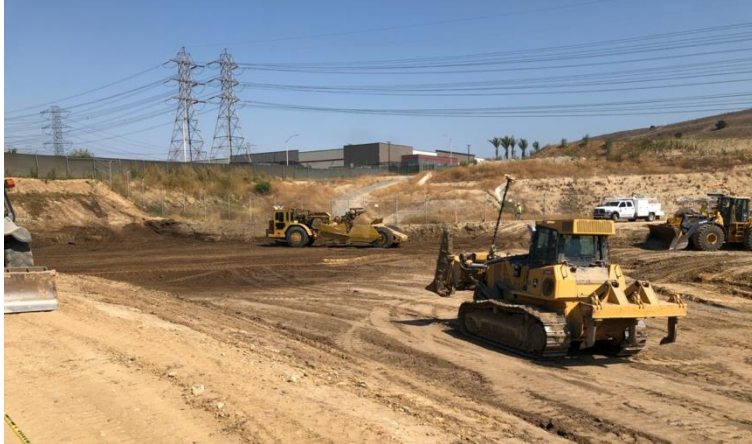
Photo 1 – Excavation and compaction of soil was underway near the eastern entrance to the project site. Photo facing southeast.
9/03/20	Mesa Substation

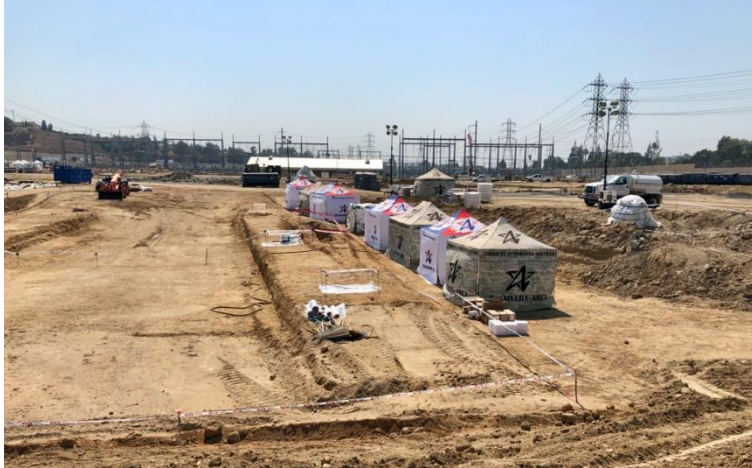
Within the construction zone for the 500-kilovolt (kV) rack area there were several areas taped off due to hazardous materials. Shade canopies were erected due to excessive heat for crews (Photo 2).

Photo 2 – Areas where hazardous materials were stored were taped off with shade tents in place due to excessive heat. Photo facing west.
9/03/20	Mesa Substation

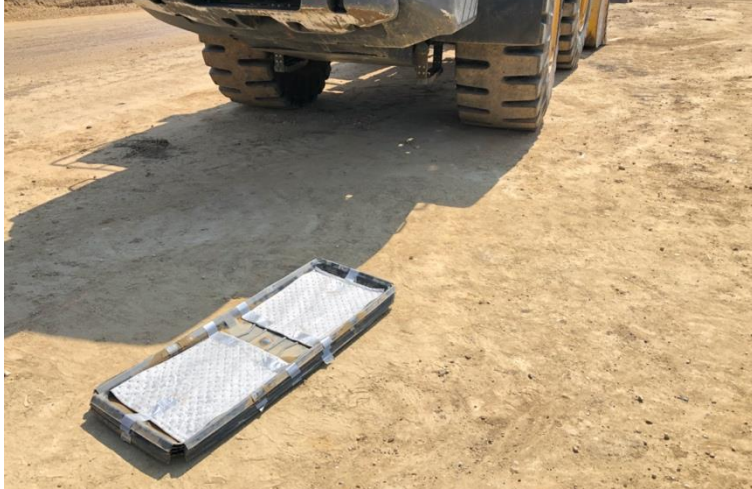
Crews were completing work for the day and some of the equipment was parked onsite. I checked on the secondary containment and several pieces of equipment did not have any drip pans underneath them (Photo 3). I mentioned this to Mr. Woodroof and he said a crew goes around at the end of the day and replaces the drip pans. Later on my site visit, I observed the crew checking for secondary containment and placing them when they were absent.

Photo 3 – A drip pan needed to be moved under the parked equipment.

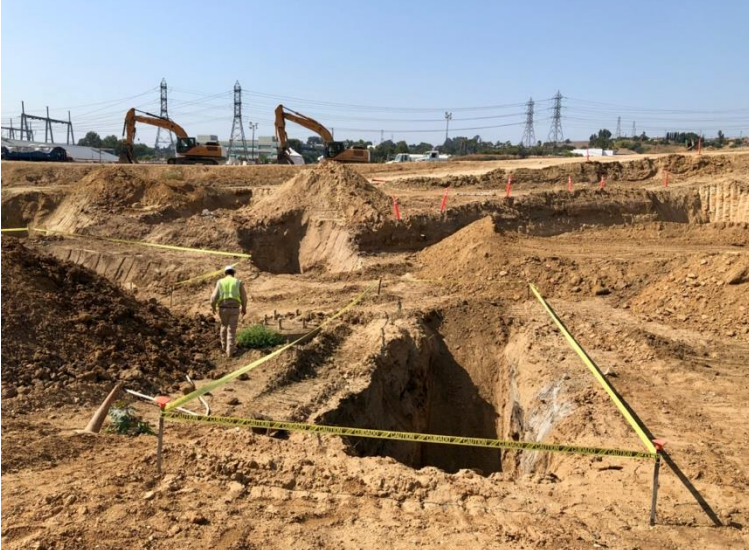
Power Grade work continued with the breakup of concrete and asphalt (Photo 7); this material was being hauled offsite. The crew were removing the existing tower foundations resulting in large deep holes (Photo 8). These holes were taped off and left with an earthen ramp to allow animals to escape. Work continued on the northern wall with crews building the upper portion of the wall with brick (Photo 9).

Photo 8 – Holes left by the foundation removal. Photo facing north.
9/03/20	Mesa Substation

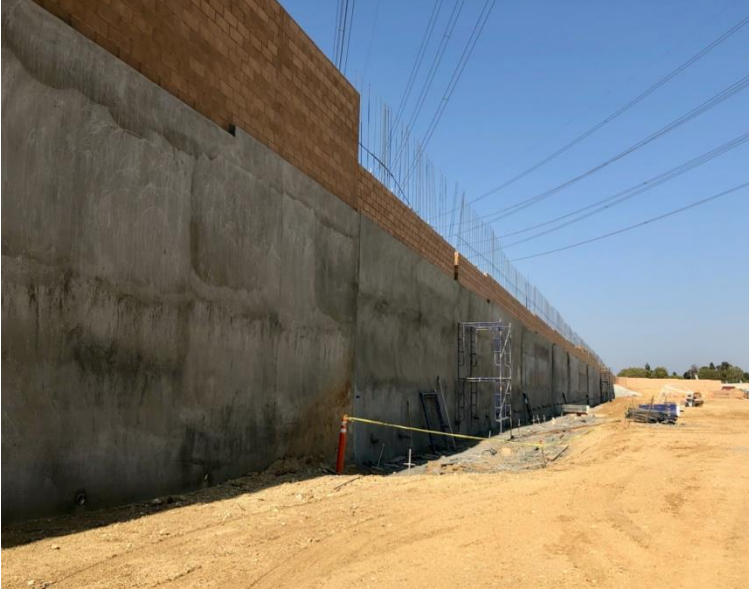
Photo 9 – Power Grade work on the northern wall laying brick. Photo facing east.

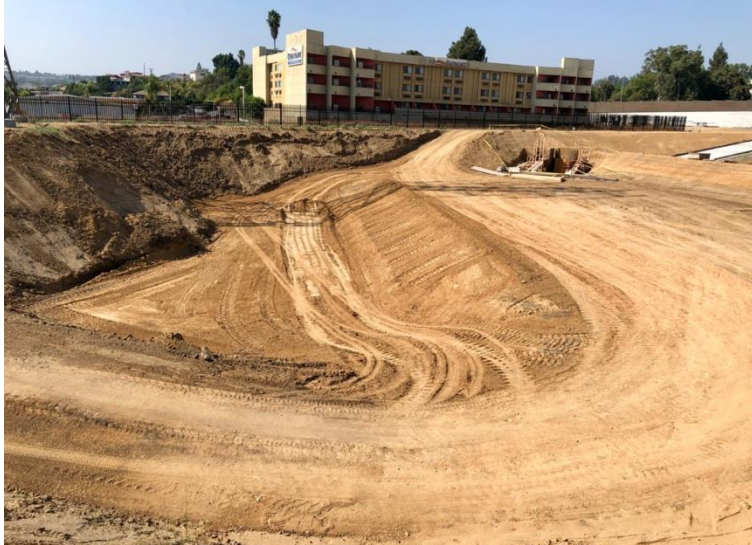
Photo 11 – Detention basin work. Excavation of the drainage culvert still needed to be completed. Photo facing north.

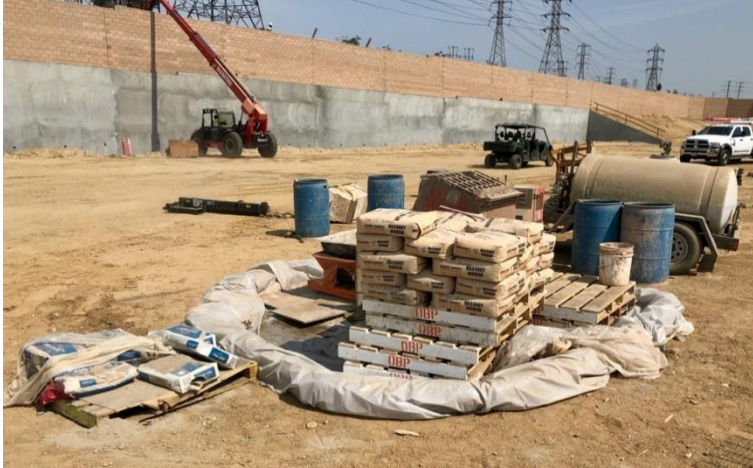
Our first stop was at the northern boundary wall construction area. A small crew continued to lay brick and a mortar mixing station was nearby (Photo 1). Mr. Daniele said he had been concerned about the spilled cement and the general lack of tidiness around the work area, but the site was in better condition. I offered to speak with the project staff about these issues.

Photo 1 – Mortar mixing station for the brick laying work on the northern boundary wall. Photo facing northeast.
9/17/20	Mesa Substation

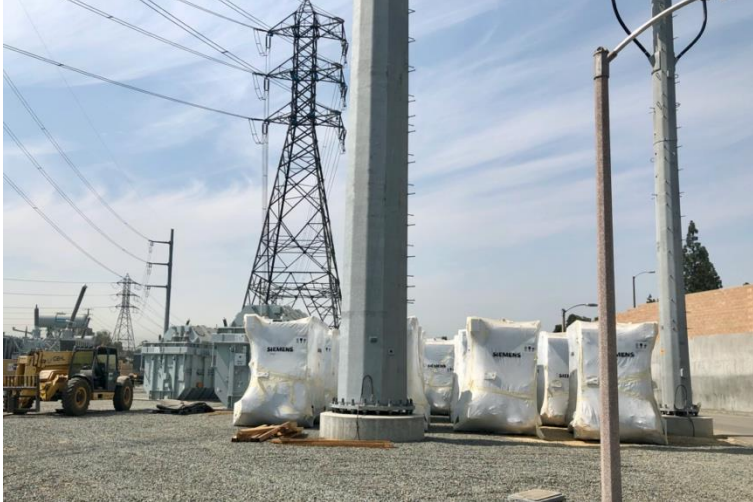
Photo 2 – 500-kV equipment was stored and assembled in the new rack areas. Photo facing west.
9/17/20	Mesa Substation

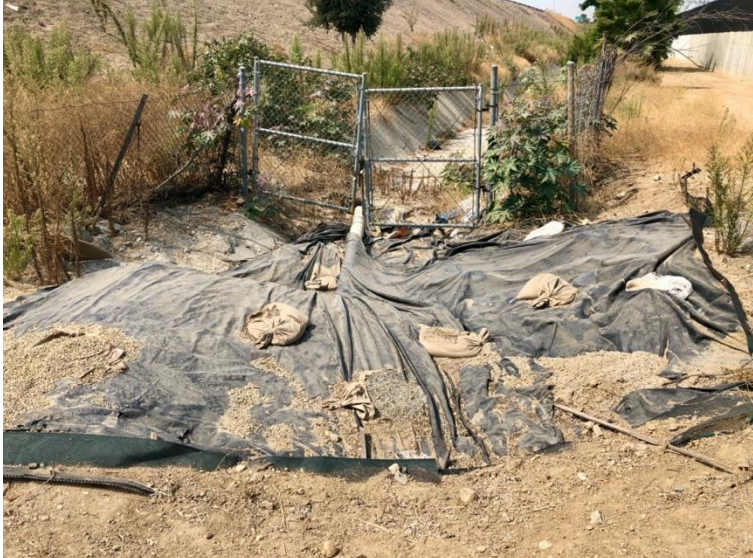
The gate was open along the southern boundary wall and I observed the drainage area leading into the California Department of Transportation (Caltrans) culvert. BMPs installed several years ago continued to be in place and needed to be removed so the area could be restored before the upcoming rainy season (Photo 3). The small triangular catch basin located in the northwestern corner of the project site was filled with sediments and needed to be cleaned out before the rainy season (Photo 4).

Photo 3 – Existing BMPs remained at the entrance to the Caltrans concrete culvert. Photo facing west.

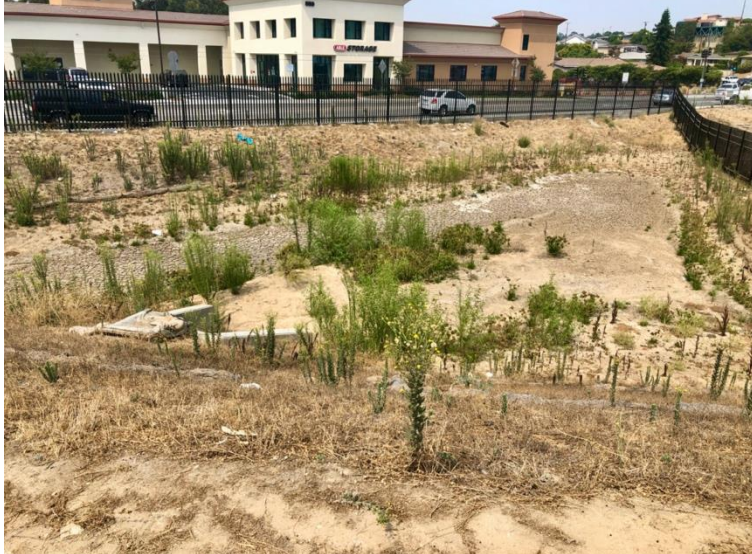
<p>Photo 4 – The small triangular catch basin remained was full of sediment and should be cleaned out before the next rainy season. Photo facing northwest.</p>
9/17/20	Mesa Substation

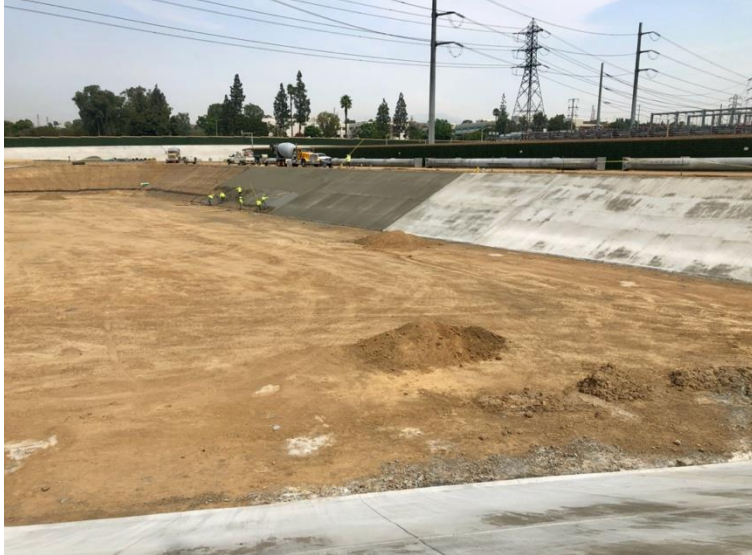
<p>Photo 5 – Shotcrete being applied to the slopes of the new bioswale area. Photo facing north.</p>
9/17/20	Mesa Substation

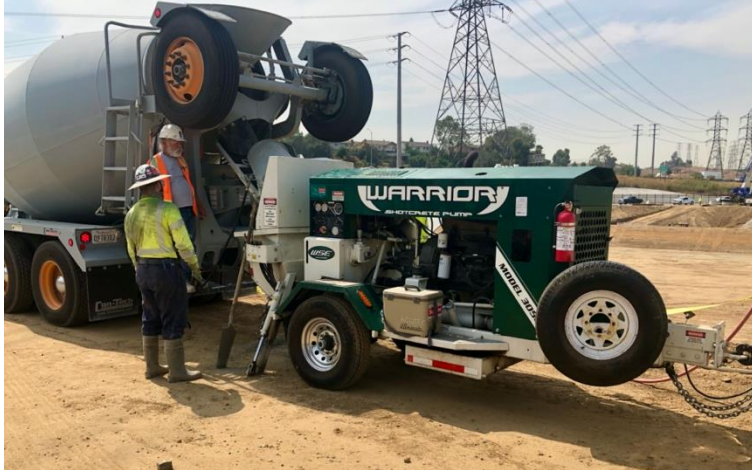
<p>Photo 6 – Concrete pumping equipment without any secondary containment. Photo facing west.</p>

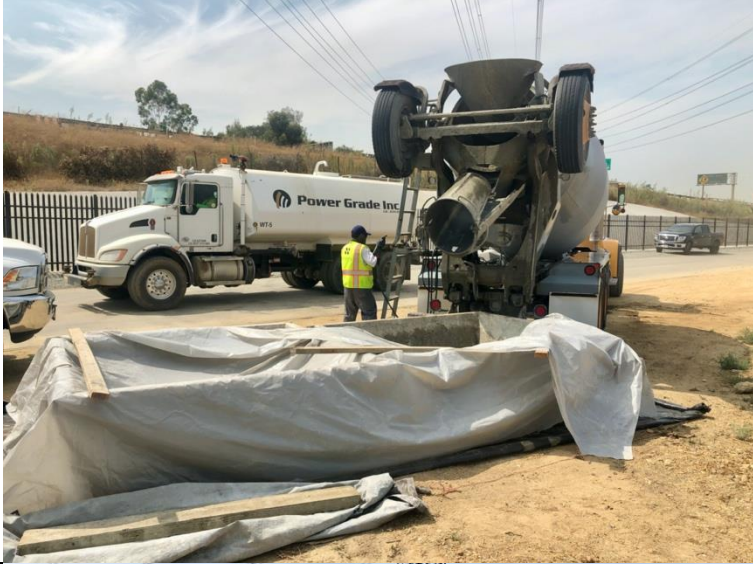
Photo 7 – Concrete washout location. Photo facing southwest.
9/17/20	Mesa Substation

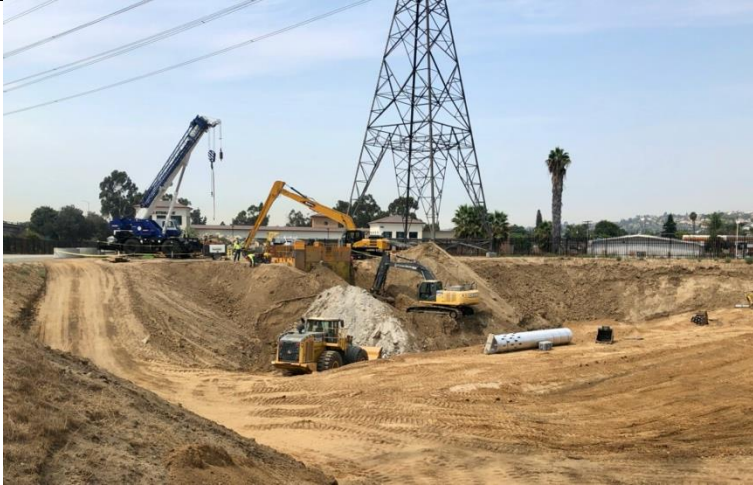
Photo 8 – Work on the new rainwater catch basin. Photo facing west.

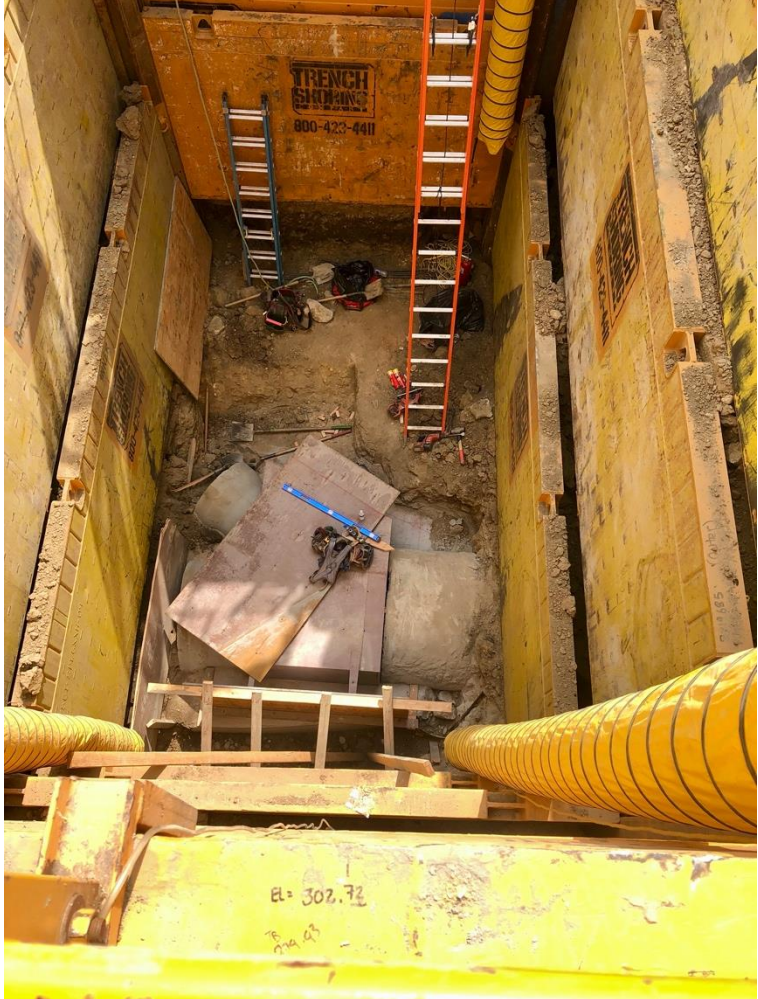
Photo 9 – Deep, well-shored excavation down to the drain outflow pipe.
9/17/20	Mesa Substation

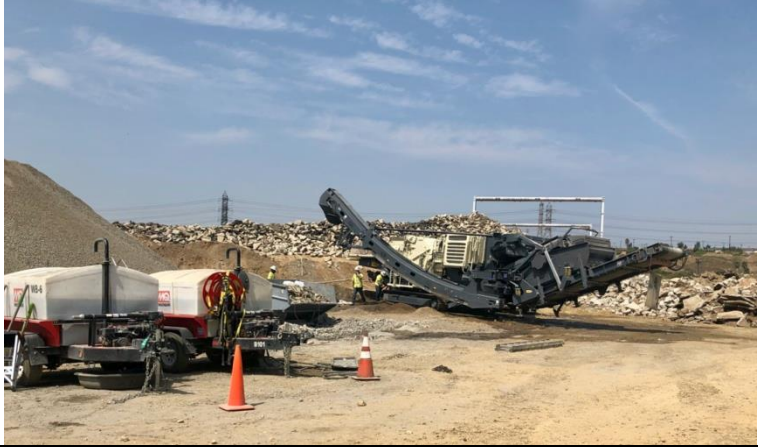
The debris grinding equipment was being washed and hauled offsite (Photo 10). According to Mr. Daniele, grinding operation had ceased because asbestos was discovered in the debris piles, so the remaining material would be handled by a hazardous waste crew.

Photo 10 – Grinding equipment being washed and readied for removal from the site. Photo facing north.

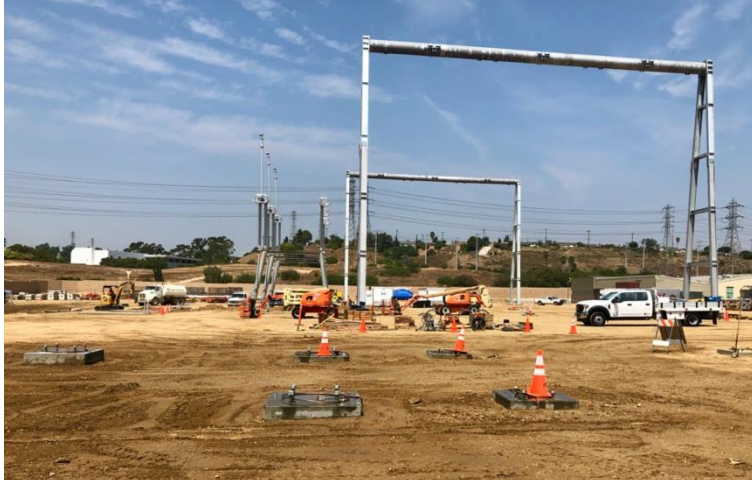
Photo 11 – Phase 4 work continued with the erection of the 500-kV infrastructure. Photo facing north.
9/17/20	Mesa Substation

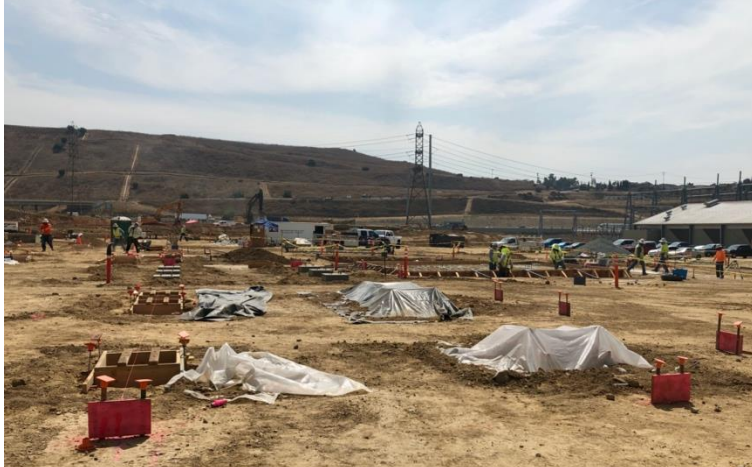
Photo 12 – Phase 4 foundation work. Photo facing south.
9/17/20	Mesa Substation

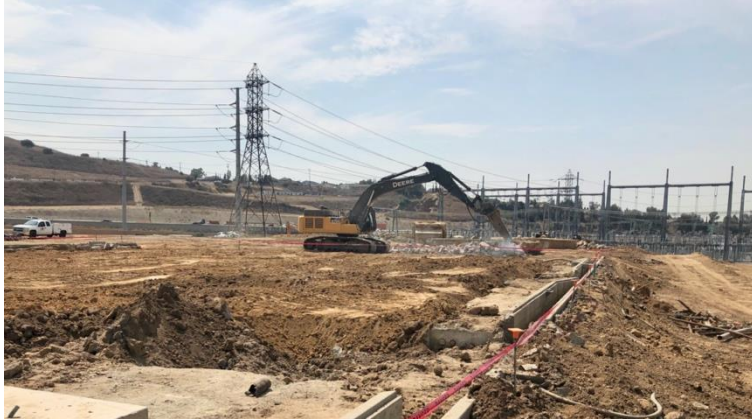
Some Power Grade equipment continued to remove and breakup the remaining existing substation foundation (Photo 13). Some deep holes and trenches are located within the existing foundations that could trap animals. I pointed this out to Mr. Daniele and he was going to address it.

Photo 13 – Excavator with a breaker bar continued to remove the existing substation foundation. Photo facing west.

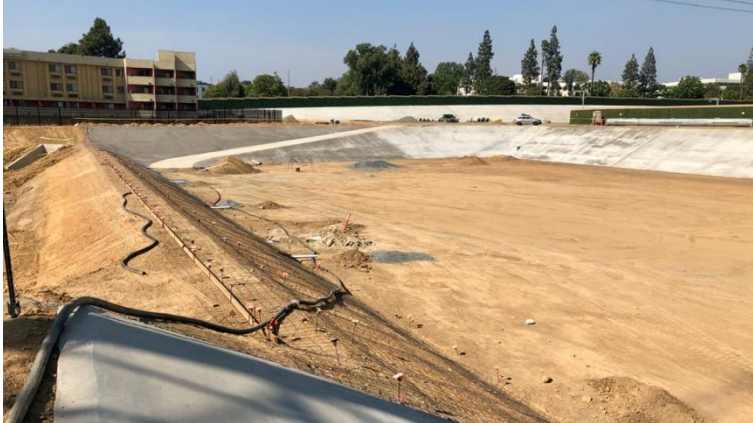
Photo 2 – Shotcrete work continued within the bioswale. Photo facing north.
9/23/20	Mesa Substation

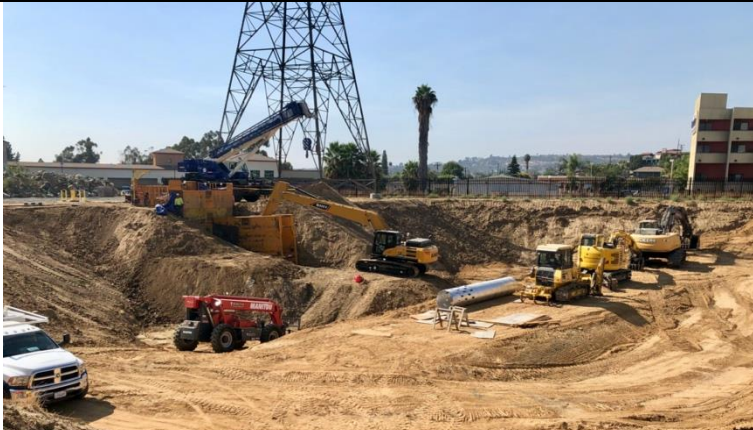
Photo 3 – Excavation work continued within the retention basin. Photo facing northwest.
9/23/20	Mesa Substation

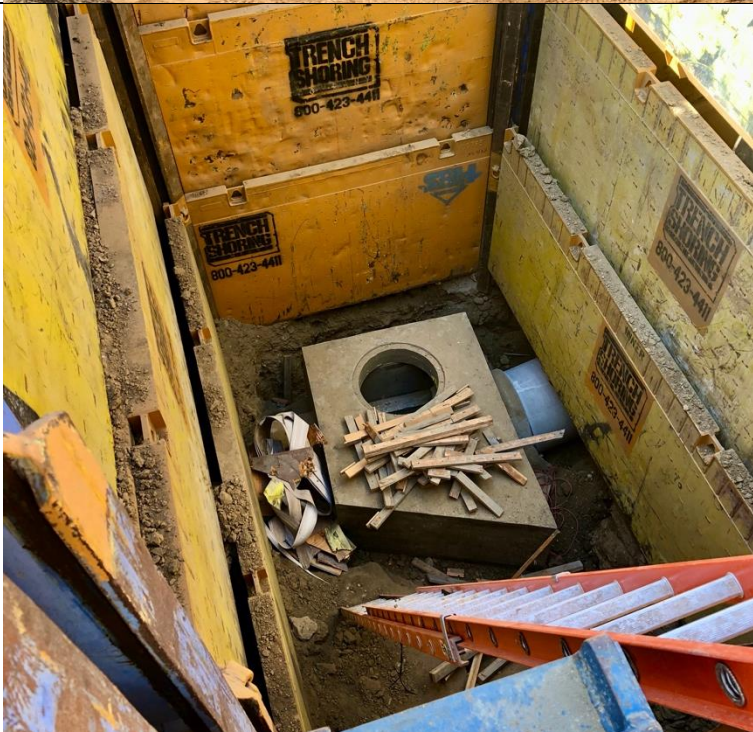
Only a small crew was working at the bioswale and retention basin. The application of shotcrete continued on the banks of the bioswale (Photo 2), and the crew was working on the drain inlet at the west end of the retention basin (Photo 3). The drain inlet work required extensive shoring to provide safe working conditions (Photo 4).

Photo 4 – Shoring protected the excavated hole to the drain outflow pipe.

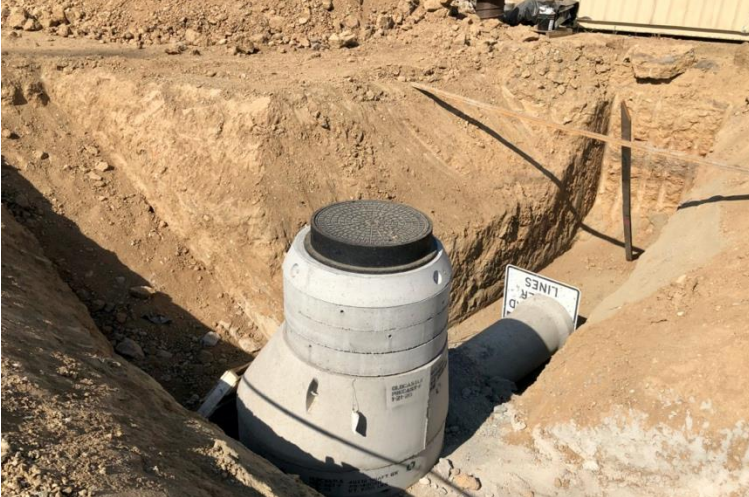
Photo 5 – A storm drain inlet with sloped sidewalls.
9/23/20	Mesa Substation

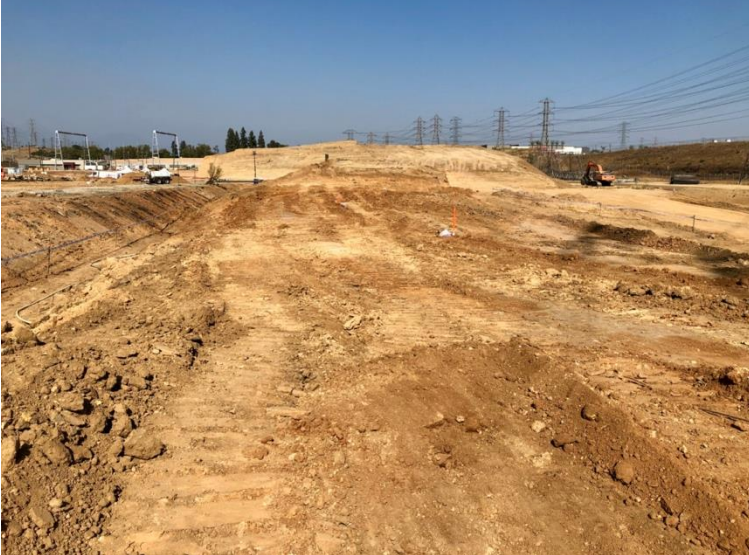
Photo 6 – Earthwork continued within the southeastern portion of the project site. Photo facing east.
9/23/20	Mesa Substation

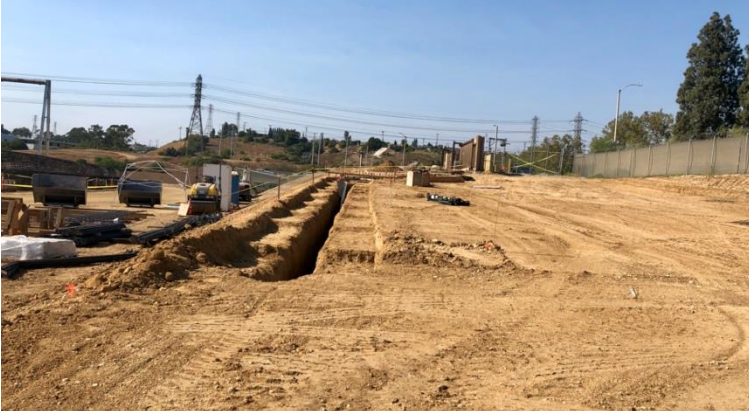
Photo 7 – Construction of the eastern boundary wall was underway. Photo facing north.

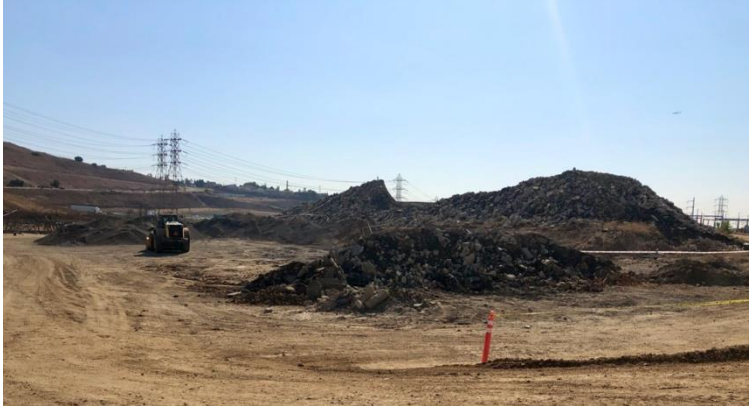
Photo 8 – Stockpiles of construction debris remained onsite. Photo facing southwest.
9/23/20	Mesa Substation

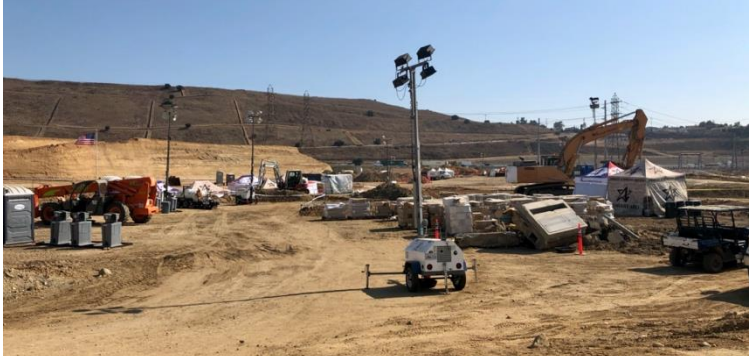
Power Grade continued to encounter the contaminated soils found under the existing substation, with many areas taped off (Photo 9).

Photo 9 – Areas with hazardous materials were taped off. Photo facing south.
9/23/20	Mesa Substation

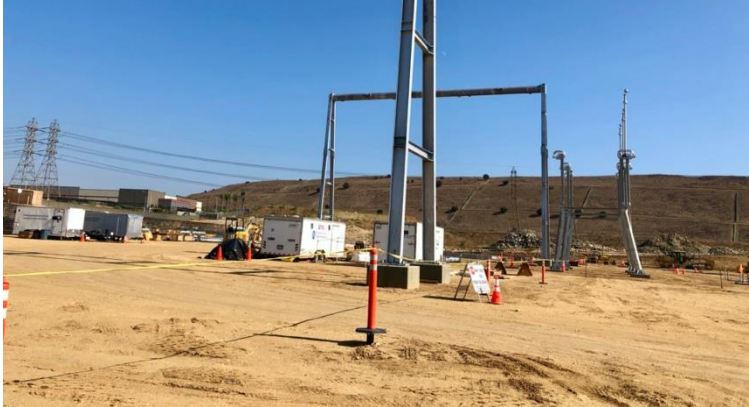
Photo 10 – The 500-kV substation infrastructure was being installed. Photo facing south.
9/23/20	Mesa Substation

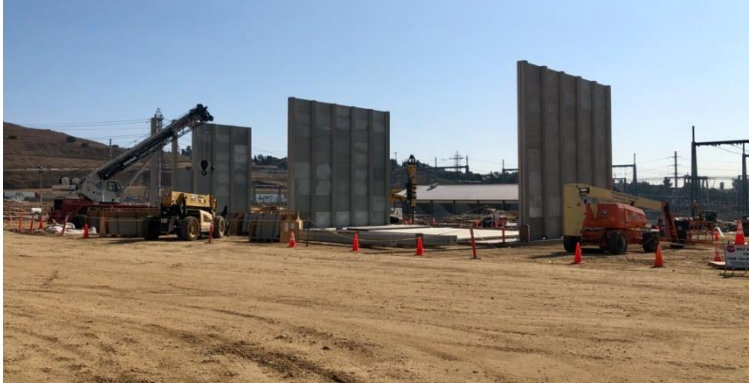
Photo 11 – Phase 4 work continued with the erection of firewalls around the 500-kV transformers. Photo facing south.

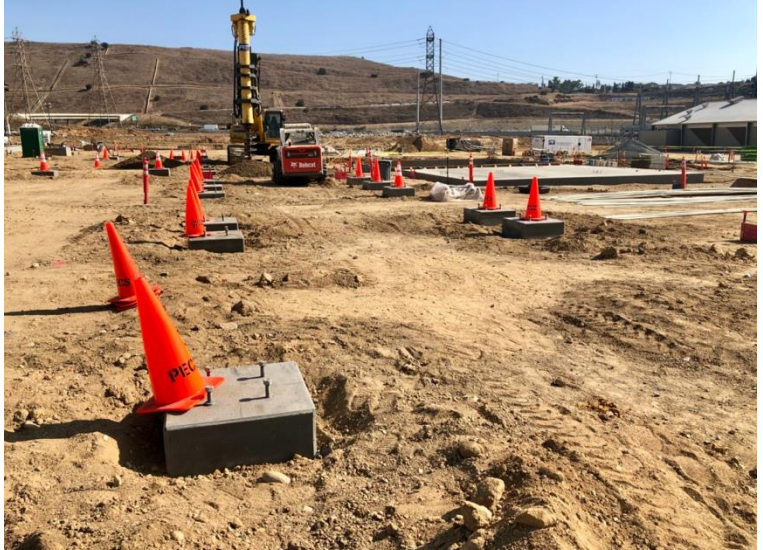
Photo 12 – Phase 4 foundation work was ongoing. Photo facing south.

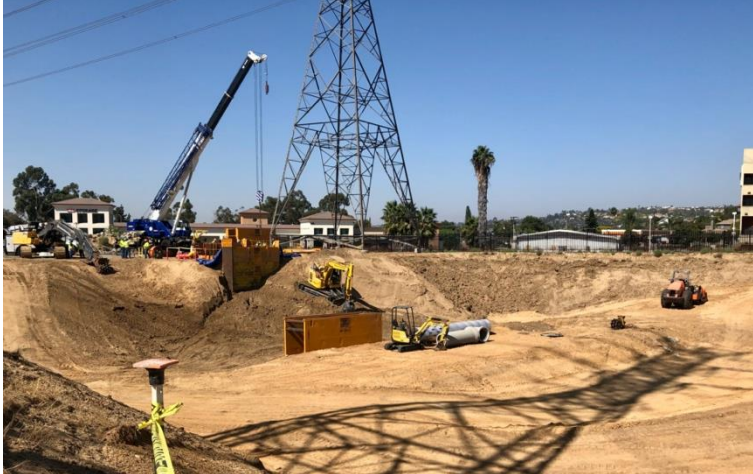
Photo 4 – Excavation work continued within the western retention basin. Photo facing northwest.
9/30/20	Mesa Substation

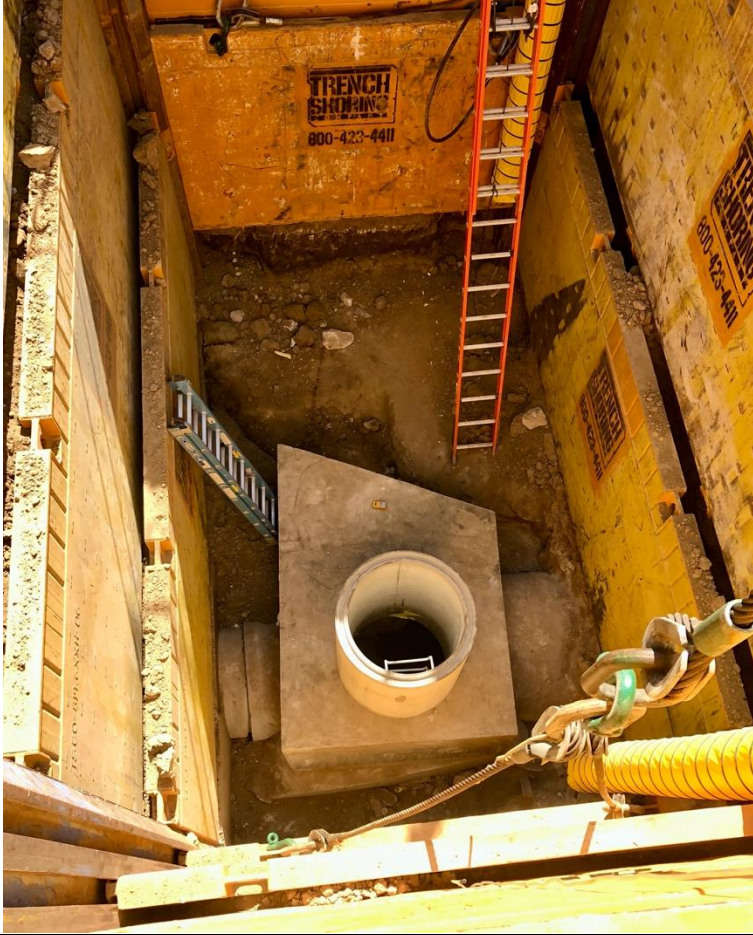
Photo 5 – Shoring protected the excavated hole to the drain outflow pipe.

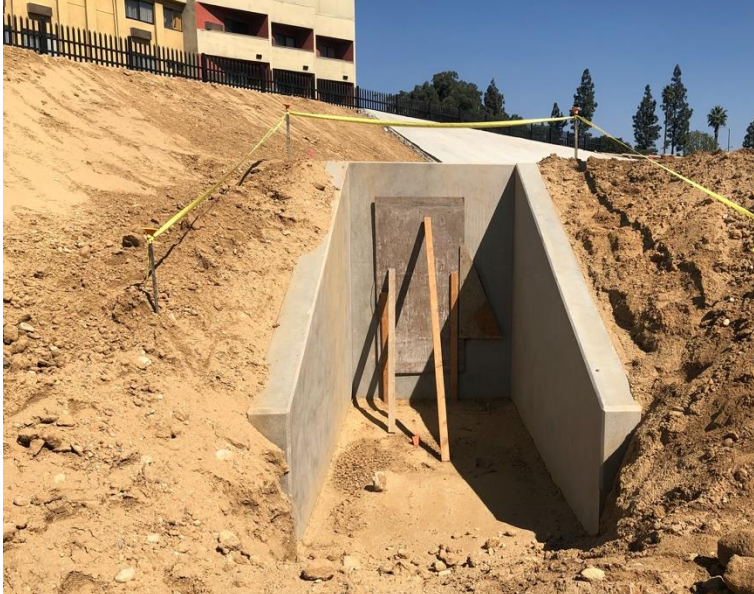
Photo 6 – A drain inlet into the western retention basin. Photo facing northeast.
9/30/20	Mesa Substation	 	Photo 7 – Weed growth along the fencing north of retention basins. Photo facing west.
9/30/20	Mesa Substation	 	Photo 8 – Weed growth outside of the boundary fence. Photo facing east.

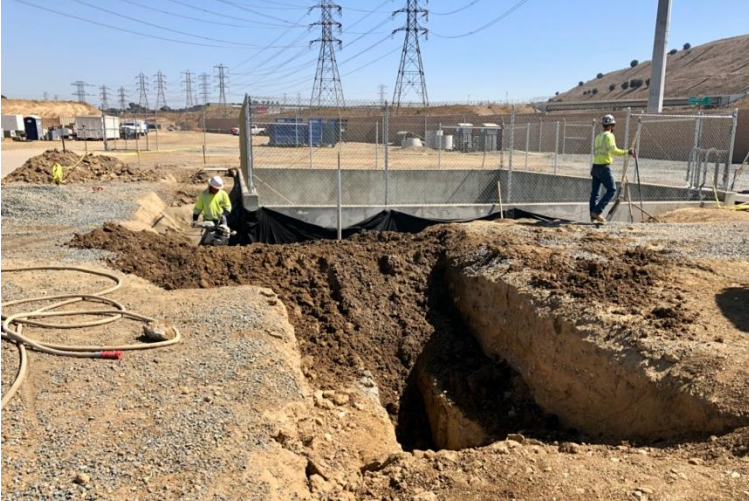
Photo 9 – Backfilling work began around the transformer catch basin. Photo facing east.
9/30/20	Mesa Substation

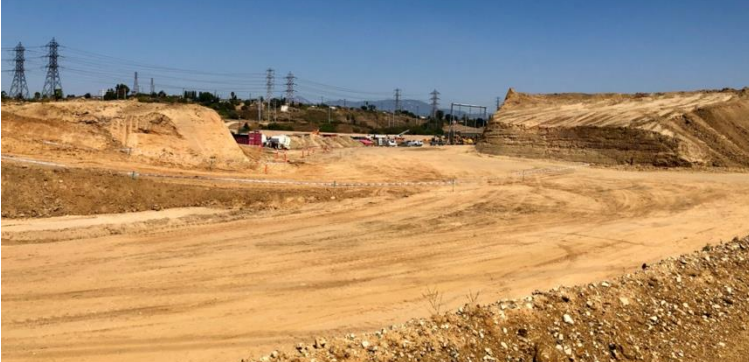
Photo 10 – Earthwork continued within the southeastern portion of the project site. Photo facing northeast.
9/30/20	Mesa Substation

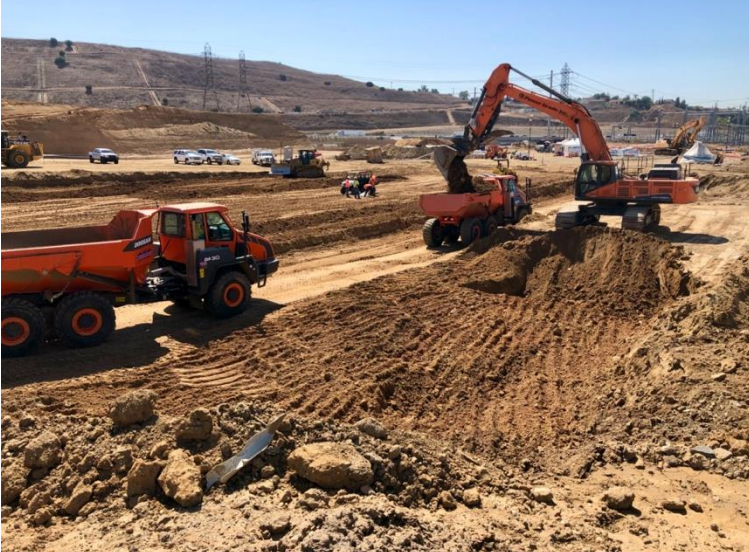
Photo 11 – Earthwork began where the hazardous materials had been removed. Photo facing southwest.

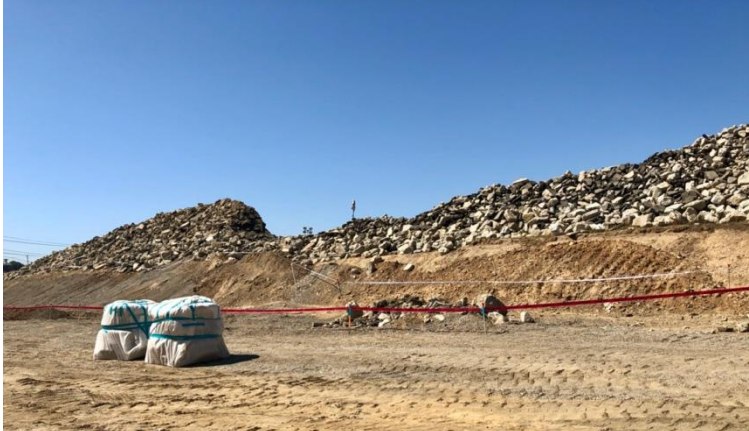
Photo 12 – Stockpiles of construction debris remained onsite. Photo facing northwest.
9/30/20	Mesa Substation

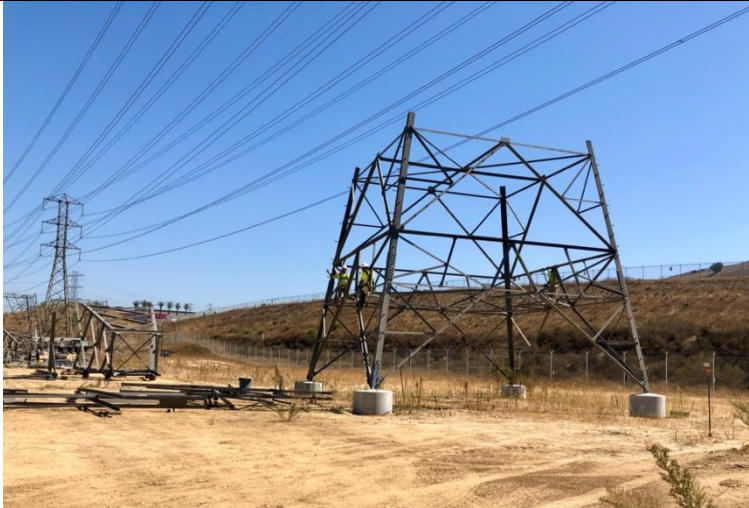
Photo 13 – Erection of one of the lattice steel towers near the ESA. Photo facing southeast.
9/30/20	Mesa Substation

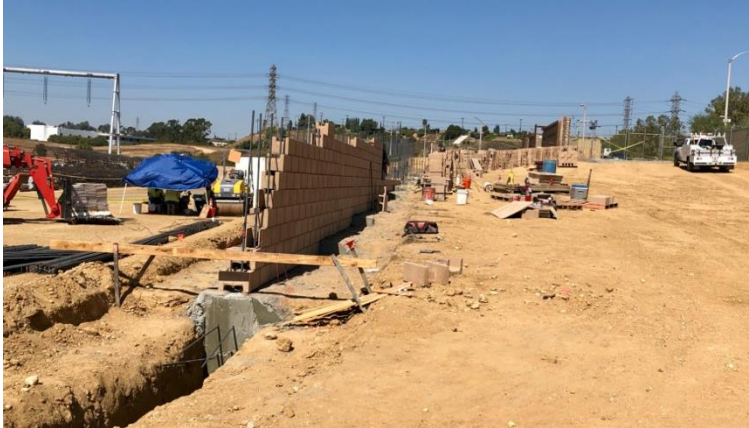
Photo 14 – Brick installation being completed on the eastern boundary wall. Photo facing north.

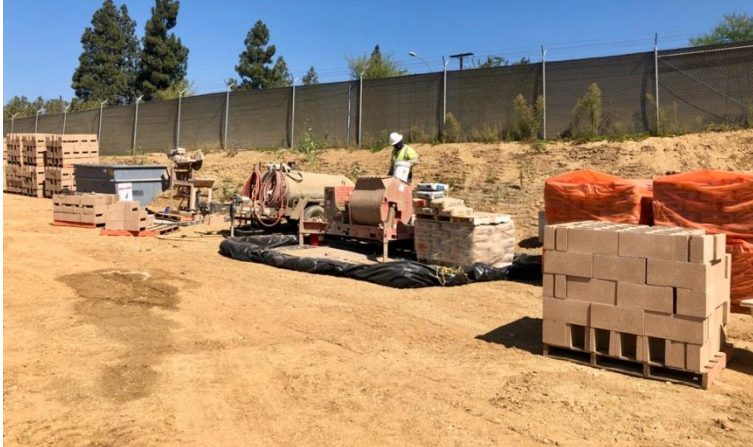
Photo 15 – Mortar mixing station near the wall installation work. Photo facing east.
9/30/20	Mesa Substation

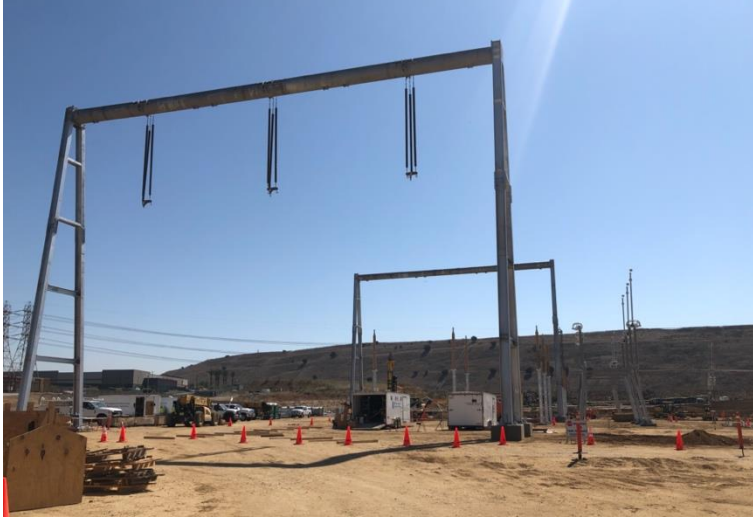
Photo 16 - The 500-kV substation infrastructure was being installed. Photo facing south.
9/30/20	Mesa Substation

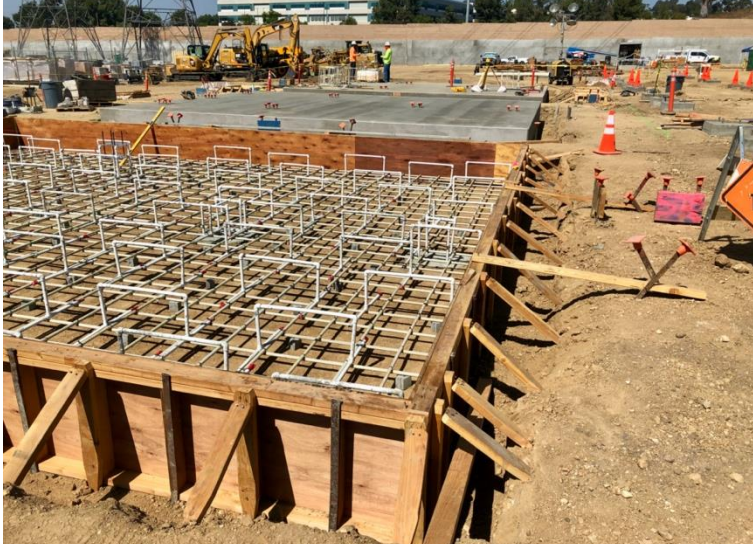
Photo 17 – Phase 4 foundation work. Photo facing north.
