March 12, 2021

**Re: Monthly Report Summary #37 for the Mesa 500-kV Substation Project**

This report provides a summary of the compliance monitoring activities that occurred during the period from **October 1 to 31, 2020**, for the Mesa 500-kilovolt (kV) Substation (Mesa Substation) Project in Los Angeles County, California. Compliance monitoring was performed to ensure that all project-related activities conducted by Southern California Edison (SCE) and their contractors comply with the requirements of the Final Environmental Impact Report (Final EIR) for the Mesa Substation Project, as adopted by the California Public Utilities Commission (CPUC) on February 9, 2017.

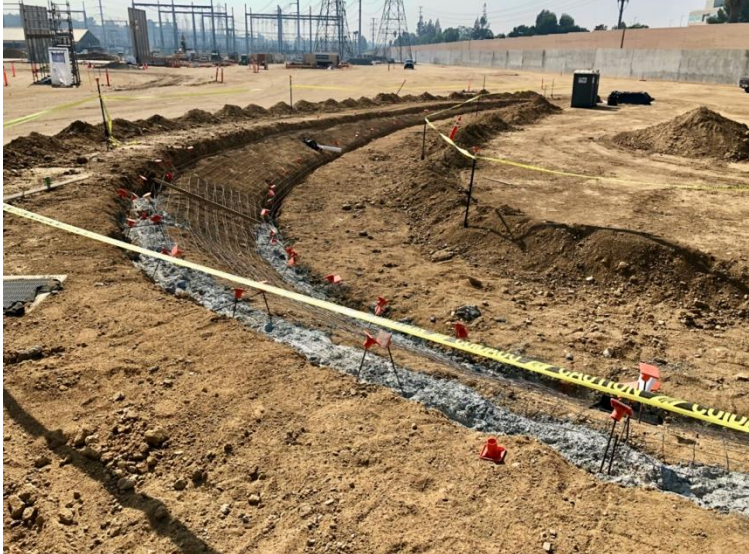
Photo 1 – Additional grading and shotcrete work near the Potrero Grande Drive entrance. Photo facing northwest.
10/07/20	Mesa Substation

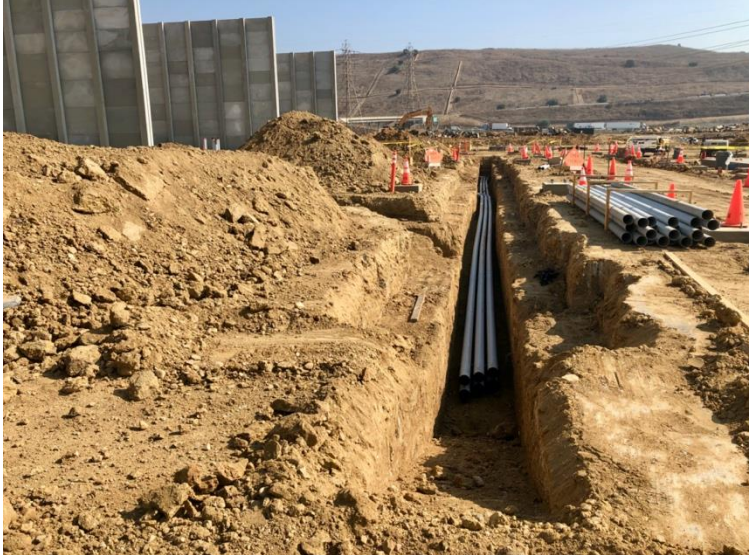
Wayne and I drove down toward the Professional Electrical Construction Services yard where crews were working on conduit installation near the new 500-kilovolt (kV) transformer firewalls and foundations (Photo 2). An earthen ramp was made at one end of the conduit trench. Mr. Woodroof was checking on the various trenches and excavations to ensure climbing structures were in place and that they were covered overnight.

Photo 2 – Trenching work alongside the new Phase 4 firewalls. Photo facing south.
10/07/20	Mesa Substation

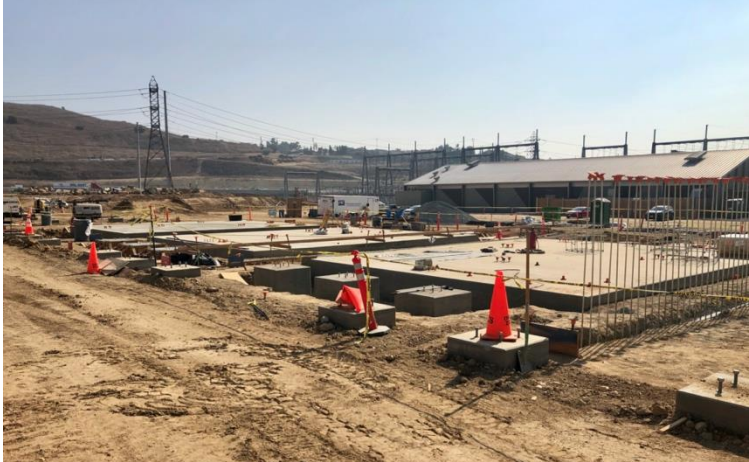
Photo 3 – Phase 4 foundation work. Photo facing southwest.

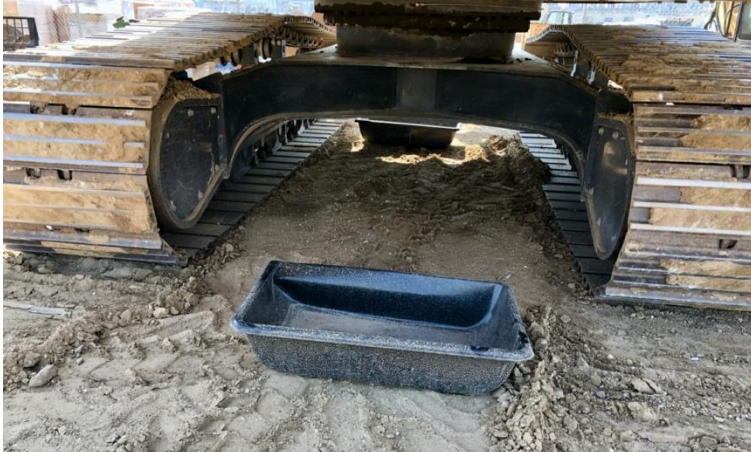
Other Phase 4 foundation work continued nearby (Photo 3). We observed the secondary containment under the parked equipment and it appeared adequate. Mr. Woodroof found one cracked drip pan and replaced it with a new one (Photo 4). Mr. Woodroof introduced me to the Professional Electrical Construction Services environmental inspector and we discussed our respective roles.

Photo 4 – Secondary containment under parked equipment.
10/07/20	Mesa Substation

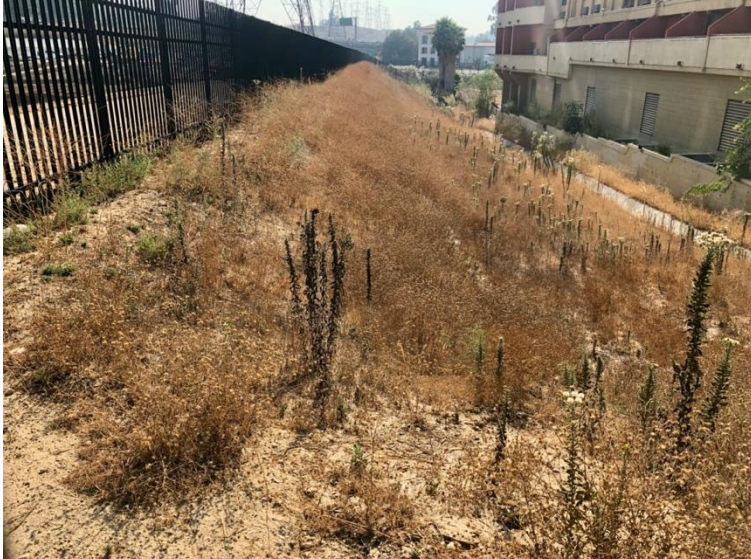
Photo 5 – Weed growth within the north facing slope near the retention basin system. Photo facing west.
10/07/20	Mesa Substation

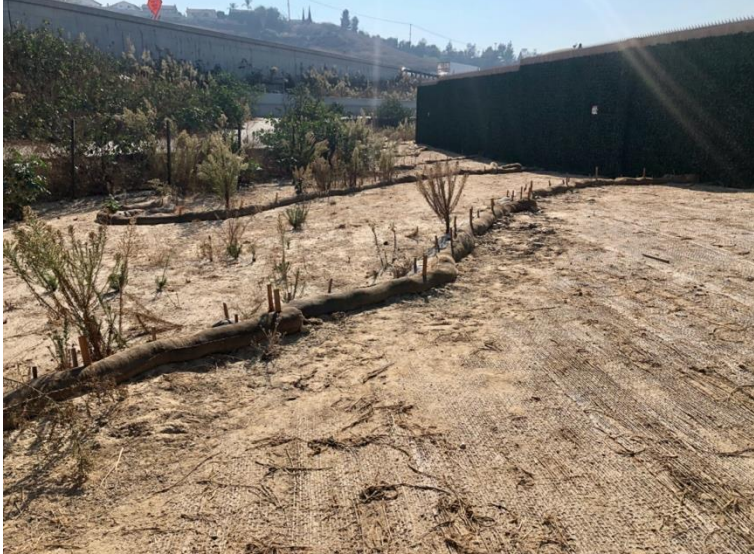
Photo 8 – BMPs outside of the southern boundary wall need to be upgraded before the coming rainy season. Photo facing southwest.
10/07/20	Mesa Substation

No weed removal was observed and no BMP upgrades had yet been made.

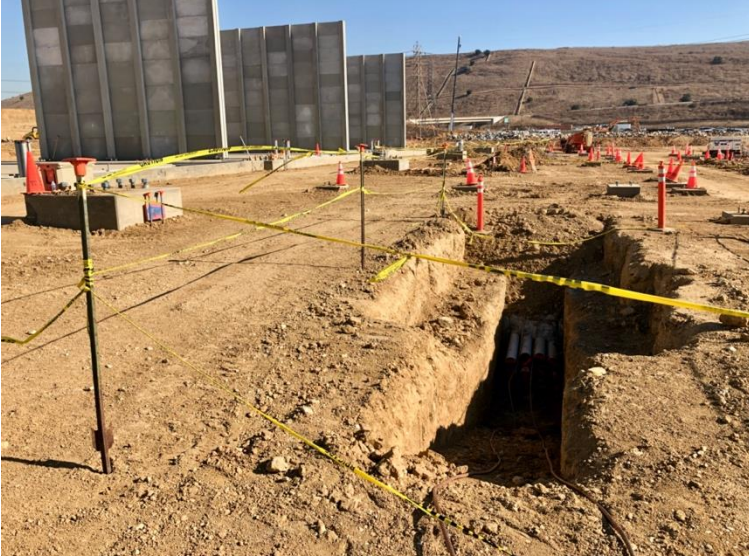
Professional Electrical Construction Services continued to erect the 500-kV substation infrastructure (Photo 7), and were backfilling conduit trenches along the transformer firewalls (Photo 8). Foundation installation was ongoing west of the transformer firewalls (Photo 9).

Photo 8 – Conduit installation near the transformer firewalls. Photo facing south.
10/14/20	Mesa Substation

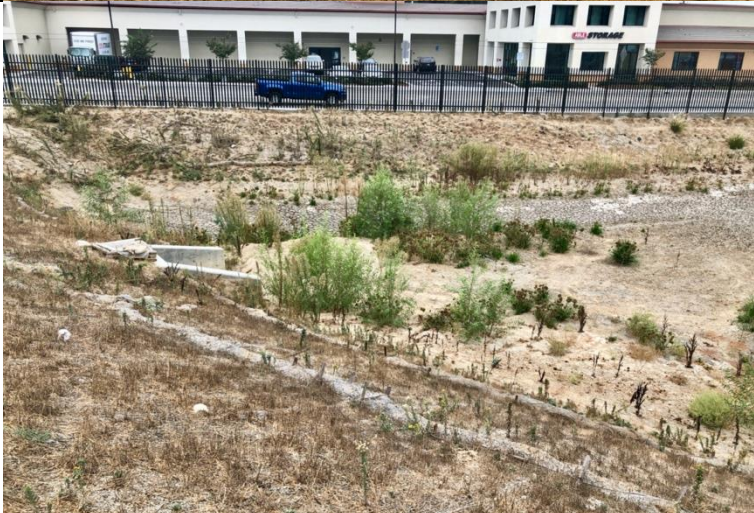
I inspected the small triangular catch basin and noted large amounts of garbage with the sediment continuing to be present and requiring cleanup. The basin was supporting a stand of willow trees (Photo 2).

Photo 2 – The small triangular catch basin needed the sediment removed. Photo facing west.
10/22/20	Mesa Substation

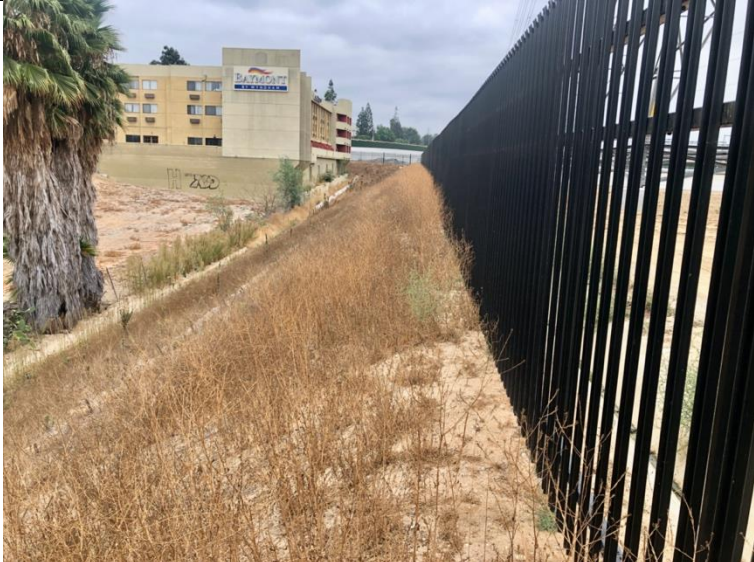
Photo 3 – Weed removal was required. Photo facing east.

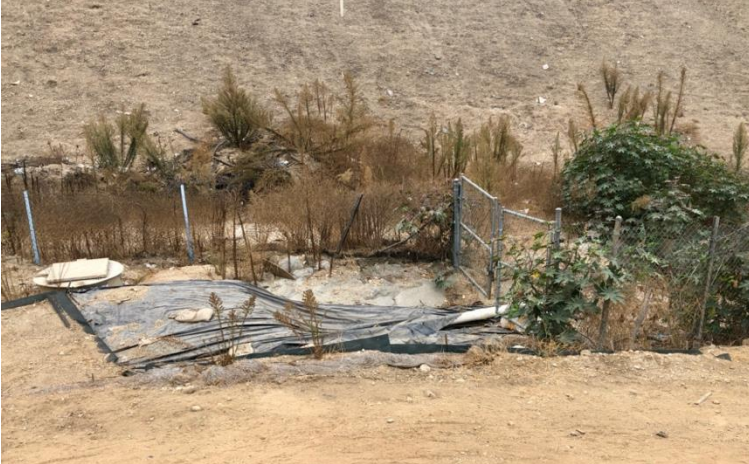
Photo 4 – Existing BMPs near the Caltrans culvert needed to be removed. Photo facing south.
10/22/20	Mesa Substation

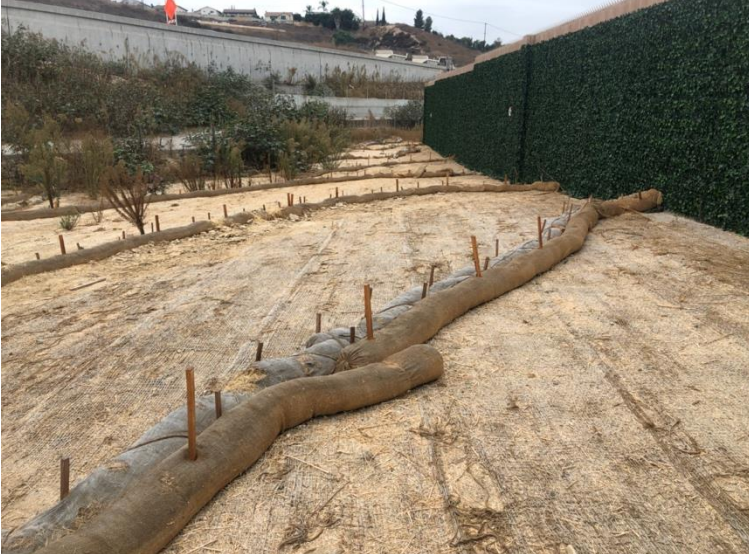
The BMPs along the outside of the southern boundary wall were in poor condition and needed to be removed and replaced, ideally with a new sediment control system (Photo 5). As observed in previous years, a large volume of runoff came from the southeastern portion of the project and regularly overwhelmed the straw wattle system allowing sediment laden water to run directly offsite. An improved sediment control plan is required for this area.

Photo 5 – Existing BMPs outside the southern boundary wall. Photo facing southwest.
10/22/20	Mesa Substation

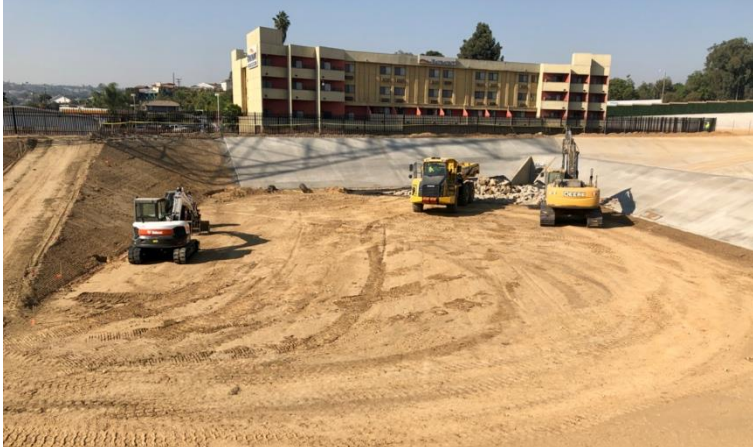
Work at the detention basin included the addition of riprap at the storm drain inflow culvert into the basin (Photo 4). I again noted the water seeping out from under the southern slope of the bioswale area (Photo 5).

Photo 4 – Work within the detention basin installing riprap. Photo facing north.
10/28/20	Mesa Substation

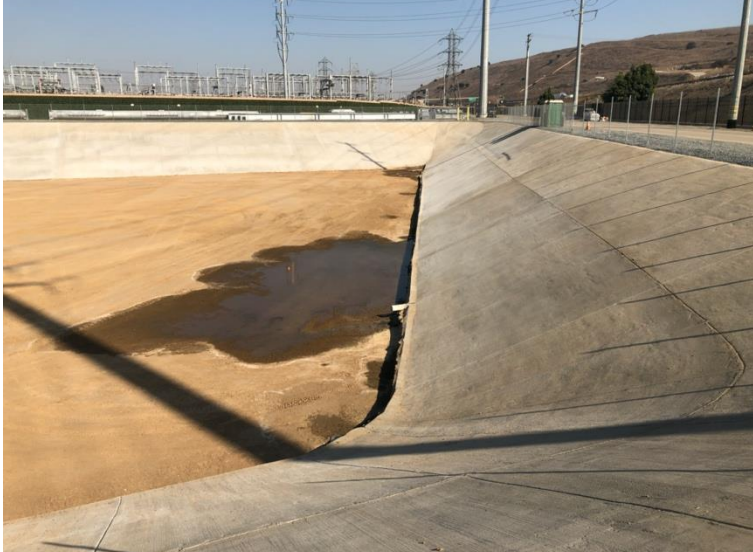
Photo 5 – Water seepage from the south slope of the bioswale. Photo facing east.
10/28/20	Mesa Substation

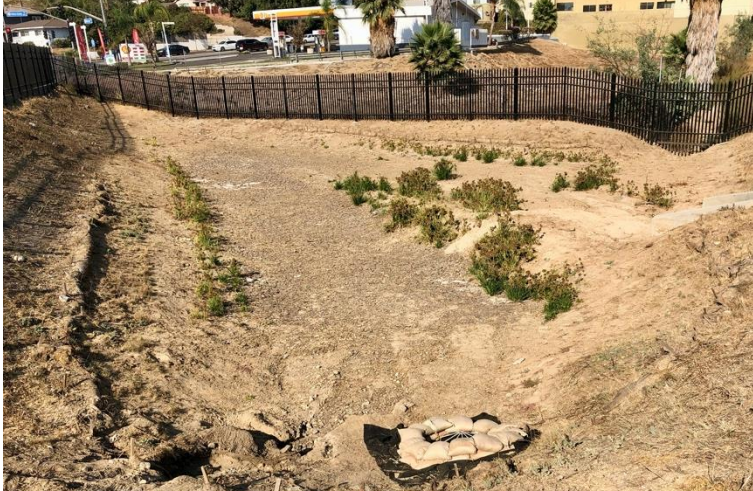
Photo 6 – The small triangular catch basin sediment needed to be removed. Photo facing north.

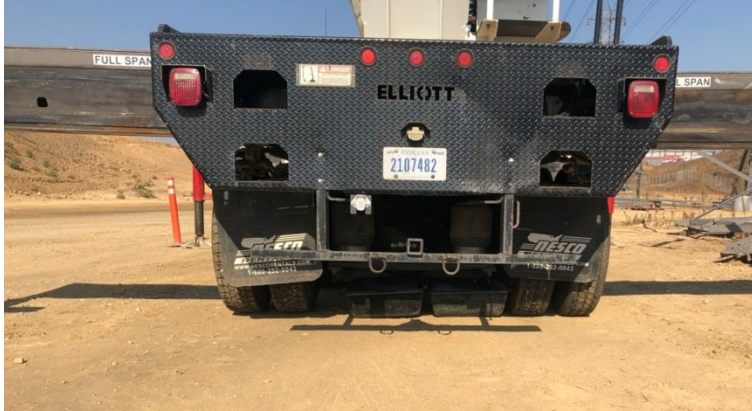
Photo 8 – Secondary containment appeared adequate.
10/28/20	Mesa Substation
