**Re: Monthly Report Summary #38 for the Mesa 500-kV Substation Project**

CPUC Site Inspection Reports  
November 4, 11, and 19, 2020

## Mesa 500–kV Substation Project CPUC Site Inspection Form

<b>Project:</b>	Mesa 500-kV Substation Project	<b>Date:</b>	November 4, 2020
<b>Project Proponent:</b>	Southern California Edison (SCE)	<b>Report #:</b>	VS142
<b>Lead Agency:</b>	California Public Utilities Commission (CPUC)	<b>Monitor(s):</b>	Vince Semonsen
<b>CPUC PM:</b>	Connie Chen, Energy Division	<b>AM/PM Weather:</b>	Warm and calm with hazy sunshine
<b>WSP CM:</b>	Silvia Yanez	<b>Start/End time:</b>	1100 to 1245 hours
<b>Project NTP(s):</b>	Notice to Proceed (NTP)-1, NTP-2

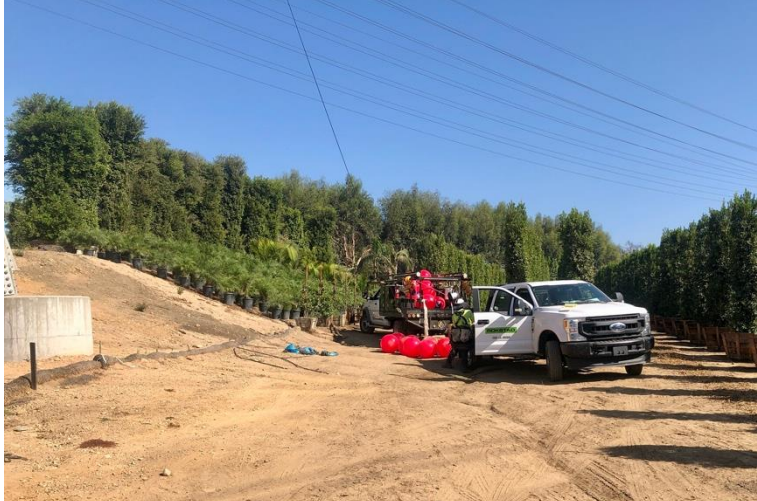
Photo 1 – Crew removing existing raptor nest exclusion balls and installing new ones. Photo facing east.
11/04/20	Mesa Substation

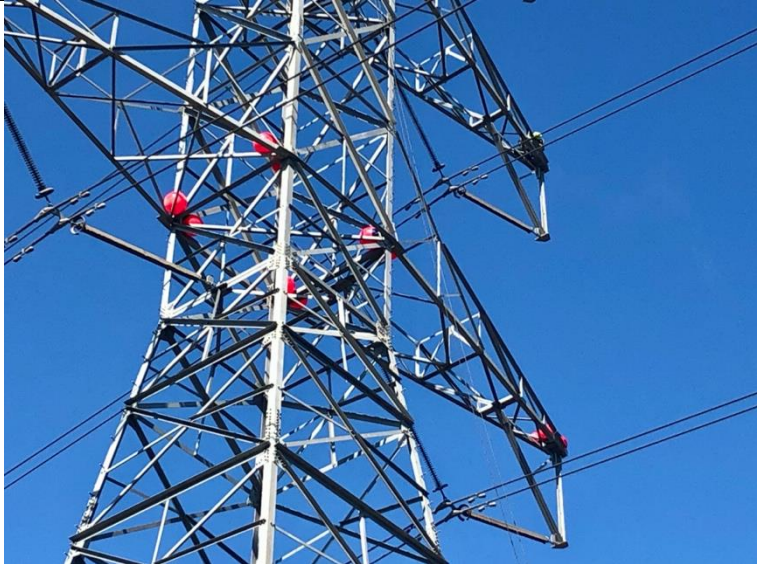
Photo 2 – Exclusion balls in one of the lattice steel towers.
11/04/20	Mesa Substation

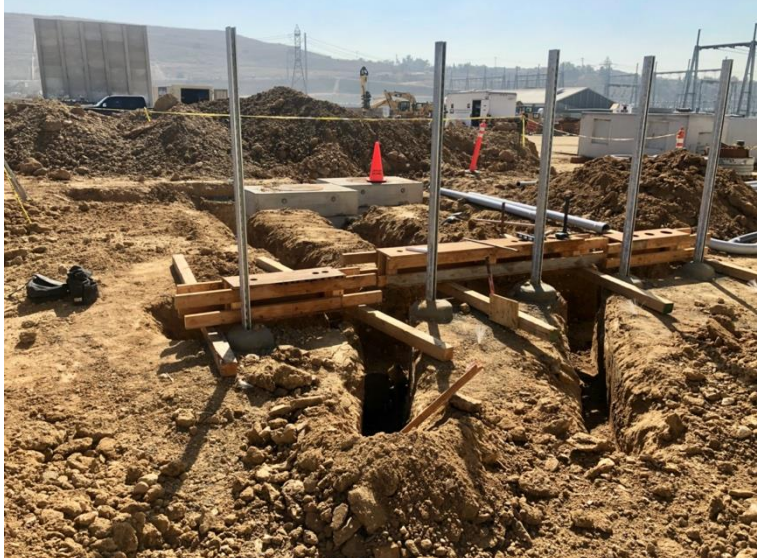
Photo 3 – Security station being installed with protective barriers. Photo facing south.

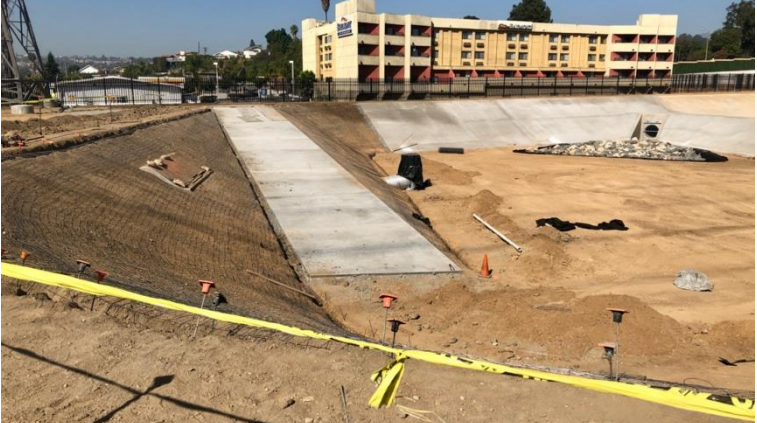
Photo 4 – Work within the detention basin. Photo facing north.
11/04/20	Mesa Substation

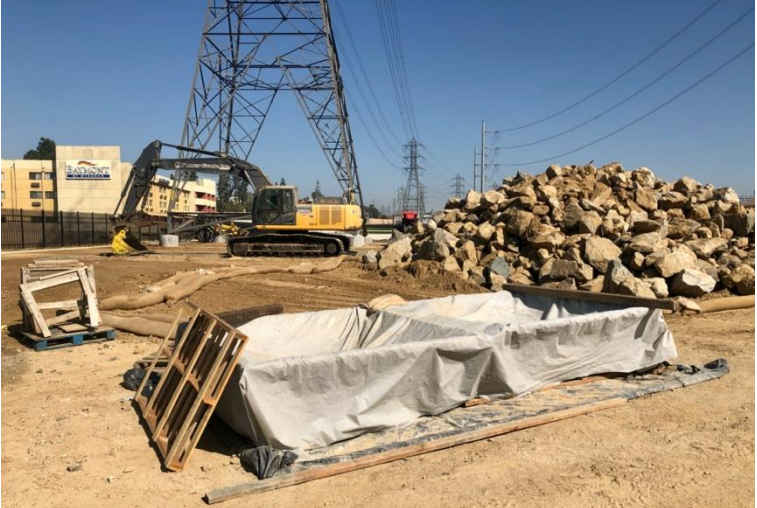
Photo 5 – Concrete washout station near the detention basin. Photo facing east.
11/04/20	Mesa Substation

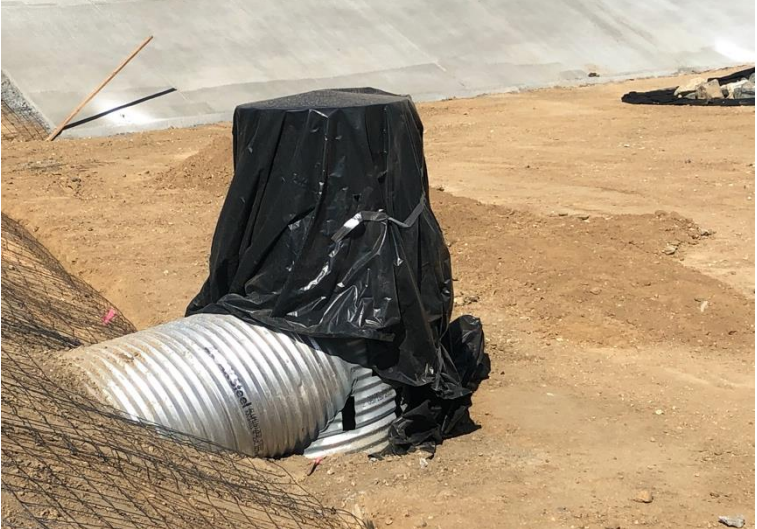
Photo 6 – Standpipe in the detention basin with holes cut in the pipe.

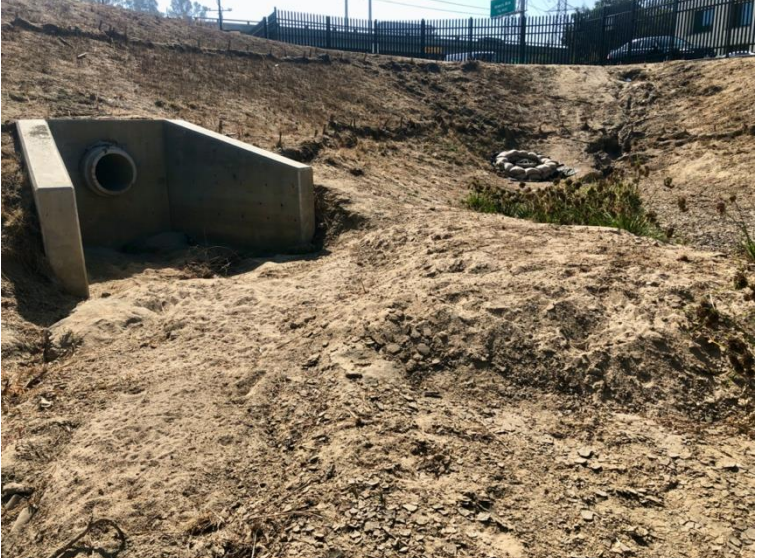
The small triangular catch basin appeared to be in the same condition as last week (Photo 7). I noted sediment in the V ditch that directed water into the small basin (Photo 8). The slope above the V ditch had been weeded. We discussed the upcoming rainy season and about the project's Qualified SWPPP Practitioner developing a Rain Event Action Plan for the project site.

Photo 7 – Small triangular catch basin with sediment present. Photo facing southwest.
11/04/20	Mesa Substation

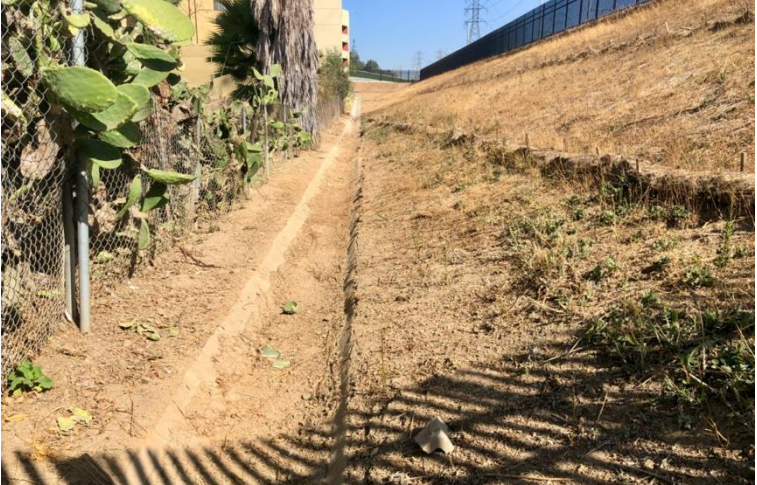
Photo 8 – Weeded slope with V ditch filled with sediment. Photo facing east.
11/04/20	Mesa Substation

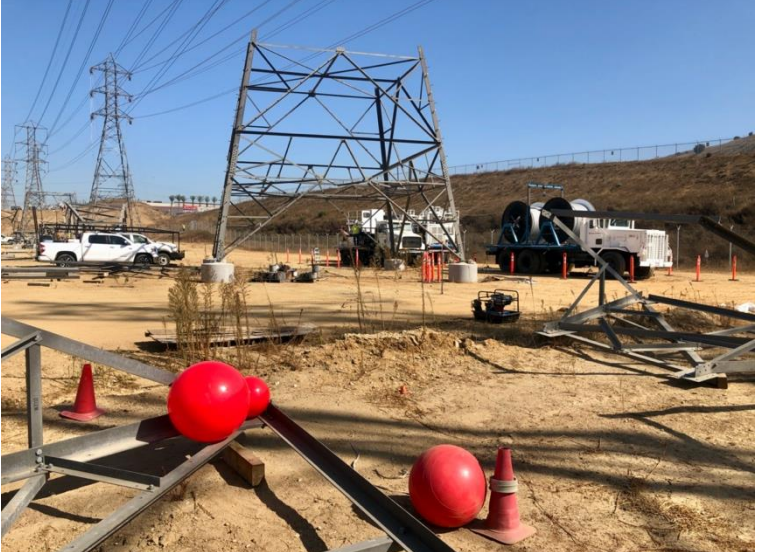
Photo 9 – New lattice steel towers with a wire stringing crew. Photo facing southeast.

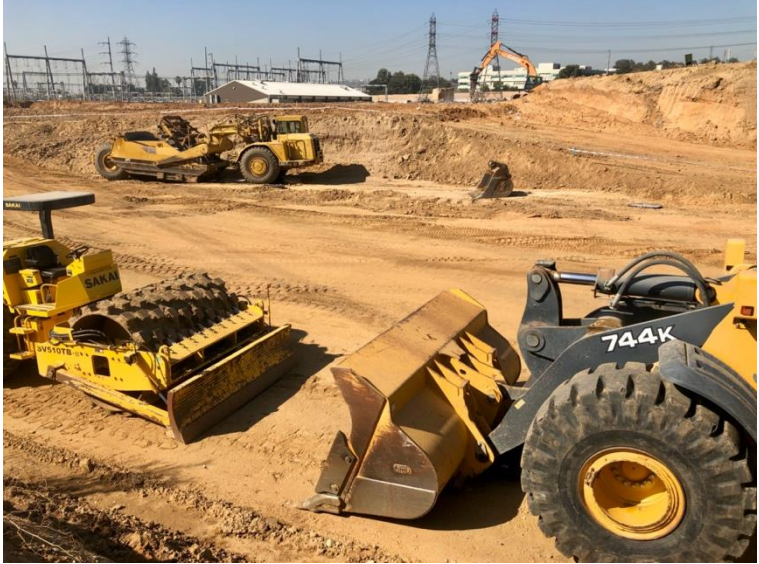
Photo 10 – Earthwork continued by Power Grade crews. Photo facing northwest.
11/04/20	Mesa Substation

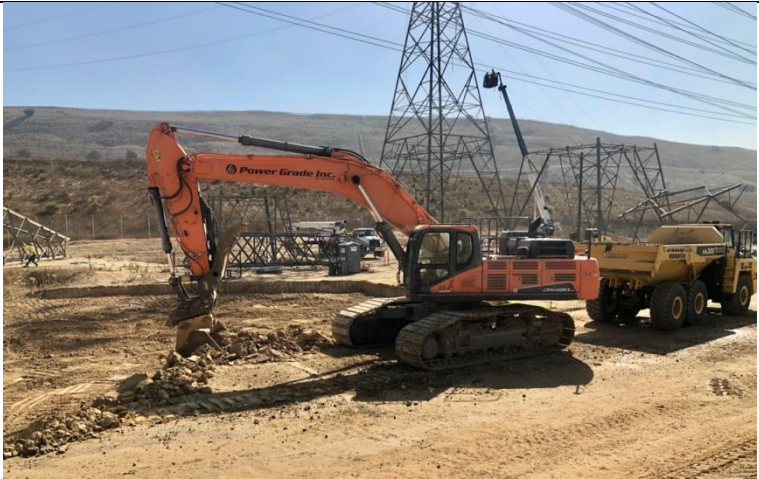
Photo 11 – Earthwork continued by Power Grade crews. Photo facing south.
11/04/20	Mesa Substation

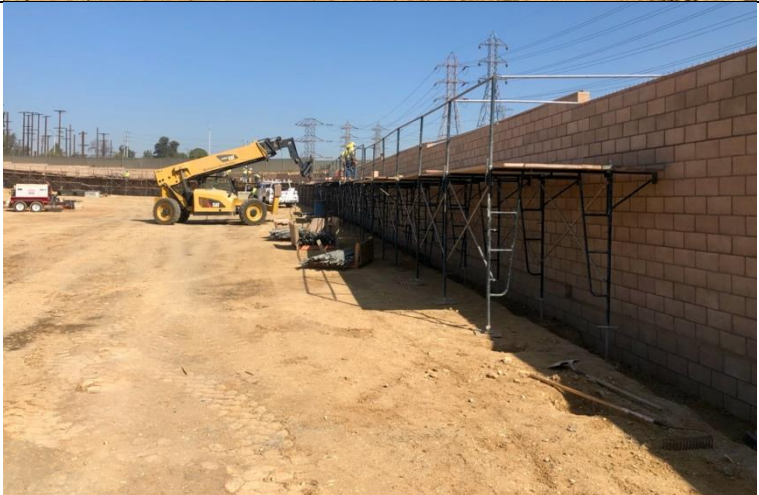
Photo 12 – Installation of the boundary wall near the southeastern corner of the project site. Photo facing east.

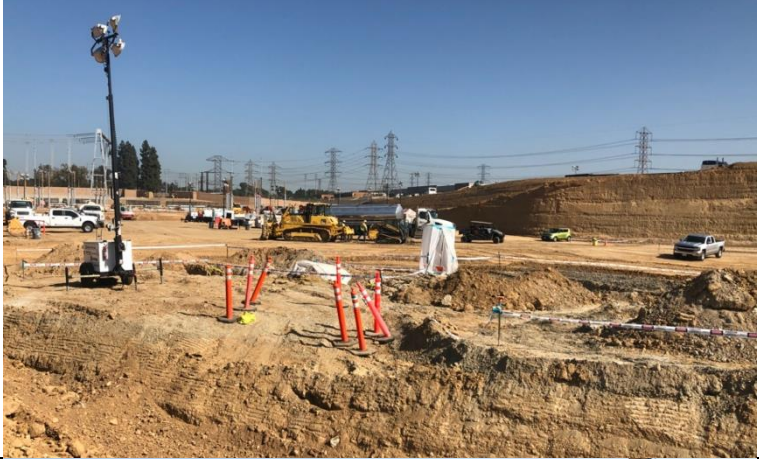
Photo 13 – Portions of the Phase 4 area taped off for removal of hazardous materials. Photo facing south.
11/04/20	Mesa Substation

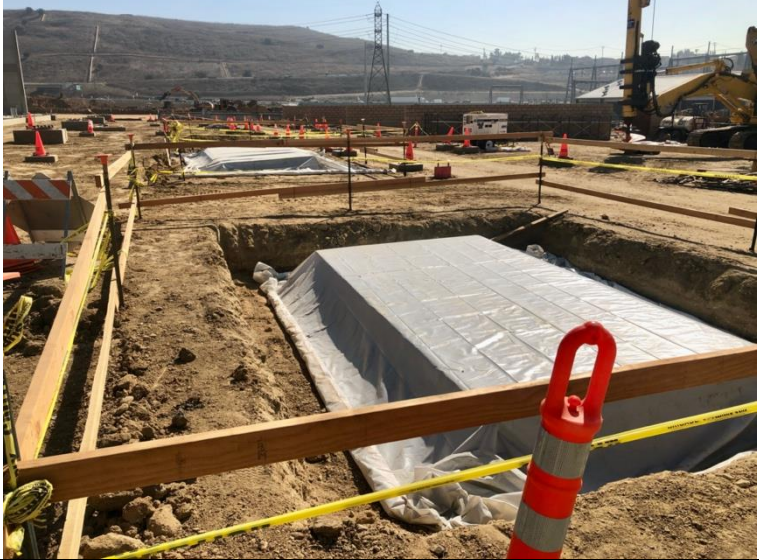
Photo 14 – Ongoing foundation work by Professional Electrical Construction Services with the Phase 4 area. Photo facing south.
11/04/20	Mesa Substation

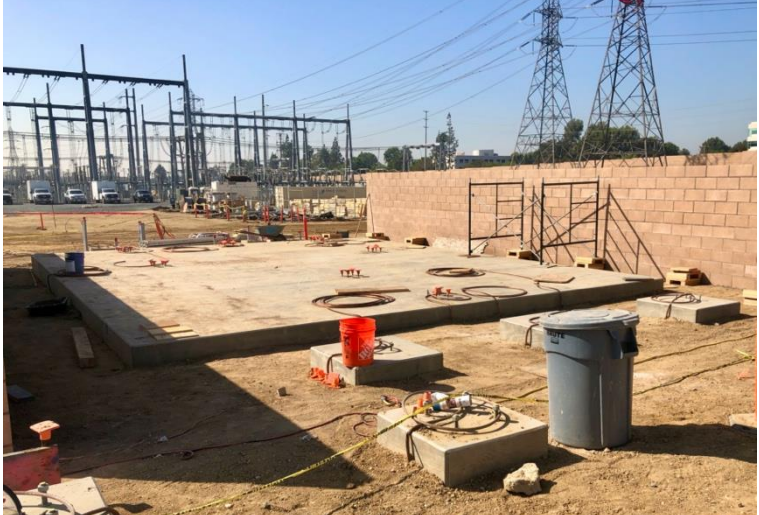
Photo 15 – Grounding wire installation around the transformer foundations. Photo facing northwest.

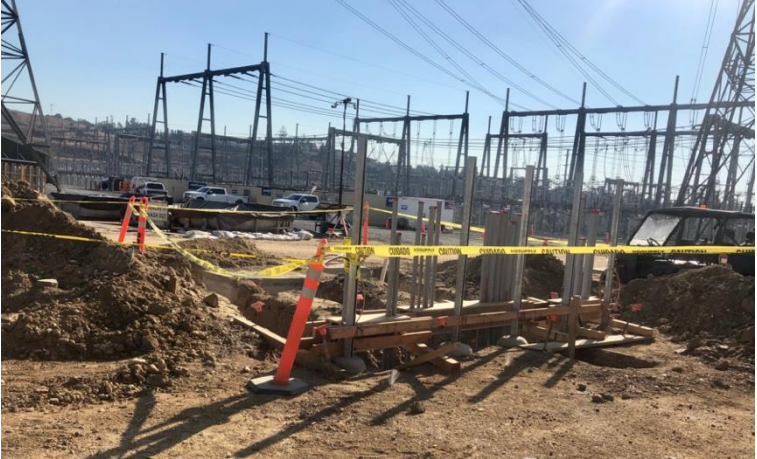
Photo 1 – Security station being installed with protective barriers. Photo facing south.
11/11/20	Mesa Substation

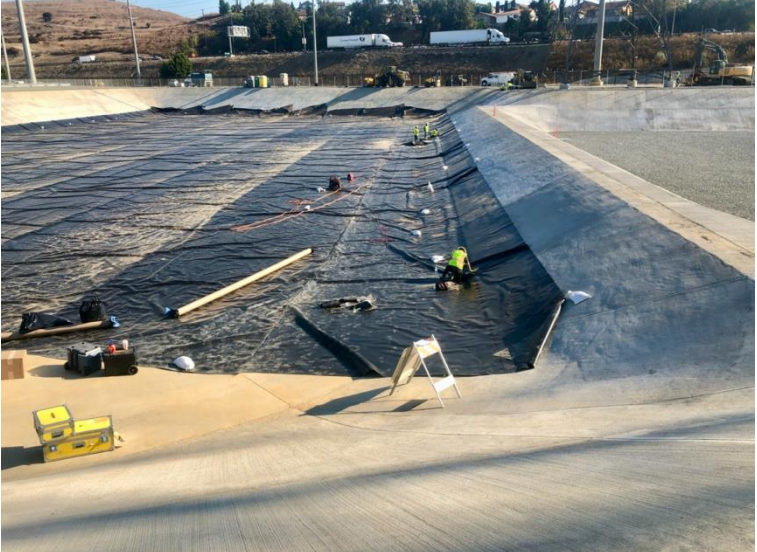
Photo 2 – Plastic being placed in the detention basin. Photo facing south.
11/11/20	Mesa Substation

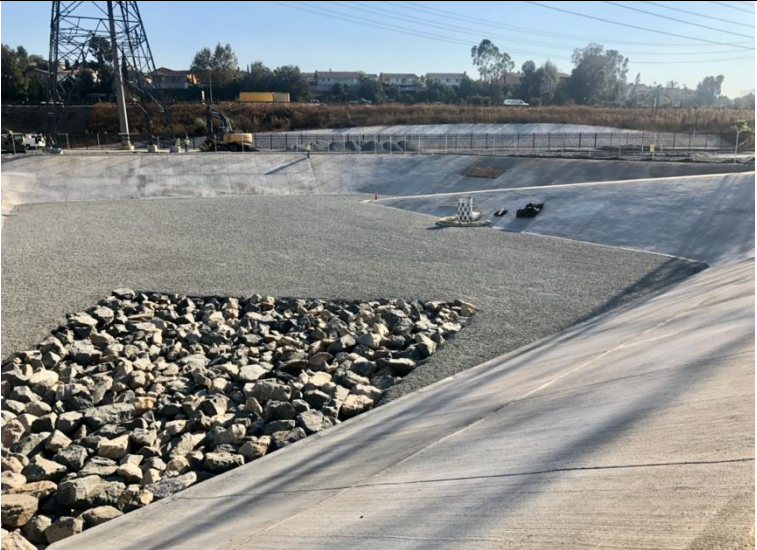
Photo 3 – Gravel was added to the western portion of the detention basin. Photo facing south.

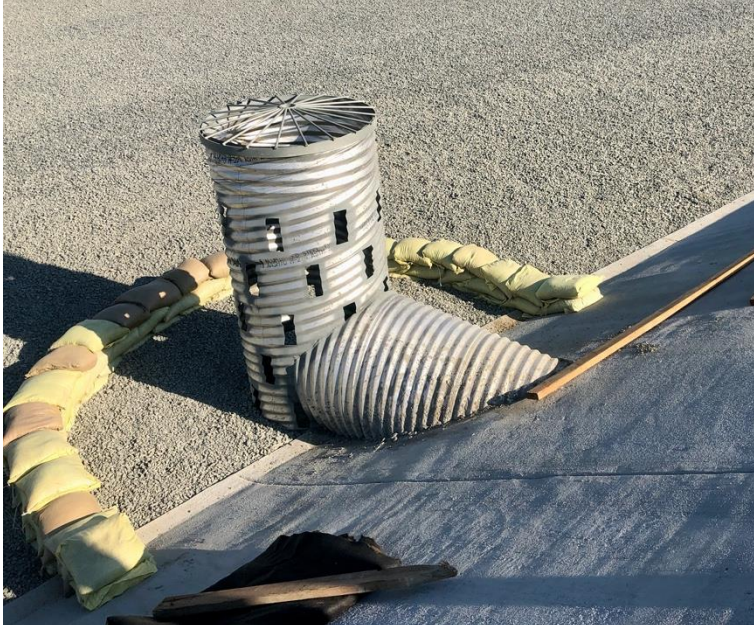
Photo 4 – The standpipe in the detention basin with numerous holes in the pipe.
11/11/20	Mesa Substation

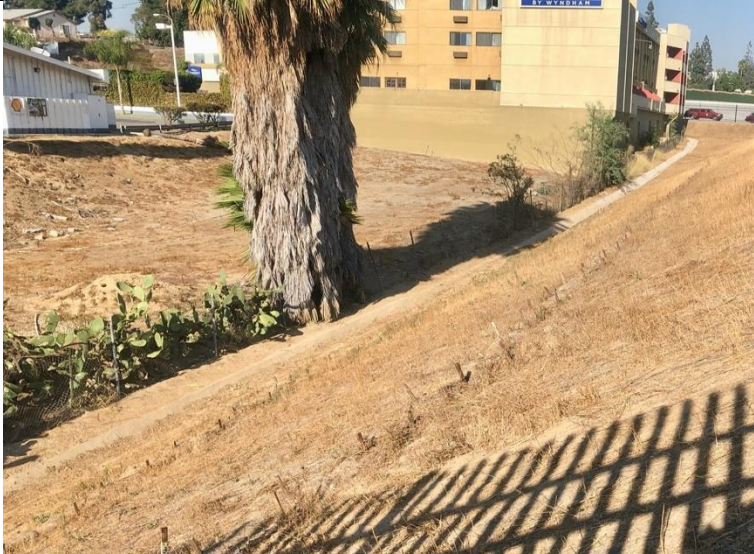
Photo 5 – Weeded slope with V ditch filled with sediment. Photo facing east.
11/11/20	Mesa Substation

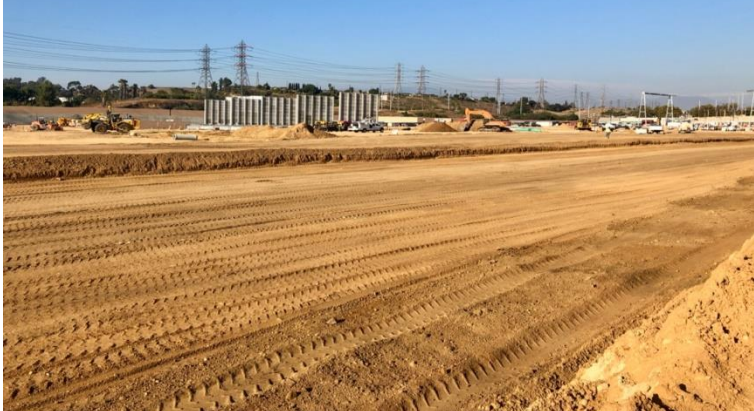
Photo 6 – Earthwork continued by Power Grade crews. Photo facing northeast.

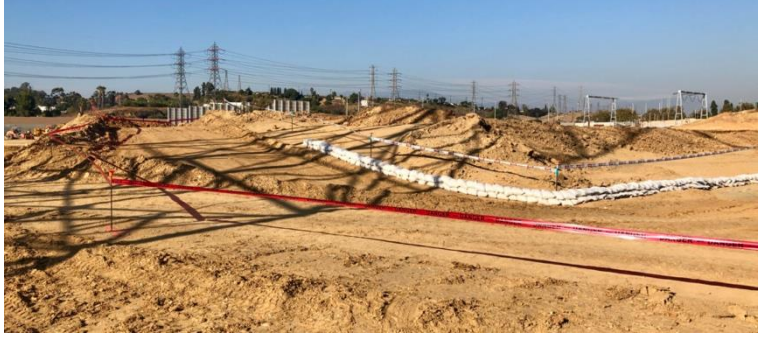
We drove east along the southern portion of the project noting the ongoing Power Grade earthwork (Photo 6). Areas of hazardous materials cleanup were taped off (Photo 7). Mr. Woodroof said a cleanup crew was coming in at night to address the hazardous materials, storing it in sealed containers and hauling it offsite (Photo 8).

Photo 7 – Areas with hazardous materials were tapped off. Photo facing north.
11/11/20	Mesa Substation

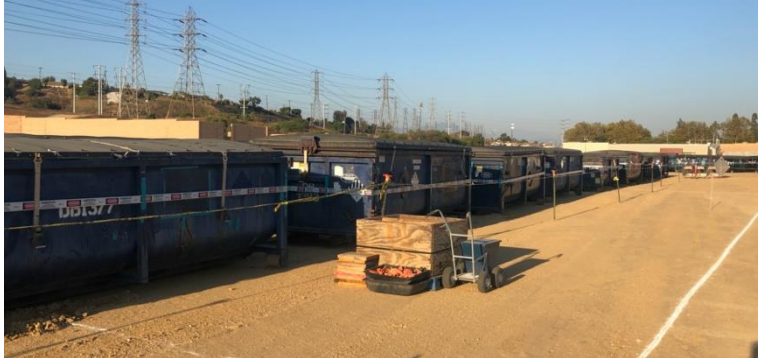
Photo 8 – Bins containing hazardous materials to be hauled offsite. Photo facing northeast.
11/11/20	Mesa Substation

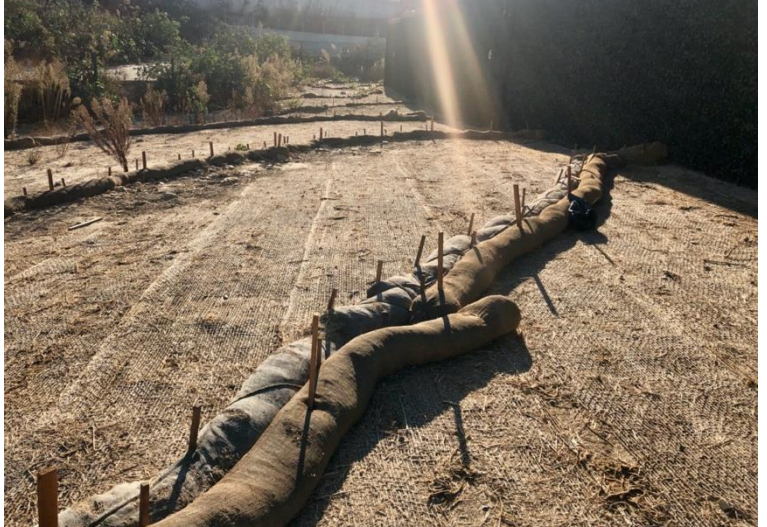
I inspected the drainage area outside of the southern boundary wall where rainwater runoff goes from the southeastern portion of the project site. The BMPs installed the previous year along this stretch were not adequate to remove sediment from the runoff and needed to be replaced (Photo 9). I was awaiting the development of a Rain Event Action Plan for the project site.

Photo 9 – Existing BMPs outside of the southern boundary wall needed to be replaced. Photo facing southwest.

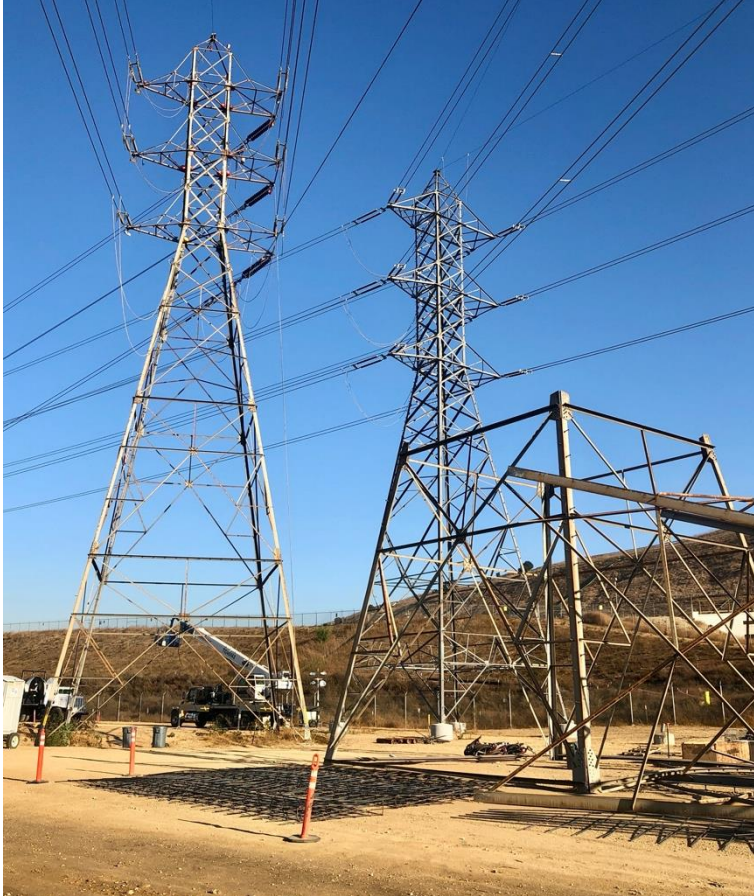
Photo 10 – New lattice steel towers with a wire stringing crew. Photo facing southeast.
11/11/20	Mesa Substation

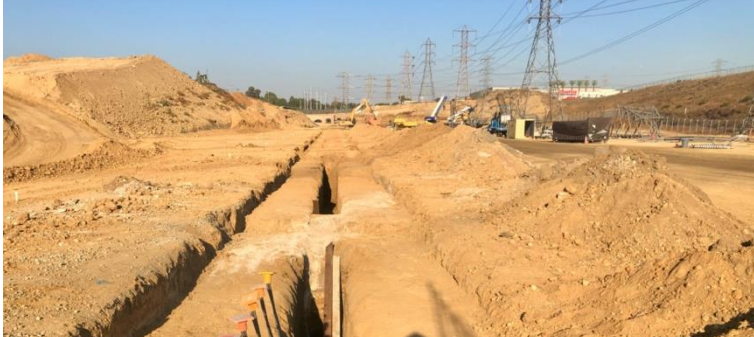
Photo 11 – Excavation of the boundary wall foundation. Photo facing east.
11/11/20	Mesa Substation

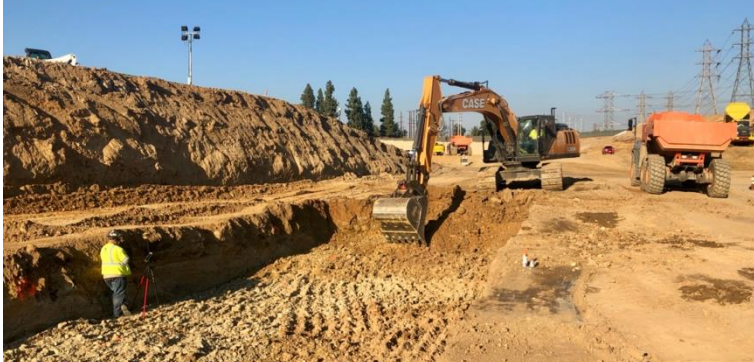
Excavation for the boundary wall foundation was being performed at several locations (Photos 11 and 12). In Photo 12, the area was being excavated for the wall foundation and the soil was transferred to another project area outside of the Mesa project boundary (Photo 13). A Power Grade crew was excavating a trench for the transformer drainage (Photo 14). The hole was very deep and Mr. Woodroof ensured an earthen ramp would be constructed for any wildlife that could fall in.

Photo 12 – Excavation being performed along the wall installation area. Photo facing east.

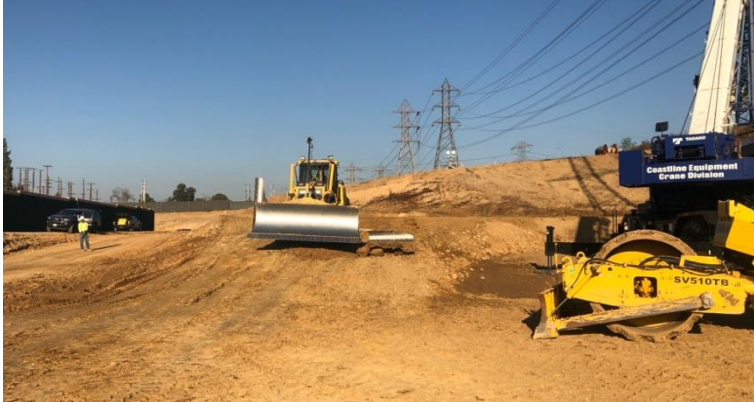
Photo 13 – Excess soil being moved to another project area outside the Mesa project boundary. Photo facing east.
11/11/20	Mesa Substation

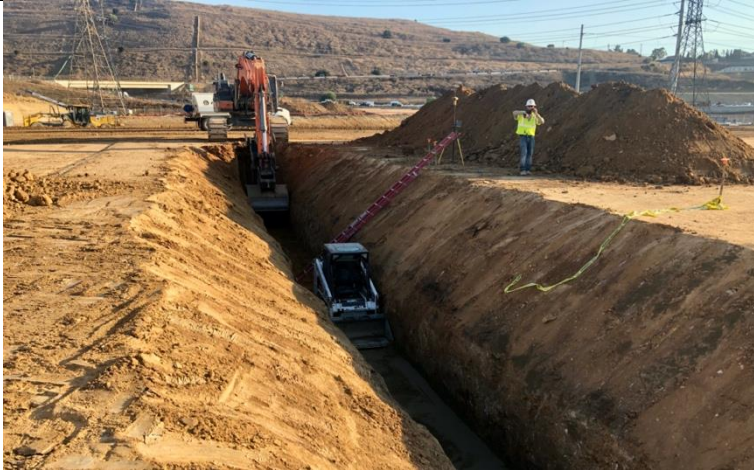
Photo 14 – Trenching for the transformer overflow pipe. Photo facing south.
11/11/20	Mesa Substation

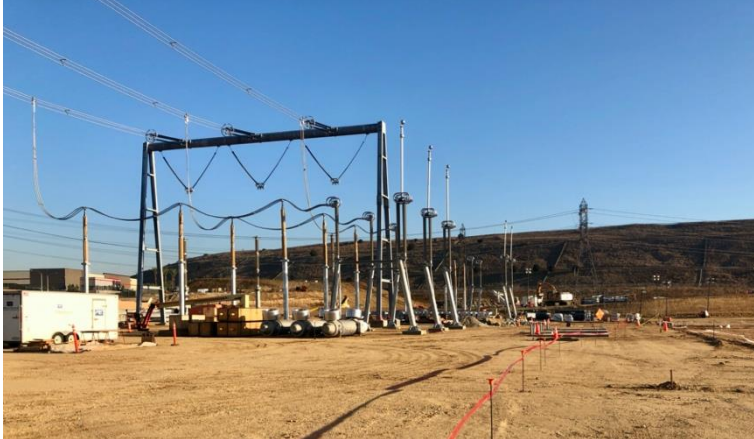
Photo 15 – Ongoing infrastructure installation within the Phase 4 area by Professional Electrical Construction Services. Photo facing south.

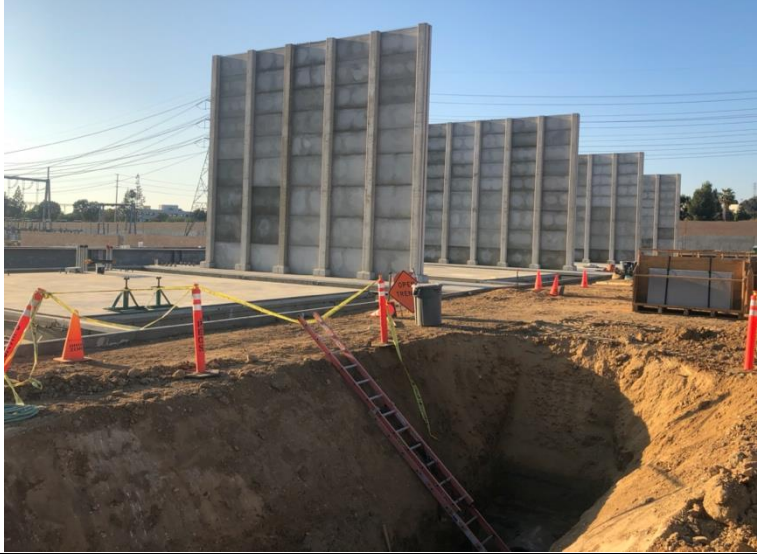
Photo 16 – Transformer fire walls built by Professional Electrical Construction Services. Photo facing northwest.

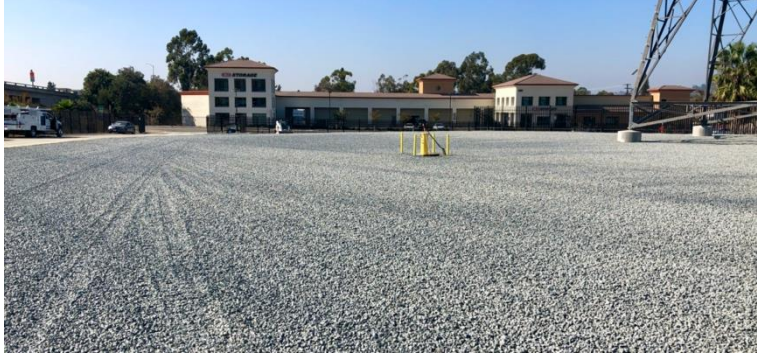
Photo 6 – Gravel delivered to cover the area west of the detention basin. Photo facing west.
11/19/20	Mesa Substation

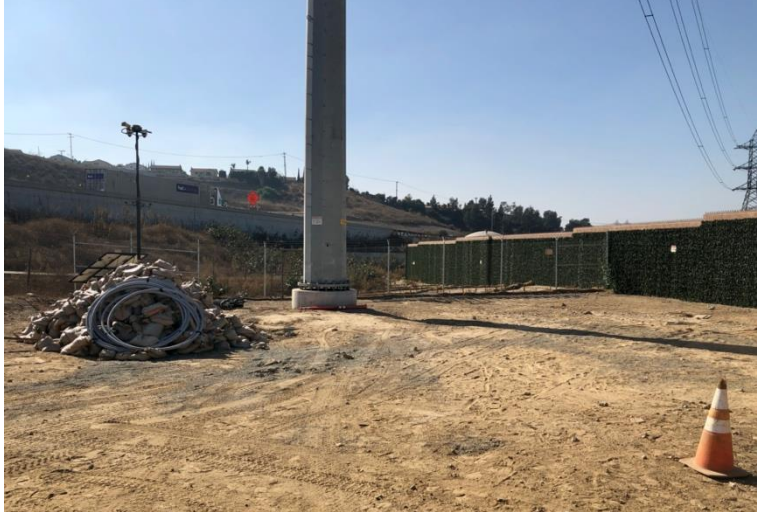
We drove to the staging area along the southern portion of the project (Photo 7). I inspected the BMPs outside of the southern boundary wall and noted that they had not been upgraded. A Rain Event Action Plan for the project site had not been developed yet.

Photo 7 – Staging area and rainwater runoff area outside of the southern boundary wall. Photo facing southwest.
11/19/20	Mesa Substation

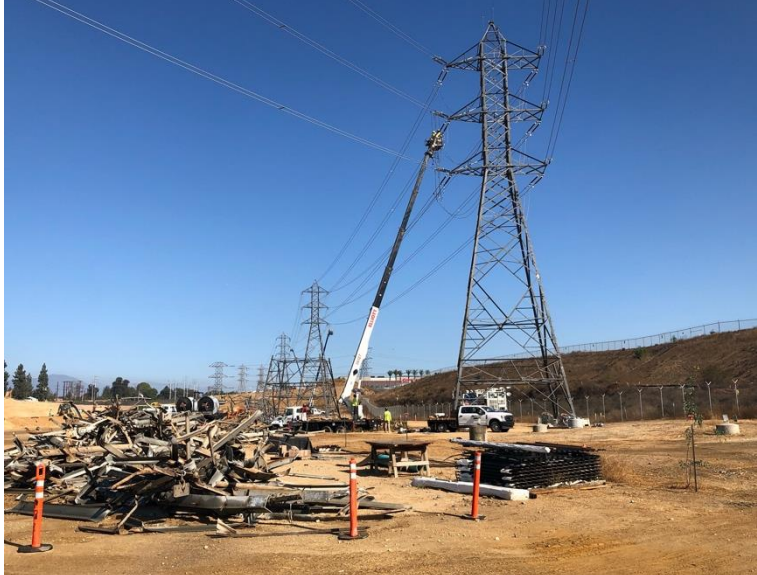
Photo 8 – Wire work in the new towers along the southern portion of the project. Photo facing east.

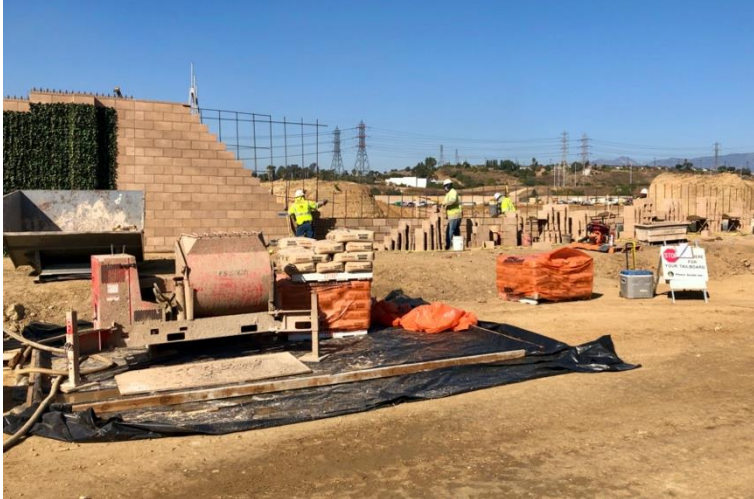
Photo 9 – Brick installation on the southern boundary wall. Photo facing north.
11/19/20	Mesa Substation

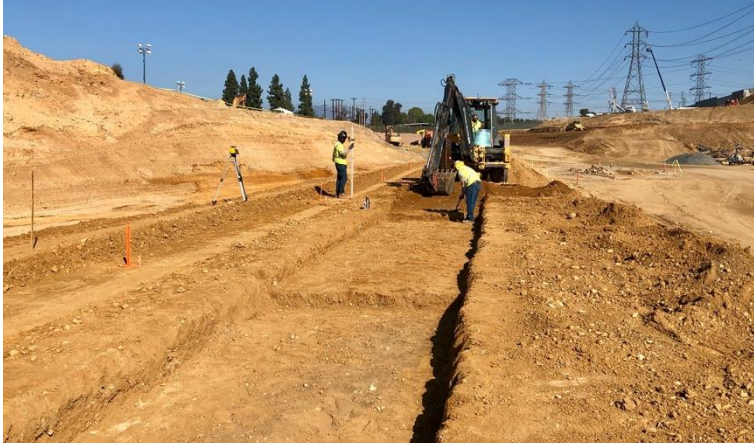
Photo 10 – Excavation for the boundary wall foundation. Photo facing east.
11/19/20	Mesa Substation

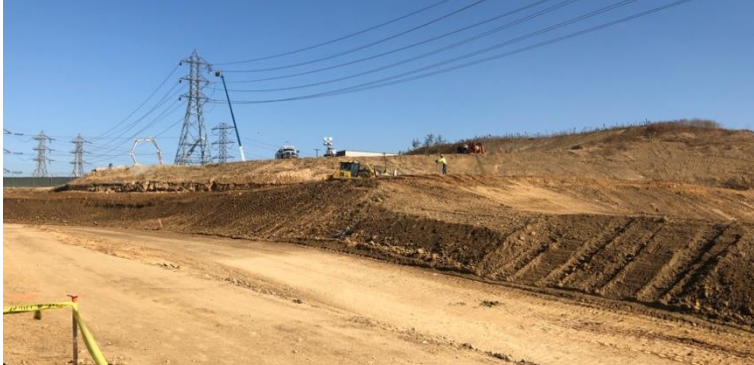
Photo 11 – Excess soil being delivered to an offsite project area. Photo facing east.

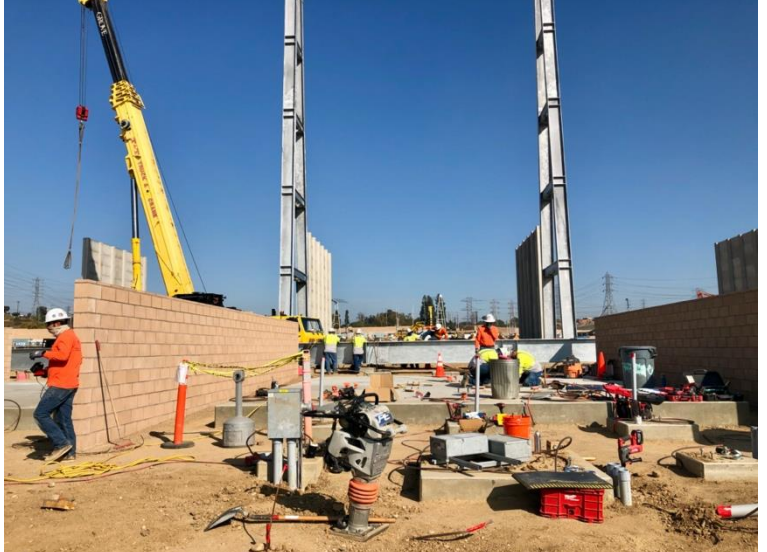
Photo 16 – Phase 4 transformer foundation preparation. Photo facing east.
