March 12, 2021

Re: Monthly Report Summary #39 for the Mesa 500-kV Substation Project

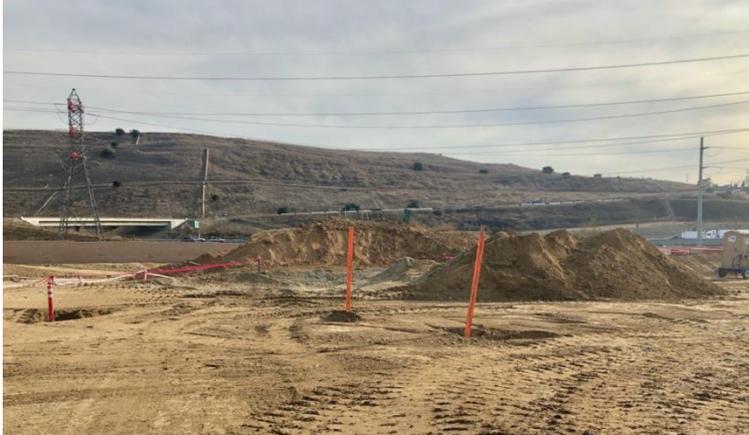
Trenching work south of the Phase 4 area halted until the asbestos-contaminated soils could be removed (Photo 7). The crews referred to the taped off contaminated area as the "Asbestos Island." Mr. Daniele indicated the removal of the hazardous material would be completed sometime in February 2021.

Photo 7 – The asbestos-contaminated area halting work south of the Phase 4 area. Photo facing south.
12/09/20	Mesa Substation

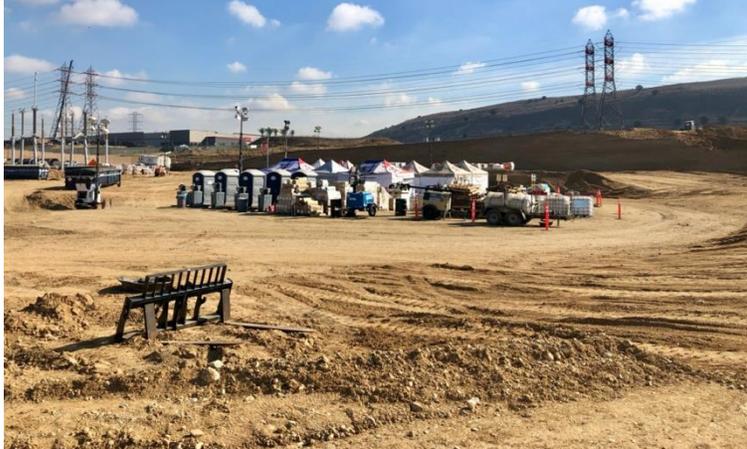
The hazardous waste removal work continued during night; the work was being completed by a company called AIS (Photo 9).

<p>Photo 9 – Asbestos removal work by AIS. Photo facing southeast.</p>
12/17/20	Mesa Substation

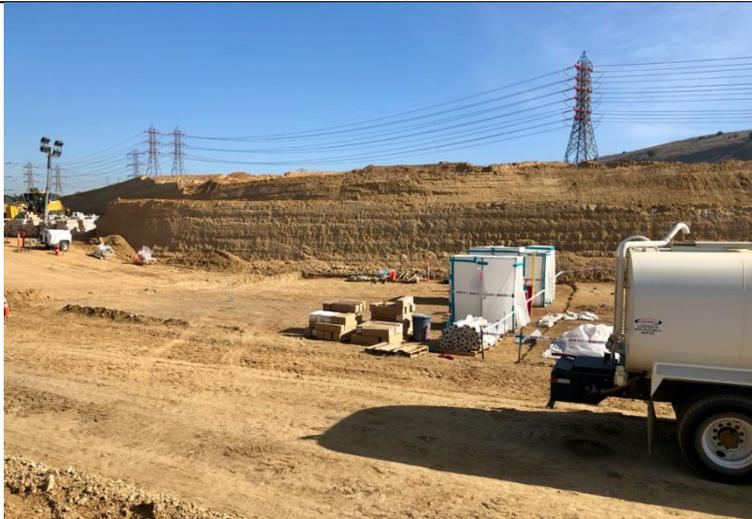
Photo 4 – Asbestos removal work area. Photo facing southeast.

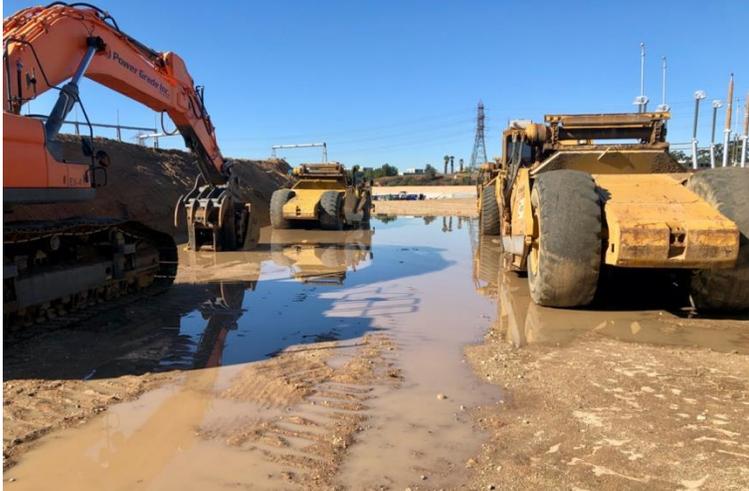
Photo 1 – Wet and muddy conditions. Photo facing north.
12/29/20	Mesa Substation

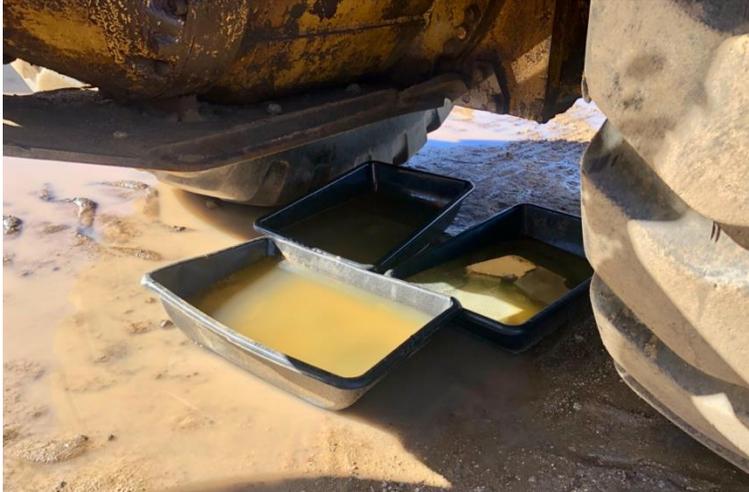
Photo 2 – Secondary containment drip pans full of rainwater.
12/29/20	Mesa Substation

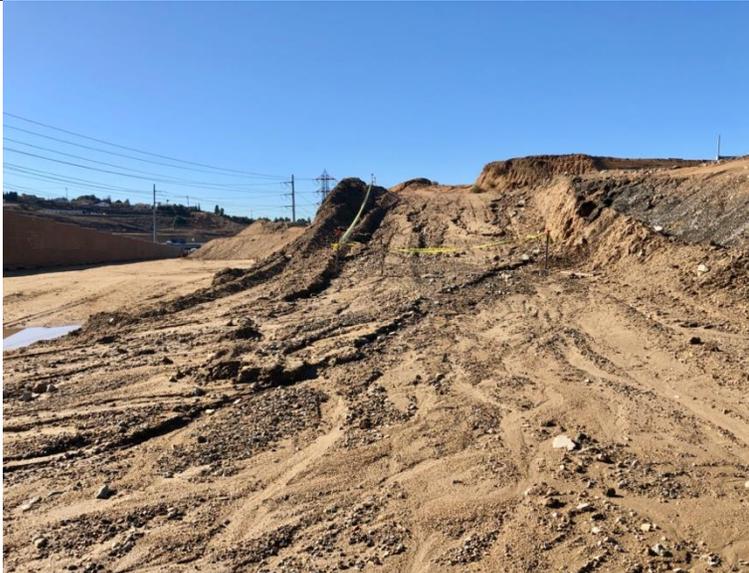
Photo 3 – Rills from the remaining berm onsite. Photo facing west.

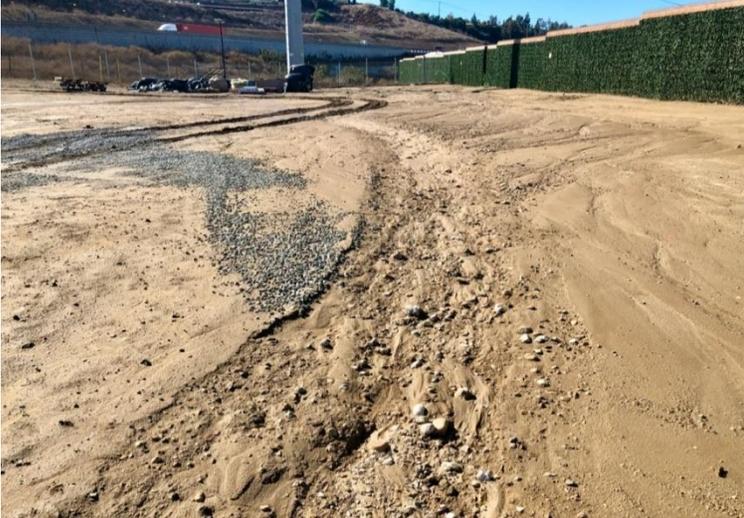
Photo 4 – Rainwater runoff channel coming down the south side of the southern boundary wall. Photo facing southwest.
12/29/20	Mesa Substation

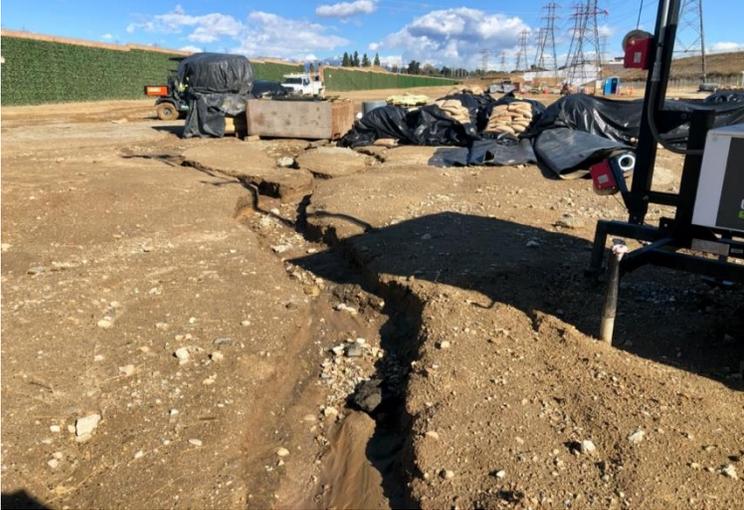
Photo 5 – Rainwater runoff rills near the stockpiled BMPs. Photo facing east.
12/29/20	Mesa Substation

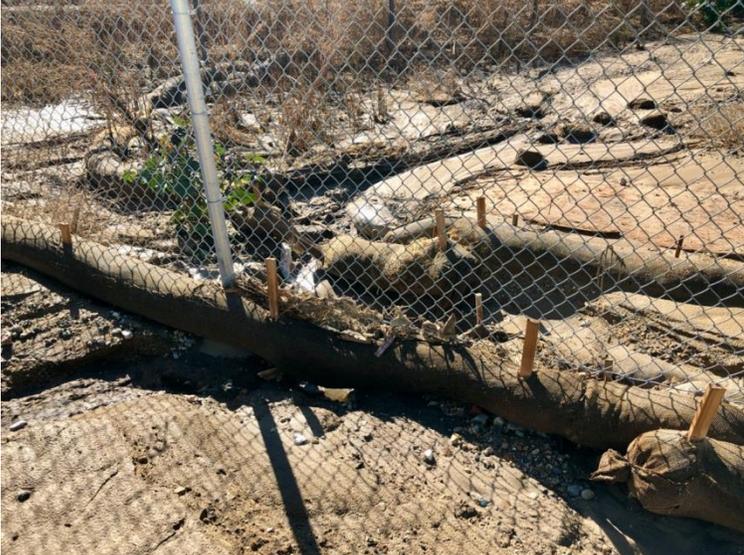
Photo 6 – Existing BMPs at the boundary fence that are no longer effective.

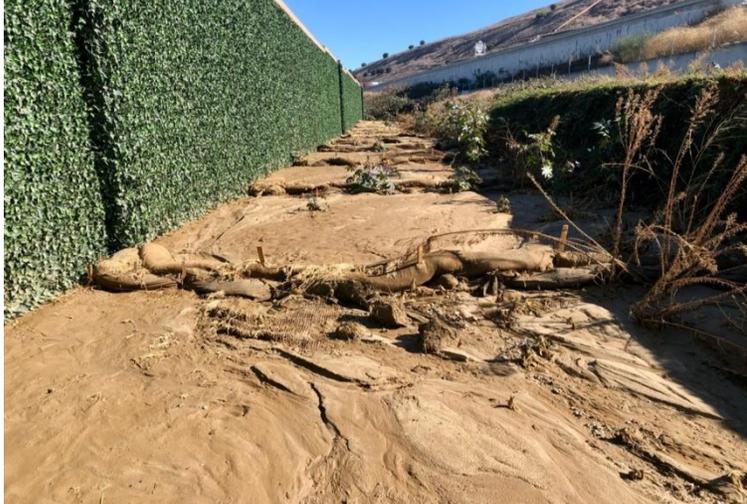
Photo 7 – BMPs outside of the southern boundary wall with overtopped and blown-out straw wattles. Photo facing east.
12/29/20	Mesa Substation

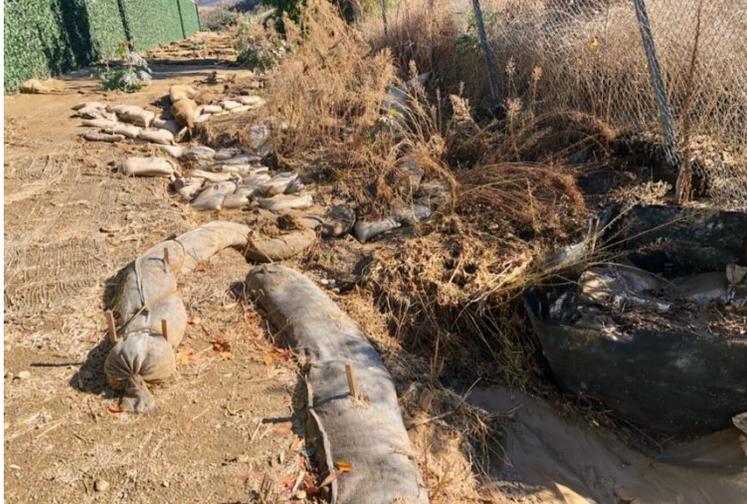
Photo 8 – BMPs near the drain inlet that were overtopped and blown out from the storm event. Photo facing east.
12/29/20	Mesa Substation

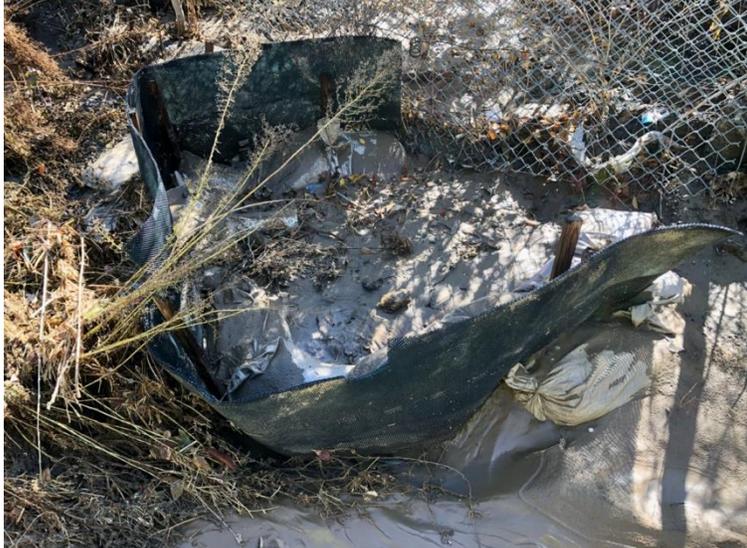
Photo 9 – The drain inlet was clogged with mud and debris.

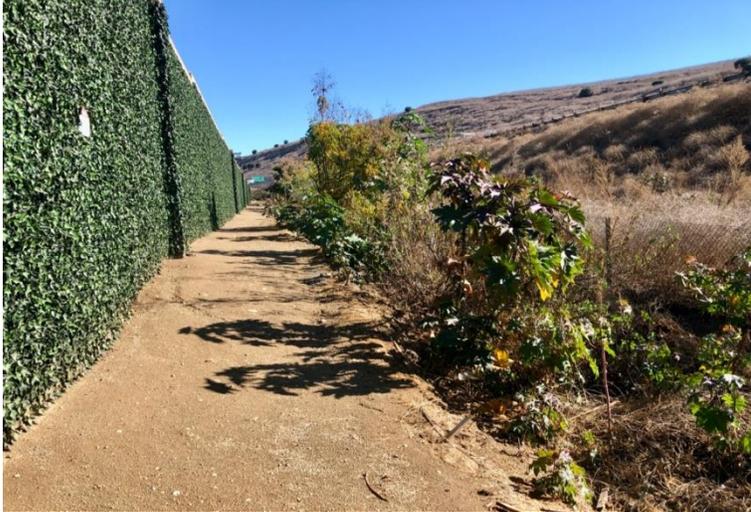
Photo 11 – Castor bean plants resprouting along the drainage channel outside of the southern boundary wall. Photo facing east.
