Re: Monthly Report Summary #43 for the Mesa 500-kV Substation Project

Mesa 500-kV Substation Project CPUC Site Inspection Form

Project:	Mesa 500-kV Substation Project	Date:	April 7, 2021
Project Proponent:	Southern California Edison (SCE)	Report #:	VS163
Lead Agency:	California Public Utilities Commission (CPUC)	Monitor(s):	Vince Semonsen
CPUC PM:	Connie Chen, Energy Division	AM/PM Weather:	Sunny and mild with a slight breeze
WSP CM:	Silvia Yanez	Start/End time:	1100 to 1300
Project NTP(s):	Notice to Proceed (NTP)-1, NTP-2

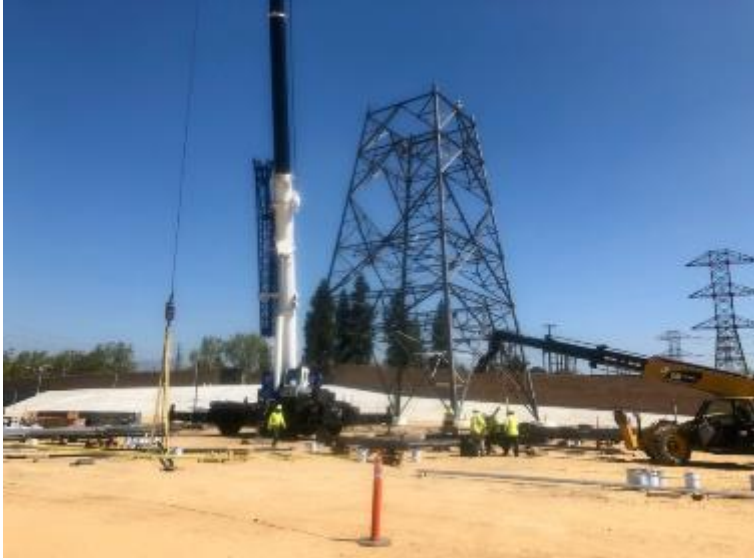
I met with the Phase 4 site representative at the Potrero Grande Drive entrance, and we walked through the 500-kilovolt (kV) substation work areas. Grounding wire installation work was underway that required shallow trenching (Photo 1). Work continued on trenching and installation of cable trays (Photo 2), with their eventual connection into the cable tray pumping station (Photo 3). Foundation work continued (Photo 4), and a crew was building and erecting a latticework tower at the eastern end of the Phase 4 work area (Photo 5).

<p>Photo 5 – Latticework tower being erected within the Phase 4 work area at the east end of the project site. Photo facing east.</p>
04/07/21	Mesa Substation

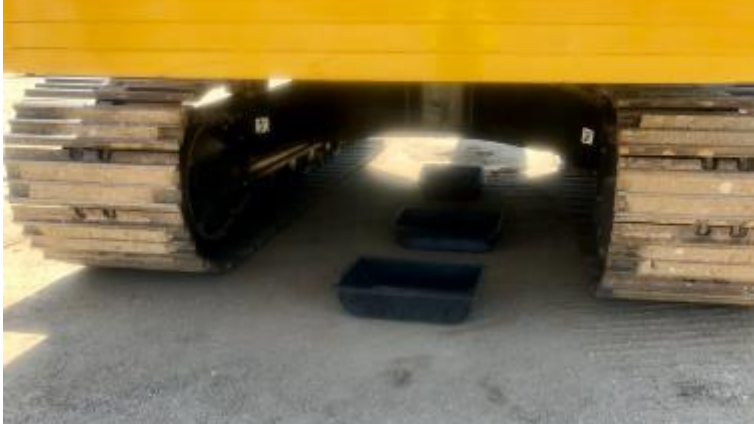
According to the site representative, most of the Power Grade heavy equipment had been moved offsite since the majority of the earthwork was completed. The Mount Mesa stockpile is set to be relocated once the nesting bird activity was completed. The few pieces of equipment that remained parked onsite had adequate secondary containment present (Photo 6).

<p>Photo 6 – Secondary containment under heavy equipment.</p>
04/07/21	Mesa Substation

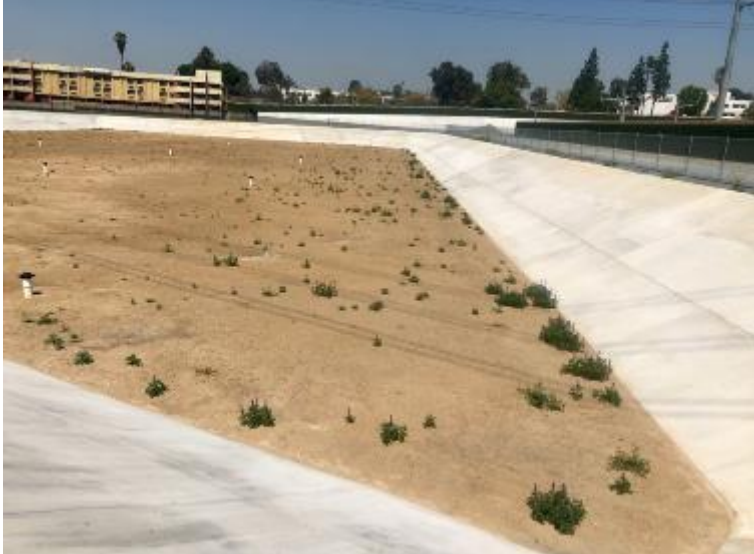
The eastern portion of the detention basin system that included the bioswale had lupines (*Lupinus* spp.) beginning to grow (Photo 7). The small triangular catch basin at the western edge of the project site remained full of sediment (Photo 8). No restoration work was completed on the existing best management practices (BMPs) at the head of the California Department of Transportation concrete-lined channel that runs outside of the southern edge of the project site.

<p>Photo 7 – Vegetation growing in the detention basin. Photo facing north.</p>

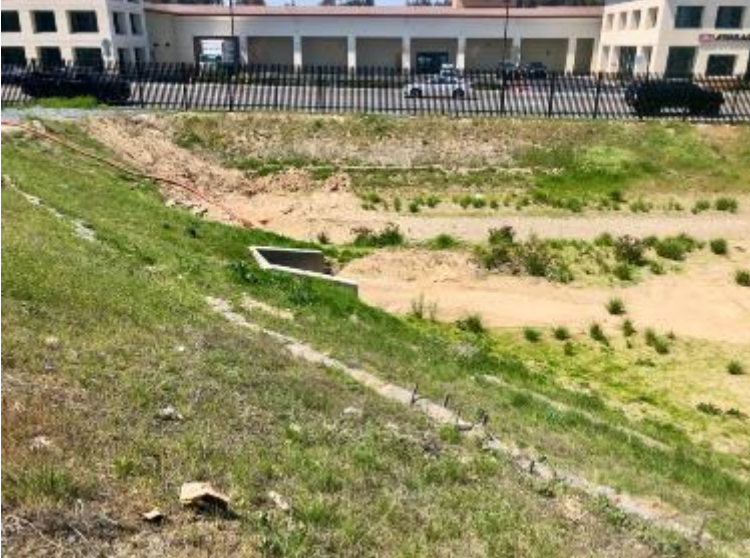
Photo 8 – Sediment remained in the small triangular catch basin. Photo facing west.
04/07/21	Mesa Substation

Check on nest buffers and the BMP installation.

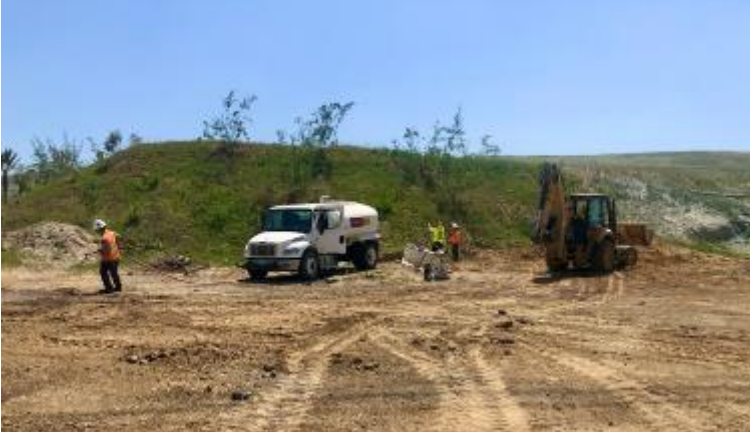
A small crew was cleaning out the construction debris on top of the Market Place Drive soil stockpile (Photo 9). The rest of the stockpile had been hydroseeded (Photo 10).

Photo 9 – Cleanup of construction debris on top of the Market Place Drive soil stockpile. Photo facing south.
04/07/21	Mesa Substation

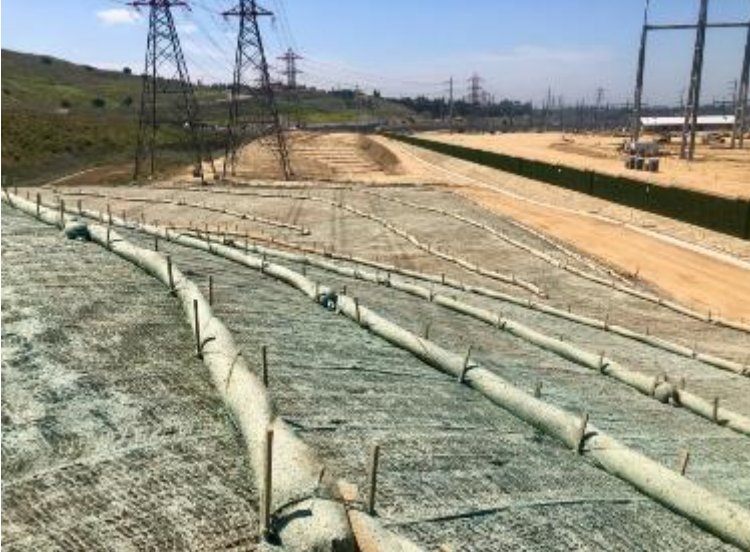
Photo 10 – The Market Place Drive soil stockpile was hydroseeded. Photo facing west.

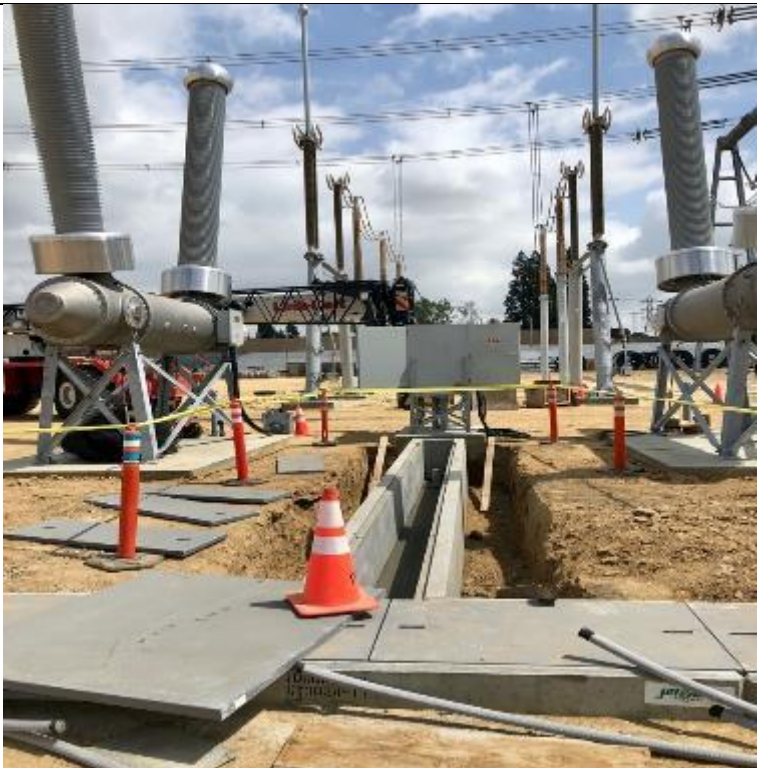
underway, including the installation of cable trays (Photo 1), the erection of the 500-kilovolt (kV) infrastructure (Photo 2), and additional foundation drilling (Photo 3).

Photo 1 – Cable tray work continued. Photo facing east.

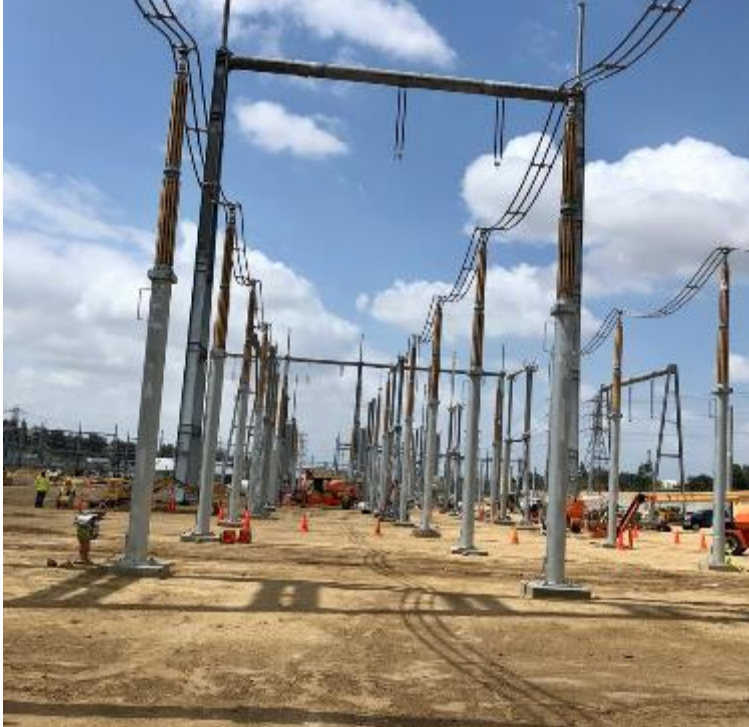
Photo 2 – Installation of the 500-kV infrastructure continued. Photo facing west.
04/14/21	Mesa Substation

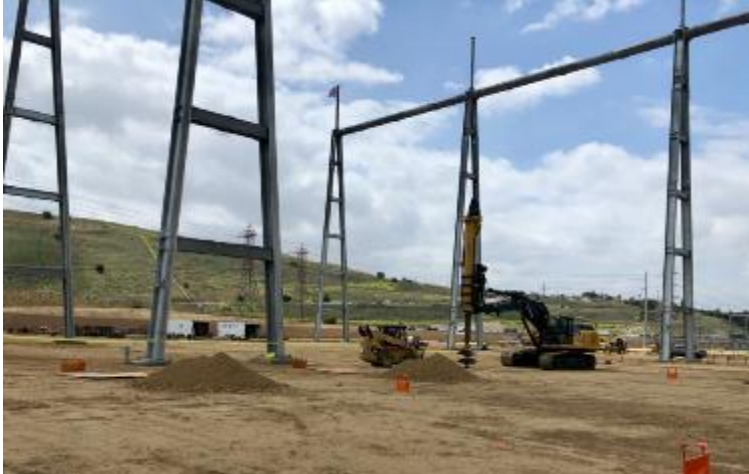
Photo 3 – Drilling foundation holes continued. Photo facing south.

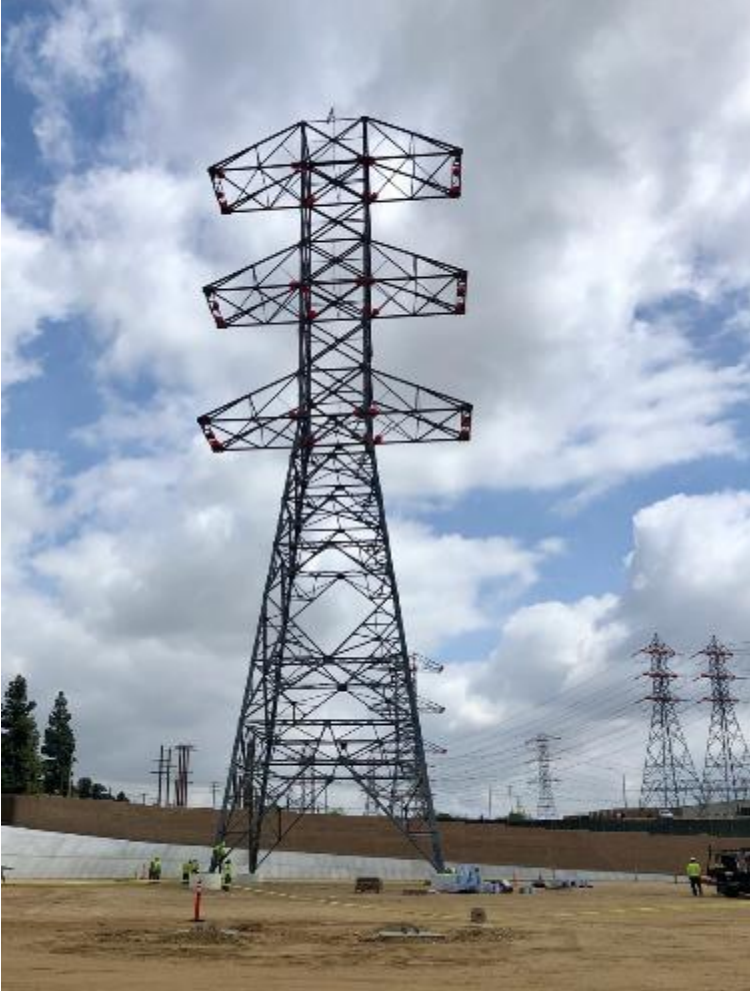
Crews were nearing completion of the latticework tower, located at the eastern end of the Phase 4 work area (Photo 4). They had installed the raptor nesting exclusion balls in the tower. Parked equipment had the necessary secondary containment in place and crews had begun covering the equipment with bird netting (Photo 5). An older belly loader parked onsite had several drip pans underneath it, but I noted hydraulic fluid leaked onto the ground where no drip pans were present; I mentioned this to the site representatives. According to the avian biologist, the California gnatcatchers (*Poliophtila californica*) in the Environmentally Sensitive Area appeared to be incubating eggs in their nest.

Photo 4 – Lattice work tower nearly completed near the Market Place Drive entrance. Photo facing east.
04/14/21	Mesa Substation

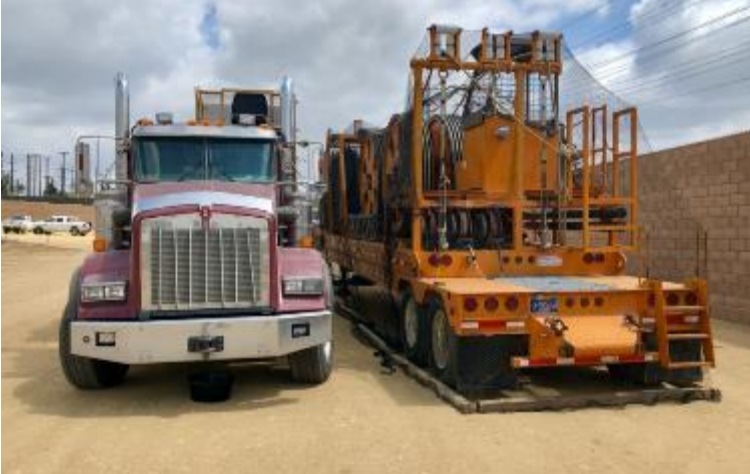
Photo 5 – Drip pans under the parked equipment and bird netting was installed. Photo facing east.

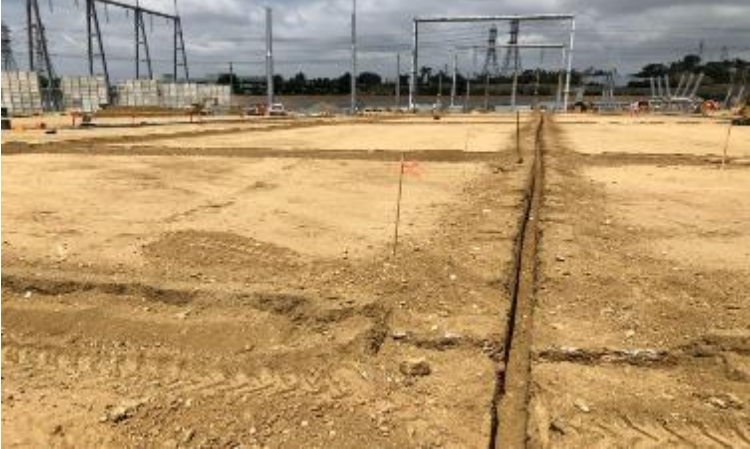
Other work within the Phase 4 construction area included grounding wire installation (Photo 6), cable tray installation (Photo 7), and the ongoing foundation work for the transformers (Photo 8). Slurry work was completed in the trenches leading to the cable tray pumping station (Photo 9).

Photo 6 – Copper wire being installed for grounding purposes. Photo facing north.
04/14/21	Mesa Substation

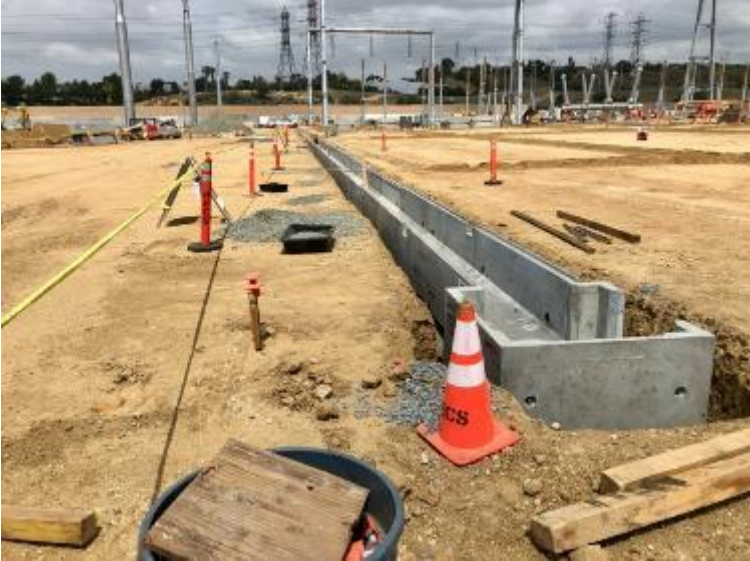
Photo 7 – Cable tray installation. Photo facing north.
04/14/21	Mesa Substation

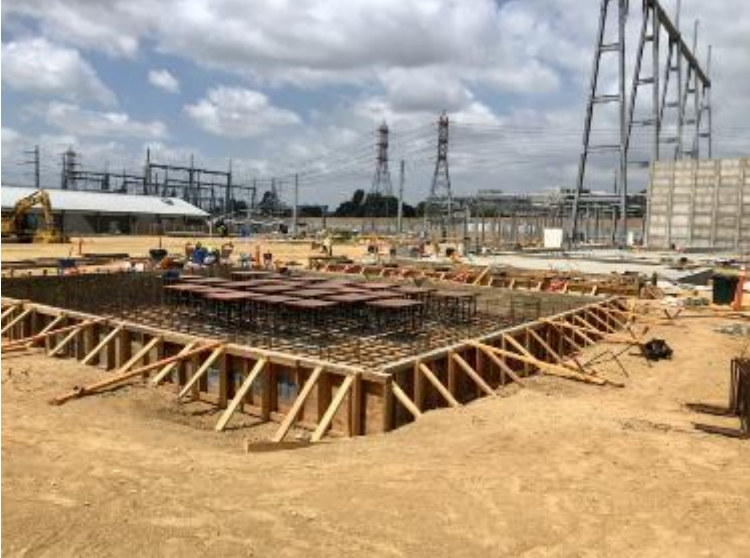
Photo 8 – Transformer foundation forms. Photo facing northwest.

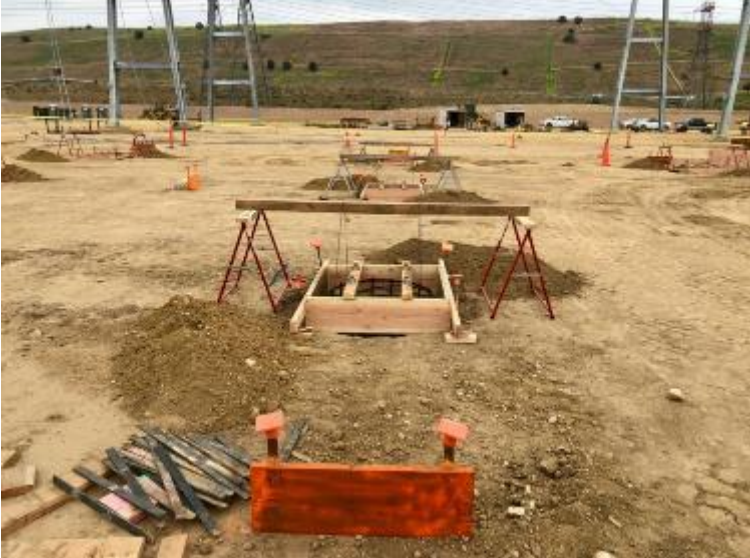
I walked through the Phase 4 portion of the construction site, escorted by the site representative. There were 12 open foundation holes about 12 feet in depth, all with rebar cages installed (Photo 3).

Photo 3 – Drilling of foundation holes continued. Photo facing south.
04/22/21	Mesa Substation

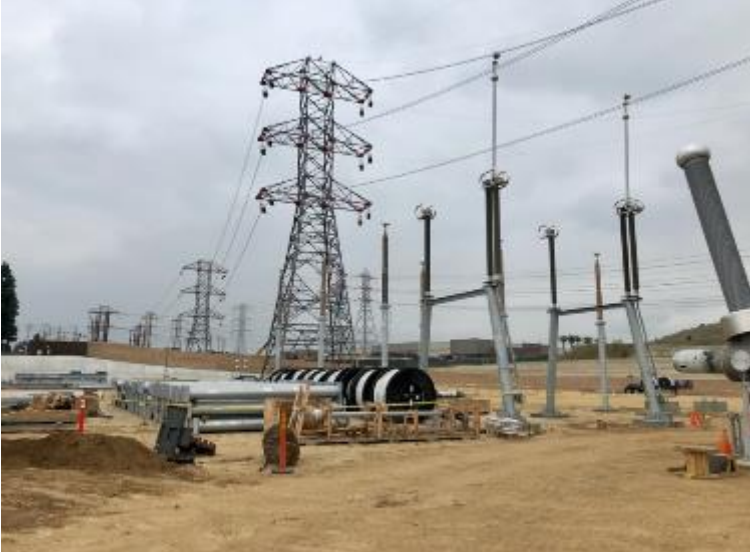
Equipment was staged within the work area waiting to be erected, along with numerous rolls of wire (Photo 4). Work continued on cable tray trenches (Photo 5). The cable tray trench in Photo 5 was a double-wide cable tray heading for the Senior Mechanical Electrical Equipment Room Building. The foundations for the large 500-kV transformers were being formed and poured (Photo 6). Conduit installation was underway (Photo 7).

Photo 4 – Equipment and materials staged, waiting to be installed. Photo facing east.

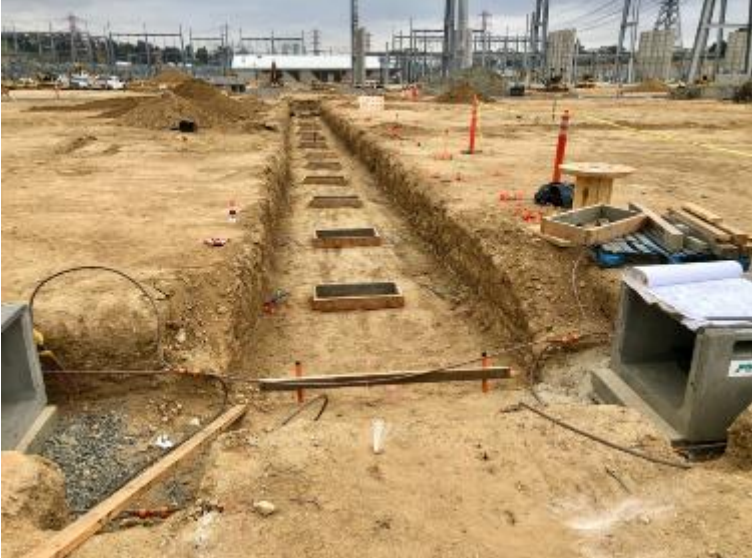
Photo 5 – Cable tray work continued. Photo facing west.
04/22/21	Mesa Substation

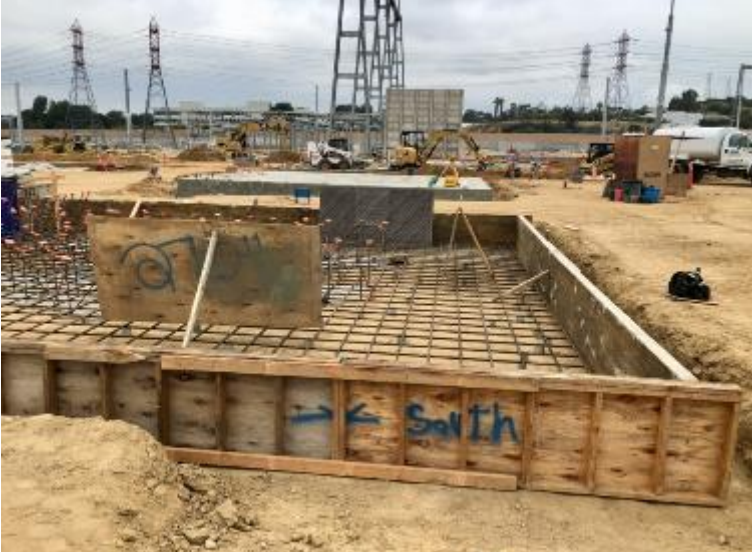
Photo 6 – Transformer foundation forms. Photo facing north.

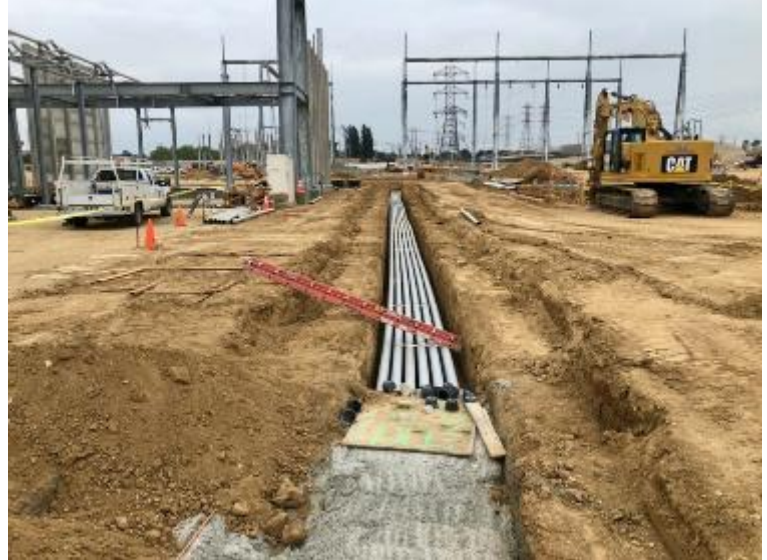
Photo 7 – Conduit installation. Photo facing east.
