Re: Monthly Report Summary #8 for the Mesa 500-kV Substation Project

CPUC Site Inspection Report

Mesa 500-kV Substation Project CPUC Site Inspection Form

Project:	Mesa 500-kV Substation Project	Date:	May 9, 2018
Project Proponent:	Southern California Edison	Report #:	VS024
Lead Agency:	California Public Utilities Commission	Monitor(s):	Vince Semonsen
CPUC PM:	Lisa Orsaba, Energy Division	AM/PM Weather:	Clear, calm, and warm
E & E CM:	Jenny Vick	Start/End Time:	0945 to 1215
Project NTP(s):	NTP-1, NTP-2

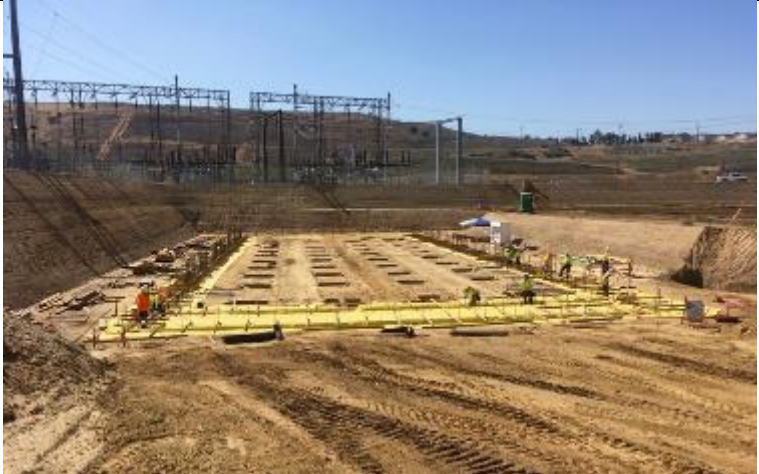
My first stop was an area listed as the Senior Mechanical Electrical Equipment Room (MEER) in the Plan of the Day (POD) (Photo 1). It appears that most of the excavation work had been completed at this location, and a crew was installing rebar on the day of my site visit. All of the small square foundation holes had escape boards placed inside (MM BR-10).

Photo 1 – Foundation work within the Senior MEER. Photo facing south.
5/09/18	Mesa Substation

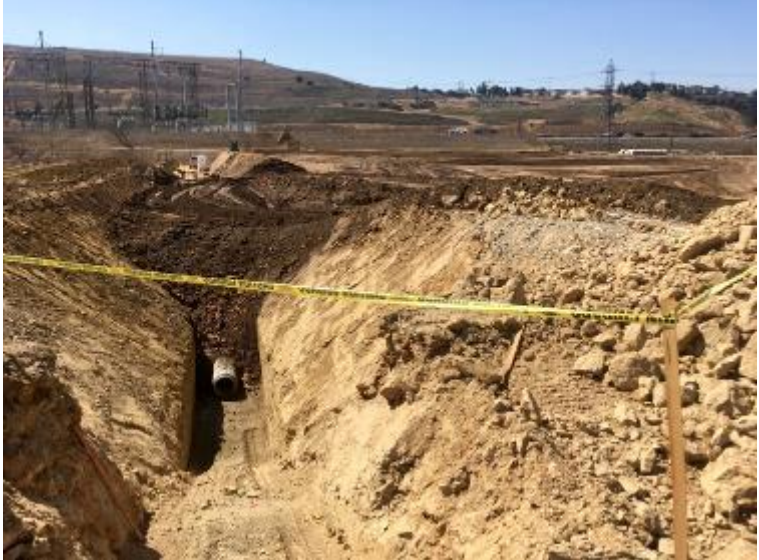
Earthmoving activity was ongoing, and a crew was using scrapers to deliver soil to the central portion of the Mesa Substation site (just west of the Senior MEER). The crew was backfilling the old water line and the new drainage piping (Photo 2). I observed water trucks wetting down the backfilling area and access roads throughout the morning (MM HY-1).

Photo 2 – Storm drain pipe installation and backfilling of the old water line trench. Photo facing south.
5/09/18	Mesa Substation

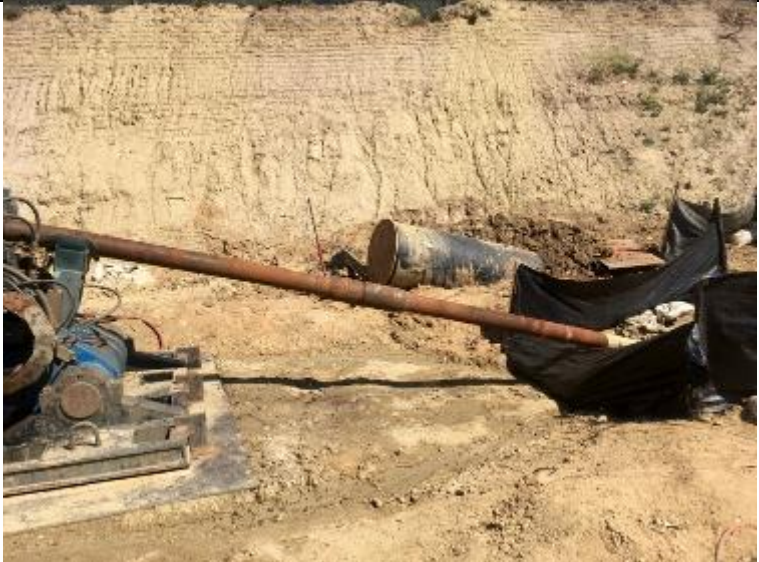
I looked at Potrero Grande Drive horizontal directional drilling (HDD) bore #2, which appeared to have had a second large plastic pipe pulled through; crews have one more pipe to pull through at this site (Photo 3). No one was working at this location during the time of my site visit, and the equipment appeared to be secured with no obvious leaks. The lattice steel tower with the bermed slurry catch basin underneath had been removed and the slurry had been spread out to dry at another onsite location.

Photo 3 – Potrero Grande Drive HDD equipment and newly pulled plastic pipe.

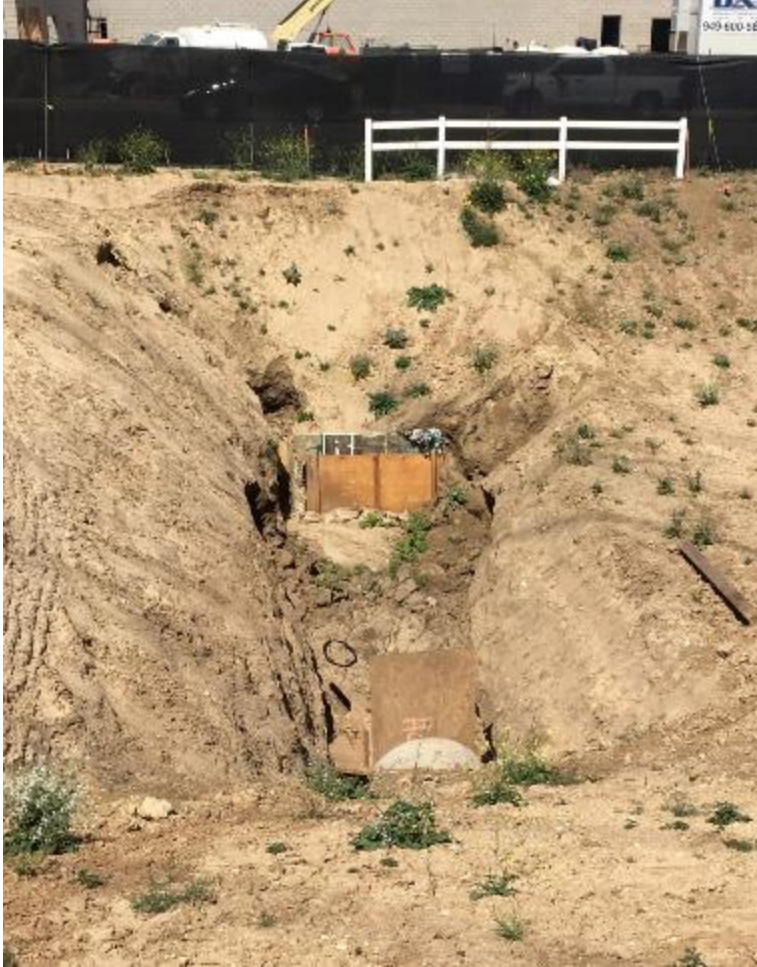
Photo 7 – Storm drain pipe at the Mesa Substation outlet location; note the escape ramp located next to the new piping. Photo facing west.
5/09/18	Mesa Substation

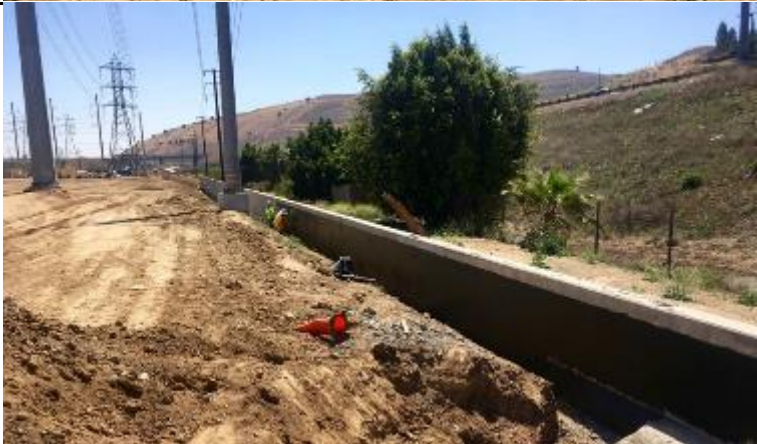
Concrete work on the southern perimeter wall looked complete, and a small crew was painting the wall with what appeared to be a thick black plastic moisture barrier (Photo 8).

Photo 8 – Southern perimeter wall; a crew is painting the wall. Photo facing east.

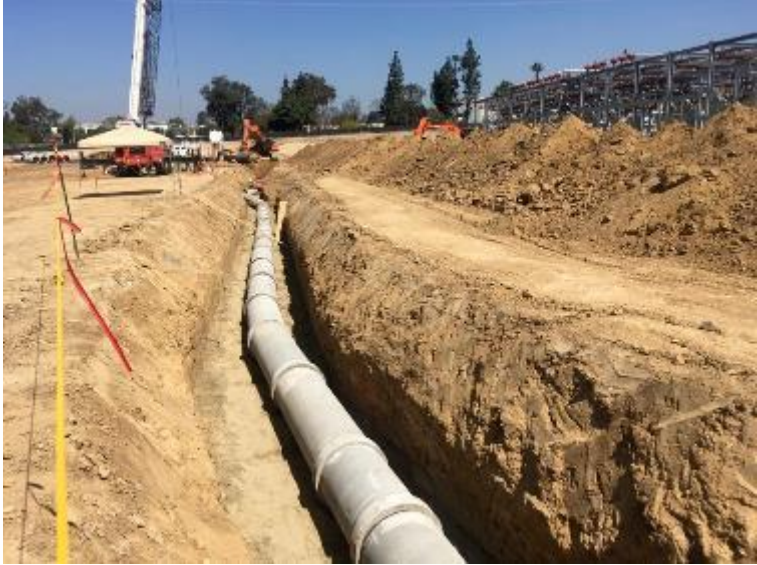
Photo 9 – Storm drain pipe installed through the center of the Mesa Substation site. Photo facing north.
5/09/18	Mesa Substation

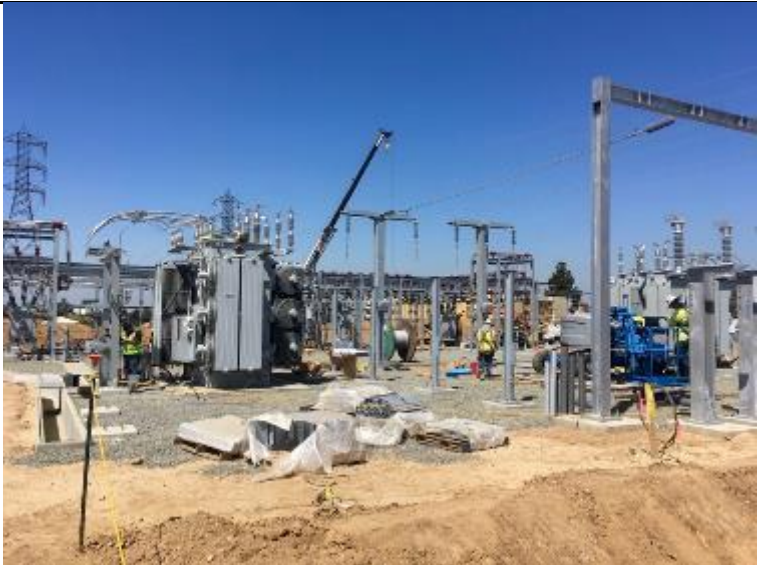
Construction activities continued at the 16-kilovolt (kV) and 66-kV switchracks (Photos 4 and 10).

Photo 10 – 16-kV switchrack area.
5/09/18	Mesa Substation

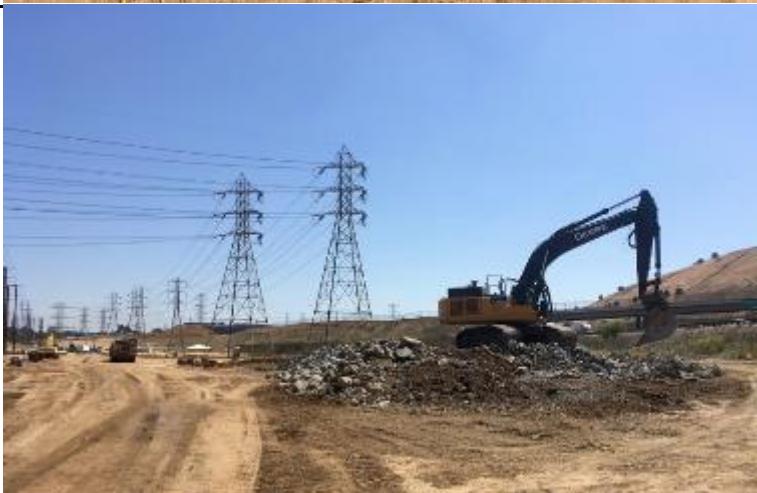
A crew was using an excavator near the southcentral portion of the Mesa Substation site to separate concrete for recycling (Photo 11).

Photo 11 – Excavator separating concrete from the pile of rubble. Photo facing east.

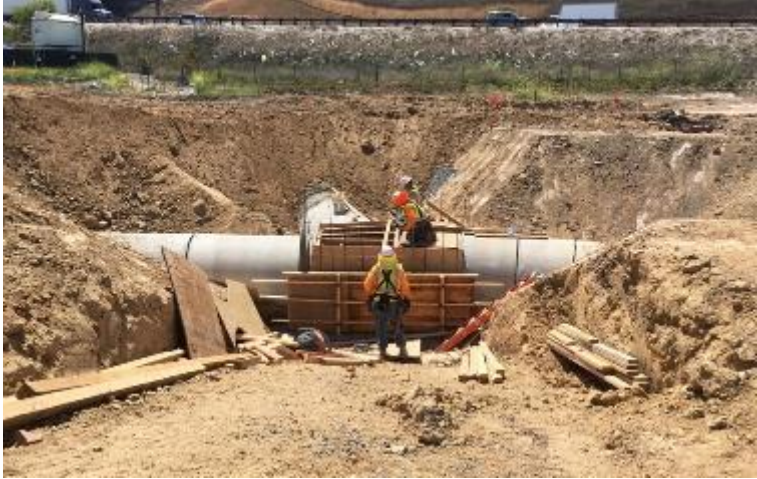
Storm drain installation continued at a number of locations throughout the Mesa Substation site. I had some concerns with the covering of the pipe overnight (Photo 5) and the lack of escape ramps (Photo 9). I sent a text to the ICF lead biological monitor Matt Daniele about these issues. A new wooden escape ramp (Photo 7) had been installed in the drainpipe trench at the westernmost end of the Mesa Substation site, and this new ramp was an improvement over the previous ramp. Crews were installing forms for the tie-in structures (Photo 12).

Photo 12 – Storm drain pipe connection site along the southern perimeter. Photo facing south.
5/09/18	Mesa Substation

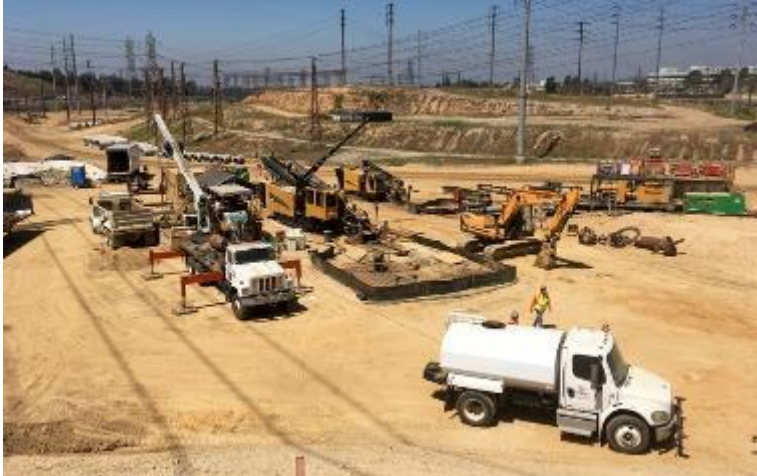
My last stop was at the MarketPlace HDD site where personnel were working to ream the borehole (Photo 13).

Photo 13 – Market Place HDD operation. Photo facing west.

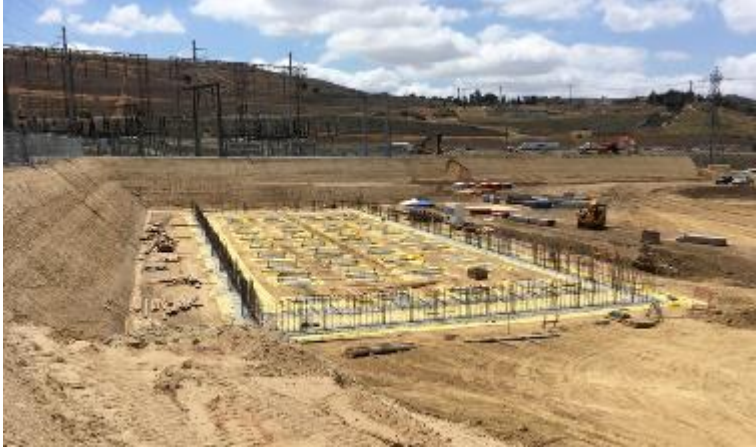
I checked the location of the Senior Mechanical Electrical Equipment Room (MEER) and it appeared that all of the footings had been poured (Photo 1). A segment of the Senior MEER storm drain system had been installed (Photo 2). There was an exit ramp out of this trench, but the storm drain pipe should have been capped (MM BR-10). I saw ICF lead biological monitor Matt Danielle and we discussed the need to cap the storm drain pipe so animals would not become trapped. He stated that he was concerned that capping the pipe would trap any animals already inside the pipe, and there was no way to look inside the pipe for animals (MM BR-1, APM-BIO-03, APM-BIO-04, APM-BIO-06, MM BR-2).

Photo 1 – Foundation work within the Senior MEER. Photo facing south.
5/17/18	Mesa Substation

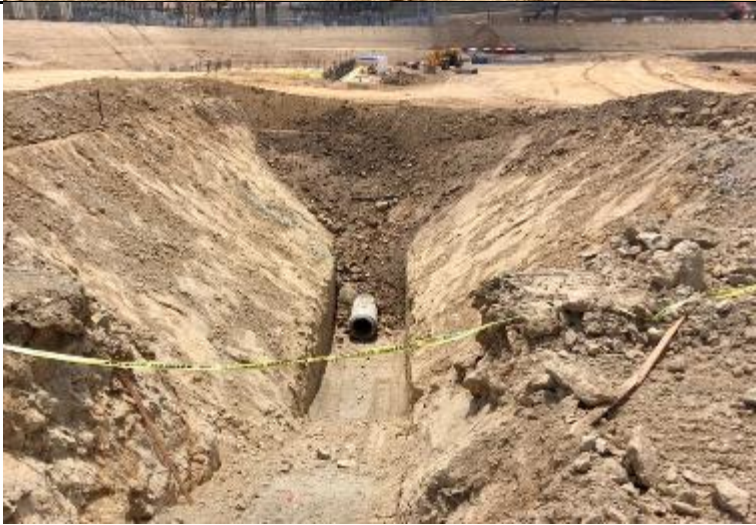
Photo 2 – Storm drain pipe installation; escape ramp is in place but the pipe is not capped.
5/17/18	Mesa Substation

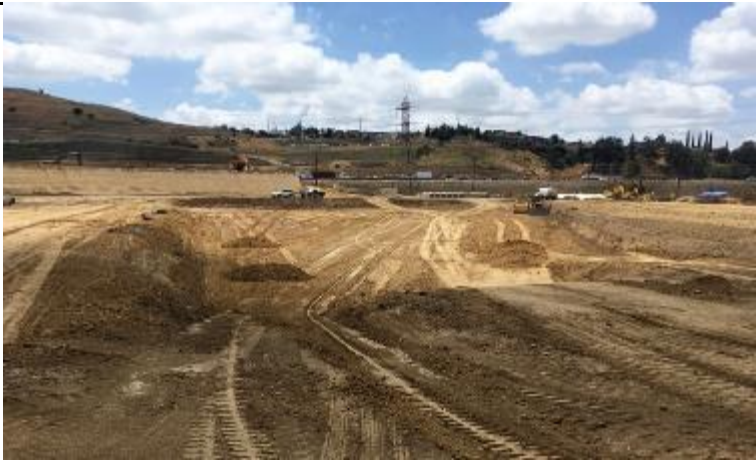
Earthmoving activities were ongoing immediately west of the Senior MEER. Soil was being delivered from other parts of the Mesa Substation site to backfill the area over the old water line (Photo 3).

Photo 3 – Backfilling continues over the old water line. Photo facing south.

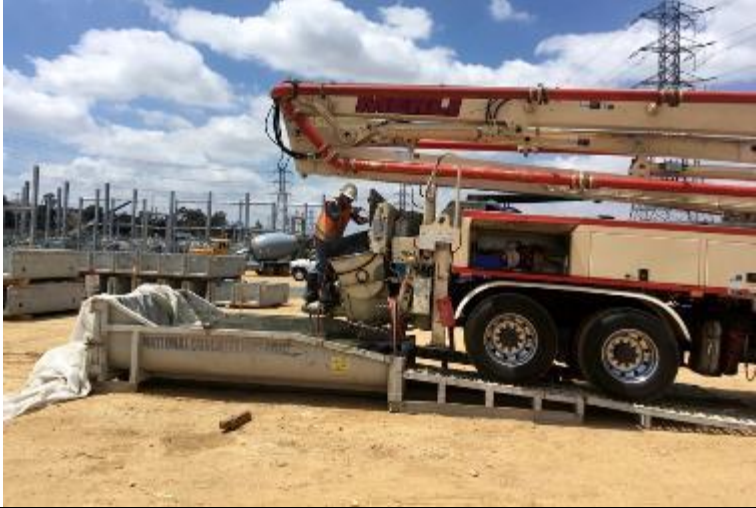
I observed water trucks wetting down the backfill material and the access roads (MM HY-1). I also observed a pumper truck and concrete trucks being rinsed in concrete catch basins (Photo 4).

Photo 4 – Pumper truck being rinsed off within a concrete catch basin.
5/17/18	Mesa Substation

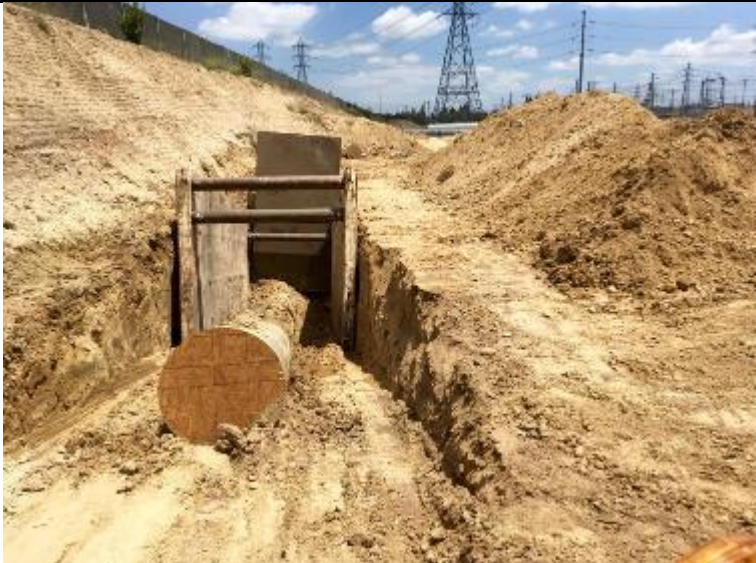
The third and final plastic conduit had been pulled through at the Potrero Grande Drive HDD bore (Photo 5). Most of the drilling equipment had been removed, and some cleanup and dust control was needed.

Photo 5 – The third pipe has been pulled at the Potrero Grande Drive HDD operation. Photo facing east.
5/17/18	Mesa Substation

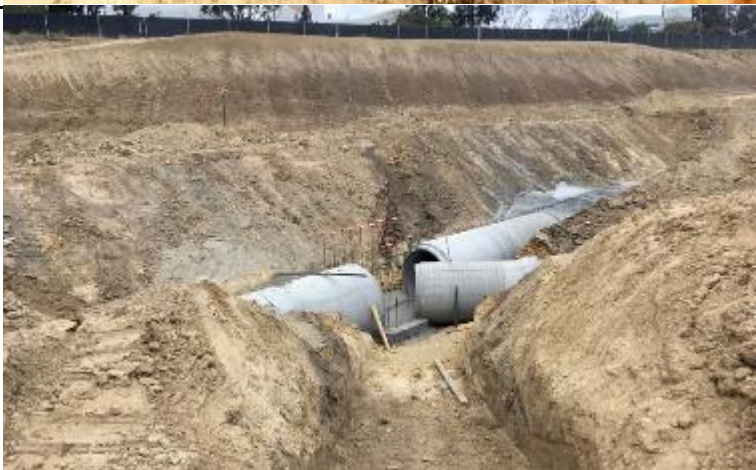
Tie-in work continued at several locations along the storm drain system (Photos 6 and 12).

Photo 6 – Tie-in work on the storm drain system.

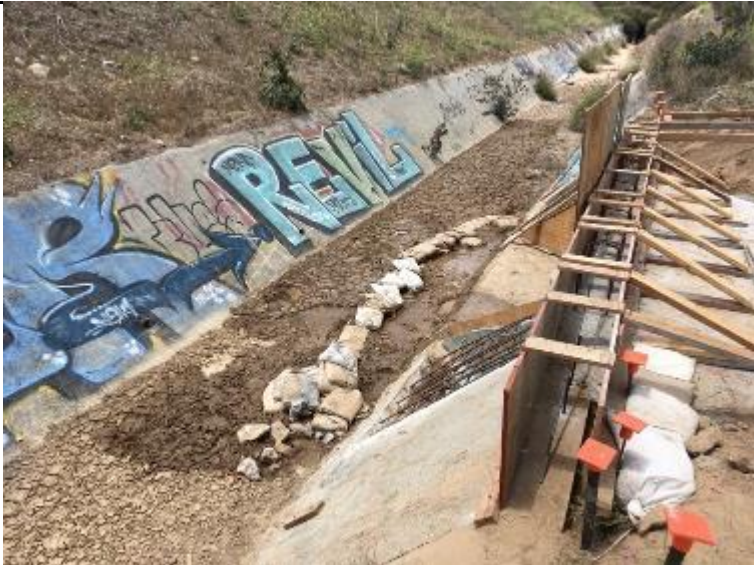
The weeds were still growing on the banks of the detention basin (Photo 8) and in the area along the south side of the southern perimeter wall (Photo 10). This area also had trash and piles of concrete (Photo 10), leftover plastic (Photo 11), and mud in the existing storm drain near the new storm drain inlet (Photo 9). The storm drain inlet was under construction, but water was seeping into the channel. I spoke with Noreas biological monitor Bob Huttar about the weeds; he said they were developing a plan for weed removal. I also expressed my concern about the trash and the mud inside the existing storm drain.

Photo 9 – Existing drainage channel near the new storm drain pipe tie-in. Several inches of mud exist in the channel. Photo facing west.

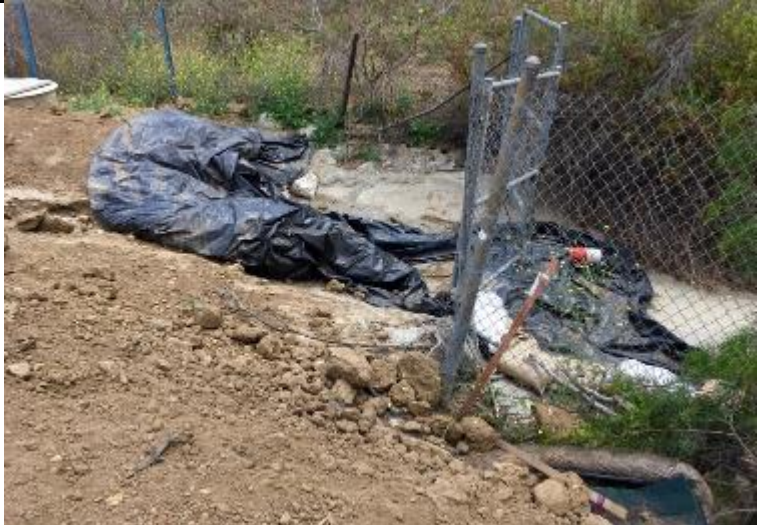
Photo 11 – Plastic left from the temporary storm water diversion channel.
5/17/18	Mesa Substation	 	Photo 12 – Storm drain pipe connection site located just south of the 66-kV switchrack area. Photo facing north.

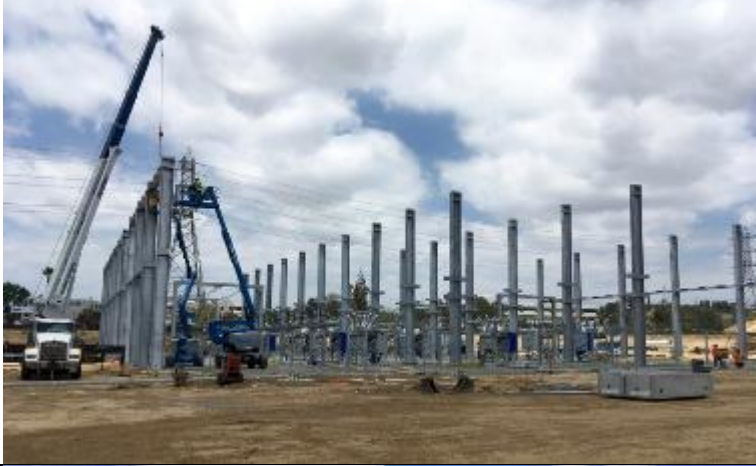
Construction activities were ongoing at the 16-kV and 66-kV switchrack areas (Photo 13). Noreas avian biological monitor Wayne Woodroof said they were closely monitoring the 66-kV switchrack area, as birds regularly try to nest there.

Photo 13 – 66-kV switchrack area.
5/17/18	Mesa Substation

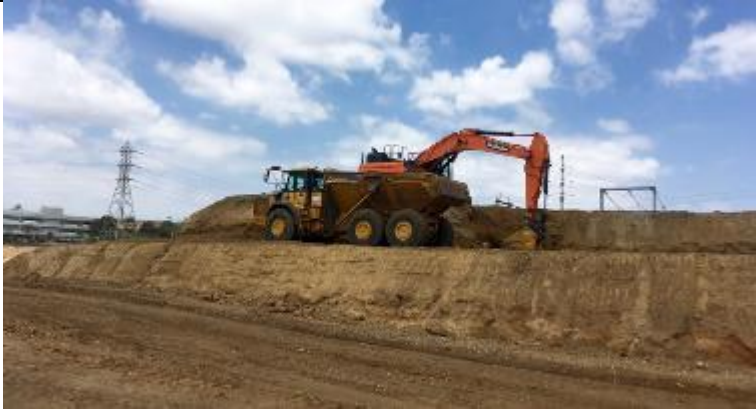
A crew was using a large excavator to load transfer trucks with soil from a portion of the newly dismantled substation (Photo 14). This soil was being used to backfill the old water line area. A long, straight-walled trench had been dug immediately west of the area where the excavator crew was working (Photo 15). This trench had an earthen ramp at one end, but I recommended another ramp to Noreas avian biological monitor Wayne Woodroof.

Photo 14 – Excavation begins for the newly dismantled portion of the old substation. Photo facing east.
5/17/18	Mesa Substation

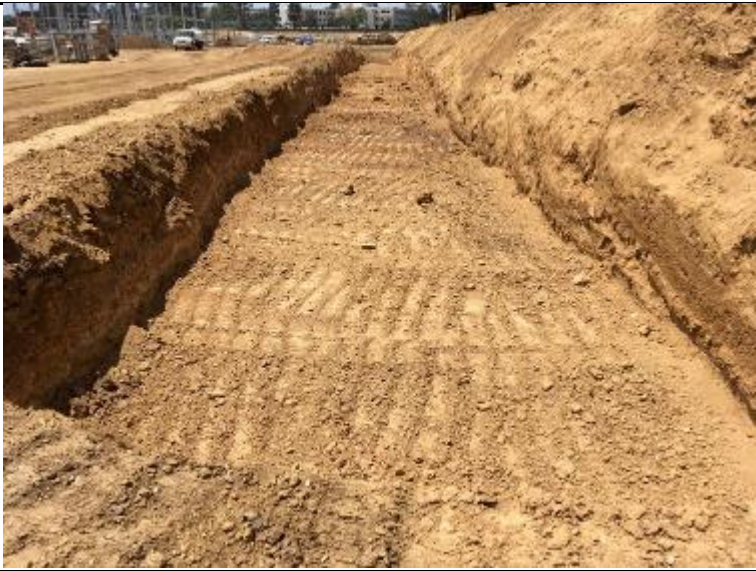
Photo 15 – Open trench. Photo facing north.

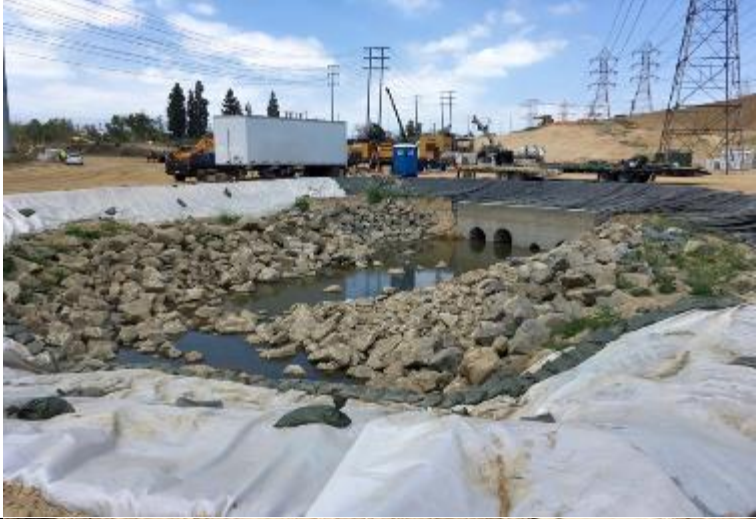
Photo 16 – Storm drain inlet and MarketPlace HDD operation. Photo facing east.
5/17/18	Mesa Substation

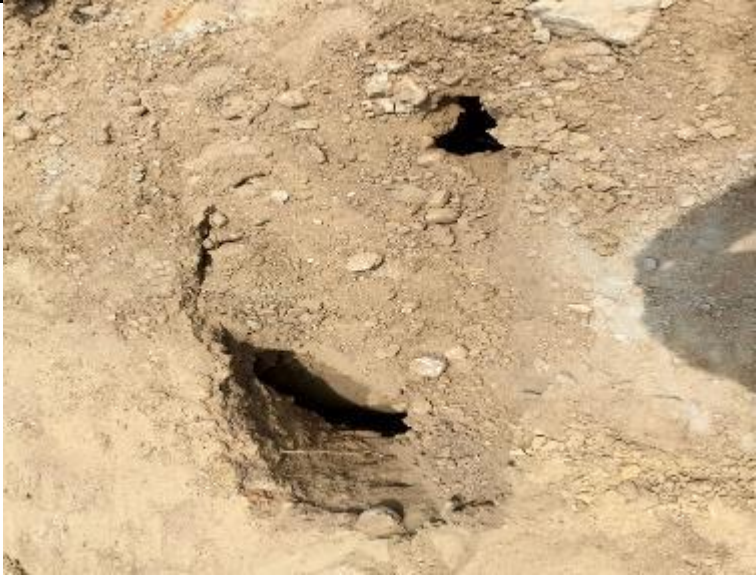
Photo 17 – Open holes located within the Market Place HDD area.

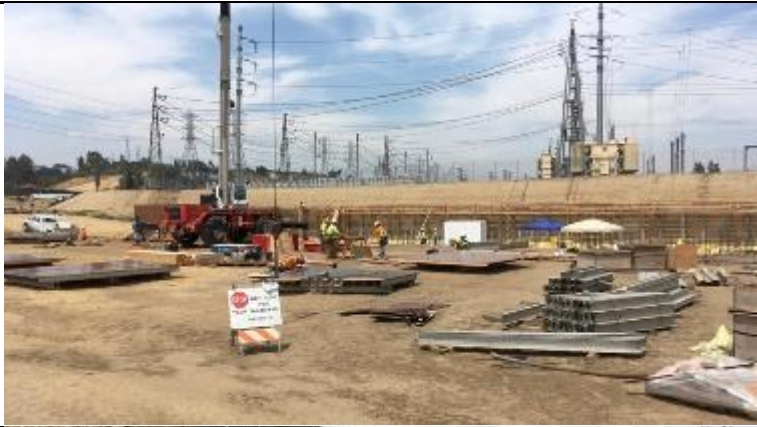
Upon entering the site I looked at the Senior Mechanical Electrical Equipment Room (MEER) location where extensive construction activity was taking place (Photo 1). More workers were required, as the aboveground portion was beginning to be built. This area looked well contained and I noted no compliance issues.

Photo 1 – Work continues within the Senior MEER. Photo facing east.
5/29/18	Mesa Substation

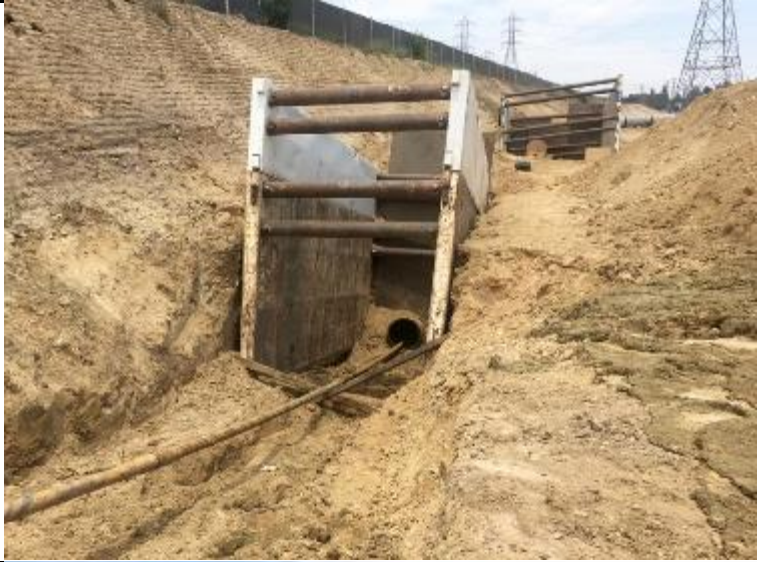
Photo 2 – Potrero Grande Drive HDD operation pulling conduit.
5/29/18	Mesa Substation

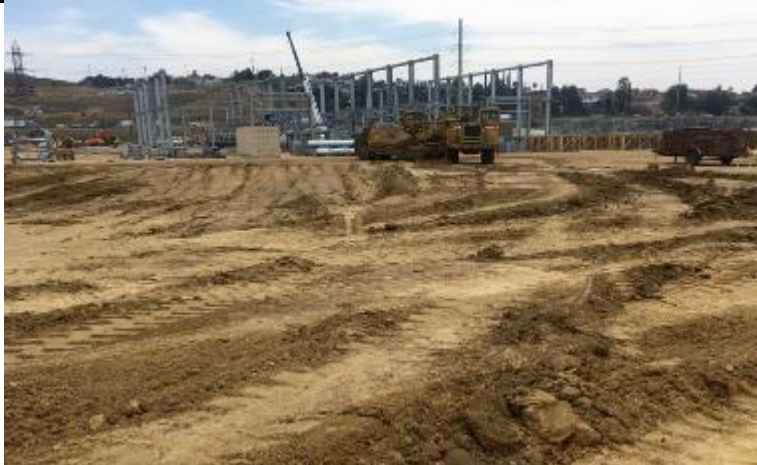
Earthmoving activities were taking place in an area just south of the Potrero Grande Drive HDD work with the use of scrapers (Photo 3). I observed water trucks providing dust control throughout the site (MM HY-1).

Photo 3 – Scrapers moving soil between the HDD area and the 66-kV switchrack. Photo facing south.
