July 24, 2018

Re: Monthly Report Summary #9 for the Mesa 500-kV Substation Project

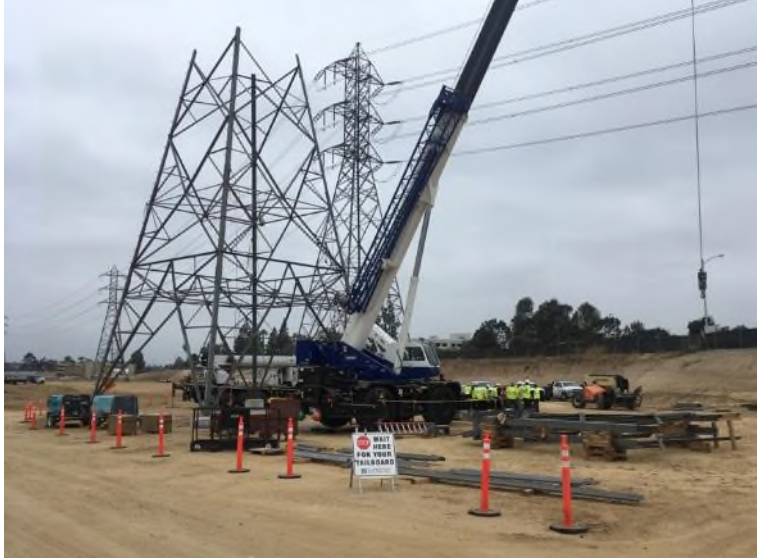
Just inside the entrance to the Mesa Substation site, I observed a crew erecting a lattice steel tower (Photo 1). The crew was conducting their morning tailboard meeting.

Photo 1 – Tower construction. Photo facing north.
6/6/18	Mesa Substation

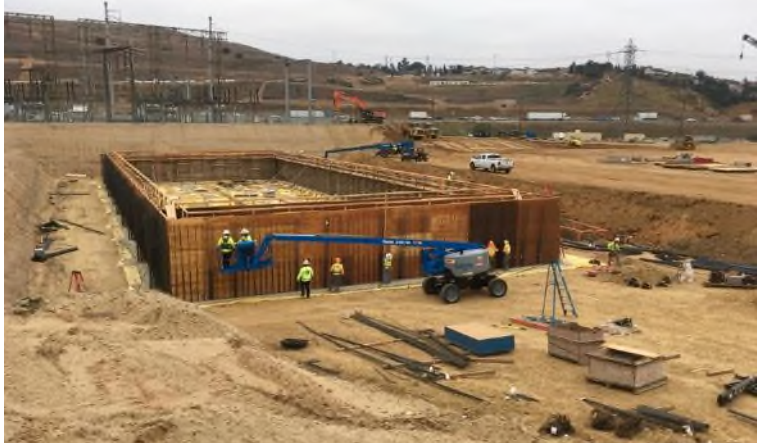
Work was being conducted on the Senior Mechanical Engineering Equipment Room (MEER), with additional wall work being completed (Photo 2). I observed water trucks providing dust control throughout the site (MM HY-1).

Photo 2 – Wall work within the Senior MEER. Photo facing south.
6/6/18	Mesa Substation

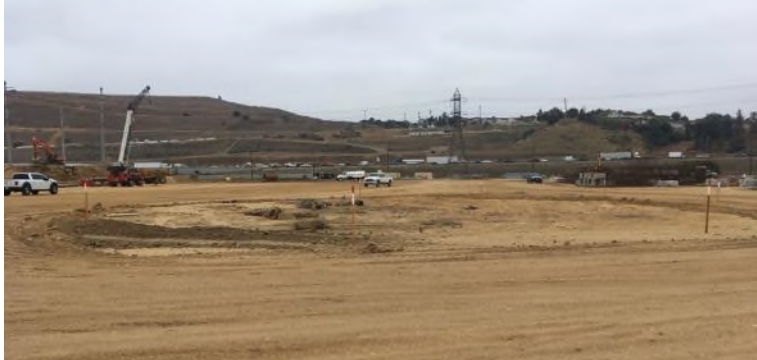
Photo 3 – A killdeer is nesting inside the buffer circle; she did not appear disturbed by the nearby construction work. Photo facing south.

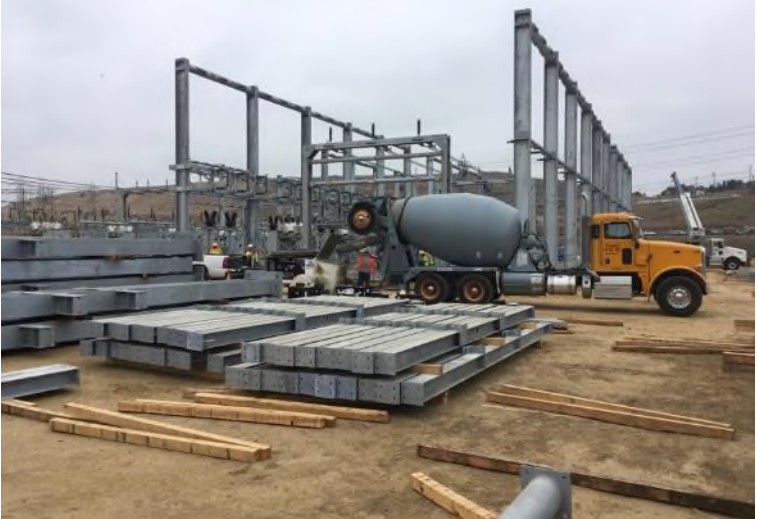
Construction activities continued at the 16-kilovolt (kV) and 66-kV switchrack areas. Crews were pouring concrete at the 66-kV switchrack (Photo 6) and conduit trenching was being conducted near the 16-kV switchrack (Photo 7). I discussed the trenching activity with Noreas avian biological monitor Wayne Woodroof, specifically inquiring about the installation of escape ramps (MM BR-10). He had been checking on the ramp installation and seemed satisfied that the construction teams understood the intent of the condition.

Photo 6 – Concrete being poured within the 66-kV switchrack area. Photo facing south.

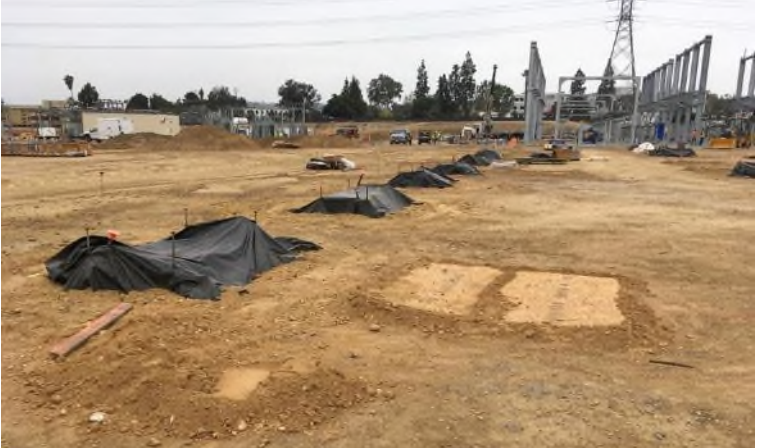
A number of foundations and foundation holes had been covered; therefore, I did not note any issues with entrapment (Photo 10).

Photo 10 – Covered foundations and foundation holes. Photo facing north.
6/6/18	Mesa Substation

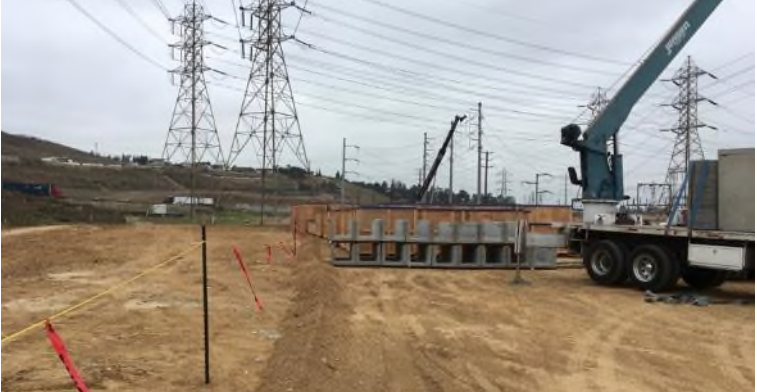
Photo 12 – Equipment being off-loaded near the roped off coastal California gnatcatcher ESA area. Photo facing southwest.

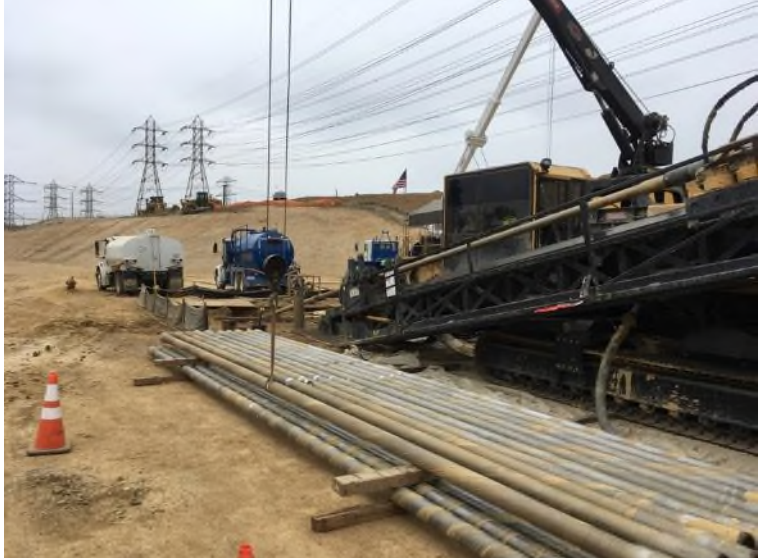
During my site visit, Market Place HDD work was being conducted and I noted no issues (Photo 13). I walked past the area where crews deposit the tailings from the HDD drilling (Photo 14).

Photo 13 – HDD crew at the Market Place drill site. Photo facing east.
6/6/18	Mesa Substation

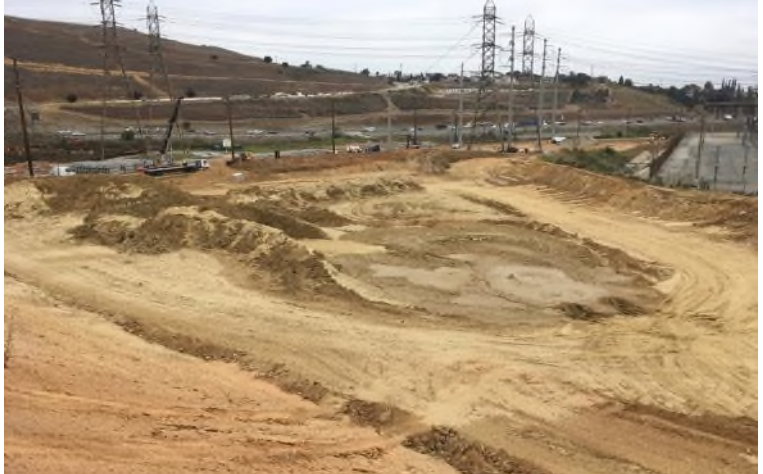
Photo 14 – Area where crews deposit the HDD tailings to dry out. Photo facing southwest.
6/6/18	Mesa Substation

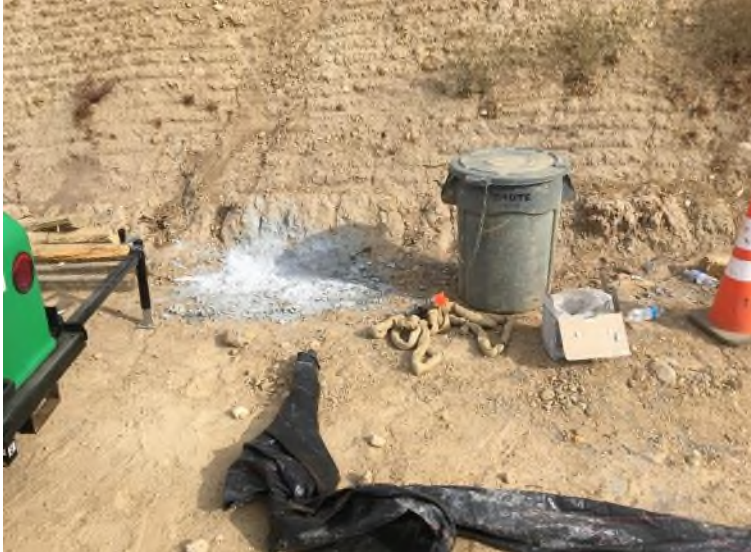
- June 15, 2018: The CPUC Compliance Monitor observed a minor spill of grouting material within the Potrero Grande Drive horizontal directional drilling (HDD) staging area. The spill remained unaddressed by crews through its second observation by the CPUC Compliance Monitor on June 28, 2018. SCE did not document the spill or their failure to clean up the spill. This incident conflicts with MM HY-1: Stormwater Pollution Prevention Plan, which requires project-related spills be cleaned up immediately and Avoidance and Minimization Measures (AMM) 2.34 Pollutants and Debris, which states no organic materials from construction shall be allowed to contaminate the soil.

The Potrero Grande Drive HDD work was nearly complete at the time of my site visit, with all of the plastic pipe pulled and slurried in place (Photo 4). As the slurry cures, it becomes hot; therefore, crews recirculate water through the pipe to keep it cool (Photo 5). This work requires baker tanks, water trucks, a large water pump, and a vacuum truck. I noted a slurry spill in one of the staging areas for this work (Photo 6).

<p>A photograph showing a construction site for a Horizontal Directional Drilling (HDD) project. The scene is set in an outdoor area with a dirt ground. There is a large spill of white slurry on the ground. A green piece of equipment is visible on the left. A grey trash can and an orange traffic cone are also present. The background shows a dirt embankment.</p>	Photo 6 – HDD staging area with trash and a slurry spill.

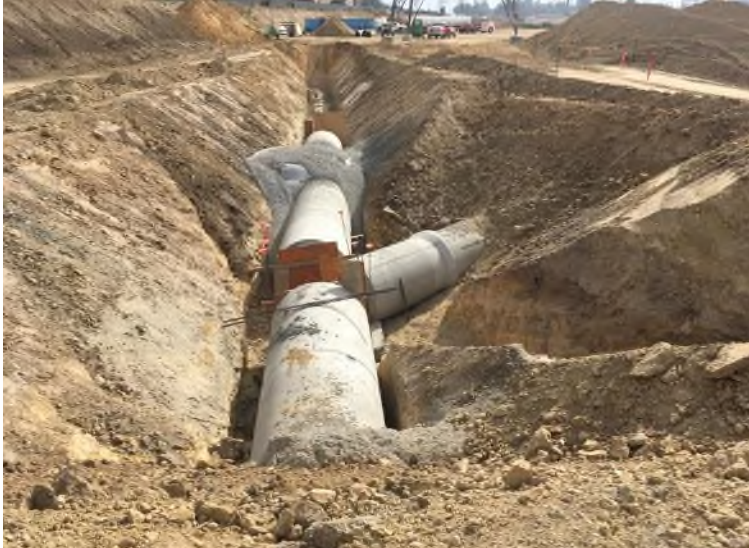
More of the storm drain trench was open along the northern border of the Mesa Substation site, west of the Potrero Grande Drive HDD work (Photo 9). I noted no issues in this area with the earthen ramps and capped pipe; however, I observed a family of ground squirrels (I saw five young) living under the drainage pipe. I mentioned this to Noreas avian biological monitor Wayne Woodroof who said he was aware of the ground squirrels and was determining the best method to remove the squirrels from the trench before it was backfilled.

Photo 9 – Storm drain pipe work. A family of ground squirrels appear to be living under one of the pipes. Photo facing east.

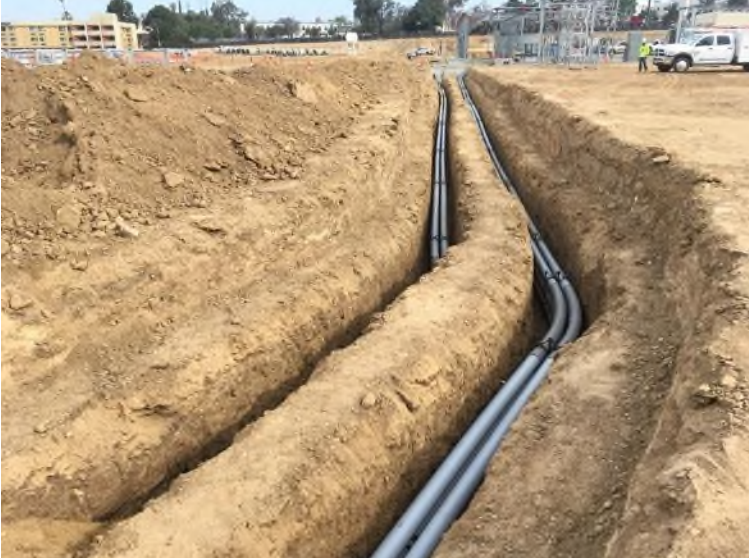
Photo 11 – Conduit in a 210-foot-long trench with only one escape ramp. Photo facing north.
6/15/18	Mesa Substation

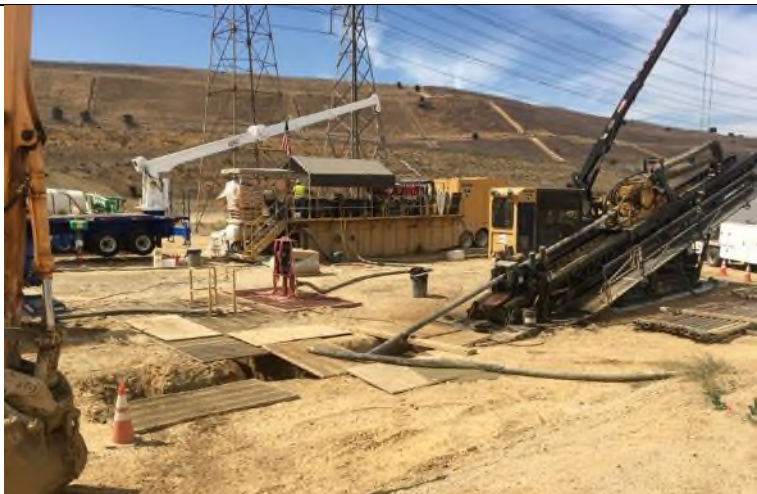
Photo 13 – HDD crew at the Market Place drill site; note the lack of silt fence around the entry hole. Photo facing south.
6/15/18	Mesa Substation

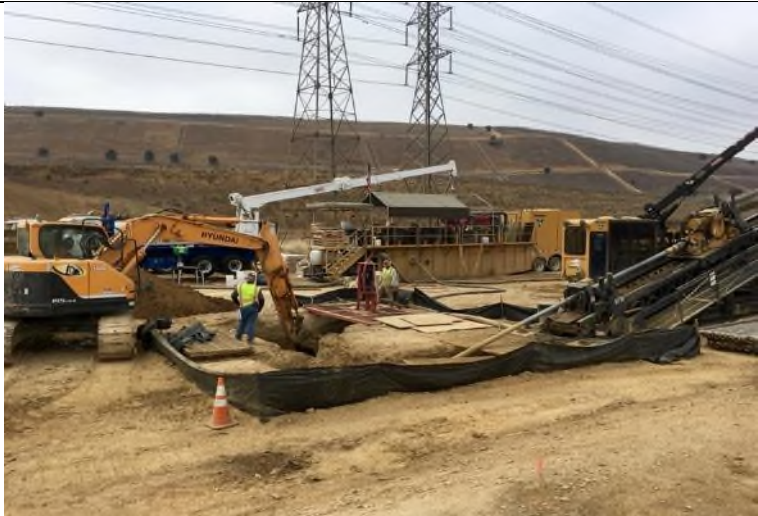
The Market Place HDD operation continued during the time of my site visit, with crews focused on reaming bore #2 (Photo 10). I observed no issues, and I signed in on their Job Safety Analysis (JSA). Paleo Solutions paleontological monitor Olivia Tierk was stationed near this location and was checking these and other excavation activities.

Photo 10 – Market Place HDD work. Photo facing south.
6/20/18	Mesa Substation

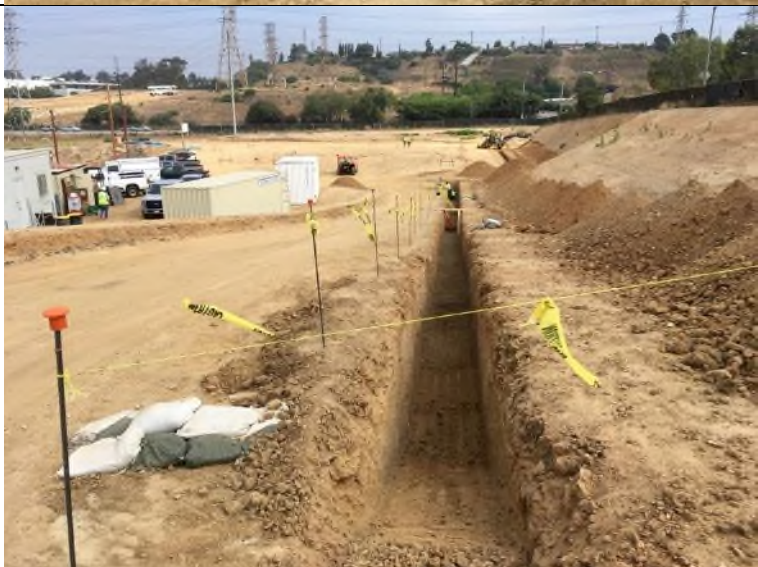
The Mesa Operations Building Site was now under construction along Market Place Drive. I stopped into the trailers to introduce myself and meet the PRAVA foreman Nathan Wardlaw. We discussed project conditions and my role as the onsite inspector for the CPUC as compared to the other project monitors. Crews had begun trenching for water and utilities, so we talked about exit ramps in the trenches (Photo 11).

Photo 11 – Trenching within the Mesa Operations Building area. Photo facing north.
6/20/18	Mesa Substation

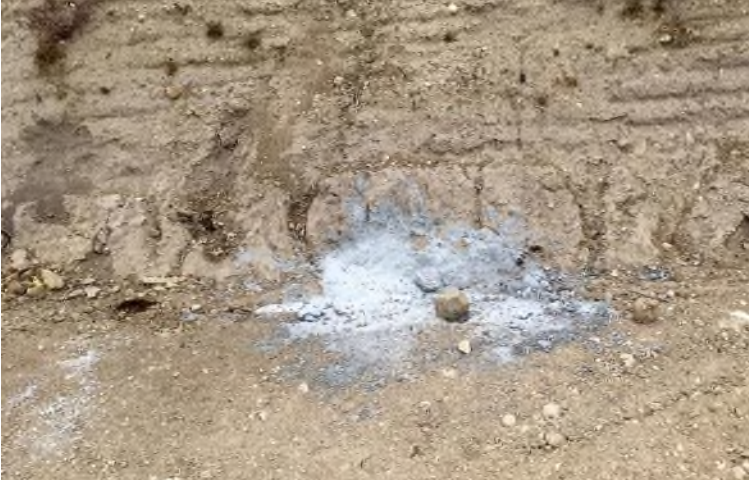
<p>Photo 5 – Material spill remains near the HDD work.</p>
6/28/18	Mesa Substation
