PUBLIC UTILITIES COMMISSION

Incident Date:	3/17/21 (for MM HY-1 and MM HY-3)	Report No.:	NCR-008
Date Submitted:	7/28/2021	Location:	Inlet located behind the southern boundary wall of the Mesa Substation
Level:	Level 2	Relevant Plan/Measure:	MM HY-1 (including SWPPP) MM HY-3
Current Land Use:	Mesa Substation	Sensitive Resources:	Public storm drain system

Site Photographs (from March 17, 2021)

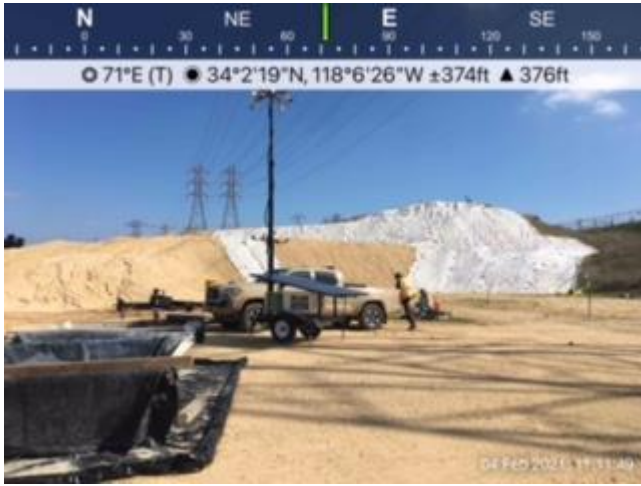
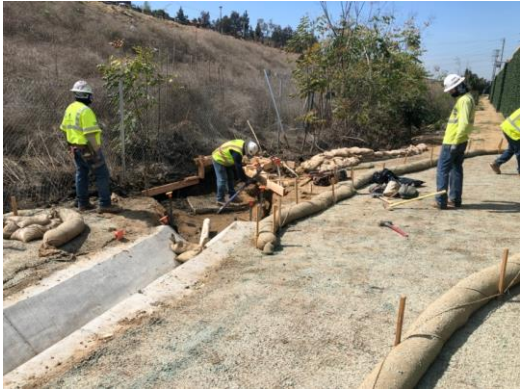
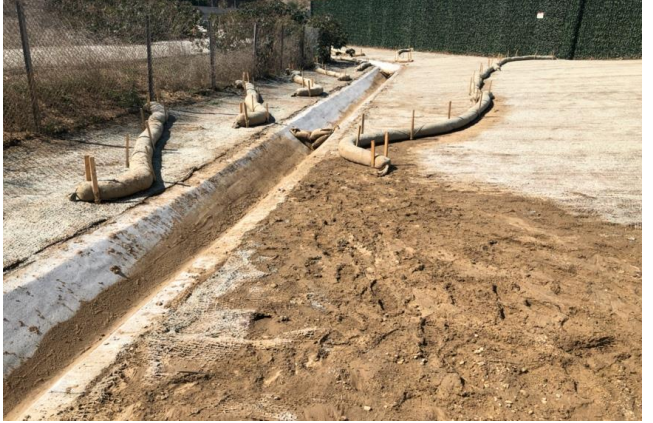
<p>The slope (aka Market Place Stockpile) and the open space downgradient from the slope lack sediment control and erosion control BMPs.</p>	<p>Per Risk Level 2 requirements, Attachment D:</p> <p>Section D.2: <i>Risk Level 2 dischargers shall provide effective soil cover for inactive areas and all finished slopes, open space, utility backfill and completed lots.</i></p> <p>Required Action: Plastic sheeting is only applied on one area of slope. Install soil stabilization BMPs on entire face of slope and in the open space downgradient from slope.</p> <p>Section E.3: <i>Risk Level 2 dischargers shall implement appropriate erosion control BMPs (runoff control and soil stabilization) in conjunction with sediment control BMPs for areas under active construction.</i></p> <p>Required Action: Install sediment control BMPs on face, toe and at grade breaks on slope.</p> <p>Per Risk Level 2 requirements, Attachment D, Section E.4: <i>Risk Level 2 dischargers shall apply linear sediment controls along the toe of the slope, face of the slope, and at the grade breaks of exposed slopes to comply with sheet flow lengths in accordance with Table 1.</i></p> <p>Required Action: Install linear Sediment Control BMPs at grade breaks on slope.</p>	<p>Per CASQA guidelines, BMPs were installed on the Mt. Mesa stockpile, temporary perimeter sediment barrier BMPs and track walking was performed on the stockpile prior to the precipitation event. Furthermore, additional BMPs were added to the area later that same afternoon to include additional fiber rolls and gravel bag berms. Cover is not advised due to proximity of energized areas and possibility of wind driven entanglement.</p> <p>The "Market Place" stockpile (located in the far East corner of the project site) is an active stockpile, with work performed as recent as early March, and the "Mt. Mesa" stockpile (located West of the Marketplace stockpile) is also an active stockpile with work performed as recent as Monday March 8, 2021. As active stockpiles, they do not have the same stabilization requirements as inactive stockpiles.</p> <p>For the soil amendment/binder application for the March 9, 2021 storm event, the first indication that this would be a qualifying storm event did not happen until Saturday, March 6, 2021 - at that time there was a 56% chance of rain. The first available workday to respond to the predicted event would have been Monday, March 8, 2021. (BMP install halted 3/9/21 due to nesting CA gnatcatcher)</p>	<ul style="list-style-type: none"> Plastic sheeting removed per CPUC Monitor Per CASQA BMP Fact Sheet EC-15, soil roughening or track walking isn't considered effective cover per CGP and CASQA BMP fact sheet EC-15. <ul style="list-style-type: none"> Have Mesa Substation QSD evaluate the applicability of applying an eco-safe, biodegradable, liquid polymer soil binder for erosion control. Per the CASQA BMP Fact Sheet EC-1 Scheduling - When rainfall is predicted, adjust the construction schedule to allow the implementation of soil stabilization and sediment treatment controls on all disturbed areas prior to the onset of rain. <ul style="list-style-type: none"> Mesa Substation Contractor and their QSP shall effectively coordinate disturbed soil stabilization prior to forecasted events CPUC Monitor observed soil binder application on 3/24/21 on Mt. Mesa Stockpile 	<p>3/17/21 CPUC Monitor observed signs of visible sediment discharge: <i>Muddy sediment was captured behind all gravel bag check dams within the "V" ditch running down to the offsite drain inlet (Photos 12 & 13). All captured sediment had been dug out of the "V" ditch, but it was obvious that a lot of sediment laden runoff drained offsite via the drain inlet or the Caltrans channel. A Power Grade crew was working on the drain inlet at the end of this "V" ditch (Photo 14).</i></p>

<p><i>Given that samples cannot be collected due to safety exemptions, to keep the Mesa Substation Project in compliance with the CGP, a notice of discharge must be filed on SMARTS and with the Los Angeles RWQCB.</i></p>

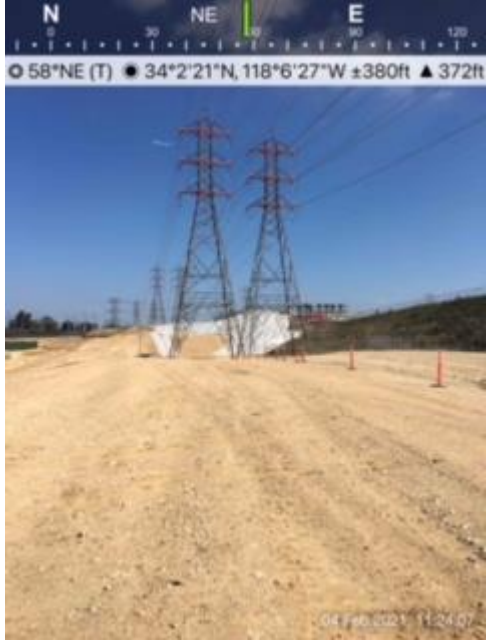
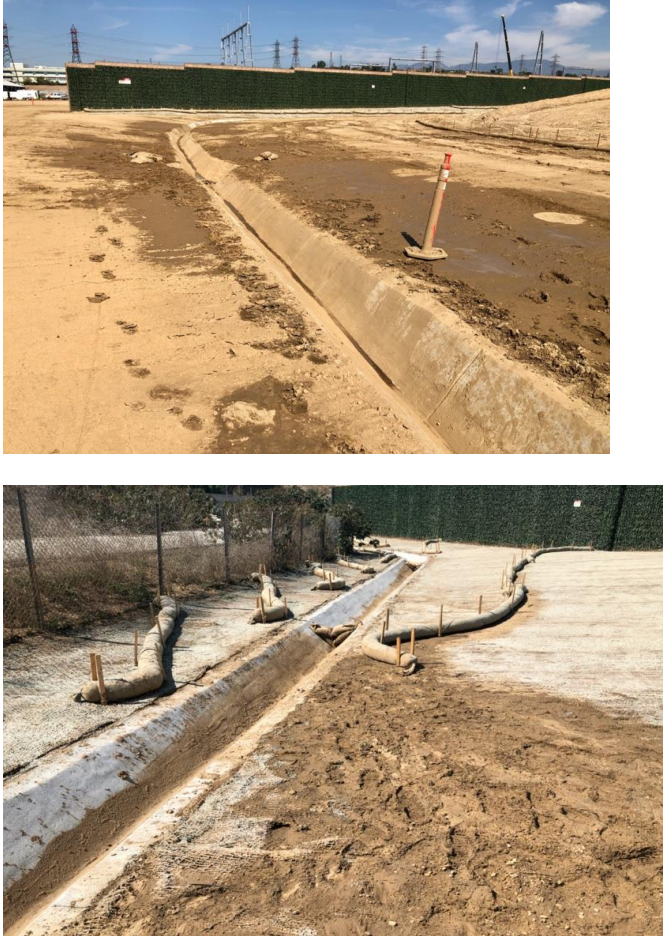
<p>Open space area lacks erosion and sediment control as well as run-off management. Area conveys flow off site</p>	<p>Per Risk Level 2 requirements, Attachment D:</p> <p>Section D.2: <i>Risk Level 2 dischargers shall provide effective soil cover for inactive areas and all finished slopes, open space, utility backfill and completed lots.</i></p> <p>Required Action: Apply soil stabilization and sediment control BMPs to this open space area.</p> <p>Section F. <i>Run-on and Run-off Controls: Risk Level 2 dischargers shall effectively manage all run-on, all run-off within the site and all runoff that discharges offsite.</i></p> <p>Required Action: Manage runoff from this area to prevent offsite sediment discharges.</p>	<p>No response regarding stabilization of this open space area provided by SCE.</p> <p>Document in Annual Report as follows:</p> <p>Question F.1: Were required erosion controls fully implemented on your site?</p> <p>Response: No</p> <p>Question H.1: Was all site run-on and run-off effectively managed?</p> <p>Response: No</p>	<p>Lack of implementing erosion control BMPs in this open space area contributed to offsite sediment discharges when the project received approximately 0.5-inches of rain during the week of 8 March 2021 and another 0.4-inches on Monday March 15, 2021.</p> <p><i>Given that samples cannot be collected due to safety exemptions, the only way to determine BMP effectiveness is based on post-storm inspections. Given the CPUC Monitor's photo documentation indicates evidence of a sediment discharge from disturbed areas, the sediment control and erosion control strategy needs to be modified to prevent offsite sediment discharges from the Mesa Substation Project and a report notifying the State Water Board was required on SMARTS no later than 10 days after the conclusion of the storm event.</i></p>

<p><i>Per CGP, Section III, Discharge Prohibitions, all discharges are prohibited except for the storm water and non-stormwater discharges specifically authorized by the CGP or another NPDES permit.</i></p> <p><i>Per Attachment D, Section 15, in the event that any sample exceeds an applicable NAL, Risk Level 2 dischargers shall electronically submit all storm event sampling results to the State Water Board no later than 10 days after the conclusion of the storm event. Although sample results are not available, photo documentation establishes that the turbidity NAL was exceeded. To keep the project in compliance, notification to the State Water Board is required.</i></p>

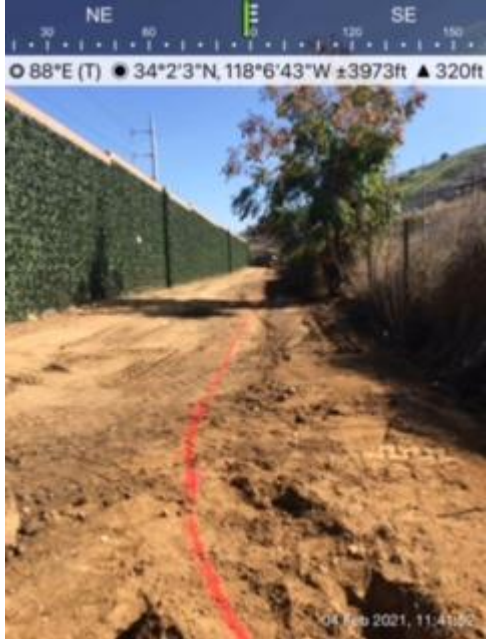
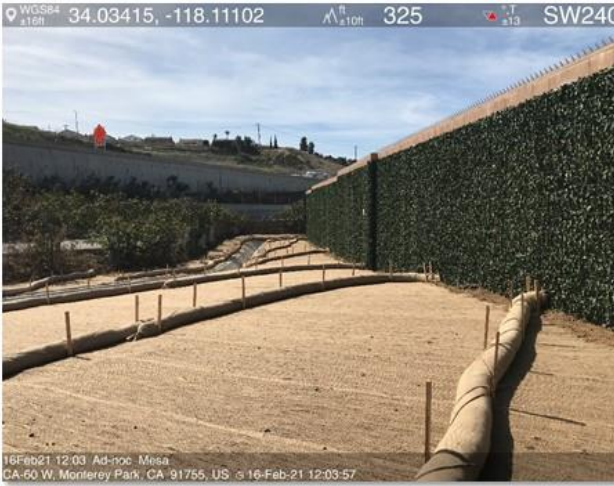
<p>Section E.3: Risk Level 2 dischargers shall implement appropriate erosion control BMPs (runoff control and soil stabilization) in conjunction with sediment control BMPs for areas under active construction.</p> <p>Required Action: Install temporary erosion and sediment control BMPs to exposed soil area.</p>

<p>16 Feb - 10 March 2021: Rolled erosion control blanket, fiber roll and hydraulic mulch applied.</p>	<p>No further action required.</p>

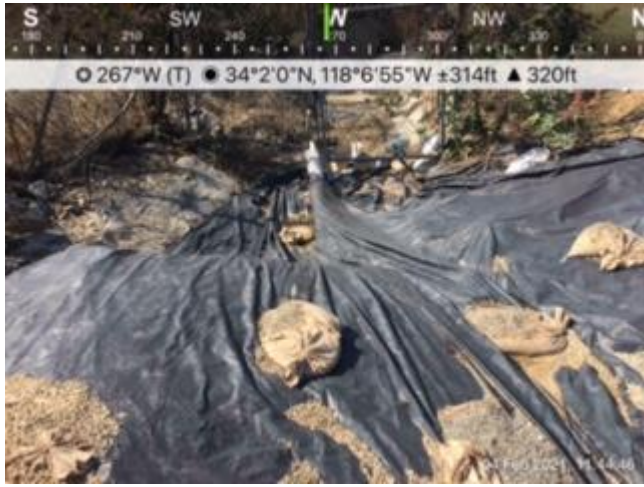
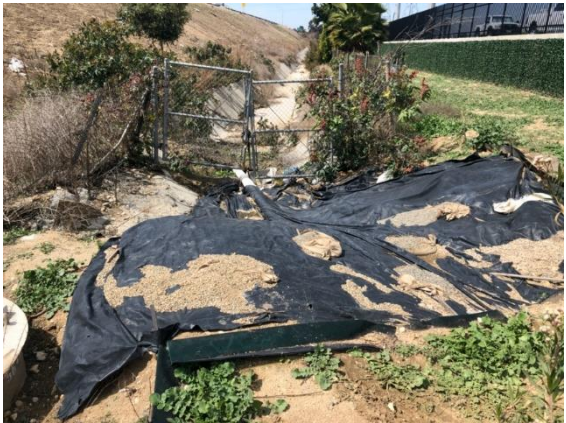
<p>PVC pipe installed at channel located outside of the southern boundary wall.</p>	<p>Required Action: Potential illicit discharge from Mesa Substation site. Ensure pipe is abandoned; remove pipe and all temporary BMPs. Stabilize area to pre-construction conditions.</p>	<p>No response received from SCE.</p>	<p>BMP repair and site restoration not implemented within 72 hours.</p> <p>Document on Annual Report:</p> <p>Question J.6: If BMP maintenance/repair or design change was needed, did implementation begin within 72 hours?</p> <p>Response: No</p>

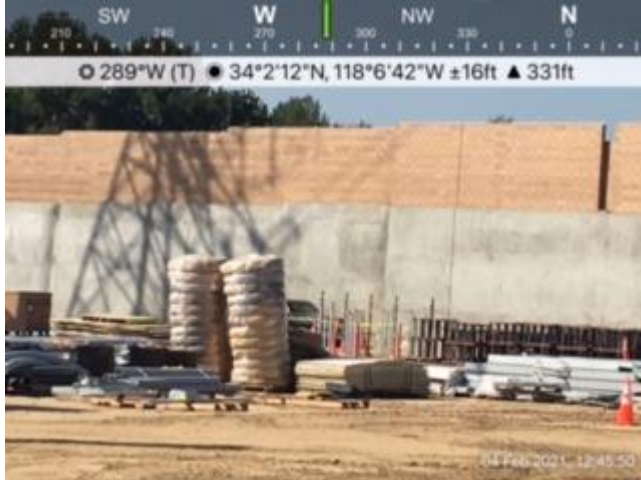
<p data-bbox="192 969 780 1022">Temporary fiber rolls – part of the Contractor’s sediment control material stock</p>	<p data-bbox="829 354 1181 439">may require either more frequent cleaning, a sediment trap or forebay.</p> <p data-bbox="829 445 1181 586">The Rain Event Action Plan dated 12/27/2020 indicates the erosion and sediment control material stock was checked and there were no deficiencies noted.</p> <p data-bbox="829 592 1181 762">Required Action: Contractor shall ensure that there is an adequate inventory of erosion control BMPs to stabilize disturbed soil areas prior to a likely rain event.</p>	<p data-bbox="1212 445 1650 469">No response in email dated 10 March 2021</p>

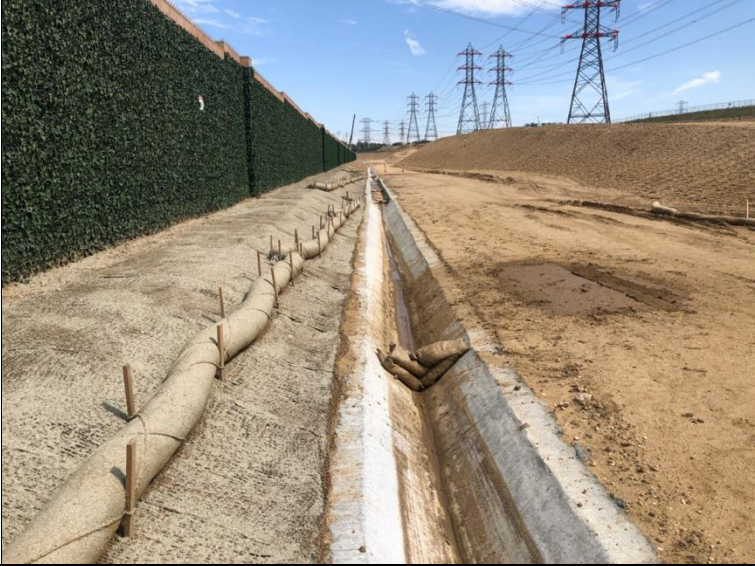
- **Post storm BMP deficiencies behind the southern boundary wall:** The CPUC Compliance Monitor noted the project area received approximately 0.5 inches of rain the week of March 8, and an additional 0.4 inches of rain on Monday March 15th. The CPUC Compliance Monitor did not report seeing stormwater runoff, however, noted muddy areas, mud stains on the V-ditch, and numerous visible erosion rivulets. For example, mud stains behind the gravel bag check dams within the V-ditch running east to west between the boundary wall and the soil stockpile showed

that sediment coming off of the site filled the area behind each of the check dams. (Attachment 2, photo 1).

Photo 1 – “V” ditch between the southern boundary wall and the soil stockpile. Photo facing east.
3/17/21	Mesa Substation

BMPs must be inspected and maintained in accordance with Construction General Permit Order No. 2009-0009-DWQ, as Amended by Order Nos. 2010-0014-DWQ and 2012-0006-DWQ for the associated Mesa Substation Project risk level. It is recommended that at the minimum, storm drain inlets be inspected weekly, prior to forecasted rain events, daily during extended rain events, and after the conclusion of rain events. Specifically, checking inlet and outlet structures for any damage or obstructions, and repair damage and remove obstructions as needed. In addition, checking the inlet and outlet areas for erosion and stabilize upland areas if required. Furthermore, to maintain the effectiveness of the V-ditch, sediment that accumulates in the V-ditch must be periodically removed.

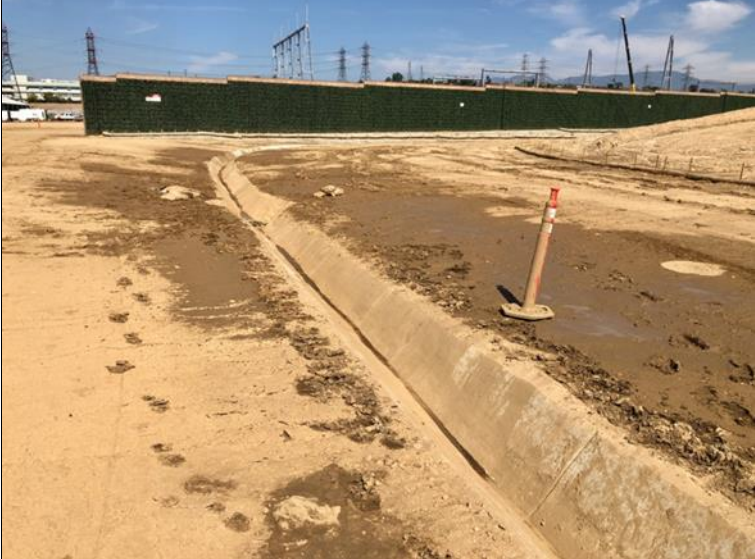
- It was also evident that the drain inlet within the V-ditch had clogged up creating a large pond. The gravel bags and filter fabric around and over this drain inlet had been pulled out to allow the water to drain out, and the materials were placed near the edge of the v-ditch (Attachment 2, photo 2).

Photo 2 – “V” ditch drain inlet area at the western end of the soil stockpile. Photo facing north.

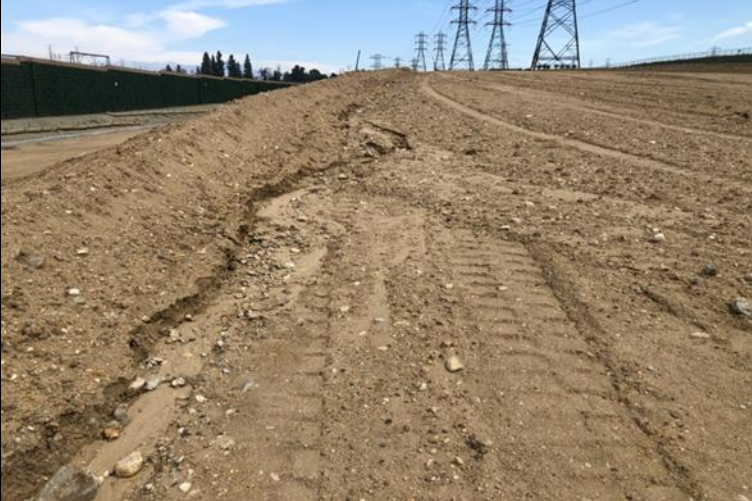
- Stormwater runoff rivulets were noted coming off the top of the soil stockpile (Attachment 2, photo 3) and coming from around the southern side of the soil stockpile (Attachment 2, photo 4)

Photo 3 – Erosion rills coming off of the soil stockpile. Photo facing north.
3/17/21	Mesa substation

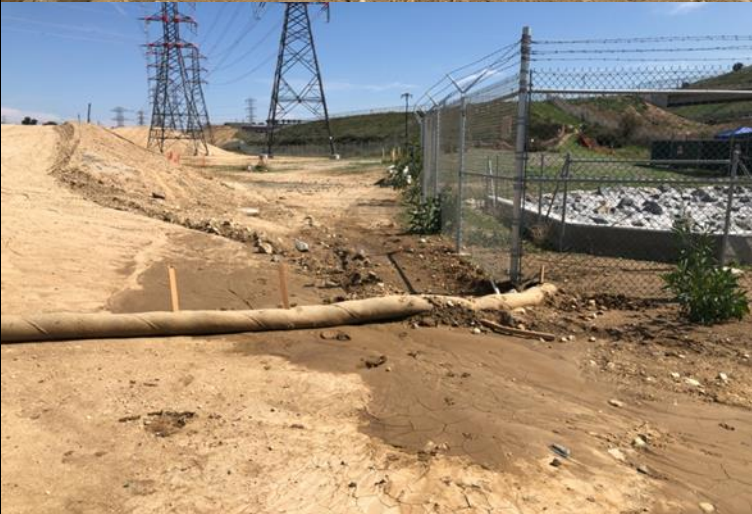
Photo 4 – Rainwater runoff from south of the soil stockpile. Photo facing north.
3/17/21	Mesa substation

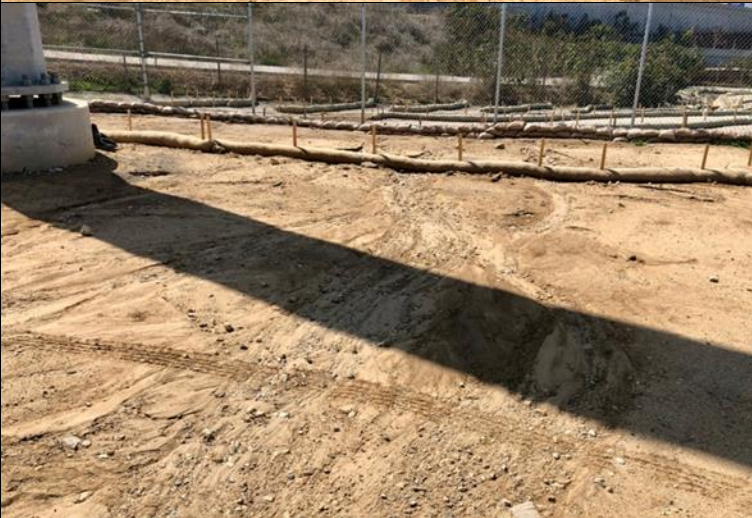
- Rivulets were noted coming into the BMP area outside of the southern boundary wall (Attachment 2, photo 5).
- Muddy sediment was captured behind all of the gravel bag check dams within the V-ditch running down to the discharge drain inlet (Attachment 2, photos 6 and 7). All of the captured sediment had been dug out of the "V" ditch, but there were obvious signs that a lot of sediment laden stormwater runoff drained offsite via the drain inlet connect to the municipal storm drain system. A construction crew was working on the drain inlet at the end of this V-ditch (Photo 8).

Photo 5 – Rainwater runoff rivulets heading down into the BMP area. Photo facing southwest.

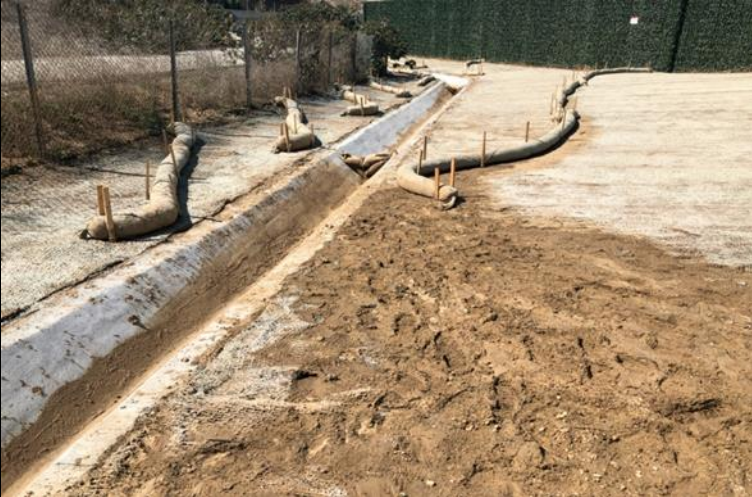
Photo 6 – Mud captured in the “V” ditch. Photo facing west.
3/17/21	Mesa substation

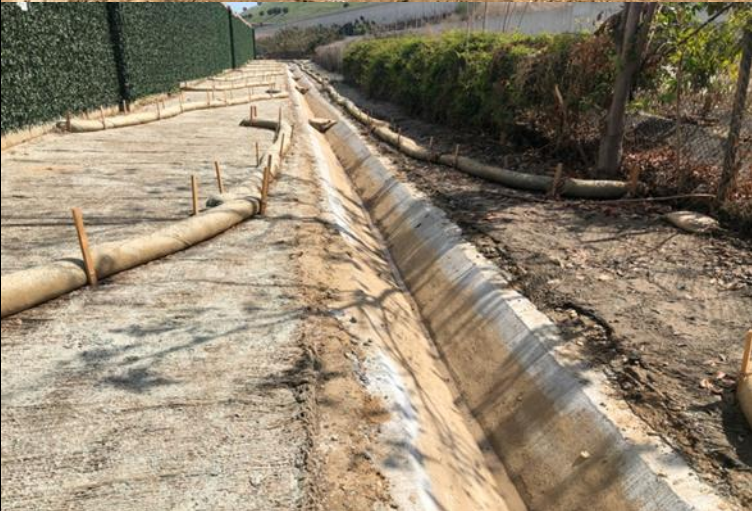
Photo 7 – “V” ditch coming down to the offsite drain inlet. Photo facing east.
3/17/21	Mesa substation

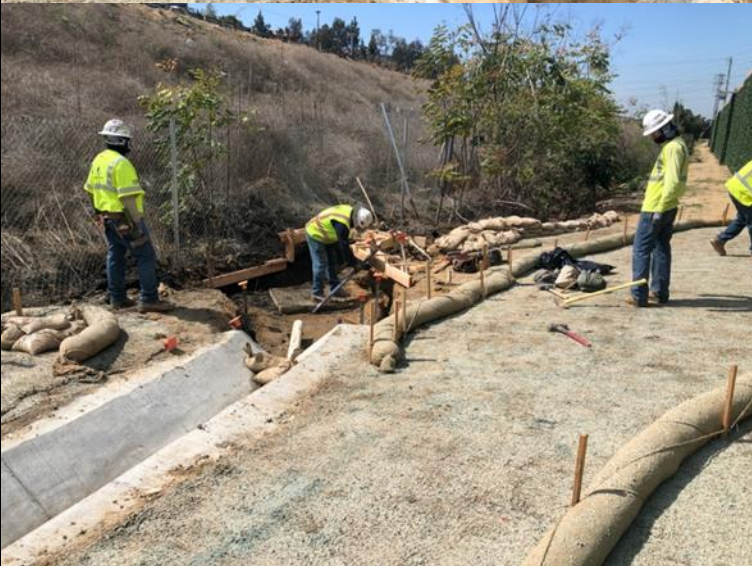
Photo 8 – Work on the drain inlet outside of the southern boundary wall. Photo facing west.

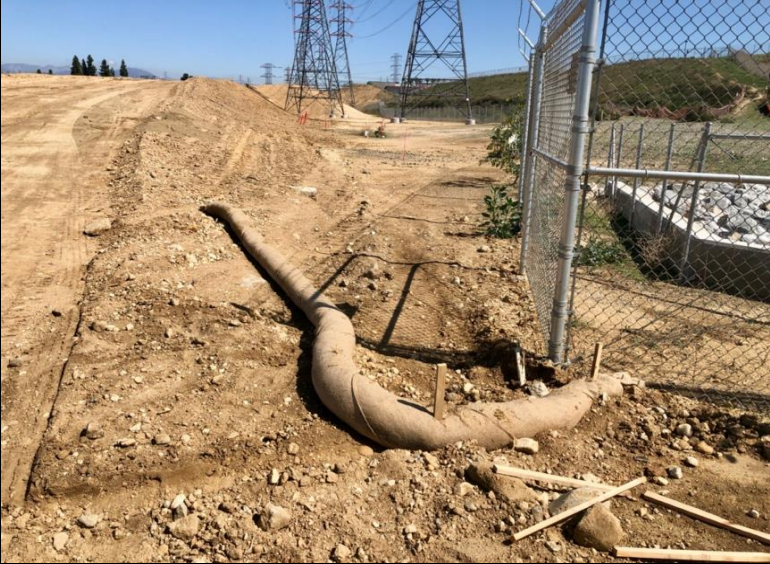
Photo 3 – Soil stockpile with one straw wattle near the riprapped drain inlet. Photo facing east.
3/5/21	Mesa Substation

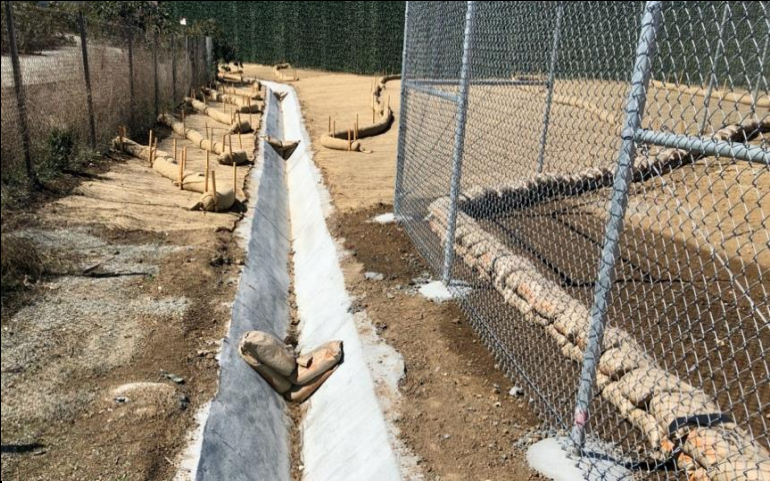
Photo 4 – Rainwater runoff from south of the soil stockpile. Photo facing north.
3/9/21	Mesa Substation

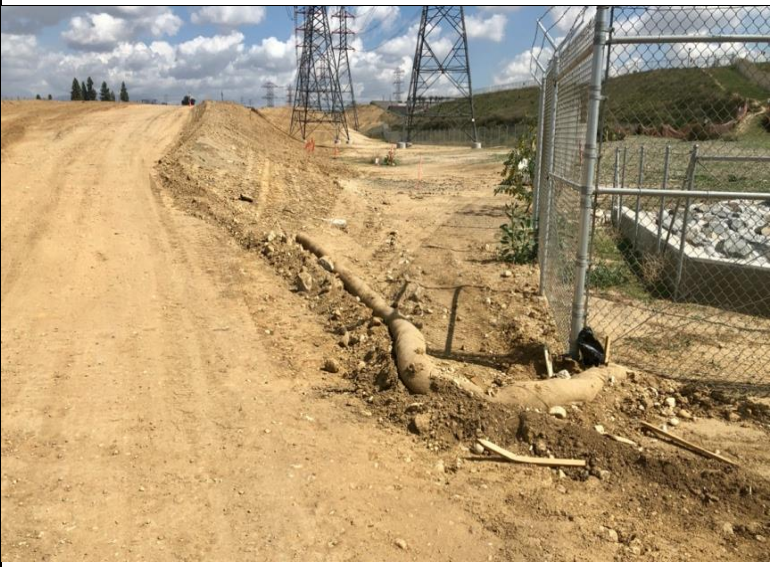
Photo 5 – Stockpiled soil and the drainage corridor along the southern side of the stockpile. Photo facing east.

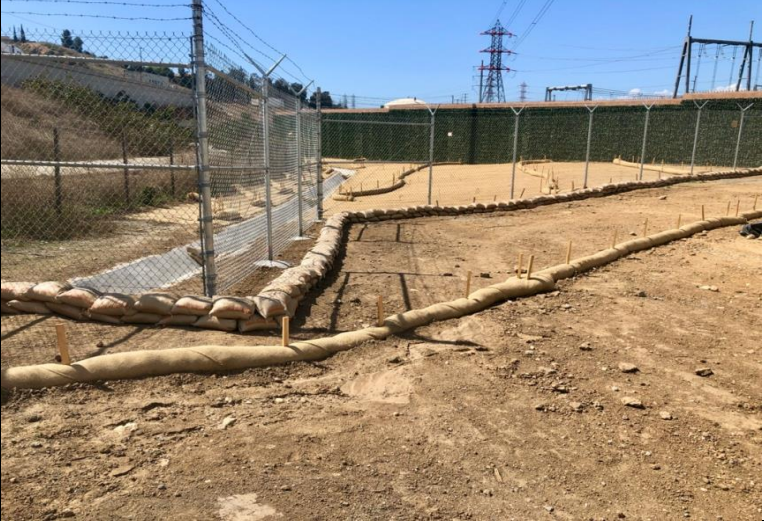
On March 9, 2021 the CPUC Compliance Monitor met with the site QSP and discussed BMP work ahead of the upcoming storm. The CPUC Compliance Monitor expressed concern with stormwater run-on coming down the southern side of the existing soil stockpile and discharging via the ripped drain inlet (Attachment 3, photo 5). The two discussed directing stormwater run-on into the V-ditch that drains to the detention basin. The BMPs along the outside of the southern boundary wall remained in place (Attachment 3, photo 6).

Photo 6 – BMPs installed along the outside of the southern boundary wall. Photo facing west.
3/17/21	Mesa Substation

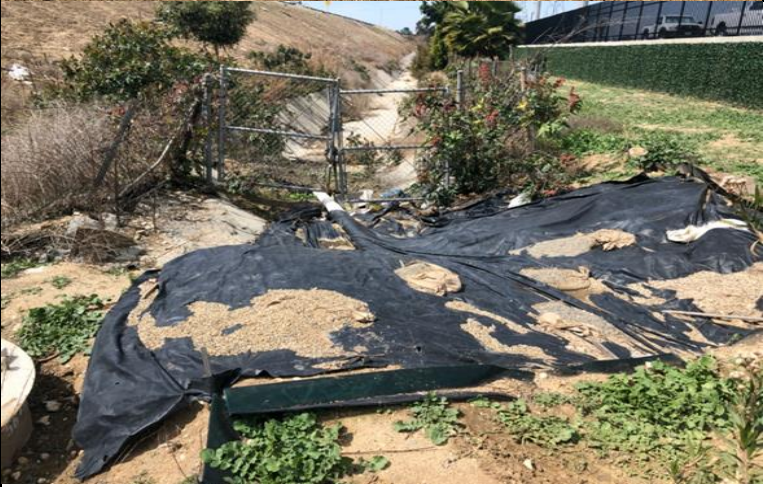
On March 17, 2021, the CPUC Compliance Monitor noted that the existing BMPs identified on February 4, 2021 (see Attachment 1, page 4) remained at the inlet to the Caltrans channel. Again, the CPUC Compliance Monitor recommended implementation of the required actions referenced in Attachment 1, page 4. Photographic documentation of the March 17, 2021 observation is presented in Attachment 3, photo 7.

Photo 7 – Existing BMPs needed to be removed and the area restored. Photo facing west.
3/24/21	Mesa Substation

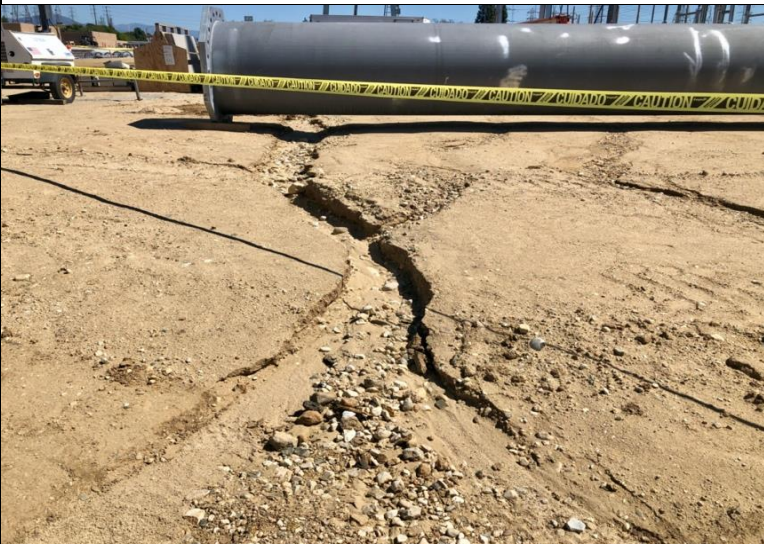
On March 24, 2021, the CPUC Compliance Monitor noted an erosion rivulet from the Phase 4 work area indicating stormwater runoff was significant with potential of circumventing BMPs and creating an offsite discharge (Attachment 3, photo 8).

Photo 8 – Stormwater runoff rivulets flowing through the Phase 4 work area. Photo facing east.

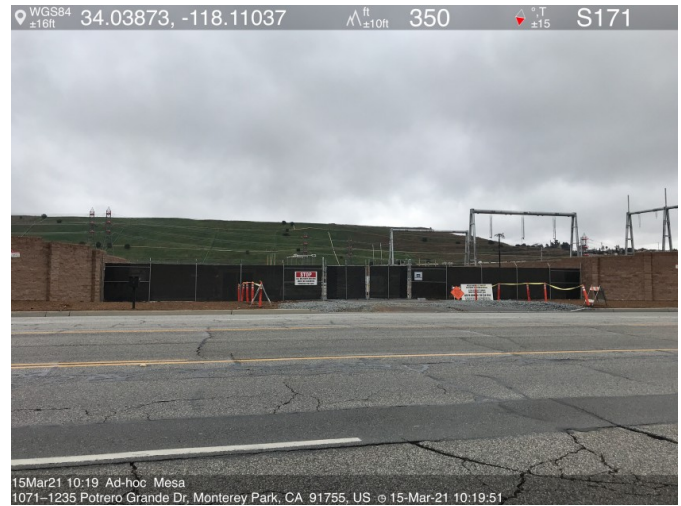
03-15-2021 10:19 AM

Comments: No project access to active construction areas due to unsafe weather conditions.
