Re: Monthly Report Summary #10 for the Sanger Substation Expansion Project

CPUC COMPLIANCE MONITORING REPORTS

Sanger Substation Expansion Project CPUC Compliance Monitoring Report

Project Proponent	Pacific Gas & Electric (PG&E)	Report No.	CM-CPUCDG-080119
Lead Agency	California Public Utilities Commission (CPUC)	Date (mm/dd/yy)	08/01/19
CPUC Project Manager	Michael Rosauer	Monitor(s)	Evan Studley
CPUC (Ecology and Environment, Inc., member of WSP [E & E]) Monitoring Manager	Silvia Yanez	AM/PM Weather	Clear, 101°F, calm
CPUC (E & E) Monitoring Supervisor	Fernando Guzman	Start/End Time	3:40 PM – 4:35 PM
Project Notices to Proceed NTP(s)	NTP #2

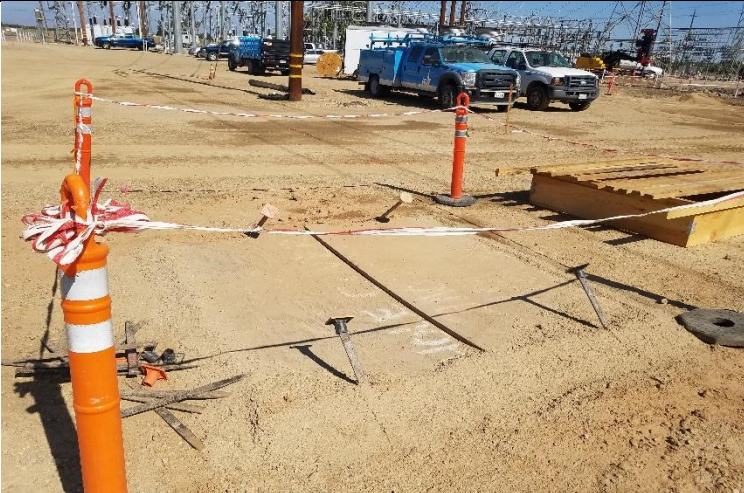
4:20 PM- I observed that all materials were neatly stockpiled in the laydown area (Photo 3). I noted that heavy machinery was turned off while not in use (APM GHG-1). I observed TSP foundation excavations to be covered and delineated with caution tape (Photo 4). Silt fence was placed along the northern boundary to protect the drainage ditch, which appeared to be in good condition (Photo 5).

<p>Photo 4- TSP foundation excavations were covered and delineated. Photo facing northeast.</p>
08/01/19	Expansion footprint

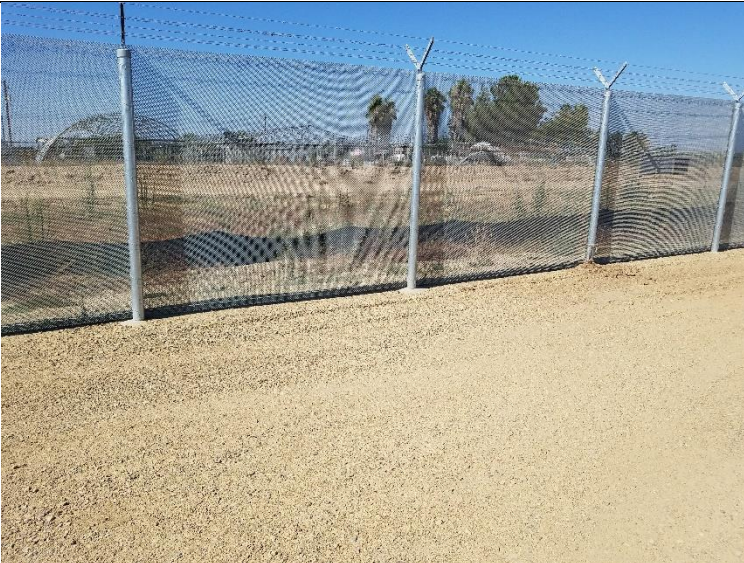
<p>Photo 5- Silt fence installed along the northern boundary and appeared to be in good condition. The fence serves to protect the drainage ditch from construction sediment. Photo facing north.</p>
08/01/19	Expansion footprint

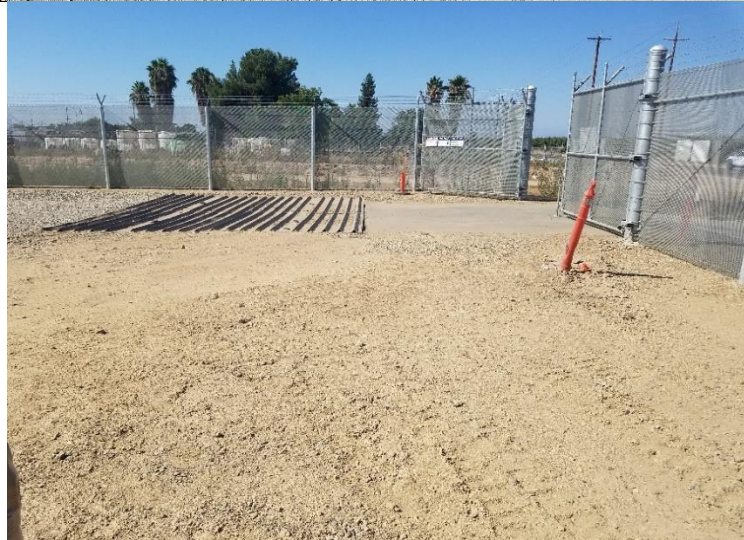
4:30 PM- I walked the eastern boundary and observed neatly stockpiled materials, and all tools and supplies in the trailers were organized. All BMPs were installed correctly and were well maintained. I spoke with Mr. Shephard at the northern gate. Both trackouts were in good shape and functioning as intended (Photo 6).

<p>Photo 6-Northern trackout appeared to be in good condition. No sediment was noted on roads from either ingress/egress points. Photo facing north.</p>

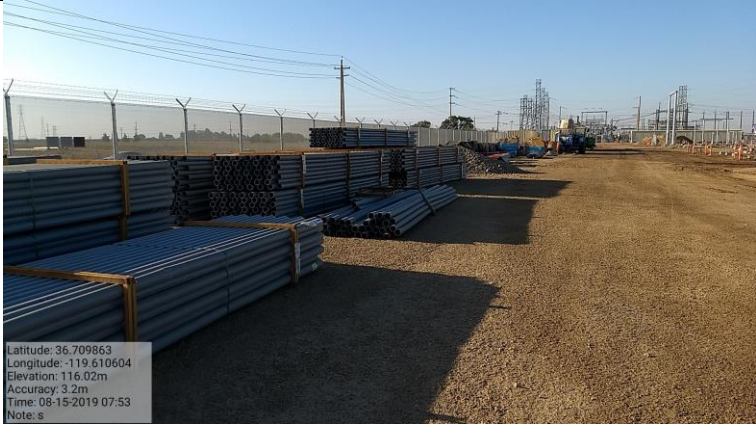
7:55 AM- I observed material stockpiled neatly (Photo 1); restrooms and handwashing station were secondarily contained (MM HAZ-1). Vaults were roped off to prevent pedestrian access, and contained a wildlife escape ramp (Photo 3). At the southern boundary of the expansion footprint, the boundary of the active substation was roped off to prevent pedestrian access, and newly constructed foundations were delineated for increased visibility (Photo 4).

<p>Latitude: 36.709863 Longitude: -119.610604 Elevation: 116.02m Accuracy: 3.2m Time: 08-15-2019 07:53 Note: s</p>	Photo 1- Materials and equipment neatly stockpiled. Photo facing south.
08/15/19	Expansion footprint	  <p>Latitude: 36.709844 Longitude: -119.610609 Elevation: 115.02m Accuracy: 4.3m Time: 08-15-2019 07:53 Note: w</p>	Photo 2- Fugitive dust control underway. Photo facing west.
08/15/19	Expansion footprint

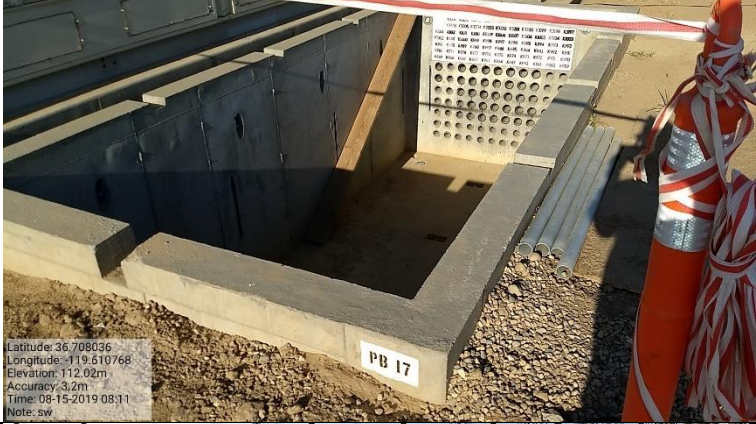
<p>Latitude: 36.708036 Longitude: -119.610768 Elevation: 112.02m Accuracy: 3.2m Time: 08-15-2019 08:11 Note: sw</p>	Photo 3- Concrete vaults are roped off and have wildlife escape ramps. Photo facing southwest.
08/15/19	Expansion footprint

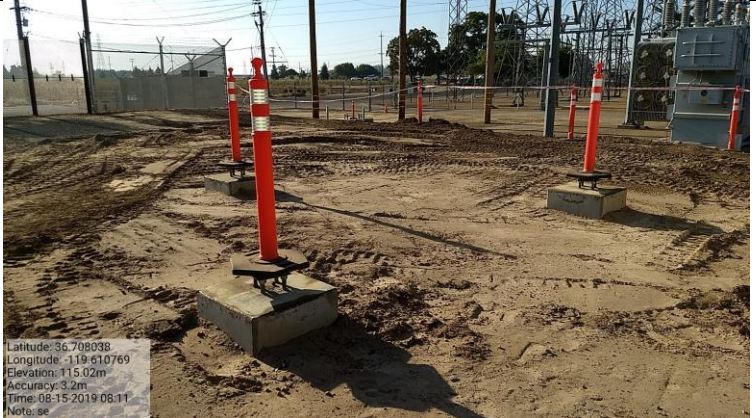
<p>Latitude: 36.708038 Longitude: -119.610769 Elevation: 115.02m Accuracy: 3.2m Time: 08-15-2019 08:11 Note: se</p>	Photo 4- Completed foundation caps are delineated for visibility. Active substation is taped off. Photo facing southeast.

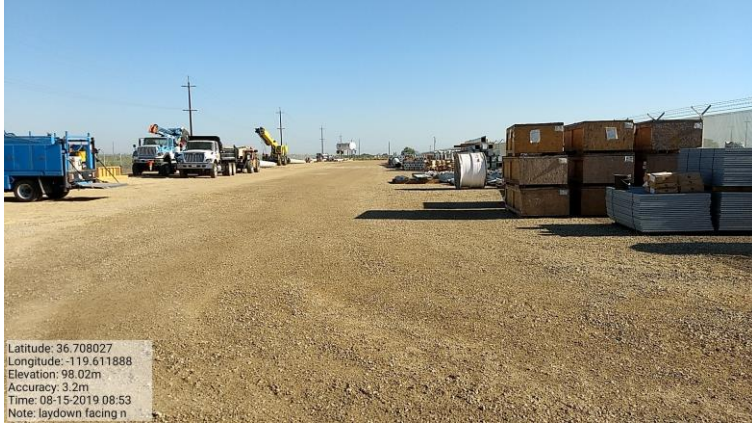
8:50 AM- I entered the laydown yard through east entrance. Materials and equipment were stockpiled neatly (Photo 5). All equipment with observed leaks had drip containers. I noted that no vehicles or equipment were left idling (APM NOI-4). A water tank generator had a drip pan to contain oil leaks (Photo 6).

<p data-bbox="456 596 602 680">Latitude: 36.708027 Longitude: -119.611888 Elevation: 98.02m Accuracy: 3.2m Time: 08-15-2019 08:53 Note: laydown facing n</p>	Photo 5- Materials and equipment are neatly stockpiled at the temporary laydown area. Photo facing north.
08/15/19	Temporary laydown/ staging area

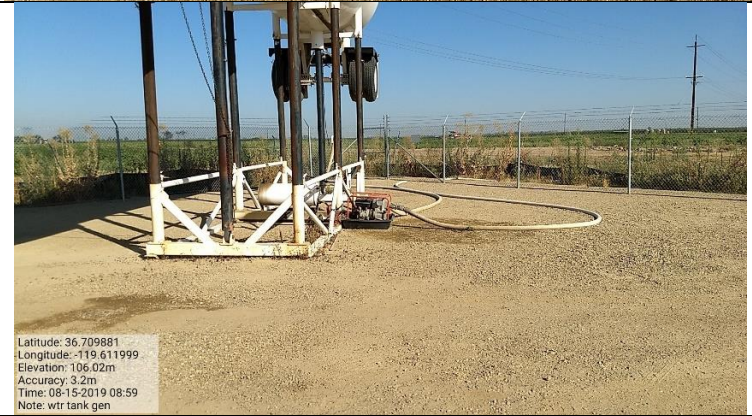
<p data-bbox="456 1016 602 1092">Latitude: 36.709881 Longitude: -119.611999 Elevation: 106.02m Accuracy: 3.2m Time: 08-15-2019 08:59 Note: wtr tank gen</p>	Photo 6- Water tank generator contained with drip pan. Photo facing northwest.
