Re: Monthly Report Summary #4 for the Sanger Substation Expansion Project

Sanger Substation Expansion Project CPUC Compliance Monitoring Report

Project Proponent	Pacific Gas & Electric (PG&E)	Report No.	CM-CPUCBA-021419
Lead Agency	California Public Utilities Commission (CPUC)	Date (mm/dd/yy)	02/14/19
CPUC Project Manager	Michael Rosauer	Monitor(s)	Ben Arax
CPUC (Ecology and Environment, Inc., member of WSP [E & E]) Monitoring Manager	Ilja Nieuwenhuizen	AM/PM Weather	62°F, partly cloudy, wind SSE 17 miles per hour (mph)
CPUC (E & E) Monitoring Supervisor	Aileen Cole	Start/End Time	10:28 AM – 11:00 AM
Project Notices to Proceed NTP(s)	NTP #1

Project Proponent	Pacific Gas & Electric (PG&E)	Report No.	CM-CPUCBA-022619
Lead Agency	California Public Utilities Commission (CPUC)	Date (mm/dd/yy)	02/26/19
CPUC Project Manager	Michael Rosauer	Monitor(s)	Ben Arax
CPUC (Ecology and Environment, Inc., member of WSP [E & E]) Monitoring Manager	Ilja Nieuwenhuizen	AM/PM Weather	66° F, Cloudy, Wind 7 miles per hour (mph)
CPUC (E & E) Monitoring Supervisor	Aileen Cole	Start/End Time	12:50 PM – 1:48 PM
Project Notices to Proceed NTP(s)	NTP #1

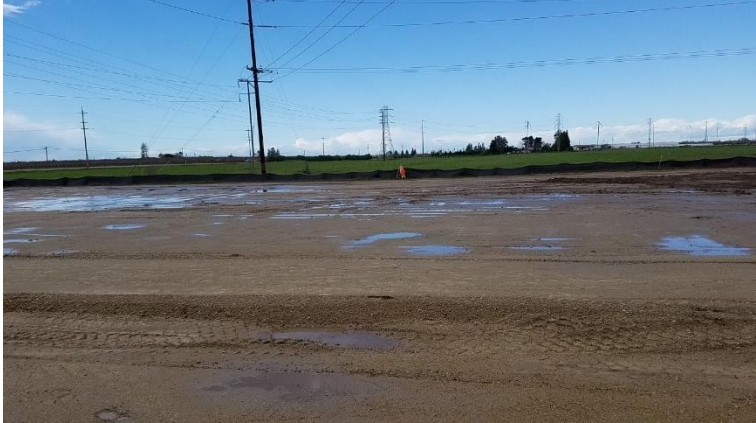
Photo 1- Muddy and saturated conditions at the laydown area. Photo facing west.
02/14/19	Existing substation

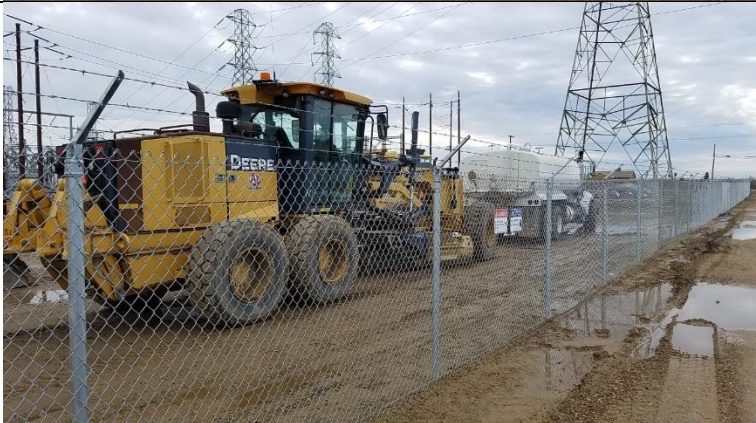
Photo 2- Parked vehicles inside the existing substation were turned off when not in use. Photo facing southeast.
02/14/19	Retention basin

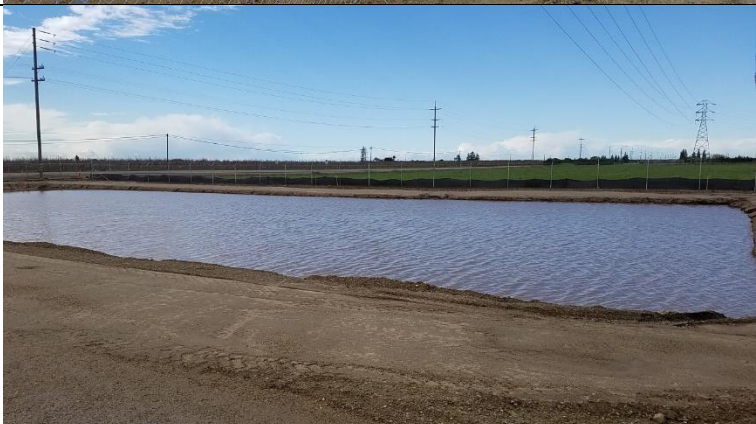
Photo 3- Completely full retention basin. Photo facing west.

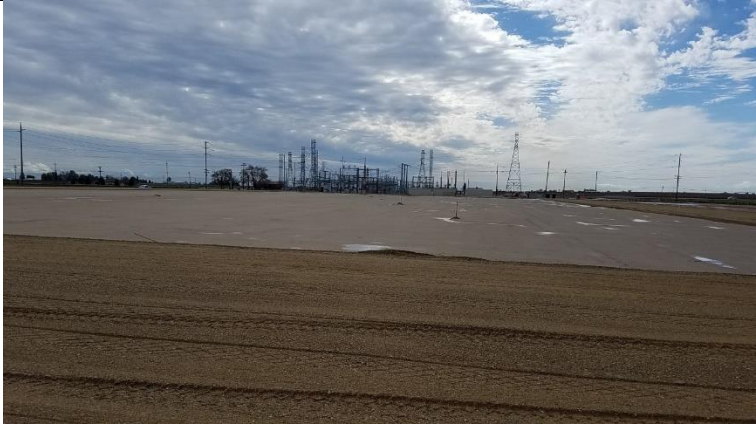
Photo 8- Overall, the substation expansion footprint appears to be well maintained. Photo facing south.
02/14/19	Expansion footprint

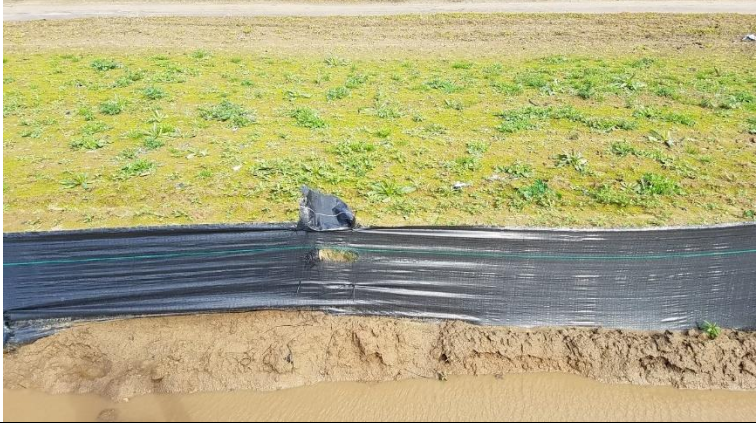
Sags and rips in portions of the silt fence were repaired since the last visit. However, some areas have opened again, and new holes and sagging has occurred in different areas due to recent storms. The silt fencing will require additional maintenance to ensure continued compliance.

Photo 9- A recent silt fence repair that reopened, likely during the recent storm events. Photo facing south.
02/14/19	Expansion footprint

<p>MITIGATION MEASURES VERIFIED MM BIO-1, APM HAZ-3, MM HAZ-2, APM GHG-1, MM HAZ-1, APM GEO-2, APM WQ-1</p> <p>See additional applicant proposed measures (APMs) and mitigation measures (MMs) listed in the Description of Observed Activities section.</p>
<p>RECOMMENDED FOLLOW-UP Silt fence needs to be repaired in several locations to address sags and minor holes. Inspect silt fence during next visit.</p>

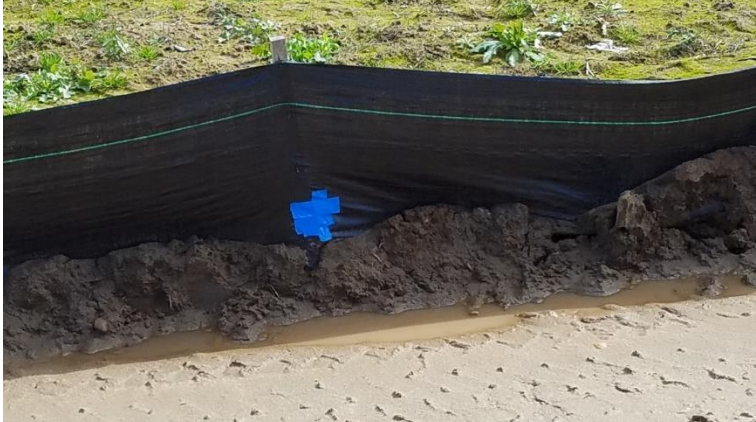
Photo 10- Tape repair on silt fence along the eastern edge of the substation expansion footprint. Photo facing north.

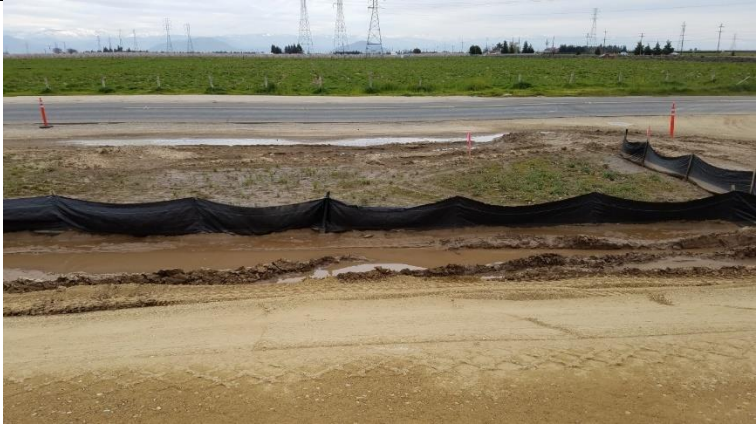
Silt fence sagas and minor holes were repaired. No further actions are necessary.

Photo 5- The silt fence is intact and working as intended. Photo facing east.
02/26/19	Expansion footprint

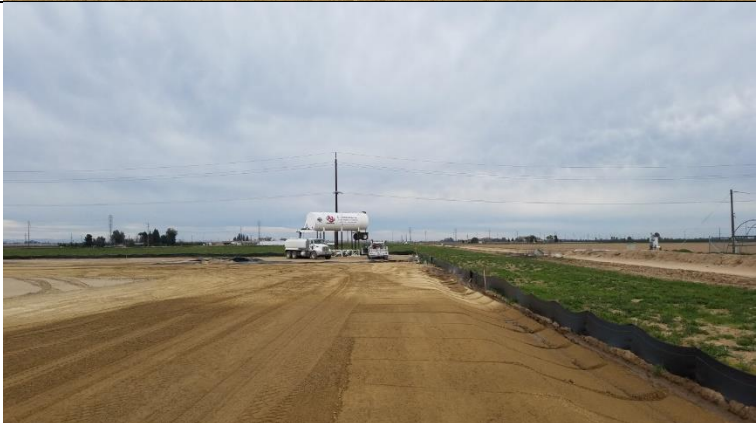
Photo 6- Water truck refilling to mitigate dust. Photo facing west.
02/26/19	Expansion footprint

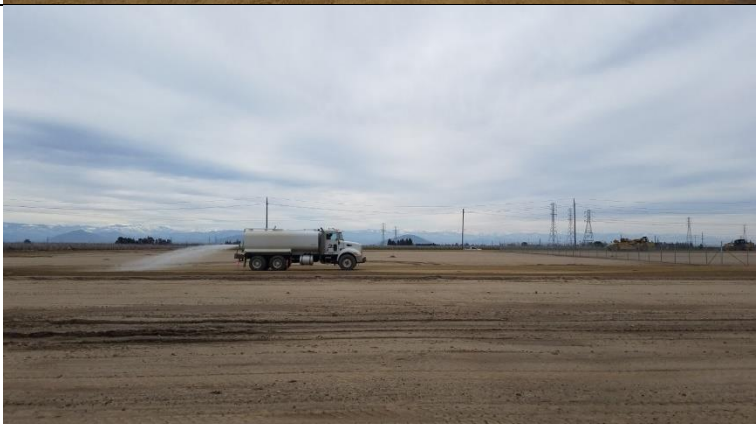
Photo 7- Water truck spraying soil. Photo facing east.
02/26/19	Retention basin

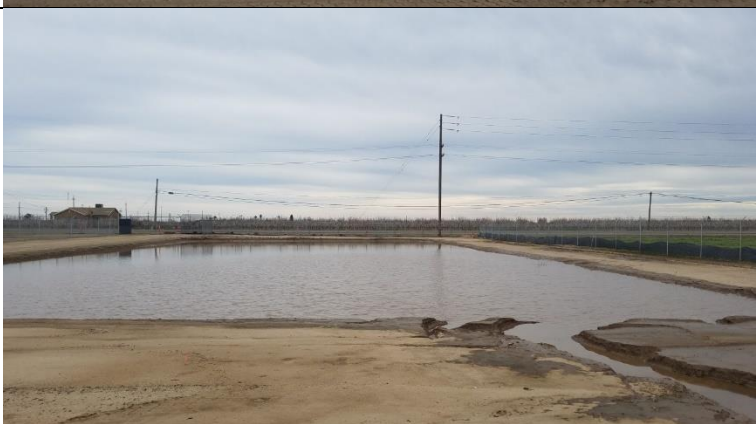
Photo 8- The retention basin was full; however, it was working as intended. Photo facing south.
