Re: Monthly Report Summary #23 for the Sanger Substation Expansion Project

## Sanger Substation Expansion Project CPUC Compliance Monitoring Report

Project Proponent	Pacific Gas & Electric (PG&E)	Report No.	CM-CPUCDG-090420
Lead Agency	California Public Utilities Commission (CPUC)	Date (mm/dd/yy)	09/04/20
CPUC Project Manager	Mike Rosauer	Monitor(s)	Sam Hopstone
CPUC (E & E) Monitoring Manager	Silvia Yanez	AM/PM Weather	Smoky, 83°F, calm
CPUC (E & E) Monitoring Supervisor	Angelica Oregel	Start/End time	0900 AM – 0930 AM
Project NTP(s)	Notice to Proceed (NTP) #2

Project Proponent	Pacific Gas & Electric (PG&E)	Report No.	CM-CPUCDG-092420
Lead Agency	California Public Utilities Commission (CPUC)	Date (mm/dd/yy)	09/24/20
CPUC Project Manager	Mike Rosauer	Monitor(s)	Ben Arax
CPUC (E & E) Monitoring Manager	Silvia Yanez	AM/PM Weather	Smoky, 74°F, breezy
CPUC (E & E) Monitoring Supervisor	Angelica Oregel	Start/End time	1000 AM – 1033 AM
Project NTP(s)	Notice to Proceed (NTP) #2

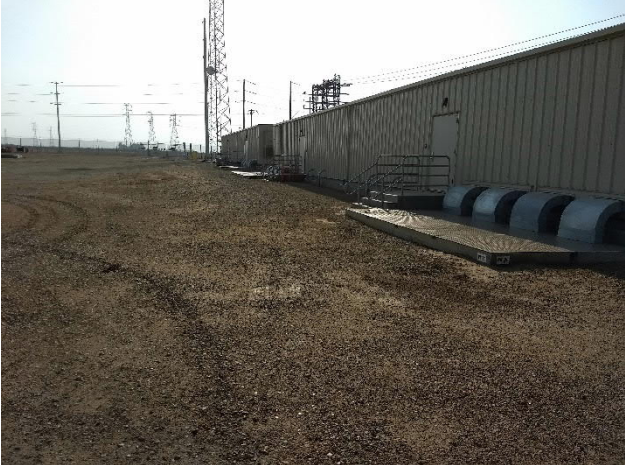
0910 AM – I proceeded along the detention basin to the south boundary and observed that weed suppression was performed at the bottom of the basin (Photo 2). The stormwater detention basin was dry, and concrete sidewalls remained in good condition. I proceeded north into the expansion footprint and observed that vaults and conduit paths were covered (APM HAZ-3) (Photo 3). I turned left and headed west into the temporary staging area.

Photo 3- Cable vaults near the control buildings were covered and protected when not in use. Photo facing east.
09/04/20	Temporary Staging Area

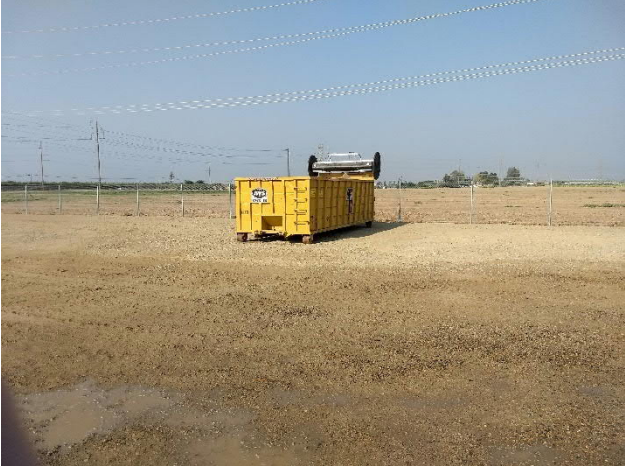
0915 AM – I observed that the roll-on rain cover was installed on the main waste dumpster (Photo 4). At the north end of the temporary staging area, the water truck was refilled at the water tank. I observed secondary containment for both the generator and refill fuel container for the generator. I returned to the south gate of the temporary staging area and proceeded east into the expansion footprint.

Photo 4- Rain cover installed on the dumpster in anticipation of rainy weather. Photo facing west.
09/04/20	Expansion Footprint

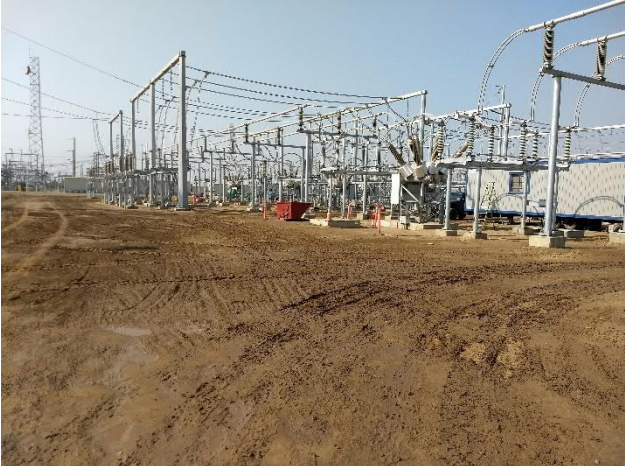
Photo 5- Dumpsters and equipment were staged out of the path of travel, and delineated. Photo facing southwest.

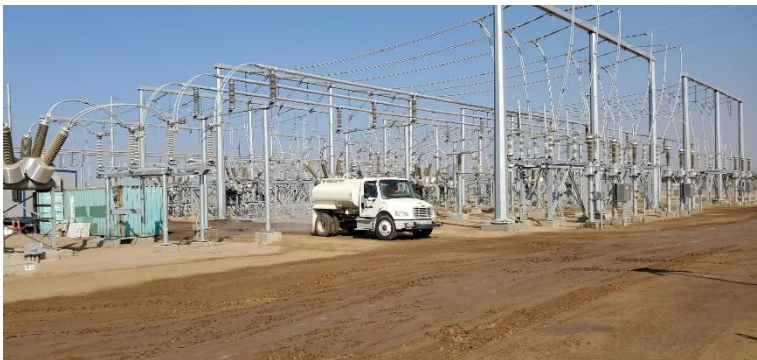
Photo 1- Water truck spraying soil for dust suppression. Photo facing northwest.
09/24/20	Expansion Footprint

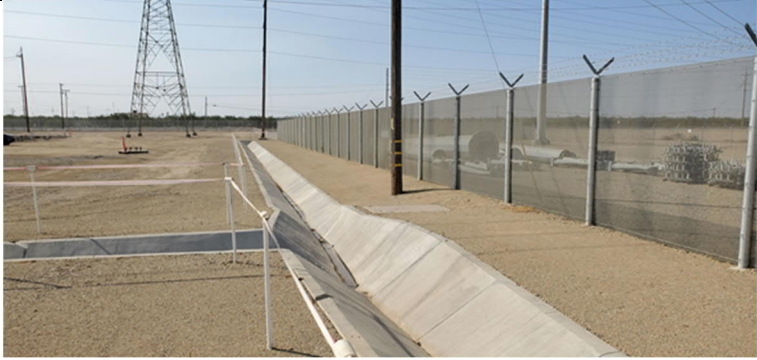
Photo 2- Well maintained channels leading to the detention pond. Photo facing south.
09/24/20	Expansion Footprint

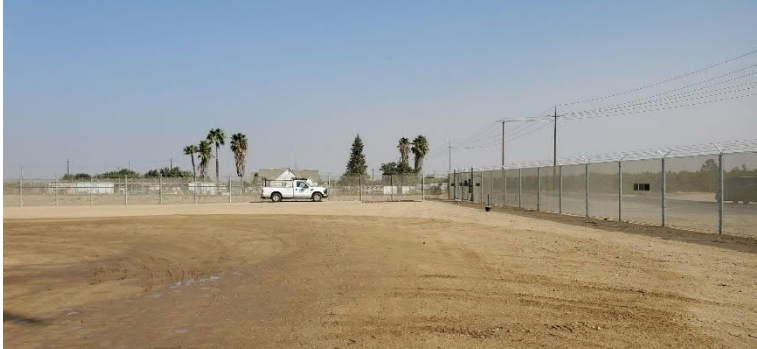
Photo 3- Crew were using the egress point on the north side of the footprint. Photo facing north.
09/24/20	Expansion footprint

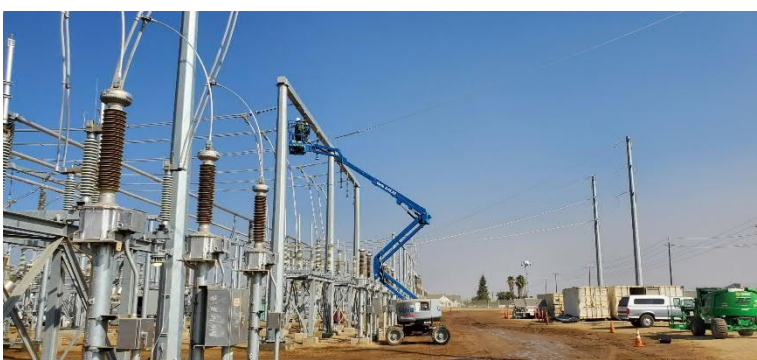
Photo 4- Crew working on power lines with a boom lift. Photo facing north.

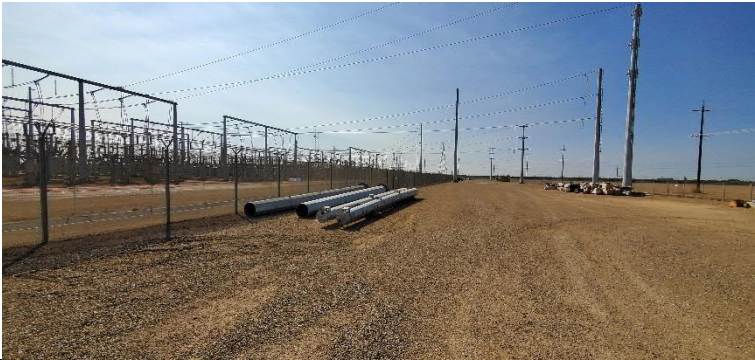
Photo 5- Materials stored in the temporary staging area. Photo facing southwest.
09/24/20	Temporary Staging Area

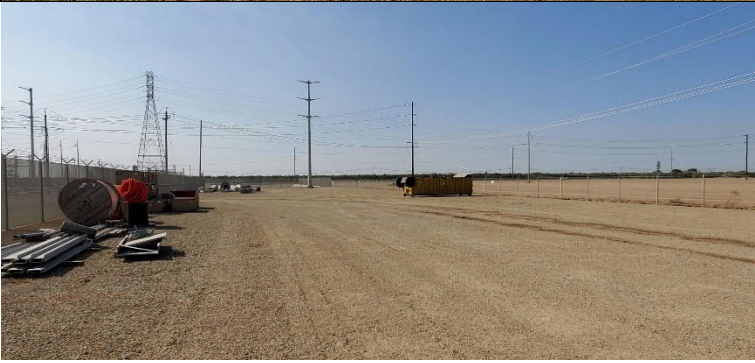
Photo 6- Additional materials stored in temporary staging area. Photo facing south.
