Re: Monthly Report Summary #24 for the Sanger Substation Expansion Project

Sanger Substation Expansion Project CPUC Compliance Monitoring Report

Project Proponent	Pacific Gas & Electric (PG&E)	Report No.	CM-CPUCDG-100720
Lead Agency	California Public Utilities Commission (CPUC)	Date (mm/dd/yy)	10/07/20
CPUC Project Manager	Mike Rosauer	Monitor(s)	Sam Hopstone
CPUC (E & E) Monitoring Manager	Silvia Yanez	AM/PM Weather	Clear, 62°F, calm
CPUC (E & E) Monitoring Supervisor	Angelica Oregel	Start/End time	0700 AM – 0730 AM
Project NTP(s)	Notice to Proceed (NTP) #2

Project Proponent	Pacific Gas & Electric (PG&E)	Report No.	CM-CPUCDG-101920
Lead Agency	California Public Utilities Commission (CPUC)	Date (mm/dd/yy)	10/19/20
CPUC Project Manager	Mike Rosauer	Monitor(s)	Sam Hopstone
CPUC (E & E) Monitoring Manager	Silvia Yanez	AM/PM Weather	Hazy, 69°F, calm
CPUC (E & E) Monitoring Supervisor	Angelica Oregel	Start/End time	0900 AM – 0945 AM
Project NTP(s)	Notice to Proceed (NTP) #2

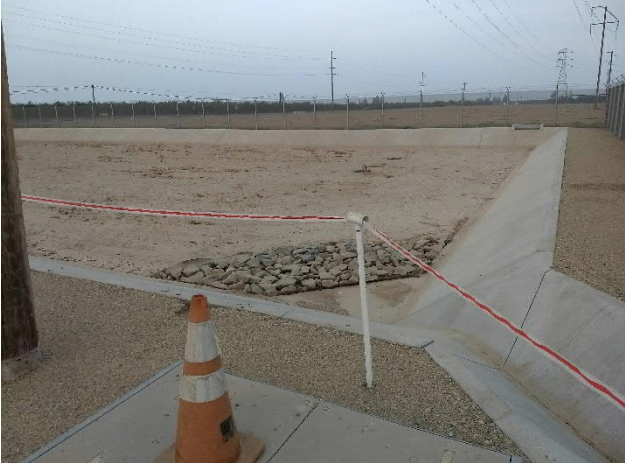
0705 AM – I proceeded west to the stormwater detention basin and observed that the basin was in good condition and ready to accept stormwater flows (Photo 1). I observed that extension cables between the construction trailers were protected from vehicular and pedestrian traffic (Photo 2). I proceeded north into the expansion footprint and observed that permanent light fixtures were installed throughout the substation (Photo 3). The conduit vaults and connections to the control rooms were protected (APM HAZ-3).

Photo 1- The detention basin was in good condition, scarified, and ready to accept stormwater flows. Photo facing southwest.
10/07/20	Existing Substation Footprint

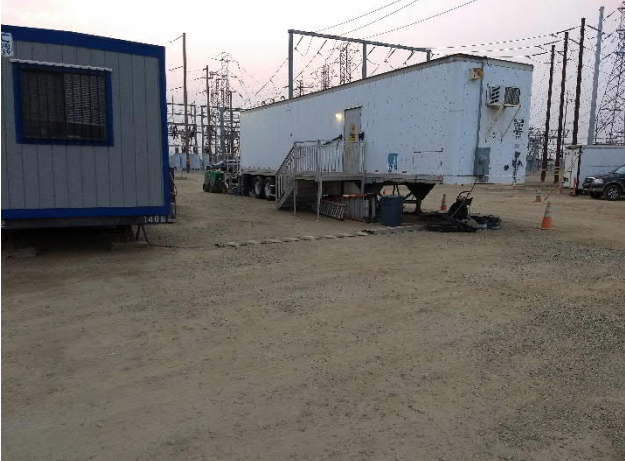
Photo 2- Electric wires passing between structures were protected. Photo facing southeast.
10/07/20	Expansion Footprint	 	Photo 3- Permanent light fixtures were installed throughout the new substation. Photo facing northeast.

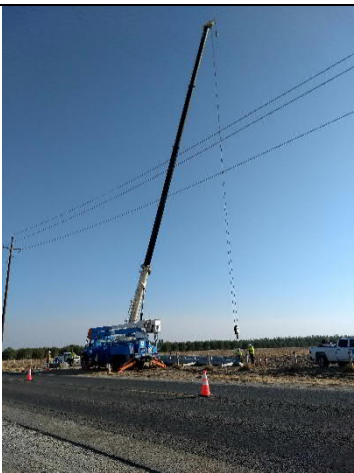
0900 AM – I arrived onsite and observed crews preparing the ground surface in the field east of McCall Avenue, and a crane staged alongside the road (Photo 1). Traffic control devices were stationed to the north, south, east, and west of the intersection of Jensen Avenue and McCall Avenue in accordance with the Traffic Control Plan (Photo 2) (MM TRAN-1). I continued south along McCall Avenue and entered through the south gate into the existing substation footprint.

Photo 1- The crane was stationed along McCall Avenue. Photo facing northeast.
10/19/20	McCall Avenue

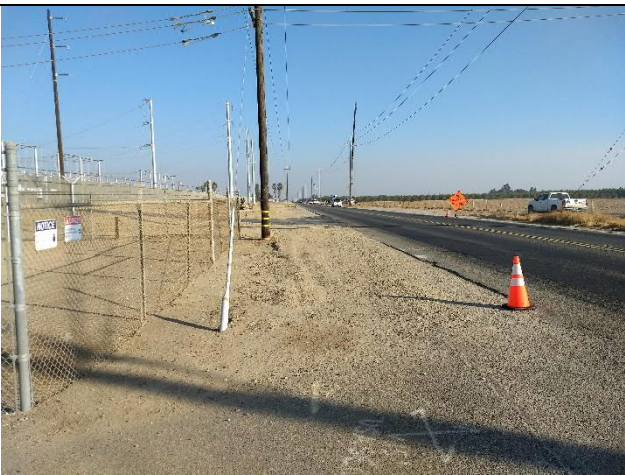
Photo 2- Traffic control implemented along McCall Avenue during proximal work. Photo facing north.

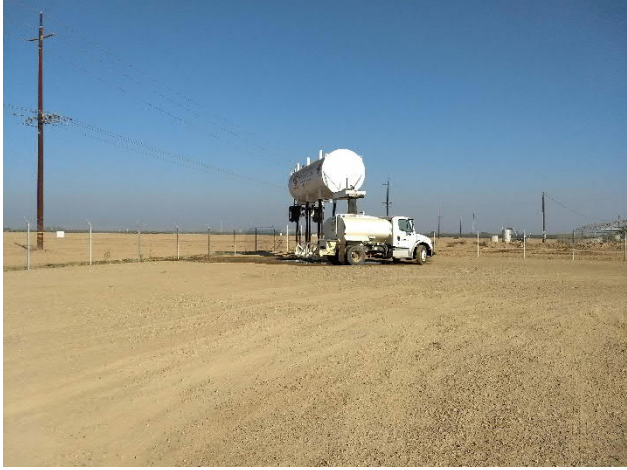
Photo 4- a water truck was mobilized adjacent to the water tank, preparing to provide dust suppression as needed. Photo facing northwest.
10/19/20	Expansion Footprint

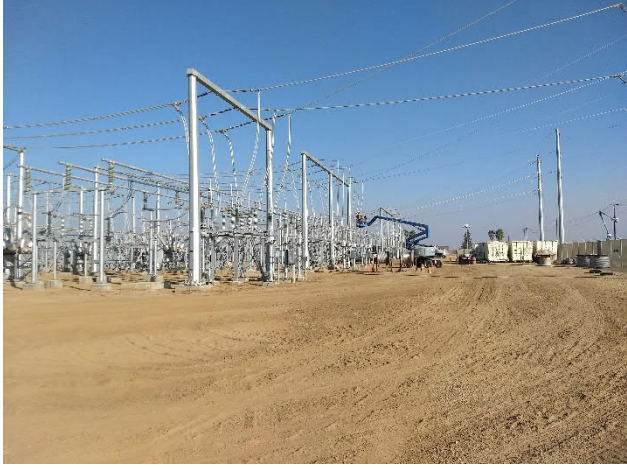
0935 AM – I continued south along the east boundary and observed SF6 tanks staged together on pallets outside the path of travel (APM GHG-2) (APM HAZ-3). I observed crews in manlifts connecting transmission lines from the substation to proximal tubular steel poles (TSPs) around the perimeter of the substation (Photo 5). I proceeded south along the east boundary and continued into the existing substation footprint.

Photo 5- Crews connected high voltage line to proximal TSPs. Photo facing north.
