Re: Monthly Report Summary #25 for the Sanger Substation Expansion Project

Sanger Substation Expansion Project CPUC Compliance Monitoring Report

Project Proponent	PG&E	Report No.	CM-CPUCDG-110320
Lead Agency	California Public Utilities Commission	Date (mm/dd/yy)	11/3/20
CPUC Project Manager	Mike Rosauer	Monitor(s)	Sam Hopstone
CPUC (E & E) Monitoring Manager	Silvia Yanez	AM/PM Weather	hazy, 64°F, calm
CPUC (E & E) Monitoring Supervisor	Angelica Oregel	Start/End time	09:00 – 09:30
Project NTP(s)	NTP #2

Project Proponent	PG&E	Report No.	CM-CPUCDG-111820
Lead Agency	California Public Utilities Commission	Date (mm/dd/yy)	11/18/20
CPUC Project Manager	Mike Rosauer	Monitor(s)	Sam Hopstone
CPUC (E & E) Monitoring Manager	Silvia Yanez	AM/PM Weather	cloudy, 64°F, drizzling
CPUC (E & E) Monitoring Supervisor	Angelica Oregel	Start/End time	07:30 – 08:00
Project NTP(s)	NTP #2

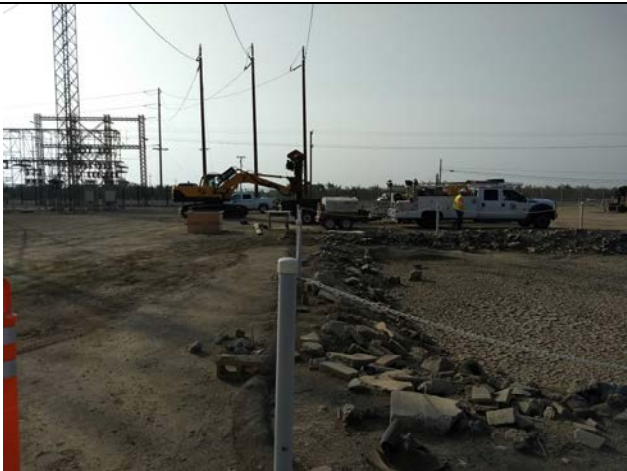
Photo 2- Crews mobilize drill rig between old substation and detention basin. View south.

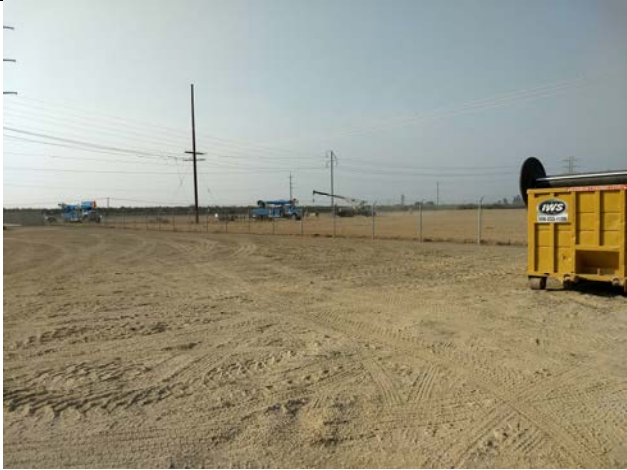
Photo 3- Crews place concrete blocks in field west of site. View southwest.
11/3/20	Expansion Footprint

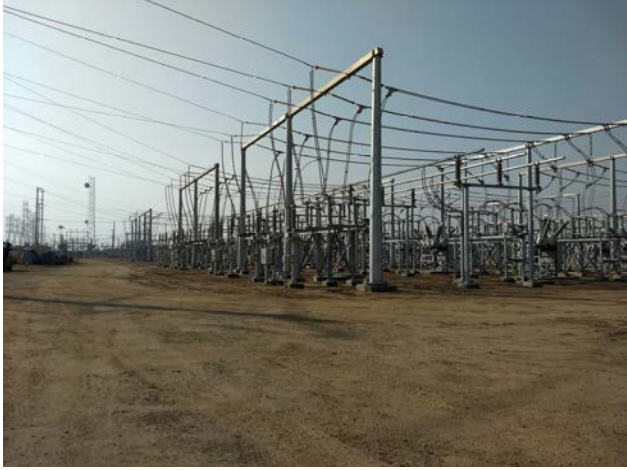
Photo 4- Cables have been hung between new substation and surrounding TSPs. View southwest.
11/3/20	Expansion Footprint

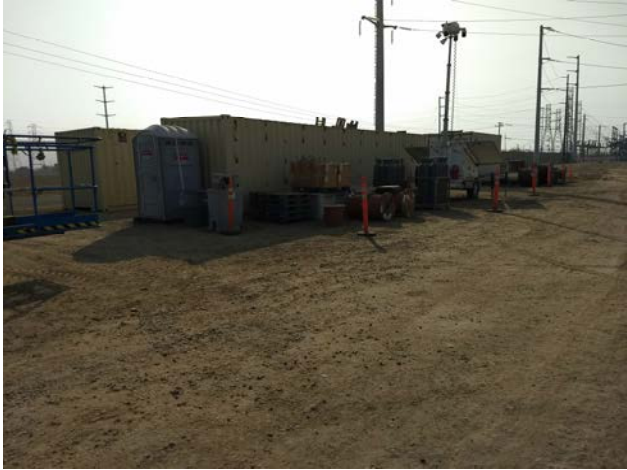
Photo 5- Remaining equipment and materials are staged out of the path of travel. View southeast.

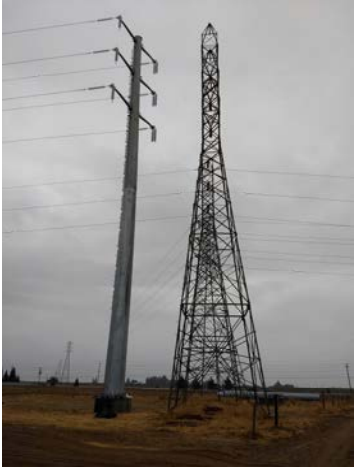
Photo 1- TSP foundations constructed in fields east of McCall are ready for TSP install. View south.
11/18/20	McCall Avenue

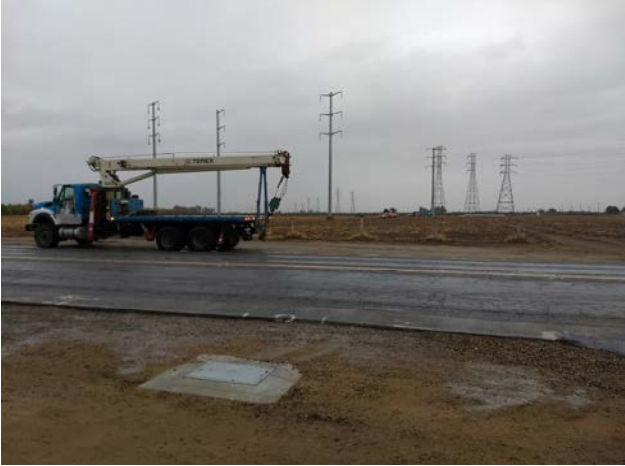
Photo 2- Crews mobilize cranes and equipment to TSP foundations. View east.
11/18/20	Expansion Footprint

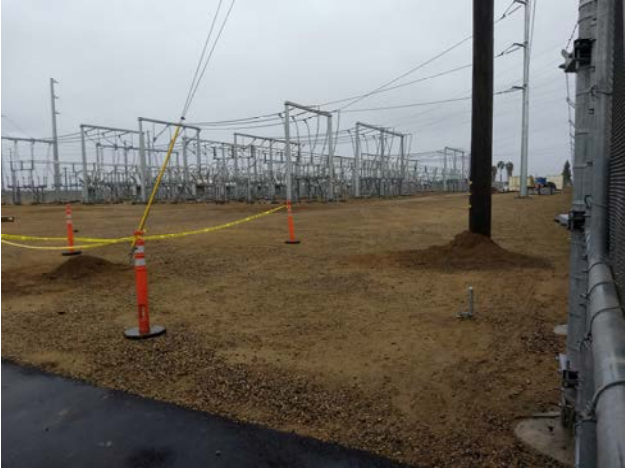
Photo 3- Guy wire adjacent to east gate is delineated. View northwest.

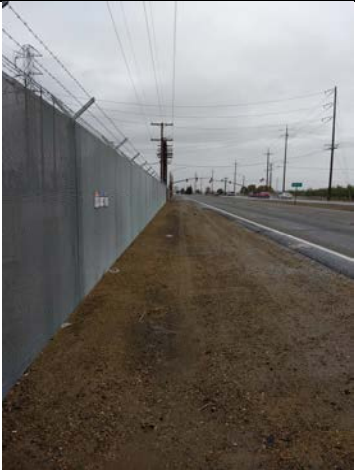
Photo 5- South site boundary fence along Jensen Avenue. View east.
