Re: Monthly Report Summary #2 for the Santa Barbara County Reliability Project

CPUC Site Inspection Report
November 2, 9, 16, and 22, 2017

Santa Barbara County Reliability Project CPUC Site Inspection Form

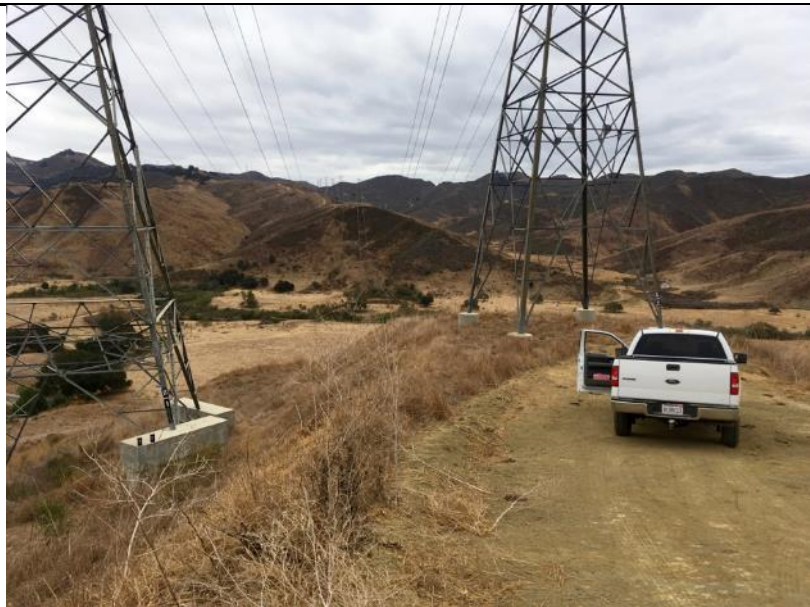
<p>Photo 1 – Constructs MG1 and MG2 along Segment 1. Matt Schaap (BRC) is conducting preconstruction surveys for the crane pad and helicopter landing area. Photo facing east</p>
11/2/17	Segment 1

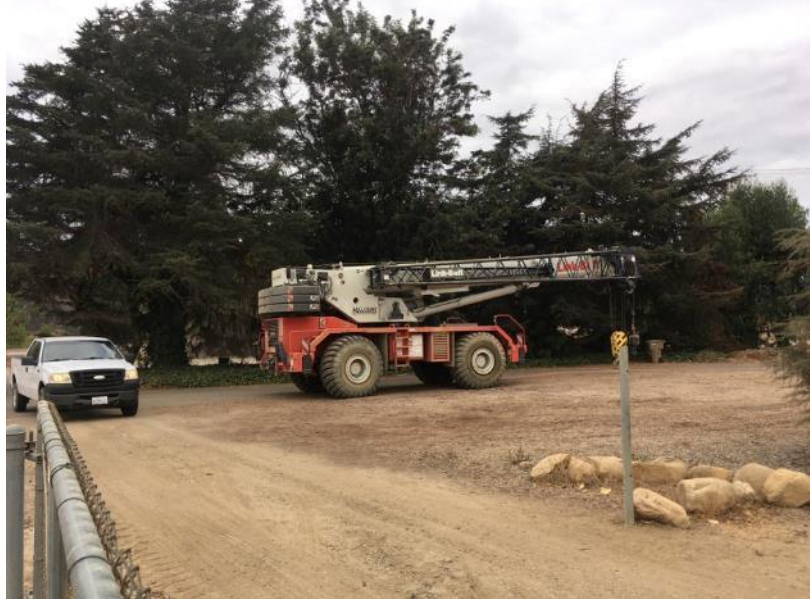
A medium-sized crane was parked at the entrance to one of the approved access roads for Segment 1 (Photo 2).

<p>Photo 2 – Parked crane at access road entrance.</p>

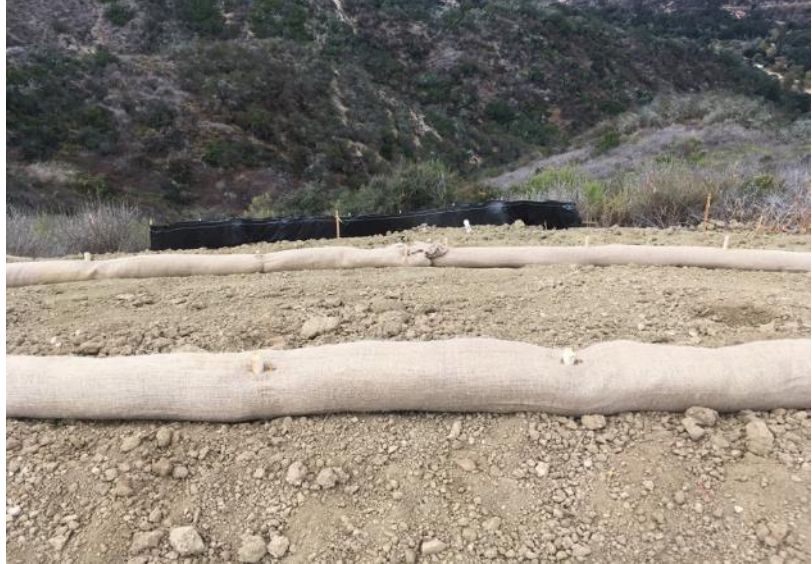
Date	Location	Photo	Description
11/9/17	Segment 3B, Construct 58

Photo 4 – BMP installation. Photo facing north
11/9/17	Segment 3B, Construct 58

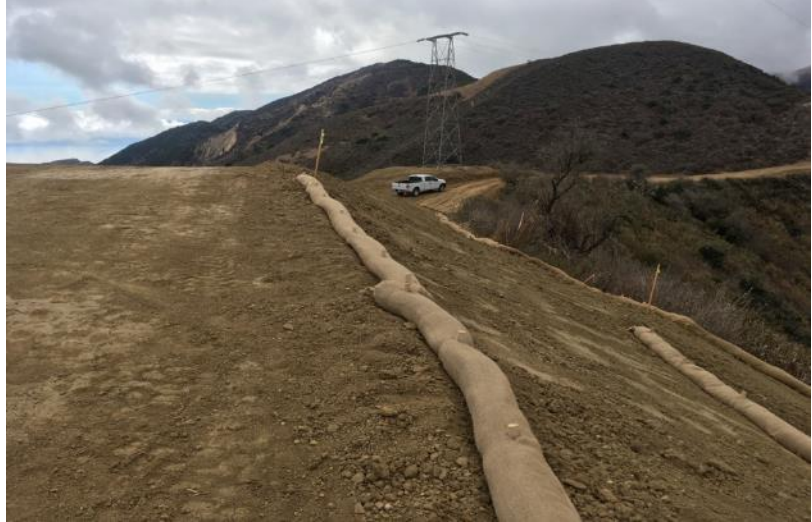
Photo 5 – The TSP pad and access road have been finished with BMPs added. Photo facing west
11/9/17	Segment 3B, Construct 62

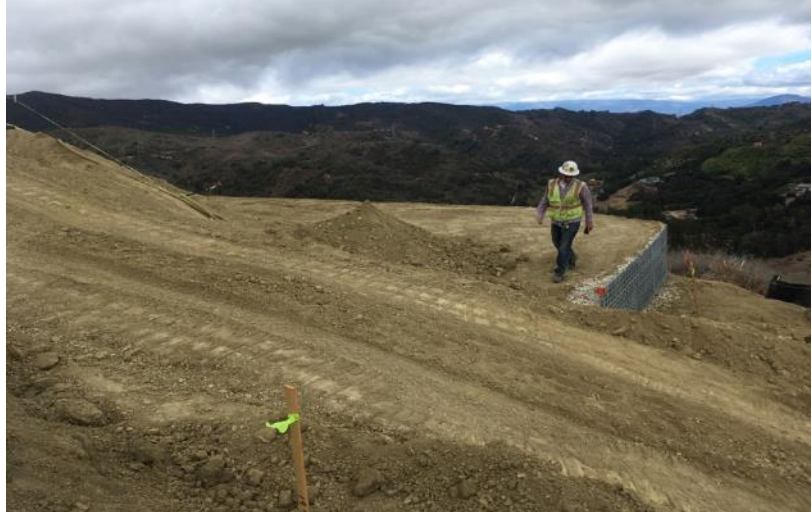
Photo 6 – The welded wire wall has been completed. Photo facing northeast.

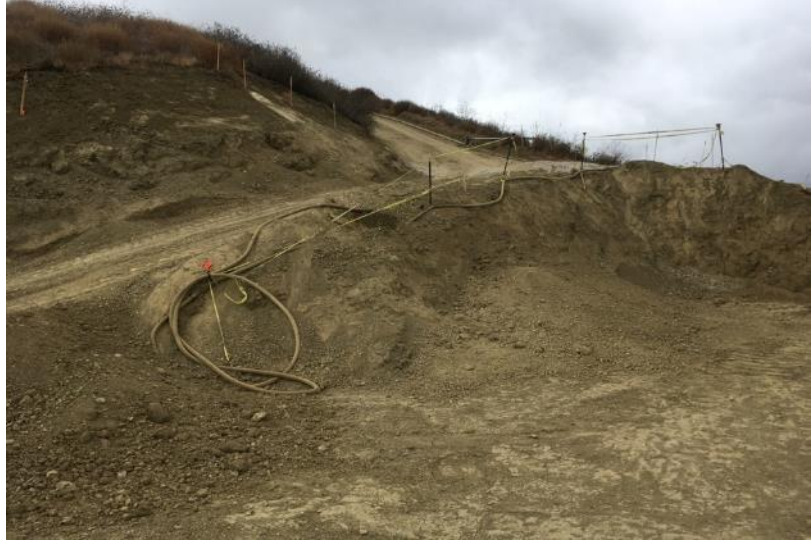
Photo 7 – The access road and TSP pad still need to be finished. Photo facing northwest
11/9/17	Segment 3B

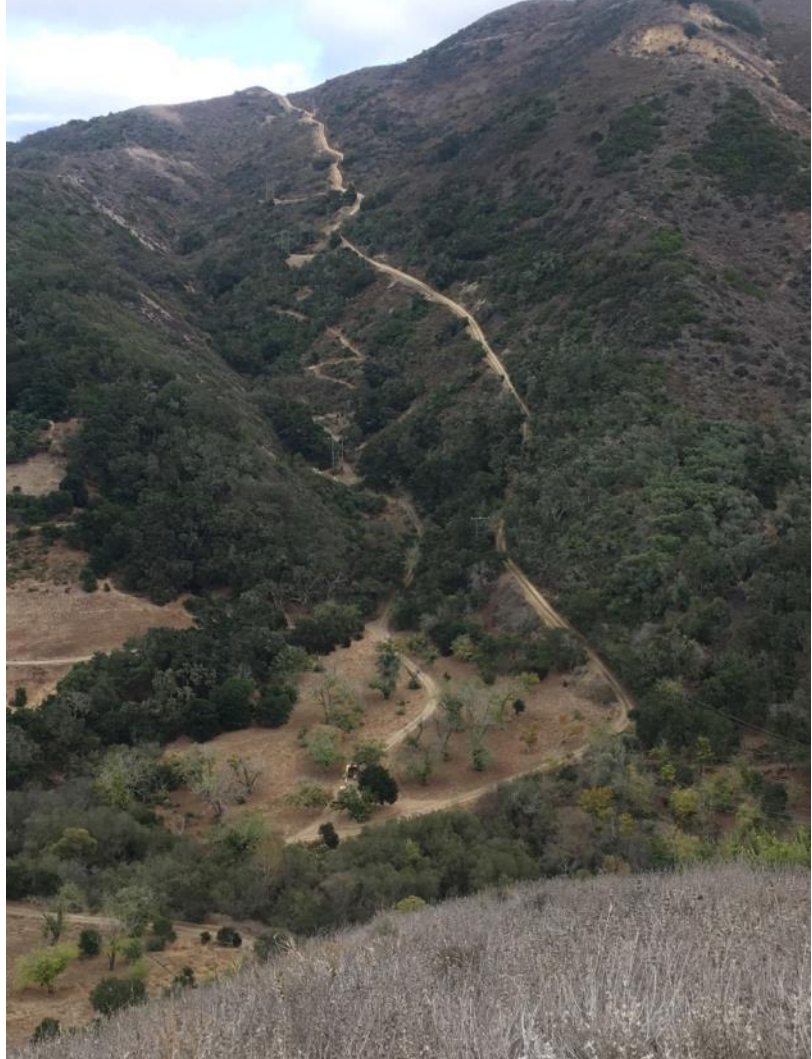
Photo 8 – Looking east from Construct 62 toward Constructs 59 and 60. Photo facing east

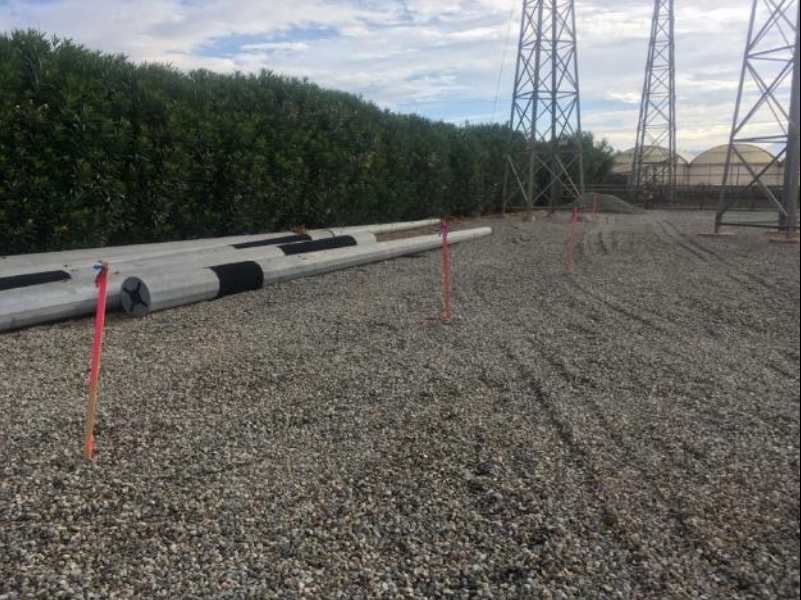
Date	Location	Photo	Description
11/16/17	Carpinteria Substation

I rode with Matt Schaap (BRC) to the Carpinteria Substation, which is located near the Carpinteria High School, as a crew was setting up to install four new tubular steel poles (TSPs) (Photo 1). The crew brought in a baker tank since they expected to hit ground water during the drilling (Photo 2). While we were at the Carpinteria Substation, a concrete truck arrived to pour shallow foundations.

Photo 1 – Stakes indicate the location of the new TSPs. Photo facing southeast.
11/16/17	Carpinteria Substation

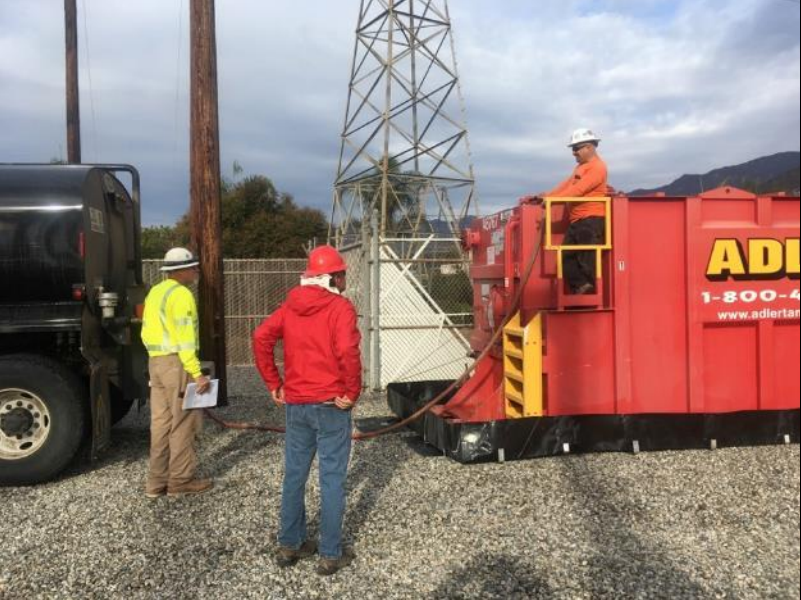
Photo 2 – Crew setting up a baker tank in the event they hit ground water. Photo facing west.

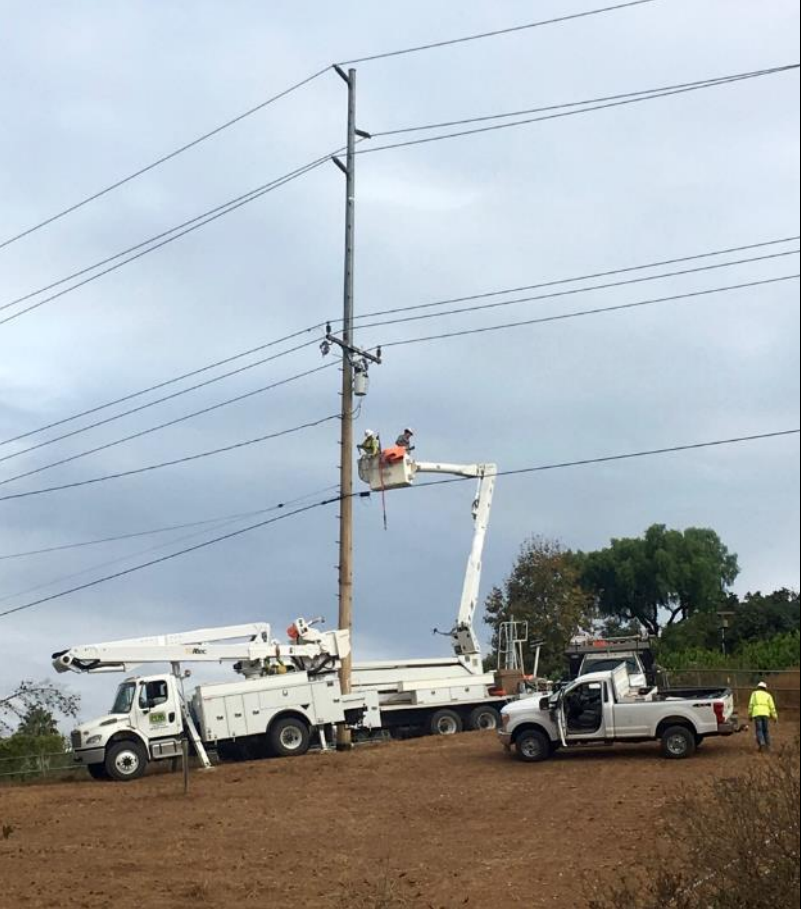
Photo 3 – A crew is painting the existing TSP.
11/16/17	Segment 3B, Construct 58

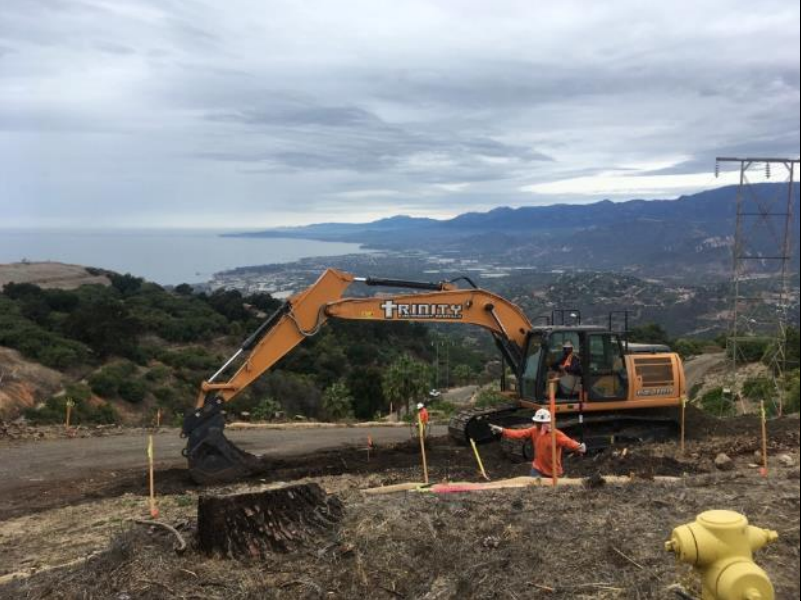
Photo 4 – Site preparation. Photo facing west.

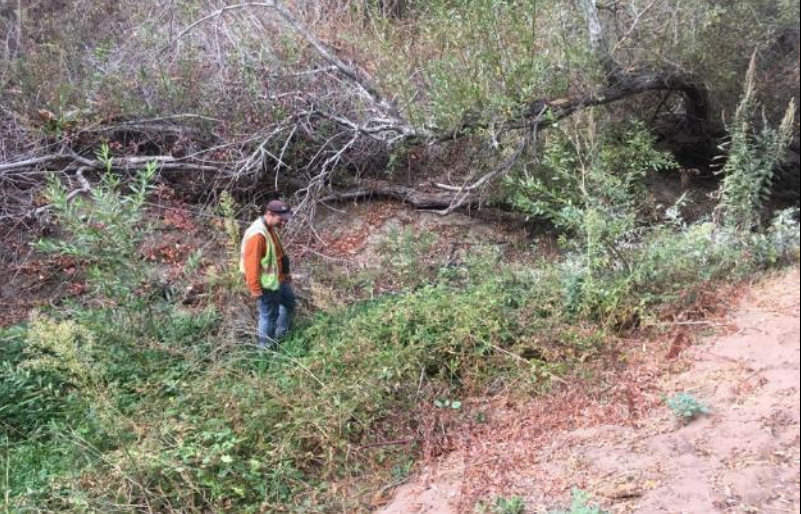
Due to the wet weather, Matt Schaap (BRC) walked along Sacus Creek looking for California red-legged frogs (MM BIO-9) (Photo 5). There was some creek flow, but the frogs' preferred habitat (i.e., deep pools) was not present, and no frogs were observed.

Photo 5 – Daytime survey for California red-legged frogs.
11/16/17	Segment 3B, Construct 58

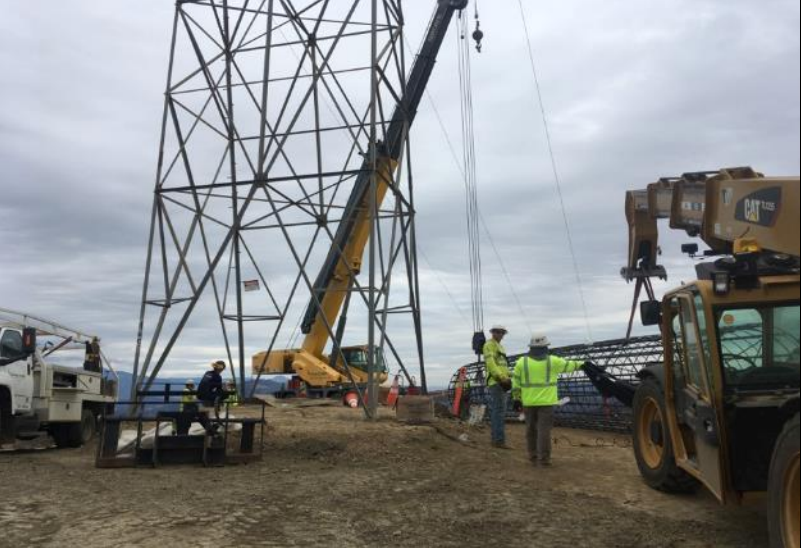
The drill rig was parked at Construct 59. I headed east with Matt Schaap (BRC) toward Construct 58 where the Henkels & McCoy (H&M) crew was preparing to drop the foundation cage into the hole (Photo 6).

Photo 6 – The rebar cage is being lowered into the hole. Photo facing east
11/16/17	Segment 3B, the “Y”

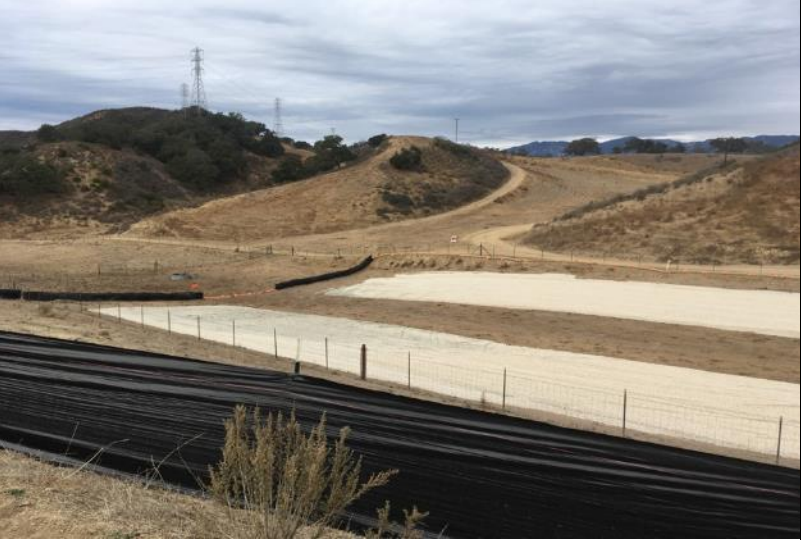
Photo 7 - BMPs and gravel are being brought into the “Y” Yard so the yard can be used. Photo facing northwest

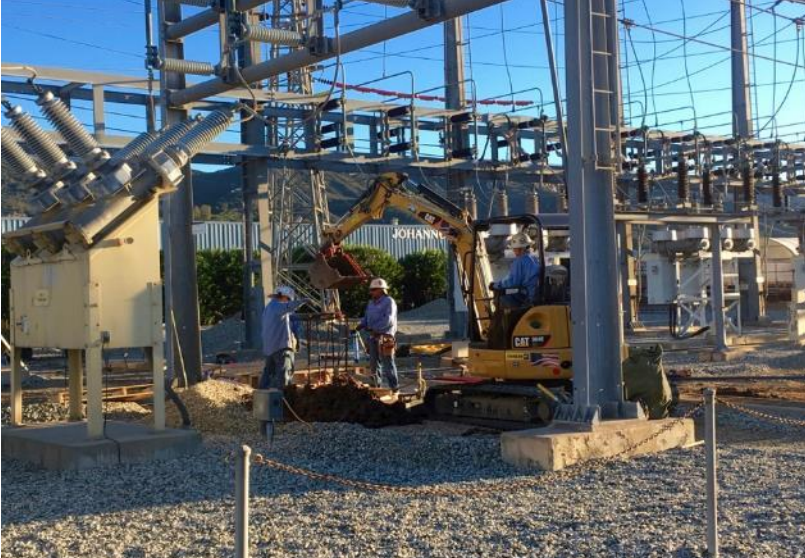
Date	Location	Photo	Description
11/22/17	Carpinteria Substation

I traveled with Matt Schaap (BRC) to the Carpinteria Substation where a crew was using a small backhoe to prepare an area for several new foundations (Photo 1). A small concrete washout catch basin had been set up at the site (Photo 2).

Photo 1 – Crew working within the Carpinteria Substation on some small, shallow foundations.
11/22/17	Carpinteria Substation

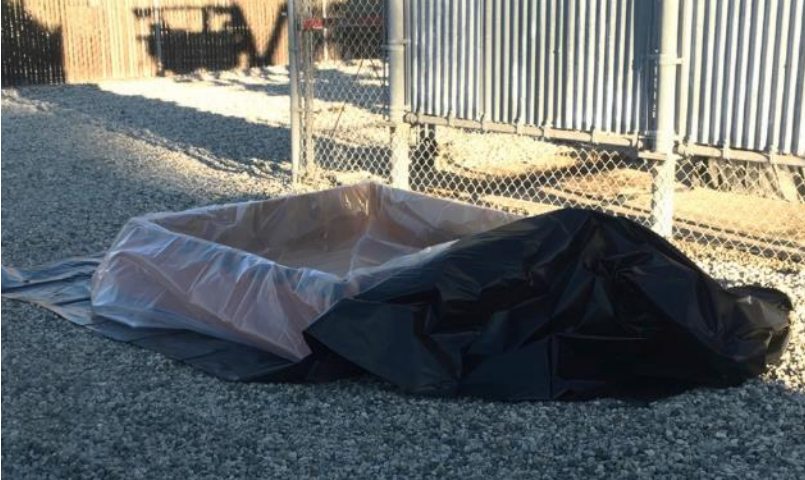
Photo 2 – Washout location for the concrete trucks.
11/22/17	Segment 3B, Construct 67

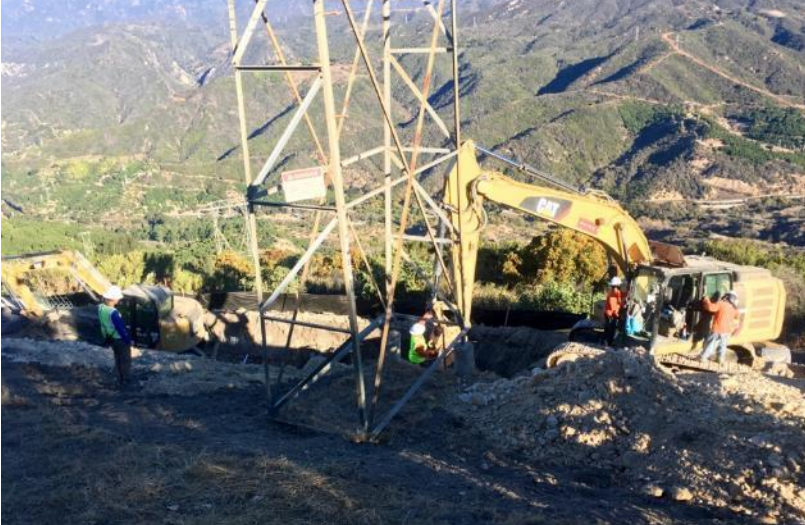
Photo 3 – A crew is continuing the work on the TSP pad. Photo facing northwest

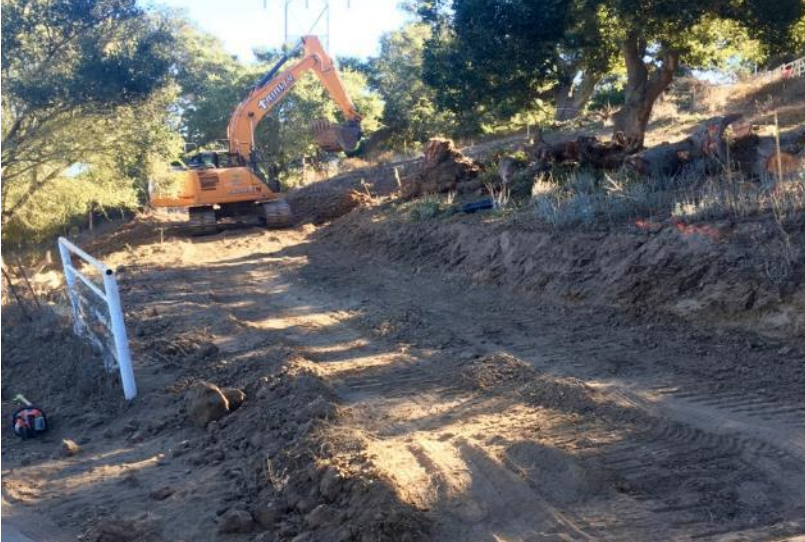
Photo 5 – Access road to the new TSP location. Photo facing east.
11/22/17	Segment 3B, Construct 70	 	Photo 6 – New road cut near Construct 70 but outside of the approved impact area. Soil pile at the end of the road is coming from the tower pad. Photo facing east.
