### **Re: Monthly Report Summary #4 for the Santa Barbara County Reliability Project**

CPUC Site Inspection Report  
January 5 and 23, 2018

## Santa Barbara County Reliability Project CPUC Site Inspection Form

<b>Project:</b>	Santa Barbara County Reliability Project	<b>Date:</b>	January 5, 2018
<b>Project Proponent:</b>	Southern California Edison	<b>Report #:</b>	VS010
<b>Lead Agency:</b>	California Public Utilities Commission	<b>Monitor(s):</b>	Vince Semonsen
<b>CPUC PM:</b>	Jensen Uchida, Energy Division	<b>AM/PM Weather:</b>	Partly cloudy with mild temperatures and a slight breeze
<b>E &amp; E CM:</b>	Jenny Vick	<b>Start/End Time:</b>	0700 to 1030
<b>Project NTP(s):</b>	NTP-1, NTP-2, NTP-3, NBMP, NIWCP

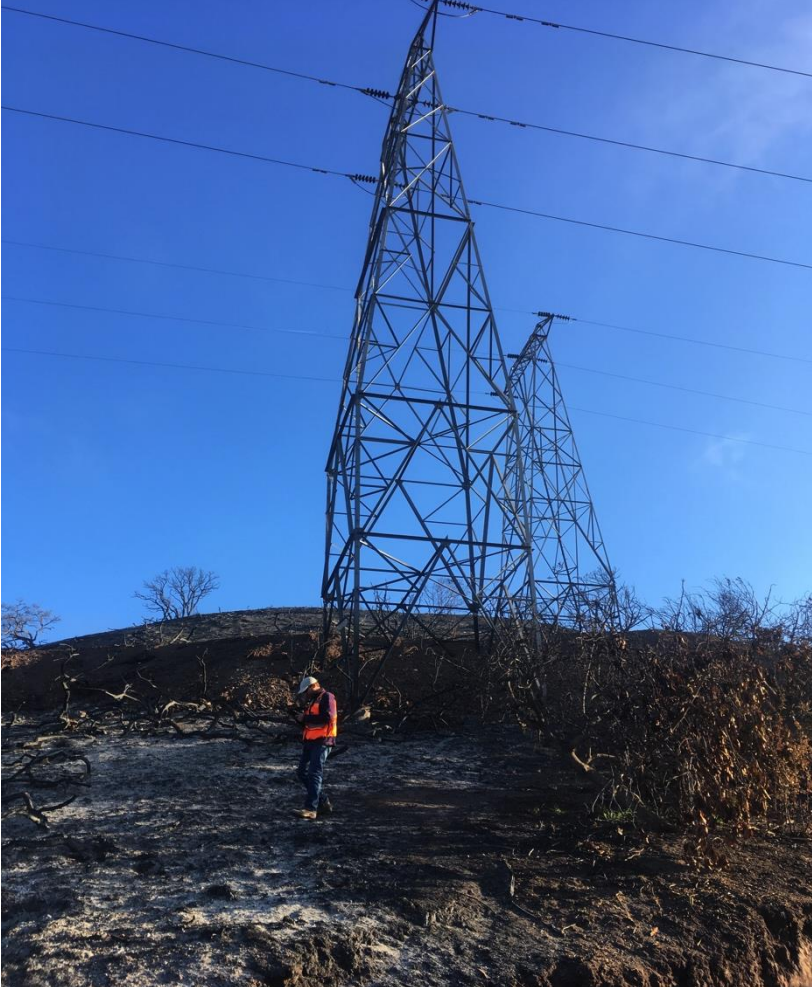
I went with James Rasico to Segment 4 where regular work activities had kicked off again after the Thomas Fire. The H&M crews had been assisting Southern California Edison (SCE) with emergency work along all of the Santa Barbara County Reliability Project (SBCRP) segments; these activities had not been overseen by the environmental crews because the work was not project related. Neither James Rasico nor I had been in this portion of Segment 4. We drove to Construct 105, which was within the burned area. No work was being conducted and no BMPs were in place (Photo 1).

<p>Photo 1 – Construct 105 is within the burn area. No work was being conducted. Photo facing north.</p>
1/5/18	Segment 4

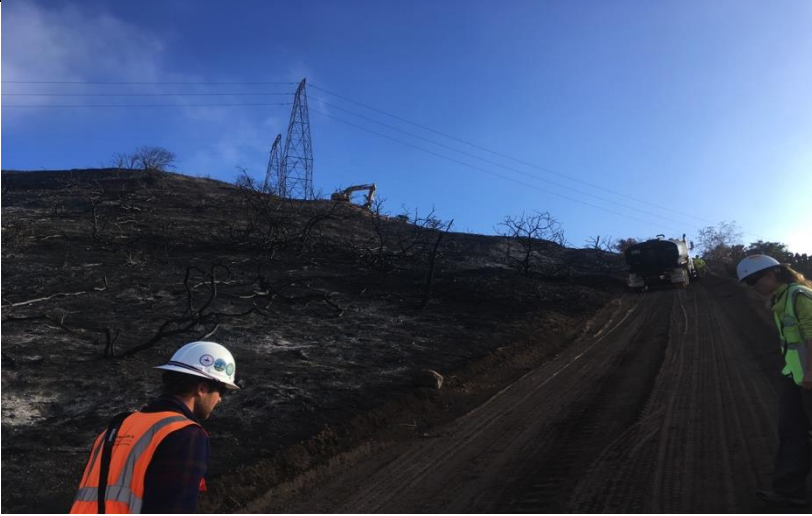
Crews were working at Constructs 103 and 104, which were also within the burned area. The access road to these towers was very steep and dusty (Photo 2). The H&M crew used a bulldozer to push the water truck up the steep road to the site. Rincon biological monitors Yuling Huo and Paulette Loubet (APM BIO-3) were onsite, along with GANDA paleontological monitor Andrew Paden (MM CR-13). An excavator was at Construct 104 (Photo 3) and crews were installing a crane pad. At Construct 103, the survey crew had reestablished the impact area, and the BMP crew had arrived to begin installing the wattles (Photo 4).

<p>Photo 2 – Steep access road leading to Constructs 103 and 104.</p>

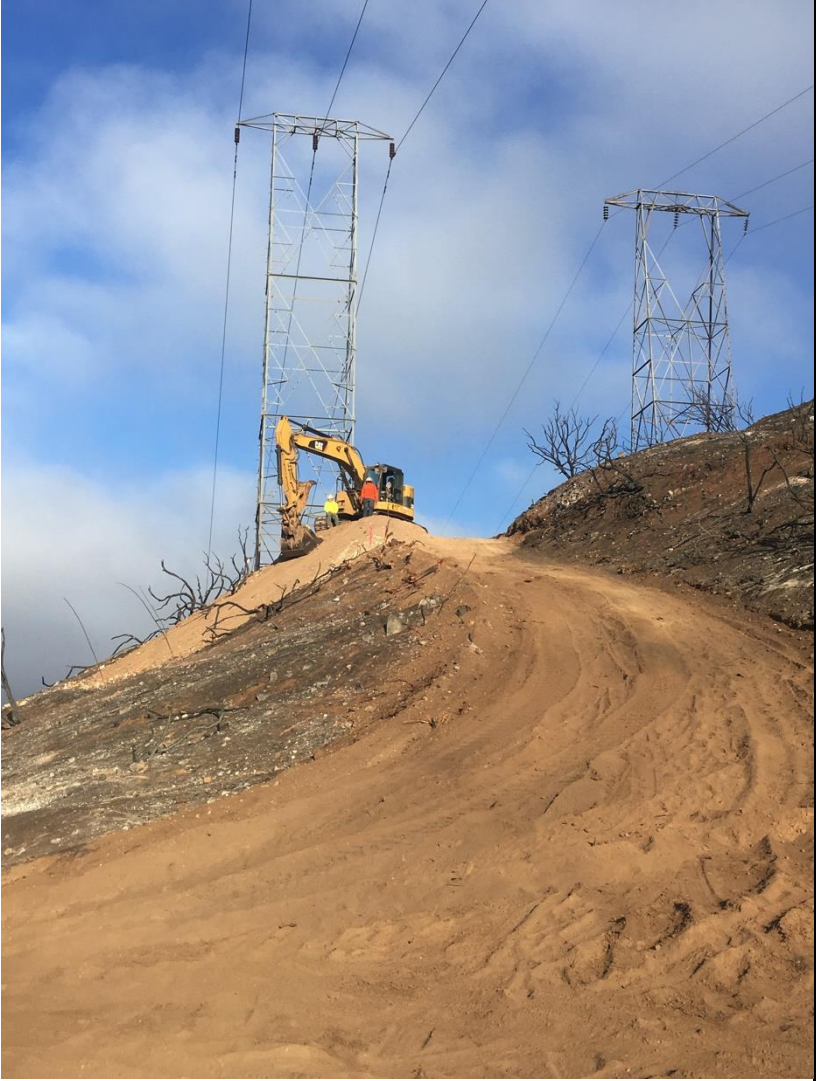
Photo 3 – A crew is ready to begin work at Construct 104, but is waiting on the arrival of a water truck.

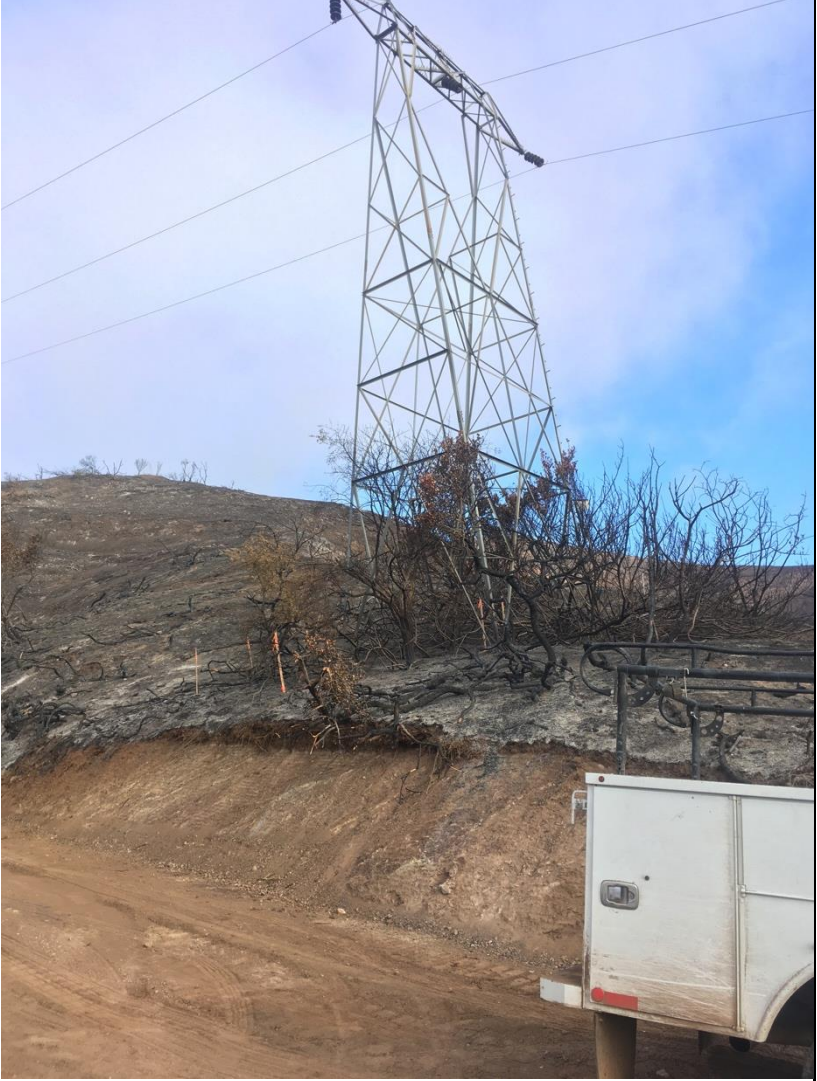
Photo 4 – The newly staked area around Construct 103, which is ready for BMP installation.

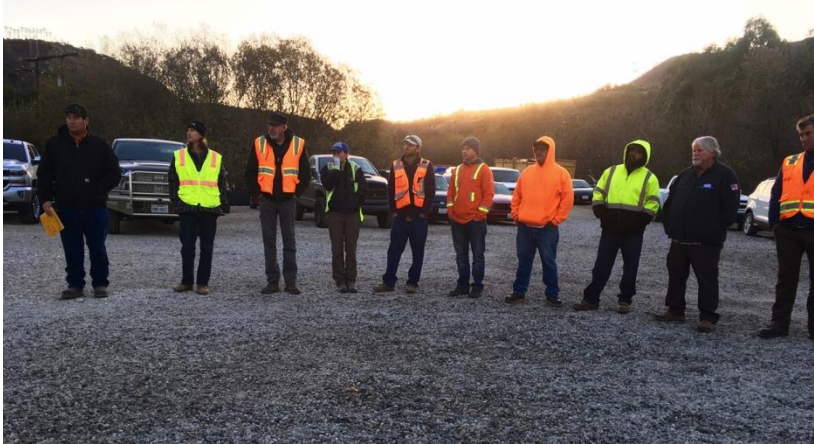
I arrived at 0700 for the tailboard meeting being held at the Highway 150 Yard (Photo 1). Environmental project manager John Hindley and lead biological monitor James Rasico, both from Rincon Consultants, Inc. (Rincon), had attended the tailboard meeting. John Hindley discussed issues with nesting birds and the use of unapproved access roads. Henkels & McCoy (H&M) crews were completing their work at Construct 64 in Segment 3B; however, most of the work was taking place along Segment 4.

Photo 1 – 0700 tailboard meeting at the Highway 150 Yard.
1/23/18	Segment 4 Construct 106

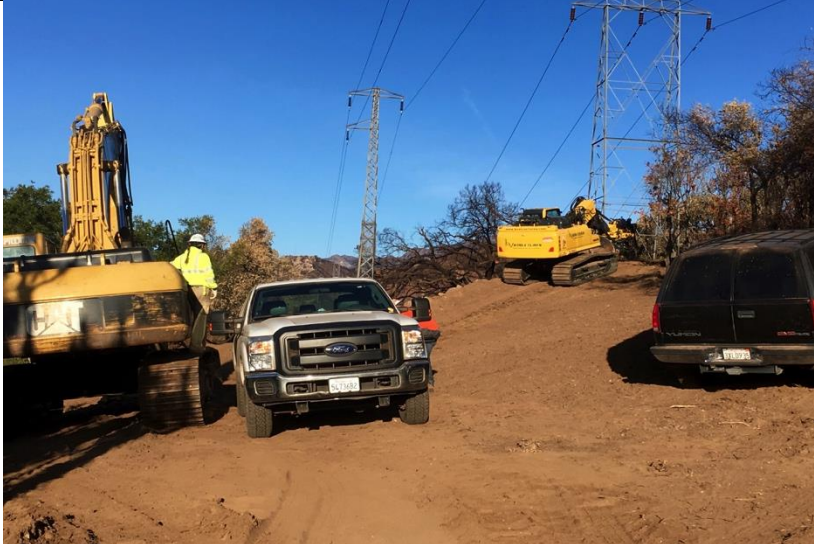
I rode with James Rasico to Segment 4. Our first stop was at Construct 106 where an H&M crew had finished the site preparation and were preparing to drill the tubular steel pole (TSP) foundation hole (Photos 2 and 3). Best management practices (BMPs) were in good condition (APM BIO-7), and Rincon biological monitor Paulette Loubet (APM BIO-3) was onsite. I examined the unapproved access road with James Rasico. The access road runs between Constructs 105 and 106, through a creek drainage between the constructs, and appears to have been cleared by fire crews. According to James Rasico, the road was also used to transport H&M equipment; however, this unapproved access road has now been staked with No Entry/Environmentally Sensitive Area (ESA) signs (Photo 4). Paleontological monitor Kim Luyties (Rincon) was also at Construct 106 and waiting for the drilling operation to begin (MM CR-13).

Photo 2 – Drill rig is onsite. Photo facing west.
1/23/18	Segment 4 Construct 106

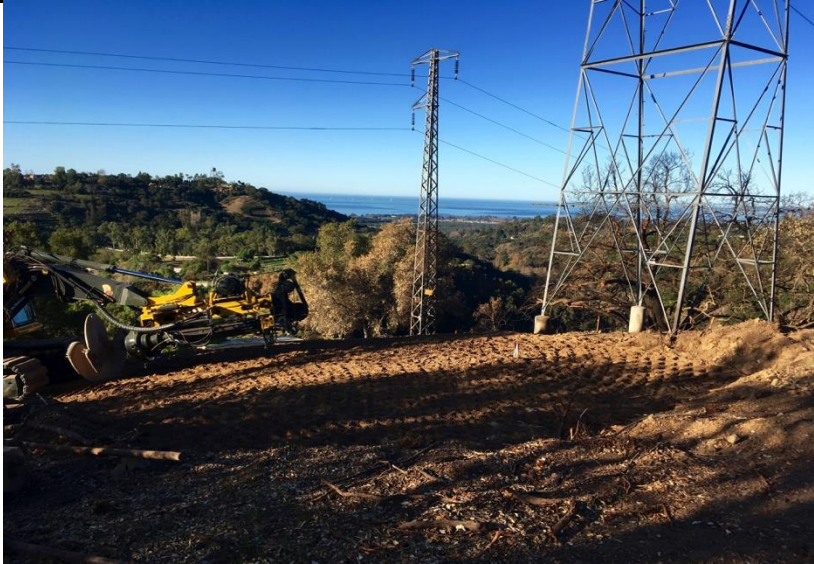
Photo 3 – The new TSP location is ready for drilling. Photo facing south.

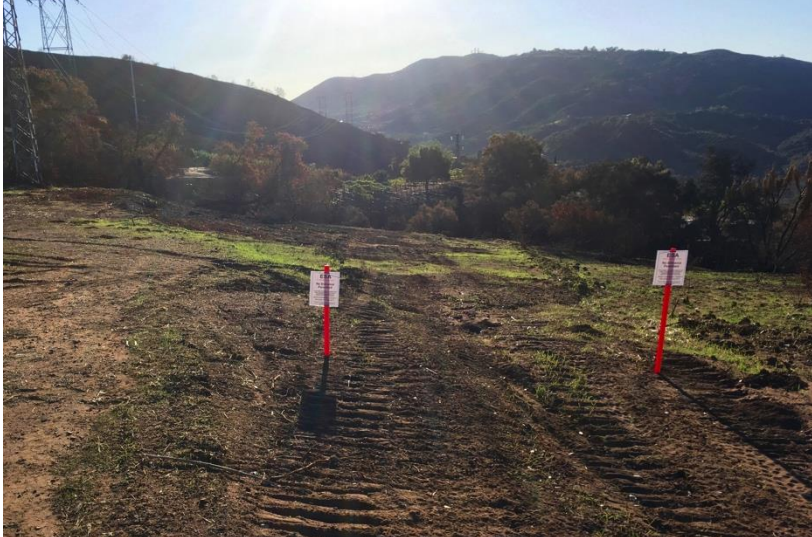
<p>Photo 4 – Access road used during emergency work between Constructs 105 and 106; no entry signs have been installed. Photo facing southeast.</p>
1/23/18	Segment 4 Access Road for Construct 100

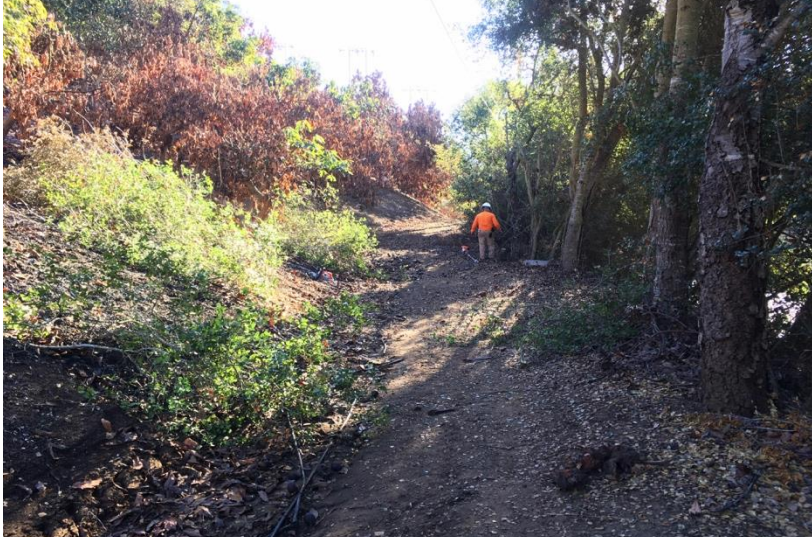
At Construct 100, a tree trimming crew was onsite preparing the access road (Photo 5). Native trees lined the roadway, but the crew was primarily trimming back the avocado trees; arborist Steve Jones (BRC) was monitoring this work (APM BIO-2, MM BIO-4). Road grading will be needed on this access road to allow equipment to reach the TSP site (APM GEO-1).

<p>Photo 5 – Tree trimming crew is clearing the access road.</p>
1/23/18	Segment 4 Access Road to Construct 99

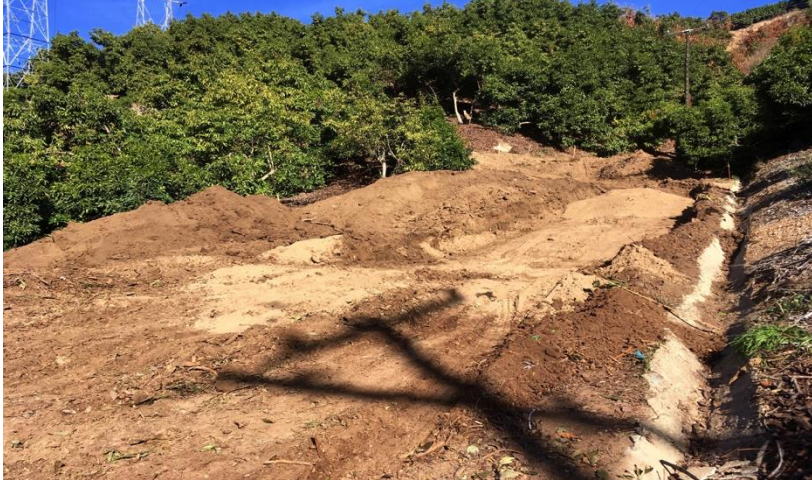
Access road preparation was also ongoing at Construct 99 where road grading was actively being conducted (Photos 6 and 7). BMPs were in place, and biological monitor Mike Moss (Rincon) was overseeing the work. Several wire walls will need to be built along this access road, and H&M crews said they would need to remove around 100 cubic yards of non-compactable soil. Since this access road merges onto a long straight stretch of Highway 150 where vehicles travel at high rates of speed, a traffic control crew was being brought in (MM TT-1).

<p>Photo 6 – The crew is exporting soil from this area and bringing in more compactable soil.</p>

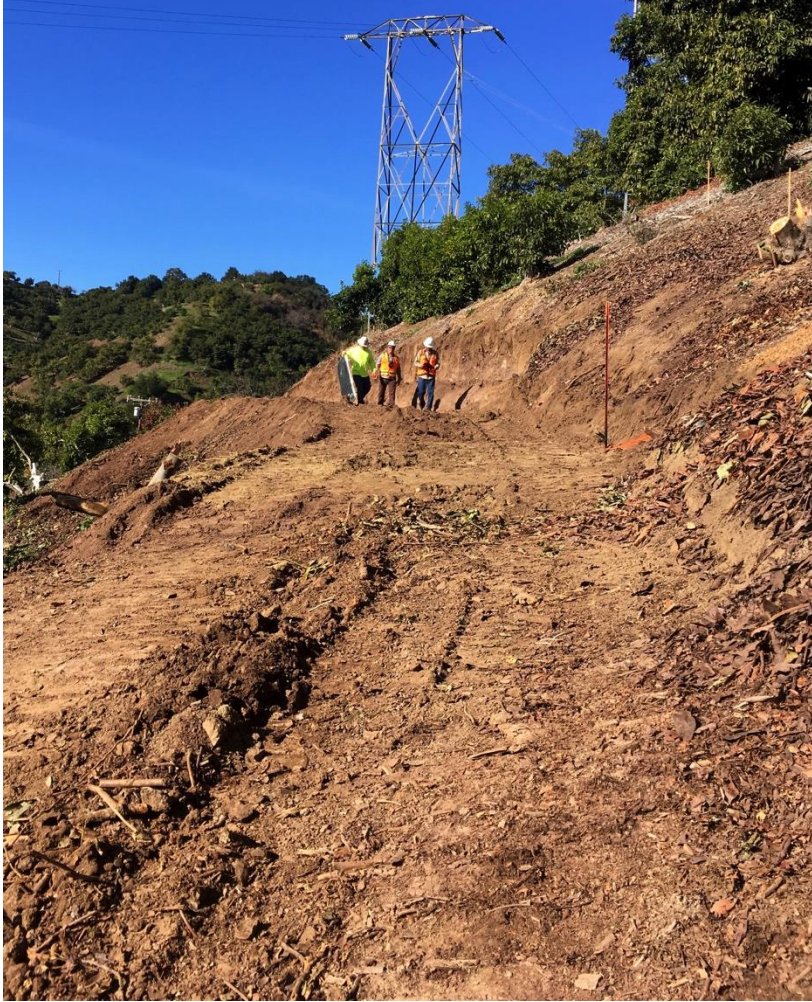
Photo 7 – This portion of the access road will need welded wire walls installed. Photo facing west
1/23/18	Segment 4 Construct 103

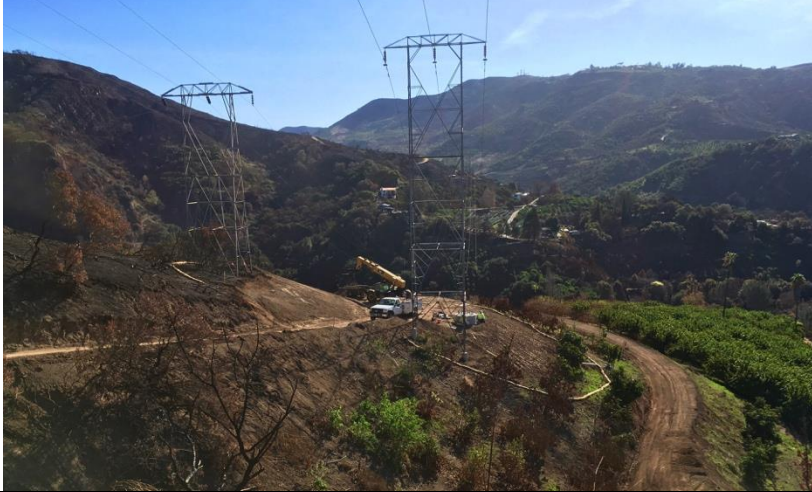
I rode with James Rasico back to Constructs 103 and 104 where an H&M crew was stripping forms off of the new TSP foundation at Construct 103 (Photo 8); some earth work was being conducted at Construct 104 (Photo 9). Biological monitor Dave Wappler (BRC) was onsite and checking both constructs. I examined the BMPs with James Rasico and Dave Wappler and I suggested the installation of additional wattles for the area above the construction site; these wattles would prevent mud from entering the work area (this entire area had been burned during the Thomas Fire).

Photo 8 – H&M crew stripping forms off of the TSP foundation at Construct 103. Photo facing southeast

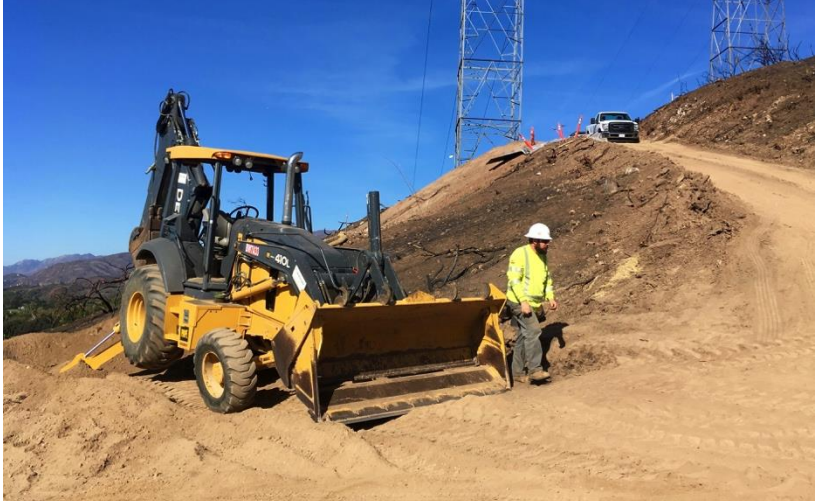
Photo 9 – Earthwork taking place; this area was badly burned. Photo facing west.
1/23/18	Segment 4 Construct 102

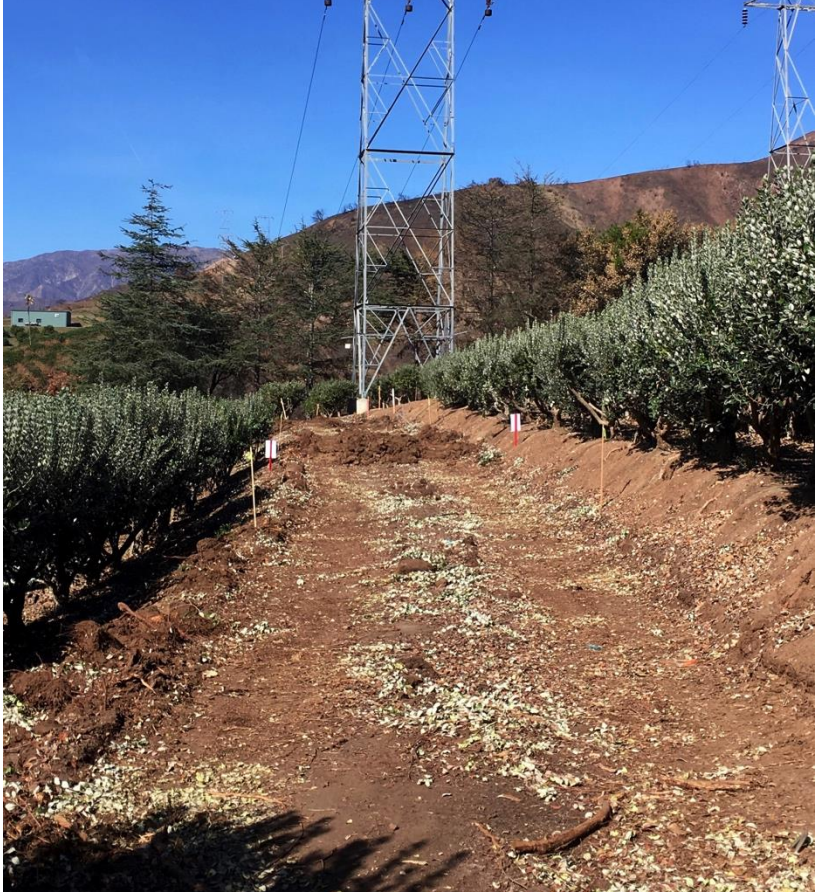
No work was being conducted at Construct 102, as a pair of red-shouldered hawks were building a nest in a small stand of trees along the access road (APM BIO-4, MM BIO-10). A 300-foot buffer had been set up with ESA signage, but the Construct 102 construction area was outside of this buffer (Photo 10). However, because crews had to travel through the buffer to get to the site, monitors would observe the crews as they drove equipment past the nest. I did not see the birds while I was onsite.

Photo 10 – Access road with ESA nesting buffer signs. Photo facing west.
