Re: Monthly Report Summary #3 for the Santa Barbara County Reliability Project

CPUC Site Inspection Report
December 21, 2017

Santa Barbara County Reliability Project CPUC Site Inspection Form

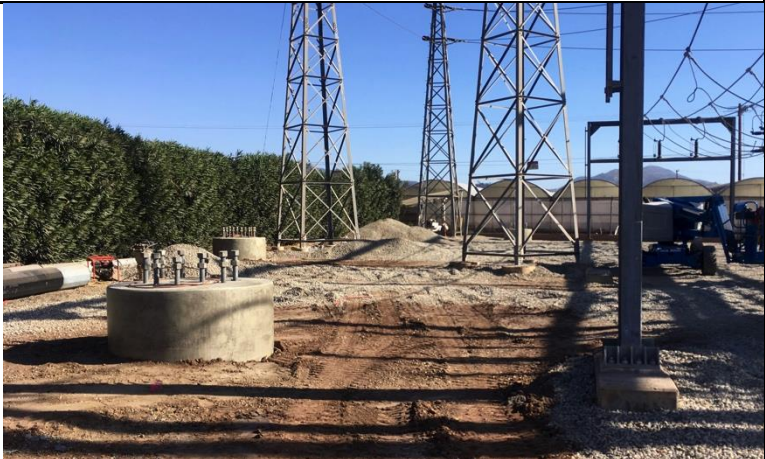
At the Carpinteria Substation, a number of new tubular steel pole (TSP) foundations had been poured along with some additional concrete pads (Photos 1 and 2). At the time of my site inspection, a new TSP foundation was being poured just outside of the Carpinteria Substation fence; precautions had been taken to prevent any concrete spillage (Photo 3). This tower is a part of Segment 4, which is a portion of the SBCRP that had been burned (Photo 4).

Photo 1 – A number of new TSP foundations are in place within the Carpinteria Substation. Photo facing east
12/21/17	Carpinteria Substation

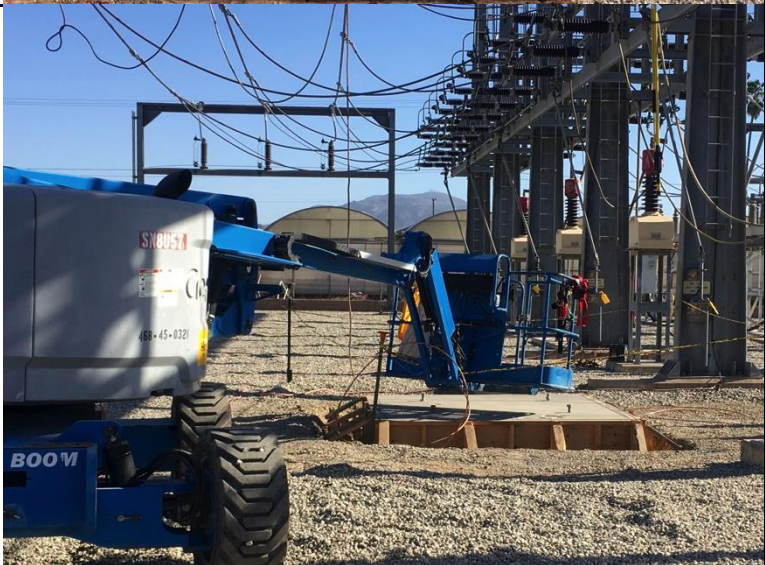
Photo 2 – Concrete pads have been poured within the Carpinteria Substation.
12/21/17	Segment 4

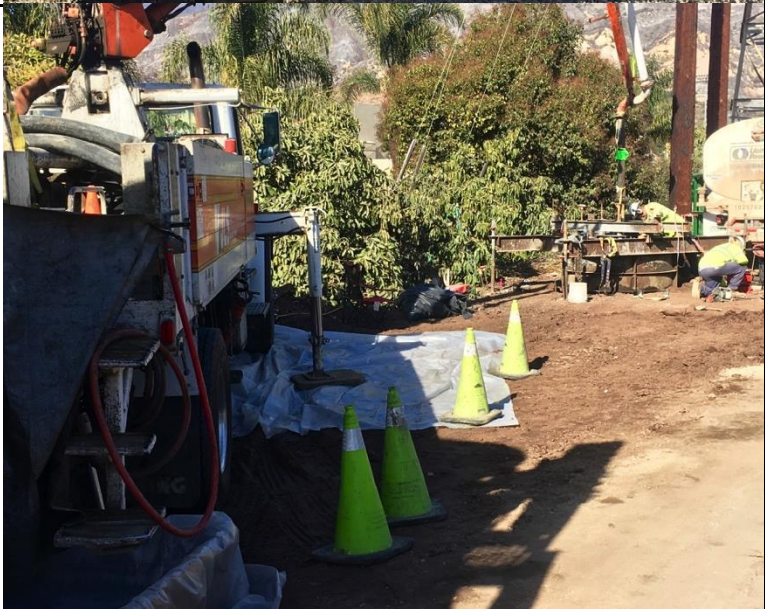
Photo 3 – A crew is pouring a new TSP foundation.

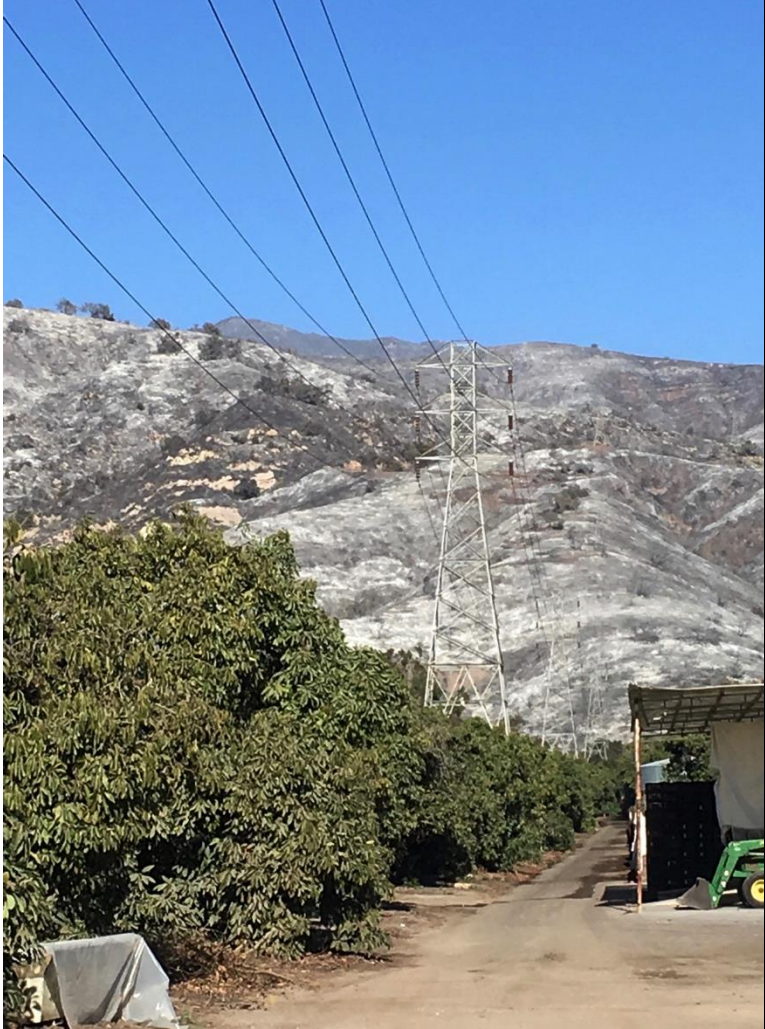
<p>Photo 4 – Much of Segment 4 was burned in the Thomas Fire. Photo taken from the Carpinteria Substation facing north.</p>
12/21/17	Roadway Outside of the Carpinteria Substation

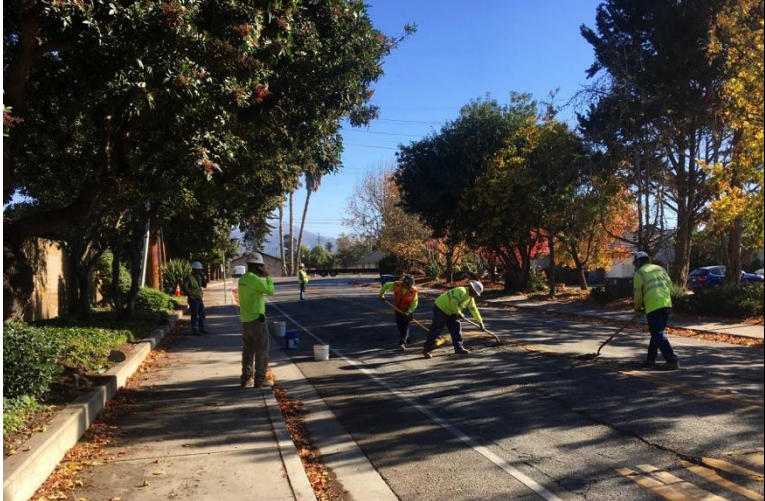
When I first arrived at the Carpinteria Substation, I noticed some fresh concrete had spilled onto the public roadway by a concrete truck turning onto the Segment 4 access road. I notified Matt Schaap and he spoke with the onsite crew. The crew immediately removed the spilled concrete from the road (Photo 5).

<p>Photo 5 – A crew is removing a concrete spill from the public roadway.</p>

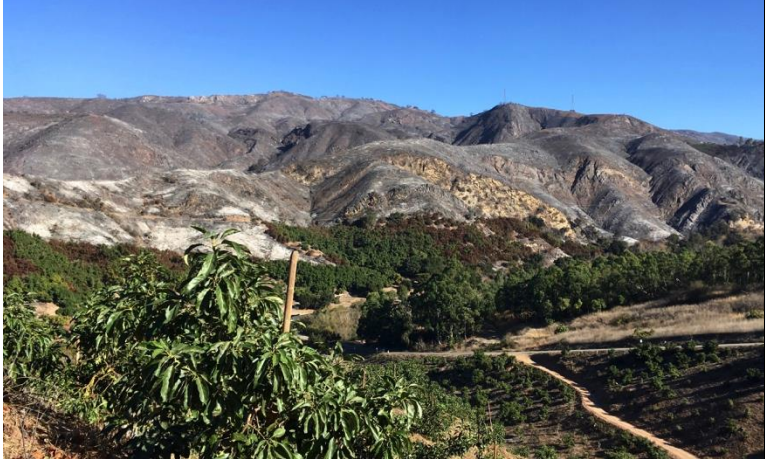
From the access road to Segment 3B, I could see how much of the SBCRP site and surrounding area had been burned during the fire (Photo 6). Matt Schaap and I stopped on Rincon Mountain at Construct 68 where a crew was removing the foundation forms and conducting final concrete preparation (Photo 7). I noted that the fire had burned right up to the tower foundation, and areas along the access road were also burned (Photo 8).

Photo 6 – Looking north toward the Highway 150 Yard.
12/21/17	Segment 3B – Construct 68

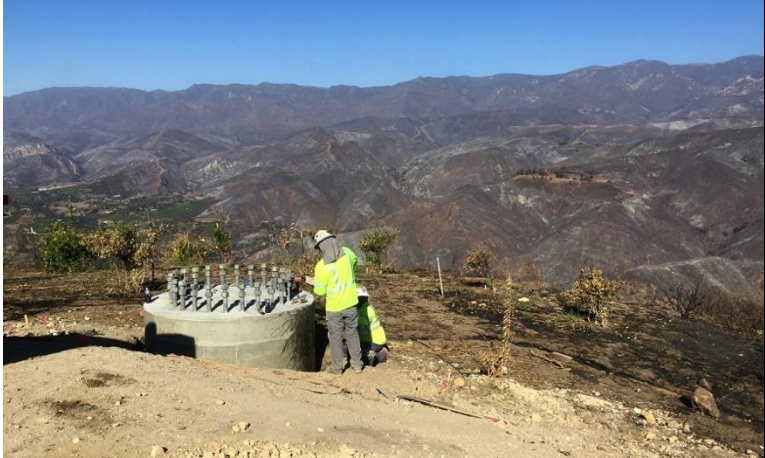
Photo 7 – Crews are cleaning up foundation work; note the burned area near the TSP. Photo facing northwest.
12/21/17	Segment 3B – Access Road

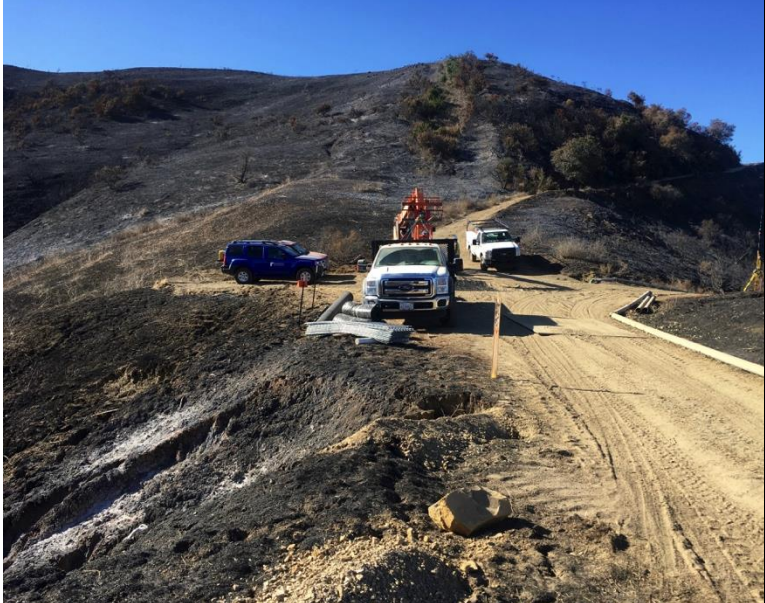
Photo 8 – Extensive fire damage. Photo facing southwest toward Rincon Mountain.

Due to the onset of the rainy season and the burned areas throughout the SBCRP, BMP installation and maintenance is very important (APM BIO-7).

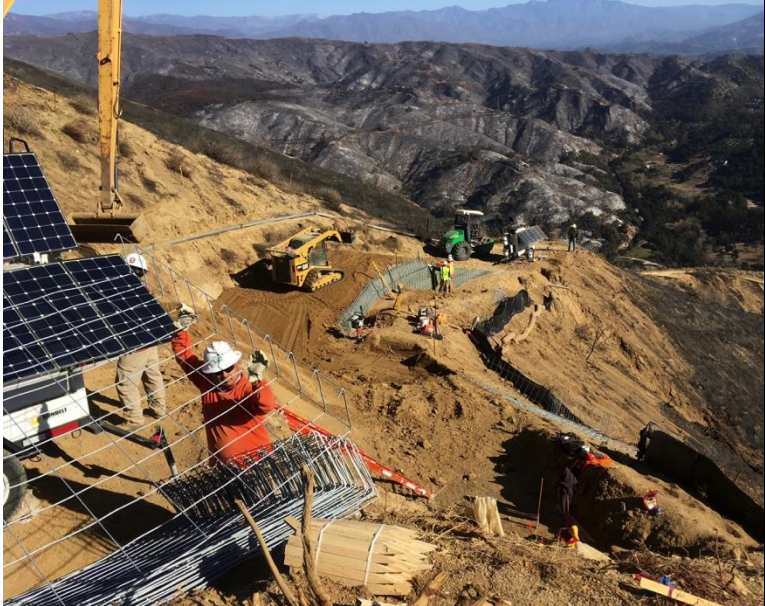
I drove east to Construct 64 where a large crew was installing the welded wire walls needed (APM GEO-1) for the drilling rig and the crane pad (Photo 9). The crew had been working long hours at this site and utilizing solar powered lights; they were aiming to finish this site before the holiday break. Matt Schaap spoke with biological monitor Yuling Huo (Rincon) (APM BIO-3) (Photo 10). Paleontological monitor Andrew Paden (GANDA) was also at this site (MM CR-13).

Photo 9 – A crew is working on the welded wire walls at Construct 64. Photo facing east
12/21/17	Segment 3B – Construct 64

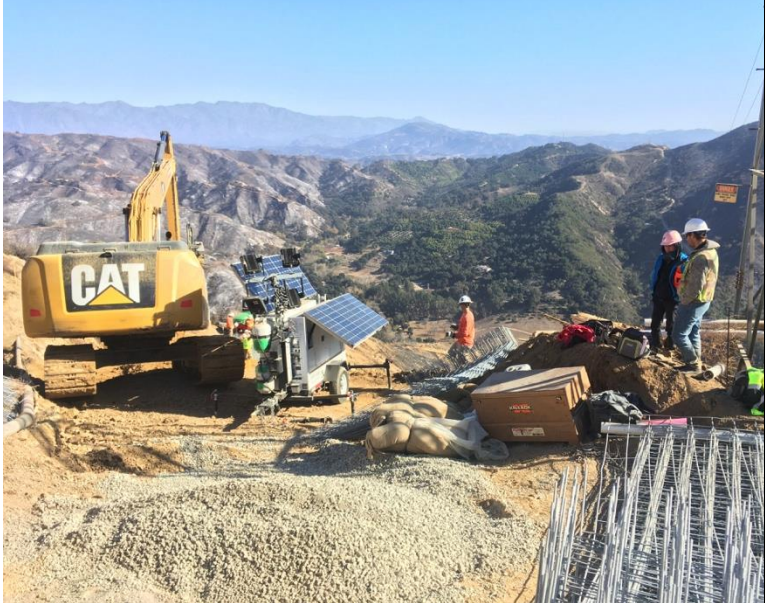
Photo 10 – Matt Schaap is speaking with onsite biological monitor Yuling Huo.
