Re: Monthly Report Summary #13 for the Santa Barbara County Reliability Project

Santa Barbara County Reliability Project CPUC Site Inspection Form

Project:	Santa Barbara County Reliability Project	Date:	October 5, 2018
Project Proponent:	Southern California Edison	Report #:	VS031
Lead Agency:	California Public Utilities Commission	Monitor(s):	Vince Semonsen
CPUC PM:	Jensen Uchida, Energy Division	AM/PM Weather:	Sunny with warm temperatures and calm winds
E & E CM:	Fernando Guzman	Start/End Time:	0700 to 1130
Project NTP(s):	NTP-1, NTP-2, NTP-3, NBMP, NIWCP

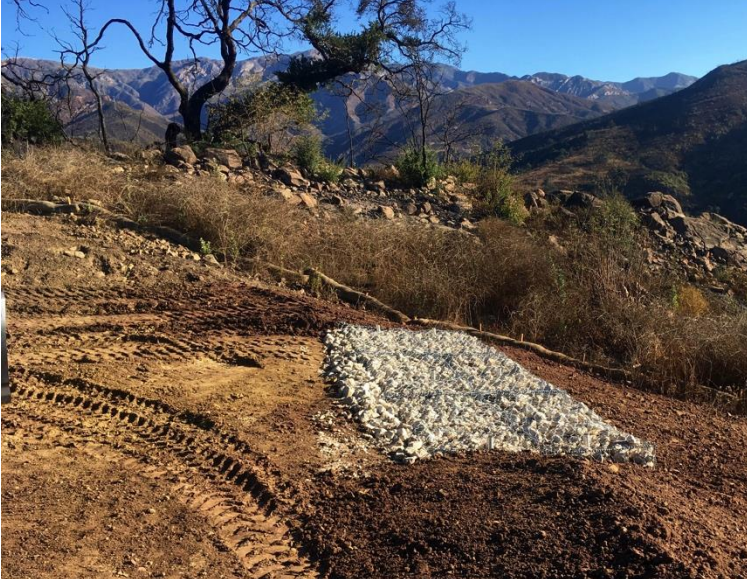
Our next stop was at TSP 112, where five pieces of construction equipment were parked. The construction pad was recontoured with BMPs and included an isolated rectangle of caged rock that appeared to slow rainwater runoff – Photo 4. A notch of disturbed area was restored and had two pieces of construction equipment parked on it – Photo 5. I asked Matt Bellini about this and he verified it was within the disturbance limits of the project. This location was under an oak tree; therefore, this location should be restored and not used to park equipment. When the H&M crew arrived, Matt Bellini discussed moving the equipment and restoring this location. The drip pans under all of the parked equipment were flattened and bent and needed to be replaced – Photo 6. An different type of drip pan should be considered for their replacements.

Photo 4 – BMPs near the TSP 112 pad. Photo facing north.
10/5/18	SBCRP – Segment 4, TSP 112

Follow-up on BMPs and restoration work at TSP 112.

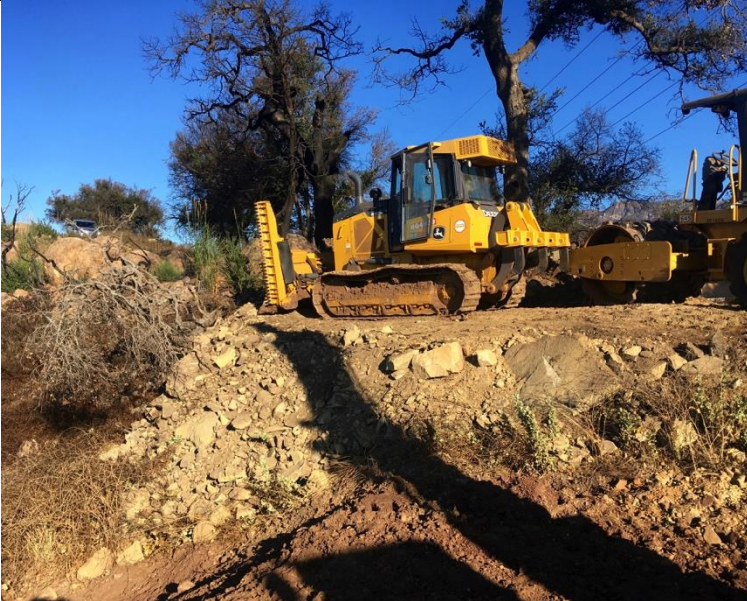
Photo 5 – Parked equipment on the construction pad.

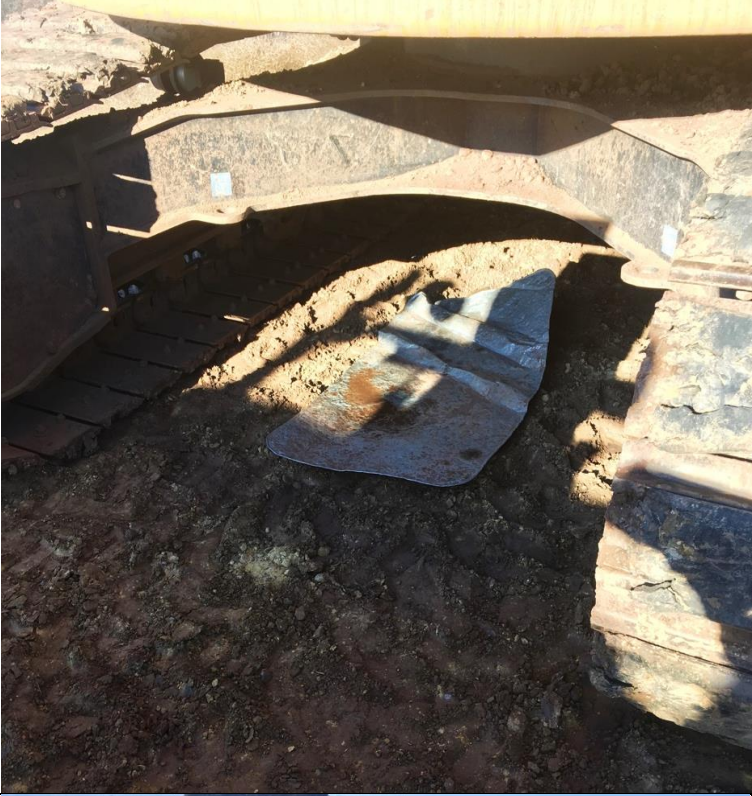
Photo 6 – Drip pan placed under equipment – note that it is flattened and bent.
10/5/18	SBCRP – Segment 4, TSP 120

The drip pans used throughout the project site are damaged; it is recommended that this type of drip pan is replaced regularly or a different type of drip pan is used.

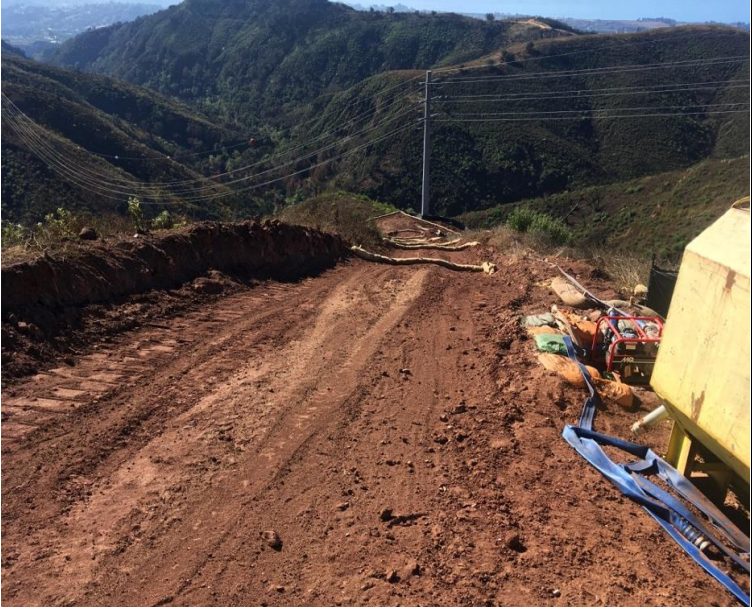
We traveled on the Franklin Trail access road to TSP 120. The last very steep section of the access road to 120 TSP had wattles installed. It appeared that not enough wattles were installed, and none of them were keyed into the ground – Photo 7. I discussed this with Matt Bellini and biological monitor Mike Moss. I explained that proper BMP installation is particularly important at this location, especially since it is up in the hills away from paved roads. Additionally, if a rain event occurs in that area, no one would be able to access the location for days afterward.

Photo 7 – BMPs on access road to TSP 120. Photo facing south.

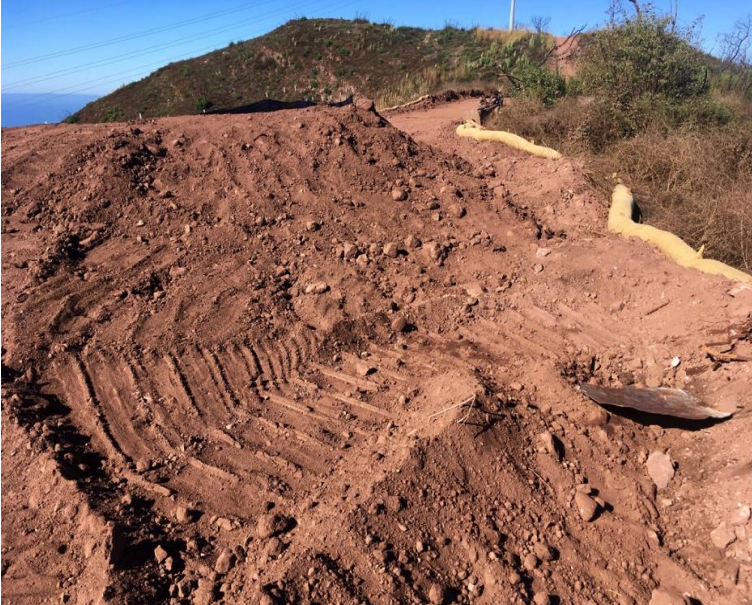
Photo 8 – Restoration needed along the access road.

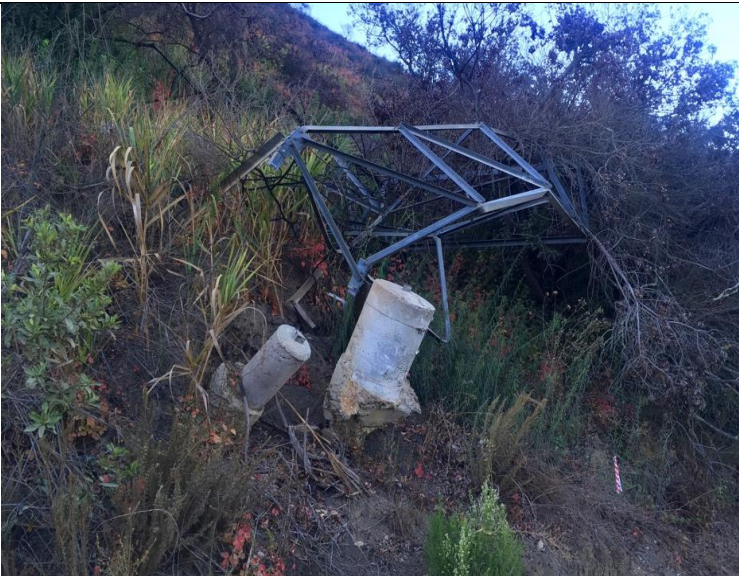
We traveled to Segment 3B near TSP 60, where a crew was removing old towers and tower foundations. Several of these old towers and foundations had native vegetation growing up and around the structures – Photo 1. Construction crews were being careful during the removal process to minimize impacts to the plants. The old steel was being stockpiled along the road for eventual pick up and recycling – Photo 2. Peter Gaede was overseeing this work, and we looked at several other locations near TSPs 63 and 64, where crews would have to remove foundations – Photos 3 & 4. According to Matt Schaap and Peter Gaede, the towers were removed with a helicopter.

Photo 1 – Removal of old towers and foundations near TSP 60.
10/18/18	SBCRP – Segment 4

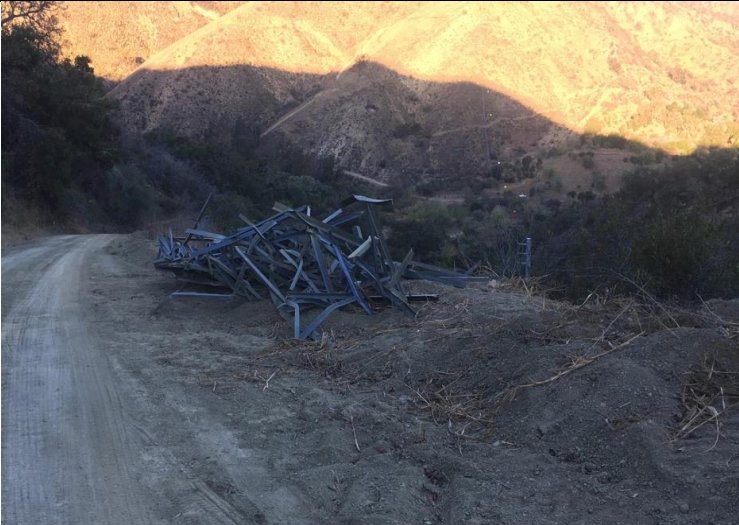
Photo 2 – Old lattice work tower stockpiled along the access road. Photo looking west.
10/18/18	SBCRP – Segment 4	 	Photo 3 – Old tower foundation removal to be completed along this ridge line near TSP 63.

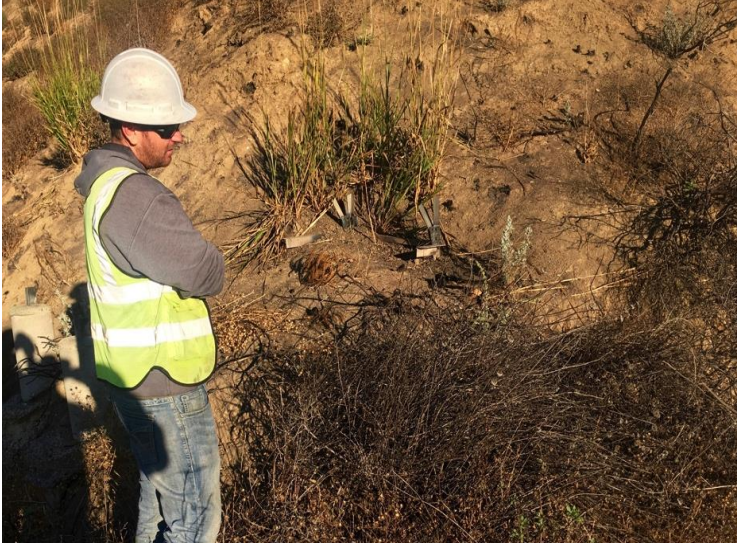
Photo 4 – Old foundation to be removed by hand near TSP 64.
10/18/18	SBCRP – Segment 3B, TSP 67

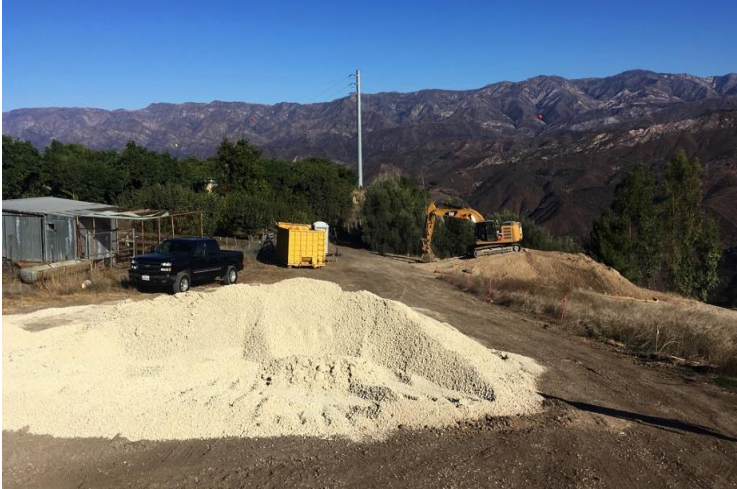
At TSP 67 staging area, the Henkels and McCoy (H&M) crew had stockpiled soil and road base for use during access road repair – Photo 5. An excavator and water truck were onsite to mix the soil with water to get the proper moisture content for compaction. A fence crew was working on a damaged portion of the landowner's fence/gate. Biological monitor Nathan Macy was overseeing the work and at TSP 76, where crews continued building a Hilfiker wall.

Photo 5 – Staging area near TSP 67. Photo facing north.
10/18/18	SBCRP – Segment 3B, TSP 67

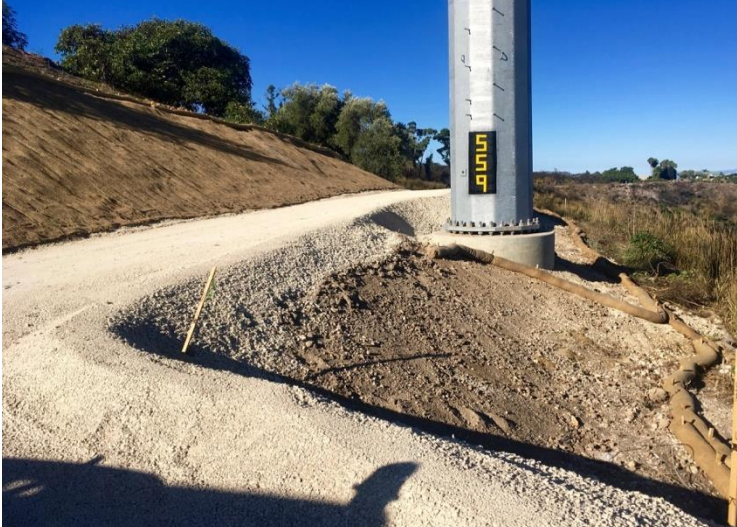
The area around TSP 67 was restored, recontoured, and stabilized with road base and best management practices (BMPs) – Photo 6. A few erosion rills caused by agricultural irrigation had developed under the jute netting. Matt Schapp and I examined the issue and noted that neither the jute netting nor the wattle were keyed in at the top of the slope. If crews dig in the jute netting and stake the wattle into a depression, then it would help to prevent water from running under the jute. The last step in the restoration was hydroseeding over the jute netting and on any open ground.

Photo 6 – Recontoured and restored area around TSP 67. Photo facing west.

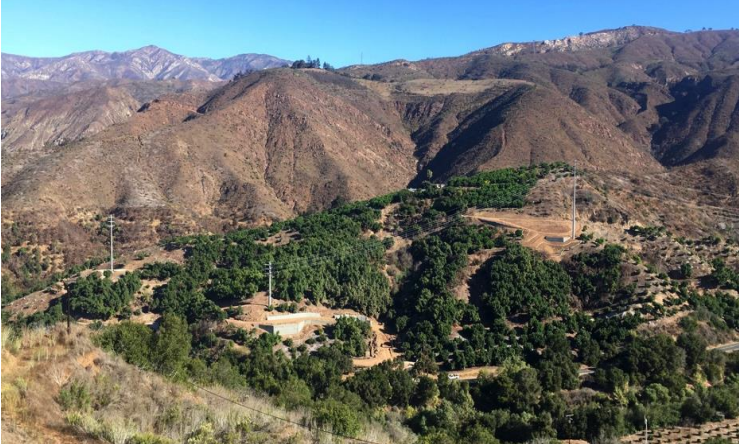
Photo 7 is a view from Rincon Mountain looking across the canyon toward TSPs 98, 99, and 100. No construction work was occurring at any of these locations.

Photo 7 – Overview showing TSPs 98, 99, and 100. Photo facing north.
10/18/18	SBCRP – Segment 3B, TSP 76

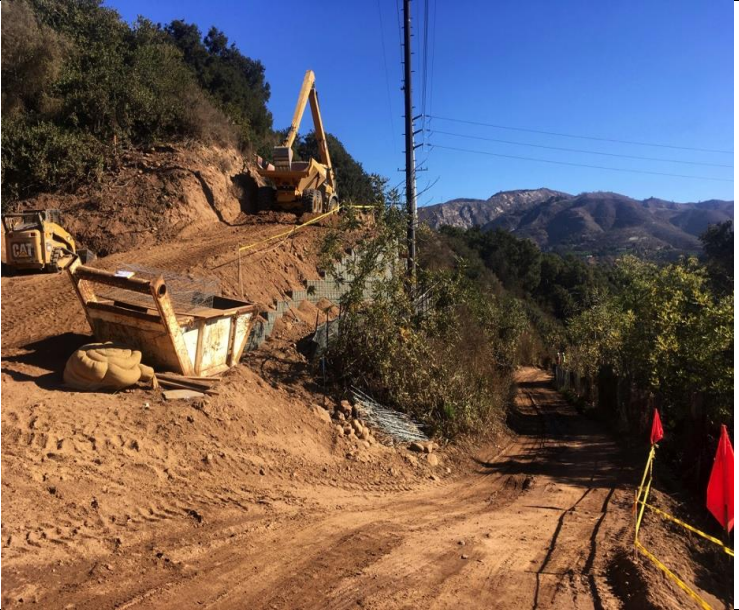
We stopped at TSP 76, where traffic control was in place along Highway 150 and mud trackout was being cleaned. Trucks were being used to deliver soil and gravel to the site for construction of the Hilfiker wall – Photo 8

Photo 8 – Hilfiker wall work. Photo facing east.
10/18/18	SBCRP – Segment 4, TSP 128

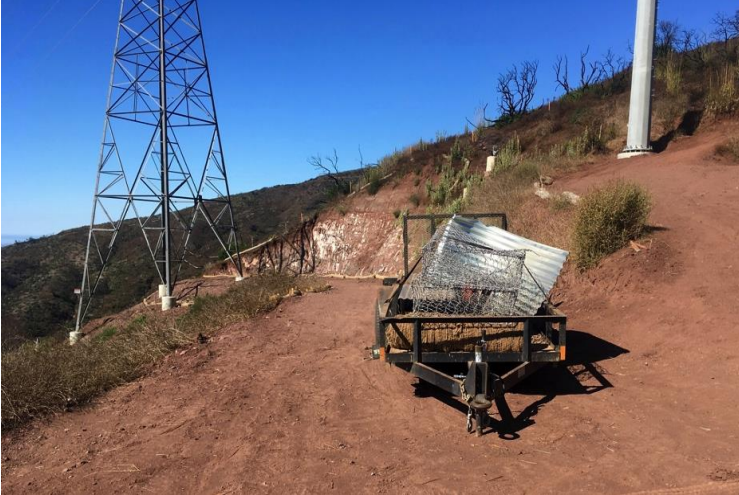
Photo 9 – Staging McCarthy drain materials. Photo facing west.

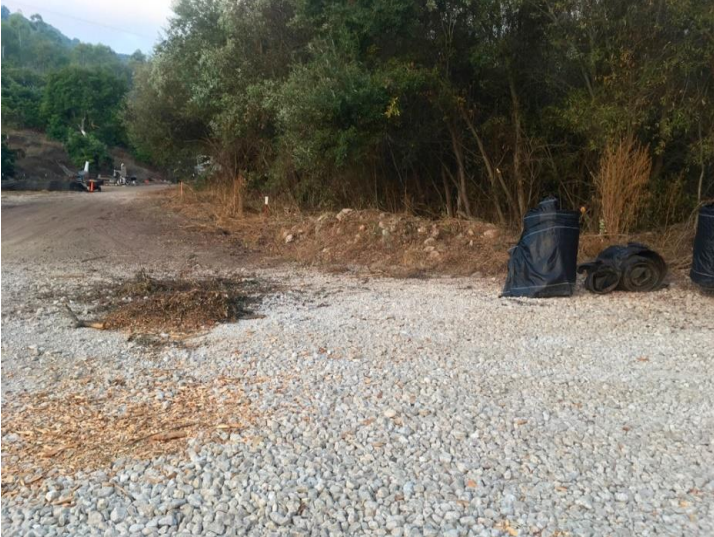
Photo 1 – Removal of equipment and fencing.
10/30/18	SBCRP – Segment 4, TSP 112

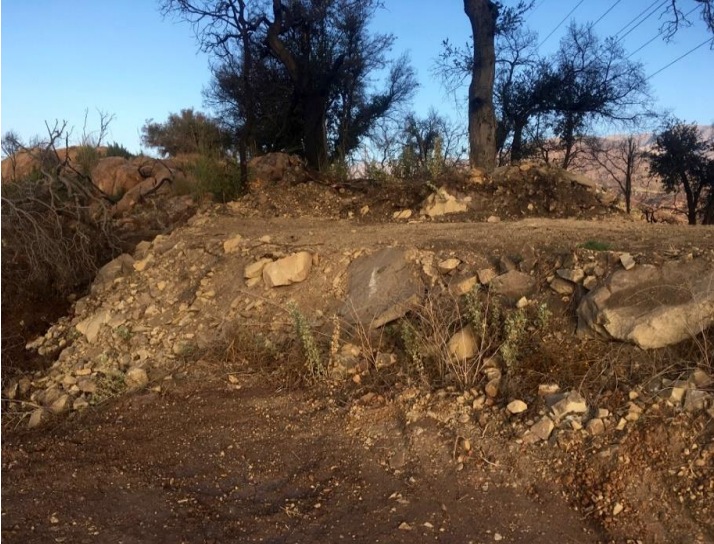
Photo 2 – Cut bank needs restoration. Photo looking west.
10/30/18	SBCRP – Segment 4, TSP 112

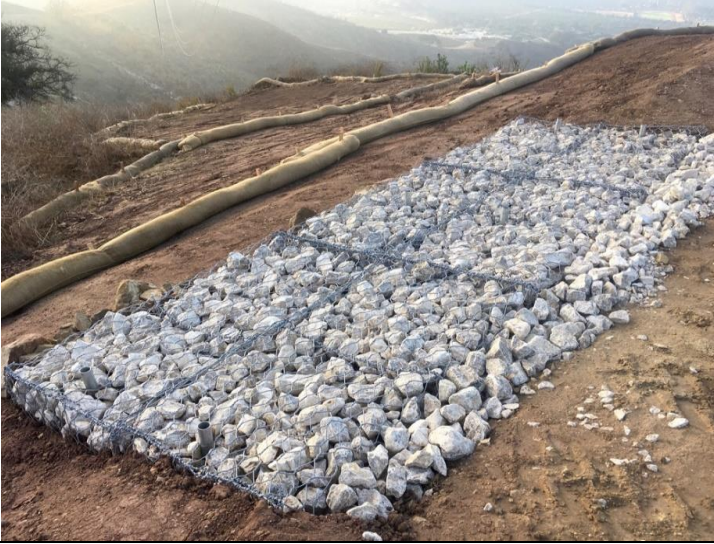
Photo 3 – Best management practices (BMPs) installed around the TSP 112 construction pad.

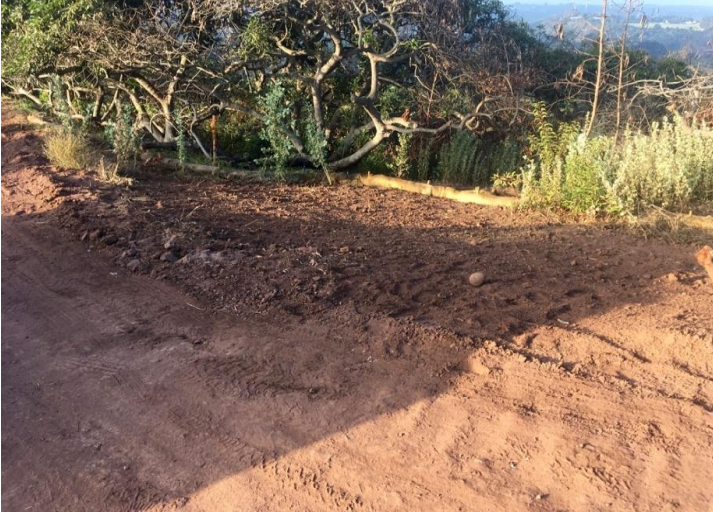
At TSP 108, the steel and the foundation from the old tower were removed – Photo 4. Hydroseeding activities would soon follow.

Photo 4 – Cleaning needed at the old tower locations.
10/30/18	SBCRP – Segment 4, TSP 107	 	Photo 5 – “Fire restoration” work being completed at TSP 107. Photo facing east.
10/30/18	SBCRP – Segment 4, TSP 120

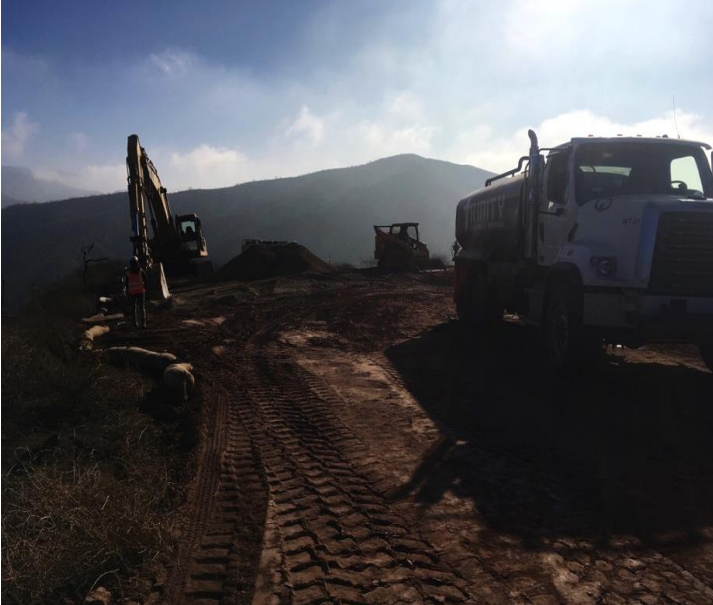
Photo 6 – Cleaning activities at the staging area, located above TSP 120. Photo facing east.

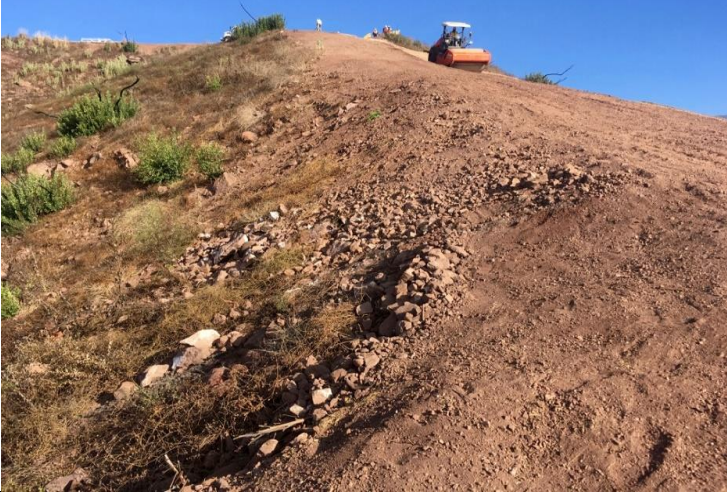
Photo 8 – Soil and rock that has sloughed from the access road.
10/30/18	SBCRP – Segment 4, TSP 120	 	Photo 9 – Road base being compacted into the access road. Photo facing north.

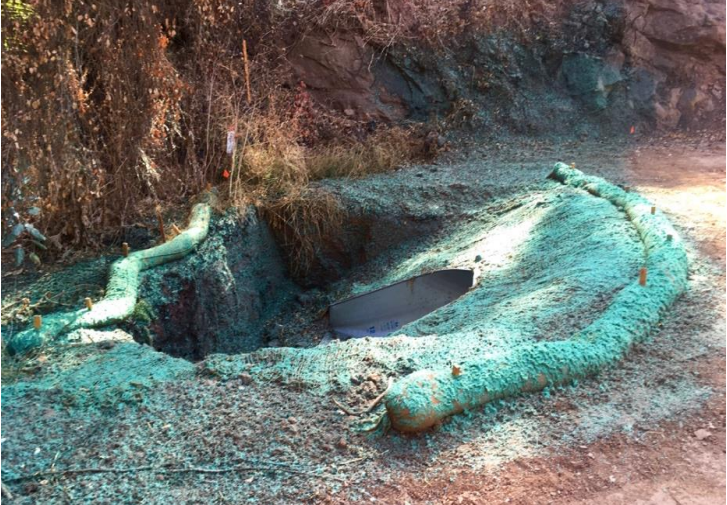
Photo 12 – Hydroseeded culvert; this area may need regarding to reduce head cutting.
