**Re: Monthly Report Summary #15 for the Santa Barbara County Reliability Project**

CPUC Site Inspection Report

## Santa Barbara County Reliability Project CPUC Site Inspection Form

<b>Project:</b>	Santa Barbara County Reliability Project	<b>Date:</b>	December 14, 2018
<b>Project Proponent:</b>	Southern California Edison	<b>Report #:</b>	VS036
<b>Lead Agency:</b>	California Public Utilities Commission	<b>Monitor(s):</b>	Vince Semonsen
<b>CPUC PM:</b>	Jensen Uchida, Energy Division	<b>AM/PM Weather:</b>	Overcast and cool temperatures with a slight breeze
<b>E &amp; E CM:</b>	Fernando Guzman	<b>Start/End time:</b>	0630 to 1200
<b>Project NTP(s):</b>	NTP-1, NTP-2, NTP-3, NBMP, NIWCP

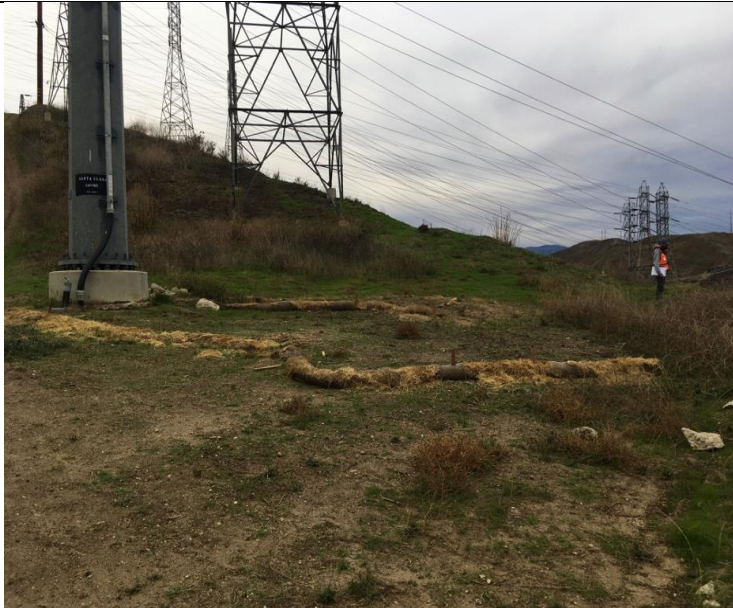
Date	Location	Photo	Description
12/14/18	SBCRP – Segment 1 TSP 201 E

Our initial stop was at TSP 201 E near the Substation – Photos 1 & 2. This area was trenched for conduit pipe installation that ran between the Substation to the tubular steel pole (TSP). The disturbed area appeared to be well vegetated and stabilized.

Photo 1 – Restored and revegetated area near the tower.
12/14/18	SBCRP – Segment 1 TSP 201 E

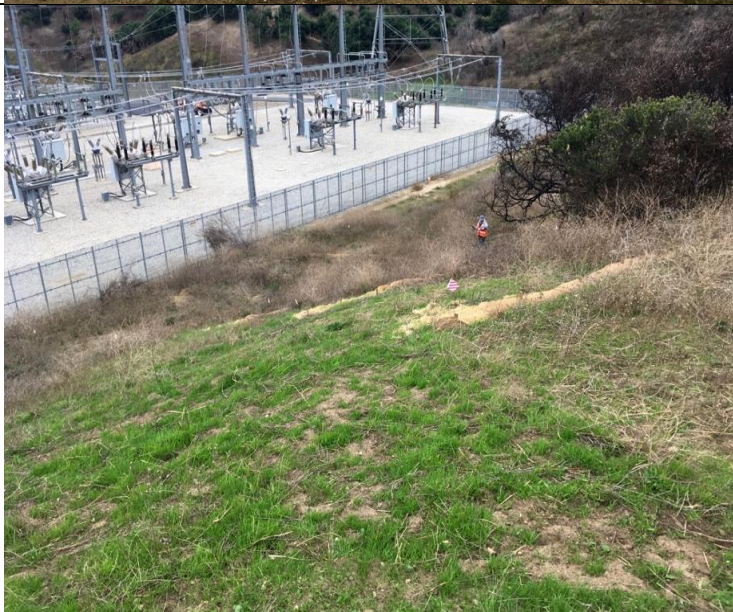
Photo 2 – Restored and revegetated slope down towards the Substation, located near the tower.

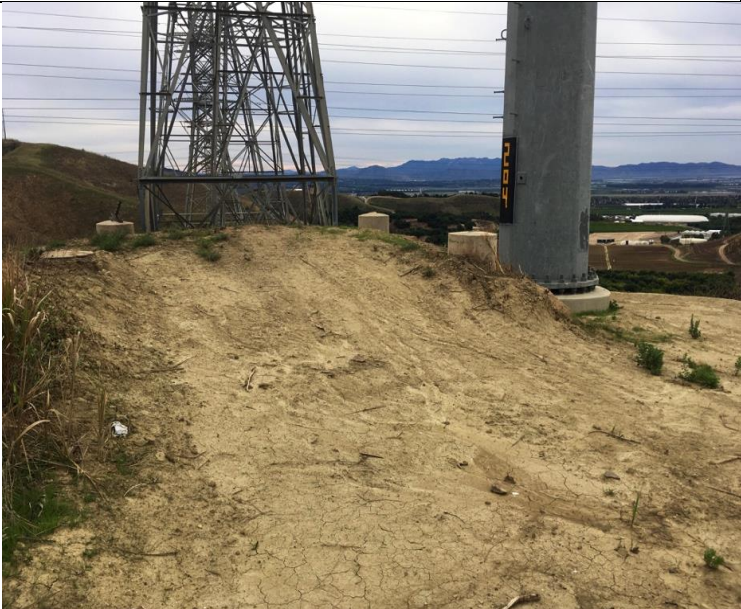
REPRESENTATIVE SITE PHOTOGRAPHS			
Date	Location	Photo	Description
12/14/18	SBCRP – Segment 1, TSP 204

Our second stop was at TSP 204, where a small ramp of soil was pushed near the TSP – Photo 3. This location had minimal cover.

Photo 3 – Revegetation of a small ramp of soil.
12/14/18	SBCRP – Segment 1, TSP 211

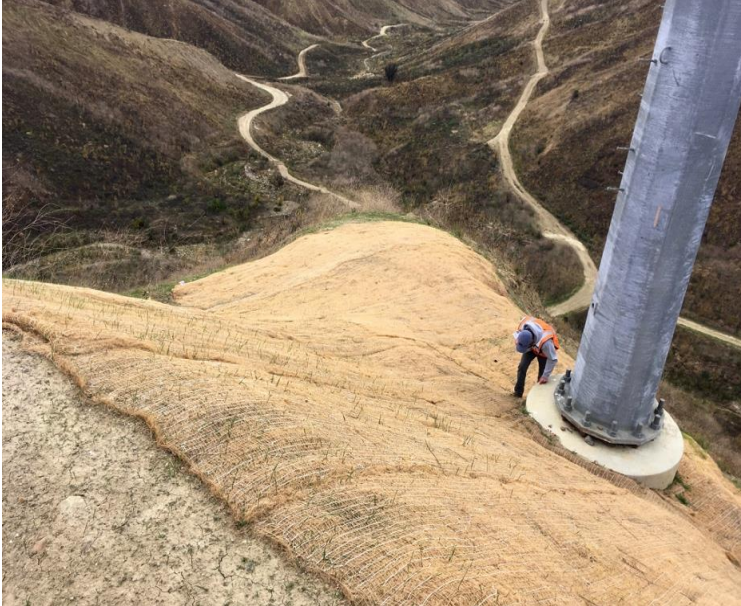
At our third location, a steep slope near TSP 211 was hydroseeded and covered with a coconut blanket – Photo 4. Plant cover was low, but a large number of diverse seedlings were growing through the erosion blanket.

Photo 4 – Revegetation evaluation of a disturbed area near the TSP.

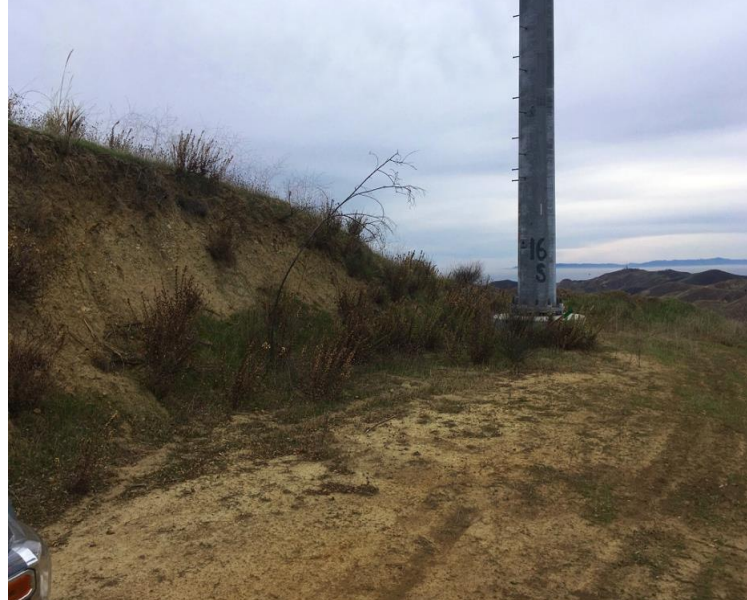
Date	Location	Photo	Description
12/14/18	SBCRP – Segment 1, TSP 216

Our fourth pole location was at TSP 216, where a cut bank was being revegetated. Plant growth was slow, but the area appeared stable – Photo 5.

Photo 5 – Evaluation of revegetation.
12/14/18	SBCRP – Segment 1, Getty Tap area

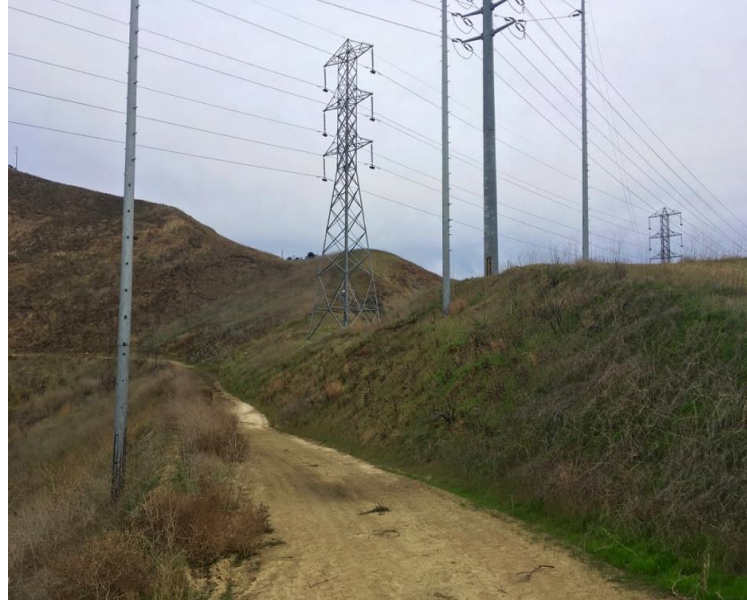
Our last stop along Segment 1 was at the Getty Tap, where a cluster of towers are located – Photo 6. During construction, crews walked into the area around guard poles; the trails were part of the quarterly evaluation. The revegetation was excellent, and it was difficult to identify where the trails were located.

Photo 6 – Revegetation was completed over some walking trails around the guard poles.
