Re: Monthly Report Summary #16 for the Santa Barbara County Reliability Project

CPUC Site Inspection Report
February 8 and 26, 2019

Santa Barbara County Reliability Project CPUC Site Inspection Form

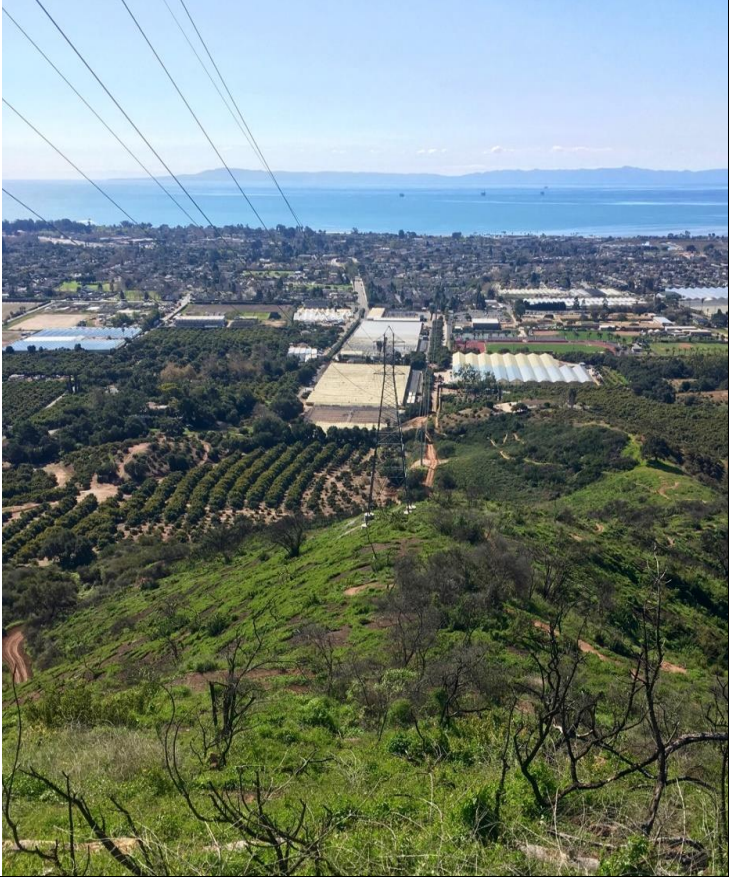
Photo 4 is the view looking down toward the power lines near the Carpinteria Substation and TSP 132. A Henkels and McCoy (H&M) foreman was preparing to operate a dozer along the access road to begin final restoration work – Photo 5.

Photo 4 – Revegetation evaluation of disturbed area near the TSP on the Franklin Trail.
02/08/18	SBCRP – Segment 4, TSP 130

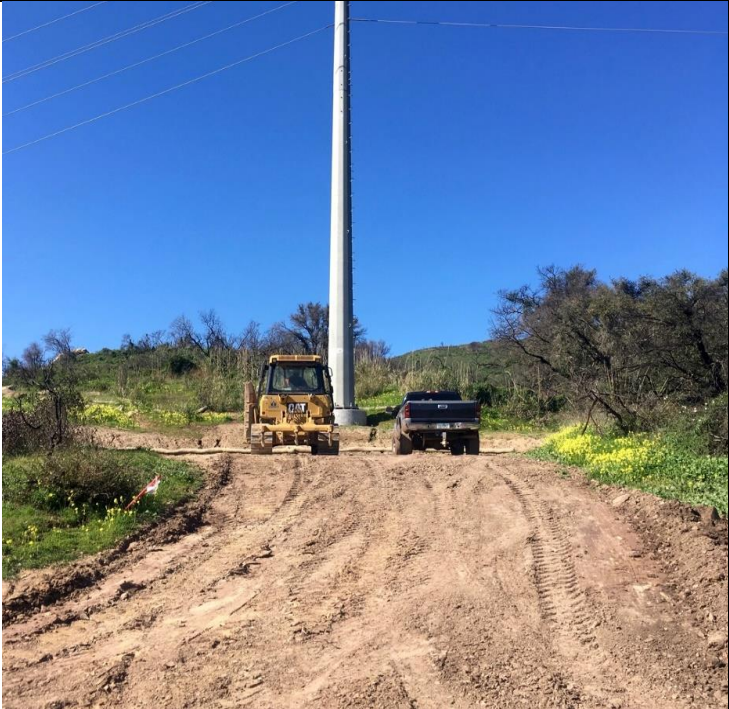
Photo 5 – Equipment onsite. Photo facing west.

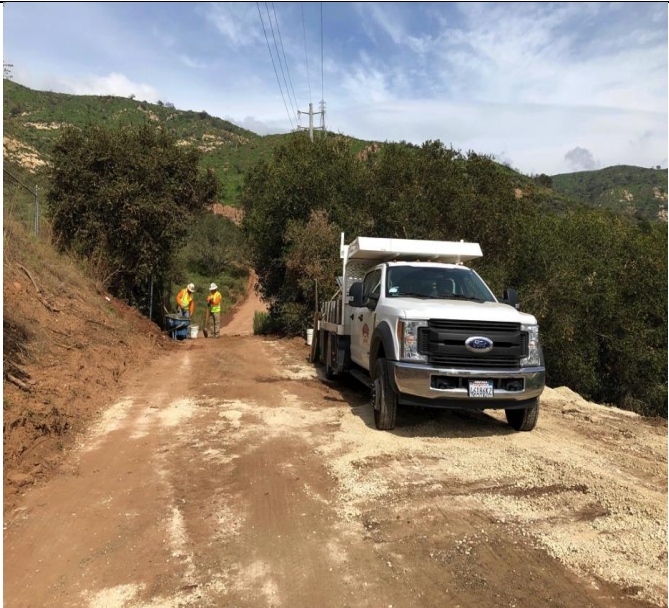
Date	Location	Photo	Description
02/26/18	SBCRP – Segment 4 TSP 133

We drove part way up the Franklin Trail access road, where a two-person crew was installing a gate directly past TSP 133 – Photo 1. Mike Moss mentioned that other work was occurring along the Franklin Trail access road, which included road repair and installation of a McCarthy drain. According to Mike, this work was classified as “Fire Restoration” or “Non-Project Related.” He also mentioned that the road was completely washed out at the Sutton Creek crossing; therefore, access was cut off from several towers.

Photo 1 – Gate installation along the Franklin Trail access road. Photo facing north.
02/26/18	SBCRP – Segment 4 TSP 112

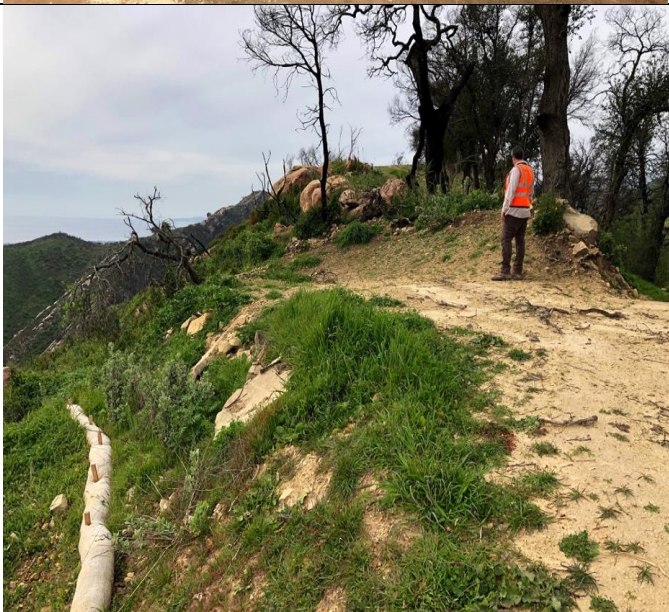
- On February 26, 2019, the CPUC Compliance Monitor inspected the work at TSP 112 and noted a small parking pad graded under the dripline of several oak trees adjacent to the TSP 112 access road and tower pad. The CPUC Compliance Monitor noted several oak tree roots damaged and left exposed following the grading. Restoration and hydroseeding were recommended.
- On February 26, 2019, the CPUC Compliance Monitor noted several installed best management practices (BMPs) near tubular steel poles (TSPs) 18 and 20 needing upgrades since most appeared washed out or nearly washed out.

Our first stop was at TSP 112, where I evaluated the revegetation. During construction, a small parking pad was graded under the dripline of several oak trees adjacent to the TSP 112 access road and tower pad. Several oak tree roots appeared damaged and had been left exposed following the grading. I commented on this location in previous reports in October 2018, recommending restoration and reseeding. At that time, I spoke to the environmental team, one of the Henkels and McCoy (H&M) foreman, and I also sent an email to Marcus Obregon from SCE. Unfortunately, the pad did not appear to be restored – Photo 2. However, Mike Moss mentioned crews delivered soil to cover the exposed oak roots.

Photo 2 – Graded parking pad needs restoration. Photo facing west.

Restoration of the small parking pad at TSP 112.

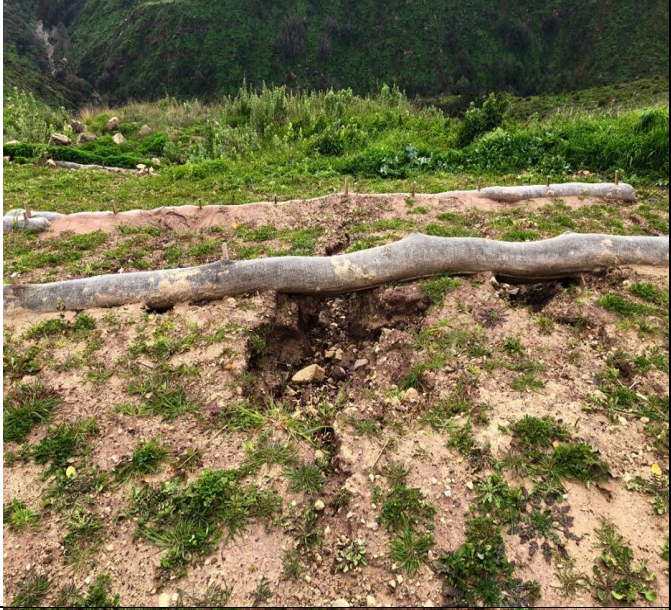
REPRESENTATIVE SITE PHOTOGRAPHS			
Date	Location	Photo	Description
02/26/18	SBCRP – Landowner's property access road

We drove out from the access road to TSP 118; the road was blocked by a slide directly past TSP 118, therefore, we walked toward the end of the road near TSP 119. There were several locations along this access road where moving rocks was required in order to have access to drive through. A few of the best management practices (BMPs) installed around the towers needed upgrades, since they were washed out – Photo 3 – or nearly washed out – Photo 5. The gabion walls placed along the roadway at the small drainage crossings appeared to have held up well – Photo 4.

Photo 3 – BMPs needing maintenance, located along the access road.
02/26/18	SBCRP – Vedder property access road

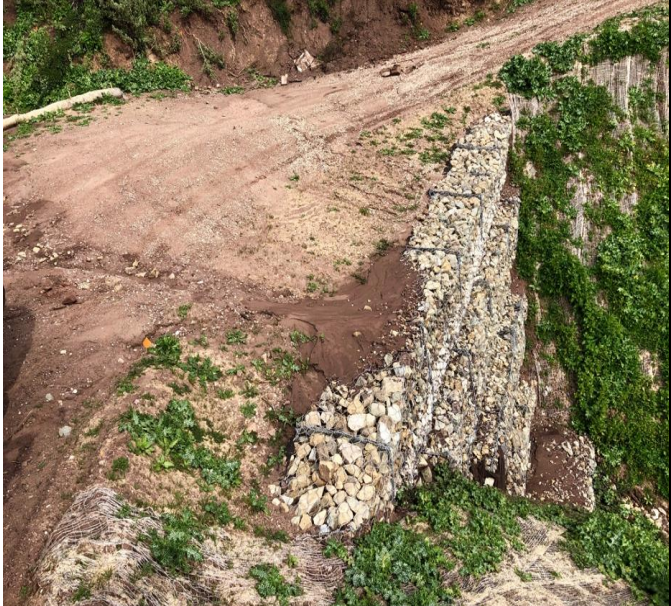
Photo 4 – Gabion walls held up well at the various drainage crossings.
