Re: Monthly Report Summary #18 for the Santa Barbara County Reliability Project

CPUC Site Inspection Report

April 17, 2019

Santa Barbara County Reliability Project CPUC Site Inspection Form

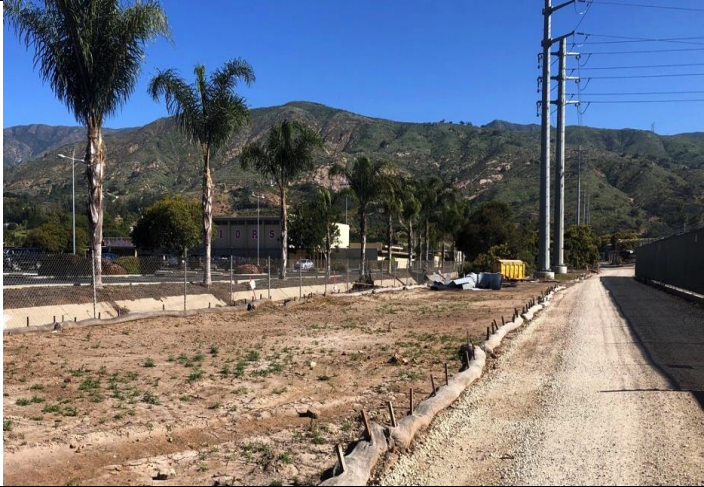
I arrived onsite and met with lead environmental biologist Mike Moss at 0930 near the Carpinteria Substation. Some staging of materials continued under the power lines near the substation – Photo 1. Best management practices (BMPs) were installed in this area. They were in poor condition; however, no rain was expected for a while now.

Photo 1 – Staging area near the Carpinteria Substation. Photo facing north.
04/17/19	SBCRP – Segment 4

- On April 17, 2019, the CPUC Compliance Monitor noted several damaged BMPs installed near the Carpinteria Substation staging area. The CPUC Compliance Monitor recommended upgrading and stabilizing these BMPs prior to rain events.
- On April 17, 2019, the CPUC Compliance Monitor noted that the bushtit nest located near tubular steel pole (TSP) 133 appeared predated. The CPUC Compliance Monitor recommended notifying the onsite avian biologist to inspect the nest.
- On April 17, 2019, the CPUC Compliance Monitor and an onsite project biologist encountered a gopher snake warming itself on the access road asphalt near TSP 112. The gopher snake was relocated away from the road so it would not get injured by traveling vehicles.

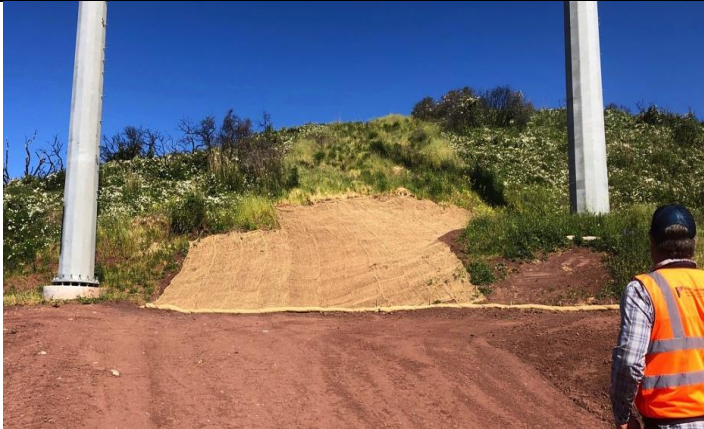
BMP upgrades were completed around TSPs 127 and 128 – Photos 2 & 3. We discussed the adequacy of the BMPs. There was also a new McCarthy drain installed to collect the rainwater runoff from the TSP 128 pad – Photo 4.

Photo 2 – BMP work at TSPs 126 & 127. Photo facing west.
04/17/19	SBCRP – Segment 4

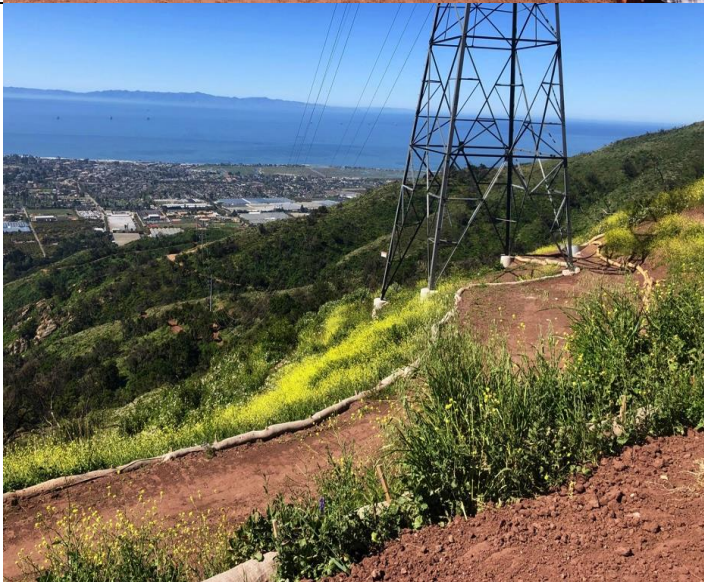
Photo 3 – Looking south down towards the power lines from TSP 128. Photo facing south.

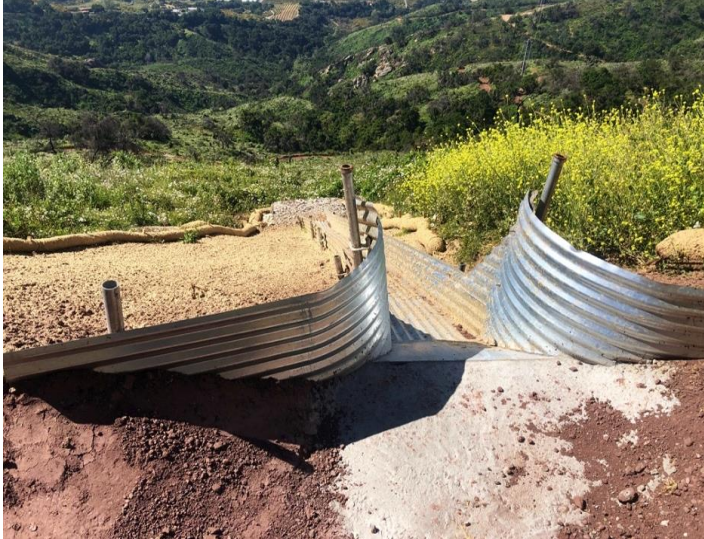
Photo 4 – McCarthy drain installed at TSP 128. Photo facing south.
04/17/19	SBCRP – Segment 4

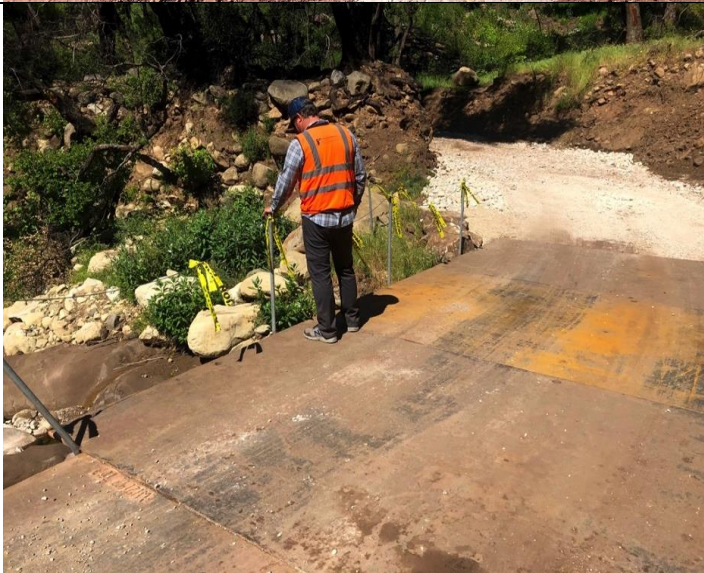
A substantial amount of “Non-Project Related” work was completed along the road, including numerous sites that were regraded, McCarthy drain installations, and the bridgework at Sutton Creek – Photo 5. According to Mike Moss, the temporary bridge installed over Sutton Creek was to be soon be removed. The “Non-Project Related” work was overseen by the biological monitors but it was not subject to the conditions of the Santa Barbara County Reliability project (SBCRP) construction efforts. This work was being completed by the Henkels and McCoy (H&M) contractor.

Photo 5 – Temporary bridge installed over Sutton Creek along the Franklin Trail access road.
04/17/19	SBCRP – TSP 120, Segment 4

An explanation for determination of work being “Non-Project Related.”

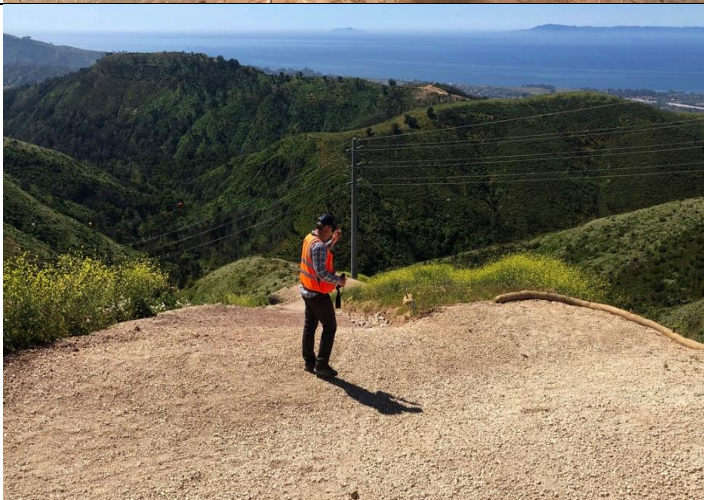
Erosion repairs have been made at TSP 120, including cutting water bars, laying gravel the access road, and lining larger rock along the rilled area – Photo 6.

Photo 6 – Erosion problems were fixed on the access road and at the tower pad. Photo facing southeast.

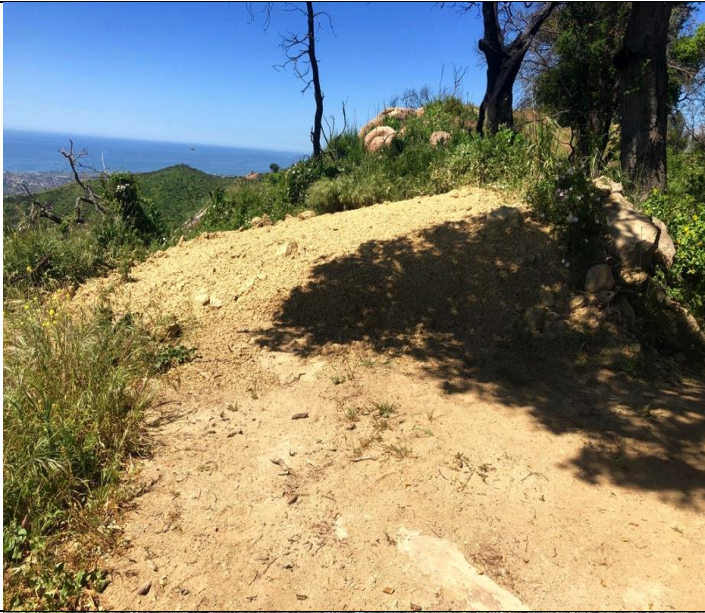
We drove onto the landowner property near TSP 112. The small parking area under the oak trees had been restored – Photo 7. Soil appeared to have been added to the cut bank and the site was hydroseeded. On the way down we encountered a gopher snake warming itself on the asphalt – we relocated it away from the road so it would not get run over by traveling vehicles – Photo 8.

Photo 7 – Restored parking spot under the oak trees. Photo facing southwest.
04/17/19	SBCRP – Segment 4

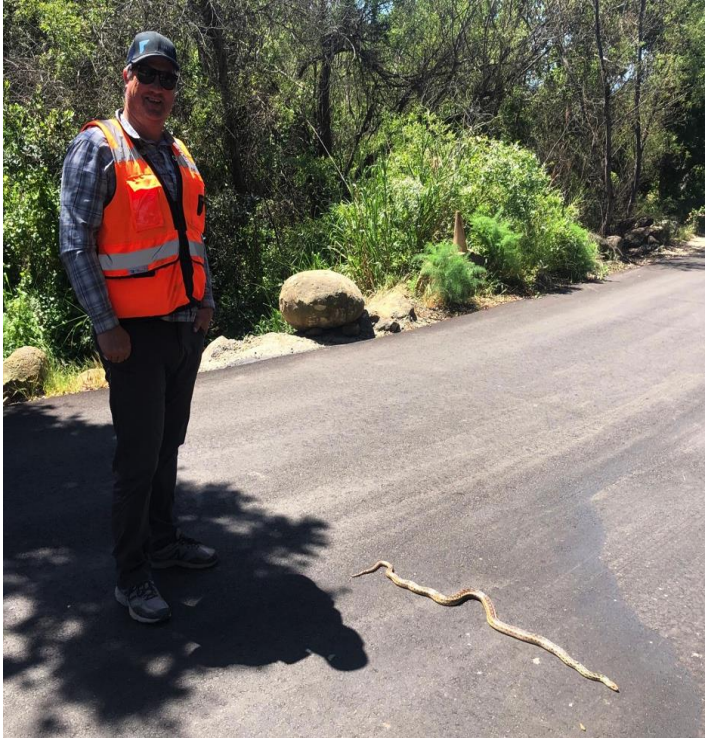
Photo 8 – Gopher snake on the road. The snake was properly relocated away from the road so it would not get injured from traveling vehicles.

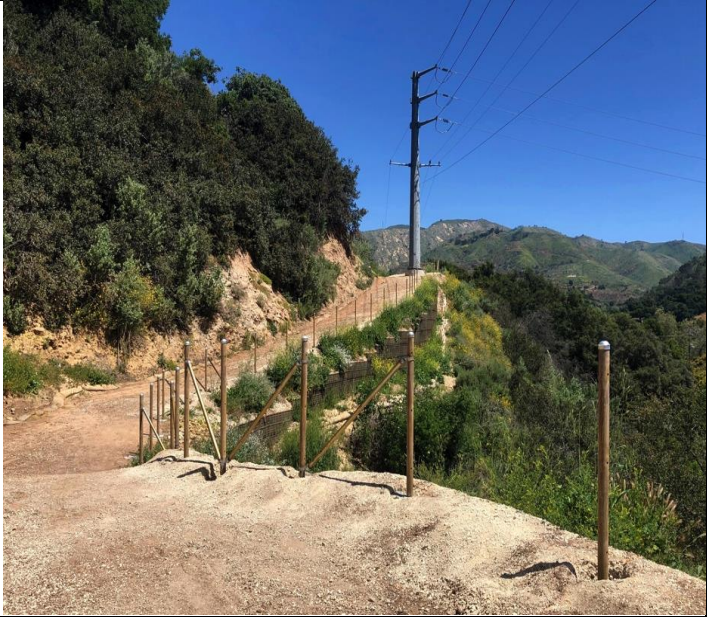
Our last stop was at TSP 76 where a crew was installing a handrail along the tower access road – Photo 9.

Photo 9 – Handrail installation along the tower access road. Photo facing east.
