### **Re: Monthly Report Summary #5 for the Santa Barbara County Reliability Project**

CPUC Site Inspection Report  
February 8 and 22, 2018

## Santa Barbara County Reliability Project CPUC Site Inspection Form

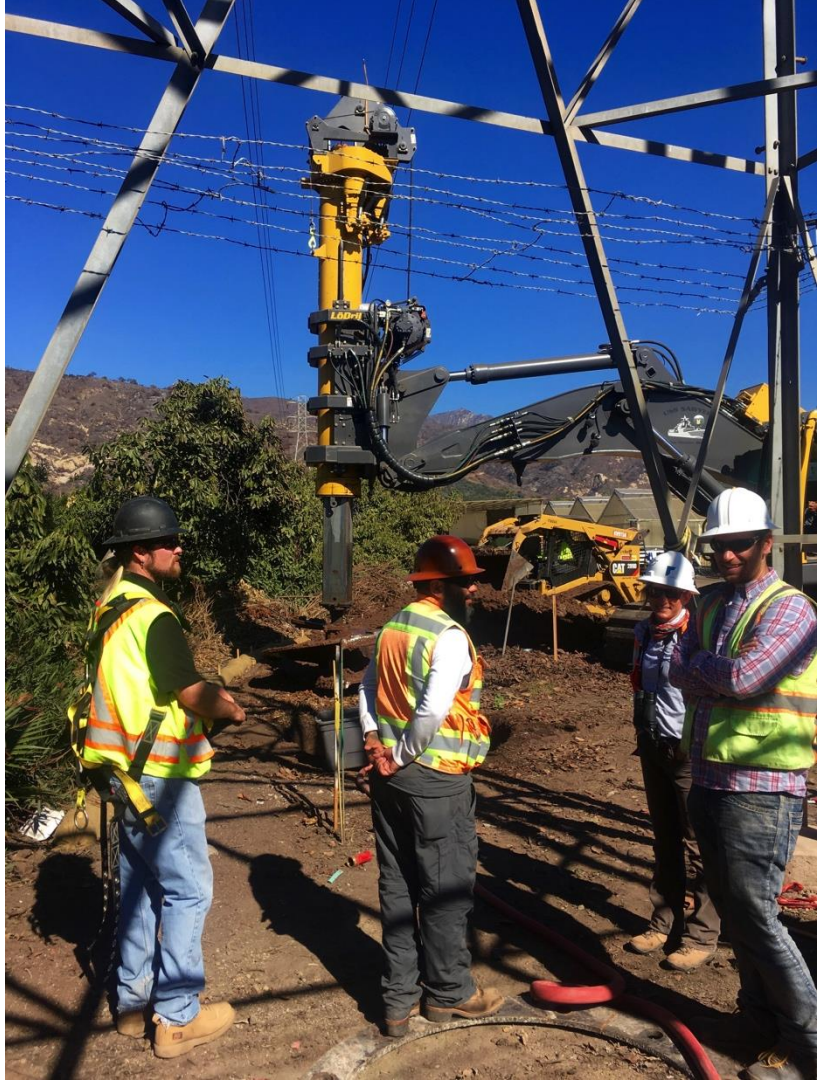
Date	Location	Photo	Description
2/8/18	Segment 4 – Construct 137

At the Carpinteria Substation, a crew was drilling the hole for Construct 137 (Photo 3). This work was being monitored by Rincon biologist Dannique Aalbu and GANDA paleontologist Andrew Paden (MM CR-13). At the time of my site visit, the drilling depth was 13 feet; the final depth will be 31 feet (Photo 4). Earlier in the day, Dannique Aalbu had observed a peregrine falcon perched on one of the power poles.

Photo 3 – A crew is drilling the foundation hole for Construct 137, which is located just outside of the Carpinteria Substation. Photo facing north.

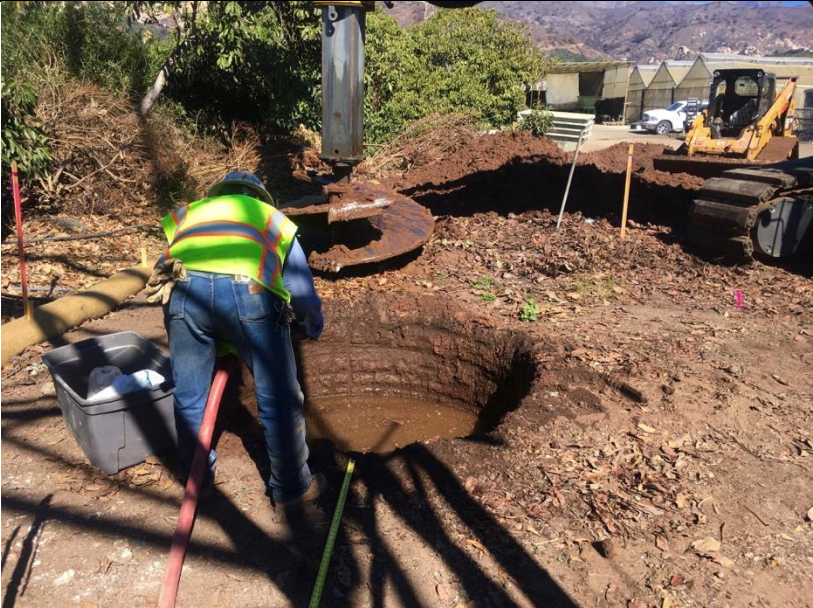
REPRESENTATIVE SITE PHOTOGRAPHS			
Date	Location	Photo	Description
2/8/18	Segment 4 – Constructs 137

Photo 4 – Foundation hole for Construct 137. Photo facing north.
2/8/18	Carp B Yard

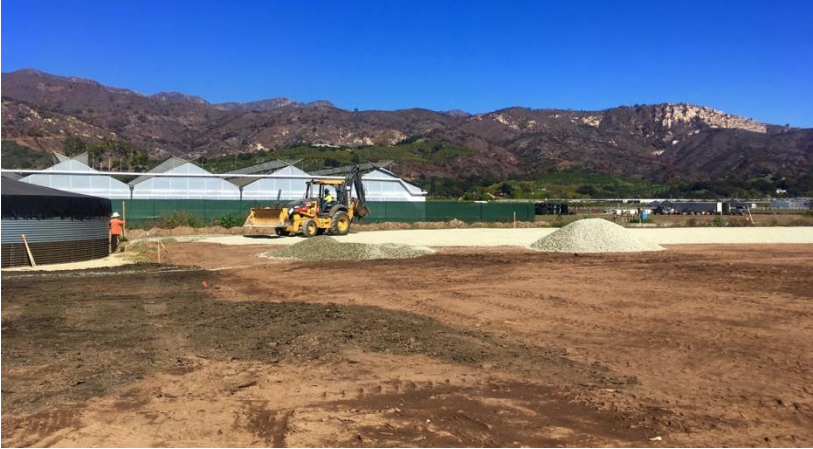
As more work moved into the Carpinteria Substation area, a Henkels & McCoy (H&M) crew was moving trailers and equipment to a new yard just east of the Carpinteria Substation (referred to as the Carpinteria Yard B). BMPs were surrounding the Carpinteria Yard B and gravel was being laid (Photos 5 and 6).

Photo 5 – A crew is spreading gravel around the new Carpinteria Yard B. Photo facing north.
2/8/18	Carp B Yard

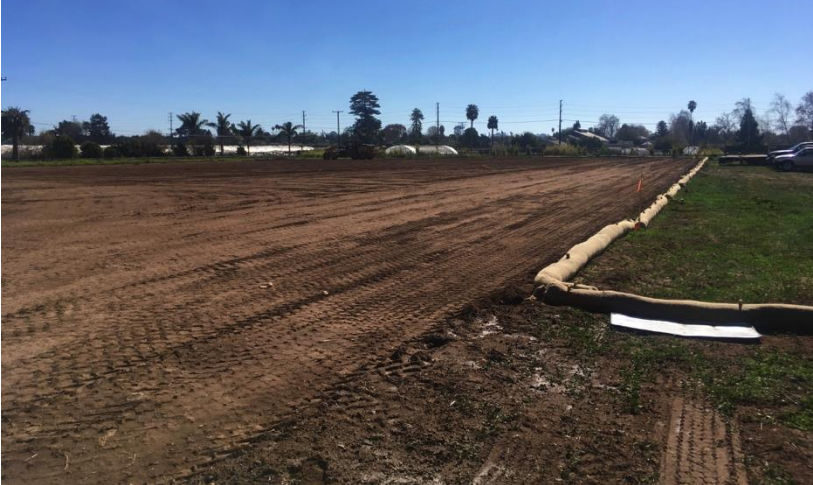
Photo 6 – BMPs are installed around the new Carpinteria Yard B. Photo facing south.

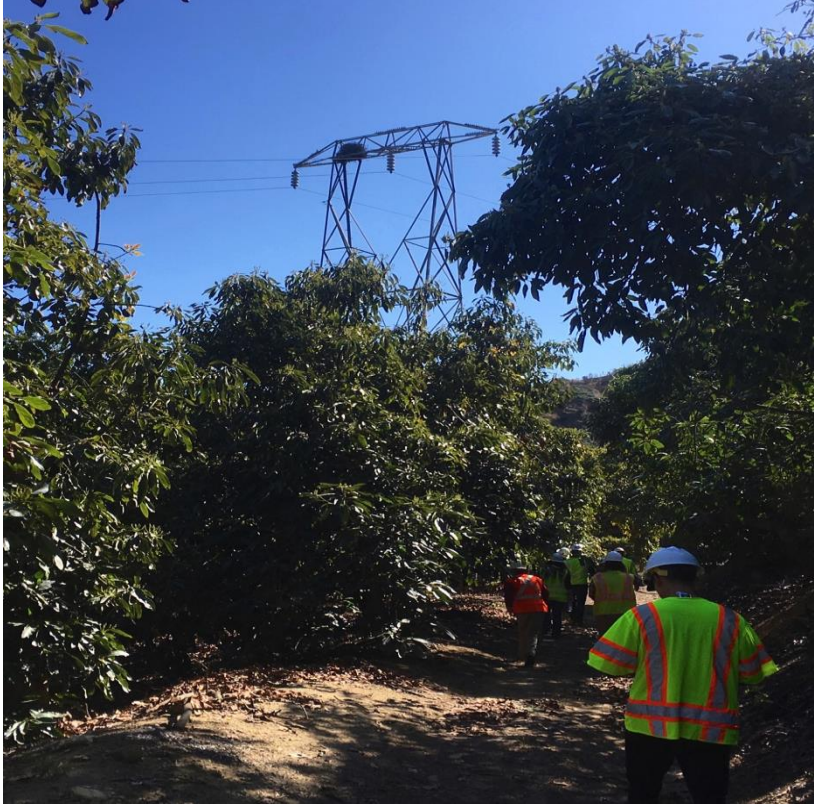
REPRESENTATIVE SITE PHOTOGRAPHS			
Date	Location	Photo	Description
2/22/18	Segment 5 – Tower M7-T4

Our first stop was along Segment 5 at Tower M7-T4. The approved access road would require extensive road improvement work, whereas the alternative route would be much simpler to prepare. Both roads run through an avocado orchard. The tower was slated for removal; therefore, only minimal equipment would be needed. Rincon lead biological monitor James Rasico was monitoring Tower M7-T4 because a pair of red-tailed hawks was nesting in the tower (APM BIO-3, APM BIO-4, MM BIO-10) (Photo 1).

Photo 1 – Red-tailed hawk nest in the tower to be removed. Photo facing east.

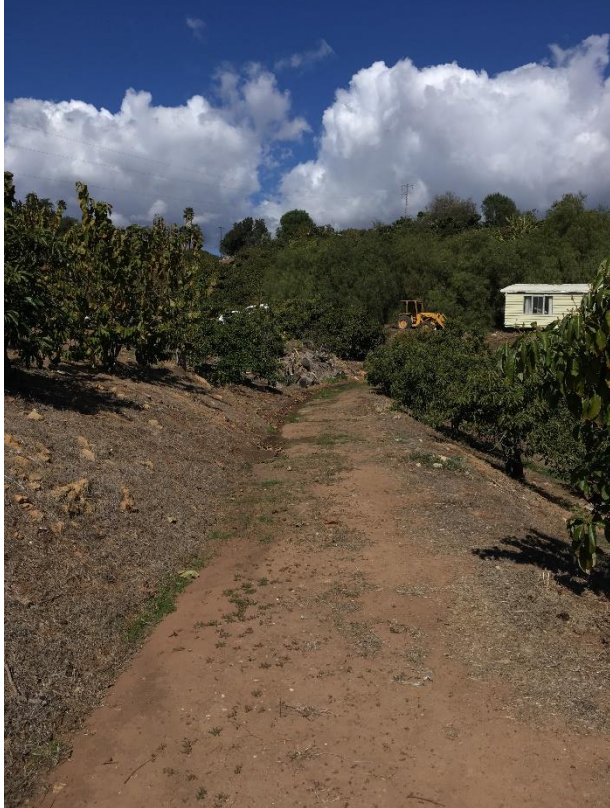
Date	Location	Photo	Description
2/22/18	Segment 4 – Tower M8-T7

Our next stop was tower M8-T7, which was also slated for removal. The landowner had recently installed an access road that provides direct access to the tower. SCE is proposing to use this access road to reduce agricultural impacts (Photo 3).

Photo 3 – SCE is proposing to use this access road recently installed by the landowner. Photo facing north.
2/22/18	Segment 4 – Constructs 126 and 127

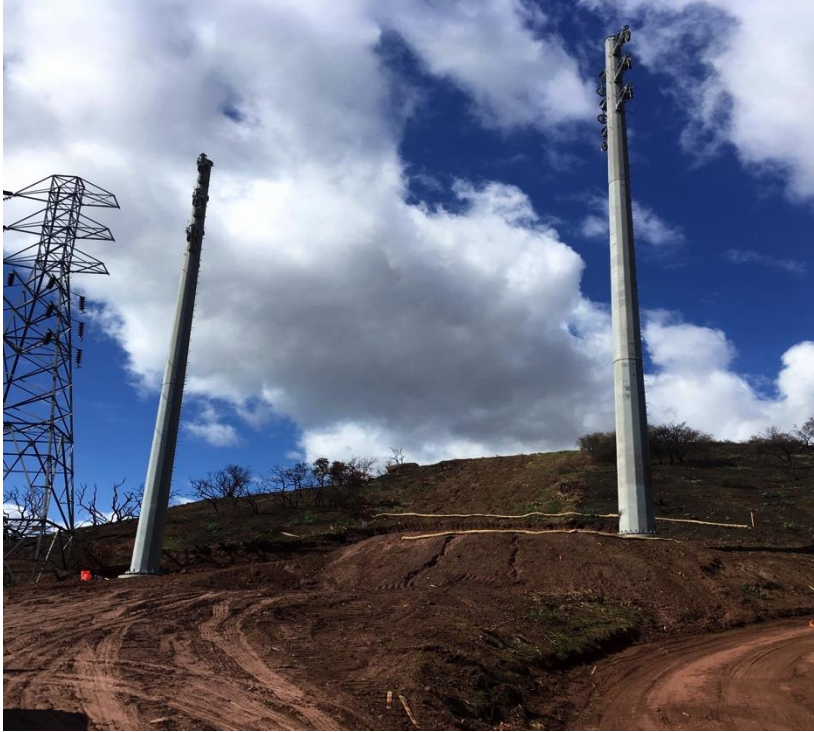
After a brief stop at the new Carpinteria Yard B, we drove to the foothills above the city of Carpinteria to look at Constructs 126 and 127 along Segment 4 (Photo 4). The area around the TSPs had been burned during the Thomas Fire, but new vegetation was slowly growing back (Photo 5). The access road to this location was scheduled for minor improvements; however, emergency crews for the Thomas Fire widened and graded this road. As a result, SCE no longer needs to make the improvements, but BMPs (e.g., water bars and gravel bags to stabilize the area) will still be necessary.

Photo 4 – TSPs in the burned foothills above the city of Carpinteria. Photo facing west.

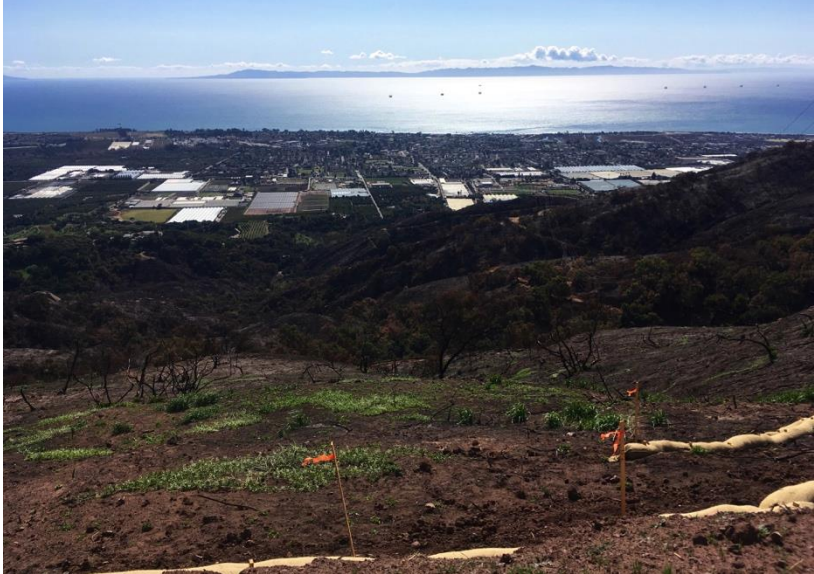
REPRESENTATIVE SITE PHOTOGRAPHS			
Date	Location	Photo	Description
2/22/18	Segment 4

<p>Photo 5 – View from Construct 126 south toward the city of Carpinteria. Photo facing south.</p>
