Re: Monthly Report Summary #6 for the Santa Barbara County Reliability Project

CPUC Site Inspection Report
March 8 and 19, 2018

Santa Barbara County Reliability Project CPUC Site Inspection Form

Project:	Santa Barbara County Reliability Project	Date:	March 8, 2018
Project Proponent:	Southern California Edison	Report #:	VS014
Lead Agency:	California Public Utilities Commission	Monitor(s):	Vince Semonsen
CPUC PM:	Jensen Uchida, Energy Division	AM/PM Weather:	Partly cloudy with mild temperatures and calm winds
E & E CM:	Jenny Vick	Start/End Time:	0700 to 1330
Project NTP(s):	NTP-1, NTP-2, NTP-3

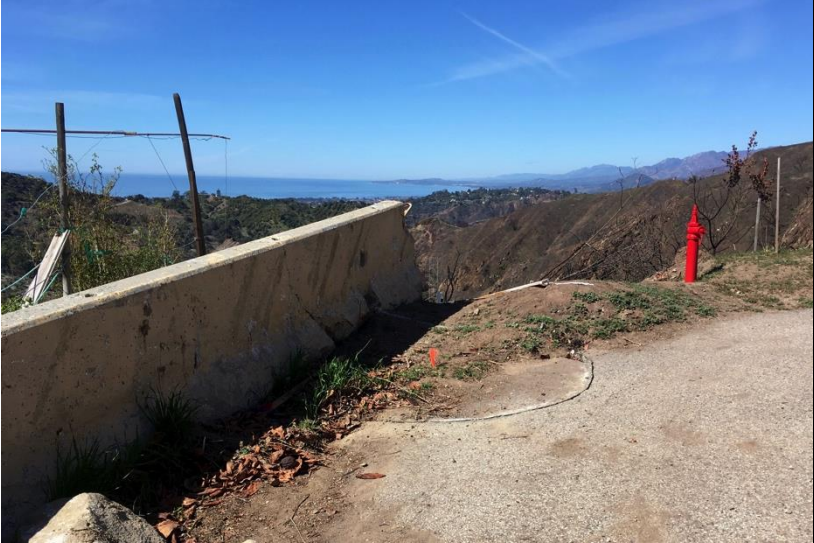
Date	Location	Photo	Description
3/8/18	Construct 95

Photo 7 – TSP location just prior to drilling. Photo facing west
3/8/18	Construct 81

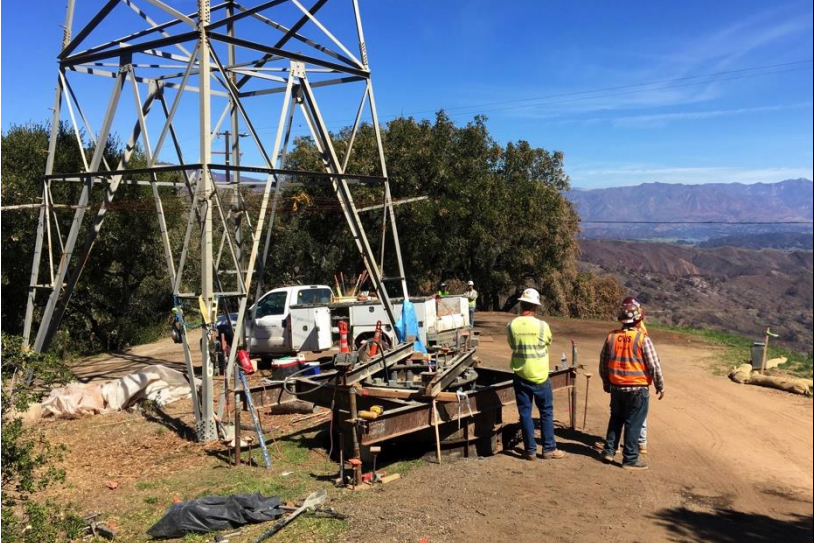
I drove with BRC lead monitor Matt Schaap east on Highway 150 to check the work at Constructs 81, 82, and 83. Crews at Construct 81 had just finished pouring the new TSP foundation (Photo 8). BRC biological monitor Chris Titus was at Construct 81. At Construct 83, crews had cleared vegetation and were hauling it off site.

Photo 8 – The TSP foundation has just been poured. Photo facing northeast.
3/8/18	Construct 88

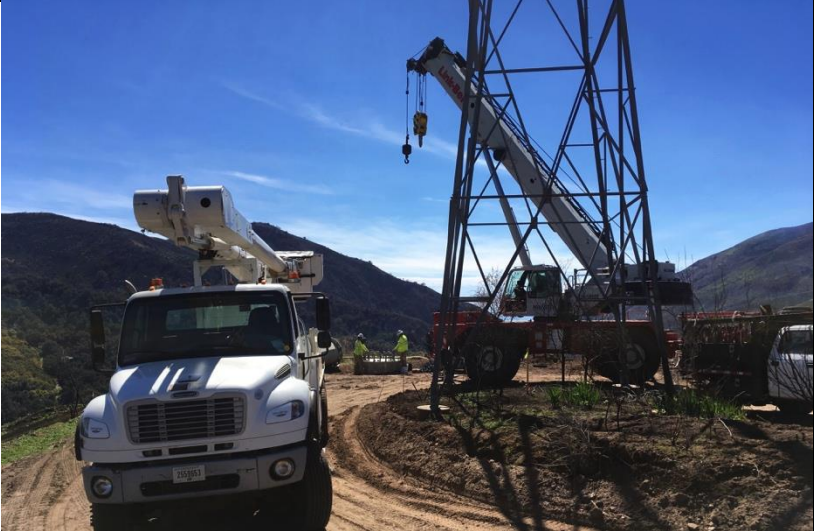
We then drove to Constructs 87, 88, and 89 where all of the TSP foundations had been previously drilled and poured. A crew had just finished setting the TSP at Construct 87 (Photo 11) and were preparing to set the TSP segments at Construct 88 (Photo 9). From there, the crew would head to Construct 89 where the TSP segments had already been stockpiled (Photo 10). BRC biological monitor Steve Jones was overseeing this construction activity.

Photo 9 – A crew is getting ready to set the TSP segments. Photo facing south.

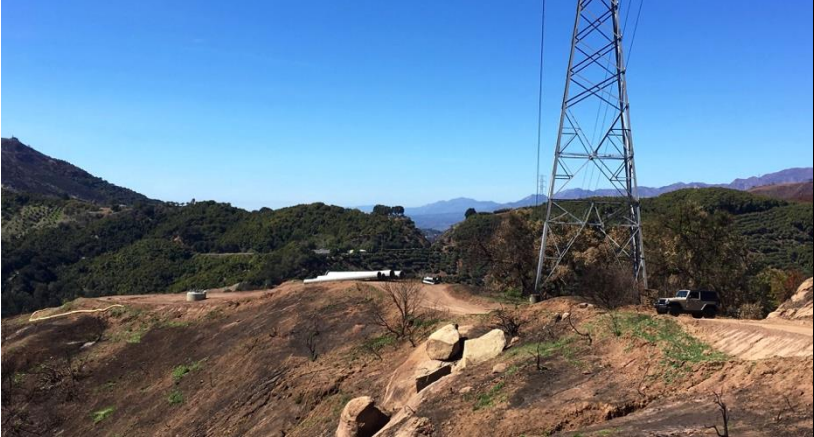
REPRESENTATIVE SITE PHOTOGRAPHS			
Date	Location	Photo	Description
3/8/18	Construct 89

Photo 10 – TSP segments stockpiled at Construct 89. Photo facing west
3/8/18	Construct 87

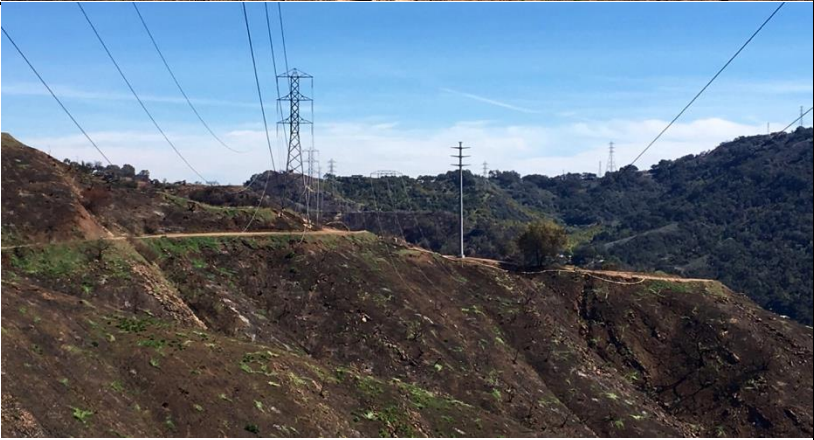
Photo 11 – Crews have just set the TSP at Construct 87. Photo facing east

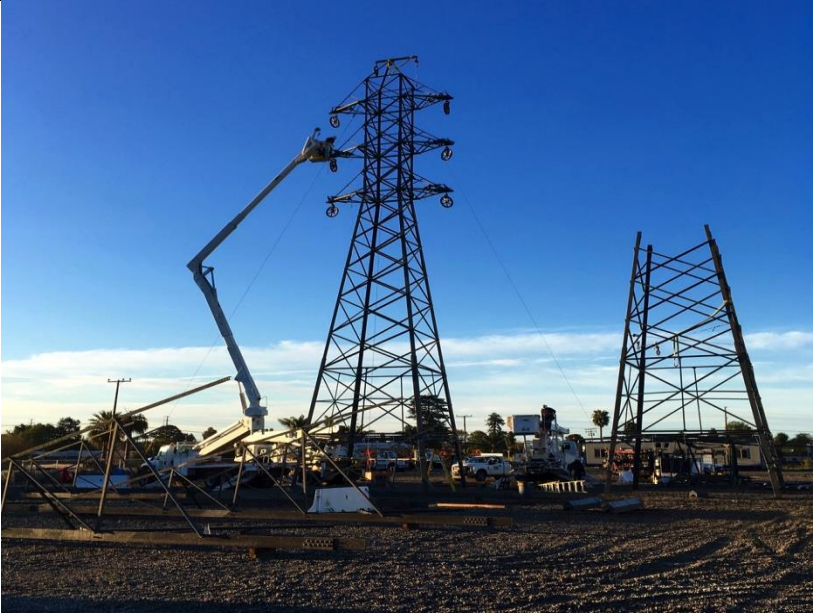
REPRESENTATIVE SITE PHOTOGRAPHS			
Date	Location	Photo	Description
3/19/18	Carpinteria Yard B

A crew was building a lattice steel tower within Carpinteria Yard B (Photo 1). Rincon lead environmental monitor James Rasico said this tower will be flown to one of the more difficult locations to access. I rode with James Rasico to check on the construction activities and monitoring crews (APM BIO-3, APM BIO-4).

Photo 1 – Tower construction in the yard.
3/19/18	Construct 85

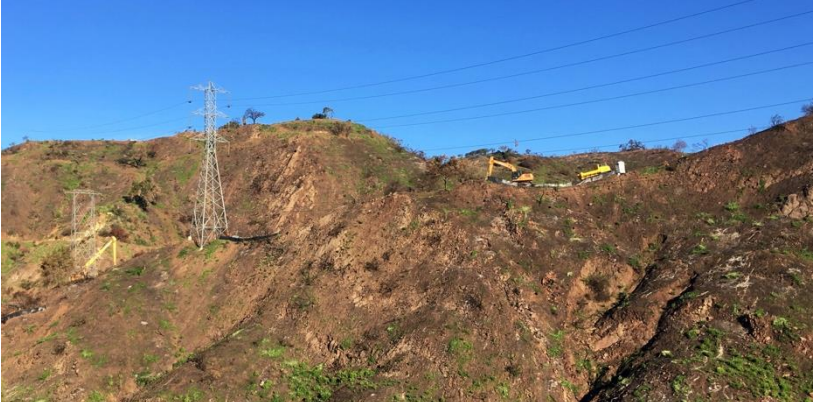
I rode with Rincon lead environmental monitor James Rasico east on Highway 150 and stopped to check Construct 85, located just north of Highway 150. The access roads were too muddy to enter this site; therefore, crews had parked the equipment along the access roads (Photo 2).

Photo 2 – Equipment parked along the access road; it is too muddy to access to Construct 85.
3/19/18	Construct 77

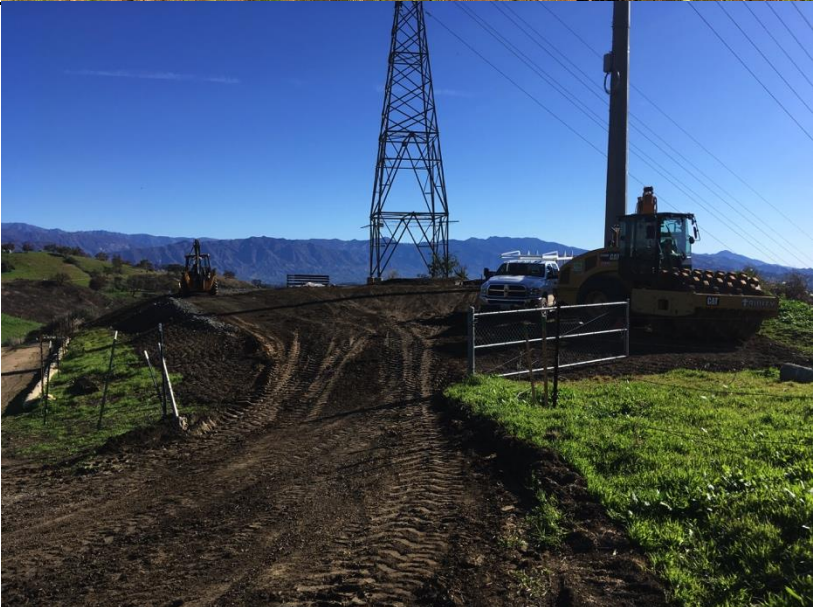
Farther east on Highway 150, we turned off at the "Y" and traveled south toward Segment 4 and Construct 77. The drilling crew had finished the foundation hole for Construct 77 during the previous week and were headed to Construct 79. The foundation hole was 44 feet deep and was covered with a metal plate and plastic (Photos 3 and 4). The crew anticipated they would drop the cage into place during the day of my site visit and then pour the foundation the following day, ahead of the storms. A crew was using a small loader/backhoe to spread the foundation hole tailings around the crane pad, in addition to prepping access to the hole. BRC biological monitor Dave Wappler was at this location.

Photo 3 – Foundation hole has been dug and the site is ready for the cage installation. Photo facing east.

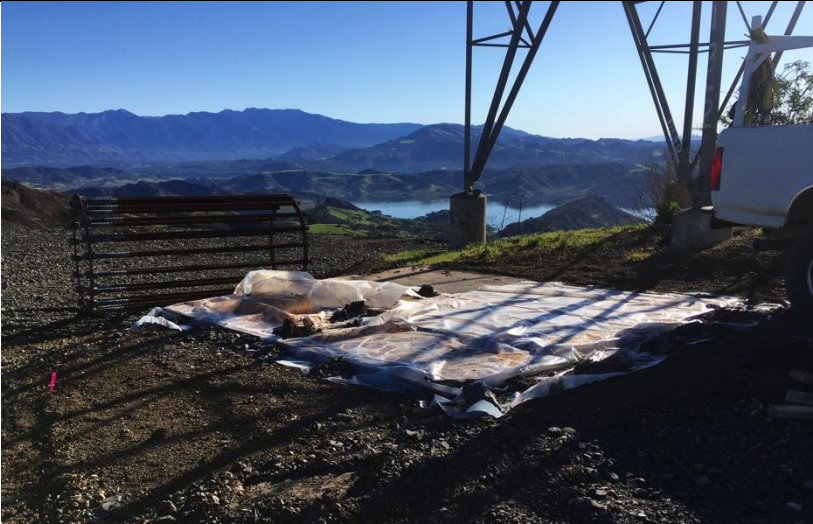
REPRESENTATIVE SITE PHOTOGRAPHS			
Date	Location	Photo	Description
3/19/18	Construct 77

Photo 4 – Foundation hole covered with a steel plate and plastic. Photo facing east.
3/19/18	Construct 78

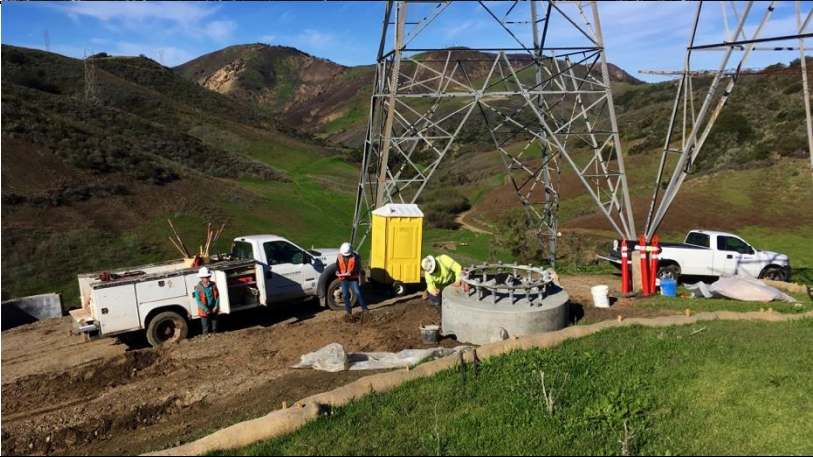
At Construct 78, a crew was stripping the forms off of the newly poured tower foundation (Photo 5). Rincon biological monitor Dannique Albu was at this site. When the drilling rig arrived at Construct 79, the crew began to set up (Photo 7).

Photo 5 – Stripping the forms off of the new tower foundation. Photo facing west.
3/19/18	Construct 80

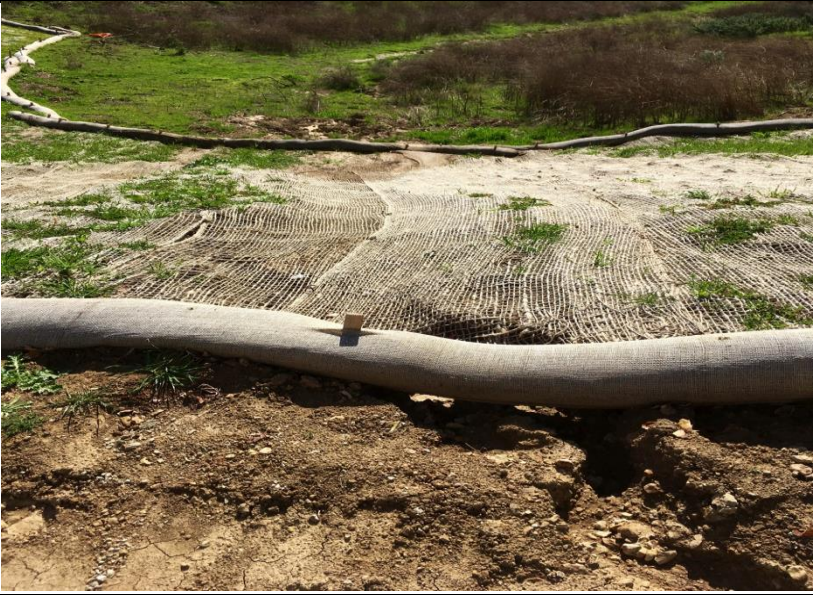
At Construct 80, the grading work had been finished a few months prior and the open ground site was stabilized with jute netting and wattles. At several locations, rainwater runoff had passed under the jute and washed out some of the slope (Photo 6). When Rincon SWPPP inspector Caitlyn Teague arrived at Construct 80, Rincon lead environmental monitor James Rasico and I discussed with her how to further stabilize the slope in preparation of the upcoming severe storms.

Photo 6 – BMP maintenance is needed at this location.

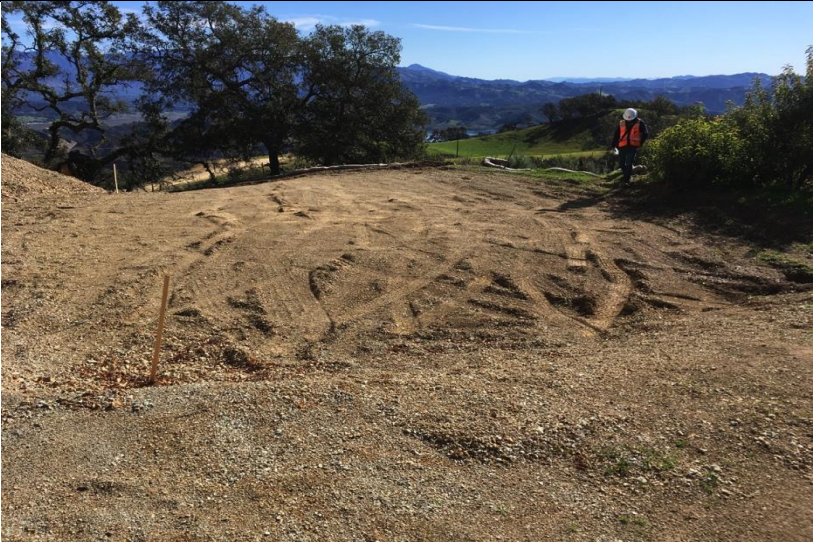
REPRESENTATIVE SITE PHOTOGRAPHS			
Date	Location	Photo	Description
3/19/18	Construct 79

Photo 7 – TSP location just prior to drilling. Photo facing east.
3/19/18	Construct 84

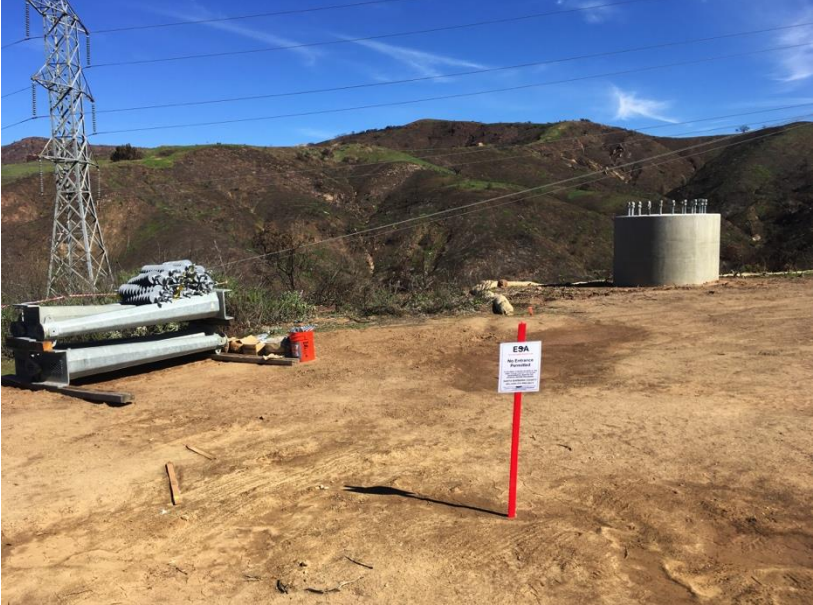
At Construct 84, the tubular steel pole (TSP) foundation had been poured and materials were stockpiled onsite (Photo 8). A bush tit nest was found north of the construction area, and ESA buffer signs had been posted (MM BIO-1, MM BIO-10). The buffer encompasses most of the TSP pad; therefore, unless the buffer is reduced, crews must wait until the nest is inactive to continue their work in this area.

Photo 8 – TSP foundation has been drilled and poured. A nest buffer now covers the construction area. Photo facing north.

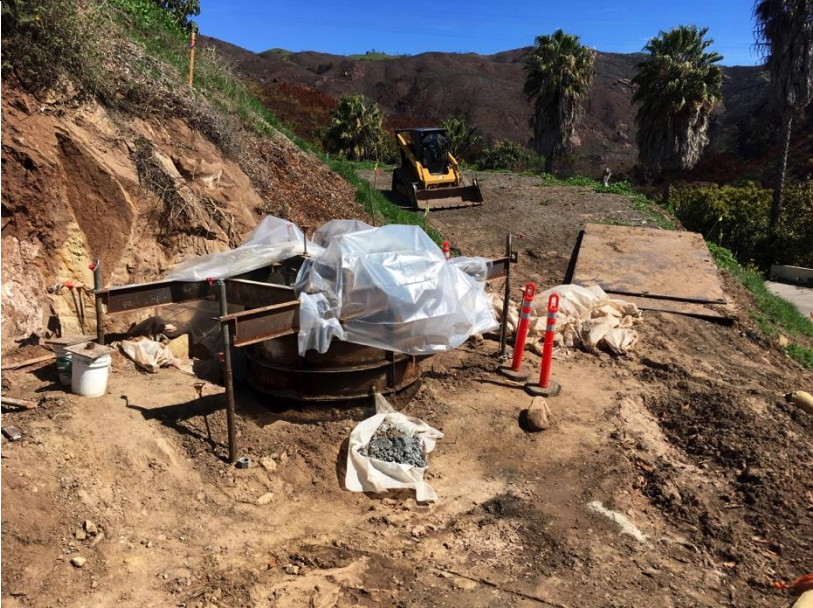
REPRESENTATIVE SITE PHOTOGRAPHS			
Date	Location	Photo	Description
3/19/18	Construct 94

The foundations for Constructs 94 and 95 had been drilled and poured (Photos 9 and 10). No work was being conducted at these towers, but Rincon avian biologist Paulette Loubet was walking the road during a nesting bird survey.

Photo 9 – The foundation has been drilled and poured.
3/19/18	Construct 95

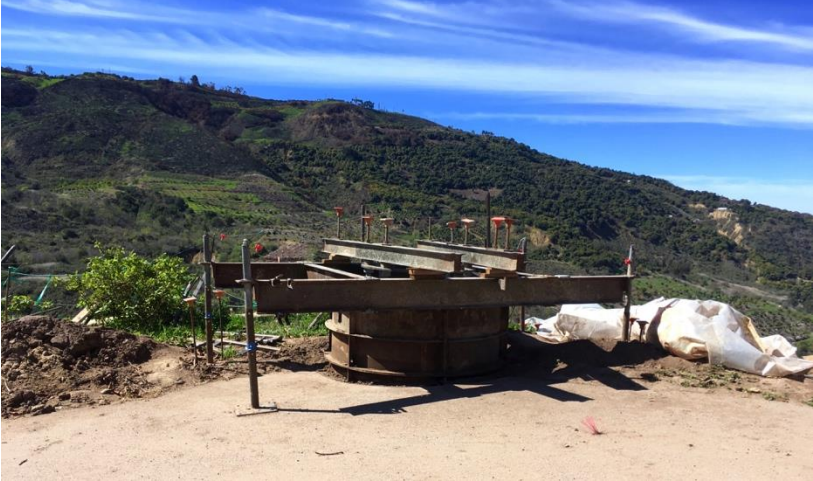
Photo 10 – Foundation has been drilled and poured.

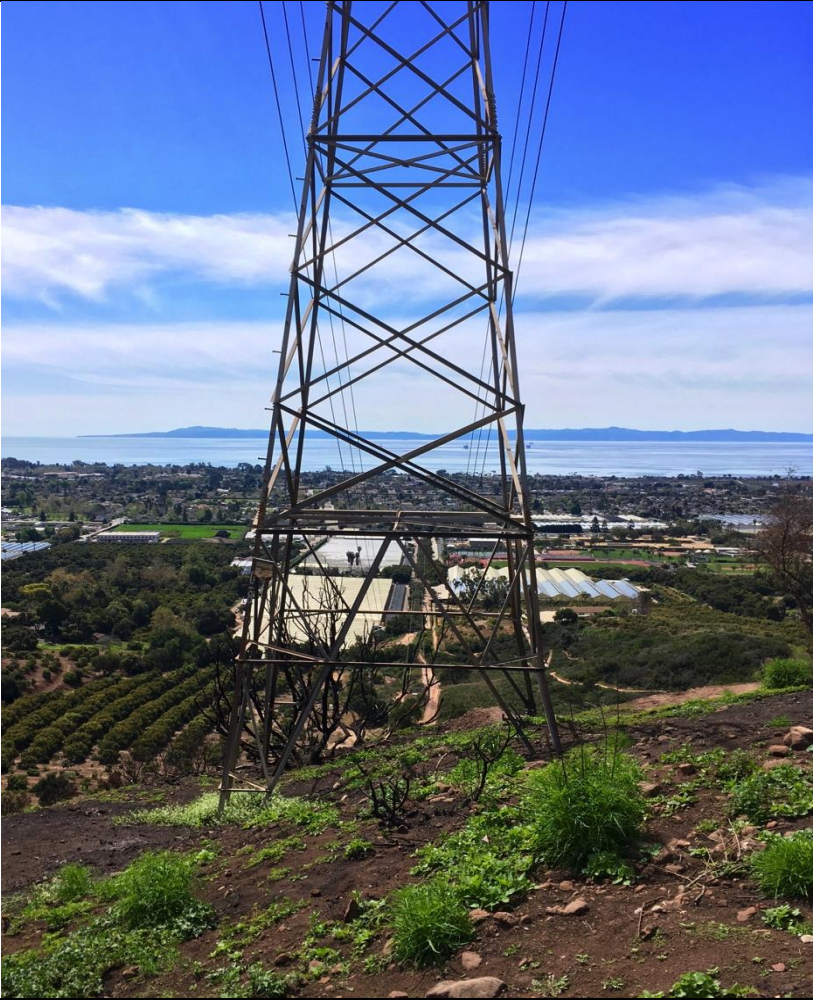
REPRESENTATIVE SITE PHOTOGRAPHS			
Date	Location	Photo	Description
3/19/18	Construct 132

I rode with Rincon lead environmental monitor James Rasico on the Segment 4 access road behind Carpinteria to its intersection with the Franklin Trail. We then walked on the trail to Construct 132 (Photo 11). Other than the trail, there is no access to this tower; therefore, all work at this location must be completed by hand.

<p>Photo 11 – This tower has very limited access located along the Franklin Trail. Photo facing south.</p>
