### **Re: Monthly Report Summary #8 for the Santa Barbara County Reliability Project**

CPUC Site Inspection Report  
May 10 and 15, 2018

## Santa Barbara County Reliability Project CPUC Site Inspection Form

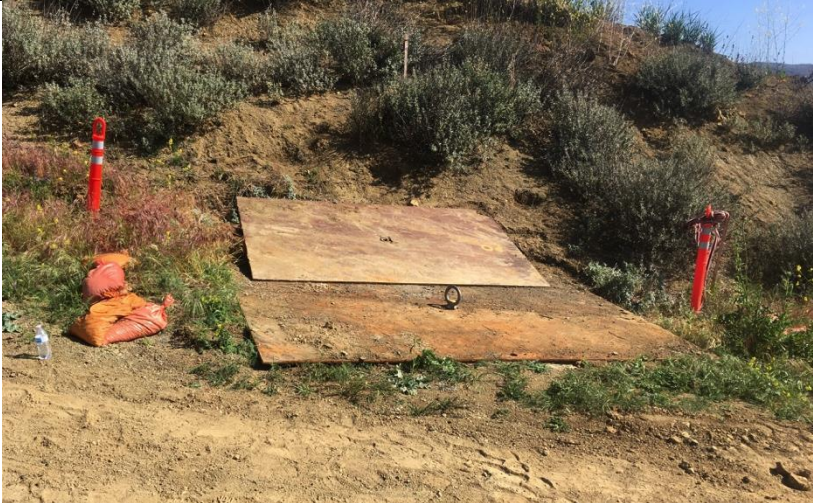
I headed to Segment 3B and Constructs 62, 63, and 64 with BRC lead biological monitor Matt Schaap. The plastic covering had been removed from Construct 63 and the kV Structures construction crew planned to drop a cage into the foundation hole. Since the steel plates and plastic covering the foundation holes at Constructs 62 and 63 had been compromised for an unknown amount of time, I asked Matt Schaap and BRC biological monitor Barrett Holland to check the hole for animals before they conduct any work within it (MM BIO-6). I also called Rincon environmental project manager John Hindley and E & E project manager Jenny Vick to discuss the proper channels to ensure that this request is carried out. We discussed the safety issues involved in looking into a deep foundation hole. I suggested they separate the steel plates (Photo 1) to allow only enough space for inspection by binoculars and a strong light.

Photo 1 – Metal plates used to cover the foundation hole.
5/10/18	Segment 3B

Biologists should use flashlights and binoculars to check the foundation holes at Constructs 62 and 63 for trapped animals when crews pull off the steel plates.

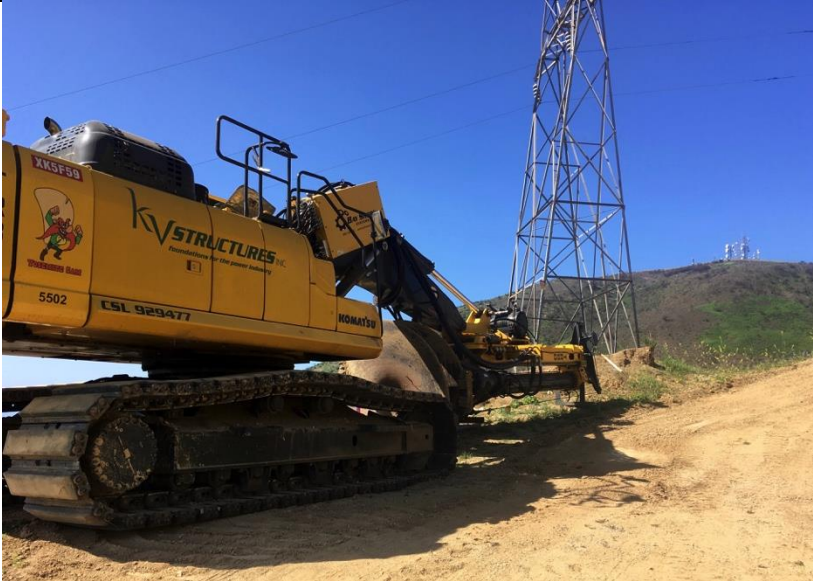
The drill rig was parked at Construct 64, and the crew planned to drill on the day of my site visit (Photo 2). At Construct 65, the foundation hole had been drilled and the cage set. The crew was waiting on concrete trucks. Work in this area had been delayed due to bird nesting issues and the very steep and rutted access road (APM BIO-3, APM BIO-4). At Construct 66, the foundation had been poured and a crew was onsite pulling off the forms and cleaning the area (Photo 3).

Photo 2 – Drill rig parked at Construct 64. Photo facing southwest.
5/10/18	Segment 3B

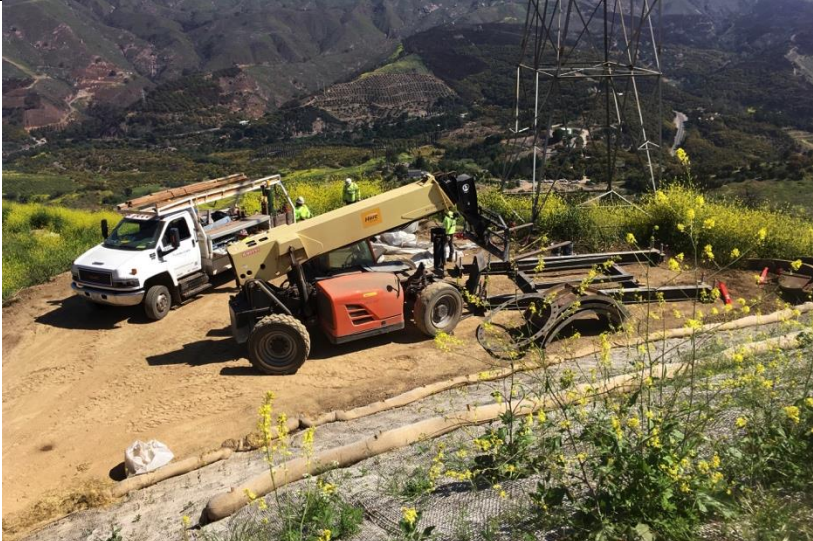
Photo 3 – Clean-up work being done at Construct 66. Photo facing north.

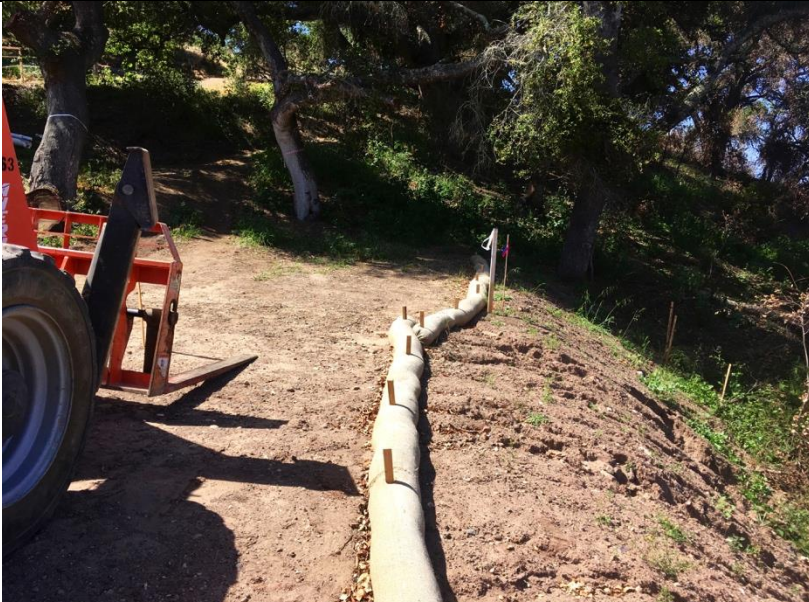
Equipment was parked at Construct 71; however, no construction activity was taking place and the site had not been drilled (Photo 4). At Construct 72, crews were relocating a water line to allow access to the site. They planned to have the water line trench backfilled before the end of the day.

Photo 4 – BMPs are in place, but tree trimming still needs to be done before drilling the foundation.
5/10/18	Segment 4, Construct 98

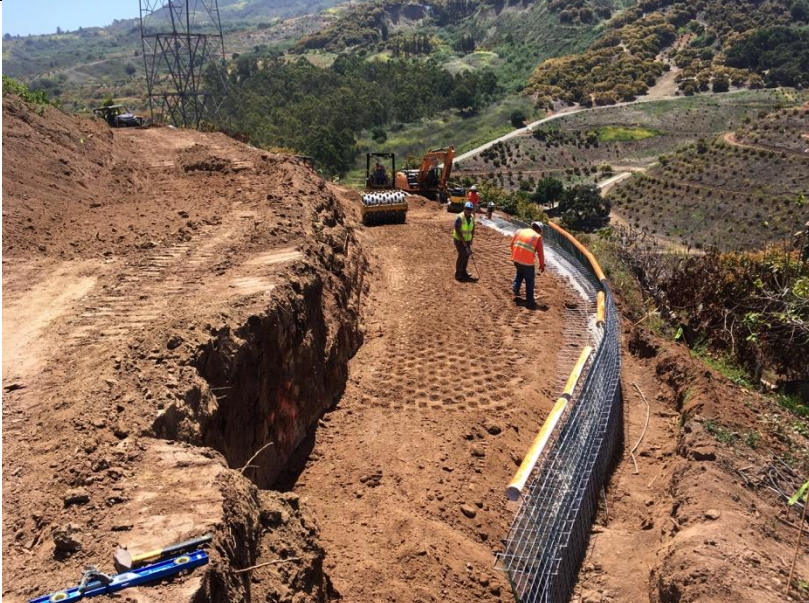
We stopped at Construct 98 where a crew continued to work on the Hilfiker wall (Photo 5).

Photo 5 – Work on the Hilfiker wall continues at this steep site located within an avocado orchard. Photo facing east.

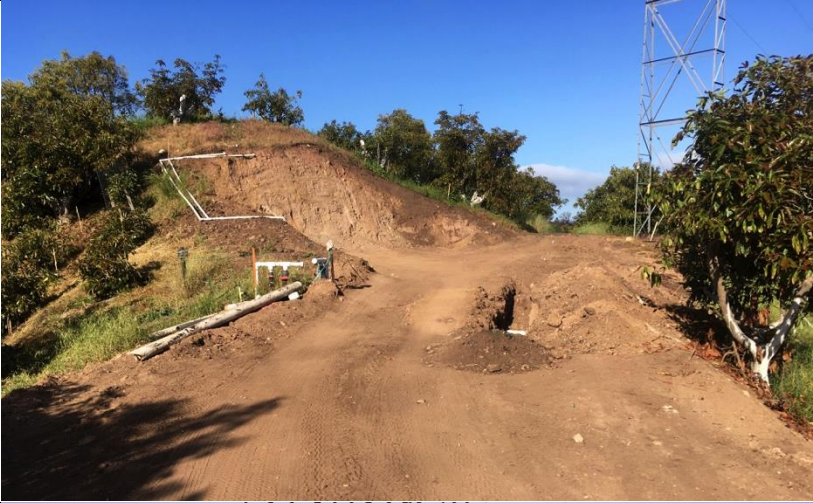
Photo 1 – Grading work and realignment of an existing water line at Construct 73.
5/15/18	Segment 3B

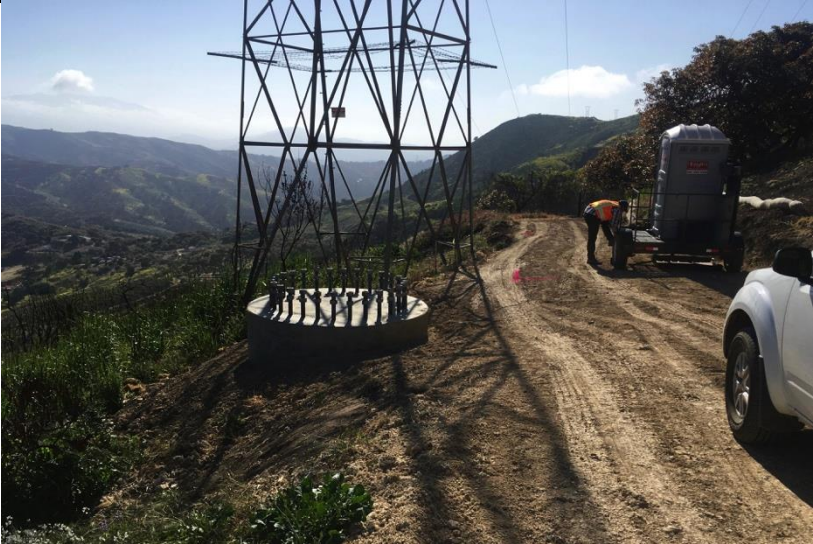
We traveled back along Segment 3B and checked Constructs 66 (Photo 2) and 65 (Photo 3), both of which had foundations poured and were ready for tower installation. The best management practices (BMPs) at these two sites required maintenance; however, with no rain in the forecast, Rincon biological monitor Mike Moss said it would be preferable to wait until the towers were set before conducting the BMP repairs.

Photo 2 – Construct 66. Photo facing east.
5/15/18	Segment 3B

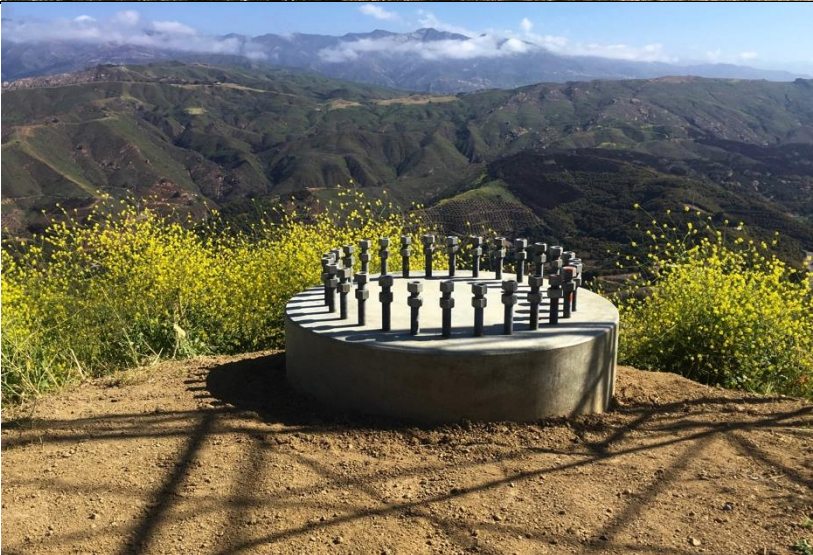
Photo 3 – Construct 65. Photo facing north.

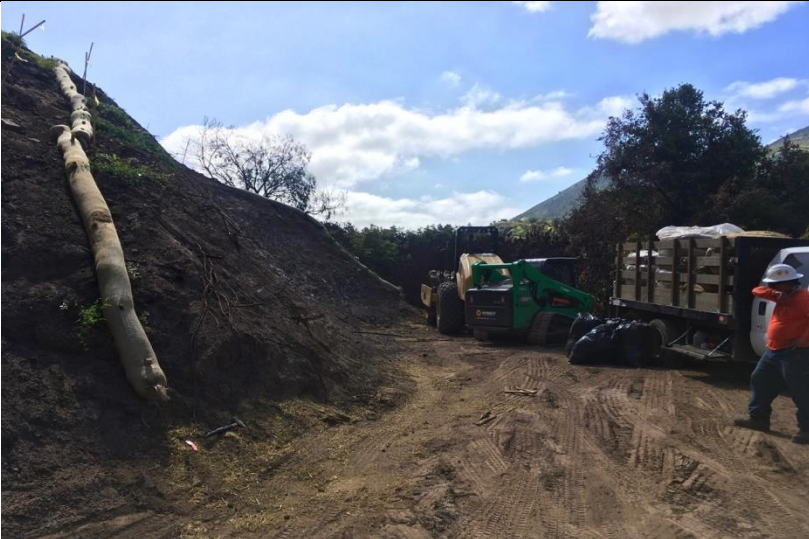
We drove to Construct 96 where several crews were onsite conducting BMP work and grading a tower pad (Photos 4 and 5). Rincon biological monitor Yuling Huo was onsite at this location and a paleontological monitor was also onsite (MM CR-13). Dust control was needed at this location (APM AQ-1). We checked in at Construct 97 where Rincon avian biologist Monica Jacinto was stationed. She showed us a black-chinned hummingbird nest in an avocado tree near the access road. The female was on the nest and did not seem disturbed by our presence.

Photo 4 – BMPs are being put in place.
5/15/18	Segment 4, Construct 96

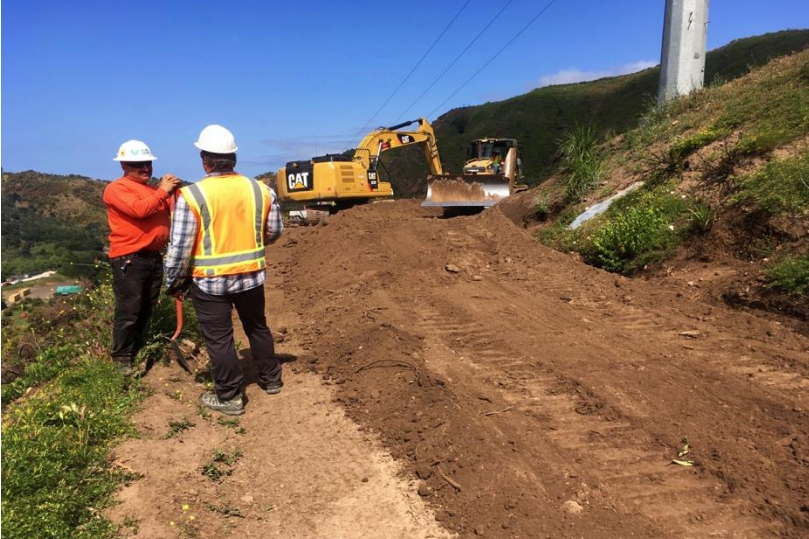
Photo 5 – Grading work continues at Construct 96. Lead biological monitor Mike Moss speaks with the crew foreman.
5/15/18	Segment 3B, Construct 62

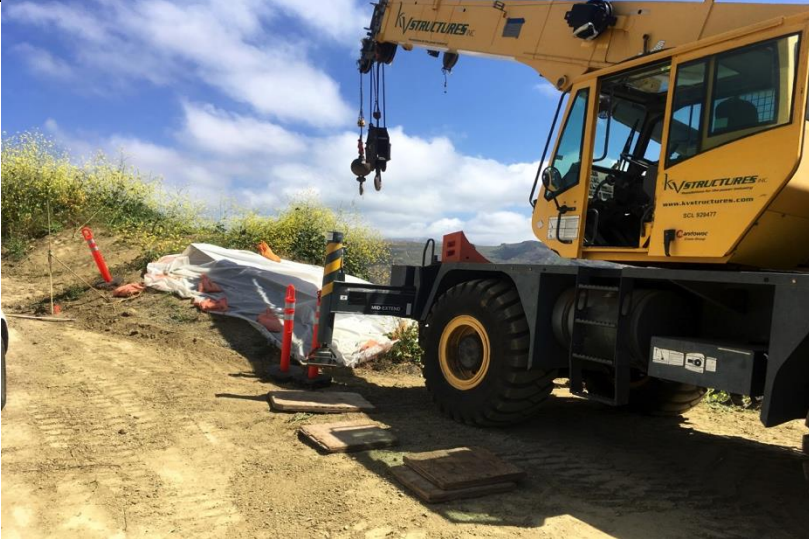
At Construct 62, the drilling crew was setting up a crane in preparation for installation of the foundation cage (Photo 6). The foundation hole was covered with steel plates, plastic, and gravel bags. Foundation holes for Constructs 62 and 63 were checked for animals before the crews began working on them (MM BIO-6). I spoke with BRC biological monitor Barrett Holland about his examination of the holes and the cooperation of the construction teams, and he said that all went well.

Photo 6 – Crane parked near the covered foundation hole.

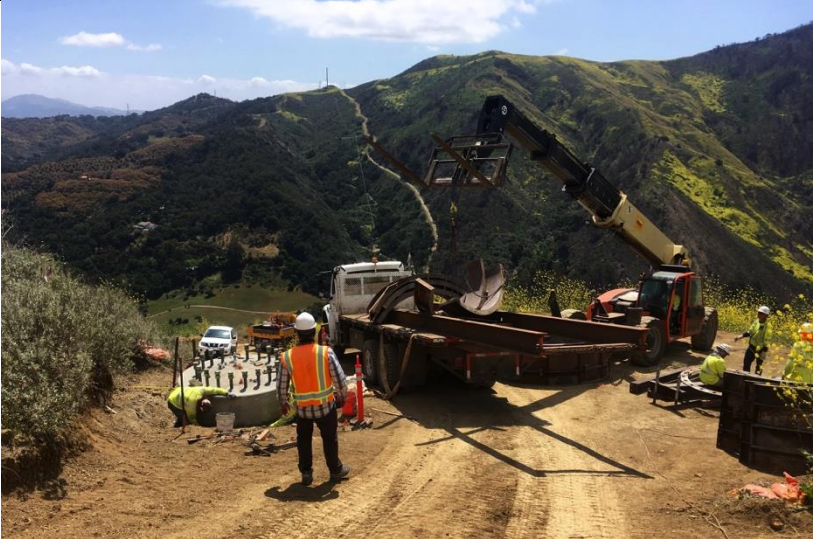
The Construct 63 foundation had been poured and a crew was removing the forms (Photo 7). No work was being conducted at Construct 61; however, a bulldozer was parked onsite. Along with Rincon lead biological monitor Mike Moss, I noted a possible house wren nest in a nearby tree. Mike Moss said he would have an avian biologist check the nest.

Photo 7 – Crew removing the foundation forms after the concrete pour. Photo facing east.
5/15/18	Segment 4

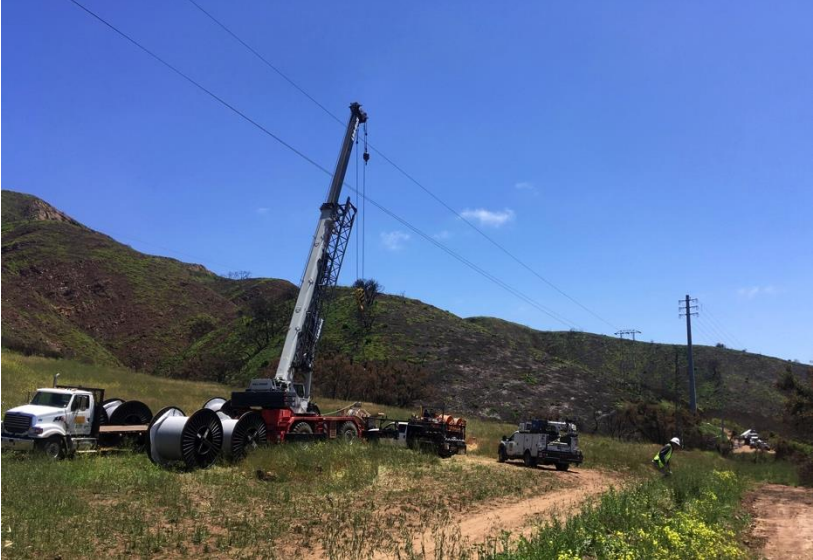
My last stop with Rincon lead biological monitor Mike Moss was at Construct 106 where the wire pulling crew was working (Photo 8).

Photo 8 – Wire pulling crew between Constructs 105 and 106. Photo facing southeast.
