Re: Monthly Report Summary #18 for the South Orange County Reliability Enhancement (SOCRE) Project

South Orange County Reliability Enhancement Project CPUC Site Inspection Form

Project:	South Orange County Reliability Enhancement (SOCRE) Project	Date:	April 4, 2019
Project Proponent:	San Diego Gas & Electric (SDG&E)	Report #:	VS029
Lead Agency:	California Public Utilities Commission (CPUC)	Monitor(s):	CPUC/Ecology and Environment (E & E) Compliance Monitor
CPUC PM:	Andrew Barnsdale, Energy Division	AM/PM Weather:	Overcast, cool, and calm with some light drizzle
CPUC CM (E & E):	Joe Donaldson	Start/End Time:	0730 to 0900
Project NTP(s):	NTP-1, NTP-2, NTP-2 Addendum 1, NTP-3, and NTP-4

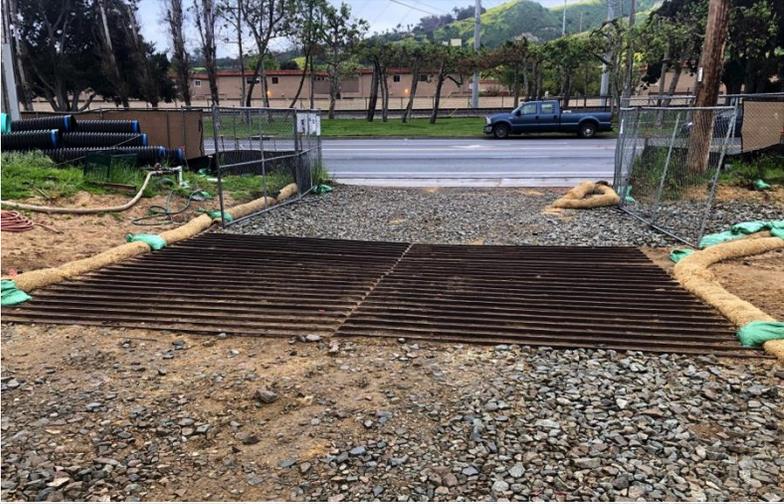
The main construction entry/exit was in good condition and had clean rumble plates (Photo 1). Work on the drainage system behind the southern boundary wall was ongoing and no issues were noted (Photo 2). The soil disturbance work below the southern slopes was nearly complete, with the slope being restored back to grade (Photo 3). The water tank was moved up to the area where the soil disturbance below the southern slopes was occurring. The SDG&E Lead Environmental Inspector indicated that reclaimed water was still being used onsite and a filling location west of the San Juan Capistrano Substation site will not be developed. Conduit work continued, and one of the trenches was filled with slurry (Photo 4). Surveyors had laid out another conduit trench and a crew was starting their excavation work (Photo 5).

Photo 1 – The main entry/exit into the San Juan Capistrano Substation site. Photo facing west.
4/04/19	San Juan Capistrano Substation

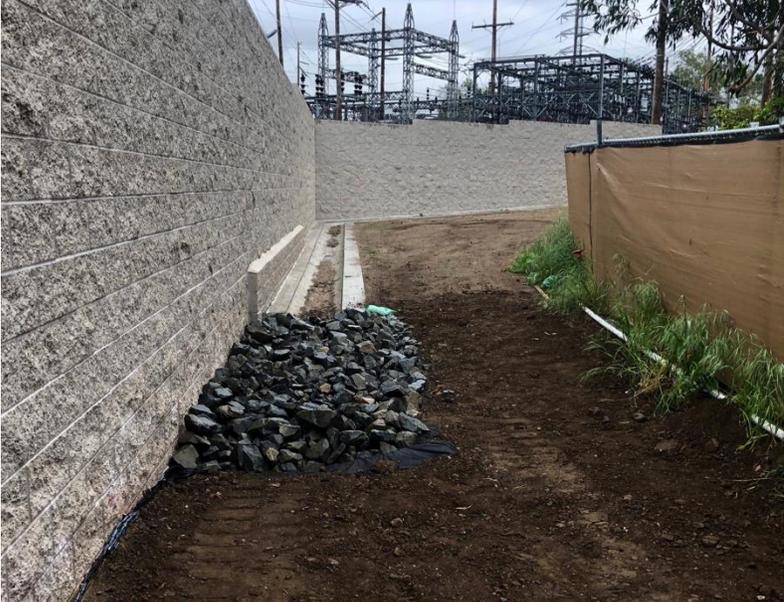
Photo 2 – San Juan Capistrano site drainage system outside of the southern boundary wall. Photo facing east.
4/04/19	San Juan Capistrano Substation

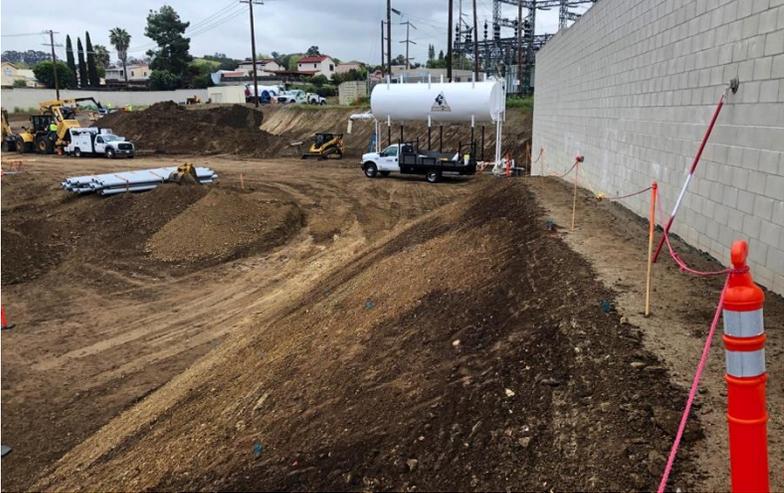
Photo 3 – Slopes cut back to grade below the southern boundary wall. Photo facing east.

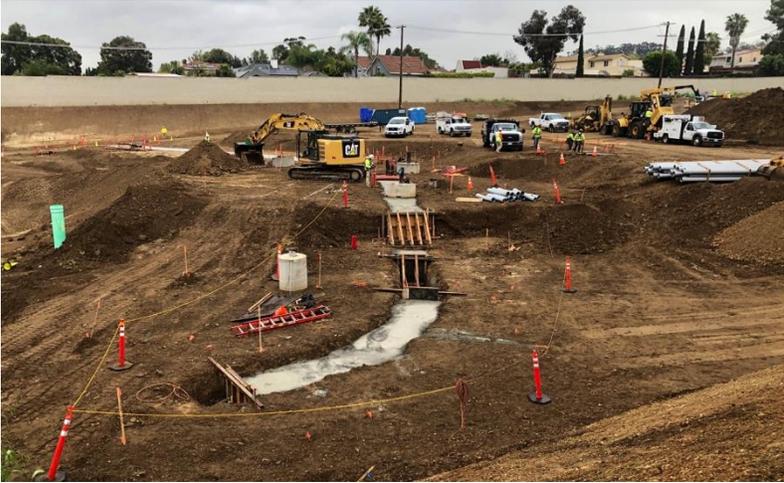
Photo 4 – Centrally located conduit work. Photo facing north.
4/04/19	San Juan Capistrano Substation

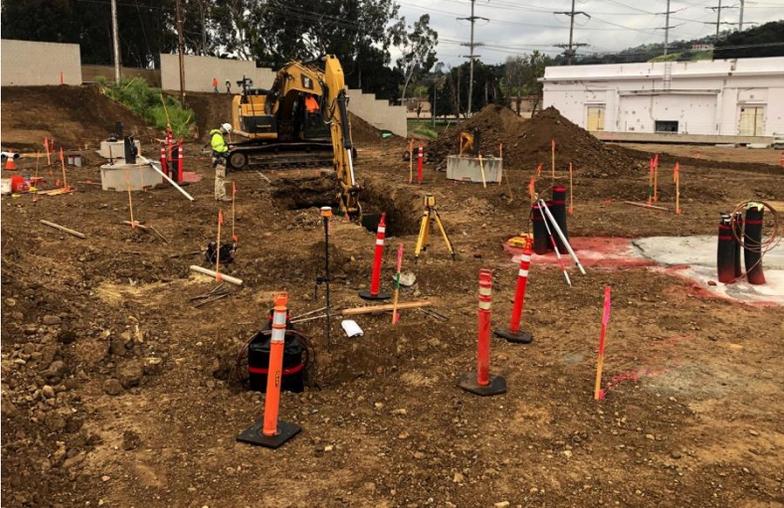
Photo 5 – Excavation begins on a conduit trench. Photo facing southwest.
4/04/19	San Juan Capistrano Substation

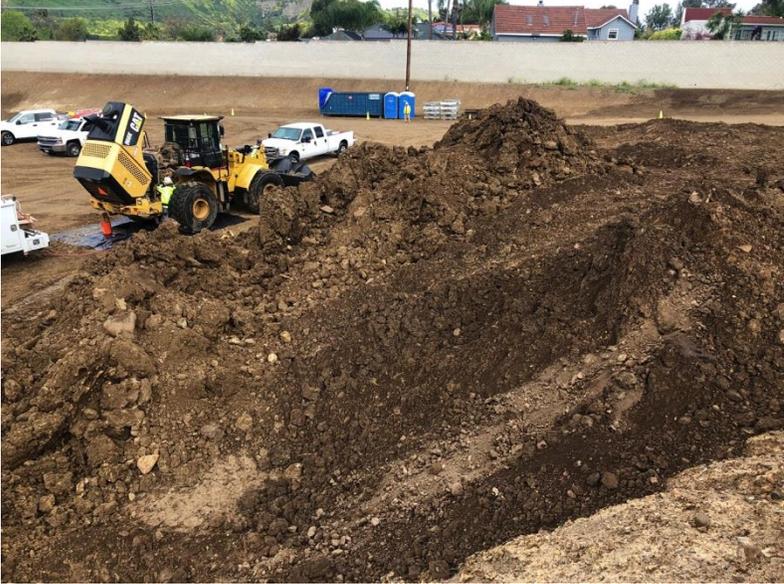
A large stockpile of soil remained onsite (Photo 6). Hazardous materials were being stored in a location next to the existing 138/12-kilovolt (kV) substation (Photo 7).

Photo 6 – Stockpiled soil onsite. Photo facing north.

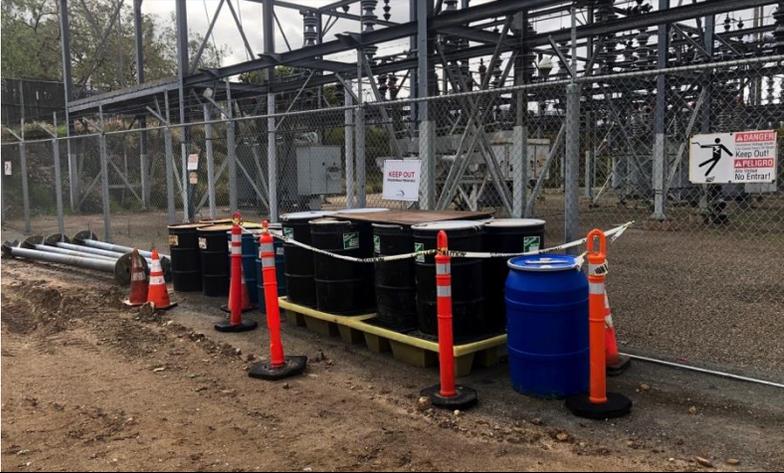
Photo 7 – Hazardous materials storage near the existing 138/12-kV substation. Photo facing east.
4/04/19	San Juan Capistrano Substation

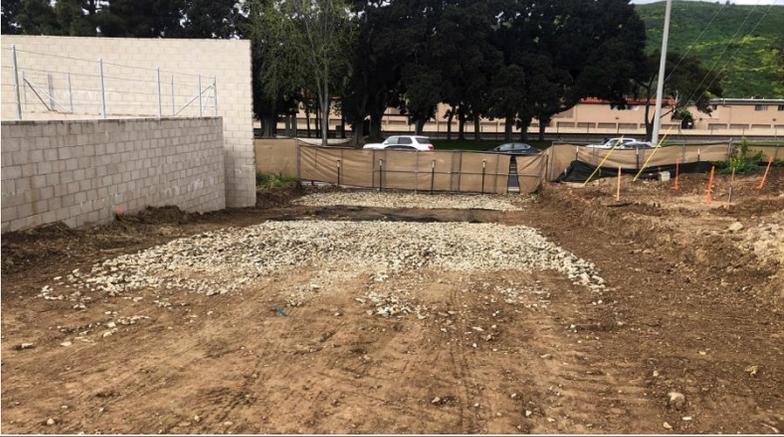
The northern entrance to the San Juan Capistrano Substation site was completed, but it was not yet being utilized because best management practices (BMPs) were not in place yet (Photo 8). The SDG&E Lead Environmental Inspector said most of the water generated during a rainstorm will drain toward the northern entrance due to a low point/catch basin near the storm drain manholes. The SDG&E Lead Environmental Inspector will check for nesting birds in stockpiled materials.

Photo 8 – New exit/entry on the north side of the San Juan Capistrano Substation site. Photo facing west.

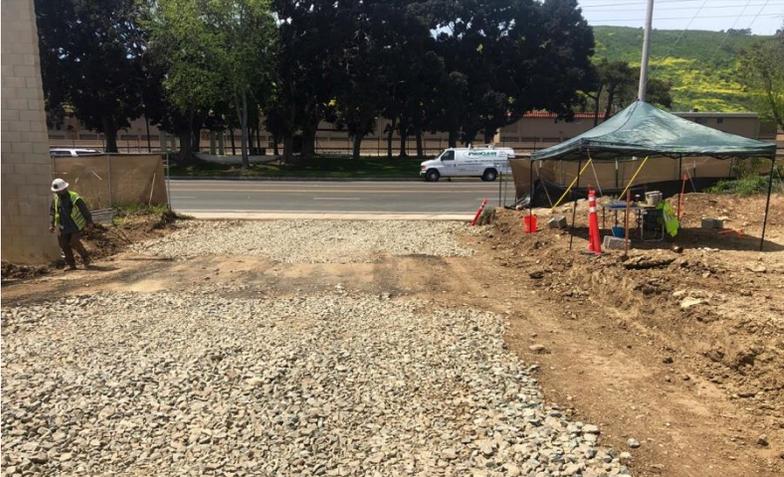
The main entry/exit location at the north end of the San Juan Capistrano Substation site was open and crews were in the process of moving the rumble plates (Photo 1). Excess soil has been removed from the site and brought to Camp Pendleton. A water truck was watering the San Juan Capistrano Substation site to control dust. A crew was using a street sweeper to remove soil from the roads outside of the San Juan Capistrano Substation site.

Photo 1 – New exit/entry at the north side of the San Juan Capistrano Substation site. Photo facing west.
4/11/19	San Juan Capistrano Substation

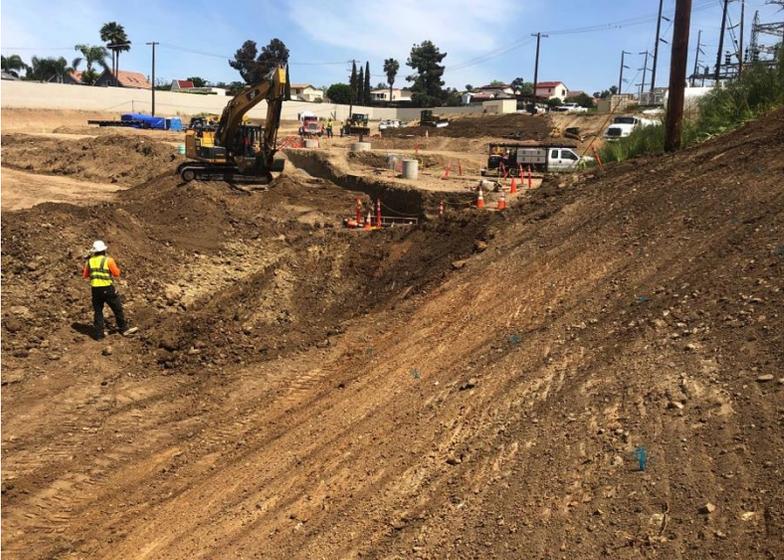
Another segment of the slope below the southern boundary wall had been restored to grade, and crew was using an excavator to pull back the excess soil from around the conduit trenches (Photo 2).

Photo 2 – Soil disturbance at the San Juan Capistrano Substation site. Photo facing northeast.
4/11/19	San Juan Capistrano Substation

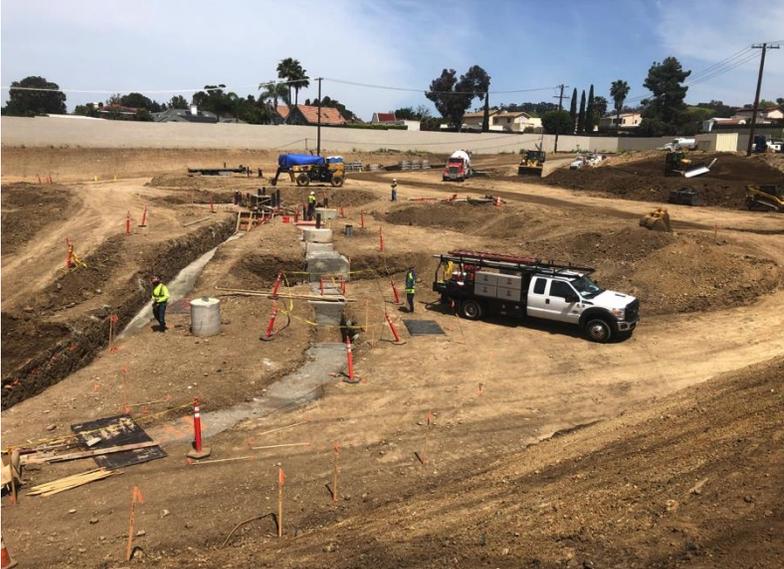
Conduit work continued, and a portion of the trench had been filled with concrete slurry (Photos 3 & 4). The concrete washout station was in good condition and had adequate containment and coverage (Photo 5). Dumpsters located onsite were also adequately covered (Photo 6). A crew with a small bulldozer was shaping the slope below the existing 138/12-kilovolt (kV) substation (Photo 7).

Photo 3 – Conduit work. Photo facing north.

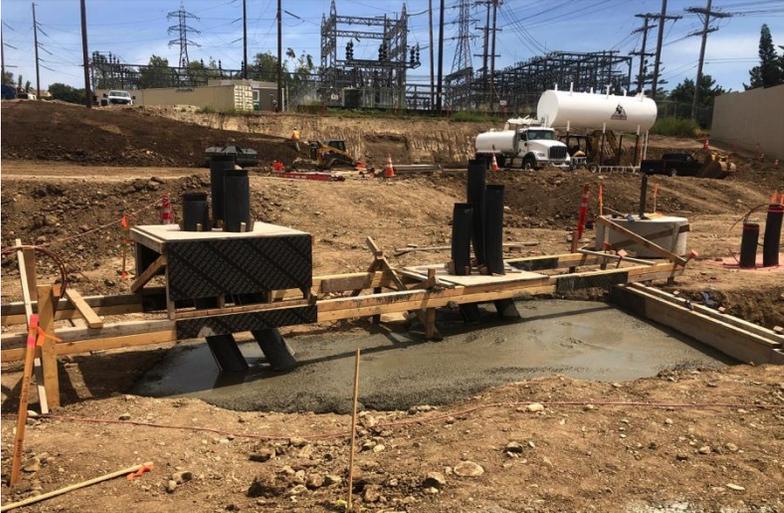
Photo 4 – Recently poured concrete slurry. Photo facing east.
4/11/19	San Juan Capistrano Substation

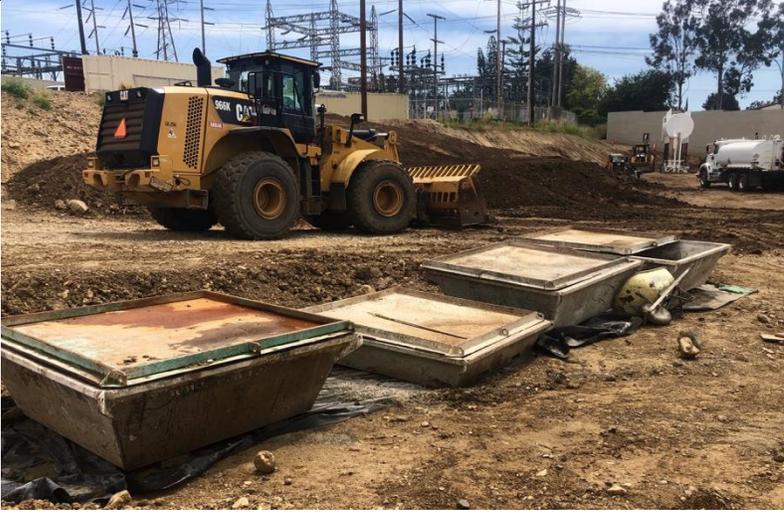
Photo 5 – Concrete washout containers. Photo facing southeast.
4/11/19	San Juan Capistrano Substation

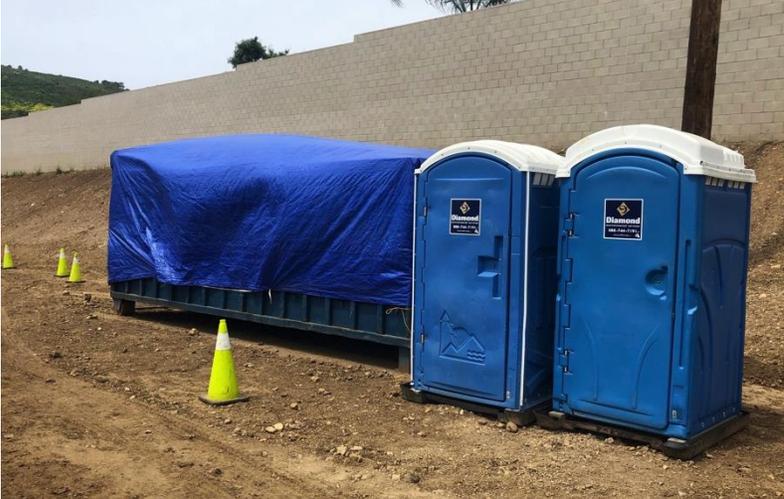
Photo 6 – A well-covered dumpster. Photo facing northwest.

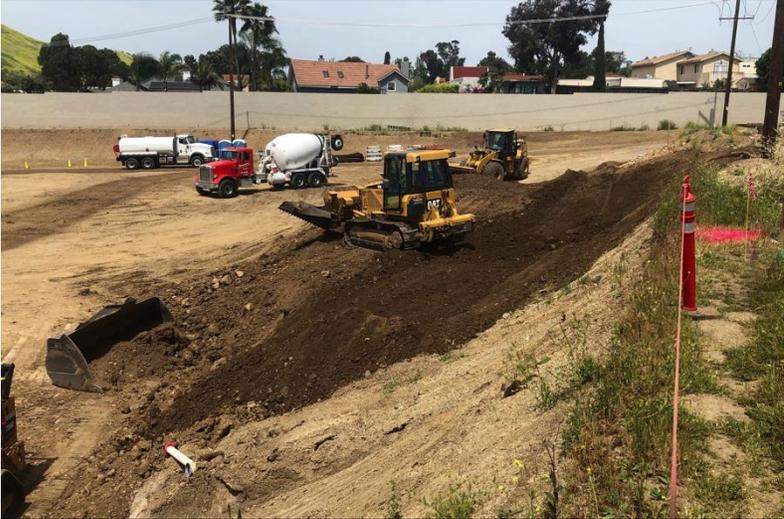
Photo 7 – A bulldozer shaping the slope below the existing 138/12-kV substation. Photo facing north.

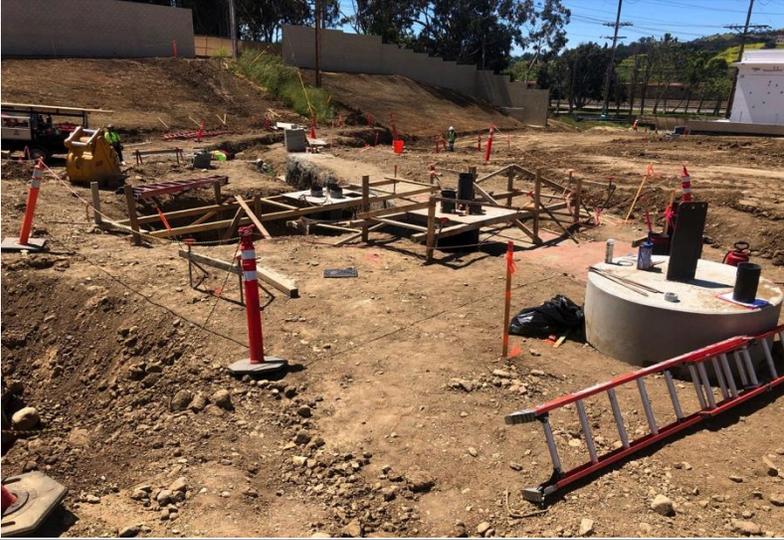
On the day of my site visit, conduit work was the primary activity occurring onsite, and I observed some open trenches (Photo 1). Minor excavation was being conducted near a newly installed vault (Photo 2) and conduit was being inspected (Photo 3). The newly installed conduit was capped to prevent debris and animals from entering the conduit (Photo 4). The SDG&E Lead Environmental Inspector said that some of the trench would be poured later in the day.

Photo 1 – Open conduit trenches. Photo facing southwest.
4/18/19	San Juan Capistrano Substation

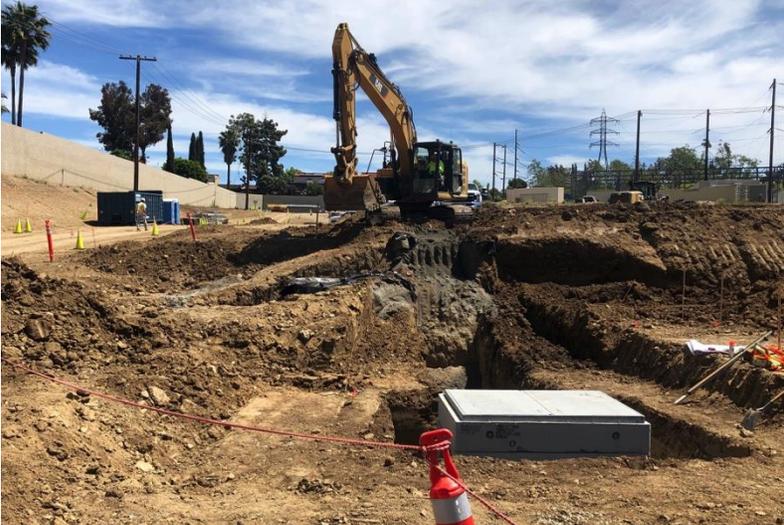
Photo 2 – Excavation work around a newly installed vault. Photo facing east.
4/18/19	San Juan Capistrano Substation

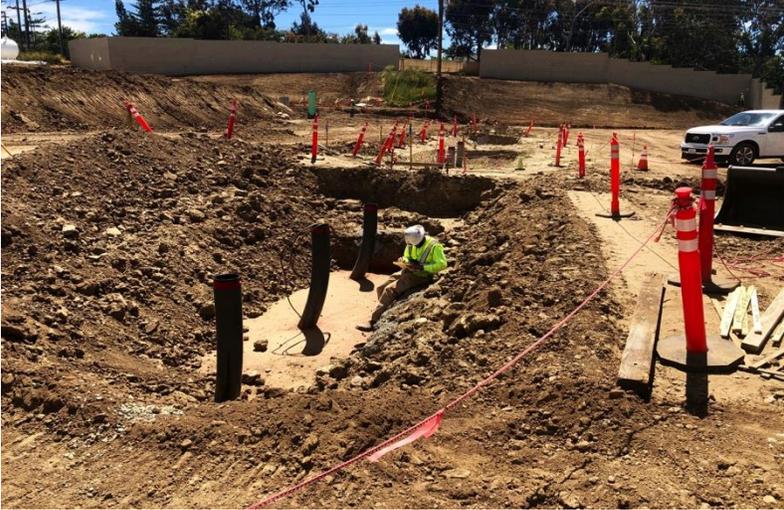
Photo 3 – Conduit work continues. Photo facing south.

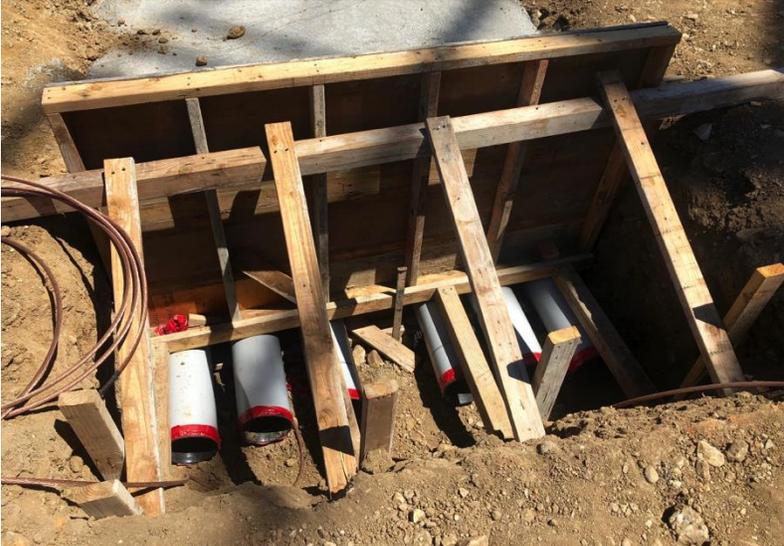
Photo 4 – Capped conduit.
4/18/19	San Juan Capistrano Substation

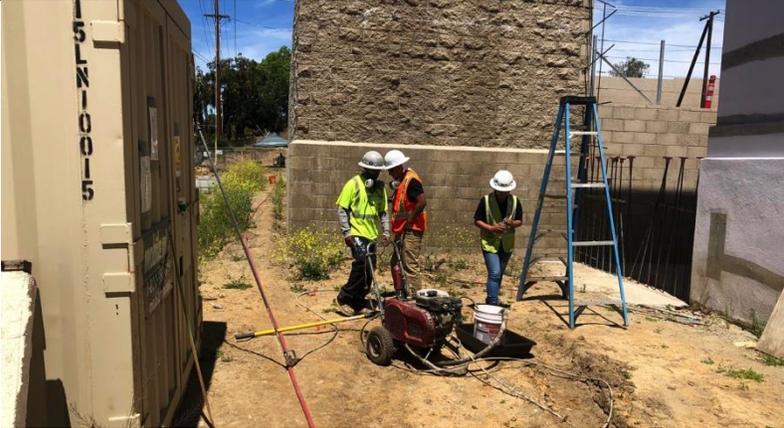
A crew was spraying the western boundary wall with a water sealant and an anti-graffiti solution (Photo 5). The SDG&E Lead Environmental Inspector said the public will eventually have access to this wall, which is why anti-graffiti solution was being applied. Climbing ivy will be planted along the wall.

Photo 5 – Crew spraying sealant on the western boundary wall. Photo facing north.
