**Re: Monthly Report Summary #10 for the South Orange County Reliability Enhancement (SOCRE) Project**

CPUC Site Inspection Reports

August 1, 9, 17, and 29, 2018

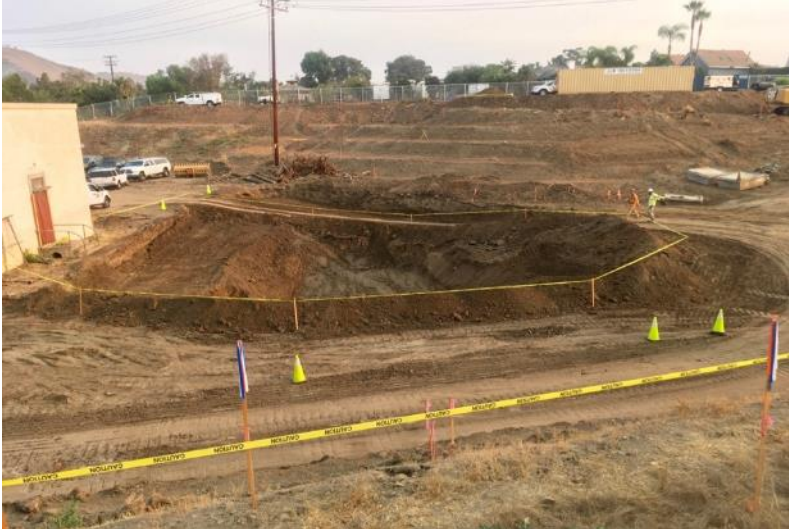
The area just east of the former utility structure was being over-excavated, with soil eventually being recompacted into the hole (Photo 1). This activity was observed by the onsite monitoring team. A portion of this area exhibited a higher amount of historic material, so several piles of the soil were set aside for additional evaluation (Photo 5). The SDG&E Lead Environmental Inspector said that archaeologists would go through this soil using shovels, but no screening would be conducted. The archaeological monitor told me that two boxes containing historic material found in the soil were being stored at the construction trailer, but nothing found in these soil piles was of significant.

Photo 1 – Over-excavation of the area just east of the former utility structure. Photo facing north.
08/09/18	San Juan Capistrano Substation

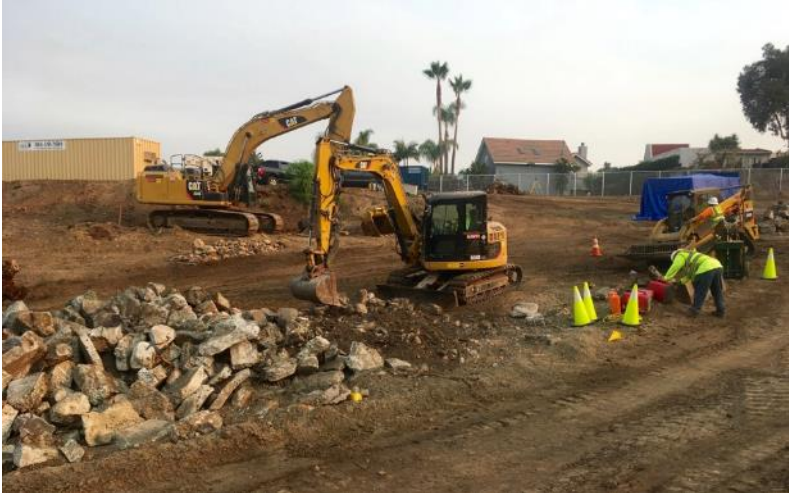
A crew was breaking up concrete and separating out the rebar so it could be trucked offsite and recycled (APM HAZ-5) (Photo 2). The SDG&E Lead Environmental Inspector said they have the recycling tags if I wanted to see them.

Photo 2 – Crew using an excavator to break up concrete for recycling. Photo facing north.
08/09/18	San Juan Capistrano Substation

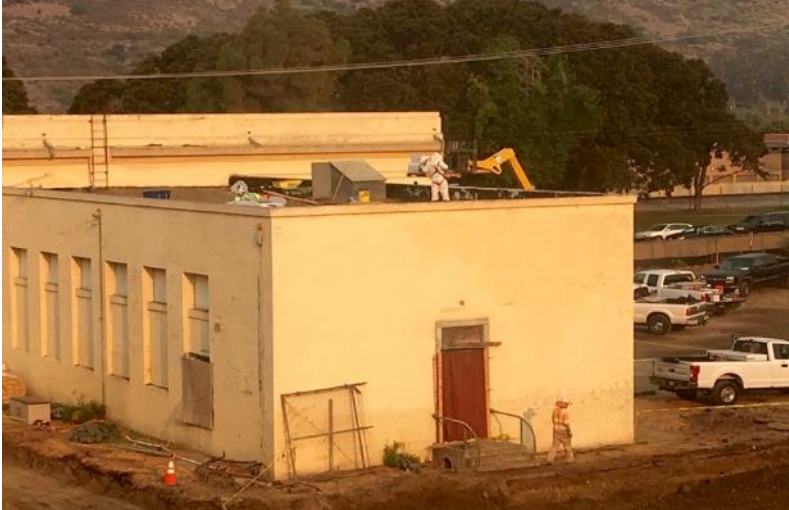
A new crew was onsite and beginning the demolition work on the former utility structure. The crew was starting the demolition work with the removal of the old roofing material from the east wing (Photo 3). This crew was planning to work on the upcoming Saturday; I spoke with the SDG&E Lead Environmental Inspector and recommended giving the monitors enough advance notice to accommodate the Saturday work schedule.

Photo 3 – Demolition crew removing the roofing from the former utility structure. Photo facing west.

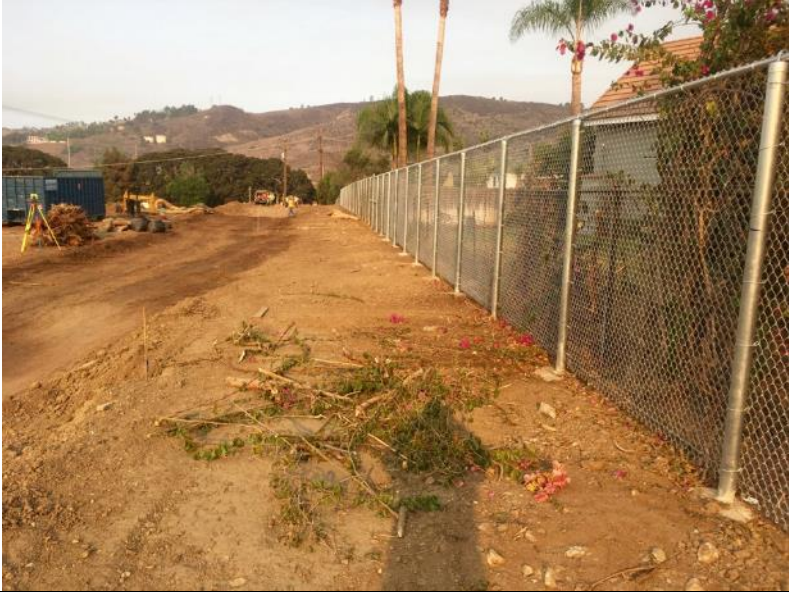
All of the chain-link fencing had been installed along the northern edge of the San Juan Capistrano Substation site and a small portion of the eastern boundary (Photo 4). A survey crew was lining out the location for the barrier wall (APM AES-3) (Photo 7).

Photo 4 – Chain-link fence installed along the northern boundary. Photo facing west.
08/09/18	San Juan Capistrano Substation

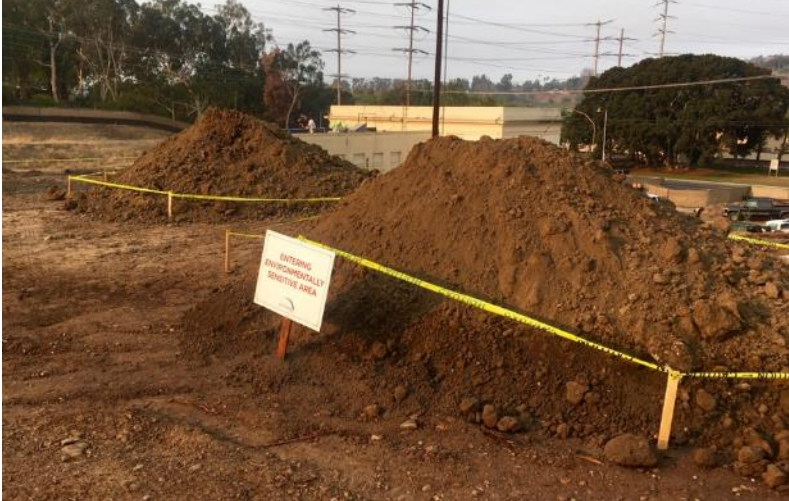
Photo 5 – Stockpiled soil waiting to be evaluated by the archaeologists.
08/09/18	San Juan Capistrano Substation

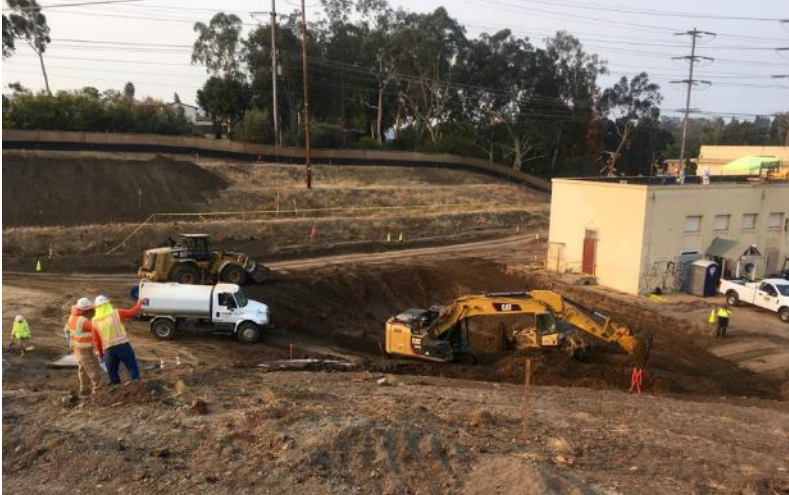
Later in the morning, equipment entered this area and continued with the excavation (Photo 6). Water trucks were using reclaimed water to minimize dust (MM PS-1, APM AQ-1) at this location. Because the offsite reclaimed water hydrant had not been installed, the reclaimed water was being trucked to the San Juan Capistrano Substation site.

Photo 6 – Equipment being used for excavation work. Photo facing south.

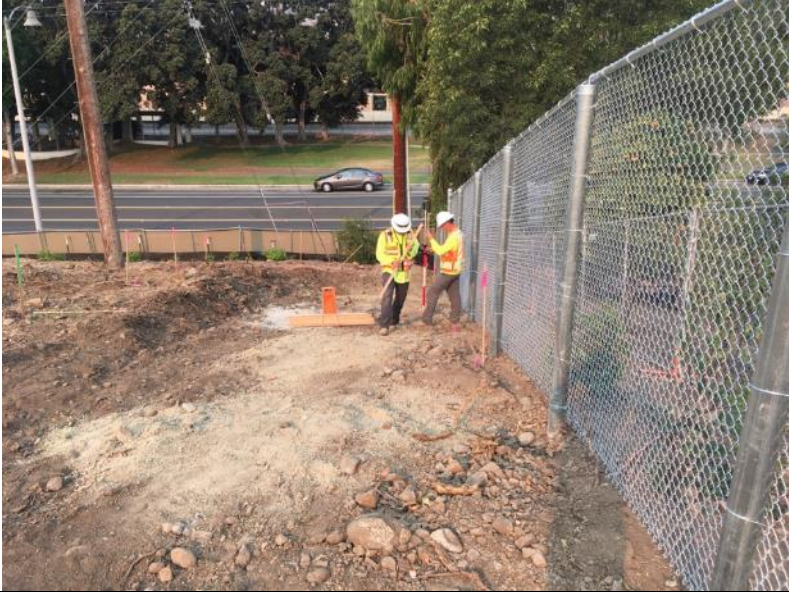
Photo 7 – Chain-link fence near the northwest corner of the San Juan Capistrano site. Photo facing west.
08/09/18	San Juan Capistrano Substation

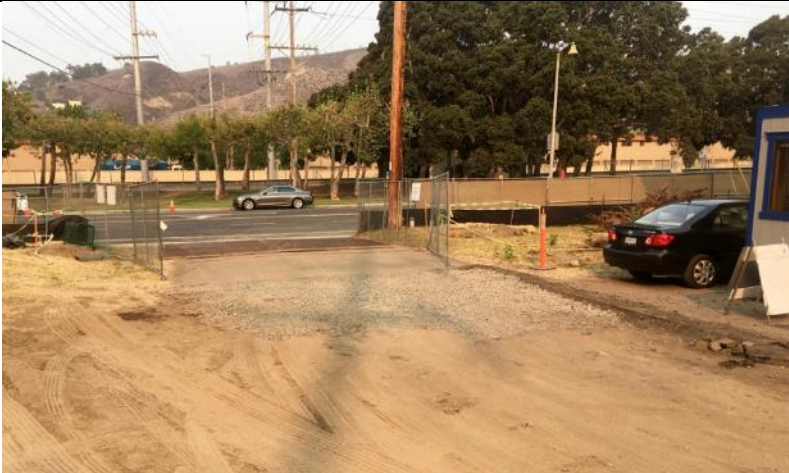
Photo 8 – Rock and rumble plates at the San Juan Capistrano Substation site entrance. Photo facing west.

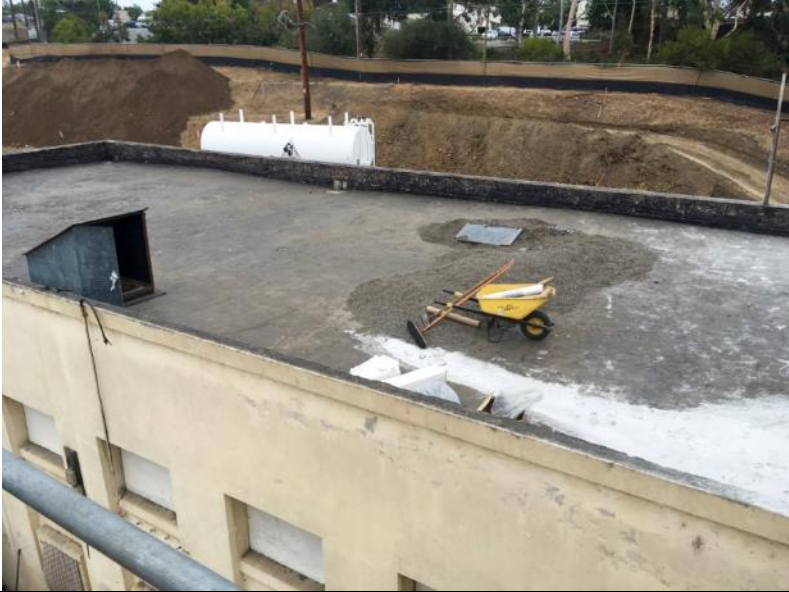
Photo 1 – Final cleanup of roof materials on the east wing of the former utility structure. Photo facing south.
08/17/18	San Juan Capistrano Substation

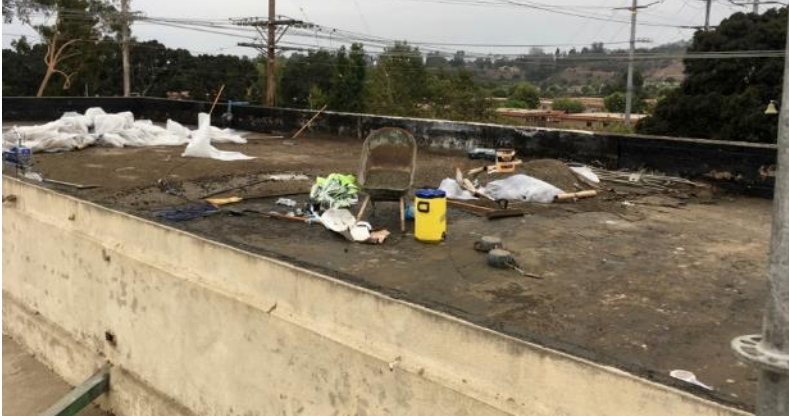
Photo 2 – Removal of roofing material on the main portion of the former utility structure. Photo facing west.
08/17/18	San Juan Capistrano Substation

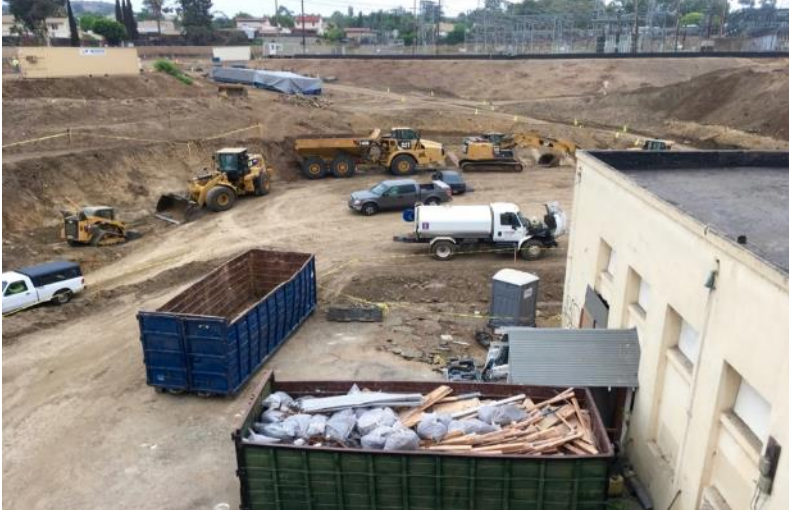
Photo 3 – Overview of the project site looking east from the roof of the main portion of the former utility structure.

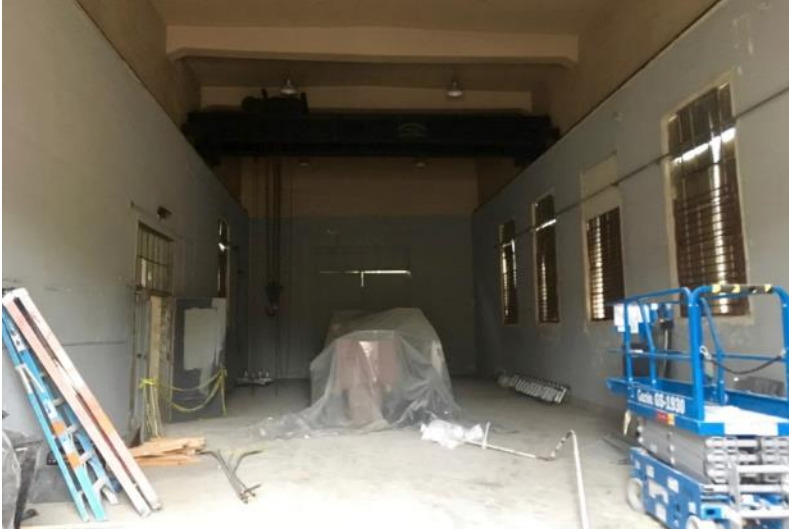
Photo 4 – Inside the main portion of the former utility structure.
08/17/18	San Juan Capistrano Substation

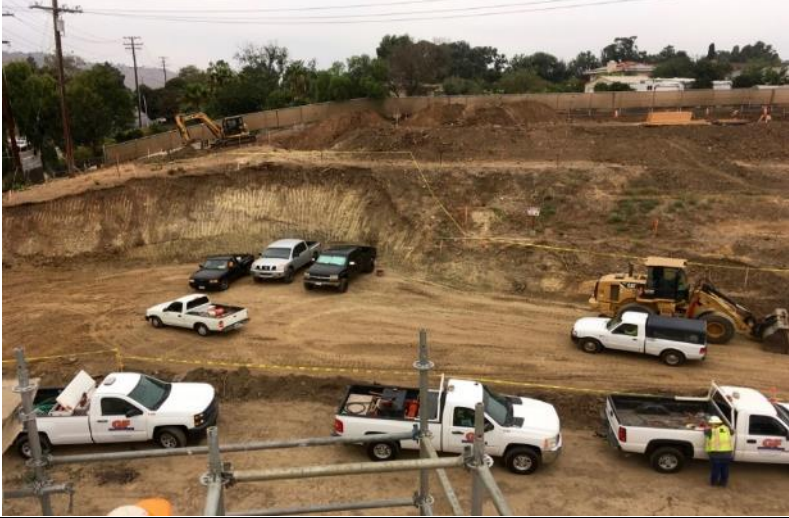
Photo 5 – Overview of the project looking to the north.
08/17/18	San Juan Capistrano Substation

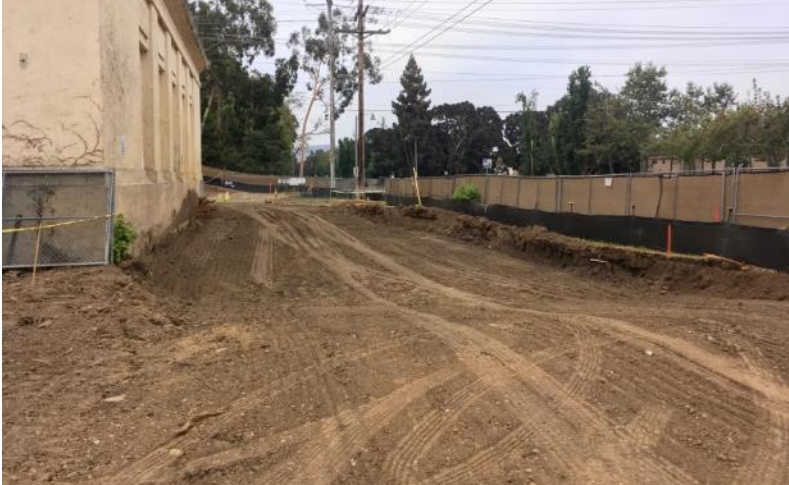
Photo 6 – Soil and tree stump removal completed just west of the former utility structure. Photo facing south.

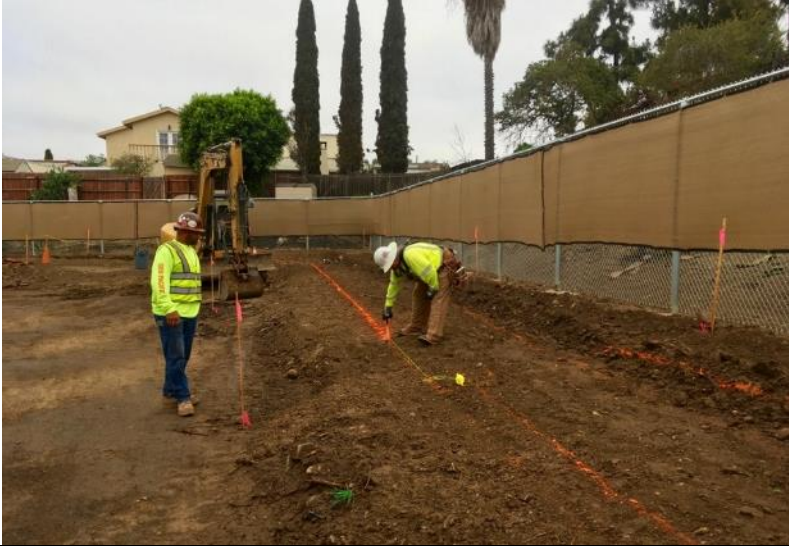
Crews continued to work on the boundary wall along the northern and eastern edges of the San Juan Capistrano Substation site, with survey crews lining out the location (APM AES-3) (Photo 7) and using an excavator to dig out the trench for the wall footing (Photo 8). Monitors were observing this work; only historic material had been found, and nothing found was of real significance. I spoke with the construction superintendent and the SDG&E Lead Environmental Inspector about escape ramps for this trench work. While there were earthen ramps at either end of the trench, the trench was several hundred feet long and more ramps were needed. The construction superintendent said additional ramps would be added by the end of the workday.

Photo 7 – Survey crew lining out the trench needed for the wall footing. Photo facing north.
08/17/18	San Juan Capistrano Substation

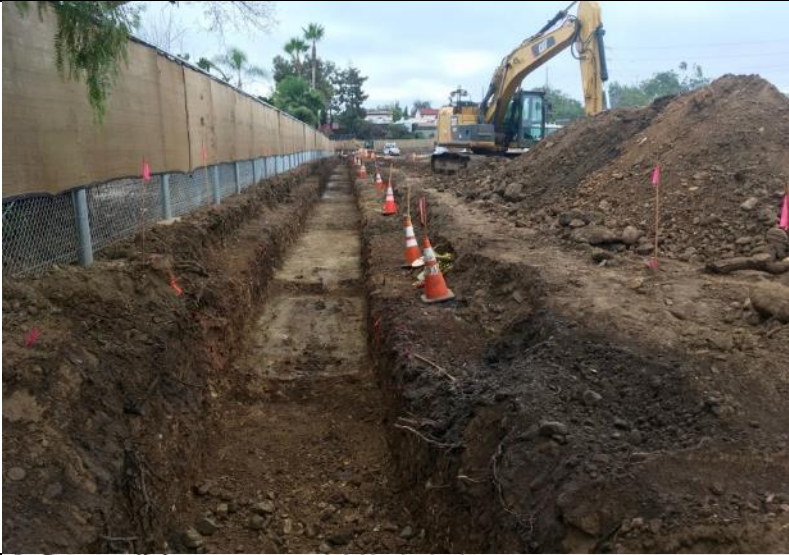
Photo 8 – Trench for the wall footing along the northern boundary of the San Juan Capistrano Substation site. Photo facing east.
08/17/18	San Juan Capistrano Substation

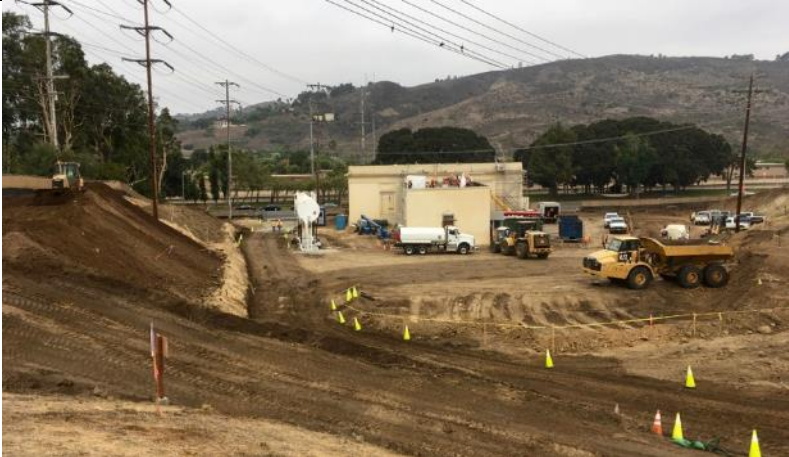
Photo 9 – Over-excavation work. Photo facing west.

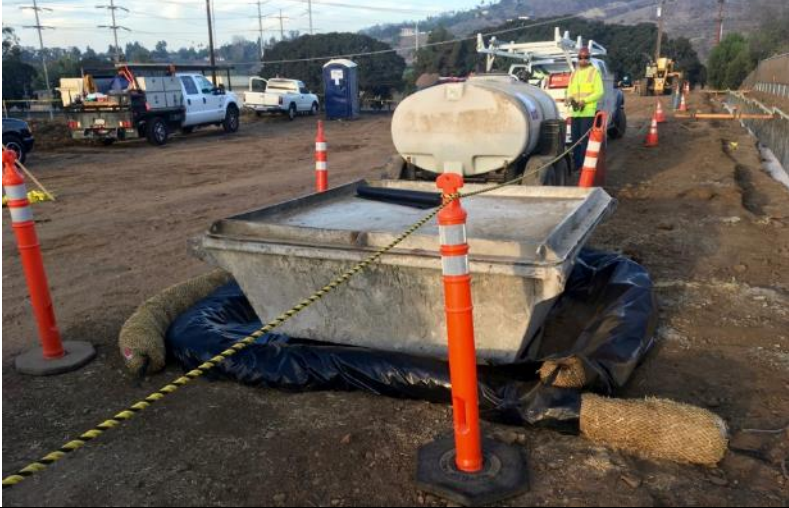
Photo 4 – Properly covered and contained concrete washout bin. Photo facing west.
08/29/18	San Juan Capistrano Substation

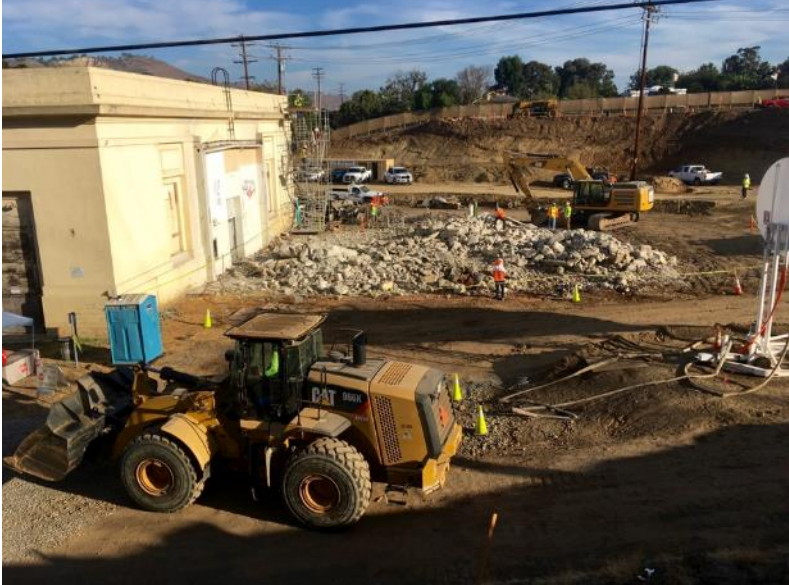
Photo 5 – Remains of the east wing of the former utility structure. Photo facing north.
08/29/18	San Juan Capistrano Substation

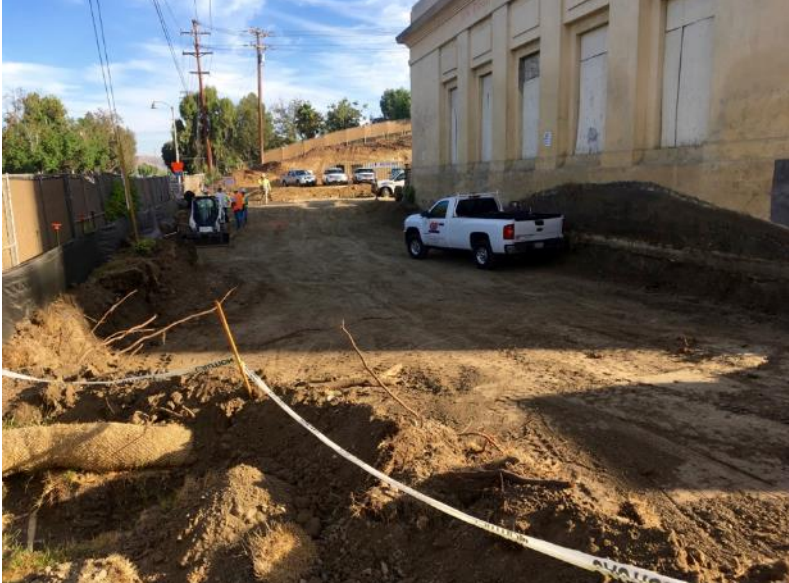
Additional earthwork was completed within the area west of the former utility structure (Photo 6) and along the southern border of the San Juan Capistrano Substation site (Photo 8). The SDG&E Lead Environmental Inspector said they would begin work on the southern boundary wall, but would first excavate the trench for the wall foundation.

Photo 6 – Earthwork just west of the former utility structure. Photo facing north.

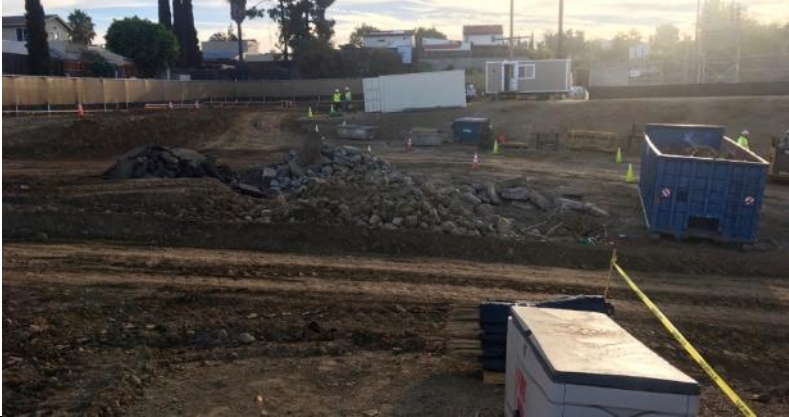
Photo 7 – Recycle piles of asphalt and concrete. Photo facing north.
08/29/18	San Juan Capistrano Substation

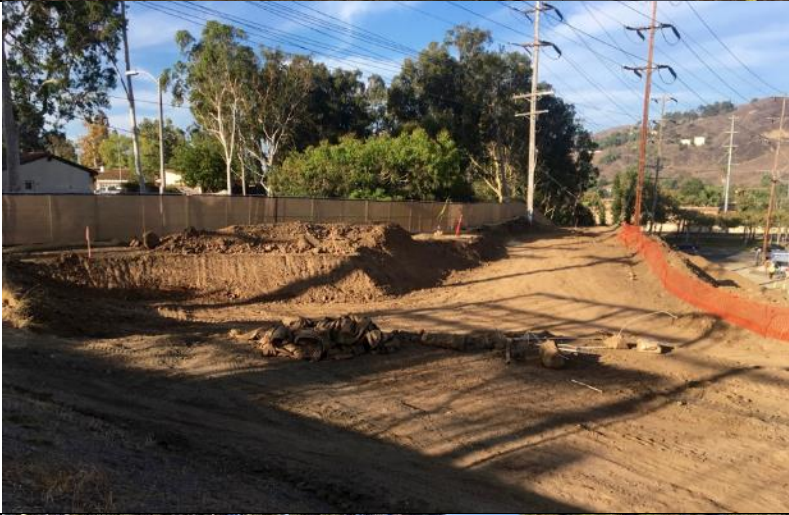
Photo 8 – Earthwork along the southern boundary of the San Juan Capistrano Substation site. Photo facing west.
08/29/18	San Juan Capistrano Substation

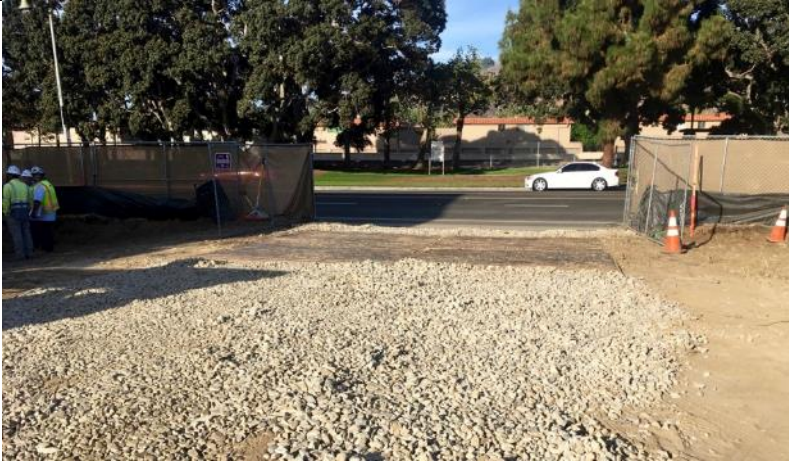
Photo 9 – Second exit/entry installed with rock and rumble plates. Photo facing west.
