**Re: Monthly Report Summary #11 for the South Orange County Reliability Enhancement (SOCRE) Project**

CPUC Site Inspection Reports  
September 6, 13, 20, and 27, 2018

## South Orange County Reliability Enhancement Project CPUC Site Inspection Form

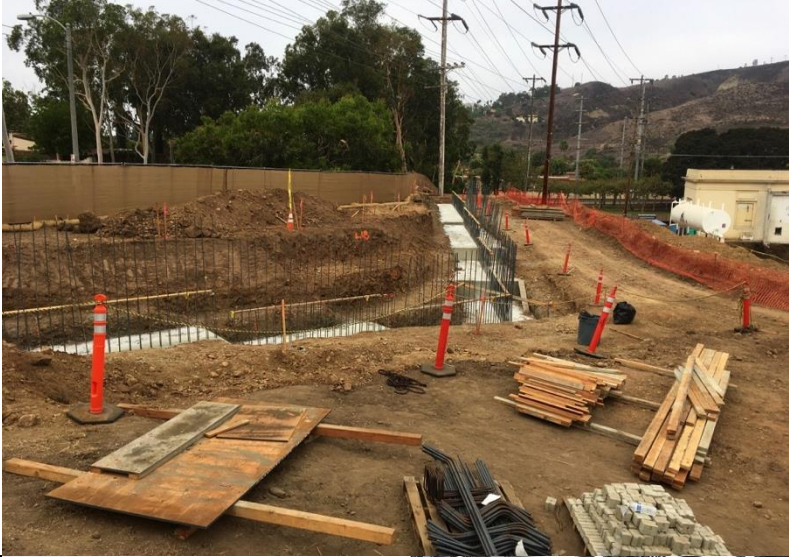
The southern perimeter wall's foundation had been poured earlier in the week (Photo 1). The trench walls were still tall enough to trap animals; accordingly, construction crews placed escape ramps in the trench. The escape ramps were properly installed and in good condition. Fence installation continued onsite (Photo 2). Work on the northern perimeter wall was temporarily on hold (Photo 3).

Photo 1 – Work on the southern perimeter wall foundation. Photo facing west.
9/13/18	San Juan Capistrano Substation

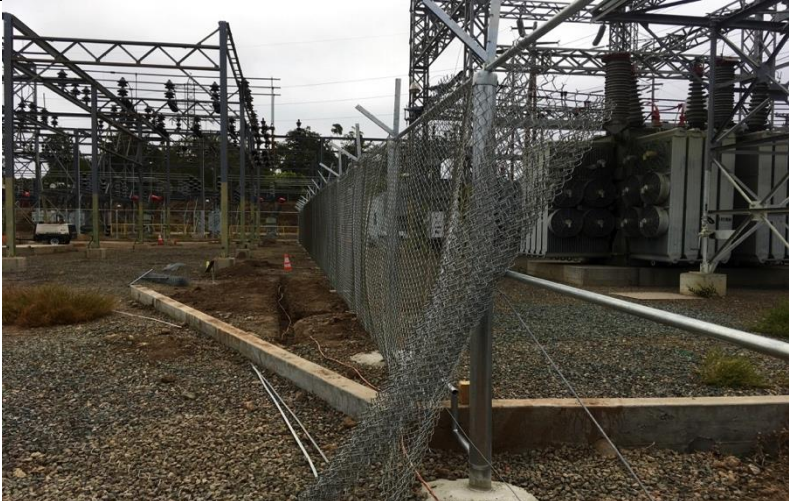
Photo 2 – Fence installation within the existing San Juan Capistrano Substation site. Photo facing east.
9/13/18	San Juan Capistrano Substation

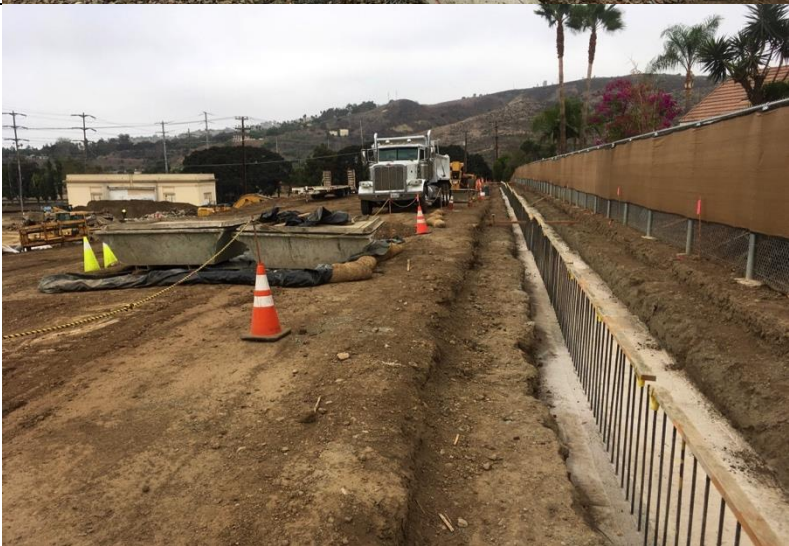
Photo 3 – Northern perimeter wall foundation. Photo facing west.

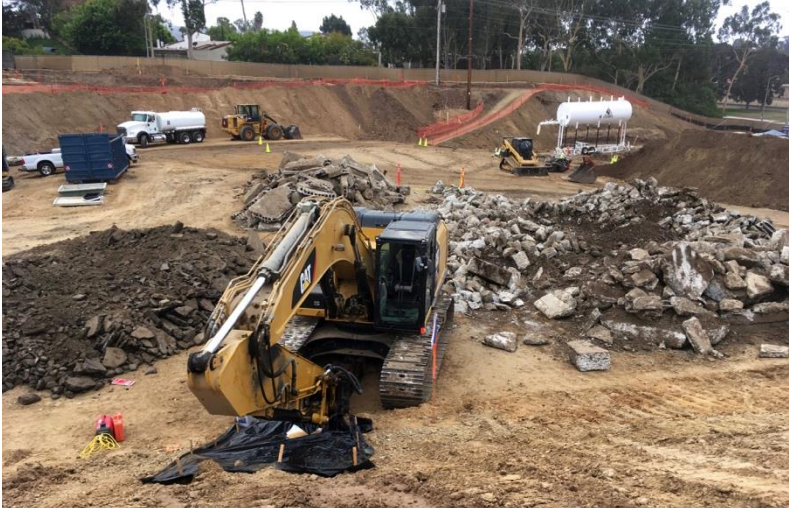
The foundation from the east wing of the former utility structure had been removed and stockpiled onsite (Photo 4). This material will be processed and recycled. Crews continued with excavation and recompaction of soil in and around the former utility structure using a bulldozer, excavator, front loader, and vibrating compactor (Photo 5). A piece of equipment was parked and had containment set up underneath its leaking hydraulic line (Photo 6).

Photo 4 – Materials stockpiled onsite. Photo facing south.
9/13/18	San Juan Capistrano Substation

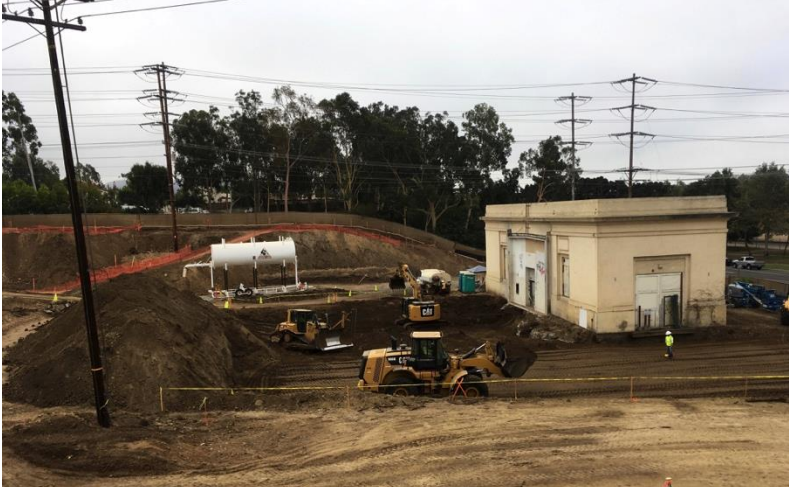
Photo 5 – Equipment working in the area around the former utility structure. Photo facing south.
9/13/18	San Juan Capistrano Substation

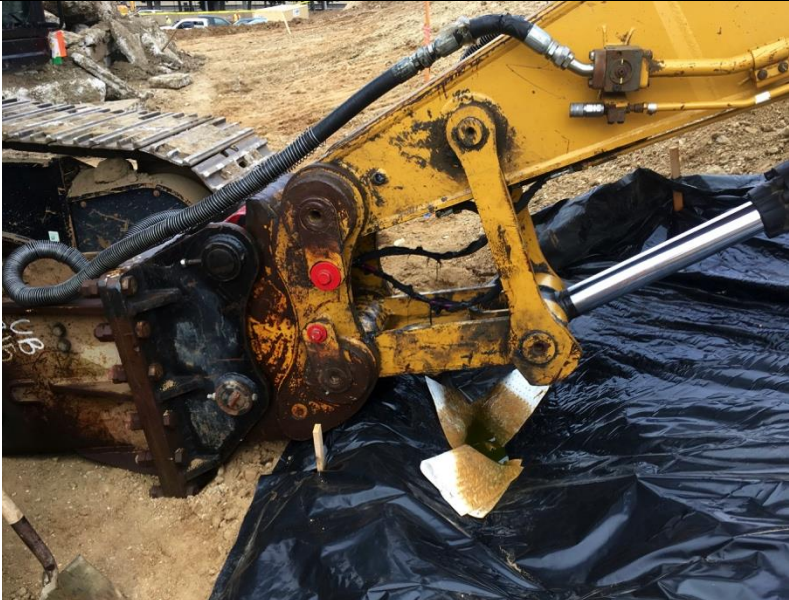
Photo 6 – Containment of leaking equipment.

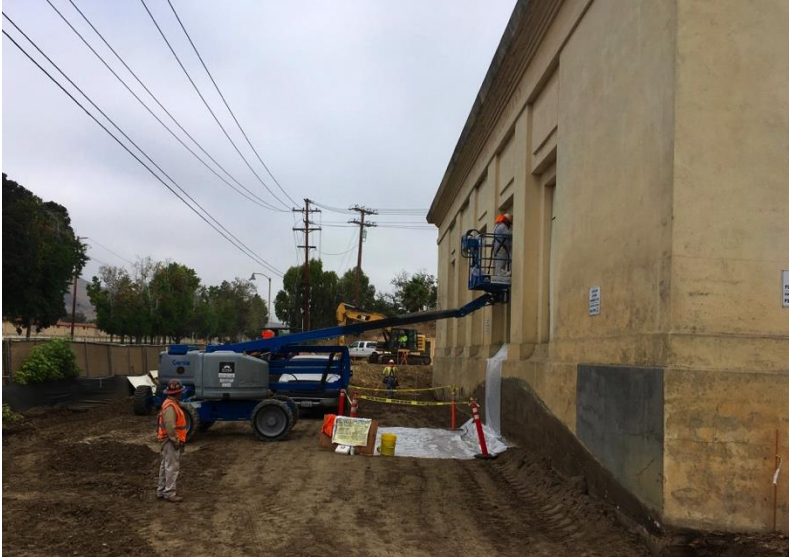
A crew continued to remove lead paint from the former utility structure's windows (Photo 7). Air sampling equipment was being used during lead paint removal (Photo 8).

Photo 7 – Lead paint removal at the former utility structure. Photo facing north.
9/13/18	San Juan Capistrano Substation

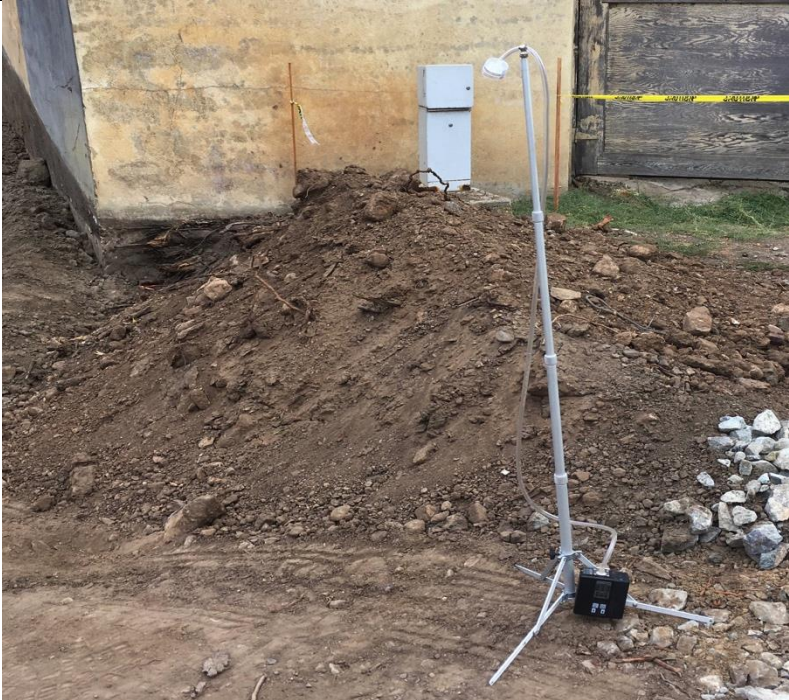
Photo 8 – Air sampling equipment at the former utility structure.

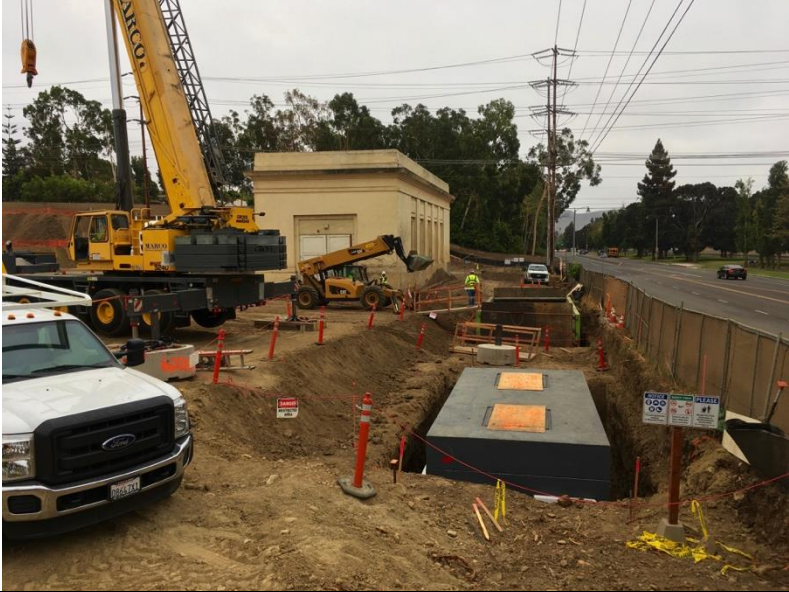
On the day of my site visit, construction activities focused on the installation of conduit vaults. One conduit vault had been installed; the second conduit vault was scheduled to arrive later in the morning (Photo 1). These vaults are located along the western edge of the San Juan Capistrano Substation site and safety measures were in place around each vault location. The SDG&E Lead Environmental Inspector checked the excavations for wildlife ahead of construction activities. The plan was to slurry in both vaults the day after my site visit. Removal of lead paint from the former utility structure was on hold until the vaults were installed. Work on the northern perimeter wall foundation was complete, but wall installation was still on hold (Photo 2).

Photo 1 – Vault installation. Photo facing south.
9/20/18	San Juan Capistrano Substation

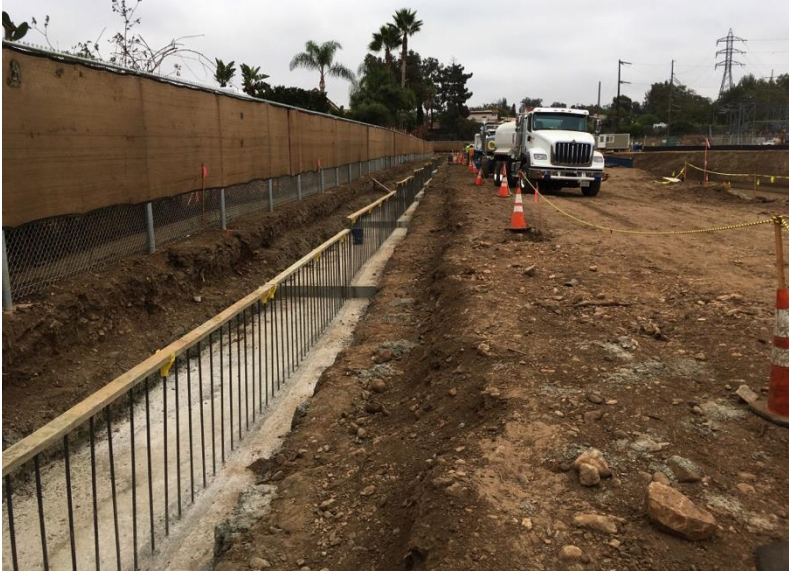
Photo 2 – Northern perimeter wall foundation. Photo facing east.
9/20/18	San Juan Capistrano Substation

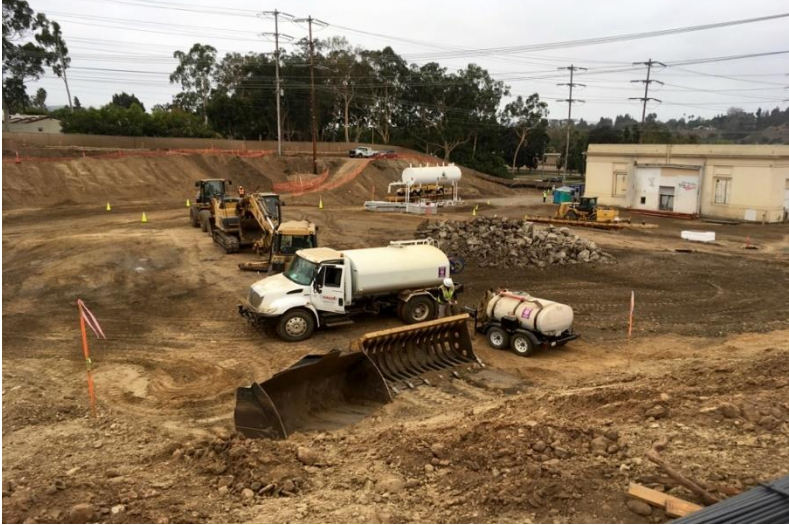
All asphalt from the San Juan Capistrano Substation site had been removed and recycled; piles of concrete remained onsite and will be hauled off and recycled (Photo 3). Several racks were removed within the San Juan Capistrano Substation site. The metal was being broken up and recycled (Photo 4). Construction crews were preparing to remove the old foundations within the San Juan Capistrano Substation site; cultural monitors were monitoring removal of the old foundations.

Photo 3 – Stockpile area with concrete rubble to be recycled. Photo facing southwest.

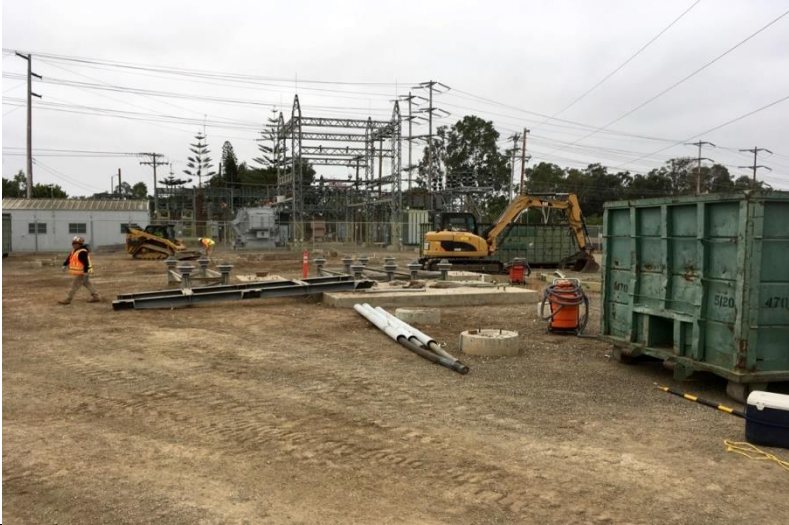
Photo 4 – Removal of old rack structures within the San Juan Capistrano substation site. Photo facing south.
9/20/18	San Juan Capistrano Substation

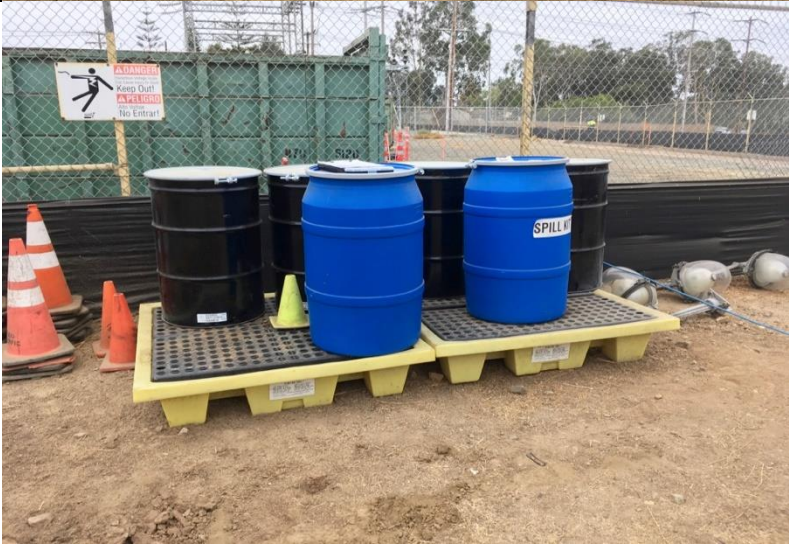
Construction crews set up a containment system for a number of 50-gallon drums. The containment system was in good condition (Photo 5).

Photo 5 – Hazardous materials containment. Photo facing south.
9/20/18	San Juan Capistrano Substation

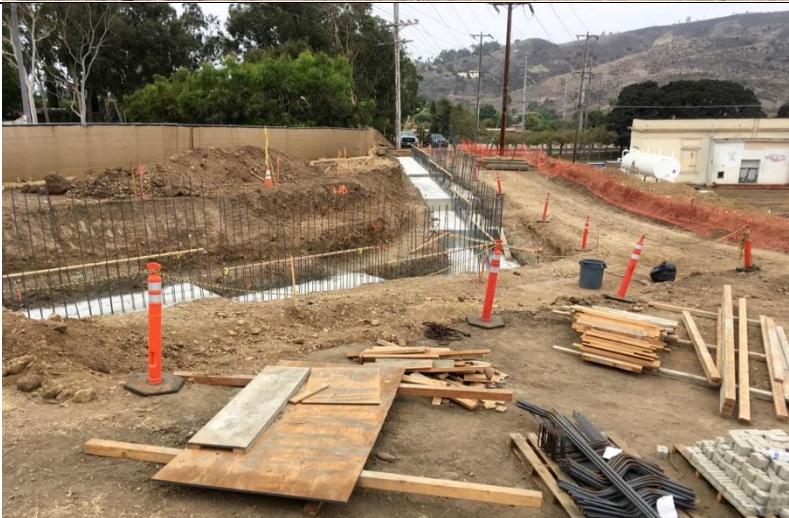
The foundation for the southern perimeter wall had been poured and escape ramps were in place (Photo 6).

Photo 6 – Southern perimeter wall construction. Photo facing west.

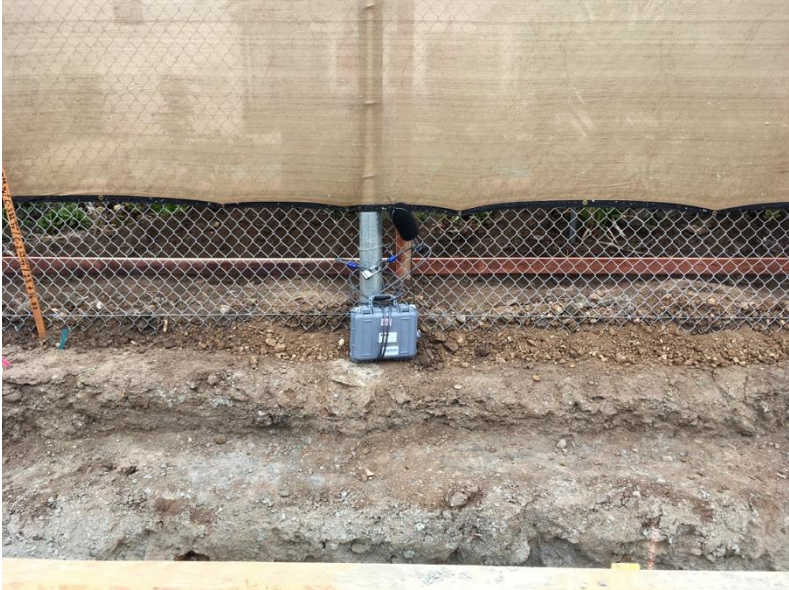
Photo 7 – Noise monitoring device attached to the northern chain link fence.

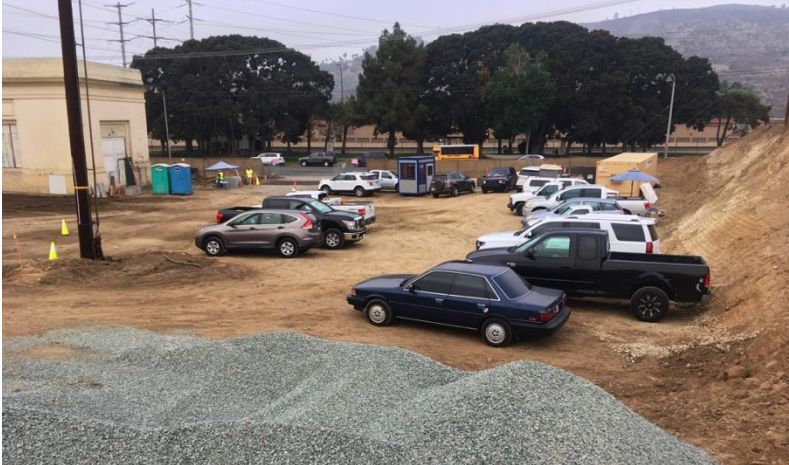
Photo 1 – Project parking and northern entrance. Photo facing west.
9/27/18	San Juan Capistrano Substation

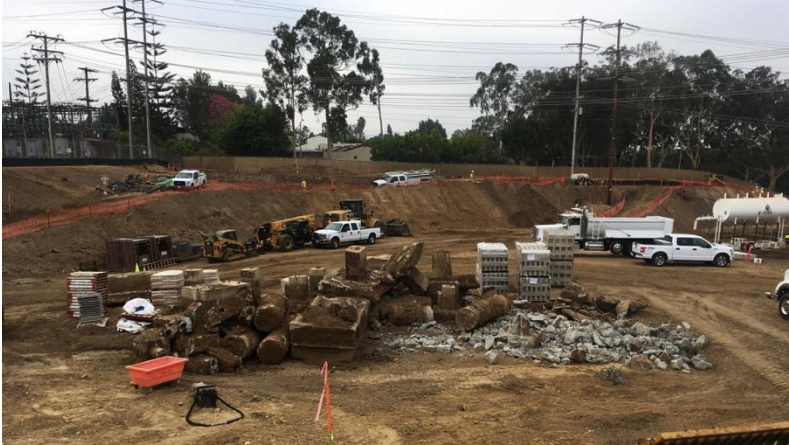
Tower and rack foundations have been excavated from within the San Juan Capistrano Substation site. These materials will be stockpiled onsite until it can be broken up and recycled (Photo 2). Some foundations remain within the San Juan Capistrano Substation site (Photo 5).

Photo 2 – Old tower foundations stockpiled onsite. Photo facing south.
9/27/18	San Juan Capistrano Substation

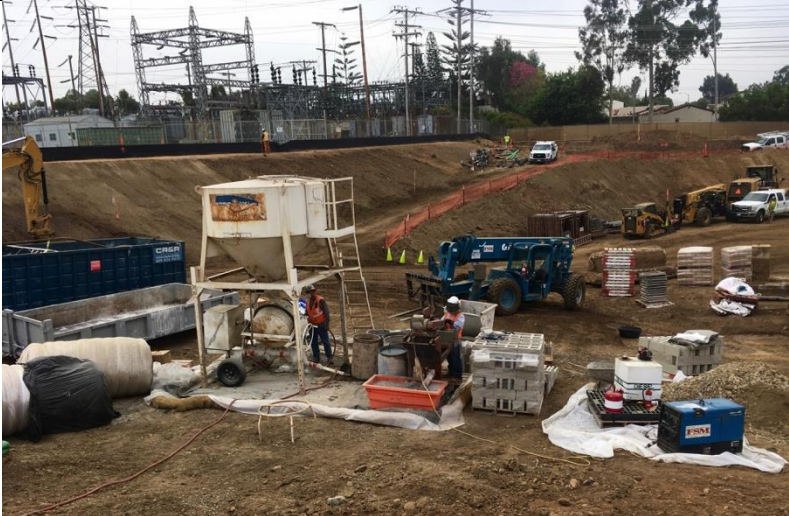
Photo 3 – Grout mixing station. Photo facing south.

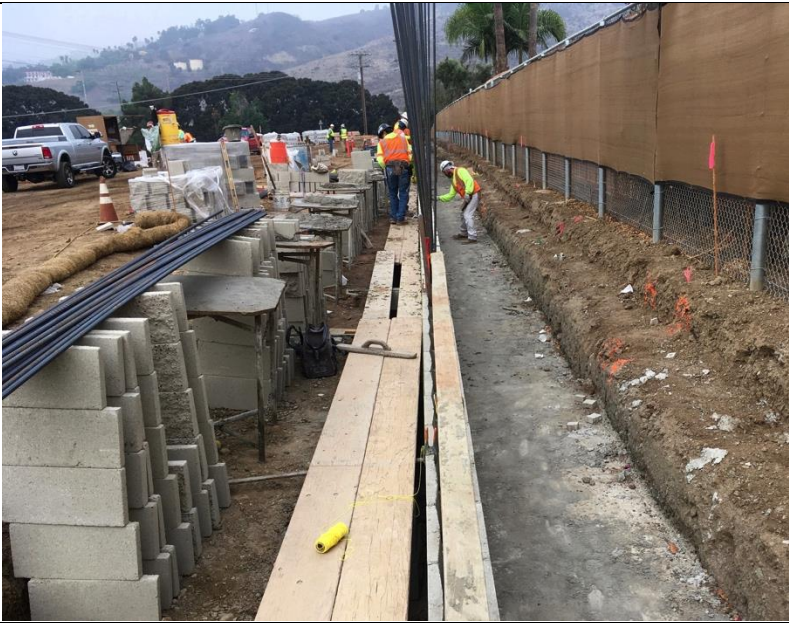
Photo 4 – Brick installation on the northern perimeter wall. Photo facing west.
9/27/18	San Juan Capistrano Substation

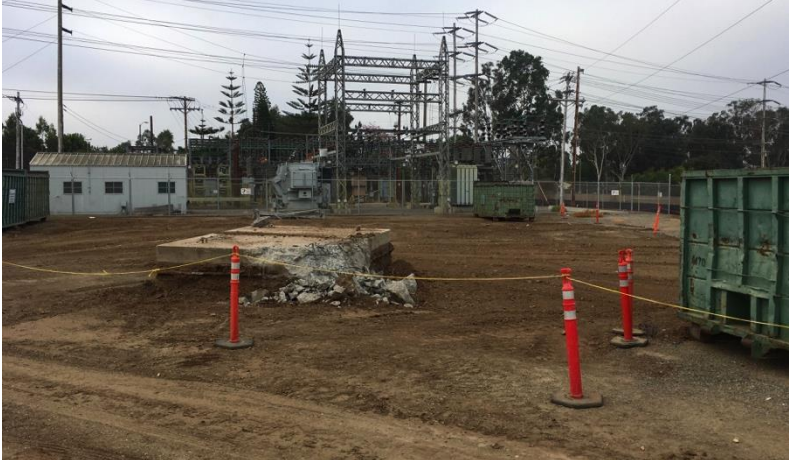
Photo 5 – Rack foundation within the San Juan Capistrano Substation site to be removed. Photo facing south.
9/27/18	San Juan Capistrano Substation

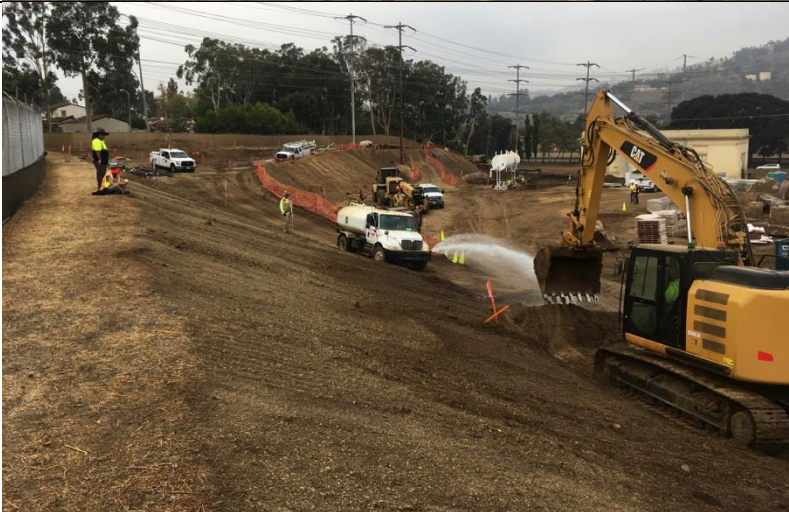
Photo 6 – Over-excitation work. Photo facing southwest.

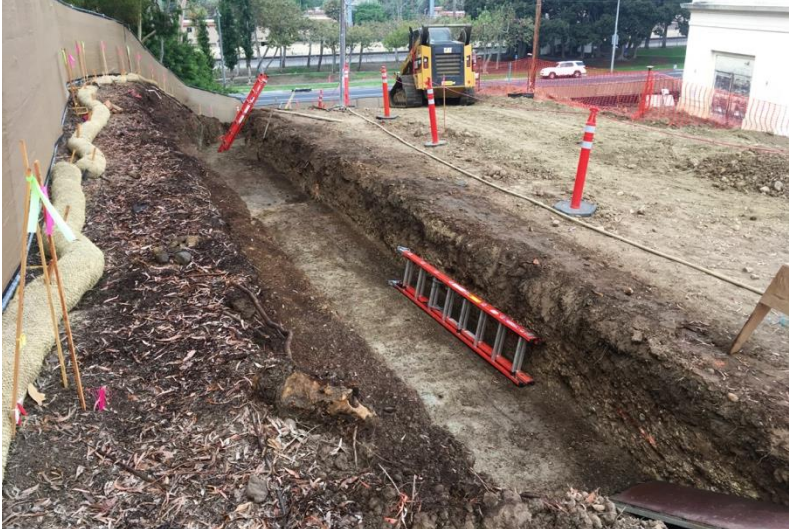
Photo 7 – Open trench for the southern perimeter wall foundation. Photo facing west.
9/27/18	San Juan Capistrano Substation

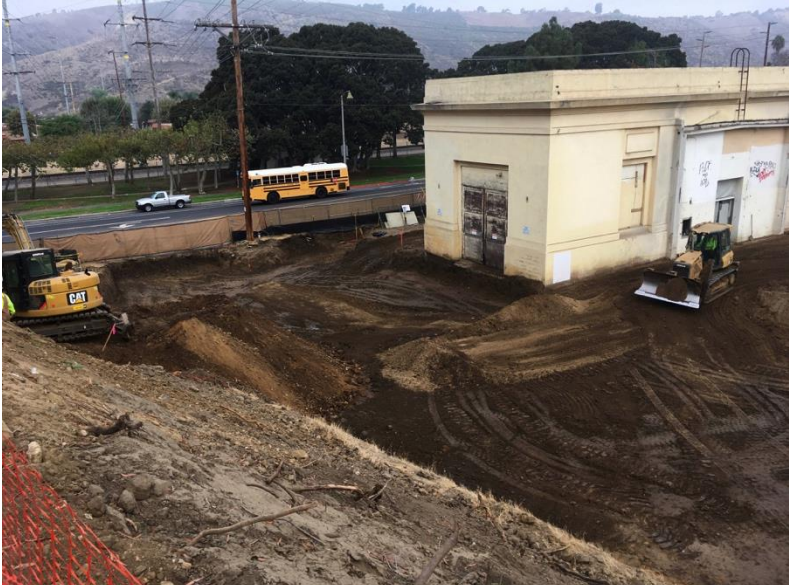
Photo 8 – Excavation and recompaction work south of the former utility structure. Photo facing west.
