Re: Monthly Report Summary #12 for the South Orange County Reliability Enhancement (SOCRE) Project

South Orange County Reliability Enhancement Project CPUC Site Inspection Form

Project:	South Orange County Reliability Enhancement Project (SOCRE)	Date:	October 1, 2018
Project Proponent:	San Diego Gas & Electric (SDG&E)	Report #:	VS011
Lead Agency:	California Public Utilities Commission (CPUC)	Monitor(s):	CPUC/Ecology and Environment (E & E) Compliance Monitor
CPUC PM:	Andrew Barnsdale, Energy Division	AM/PM Weather:	Sunny and warm with a slight breeze
CPUC CM (E & E):	Joe Donaldson	Start/End Time:	1015 to 1200
Project NTP(s):	NTP-1, NTP-2, NTP-2 Addendum 1, and NTP-3

Project:	South Orange County Reliability Enhancement (SOCRE) Project	Date:	October 26, 2018
Project Proponent:	San Diego Gas & Electric (SDG&E)	Report #:	VS012
Lead Agency:	California Public Utilities Commission (CPUC)	Monitor(s):	CPUC/Ecology and Environment (E&E) Compliance Monitor
CPUC PM:	Andrew Barnsdale, Energy Division	AM/PM Weather:	Sunny, cool and calm
CPUC CM (E & E):	Joe Donaldson	Start/End Time:	0700 to 0845
Project NTP(s):	NTP-1, NTP-2, NTP-2 Addendum 1, and NTP-3

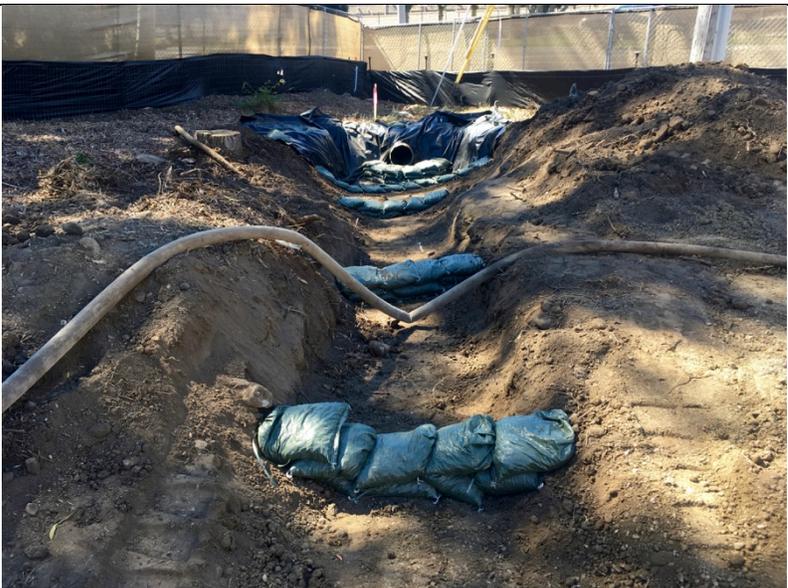
The earthwork occurring on the day of my site visit included installation of a stormwater filtration catch basin in the southwest corner of the San Juan Capistrano Substation site, near the street drain (Photo 1). The forecast indicated a storm during the day, but only 0.25 inch of rain was predicted. The construction contractors were preparing the San Juan Capistrano Substation site for the rainy season, which officially begins on November 1. Preparations included bringing in gravel and setting up the stormwater filtration catch basin. The sediment trap has five rows of gravel bags to slow the rainwater runoff and allow any sediment to drop out. I observed that the stormwater filtration catch basin looked small, considering the size of the site.

Photo 1 – Sediment basin located in the southwestern corner of the site.
10/1/18	San Juan Capistrano Substation

Check in on the Stormwater Pollution Prevention Plan (SWPPP) preparations, specifically the stormwater filtration catch basin.

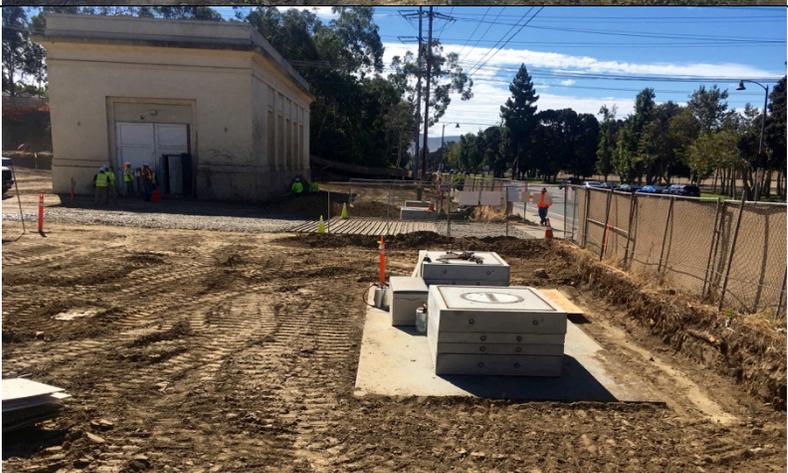
The two conduit vaults were installed and backfilled, with one on either side of the San Juan Capistrano Substation entrance (Photo 2). Water trucks continued to minimize the construction dust by using reclaimed water (Mitigation Measures [MMs] PS-1, Applicant Proposed Measure [APM] AQ-1). A large pile of old foundation material remained onsite but will be broken up and recycled (Photo 3). Concrete trucks were bringing cement to a pumper truck and the northern perimeter wall being poured (Photo 4).

Photo 2 – Vault installation. Photo facing south.
10/1/18	San Juan Capistrano Substation

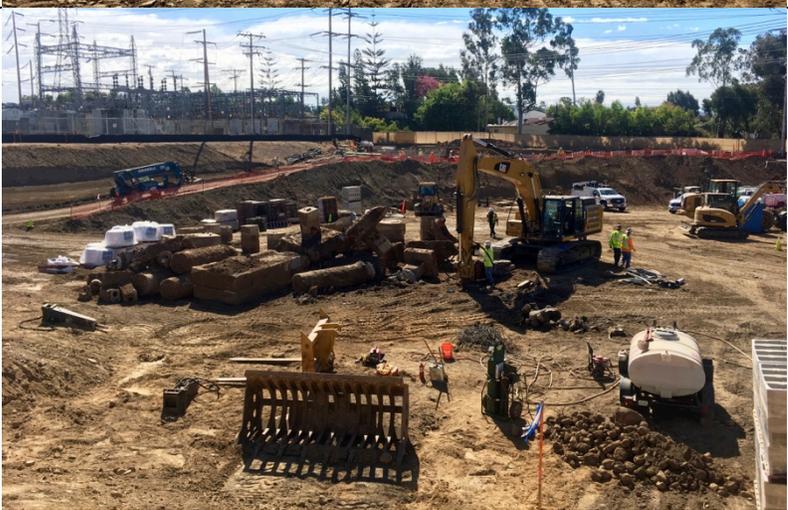
Photo 3 – Stockpile area with concrete rubble to be recycled. Photo facing south.

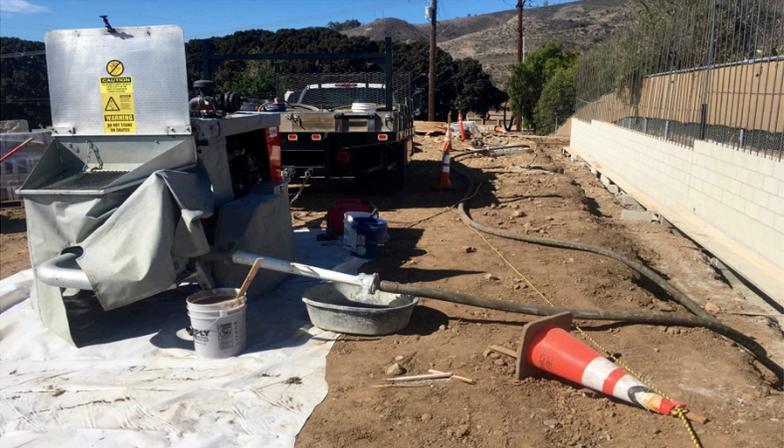
Photo 4 – Northern perimeter wall work. Photo facing west.
10/1/18	San Juan Capistrano Substation

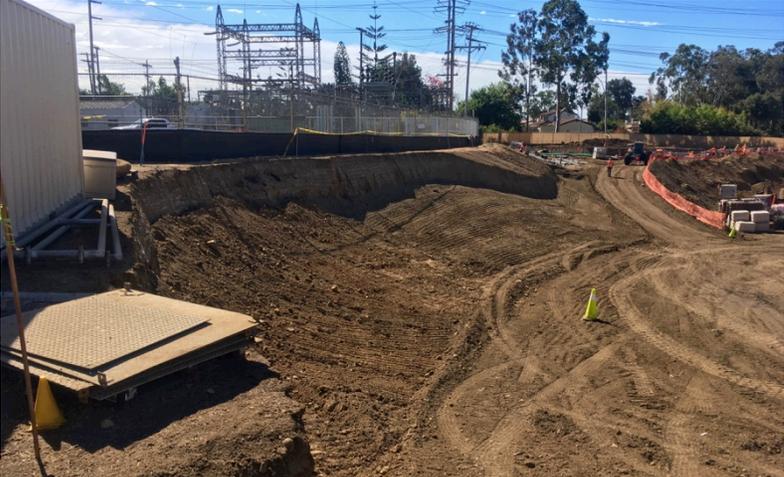
The slope just west of the Capistrano Substation (former utility structure) has been laid back (i.e., excavated and shaped to a less steep slope) (Photo 5). The area within the former utility structure has been regraded and graveled; all of the construction trailers will be moved to this location (Photo 6). The southern perimeter wall was being built (Photo 7) and the foundation trench remained at the western end of the southern perimeter wall (Photo 8).

Photo 5 – Project excavation location. Photo facing south.
10/1/18	San Juan Capistrano Substation

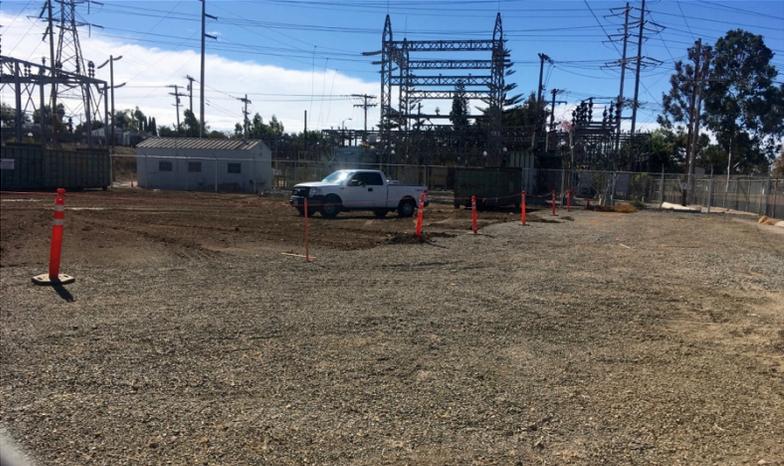
Photo 6 – Future construction trailer location. Photo facing south.

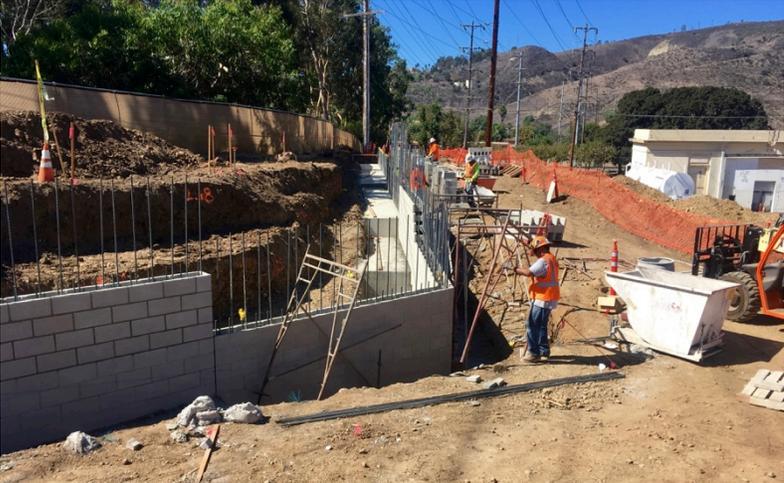
Photo 7 – Southern perimeter wall construction. Photo facing west.
10/1/18	San Juan Capistrano Substation

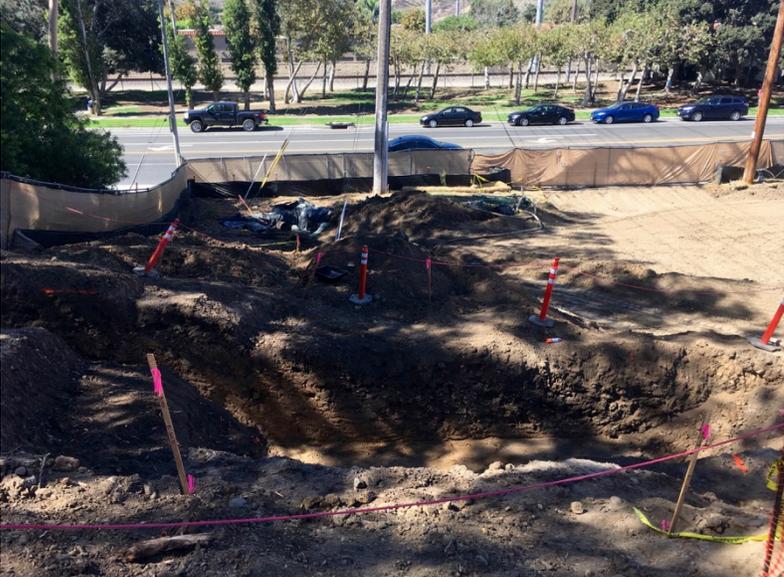
Photo 8 – Wall foundation trench. Photo facing west.

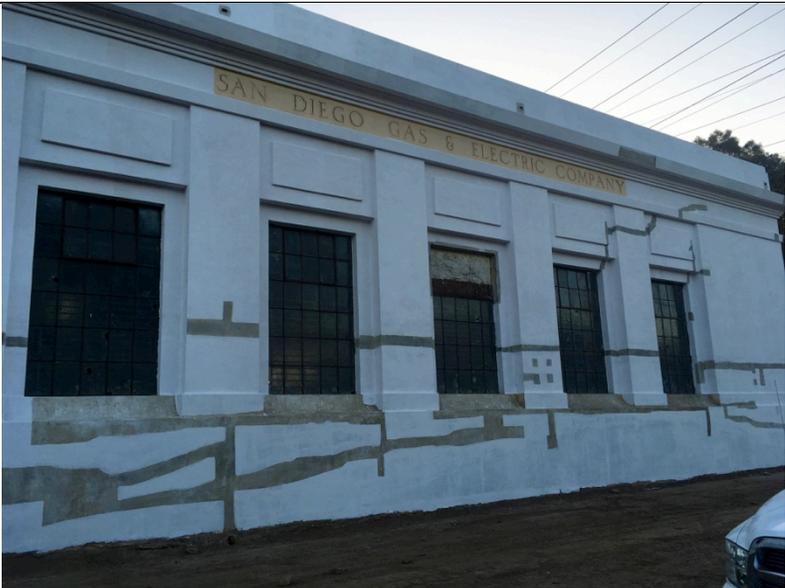
Photo 1 – Former utility structure. Photo facing south.
10/26/18	San Juan Capistrano Substation

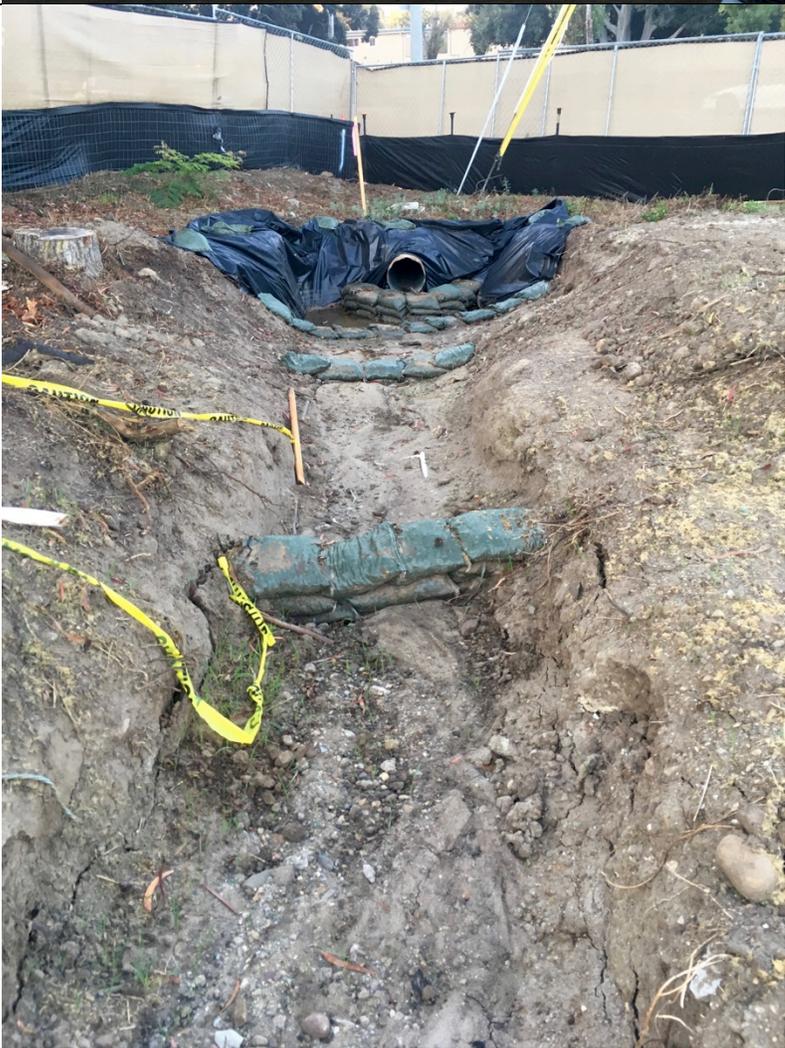
Most of the lead abatement work on the Capistrano Substation (former utility structure) was complete and a special paint was applied to seal the walls (Photo 1). I observed that the sediment catch basin filled up after one small storm (Photo 2). I spoke with the SDG&E Lead Environmental Inspector about cleaning out the sediment trapped behind the gravel berms and possibly expanding the basin, as a larger storm may overwhelm the basin in its current size. The SDG&E Lead Environmental Inspector said an upgrade would be made, as needed, based on the weather. A crew was installing a portion of the stormwater drainage system near the San Juan Capistrano Substation entrance, just south of the Capistrano Substation (Photo 3).

Photo 2 – Stormwater filtration catch basin. Photo facing southwest.

Check in on the Storm Water Pollution Prevention Plan (SWPPP) preparations, specifically the stormwater filtration catch basin.

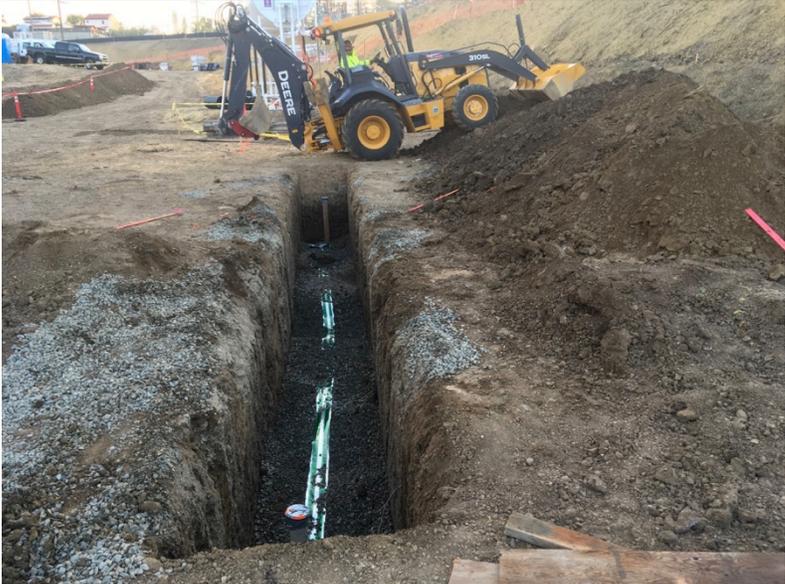
Photo 3 – Storm drain installation. Photo facing east.
10/26/18	San Juan Capistrano Substation

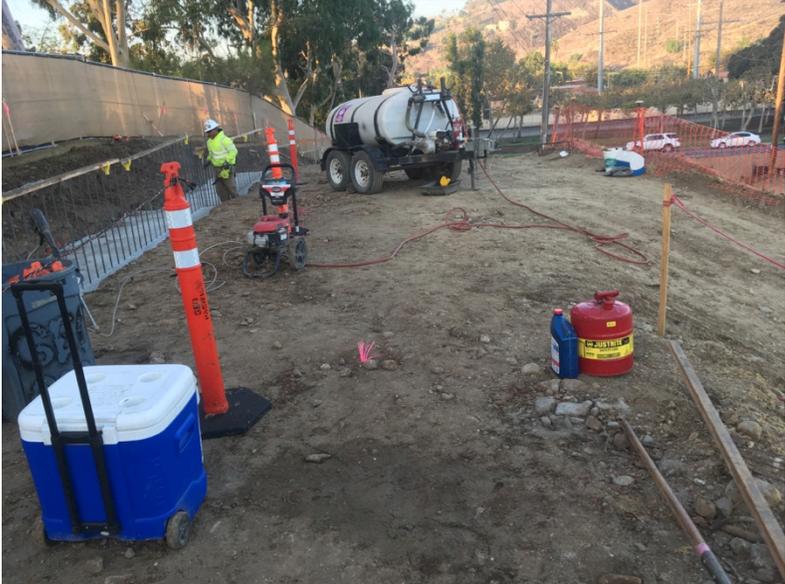
Work on the southern perimeter wall was ongoing (Photo 4). I noted that a gas container and an oil can being used to fuel the portable generator were not contained. I mentioned this to the SDG&E Lead Environmental Inspector and he spoke with the construction contractors about placing the gas container and oil can within a drip pan.

Photo 4 – Southern perimeter wall; note the oil and gas containers have no secondary containment. Photo facing west.
10/26/18	San Juan Capistrano Substation

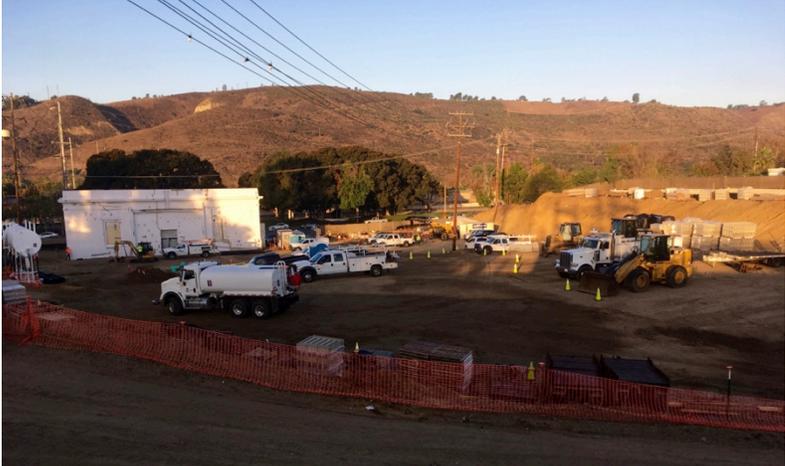
Water trucks using reclaimed water continued to minimize dust created by construction activities (Mitigation Measure [MM] PS-1, Applicant Proposed Measure [APM] AQ-1; Photo 5). Work on the northern perimeter wall was ongoing; crews were using a moisture sealant paint on the wall (Photo 6). An excavator was pulling back some of the soil from the base of the wall to allow crews to do the sealant work (Photo 7).

Photo 5 – Overview of the San Juan Capistrano Substation site; a water truck is conducting dust control. Photo facing west.

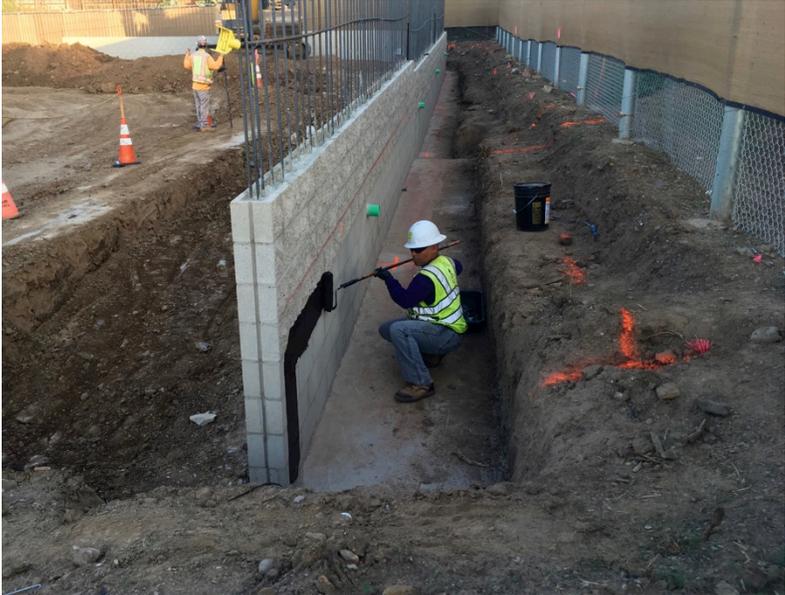
Photo 6 – Sealing the northern perimeter wall. Photo facing north.
10/26/18	San Juan Capistrano Substation

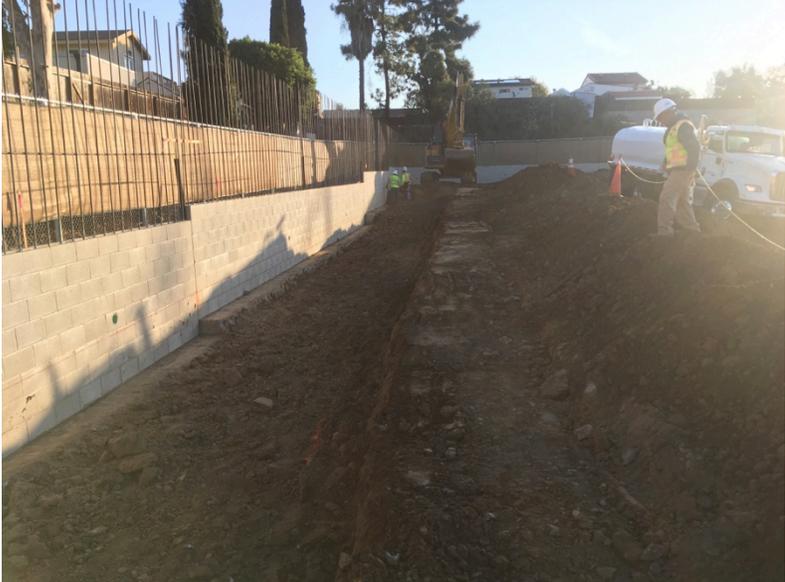
Photo 7 – Soil removal along the northern perimeter wall. Photo facing east.
10/26/18	San Juan Capistrano Substation

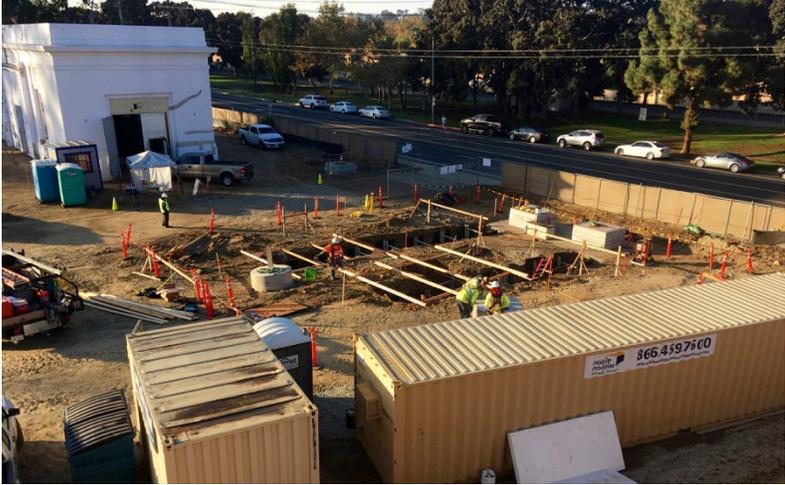
Conduit installation was taking place in the two trenches associated with the two large vault boxes (Photo 8). These were deep, straight-walled trenches, and escape ramps were not installed. I spoke with the SDG&E Lead Environmental Inspector about his examination of these trenches for any animals; the SDG&E Lead Environmental Inspector said that the trenches are checked often. In addition, the SDG&E Lead Environmental Inspector has directed the construction contractors to report any animals that they observed.

Photo 8 – Conduit installation. Photo facing southwest.

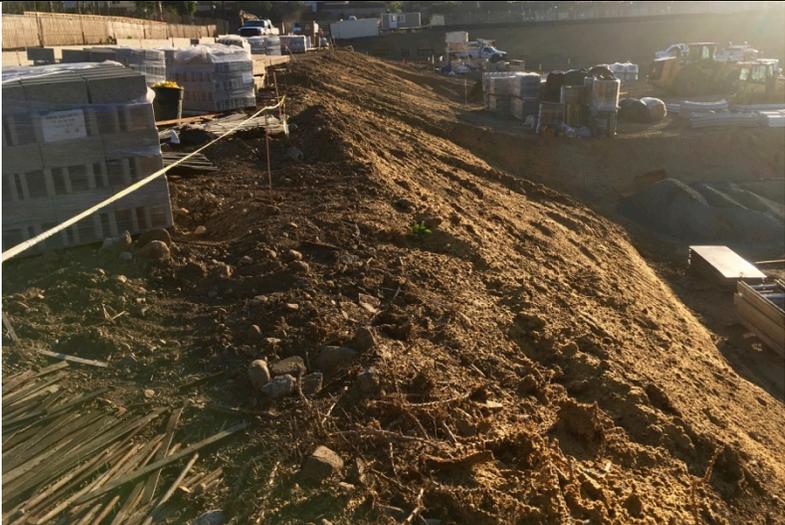
Most of the exposed soil throughout the San Juan Capistrano Substation has been hydromulched (Photo 9).

Photo 9 – Exposed soil has been hydromulched. Photo facing east.
