Re: Monthly Report Summary #14 for the South Orange County Reliability Enhancement (SOCRE) Project

CPUC Site Inspection Reports
December 5, 12, and 19, 2018

South Orange County Reliability Enhancement Project CPUC Site Inspection Form

Project:	South Orange County Reliability Enhancement Project	Date:	December 5, 2018
Project Proponent:	San Diego Gas & Electric (SDG&E)	Report #:	VS017
Lead Agency:	California Public Utilities Commission (CPUC)	Monitor(s):	CPUC/Ecology and Environment (E & E) Compliance Monitor
CPUC PM:	Andrew Barnsdale, Energy Division	AM/PM Weather:	Clear, sunny, cool, and calm
CPUC CM (E & E):	Joe Donaldson	Start/End Time:	0700 to 0930
Project NTP(s):	NTP-1, NTP-2, NTP-2 Addendum 1, and NTP-3

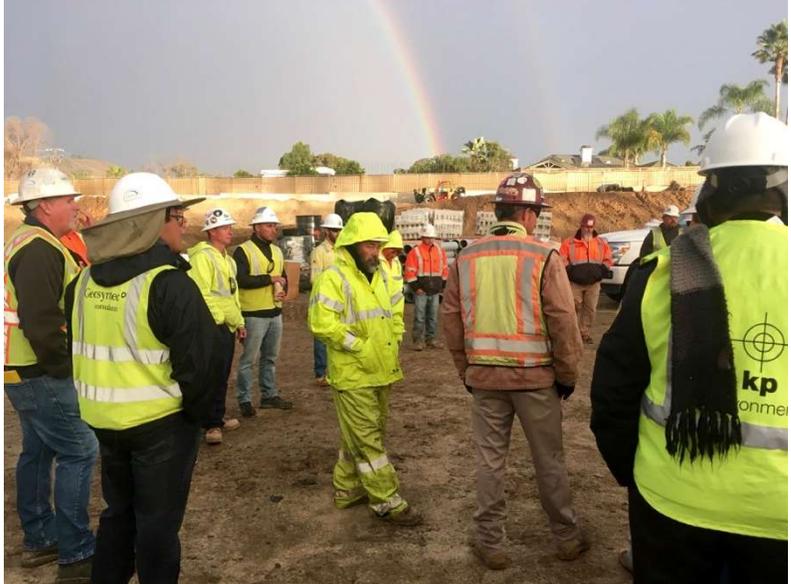
I arrived at the San Juan Capistrano Substation site at 0700 to attend the tailboard meeting. A storm was forecasted, and it started to rain during the meeting (Photo 1). The SDG&E Lead Environmental Inspector stated that the San Juan Capistrano Substation site received 1.5 inches of rain during the previous week, and there were lessons learned about project site runoff from the substation through the construction site. The water was directed into an existing culvert (Photo 2), and piping was added to transport the water to the offsite drain (Photo 6).

Photo 1 – 0700 tailboard meeting. Photo facing north.
12/5/18	San Juan Capistrano Substation

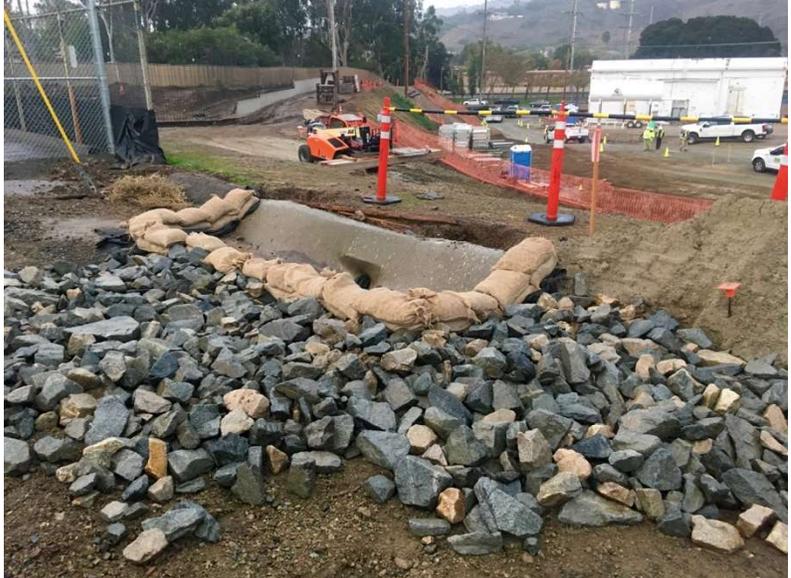
Photo 2 – Best management practices (BMPs) around the culvert that drains from the San Juan Capistrano Substation. Photo facing west.

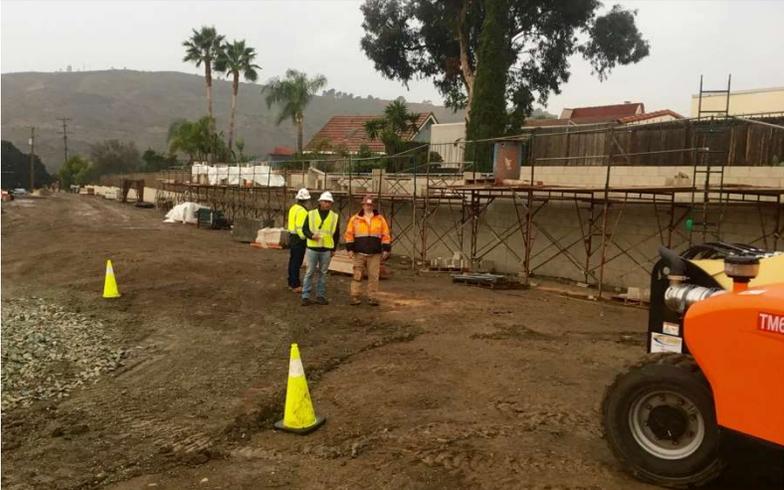
Much of the work at the San Juan Capistrano Substation site was on hold due to the forecasted storm. A construction crew was onsite waiting to do work on the northern boundary wall, weather permitting (Photo 3).

Photo 3 – Crews near the northern boundary wall. Photo facing northwest.
12/5/18	San Juan Capistrano Substation

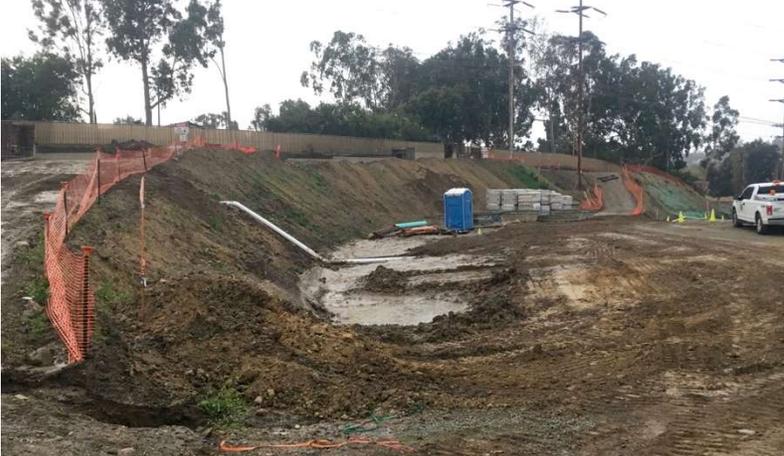
Rainwater runoff had pooled in a low spot near the southern portion of the San Juan Capistrano Substation site. The pooled water traveled down the access road to the small catch basin located in front of the offsite drain (Photo 4). The SDG&E Lead Environmental Inspector said crews dug out the drainage channel in the catch basin and removed about 3 feet of soil; crews then filled the catch basin with rock (Photo 6). Filling the catch basin with rock will slow the rainwater runoff rate and allow sediment to drop out.

Photo 4 – Catch basin along the access road. Photo facing southwest.
12/5/18	San Juan Capistrano Substation

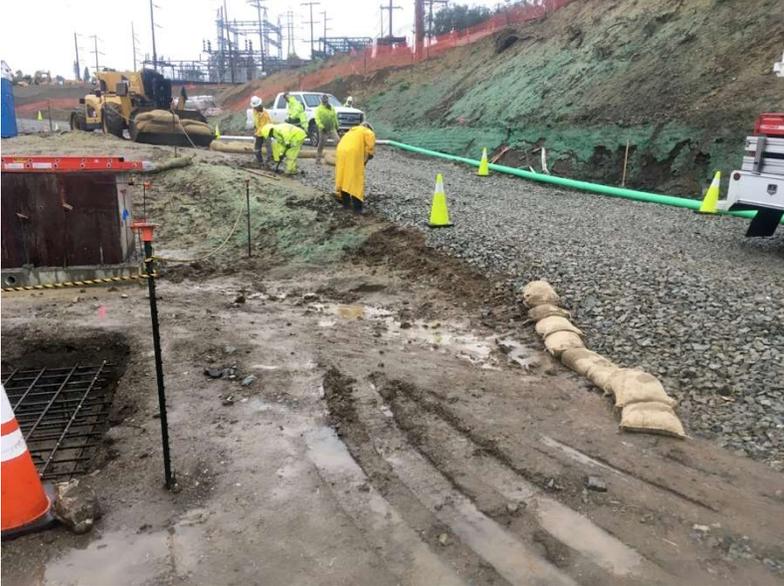
Crews began adding gravel bag check dams and straw wattles at various locations throughout the San Juan Capistrano Substation site to further control runoff (Photo 5).

Photo 5 – Crews installing straw wattles. Photo facing east.

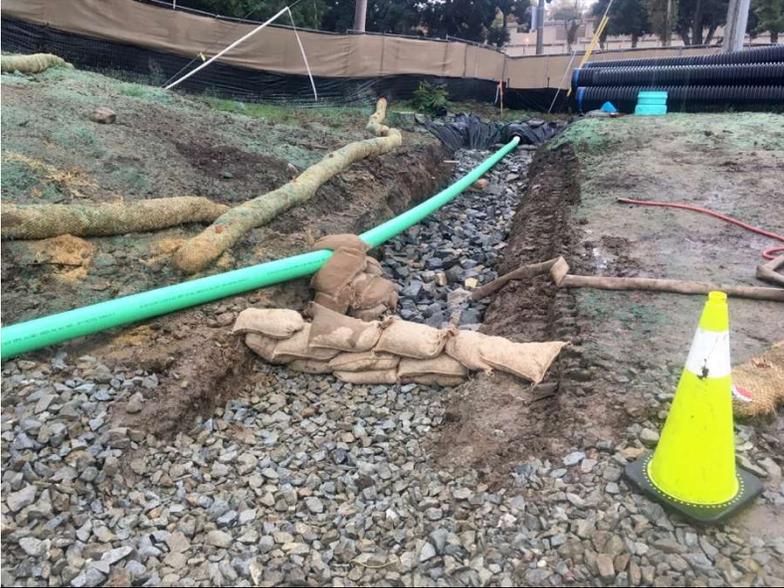
Photo 6 – Rock filled catch basin at the southwest corner of the San Juan Capistrano Substation site. Photo facing southwest.
12/5/18	San Juan Capistrano Substation

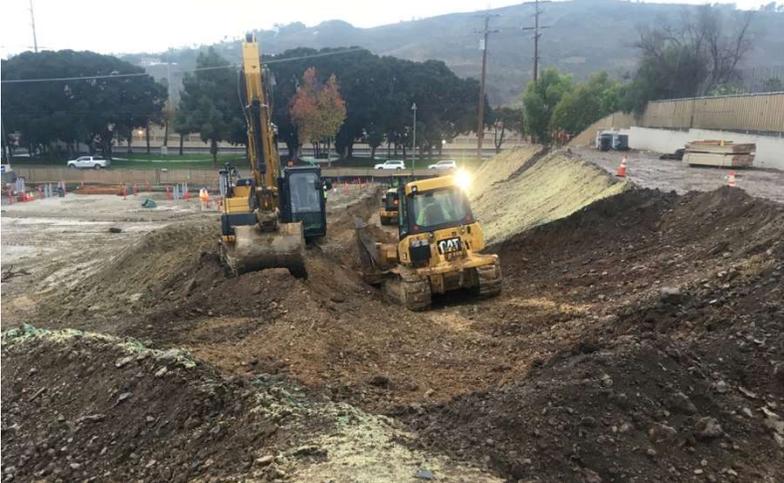
Excavation work commenced ahead of the rain (Photo 7). The paleontological resources monitor was onsite and observing the excavation activity.

Photo 7 – Excavation work near the northern boundary wall. Photo facing west.

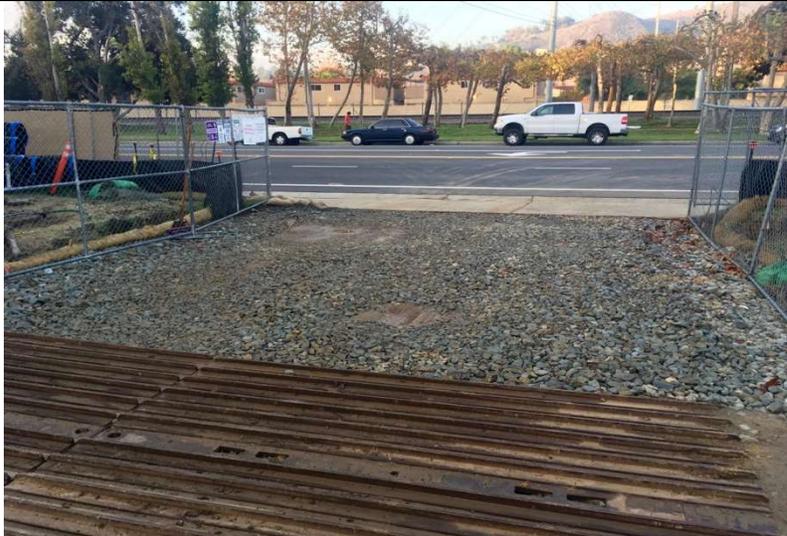
I arrived onsite at 0715. I observed that the site entry/exit best management practices (BMPs) could use some attention, including additional rock and sweeping the public road (Photo 1).

Photo 1 – Site exit/entry. Photo facing west.
12/12/18	San Juan Capistrano Substation

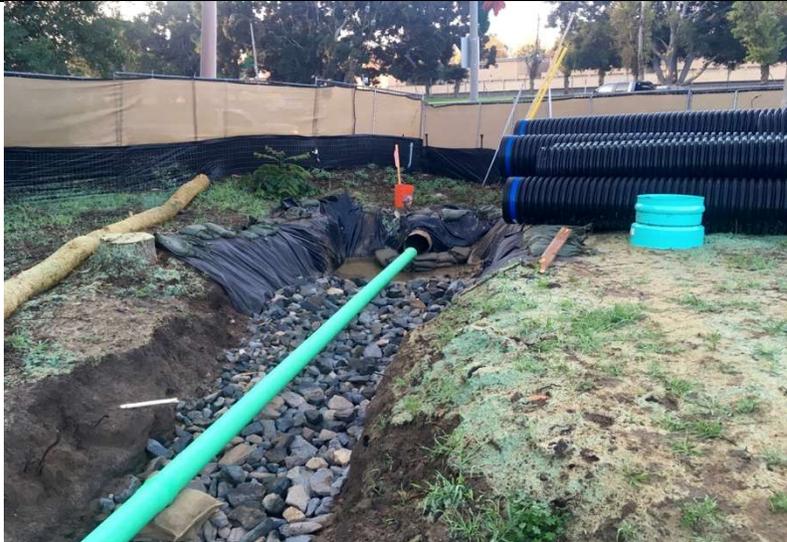
I met with the SDG&E Lead Environmental Inspector and the Construction Superintendent. We discussed the recent rain event and talked about how the site held up to the rain. The SDG&E Lead Environmental Inspector said there had been 1.7 inches of rain, with rain falling for a brief period at nearly 1 inch per hour. I suggested adding some gravel bag check dams to the rocky catch basin and extending the San Juan Capistrano Substation drain pipe into the offsite pipe (Photo 2).

Photo 2 – Catch basin draining into the offsite culvert. Photo facing southwest.

Expansion of the onsite catch basins is recommended.

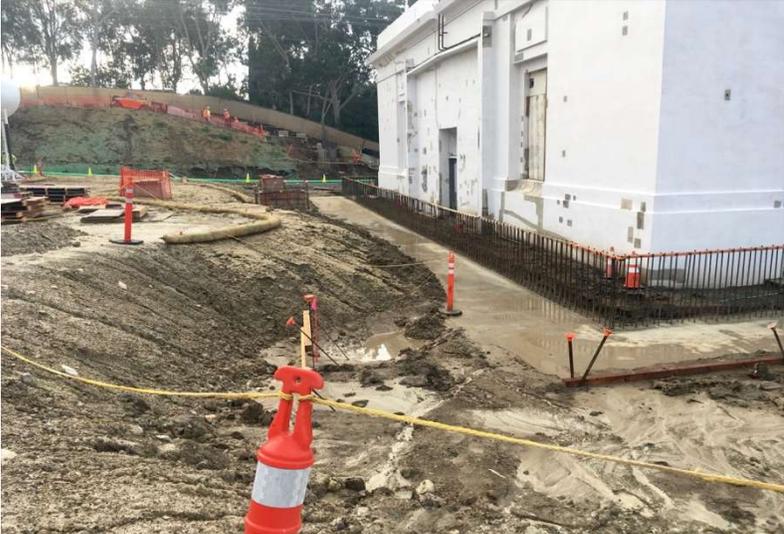
Work was being conducted around the former utility structure, with the focus on mud cleanup (Photo 3). The catch basin below the existing 138/12-kilovolt (kV) substation was still retaining water and mud (Photo 4). Work on the southern and northern boundary walls was being conducted, including the addition of bricks and building the brow ditch (Photos 5 & 8).

Photo 3 – Work around the former utility structure. Photo facing southwest.
12/12/18	San Juan Capistrano Substation

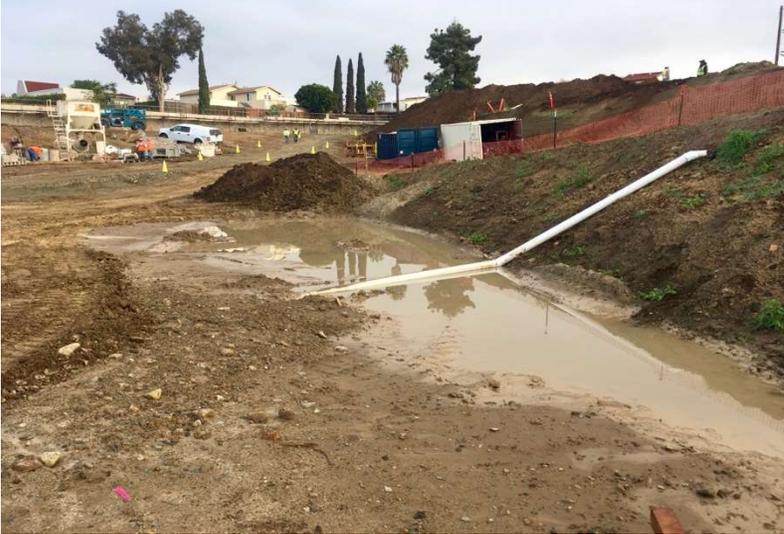
Photo 4 – First catch basin along the access road. Photo facing northeast.
12/12/18	San Juan Capistrano Substation

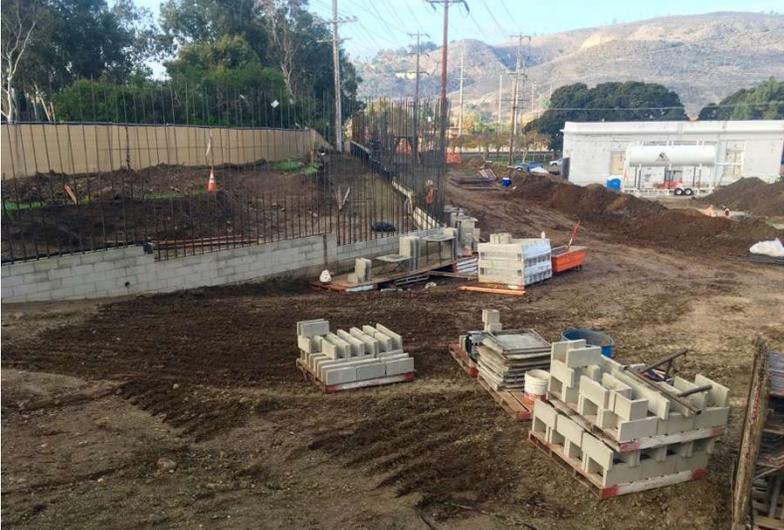
Photo 5 – Work on the southern boundary wall. Photo facing west.

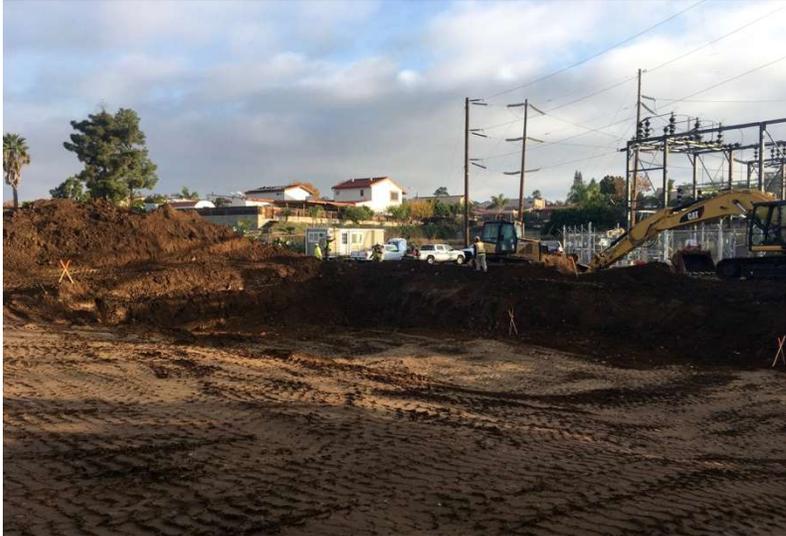
A portion of the existing 138/12-kV substation was being overexcavated at a depth of between 6 to 8 feet (Photo 6). The spoil was stockpiled nearby and sprayed with water prior to compacting the spoil for placement back into the ground (Photo 7). The water used for this activity was pumped into the water truck from the various ponded water locations onsite (Photo 9). The paleontological resources monitor was onsite and observing this activity, along with a cultural resources monitor and archaeological resources monitor.

Photo 6 – Overexcavation work near the existing 138/12-kV substation. Photo facing east.
12/12/18	San Juan Capistrano Substation

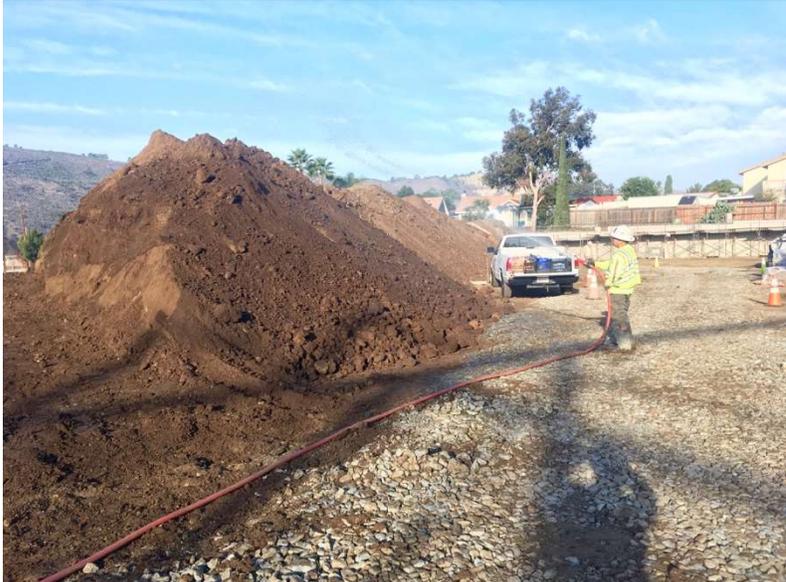
Photo 7 – Watering the spoil pile. Photo facing northwest.
12/12/18	San Juan Capistrano Substation

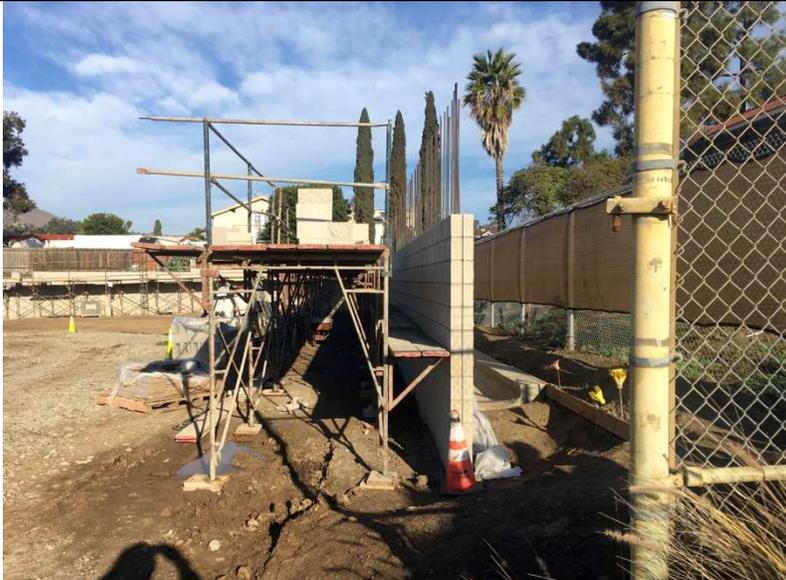
Photo 8 – Work on the northern boundary wall. Photo facing north.

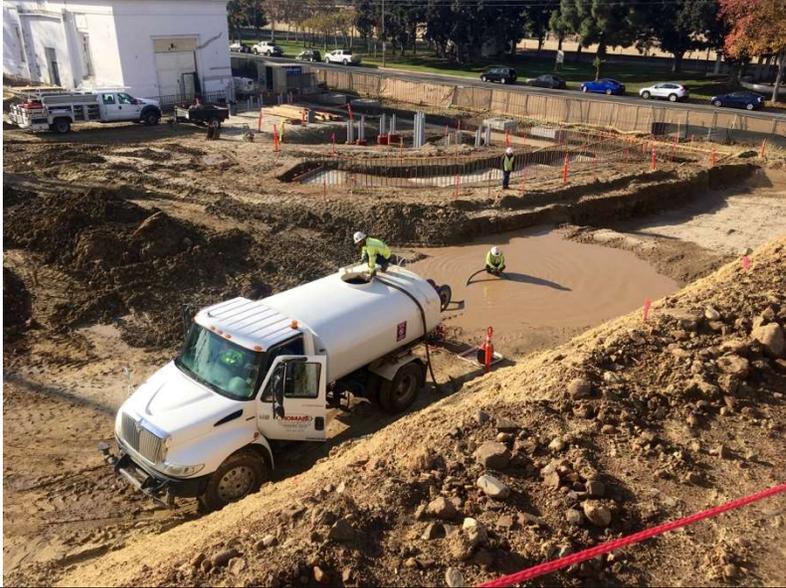
Photo 9 – Crew pumping ponded water into a water truck.

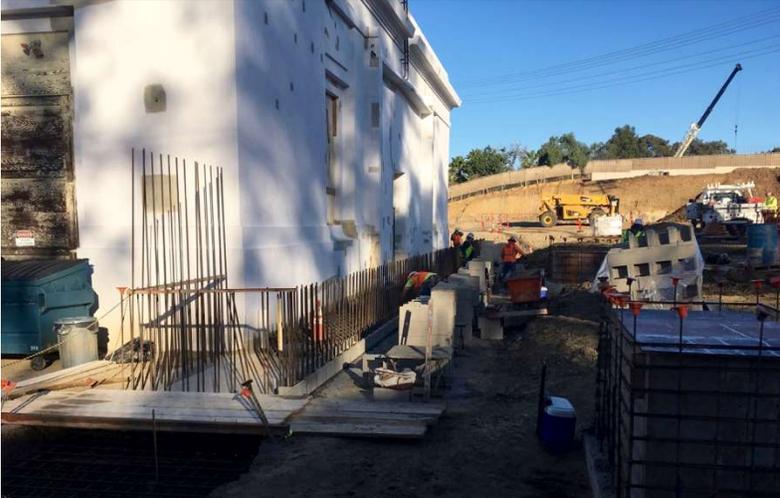
Construction activities occurring onsite included wall work around the former utility structure (Photo 1) as well as work on the southern boundary wall (Photo 3) and the northern boundary wall (Photo 6). With wall work occurring at three locations, use of the mortar mixing station was high (Photo 7). The concrete pumper was being set up near the northern boundary wall and construction crews planned to finish pouring the brow ditch that runs along the outside of the wall (Photo 9).

Photo 1 – Wall installation on the east side of the former utility structure. Photo facing north.
12/19/18	San Juan Capistrano Substation

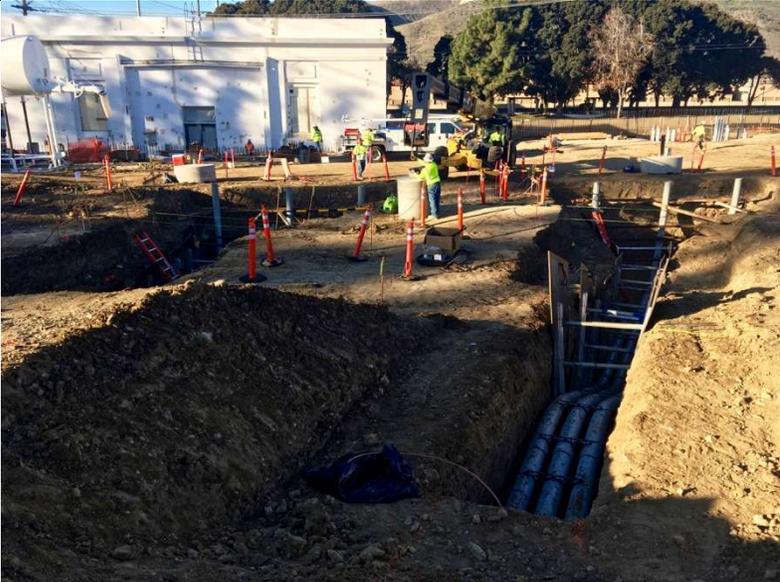
Conduit installation was occurring just to the east of the former utility structure (Photo 2).

Photo 2 – Conduit installation work. Photo facing west.
12/19/18	San Juan Capistrano Substation

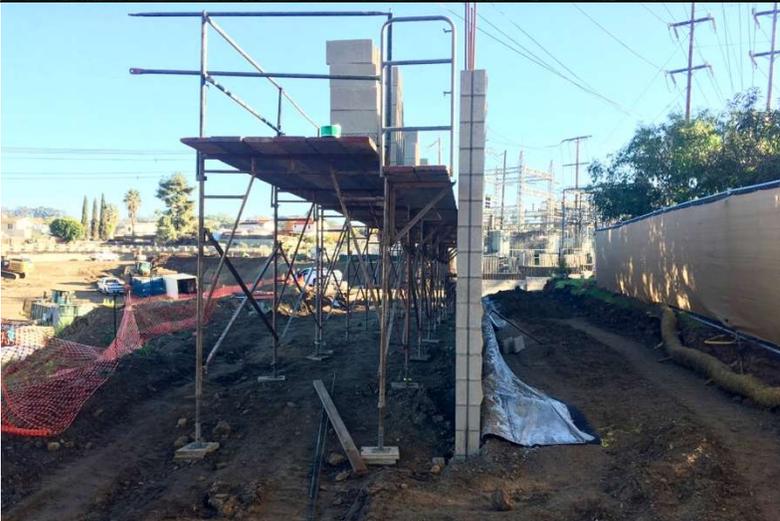
Photo 3 – Brick installation on the southern boundary wall. Photo facing east.

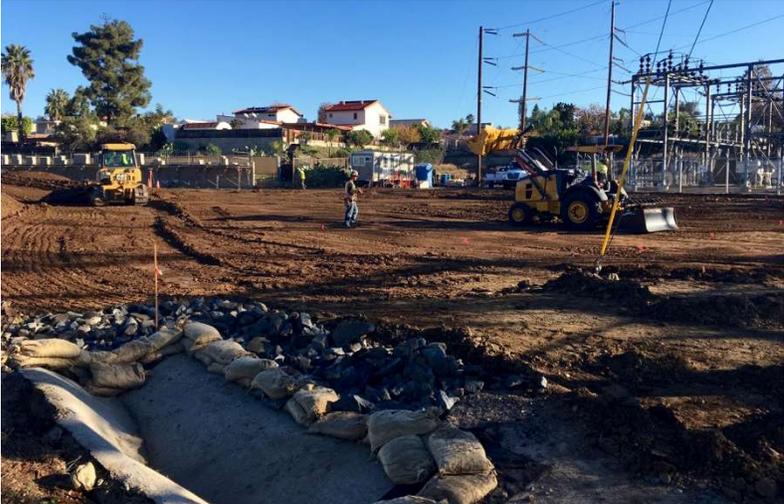
The area that has been overexcavated within the existing 138/12-kilovolt (kV) substation has been backfilled and was being restored with a bulldozer and a skip loader providing the final grade (Photo 4). According to the construction foreman, final grading should be completed soon and the road base will be brought up to stabilize the area. After the road base is installed, the construction trailers will be brought onsite.

Photo 4 – Final grading of the overexcavated area within the 138/12 kV substation site. Photo facing east.
12/19/18	San Juan Capistrano Substation

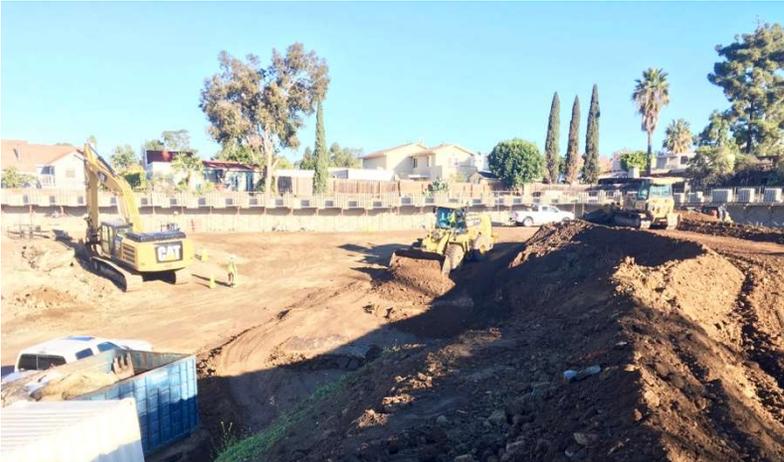
Excavation work was occurring with a front loader located on a slope below the existing 138/12-kV substation location (Photo 5). The archaeological resources monitor and the cultural resources monitor were onsite and observing this work. An excavator was also digging soil closer to the northwestern corner of the San Juan Capistrano Substation site (Photo 8).

Photo 5 – Earthwork being completed with monitors present. Photo facing north.
12/19/18	San Juan Capistrano Substation

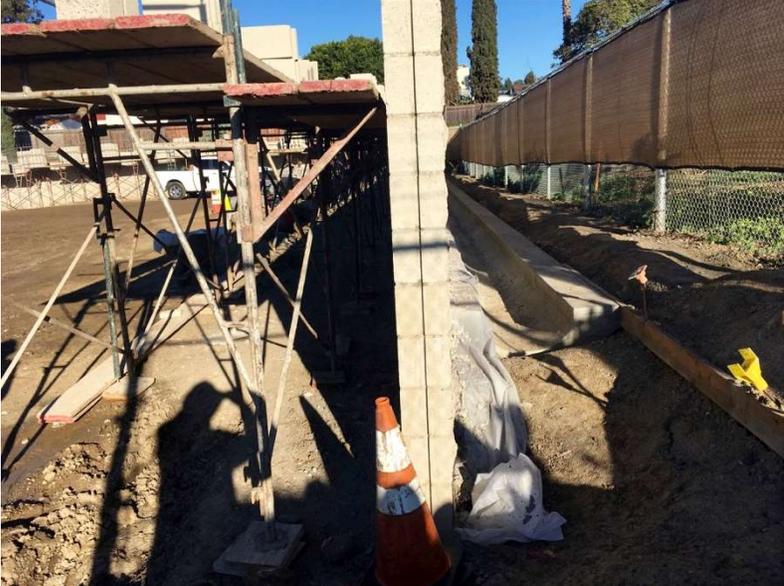
Photo 6 – Work on the northern boundary wall (note the brow ditch outside of the wall). Photo facing north.

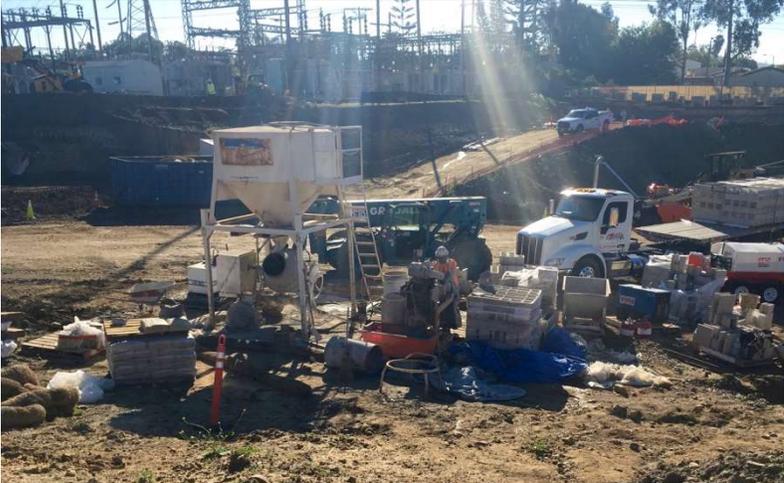
Photo 7 – Mortar mixing station. Photo facing south.
12/19/18	San Juan Capistrano Substation

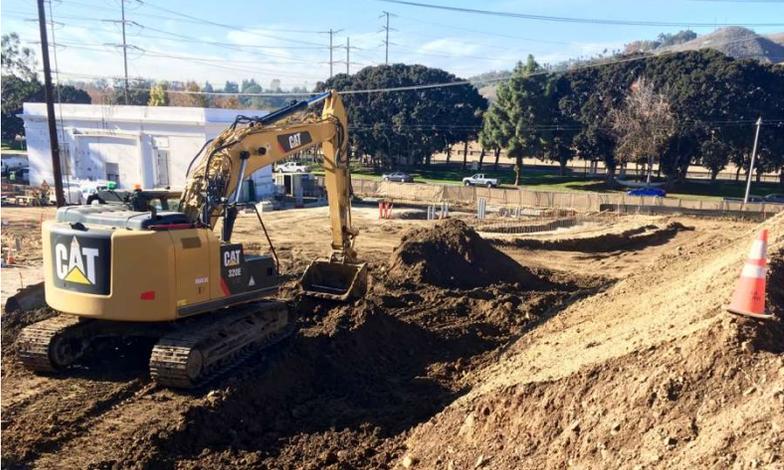
Photo 8 – Earthwork within the San Juan Capistrano Substation site. Photo facing west.
12/19/18	San Juan Capistrano Substation

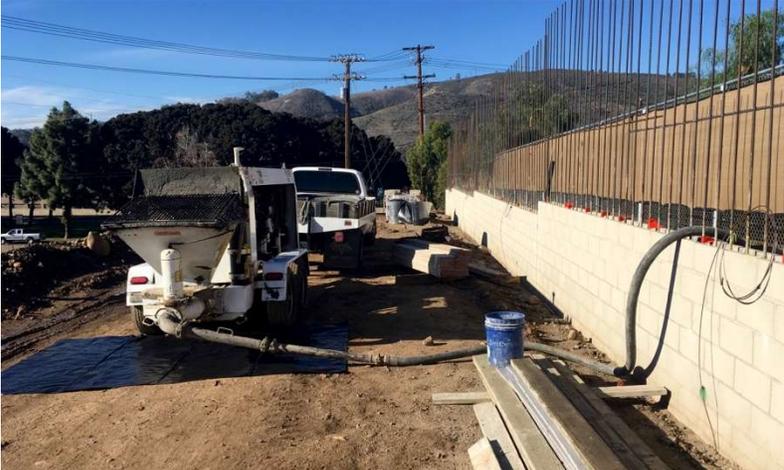
Photo 9 – Concrete pumping equipment set up near the northern boundary wall. Photo facing west.

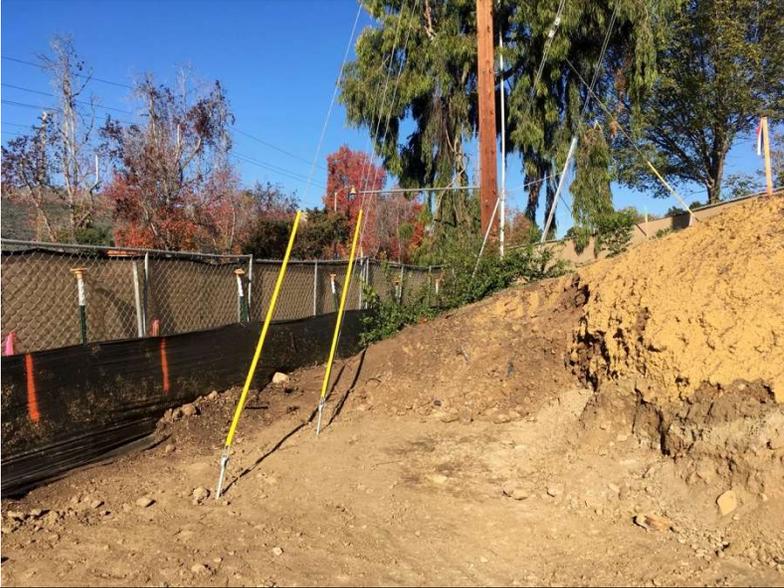
The construction superintendent said they had relocated the stabilizing cables for one of the power poles in the northwest corner of the San Juan Capistrano Substation site (Photo 10). Before leaving the San Juan Capistrano Substation site, I spoke with the construction superintendent about site preparations before the Christmas holiday, specifically about adding rock to the entrance road.

Photo 10 – Relocated stabilizing cables for one of the power pole. Photo facing north.
