Re: Monthly Report Summary #21 for the South Orange County Reliability Enhancement (SOCRE) Project

CPUC Site Inspection Reports

South Orange County Reliability Enhancement Project CPUC Site Inspection Form

Project:	South Orange County Reliability Enhancement (SOCRE) Project	Date:	July 10, 2019
Project Proponent:	San Diego Gas & Electric (SDG&E)	Report #:	VS040
Lead Agency:	California Public Utilities Commission (CPUC)	Monitor(s):	CPUC/Ecology and Environment (E & E) Compliance Monitor
CPUC PM:	Andrew Barnsdale, Energy Division	AM/PM Weather:	Sunny and breezy with mild temperatures
CPUC CM (E & E):	Joe Donaldson	Start/End Time:	1200 to 1300
Project NTP(s):	Notice to Proceed (NTP) -1, NTP-2, NTP-2 Addendum 1, NTP-3, NTP-4, and NTP-5

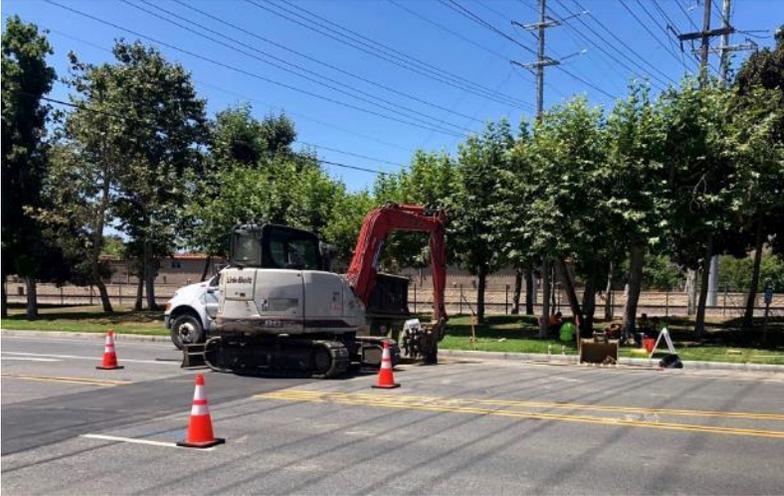
Upon arrival, I noted that construction crews were continuing their work on the southern trench crossing within Camino Capistrano (Photo 1). Excess spoil from the roadwork was stockpiled near the former utility structure (Photo 2).

Photo 1 – Work within Camino Capistrano. Photo facing west.
7/10/19	San Juan Capistrano Substation

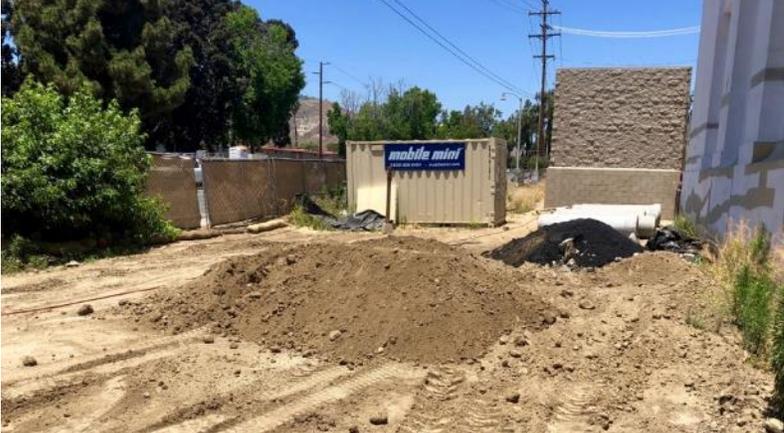
Photo 2 – Spoil stockpiled west of the former utility structure. Photo facing north.
7/10/19	San Juan Capistrano Substation

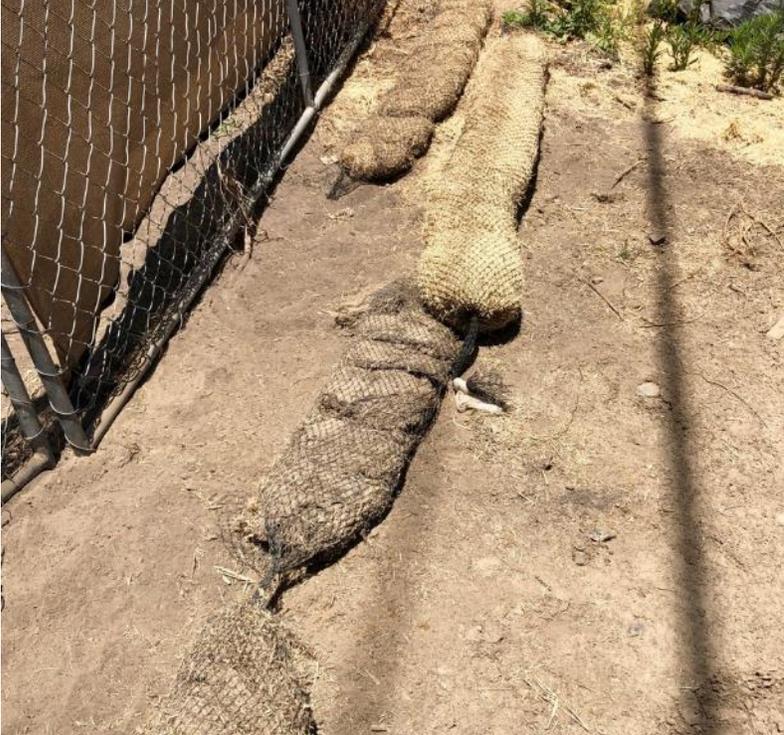
Some older straw wattles wrapped in plastic mesh were placed along the western construction fencing within the San Juan Capistrano Substation site for erosion control (Photo 3). As the straw degrades, the plastic mesh containing these older straw wattles could entrap lizards and snakes. I recommended that these older straw wattles be removed and discarded and then replaced with wattles contained in burlap.

Photo 3 – Old straw wattles wrapped in plastic mesh.

Use of burlap covered straw wattles is recommended for future erosion control work and use of secondary containment for all gas engines is recommended.

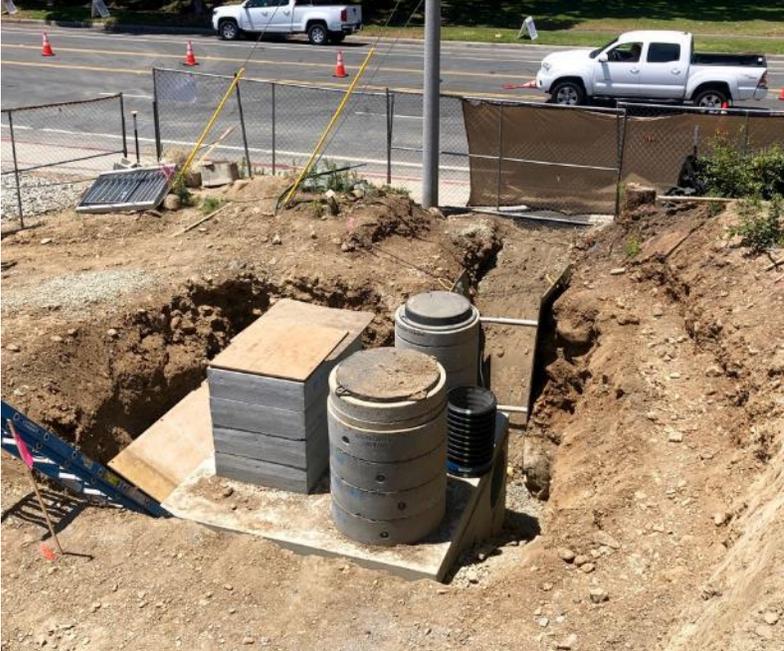
The small modular wetland installed in the northwestern corner of the San Juan Capistrano Substation site had yet to be backfilled (Photo 4).

Photo 4 – The northern modular wetland. Photo facing west.
7/10/19	San Juan Capistrano Substation

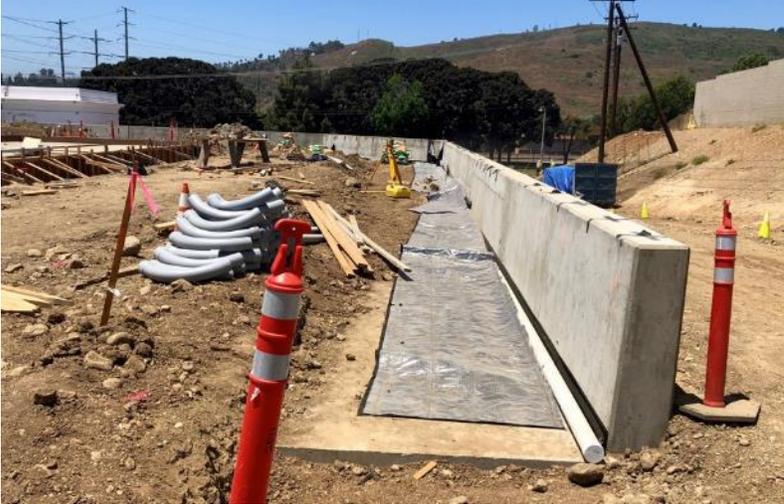
Photo 5 – Moisture protection work continues. Photo facing west.
7/10/19	San Juan Capistrano Substation

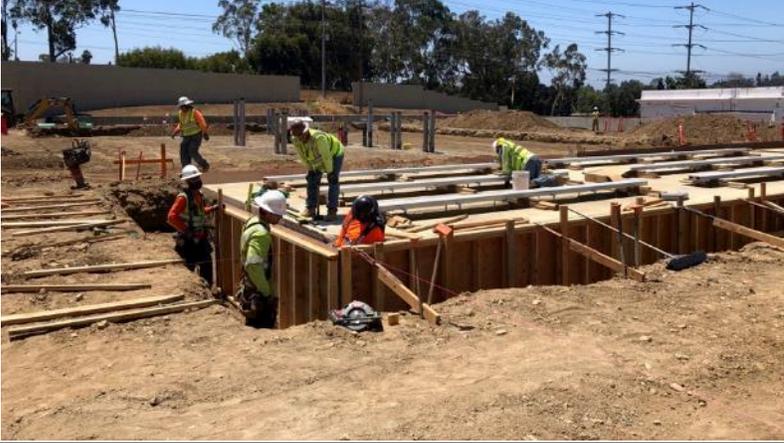
Photo 6 – Building construction has begun. Photo facing southwest.

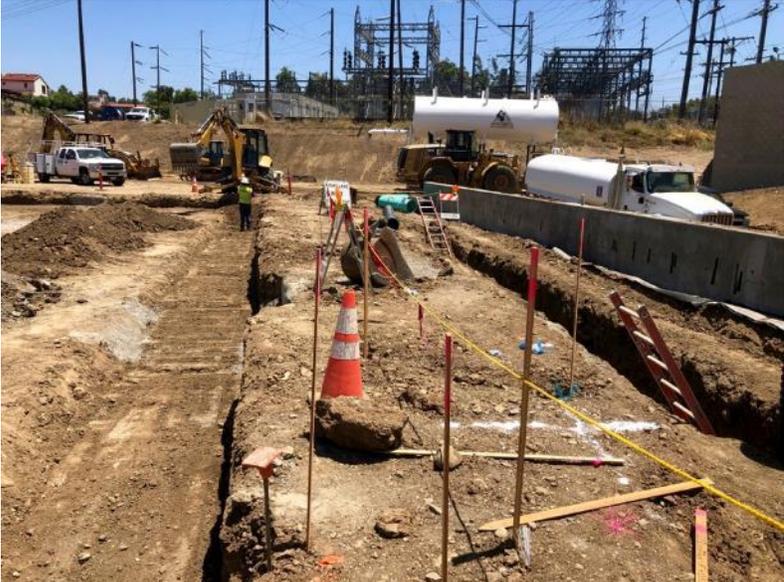
I met with the SDG&E representative acting as the Environmental Coordinator at the northern entrance. We looked over the 138-kilovolt (kV) gas insulated substation (GIS) building pad. According to the SDG&E representative, a new construction crew was onsite working on the 138-kV GIS building. The work included installation of the moisture barrier material and drainage piping (Photo 5), the first stages of building construction (Photo 6), and installation of the stormwater drainage pipe that will be connected to the modular wetlands (Photos 7 & 8).

Photo 7 – Stormwater drainage pipe installation. Photo facing east.
7/10/19	San Juan Capistrano Substation

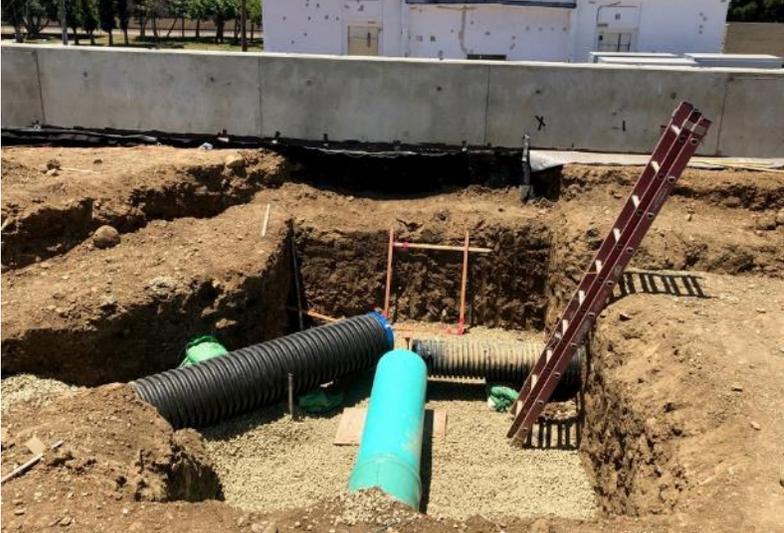
Photo 8 – Stormwater drainage pipe installation within the 138-kV gas insulated substation (GIS) building pad. Photo facing west.
7/10/19	San Juan Capistrano Substation

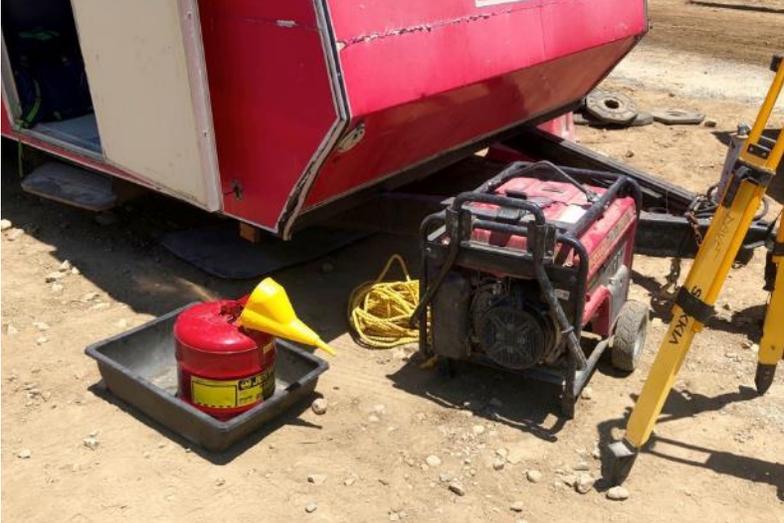
A gas generator and a gas can were within the building pad; the gas can was within secondary containment (i.e., a drip pan); however, the generator was not within secondary containment (Photo 9). I spoke with the SDG&E representative about the need for secondary containment for all gas engines.

Photo 9 – Generator without secondary containment

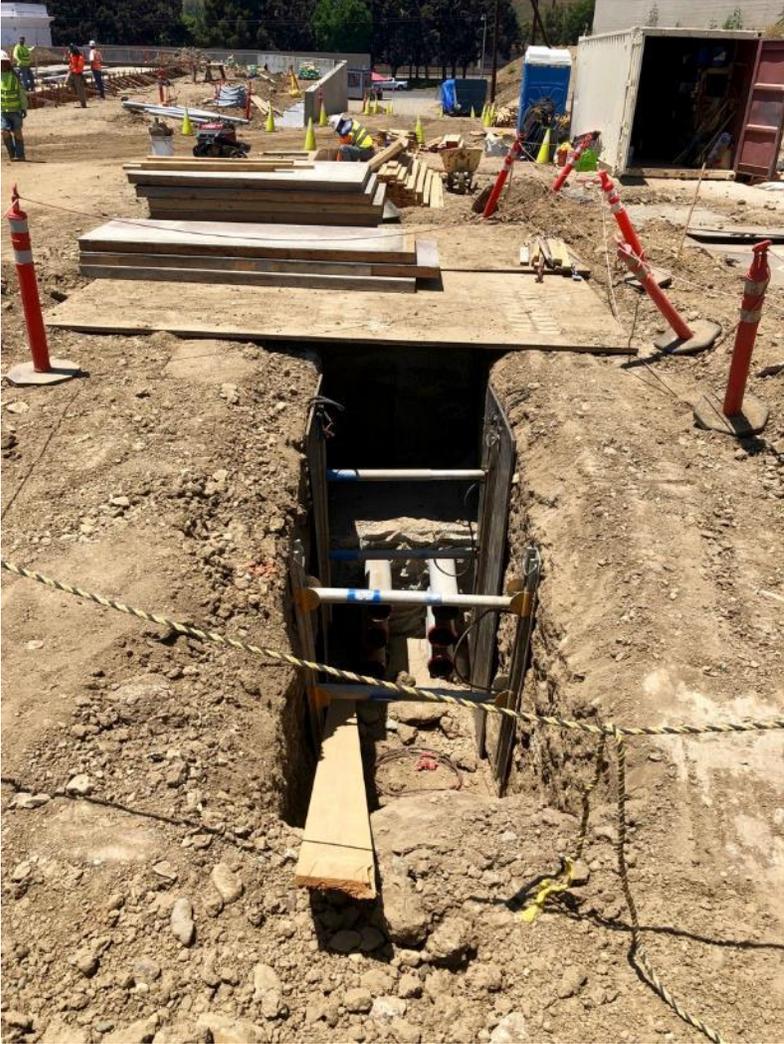
The conduit trenches by the northern boundary wall are open and wooden climbing structures have been placed within the excavations (Photo 10).

Photo 10 – Open conduit trench with a climbing structure in place. Photo facing west.
7/10/19	San Juan Capistrano Substation

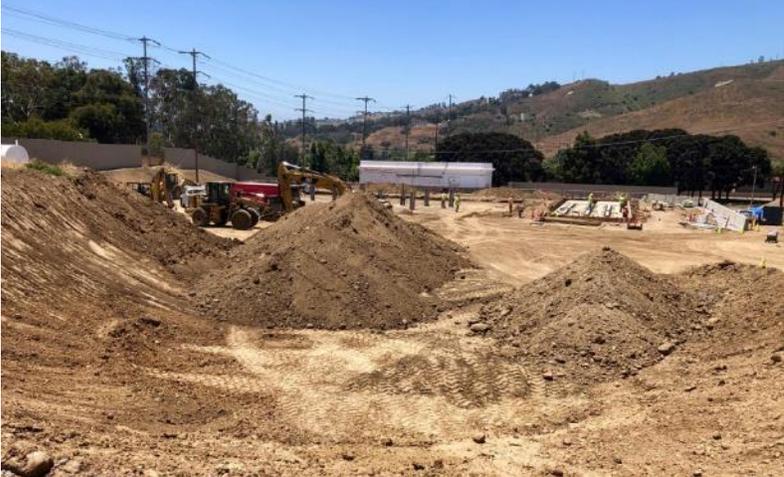
Excess spoil from building construction has been being stockpiled in the area southwest of the construction trailer pad (Photo 11). I spoke with the SDG&E representative about ongoing dust control efforts; the SDG&E representative said this has been a main focus during construction, given the proximity of the construction activities to residential homes just outside of the San Juan Capistrano Substation site to the north and east.

Photo 11 – Spoil stockpile area. Photo facing west.

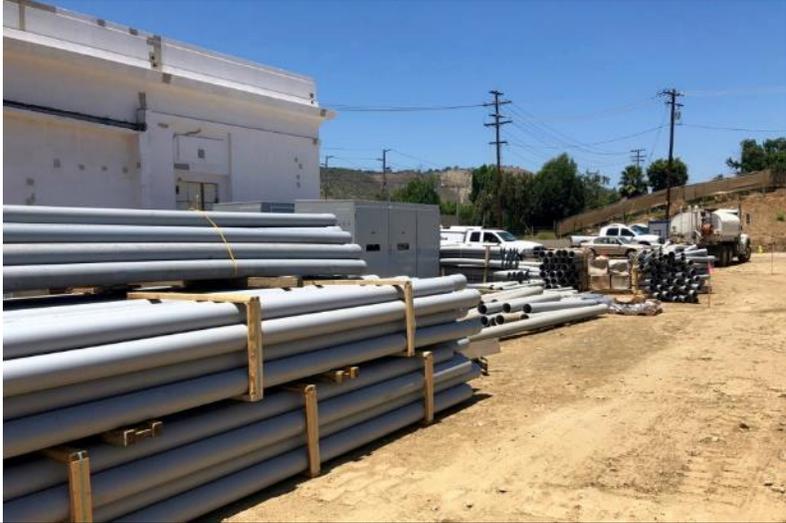
A large amount of conduit is being staged east of the former utility structure (Photo 12).

Photo 12 – Conduit staged onsite east of the former utility structure. Photo facing north.

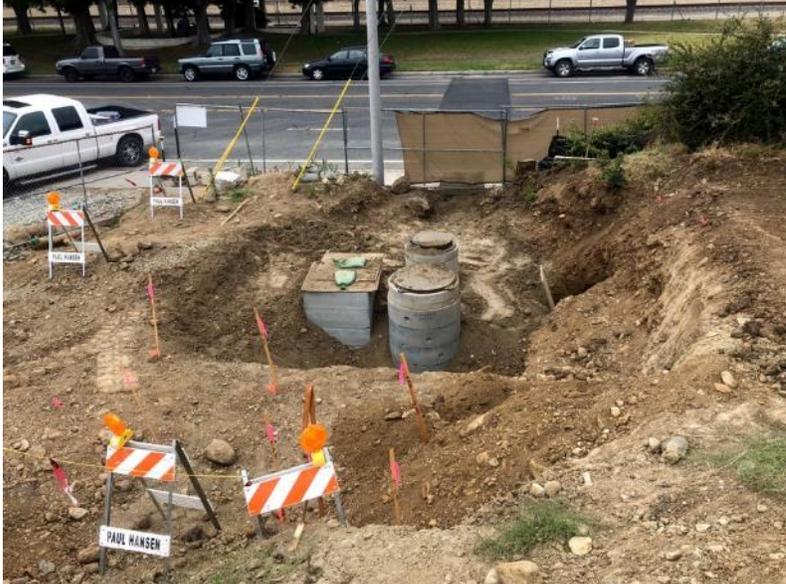
Photo 1 – The northern modular wetland. Photo facing west.
7/18/19	San Juan Capistrano Substation

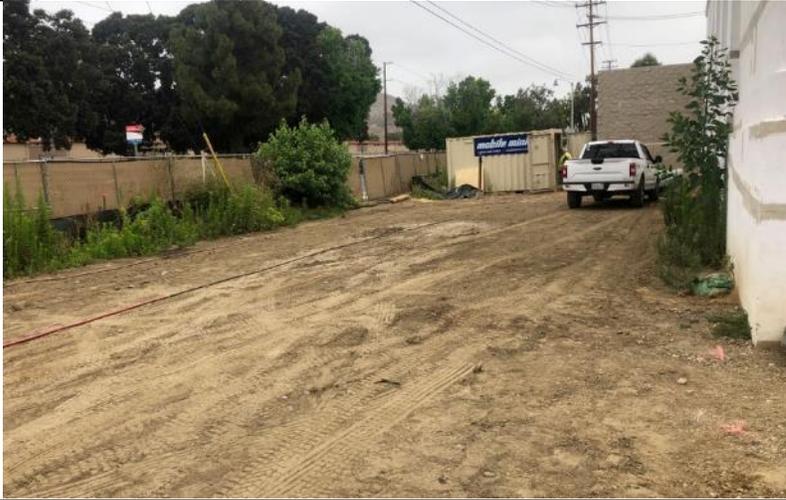
Photo 2 – Spoil piles have been removed from an area near the former utility structure. Photo facing north.
7/18/19	San Juan Capistrano Substation

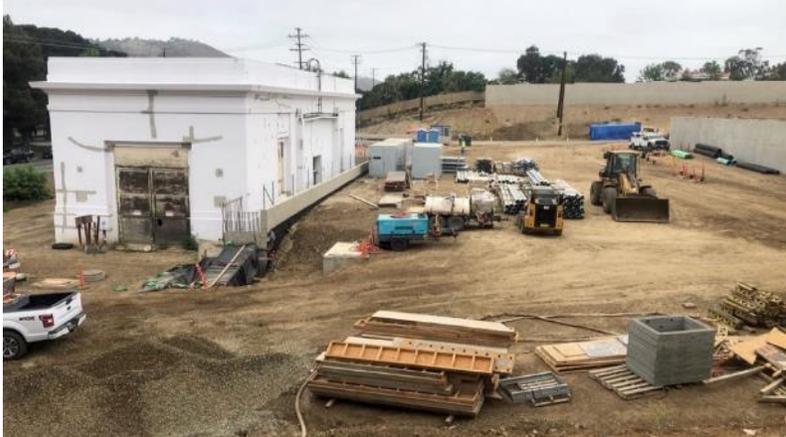
Photo 3 – Staging areas near the former utility structure. Photo facing north.

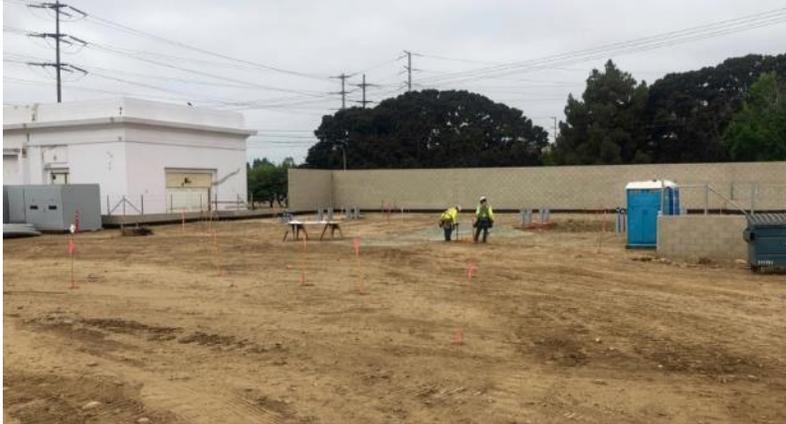
Photo 4 – Surveyors completing surveys for upcoming construction activities. Photo facing southwest.
7/18/19	San Juan Capistrano Substation

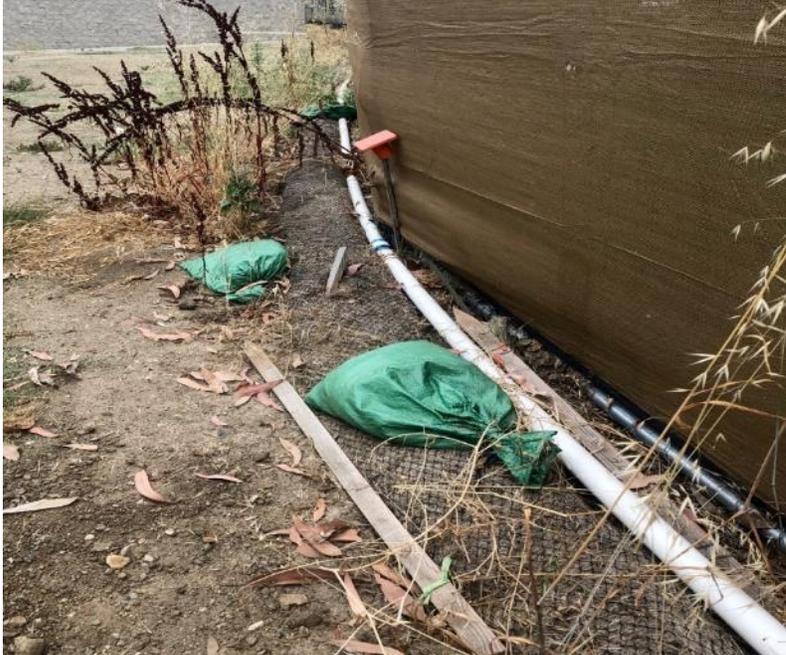
The temporary southern boundary fencing was lined with straw wattles contained in plastic mesh (Photo 5). As mentioned in the 07/10/2019 report, as the straw degrades and the plastic mesh covering becomes exposed, lizards and snakes can become entrapped. I recommend that these older best management practices (BMPs) be removed and discarded as soon as practicable and replaced with wattles contained in burlap.

Photo 5 – Old straw wattles covered in plastic mesh.
7/18/19	San Juan Capistrano Substation

Remove all old plastic covered straw wattles and replaced with burlap covered straw wattles.

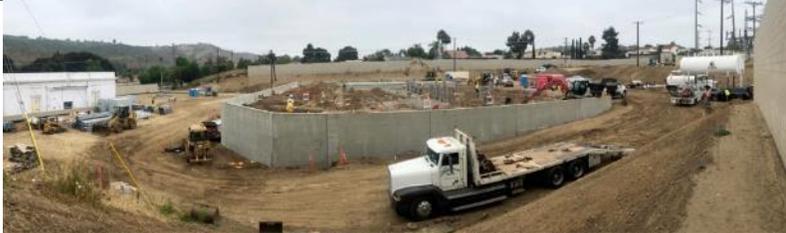
Photo 6 – Overview of the 138-kV gas GIS. Photo facing north.

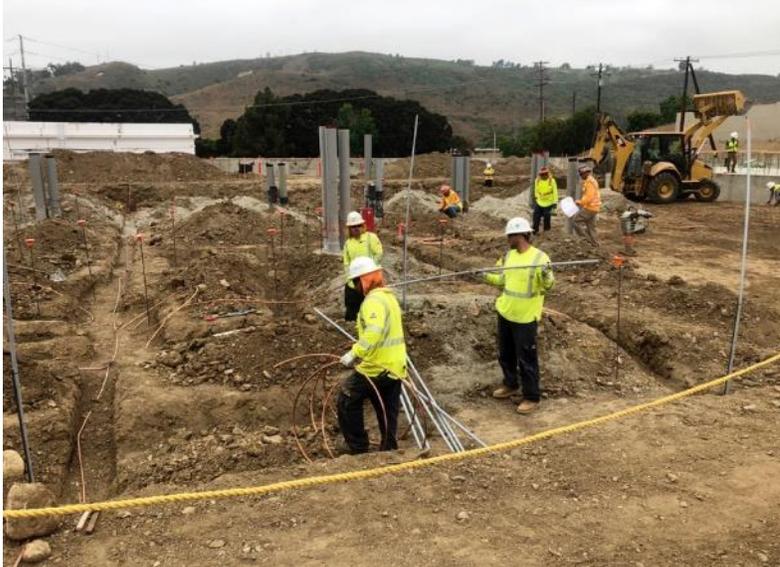
Photo 7 – Installation of copper grounding wire within trenches. Photo facing west.
7/18/19	San Juan Capistrano Substation

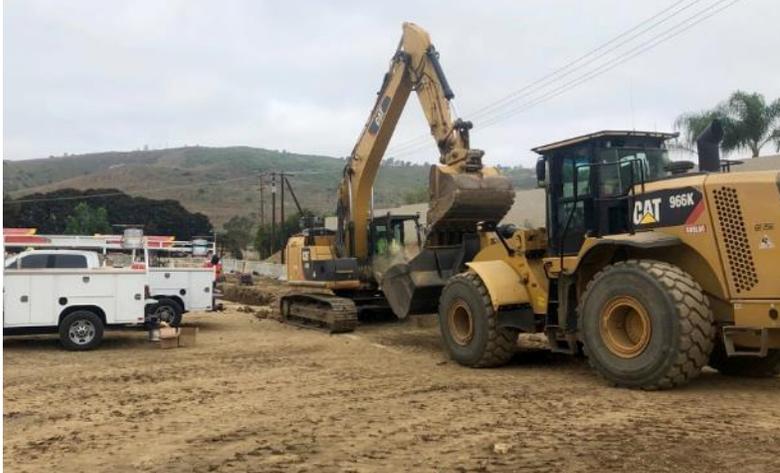
Photo 8 – Trenching work within the 138-kV GIS building pad. Photo facing west.
7/18/19	San Juan Capistrano Substation

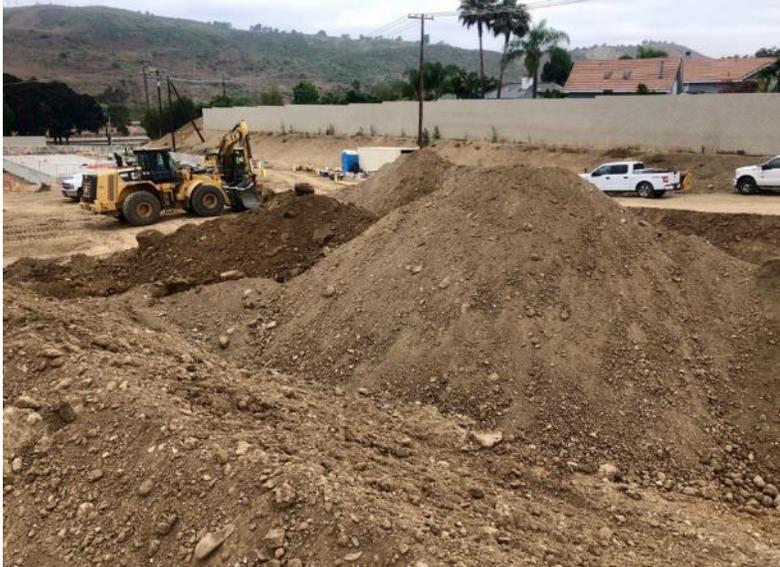
Photo 9 – Excess spoil stockpiled southwest of the construction trailer pad. Photo facing northwest.

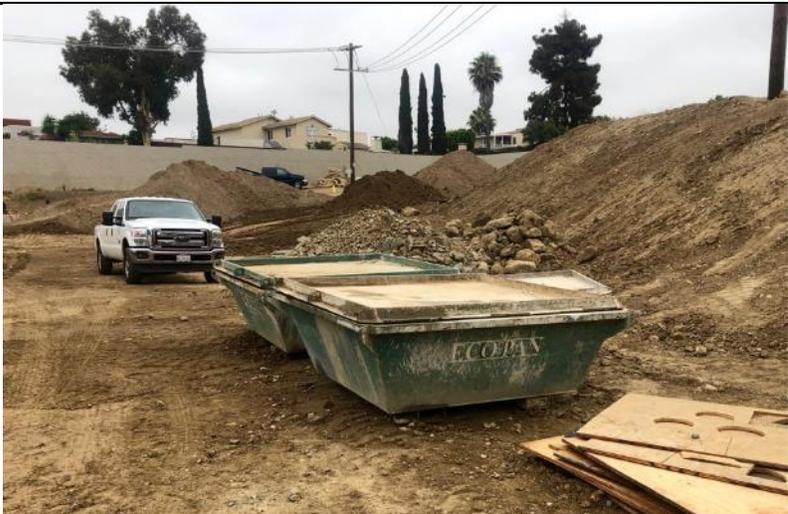
Photo 10 – Covered concrete washout bins. Photo facing north.

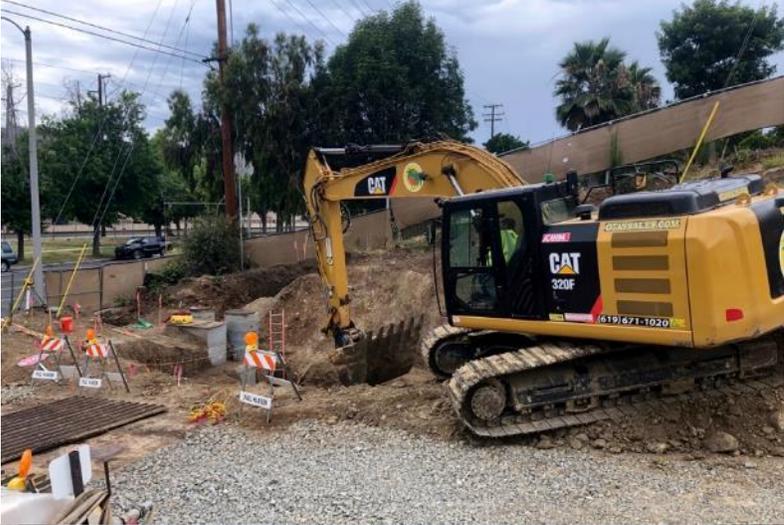
A crew using an excavator was beginning to dig a trench near the northern modular wetland (Photo 1). Per the SDG&E Environmental Coordinator, the storm drain trench will be approximately 80 feet in length and connect to the northern modular wetland. A paleontological resource monitor was onsite observing excavation activities. The paleontological resource monitor explained that the trenching would extend into the Capistrano formation, which is described as a deep marine layer. This formation is found throughout the area and has revealed numerous marine animal fossils. As a part of this trenching work, construction crews were shifting the San Juan Capistrano Substation site entry to the original southern location. Construction crews were moving rumble plates and the check-in stand as part of relocation efforts (Photo 2). A crew was using a water truck for dust control.

Photo 1 – Crew using an excavator to dig a stormwater drainage trench from the northern modular wetland. Photo facing northwest.
7/25/19	San Juan Capistrano Substation

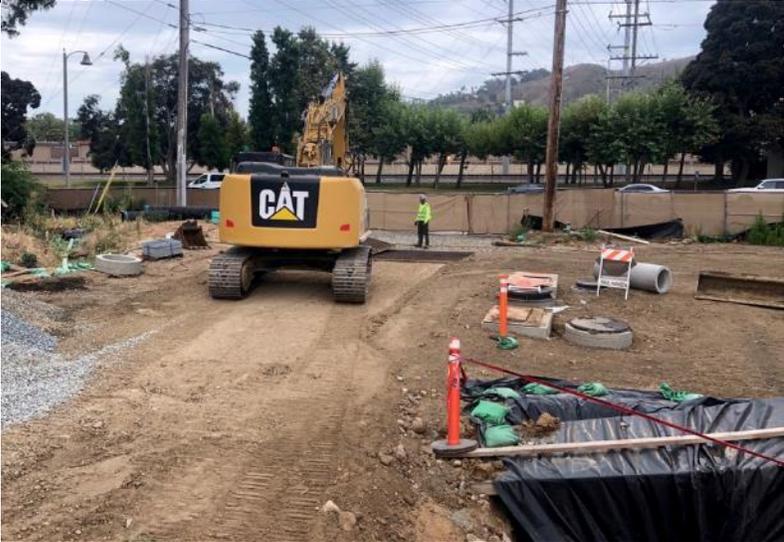
Photo 2 – Construction crews moving the rumble plates to the southern entrance. Photo facing west.
7/25/19	San Juan Capistrano Substation

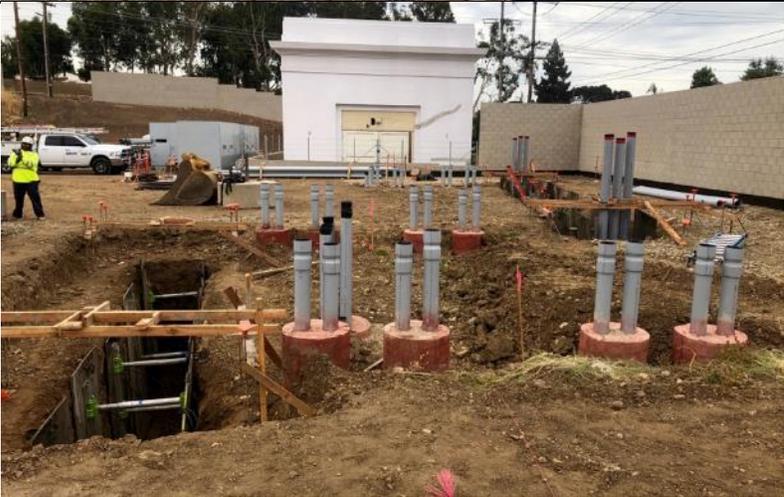
Photo 3 – Conduit work occurring in the area just north of the former utility structure. Photo facing south.

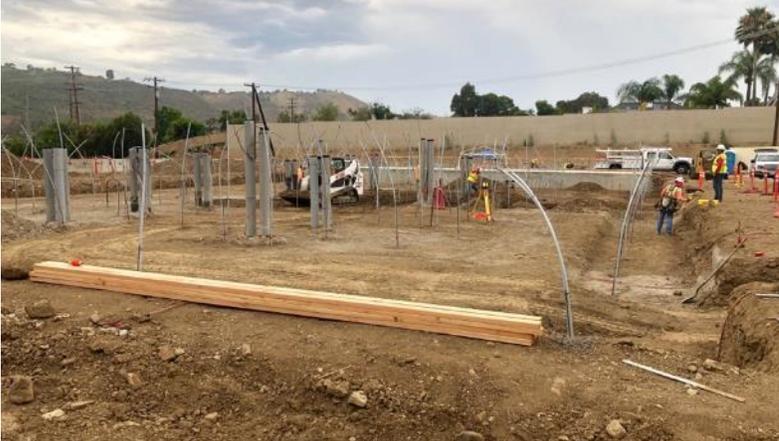
Photo 4 – Construction activities within the new 138-kV GIS. Photo facing north.
7/25/19	San Juan Capistrano Substation

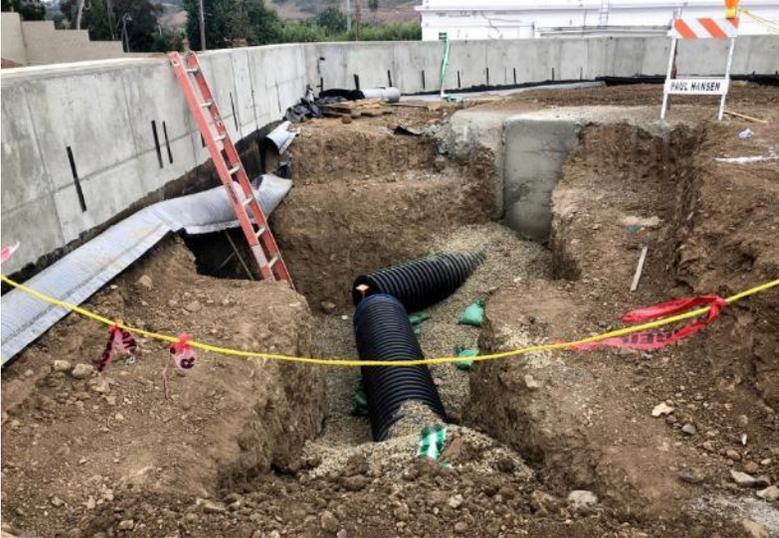
Photo 5 – Stormwater drainage piping within the 138-kV GIS substation. Photo facing west.
7/25/19	San Juan Capistrano Substation

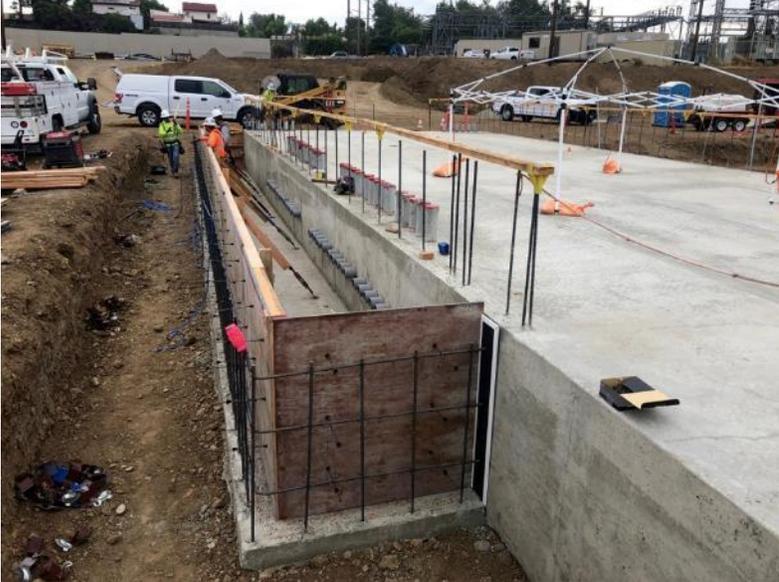
Photo 6 – Work on the cable trench. Photo facing east.

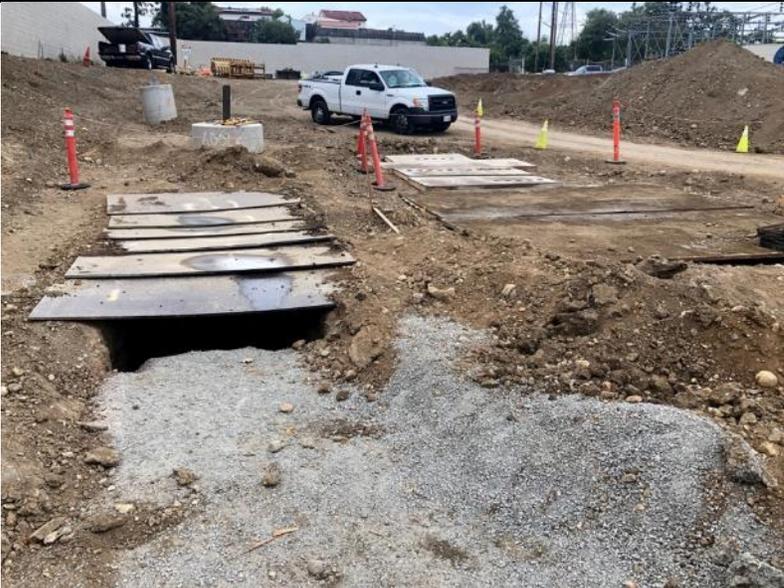
Photo 7 – Open trenches. Photo facing east.
7/25/19	San Juan Capistrano Substation

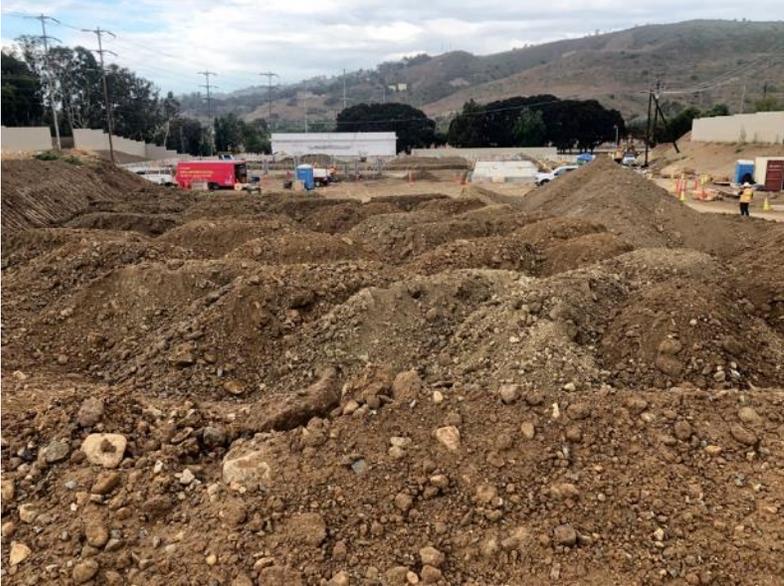
Photo 8 – Soil stockpile area. Photo facing west.

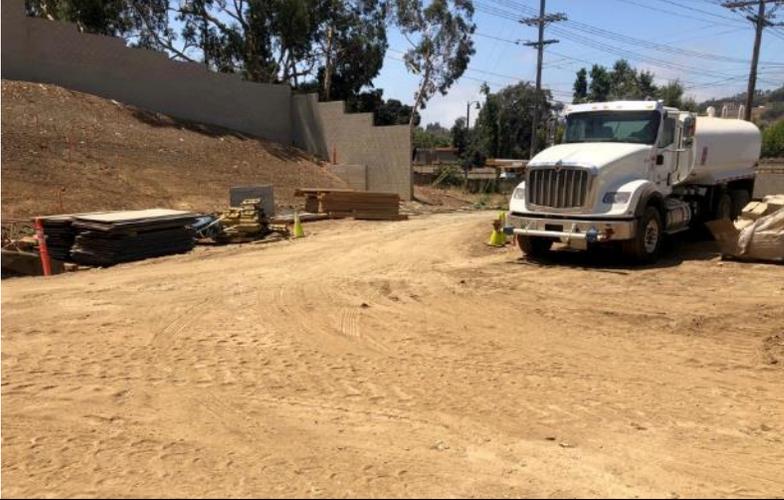
I noted that some of the roads within the San Juan Capistrano Substation site needed dust control. A water truck was scheduled to wet the roads later in the day (Photo 1). The roadway leading to the soil stockpile area also required dust control (Photo 9), and the SDG&E Environmental Coordinator requested that additional water be sprayed in this area. The stockpiled soil was moist and consisted of clay components; therefore, dust was not an issue for the stockpiled soil.

Photo 1 – Dusty construction roads. Photo facing southwest.
7/31/19	San Juan Capistrano Substation

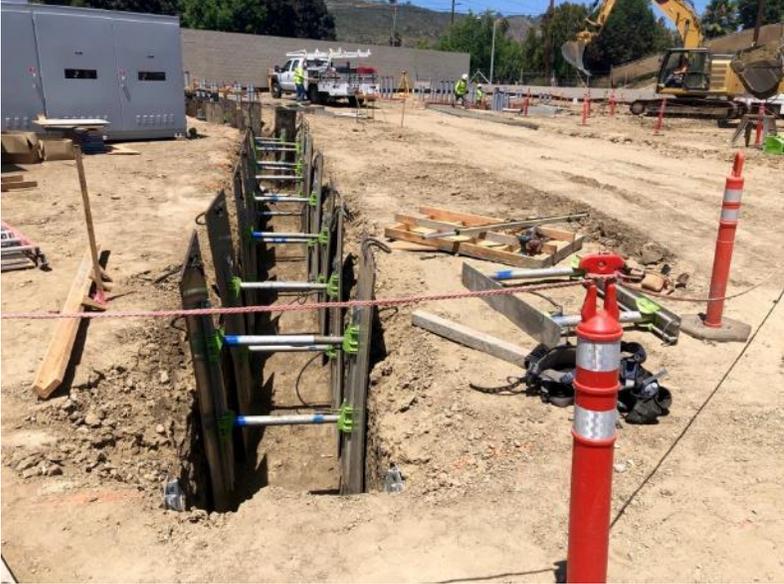
Photo 2 – New conduit trench in the area just north of the former utility structure. Photo facing west.
7/31/19	San Juan Capistrano Substation

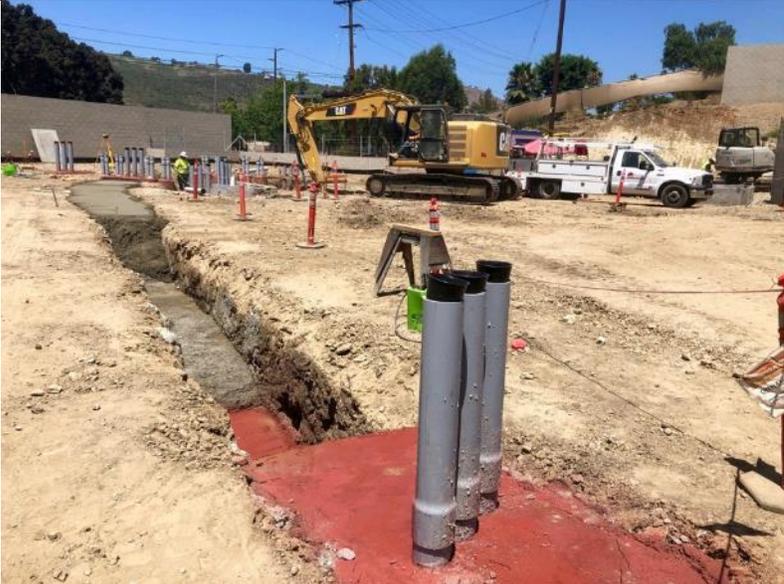
Photo 3 – Newly slurred conduit pipe in the area just north of the former utility structure. Photo facing northwest.

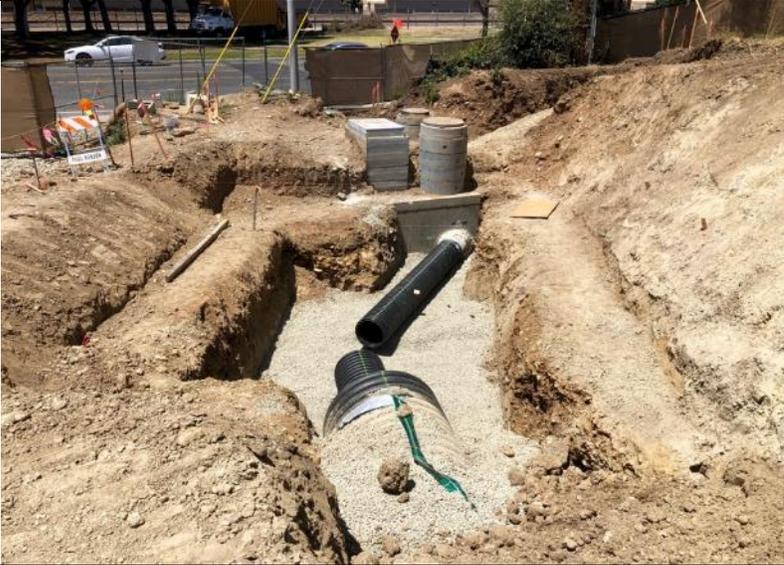
Photo 4 – Drain pipe leading to the modular wetland. Photo facing west.
7/31/19	San Juan Capistrano Substation

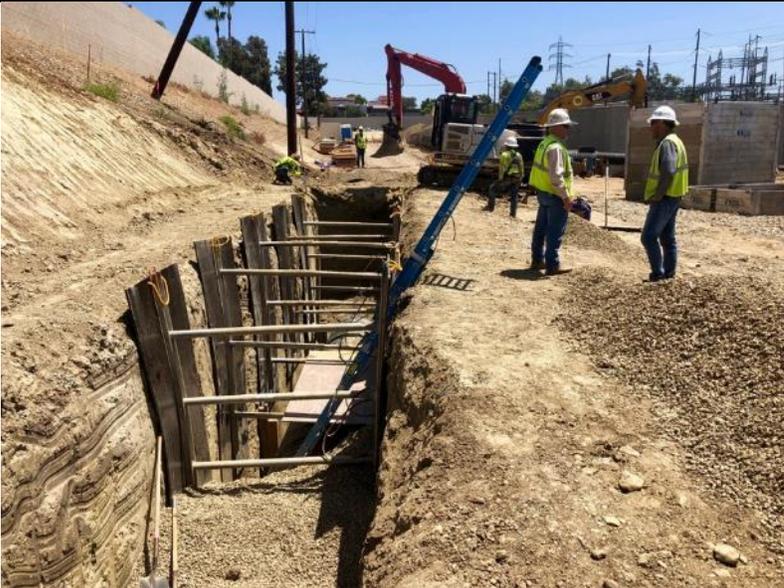
Photo 5 – Storm drain work along the northern portion of the San Juan Capistrano Substation site. Photo facing east.
7/31/19	San Juan Capistrano Substation

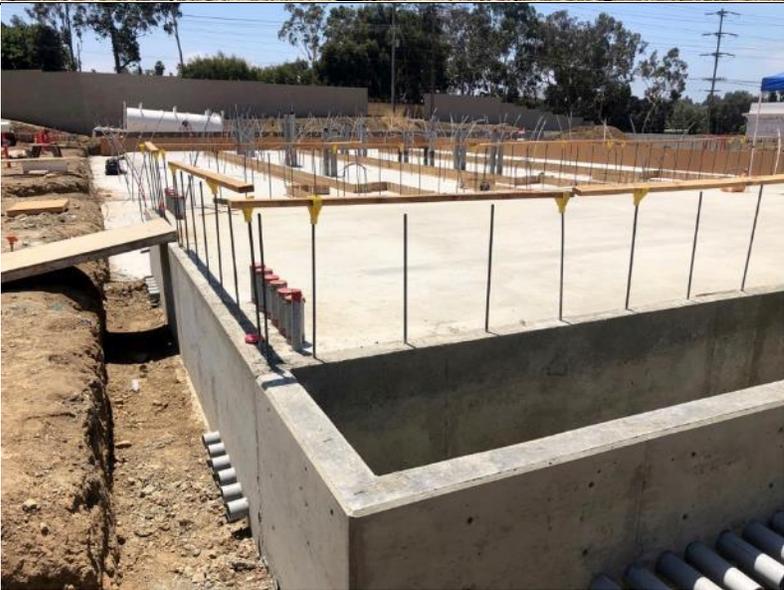
Photo 6 – The cable trench has been poured. Photo facing south.

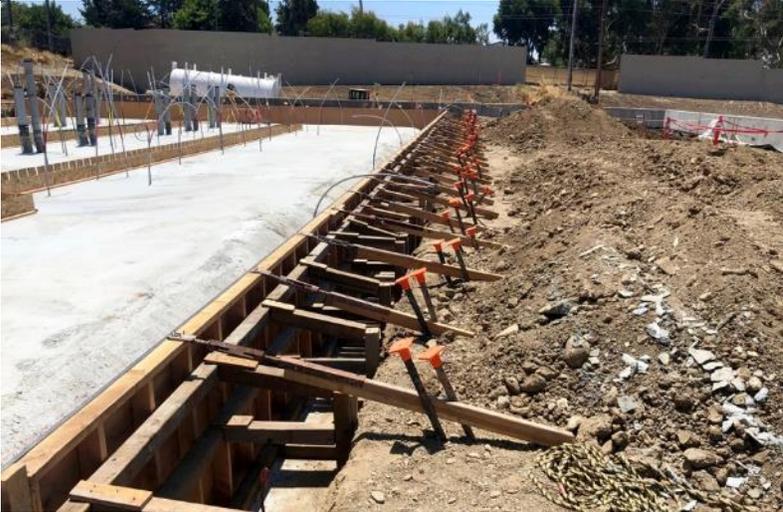
Photo 7 – Concrete forms around the 138-kV GIS pad. Photo facing south.
7/31/19	San Juan Capistrano Substation

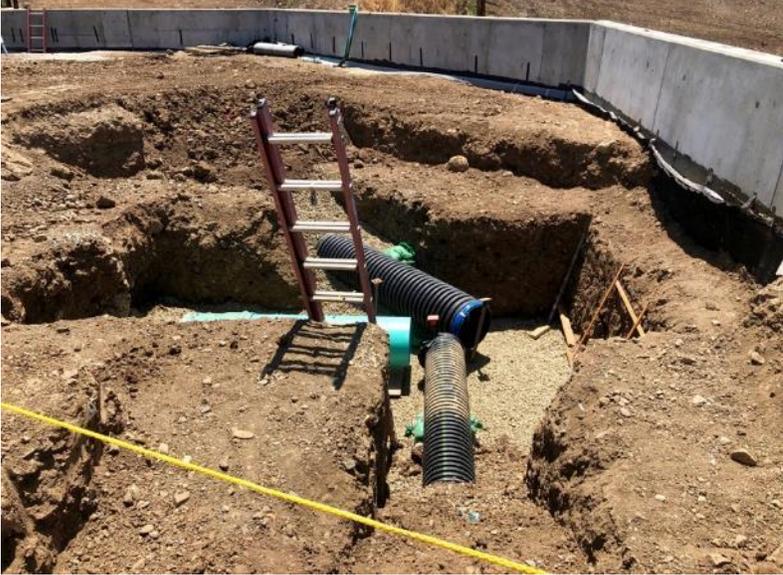
Photo 8 – Storm drain piping within the new 138-kV GIS. Photo facing south.
7/31/19	San Juan Capistrano Substation

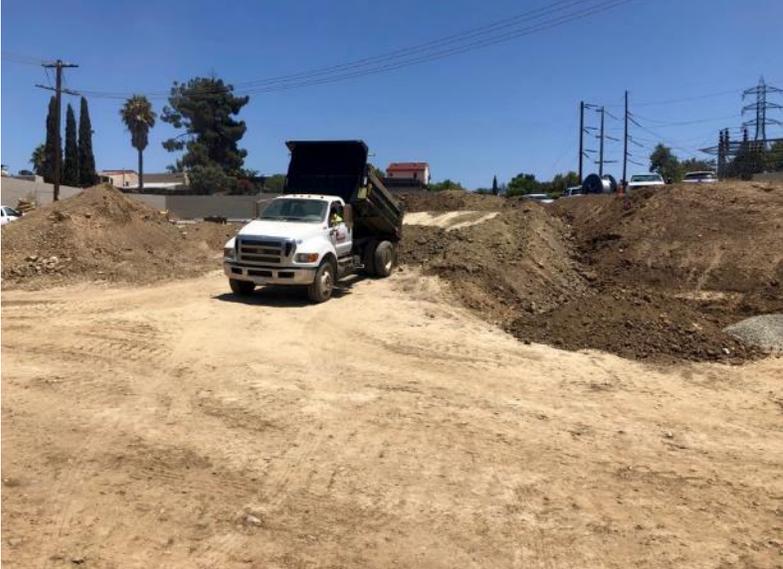
Photo 9 – Soil stockpile area. Photo facing east.

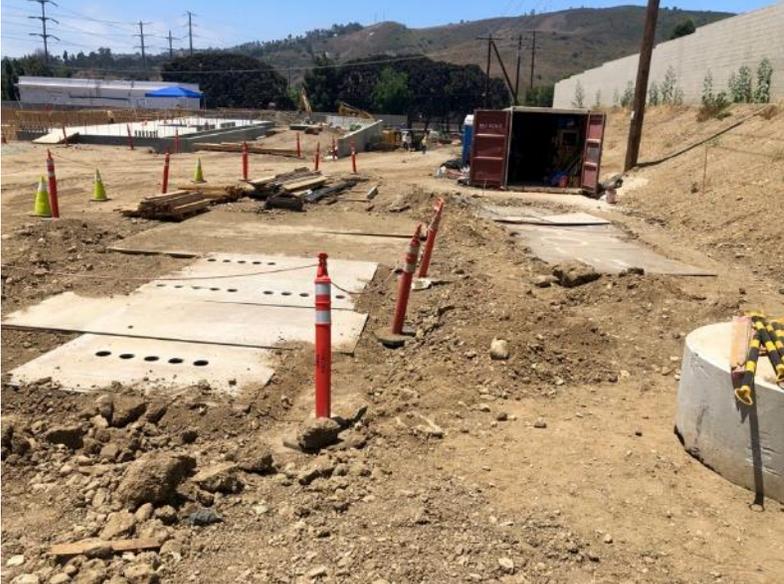
Photo 10 – Covered trenches. Photo facing west.
7/31/19	San Juan Capistrano Substation

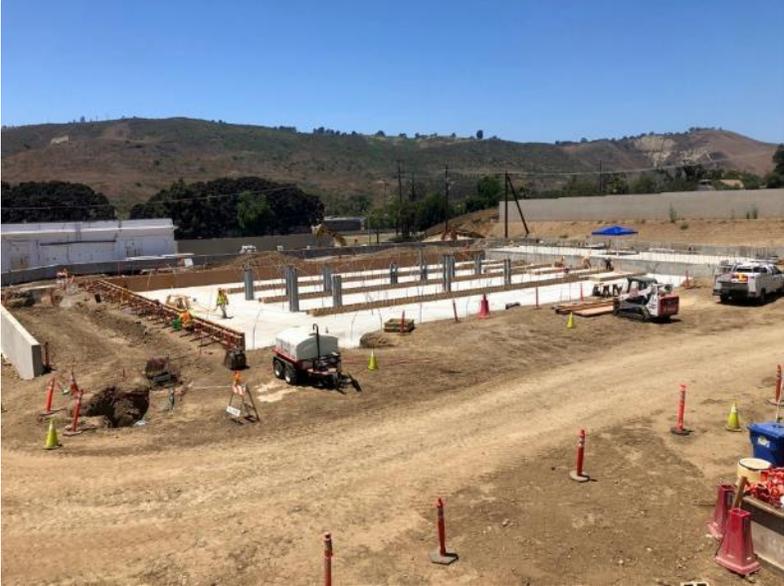
Photo 11 – Overview of the 138-kV GIS area. Photo facing northwest.
