**Re: Monthly Report Summary #22 for the South Orange County Reliability Enhancement (SOCRE) Project**

CPUC Site Inspection Reports  
August 7, 16, 22, and 27, 2019

## South Orange County Reliability Enhancement Project CPUC Site Inspection Form

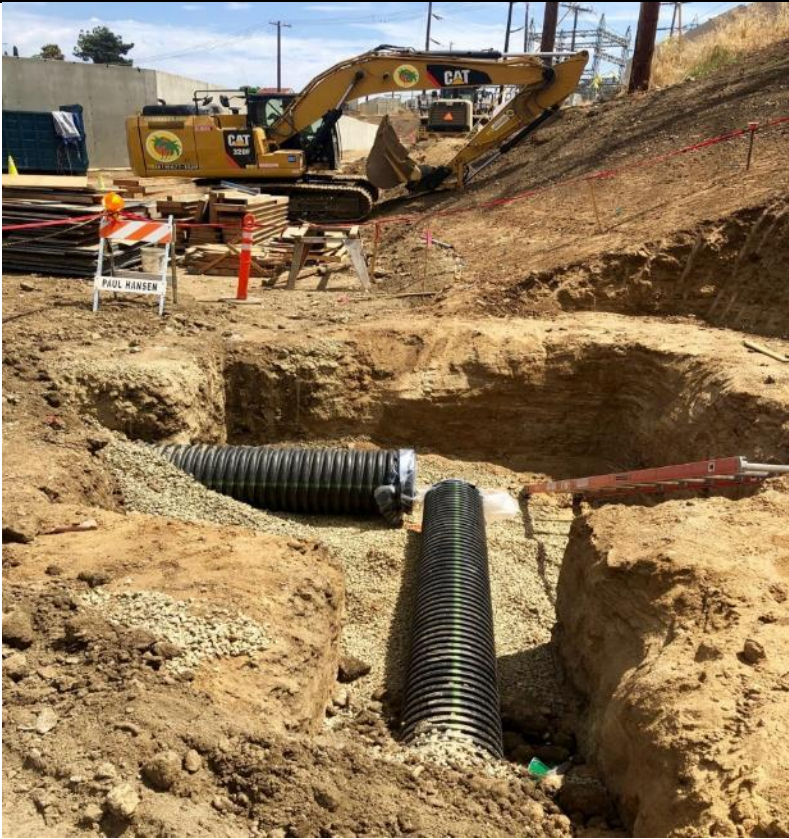
Storm drain work was occurring near the southern entrance to the project site (Photo 1). Trenching for the storm drain will continue to the east, after relocation of guy wire anchors (Photo 2). A new wooden pole was added for the shortened guy wires. The SDG&E Environmental Coordinator reported that both an Archaeological Resources Monitor and a Native American Monitor were onsite to observe this work. Nothing of significance was unearthed by the work.

Photo 1 – Storm drain pipe near the southwestern corner of the project site. Photo facing east.
8/07/19	San Juan Capistrano Substation	 	Photo 2 – New pole installed and relocated guy wires. Photo facing south.

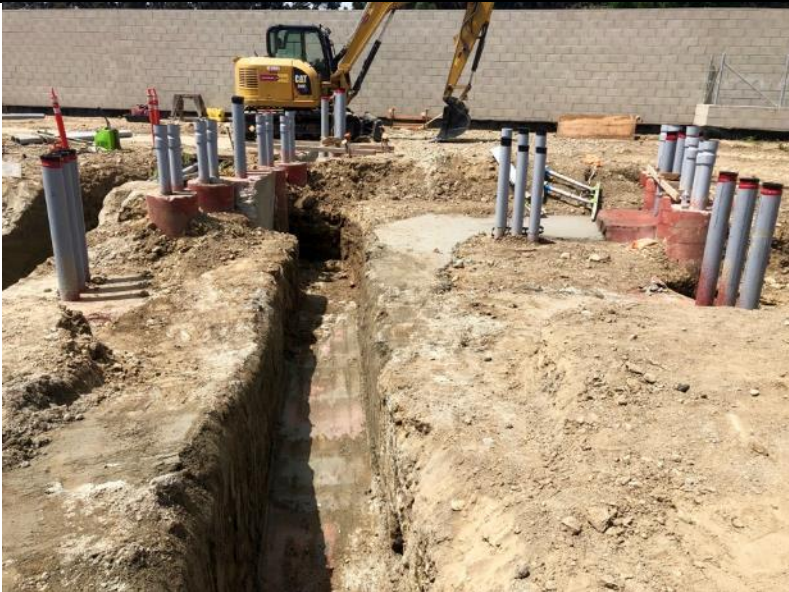
Photo 5 – Conduit trench being excavated in the switching rack area. Photo facing west
8/07/19	San Juan Capistrano Substation

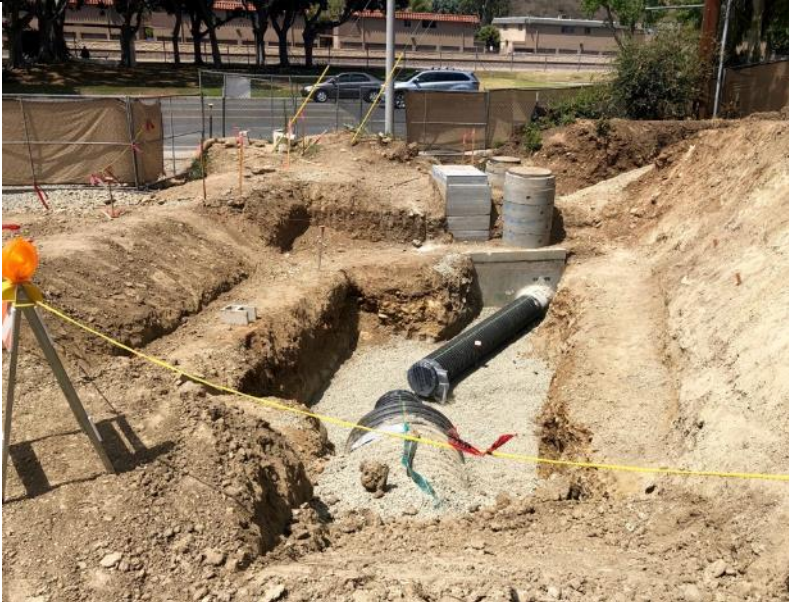
The modular wetland near the northern entrance appeared in the same condition as noted during the previous site visit (Photo 6). Aluminum shoring had been added at the storm drain vault location just east of the modular wetland. Delivery of the vault was still pending (Photo 7).

Photo 6 – Storm drain pipe near the modular wetland. Photo facing west.
8/07/19	San Juan Capistrano Substation

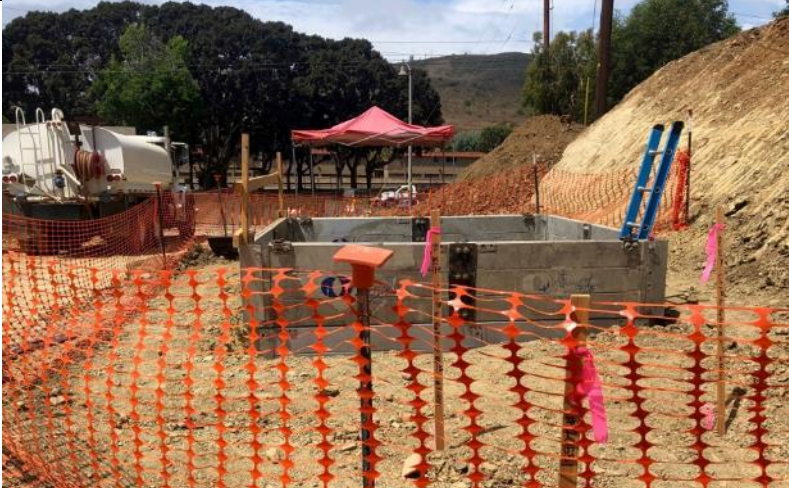
Photo 7 – Storm drain vault location. Photo facing west.

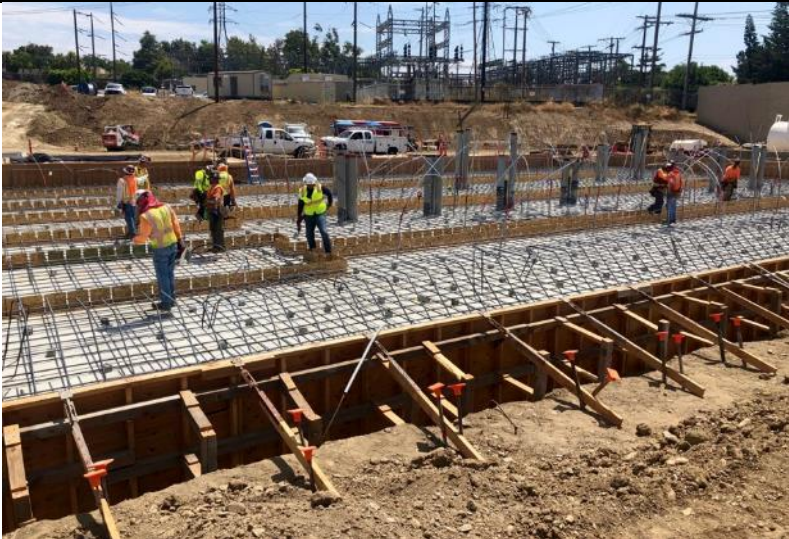
Construction activities within the 138-kilovolt (kV) gas-insulated substation (GIS) building pad continued with the installation of rebar (Photo 8). Storm drain pipe connection locations remained open at several locations within the new substation (Photo 9). Gas generators used near the building pass were well contained (Photo 10).

Photo 8 – Rebar installation within the new 138-kV substation. Photo facing east
8/07/19	San Juan Capistrano Substation

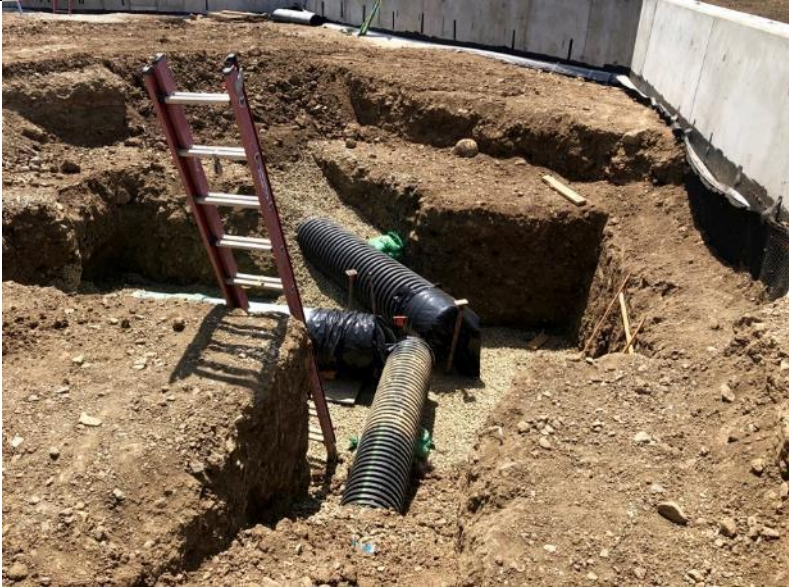
Photo 9 – Storm drain piping within the 138-kV GIS building pad. Photo facing south.
8/07/19	San Juan Capistrano Substation

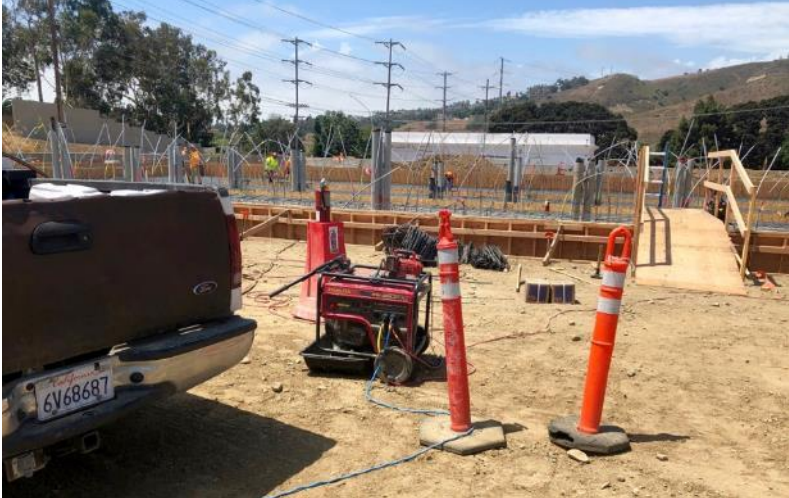
Photo 10 – Gas generator with adequate containment. Photo facing west.

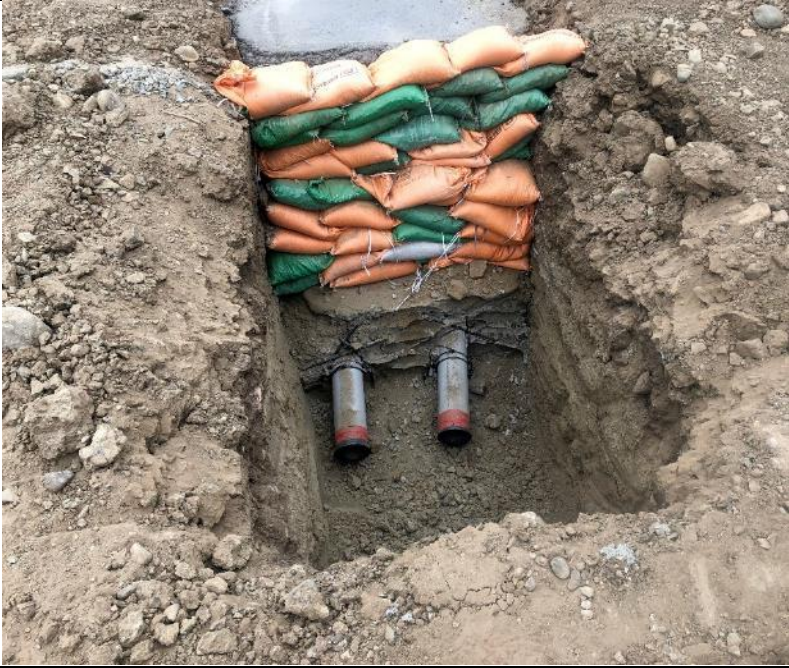
Photo 6 – Conduit trench needing to be covered or have an escape ramp installed.
8/16/19	San Juan Capistrano Substation

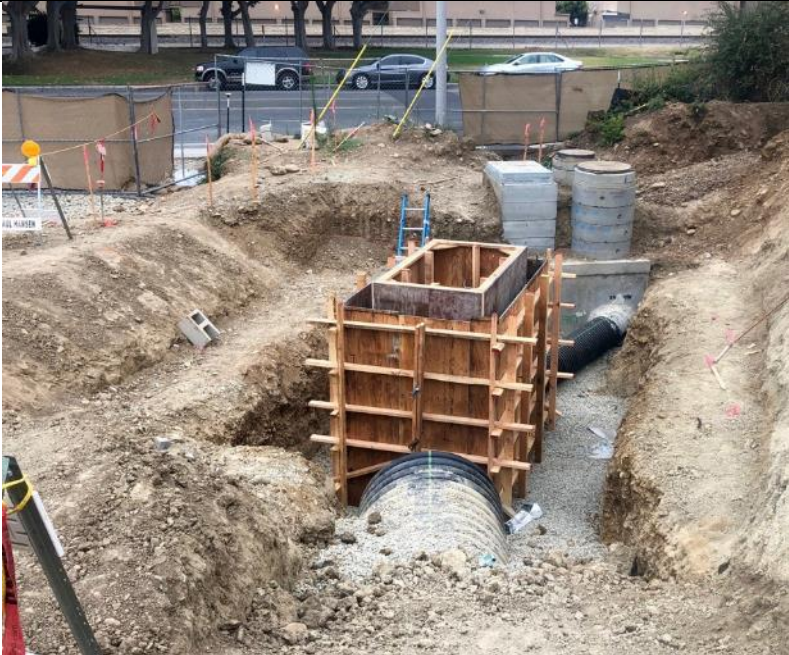
Photo 7 – Storm drain vault construction near the modular wetland. Photo facing west.

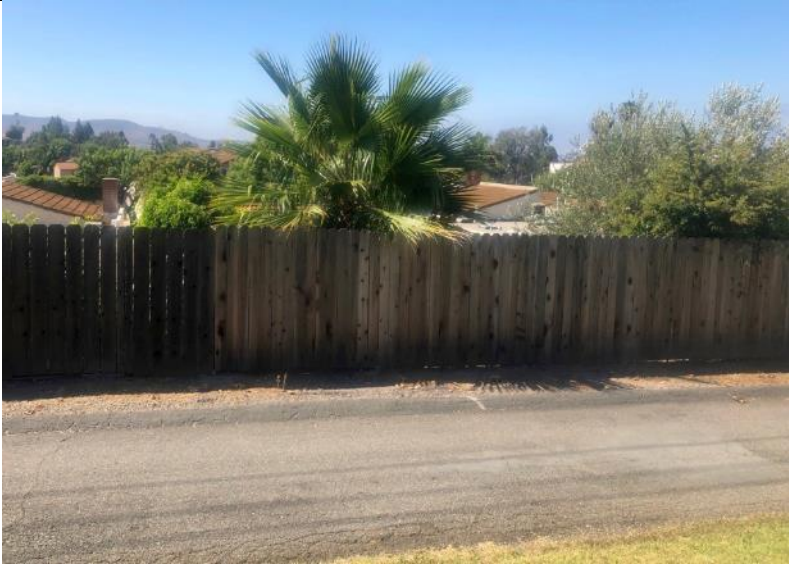
Photo 14 – Palm tree with a hooded oriole nest adjacent to the south side of Serra Park. Photo facing south.

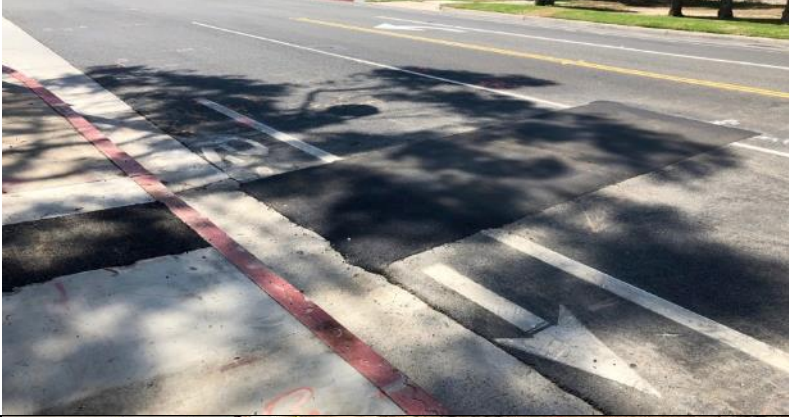
At the substation construction area, I noted that the excavated area within Camino Capistrano had been paved (Photo 2).

Photo 2 – New roadway pavement on Camino Capistrano. Photo facing southwest
8/22/19	San Juan Capistrano Substation	 	Photo 3 – Portion of the storm drain system remains open. Photo facing east

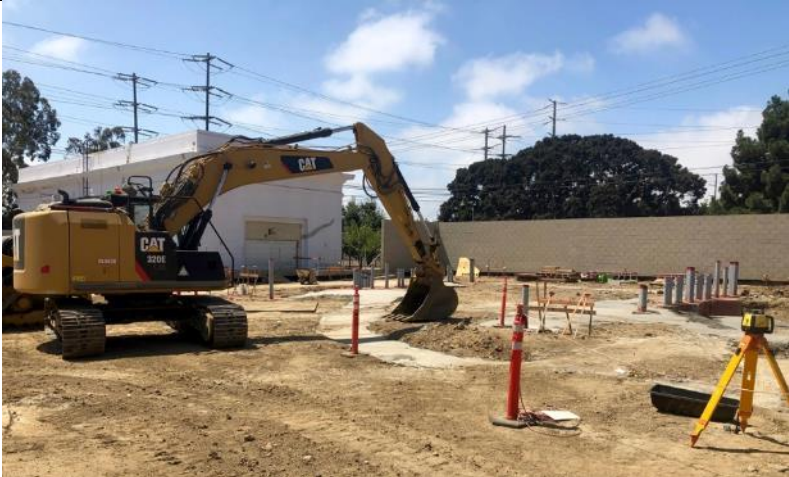
Some of the storm drainage system remained open and waiting for manhole installation (Photo 3). During my site visit, there was no activity occurring in the switch rack area (Photo 4); however, there was some grading being conducted nearby for transformer foundations. The conduit trench near the switch rack area remained open without a climbing structure or escape ramp (Photo 5). I discussed this with the SDG&E Environmental Coordinator who said they check all open holes every morning for trapped animals.

Photo 4 – Switch rack area. Photo facing southwest
8/22/19	San Juan Capistrano Substation

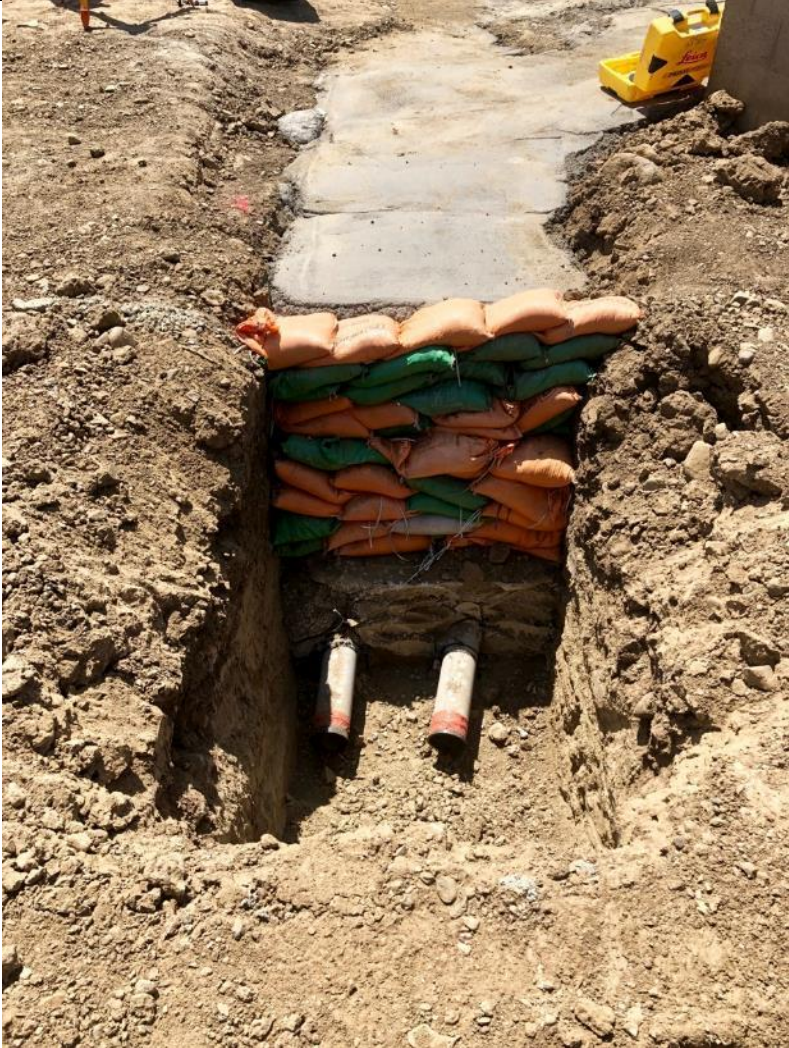
Photo 5 – Conduit trench needing a cover or escape ramp.

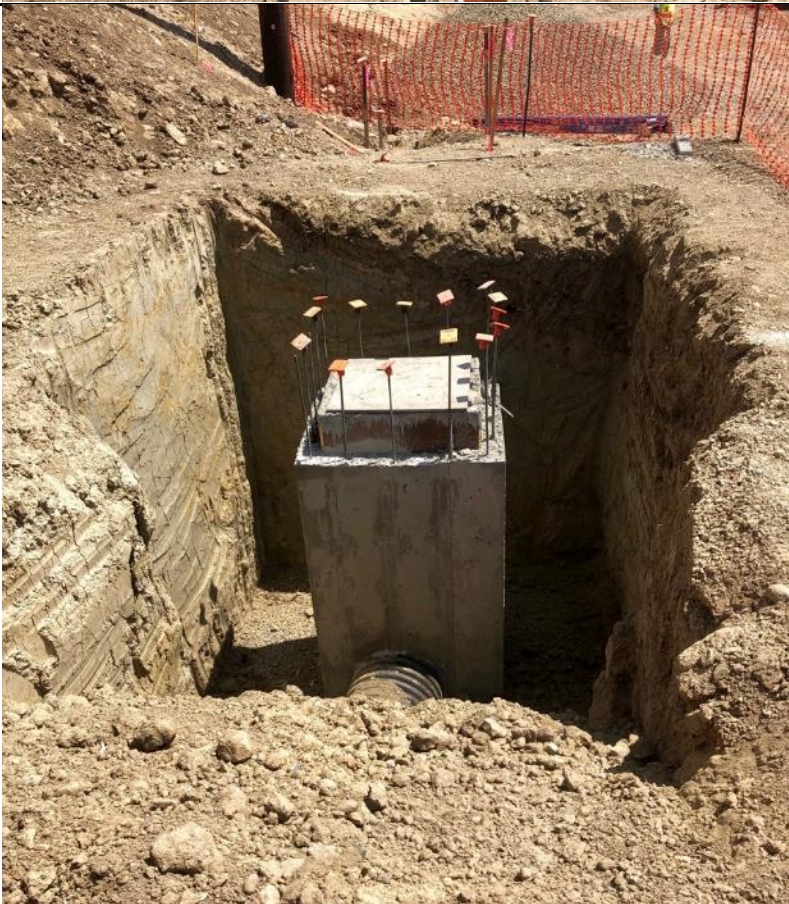
Photo 7 – Storm drain vault construction.

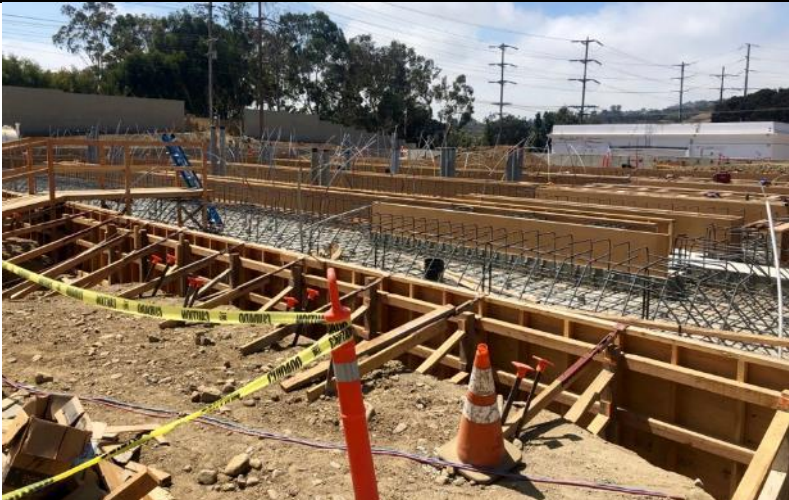
Photo 8 – Rebar and concrete form installation within the 138-kV GIS building pad. Photo facing southwest.
8/22/19	San Juan Capistrano Substation	 	Photo 9 – Storm drain vaults to be poured. Photo facing south.
8/22/19	San Juan Capistrano Substation	 	Photo 10 – Soil stockpile area. Photo facing east.

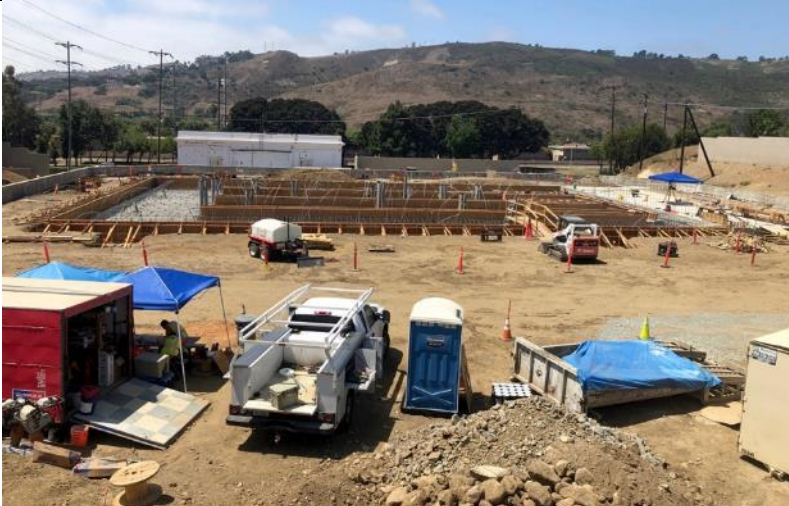
Photo 11 – Overview of the 138-kV GIS building pad. Photo facing west.
8/22/19	San Juan Capistrano Substation – Serra Park

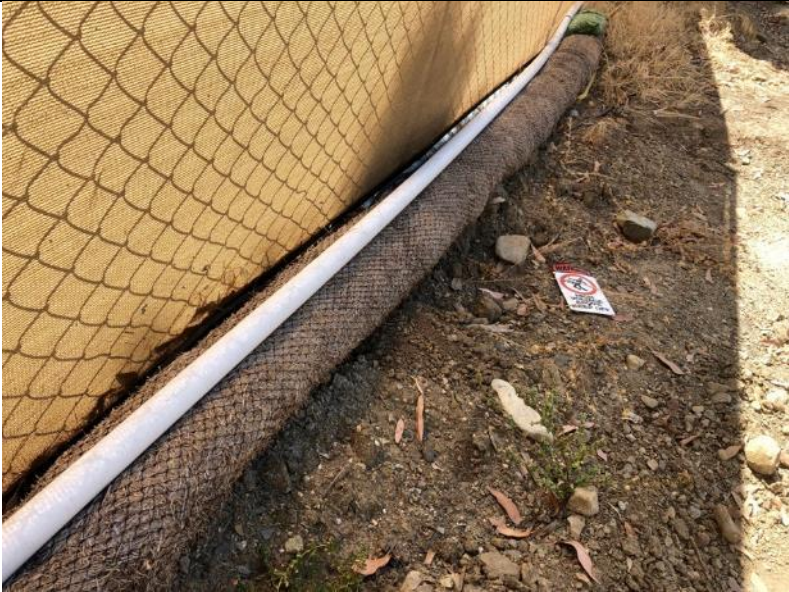
Photo 12 – Straw wattles covered in plastic netting along the park boundary fencing.

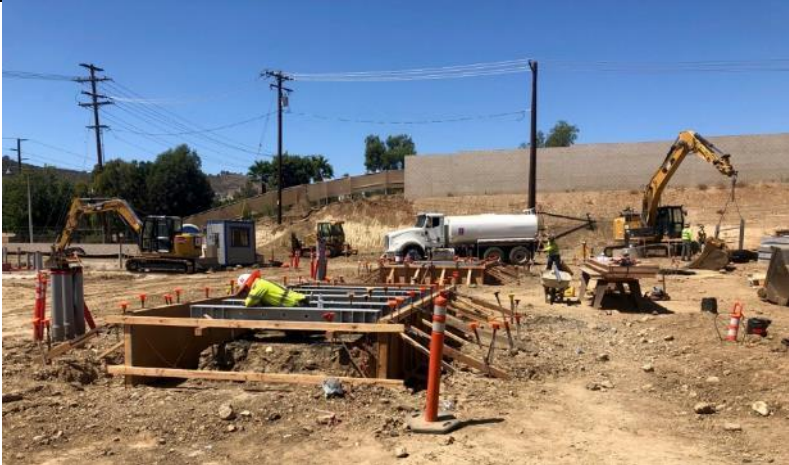
Photo 3 – Preparation work on the transformer foundations. Photo facing north.

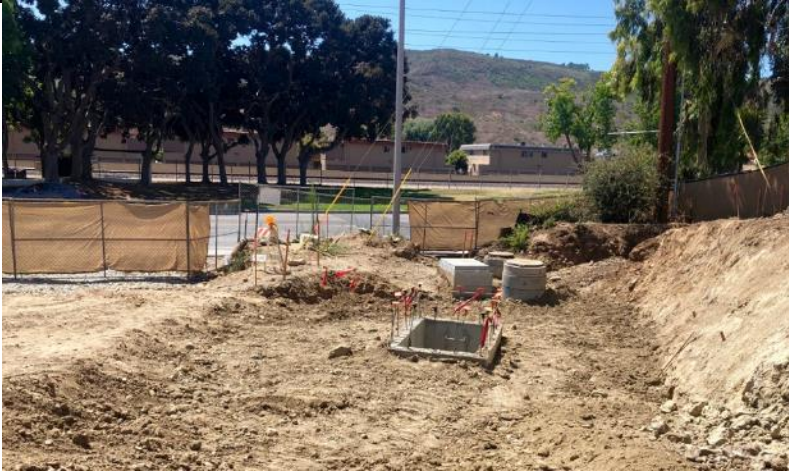
Photo 5 – Storm drain manhole has been backfilled near the modular wetland. Photo facing west.

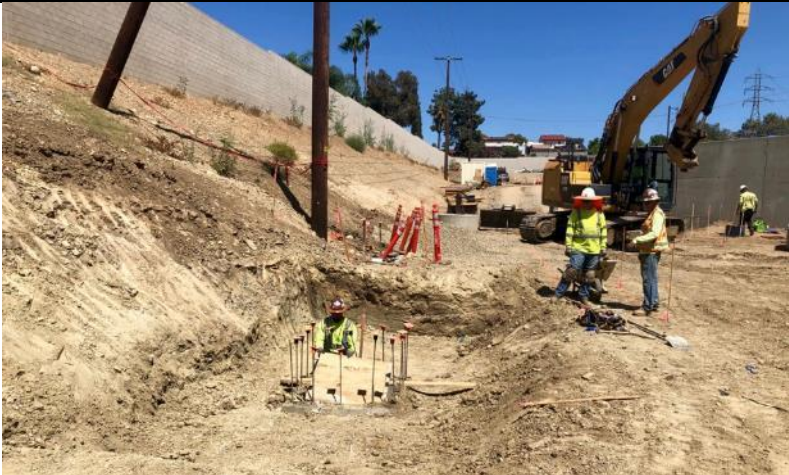
Photo 6 – Storm drain vault construction. Photo facing east.
8/27/19	San Juan Capistrano Substation

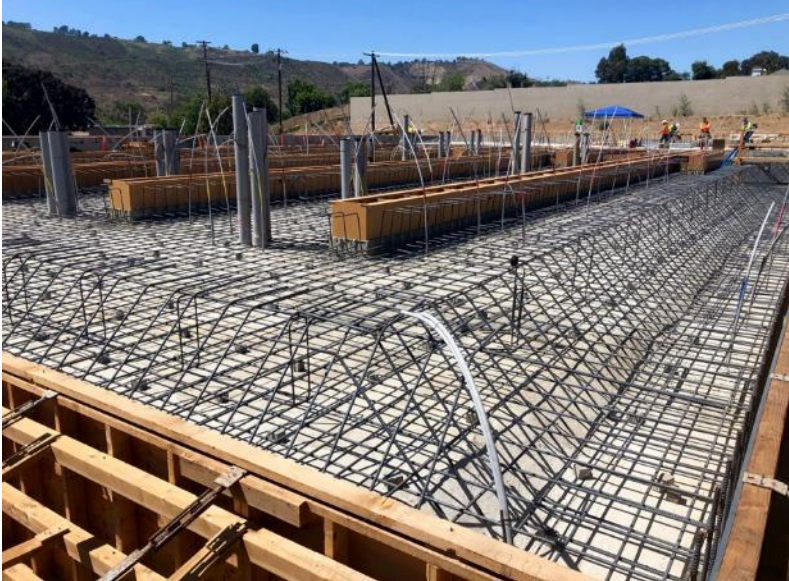
Photo 7 Rebar and concrete form installation within the 138-kV GIS building pad. Photo facing northwest.
8/27/19	San Juan Capistrano Substation

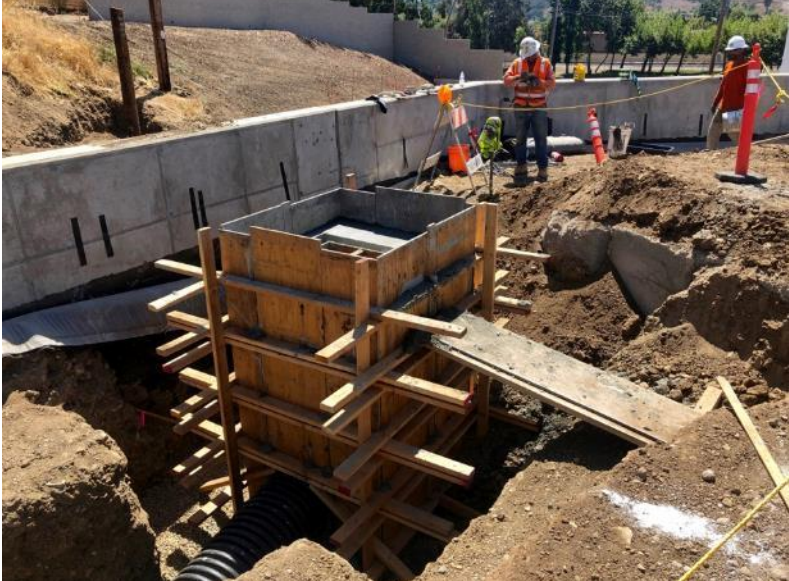
A concrete truck was leaving the substation area after washing out in the designated washout bins (Photo 2). I spoke with the onsite Environmental Resources Monitor who indicated that the storm drain manhole foundations located within the 138-kilovolt (kV) gas-insulated substation (GIS) building pad had been poured (Photo 8).

Photo 8 – Storm drain vaults recently poured within the 138-kV GIS building pad. Photo facing southwest.

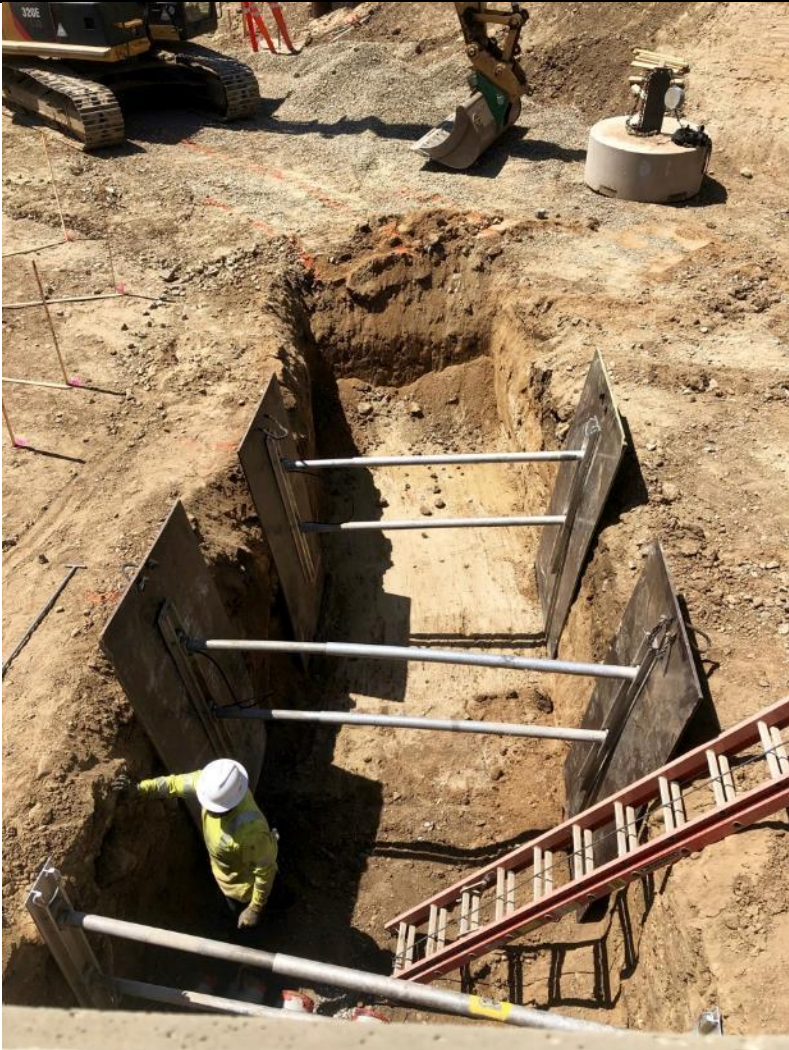
A storm drain trench was dug to connect the piping coming out of the 138-kV GIS building pad with the line running into the northern modular wetland (Photo 9). The construction foreman signaled his crew to put some boards in the trench to act as an escape ramp. I suggested that laying back the end of the trench would be a simpler way of complying with conditions concerning trapped animals. The foreman said this would be difficult to accomplish since they had stopped at a bend in the piping; however, for a straight trench, they would lay back the end of the trench.

Photo 9 – Trenching work for the storm drain system.
8/27/19	San Juan Capistrano Substation

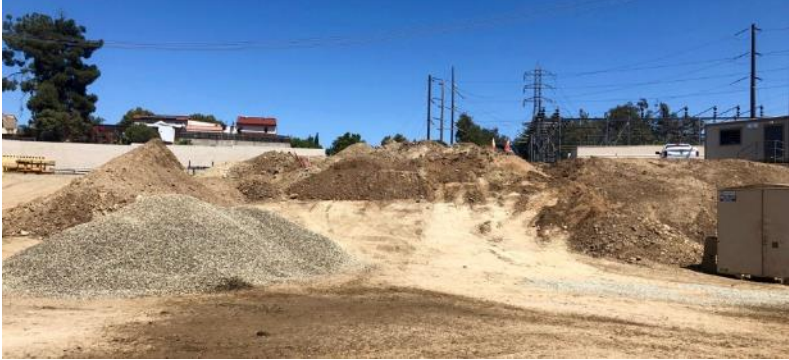
Photo 10 – Soil stockpile area. Photo facing east.
