December 12, 2019

Re: Monthly Report Summary #24 for the South Orange County Reliability Enhancement (SOCRE) Project

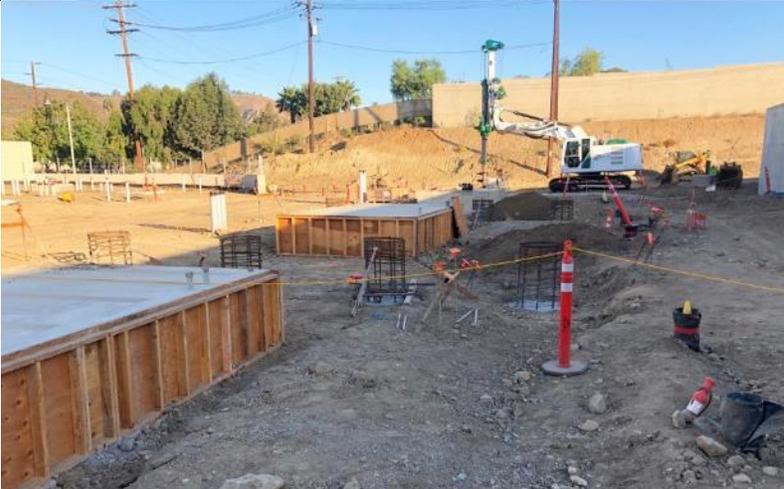
A drill rig was onsite, which had been used to drill foundation holes around the transformer pads. Rebar cages had been dropped into the holes and a cement slurry had been poured. The SDG&E LEI indicated that these new circular foundations were for fire walls (Photo 2).

Photo 2 – Foundation work around the new transformer pads. Photo facing north.
10/04/19	San Juan Capistrano Substation

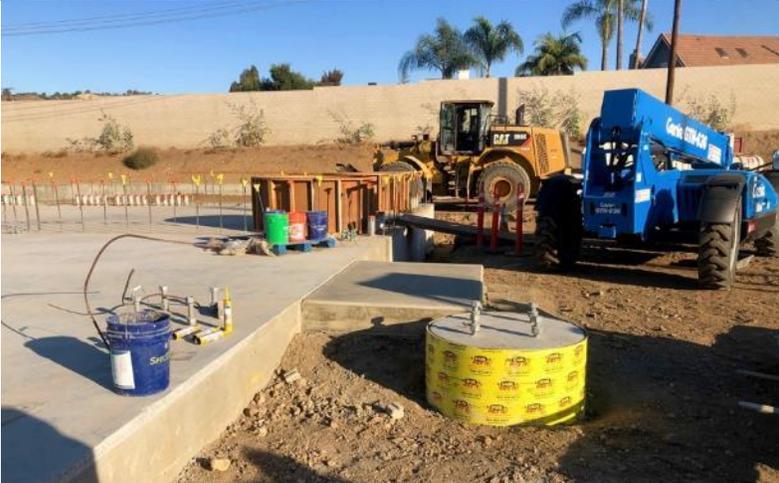
Work continued around the 138-kilovolt (kV) gas insulated substation (GIS) building pad, including small pours for entryways and drilling for lighting tower foundations (Photo 6). The GIS building pad was mostly complete (Photo 7), and the SDG&E LEI indicated that a contractor would begin construction on the building soon.

Photo 6 – Additional foundation work around the 138-kV GIS building pad. Photo facing north.

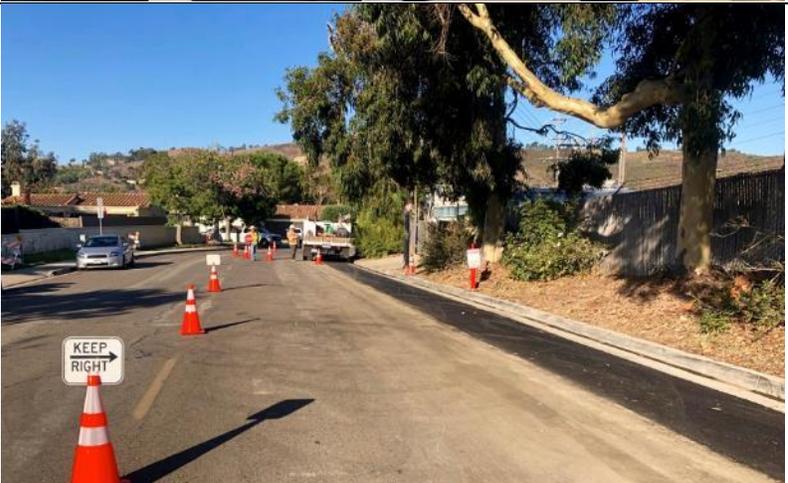
The underground conduit work had been installed on Calle Bonita, and the trench had been paved with asphalt (Photo 8). No paving work had been completed over the newly installed conduit trench along the south side of Serra Park (Photo 9). Surveyors had staked out the new tower location at the east end of the park near the freeway (Photo 10). The SDG&E LEI stated that they would start drilling the foundation the following week. There was some mud in the staging area (Photo 11); however, overall, the staging area appeared to be in good condition. The SDG&E LEI stated that he would inquire about the watering schedule for Serra Park, since the mud in the staging area could be related to water from the park's irrigation system.

Photo 8 – Asphalt paving of the conduit trench on Calle Bonita. Photo facing west.
10/04/19	Serra Park, near San Juan Capistrano Substation

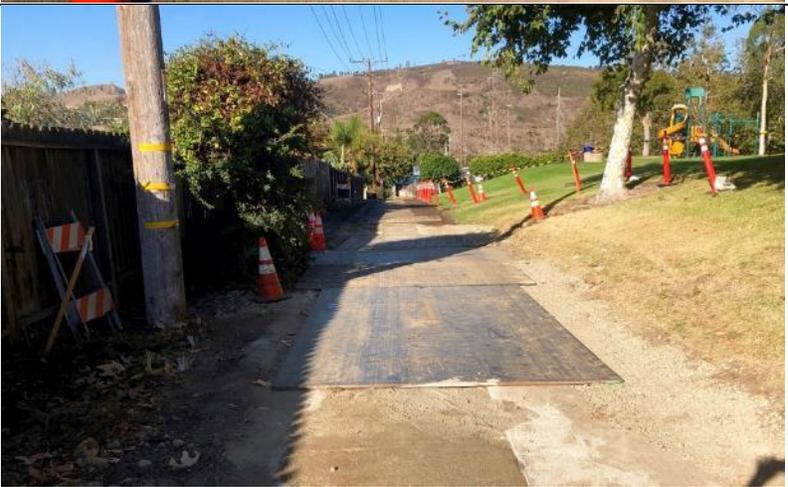
Photo 9 – Conduit trench along the south side of Serra Park. Photo facing west.

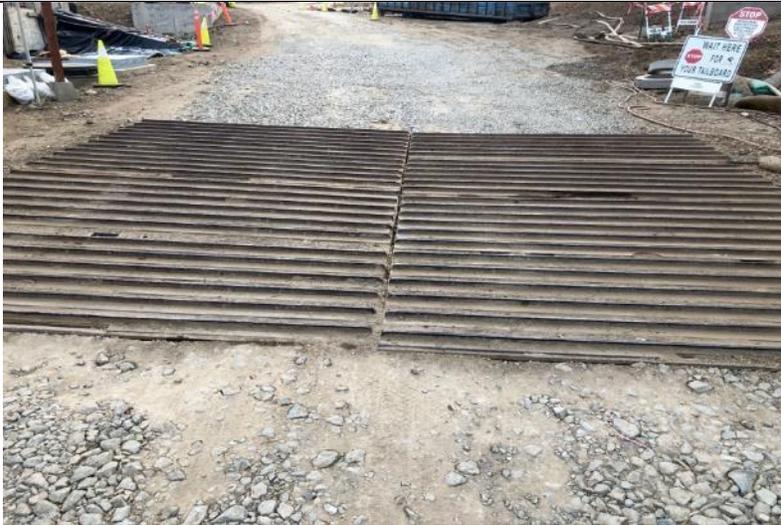
Best management practices (BMPs) at the main entry/exit were a combination of rumble plates and larger sized rock (approximately 3 to 4 inches). The rumble plates were clean and in good condition, but the rock needed to be upgraded with additional, larger rock (Photo 1). I notified the EI of this needed upgrade.

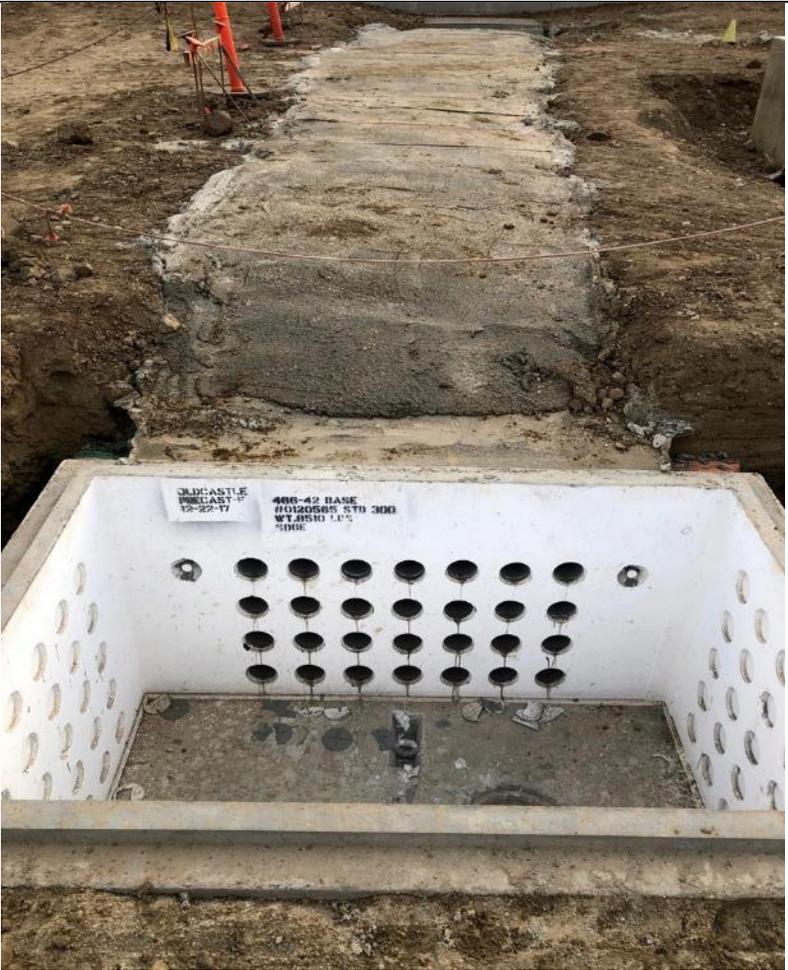
Photo 3 – Open conduit vault with uncapped piping. Photo facing east.
10/09/19	San Juan Capistrano Substation

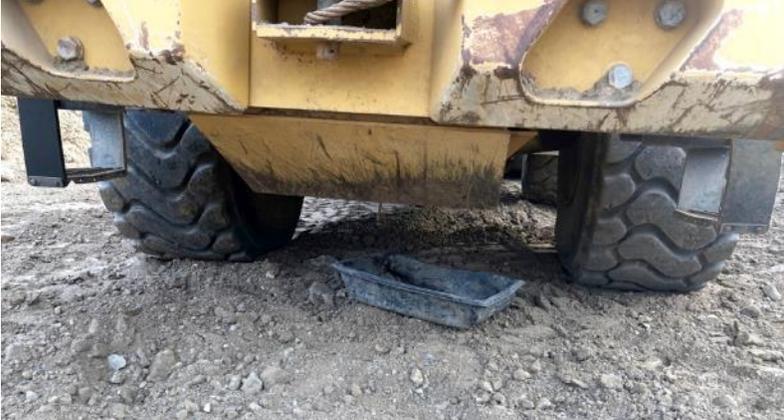
Photo 9 – A drip pan that is too small for adequate containment.
10/09/19	San Juan Capistrano Substation

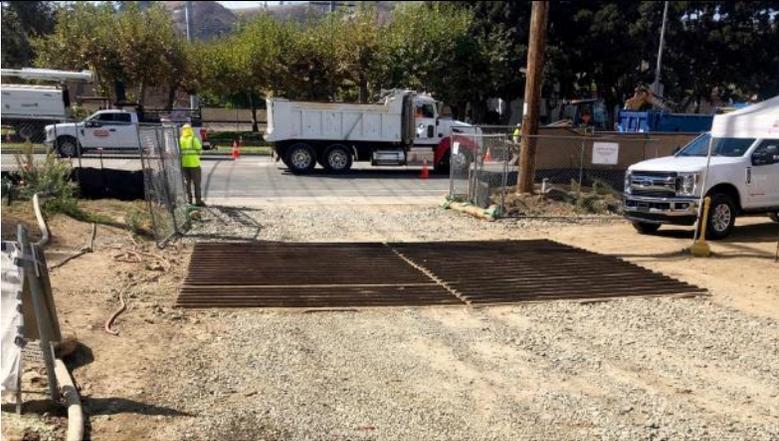
Photo 7 –Main entry/exit where additional, larger rock is needed around the rumble plates. Photo facing west.

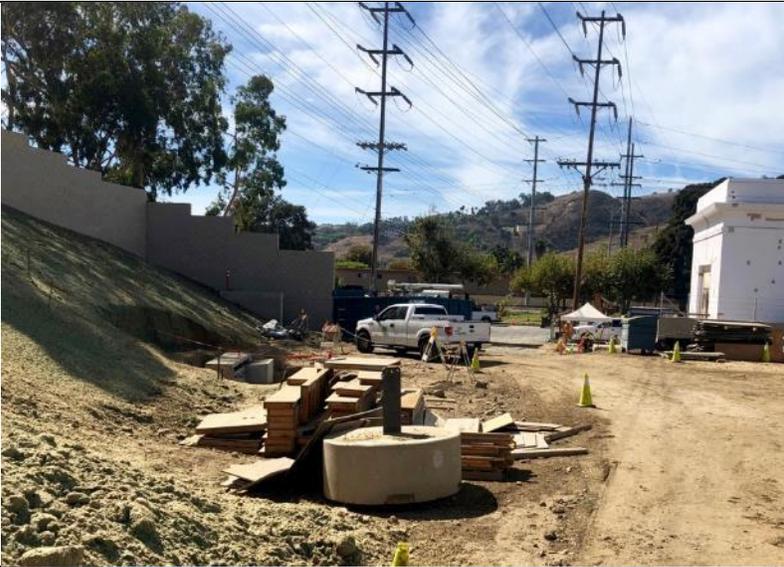
Photo 14 – Area considered for upgrade into a possible catch basin during rain events. Photo facing west.
10/16/19	Ganado Road, east of Interstate 5

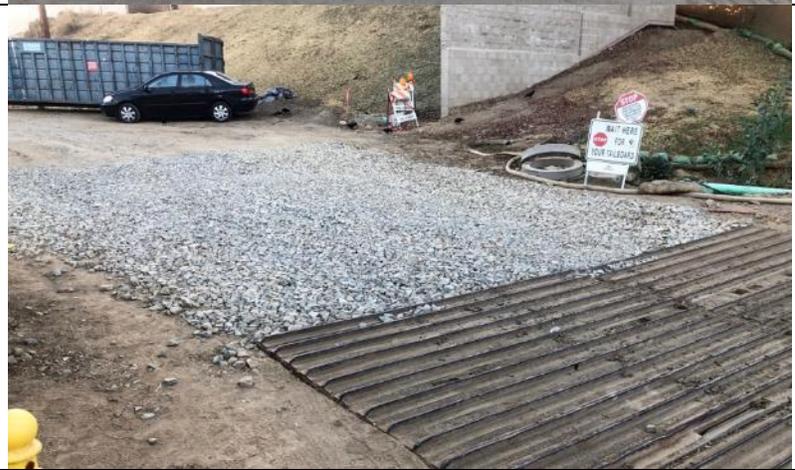
Photo 3 – Upgraded BMPs consisting of additional rock at the west entry. Photo facing south.

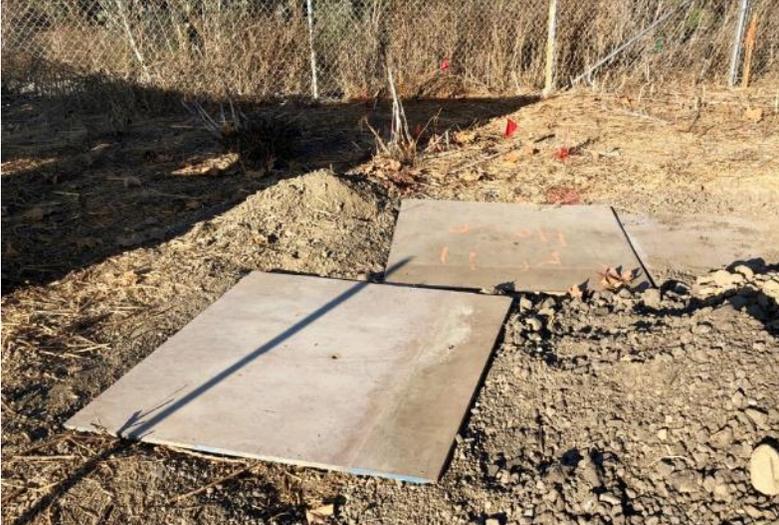
Photo 12 – Potholes covered with boards but not sealed outside of the new staging area east of Interstate 5.
