Re: Monthly Report Summary #25 for the South Orange County Reliability Enhancement (SOCRE) Project

CPUC Site Inspection Reports
November 5, 14, 21, and 26, 2019

South Orange County Reliability Enhancement Project CPUC Site Inspection Form

Project:	South Orange County Reliability Enhancement (SOCRE) Project	Date:	November 5, 2019
Project Proponent:	San Diego Gas & Electric (SDG&E)	Report #:	VS056
Lead Agency:	California Public Utilities Commission (CPUC)	Monitor(s):	CPUC/Ecology and Environment (E & E) Compliance Monitor
CPUC PM:	Andrew Barnsdale, Energy Division	AM/PM Weather:	Sunny and warm with a slight breeze
CPUC CM (E & E):	Joe Donaldson	Start/End Time:	1215 to 1400
Project NTP(s):	Notice to Proceed (NTP)-2, NTP-2 Addendum 1, NTP-3, NTP-4, and NTP-5

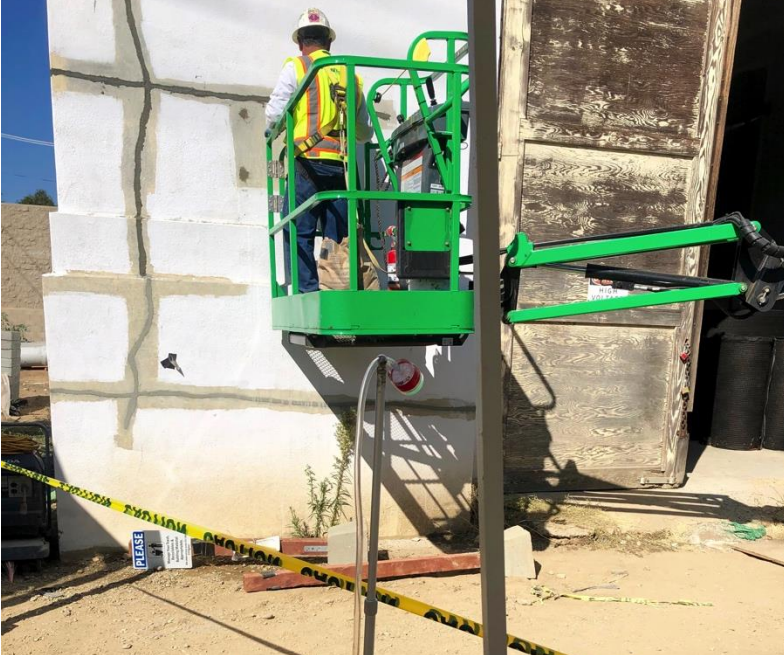
I arrived onsite at the San Juan Capistrano Substation at 1215. Work continued on the repair of the former utility structure. A lead abatement crew was working on the building, so air sampling equipment had been set up around the area (Photo 1).

A worker in a high-visibility vest and hard hat stands on a green scissor lift. The lift is positioned against a light-colored concrete wall. A large air monitor is attached to the lift. Yellow caution tape is strung across the foreground. A sign on the ground reads "PLEASE STAY BEHIND THIS TAPE".	Photo 1 – Cleaning and patching the former utility structure with an air monitor in the foreground. Photo facing north.
11/05/19	San Juan Capistrano Substation

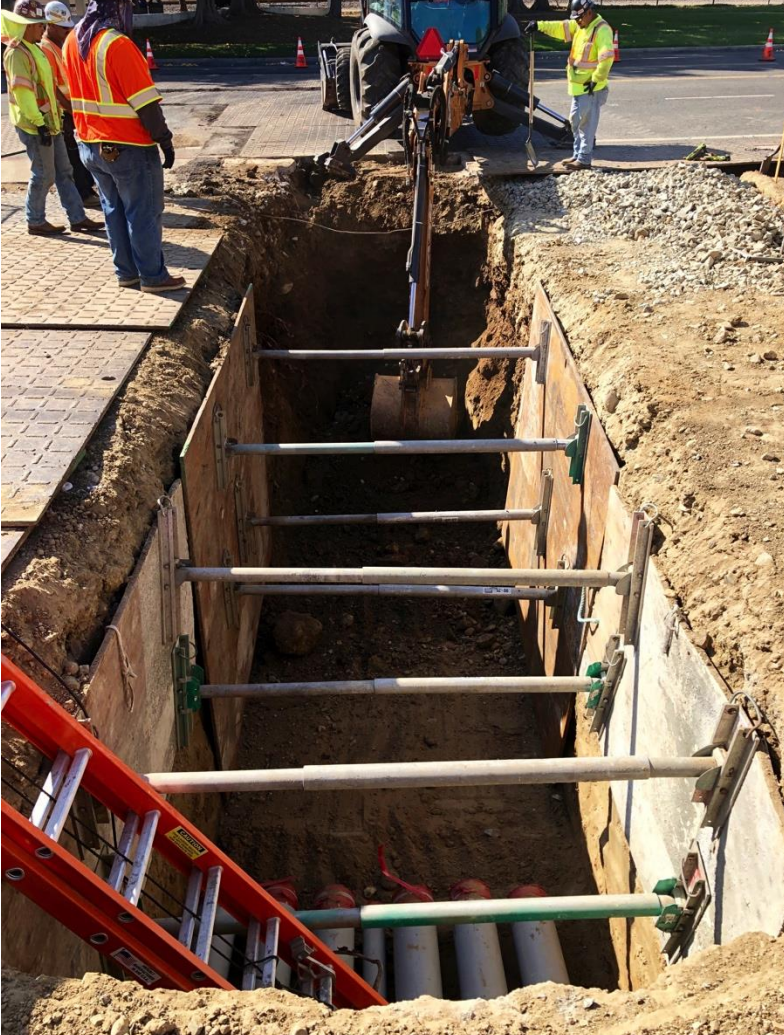
A trenching machine is in the process of digging a deep trench. The trench is lined with metal sheet piling. Several workers in high-visibility vests are standing around the trench. A red ladder is leaning against the side of the trench. The ground is dirt and gravel.	Photo 2 – Conduit trenching leading to Camino Capistrano. Photo facing west.

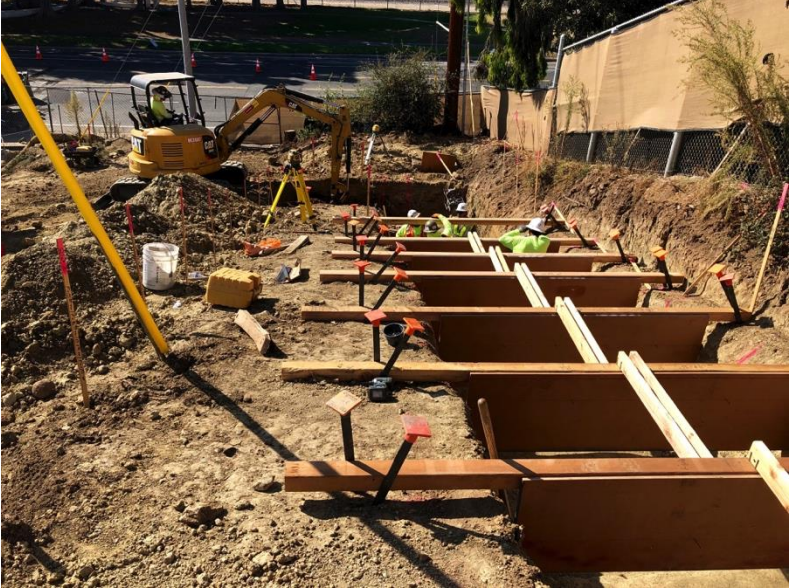
A small backhoe was being used for the foundation footings for the northern wall, extending west down the slope to the roadway (Photo 3). Foundation forms had been set up, and foundations were nearly ready to be poured.

Photo 3 – Footing work for the northern wall extension. Photo facing west.
11/05/19	San Juan Capistrano Substation

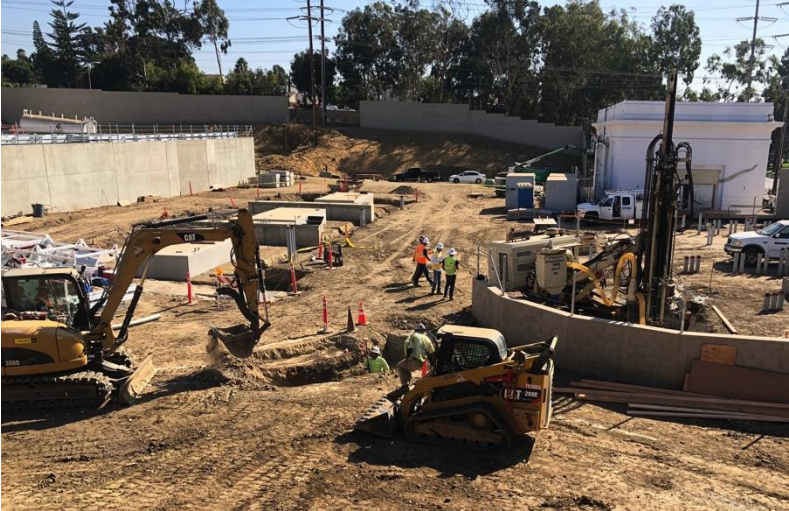
Photo 4 – Conduit vault excavation exiting the switch rack area. Photo facing south.
11/05/19	San Juan Capistrano Substation

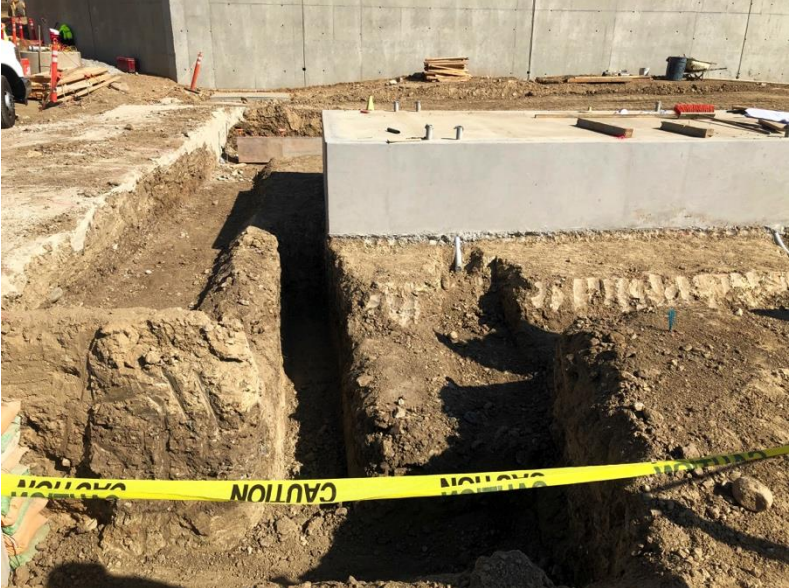
Trenches were still open around the transformer foundations. The SDG&E LEI explained that the trenches were for the containment basins around the transformers (Photo 5).

Photo 5 – Containment basin work around the transformer foundations. Photo facing east.

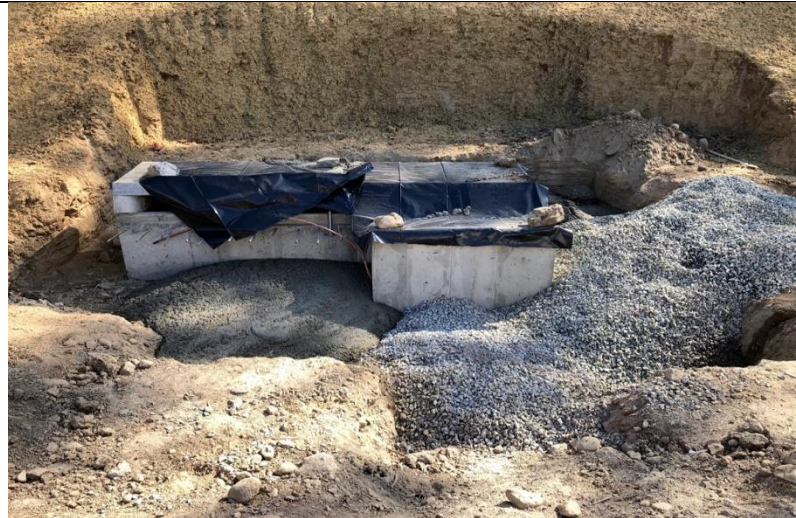
Photo 6 – Drain inlet after being slurried. Photo facing south.
11/05/19	San Juan Capistrano Substation

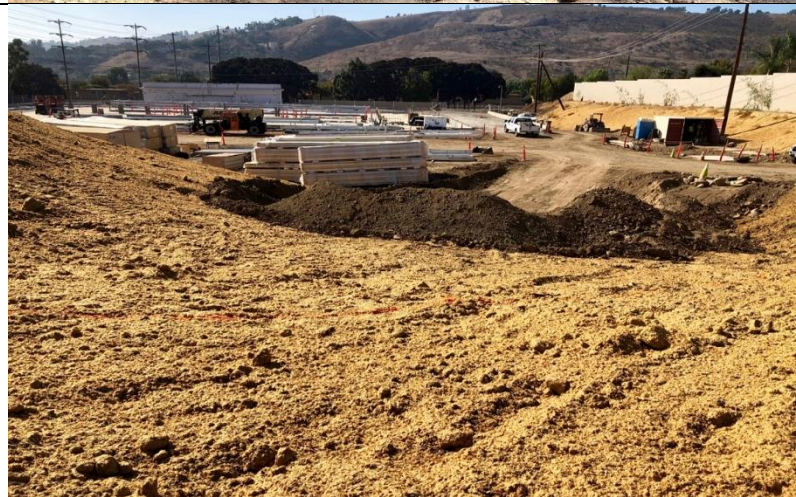
Excess soil was being deposited in the stockpile area (Photo 7).

Photo 7 – Soil stockpile area. Photo facing west.
11/05/19	San Juan Capistrano Substation

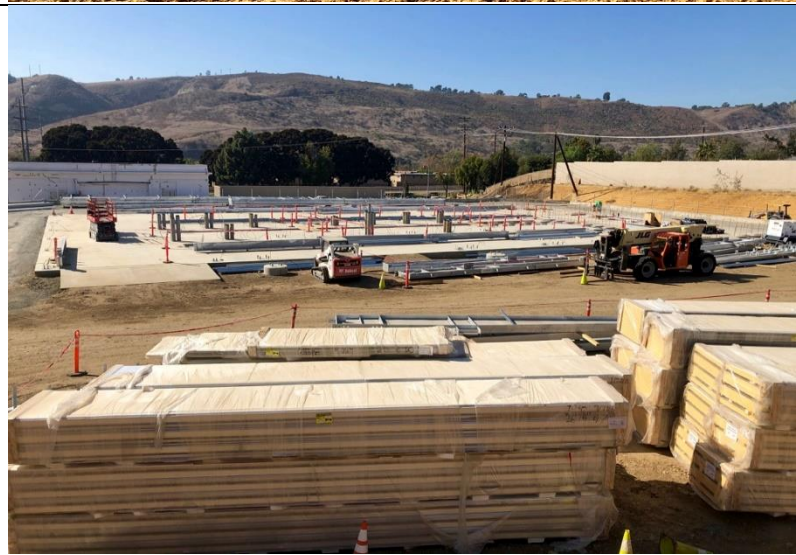
The SDG&E LEI said the work on the 138-kilovolt (kV) gas insulated substation (GIS) building was on hold due to delivery of materials, and they were investigating some cracks in the concrete foundation (Photo 8).

Photo 8 – Building materials stockpiled around the 138-kV GIS building pad. Photo facing west.

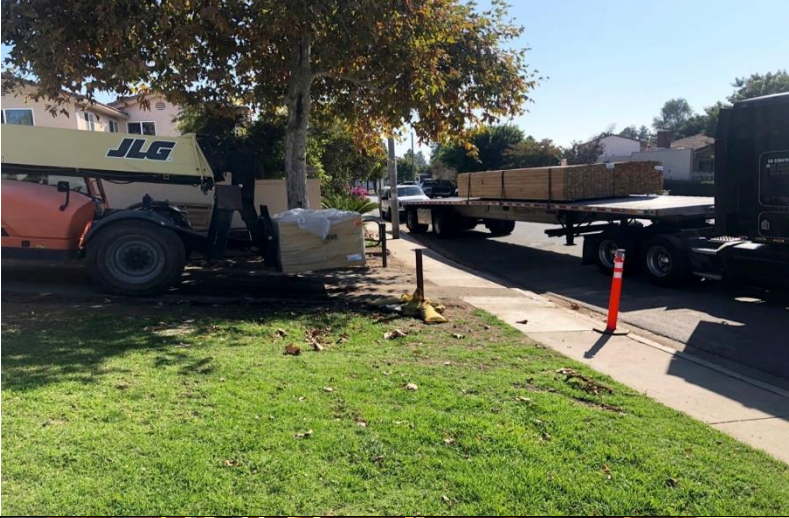
Photo 9 – Materials being moved to the Serra Park staging area. Photo facing south.
11/05/19	Serra Park, near San Juan Capistrano Substation

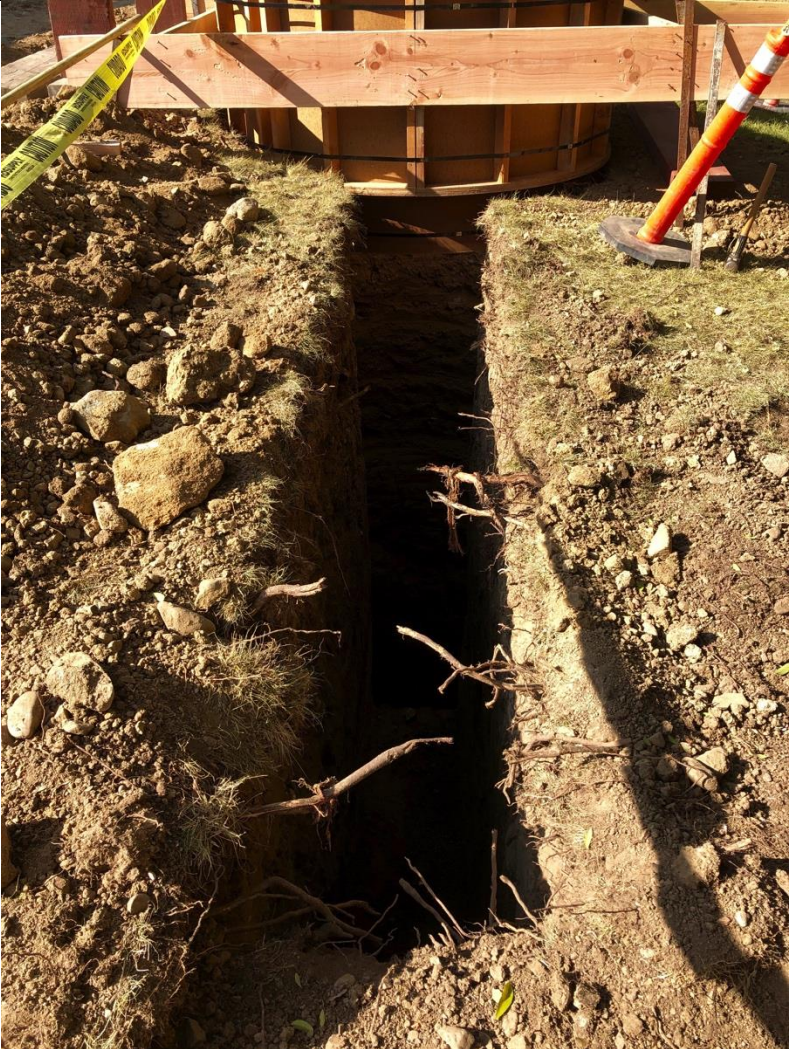
A large drill rig had been used to dig the first of two tower foundation holes. I spoke with the EI about sealing the holes overnight (Photo 10). According to the EI, the foundation hole is approximately 6 feet long by 21 feet deep. The foundation cage was being brought to the site for installation. The SDG&E LEI later sent a photo depicting the measures taken to seal the excavation.

Photo 10 – Tower foundation hole and concrete forms. Photo facing north.

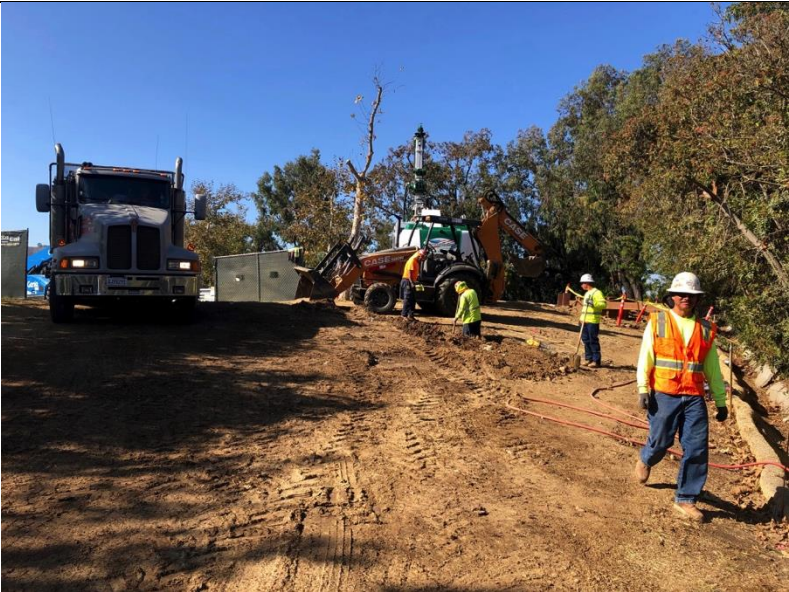
Photo 11 – Preparation for drilling the second tower foundation. Photo facing north.
11/05/19	Rancho Viejo, near San Juan Capistrano Substation

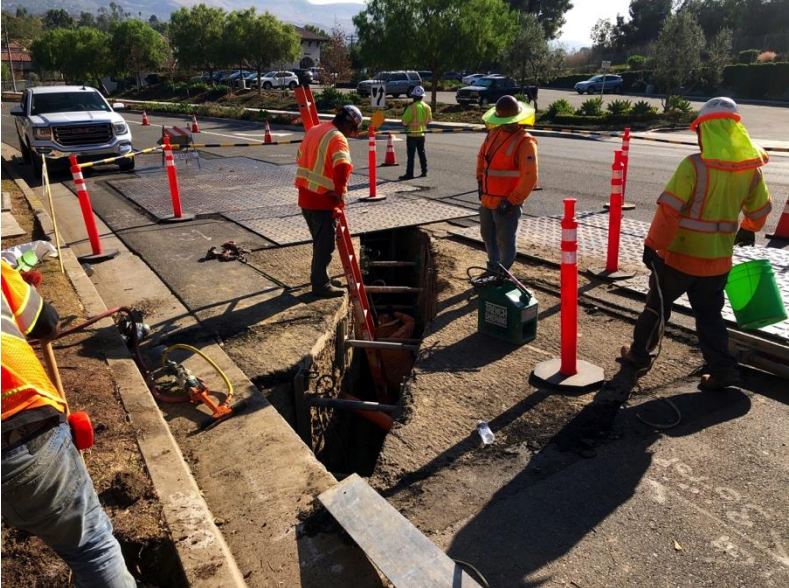
Photo 12 – Conduit installation within Rancho Viejo.

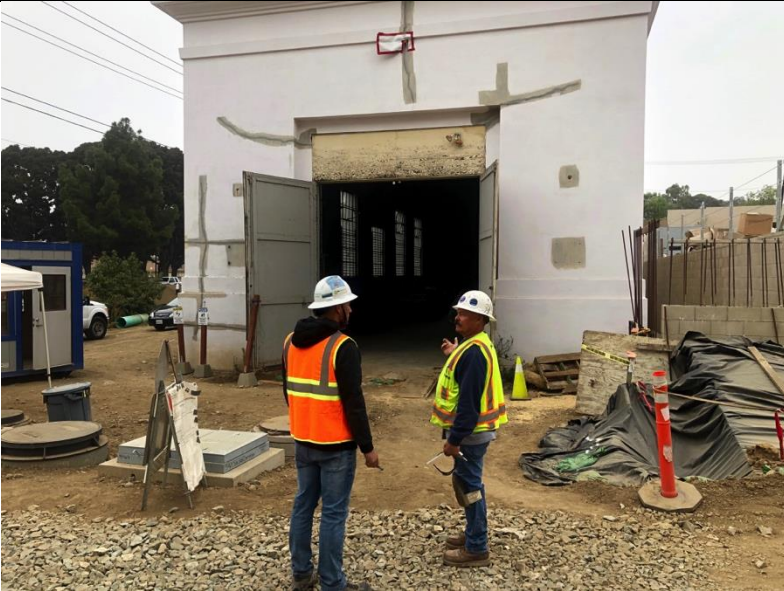
Photo 1 – Patching and painting the former utility structure. Photo facing north.
11/14/19	San Juan Capistrano Substation

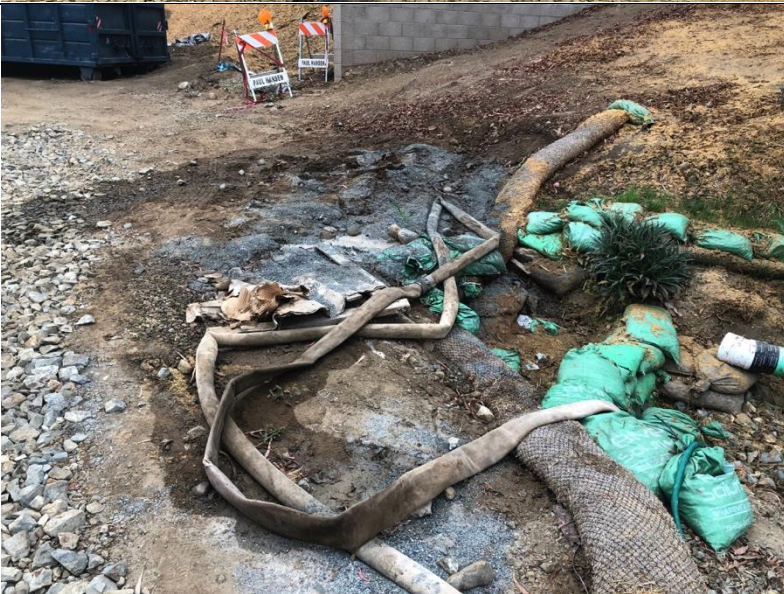
Photo 2 – Washout near the offsite drainage system.

Upgrades are needed by the offsite drain prior to the rainy season. Straw wattles are recommended as climbing structures in trenches and excavated holes.

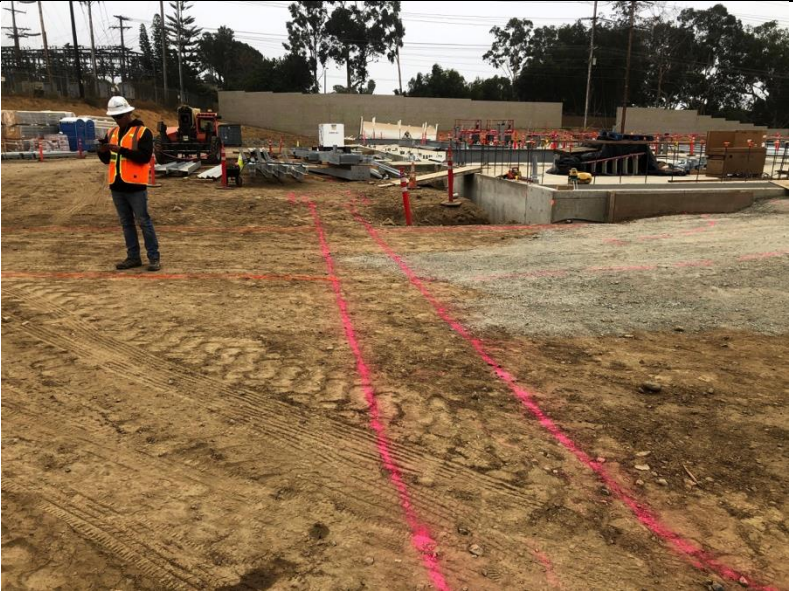
Photo 7 – Lines showing planned conduit trenching. Photo facing south.
11/14/19	San Juan Capistrano Substation

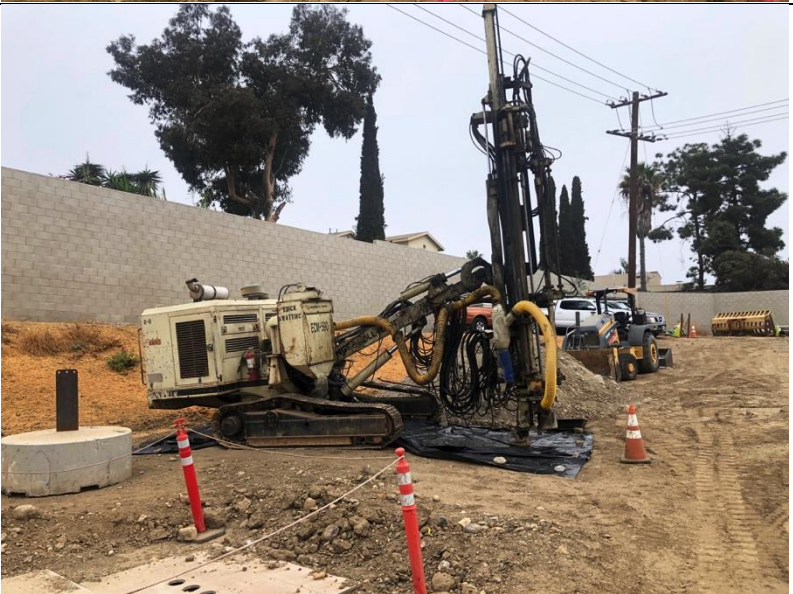
An old drill rig was parked onsite (Photo 8). It has been parked on large plastic sheeting to capture any potential leakage. The SDG&E LEI indicated that, if it becomes an issue, a newer drill rig will be brought in to replace it.

Photo 8 – Old drilling rig parked onsite with adequate containment. Photo facing east.

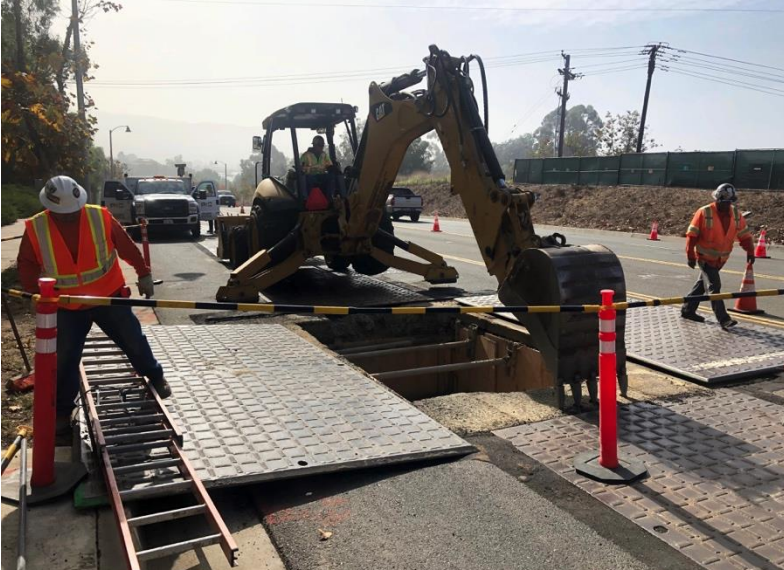
Photo 14 – Conduit installation at Rancho Viejo.
11/14/19	Rancho Viejo, near San Juan Capistrano Substation

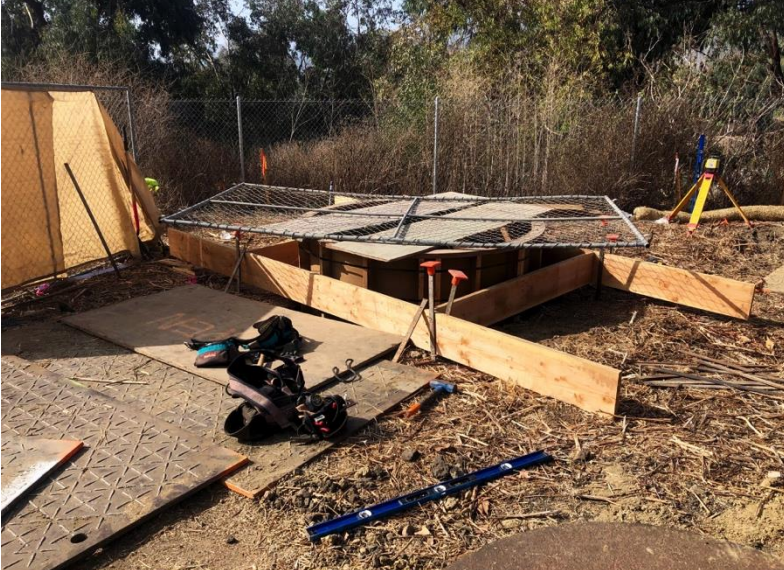
The drill rig had been moved to the laydown yard along Rancho Viejo. One foundation hole had been excavated (Photo 15), with excavation of the second foundation hole underway (Photo 16). Monitors were onsite observing the tailings from the hole.

Photo 15 – Newly drilled tower foundation east of Highway 5. Photo facing west.

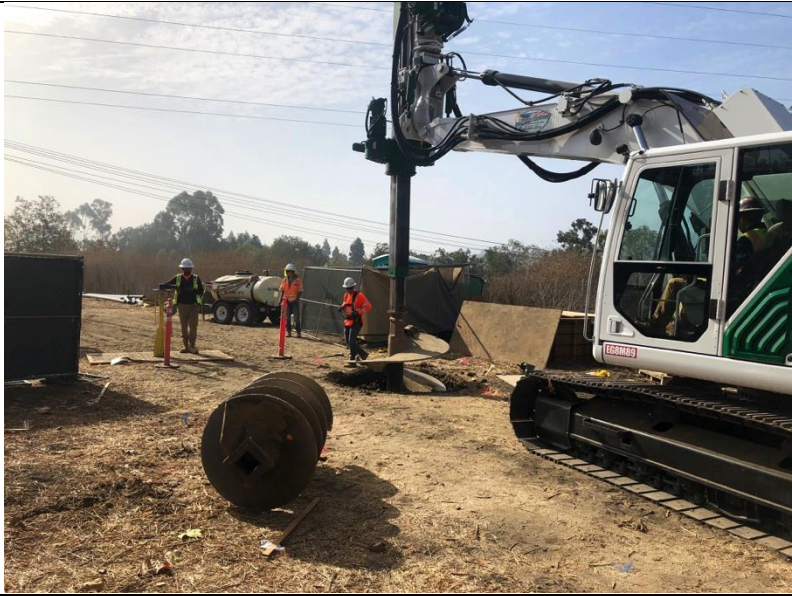
Photo 16 – Drilling the second tower foundation hole near the entrance to the staging area. Photo facing south.

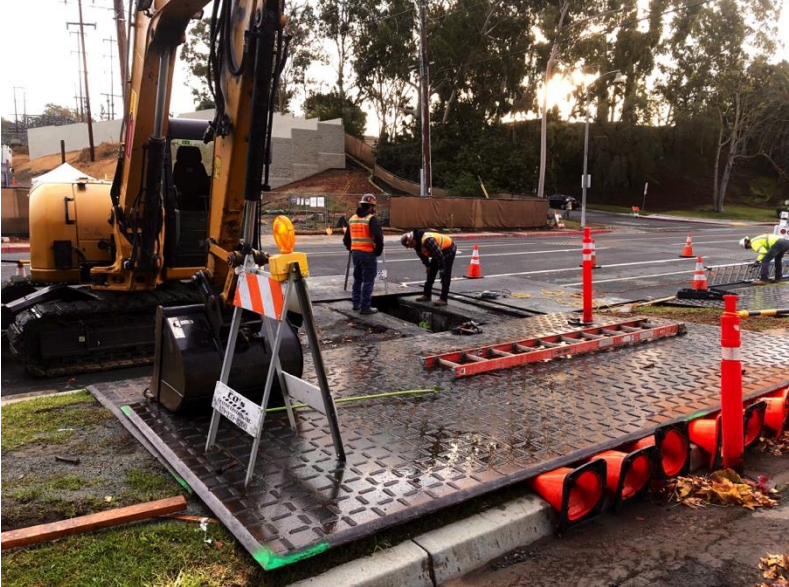
Photo 1 – Work at Camino Capistrano connecting storm drain piping. Photo facing southeast.
11/21/19	San Juan Capistrano Substation

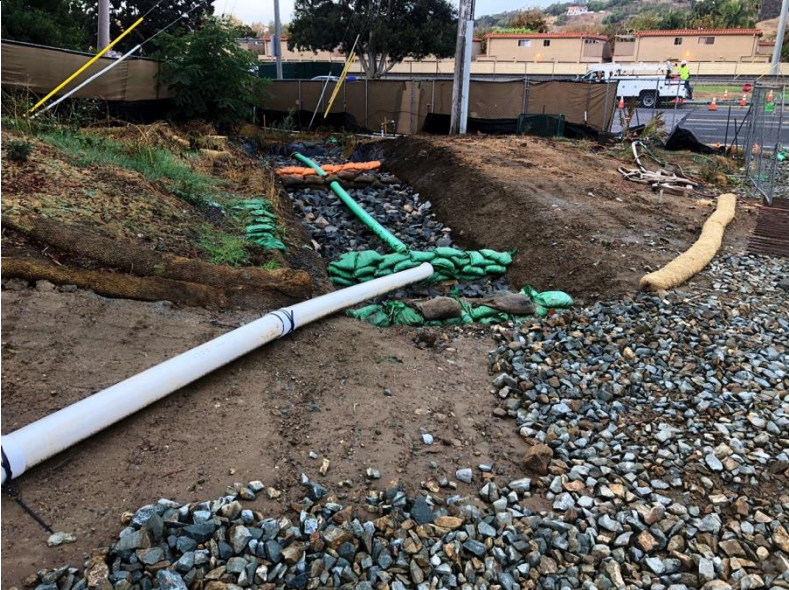
In preparation for the rain, crews had reconnected piping to direct water from the existing substation into the offsite drain (Photo 2). They also removed the rock from the catch basin in front of the drain inlet, excavated the basin, added filter fabric, and replaced the large rock.

Photo 2 – Catch basin and drain outlet with piping installed from the existing substation. Photo facing west.

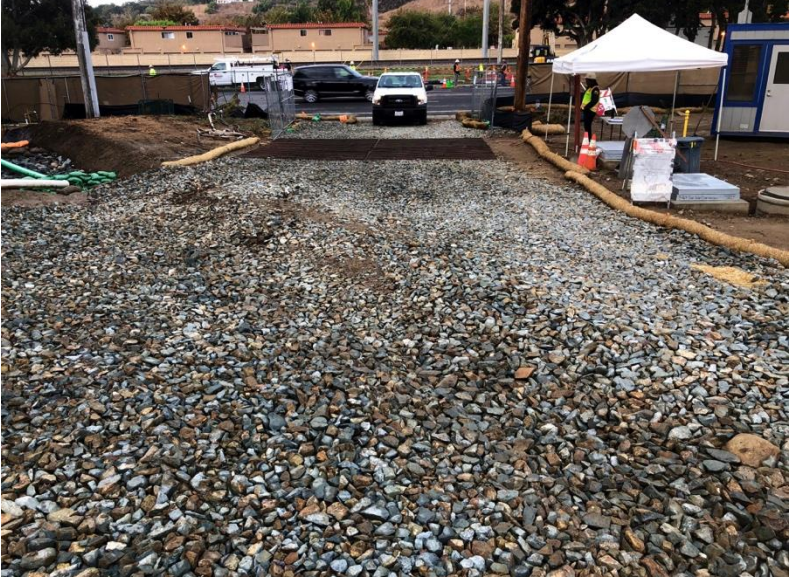
Photo 3 – A graded diversion berm covered with rock. Photo facing west.
11/21/19	San Juan Capistrano Substation

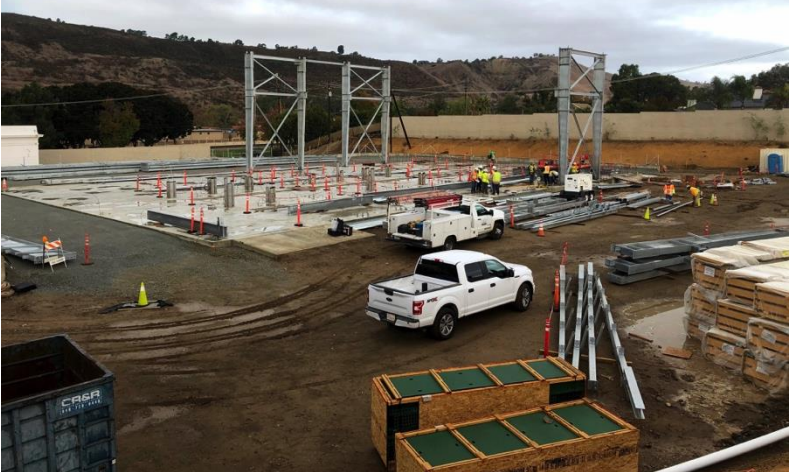
Photo 4 – The first installed beams of the 138-kV GIS building. Photo facing northwest.
11/21/19	San Juan Capistrano Substation

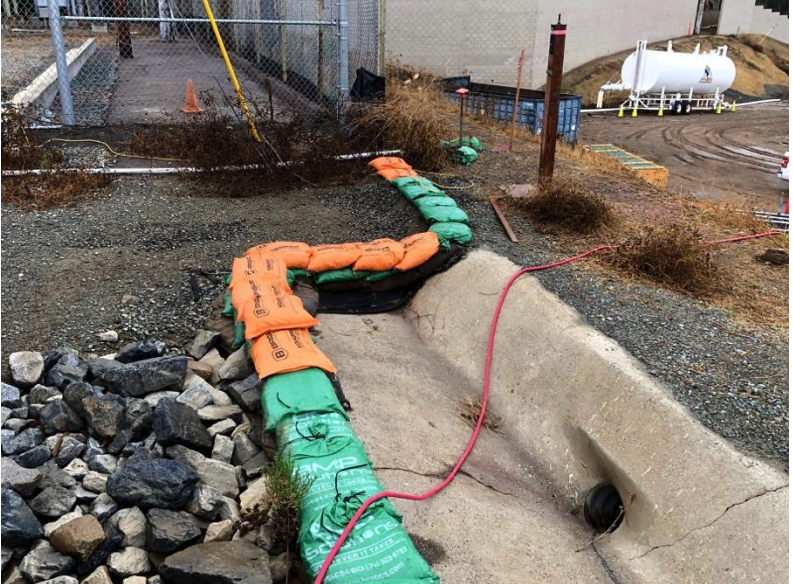
Photo 5 – Gravel bags around the inlet drains for the former substation and the construction trailer parking area. Photo facing south.

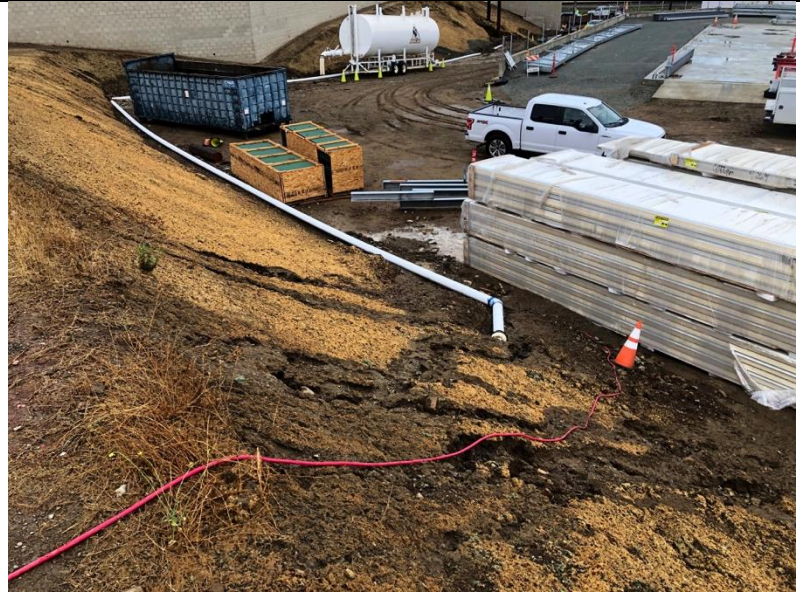
I noted two stormwater drainage issues onsite. The first issue was located at the eastern end of the southern wall. Water was coming off the substation, and water from outside the project site was entering the site as well. The EI and I discussed how to redirect this runoff away from the project site. The second issue was located near the construction trailers. Water from the substation was draining into the culvert connected to the newly installed piping (Photo 5). Gravel bags were placed around the inlet, but the height of the gravel bags caused water to overflow, creating some erosion (Photo 6). Lowering the gravel bag berm and relocating the extra gravel bags would resolve this issue.

<p>Photo 6 – Slope below the drain inlet shown in Photo 5. Too many gravel bags caused some overflow of water and subsequent erosion. Photo facing south.</p>
11/21/19	San Juan Capistrano Substation

Address the two stormwater drainage issues noted onsite.

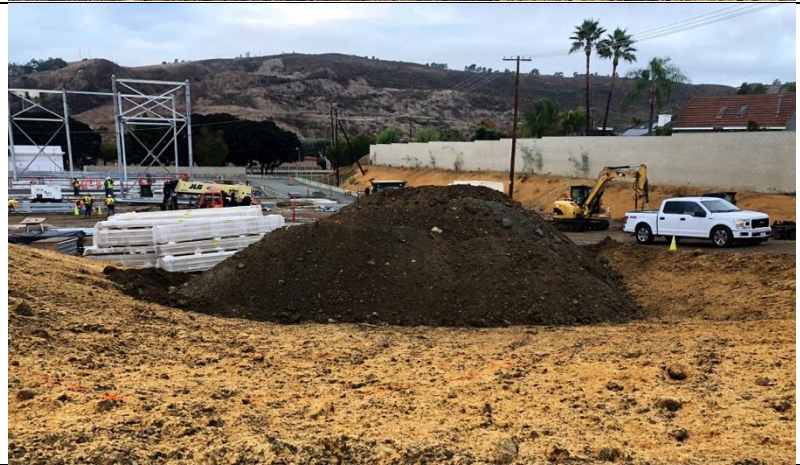
<p>Photo 7 – Soil stockpile area. Photo facing west.</p>
11/21/19	San Juan Capistrano Substation

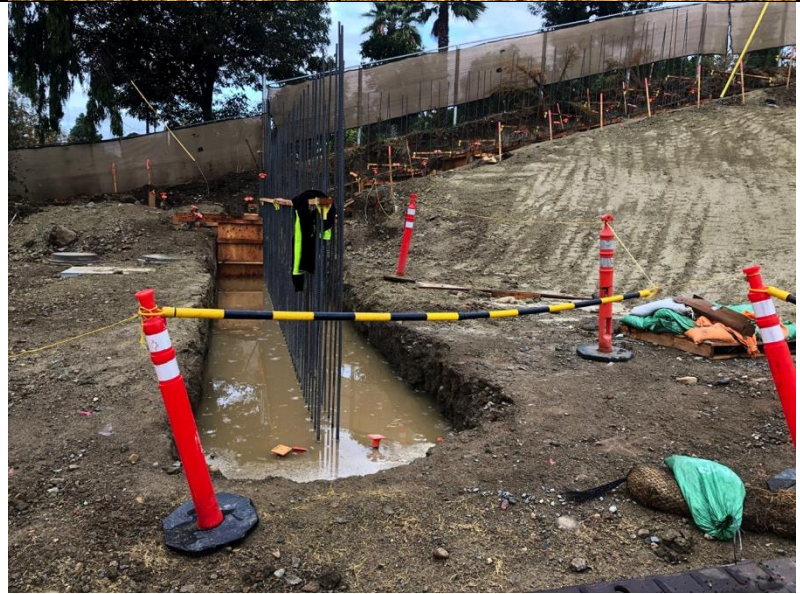
The foundation footings for the last portion of the northern wall have been poured (Photo 8).

<p>Photo 8 – Northern wall footing foundation. Photo facing north.</p>

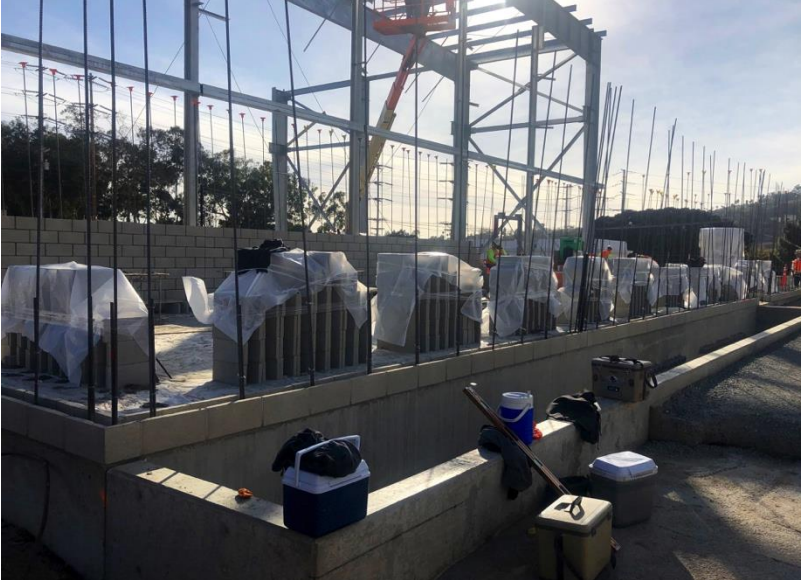
Photo 6 – Brick wall installation around the 138-kV GIS building. Photo facing west.
11/26/19	San Juan Capistrano Substation

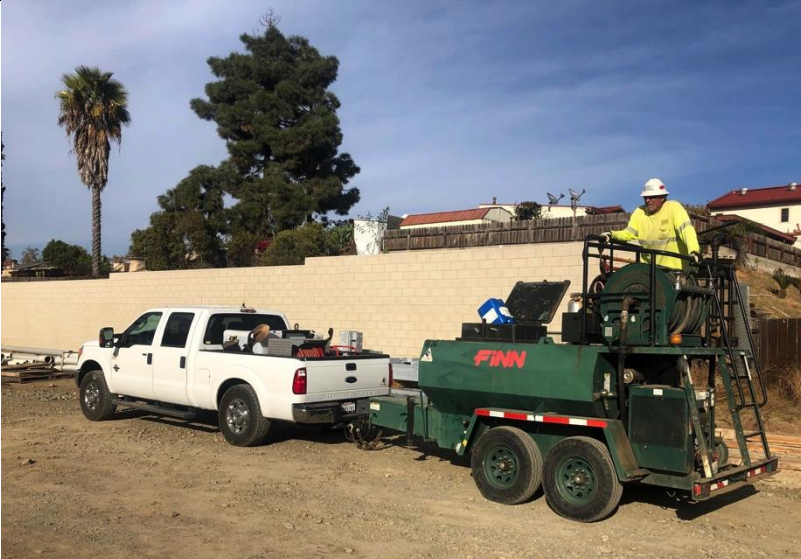
Photo 7 – Hydro-mulcher being filled with a soil sealant. Photo facing northeast.
11/26/19	San Juan Capistrano Substation

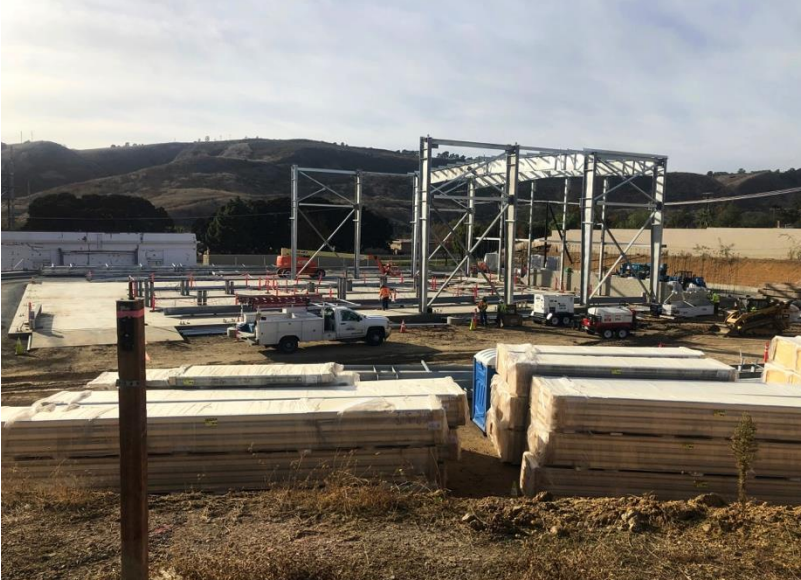
Photo 8 – Overview of the 138-kV GIS building pad. Photo facing west.

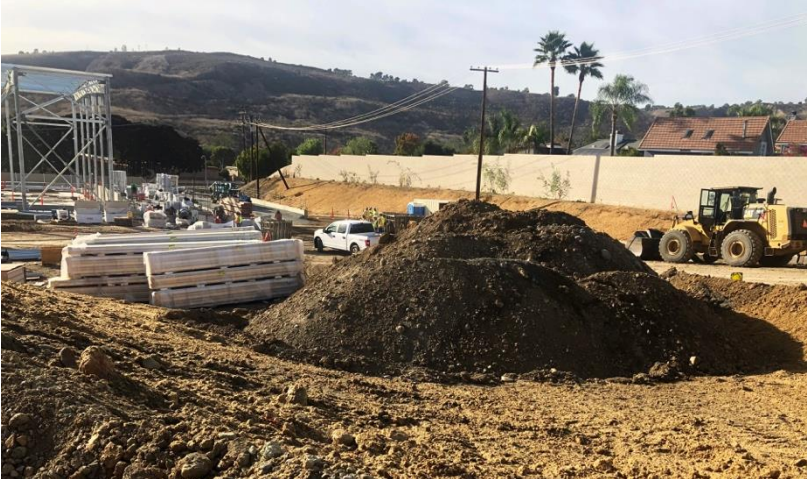
Photo 9 – Soil stockpile area. Photo facing northwest.
11/26/19	Long Park, west of the San Juan Capistrano Substation	 	Photo 10 – Tower locations and the entrance to the laydown yard along Rancho Viejo. Photo facing south.
