Re: Monthly Report Summary #27 for the South Orange County Reliability Enhancement (SOCRE) Project

CPUC Site Inspection Reports
January 10, 17, 23, and 29, 2020

South Orange County Reliability Enhancement Project CPUC Site Inspection Form

Project:	South Orange County Reliability Enhancement (SOCRE) Project	Date:	January 10, 2020
Project Proponent:	San Diego Gas & Electric (SDG&E)	Report #:	VS063
Lead Agency:	California Public Utilities Commission (CPUC)	Monitor(s):	CPUC/Ecology and Environment, Inc., member of WSP (E & E) Compliance Monitor (CM)
CPUC PM:	Andrew Barnsdale, Energy Division	AM/PM Weather:	Clear and calm with cold temperatures
CPUC CM (E & E):	Joe Donaldson	Start/End Time:	0730 to 0945
Project NTP(s):	Notice to Proceed (NTP)-3, NTP-4, NTP-5, and NTP-6

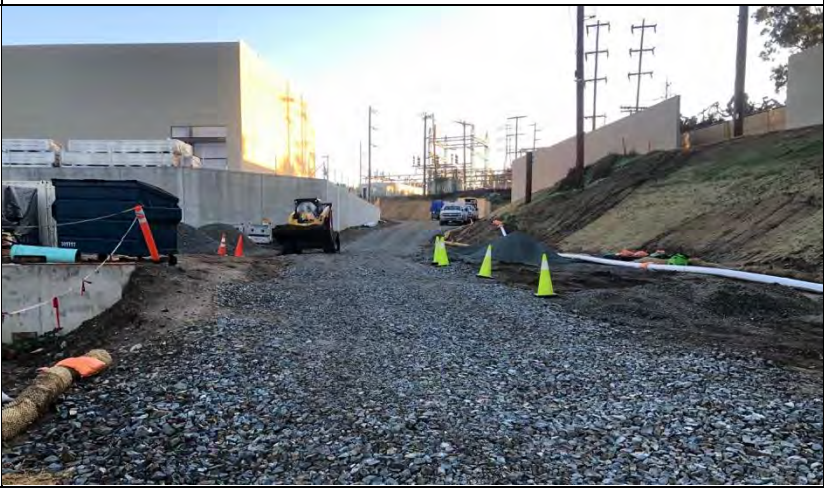
The access road into the substation site from the southwestern entrance had been lined with rock, which will help minimize mud and stormwater runoff issues (Photo 1).

Photo 1 – The main access road into the substation site, which has been lined with rock. Photo facing east.

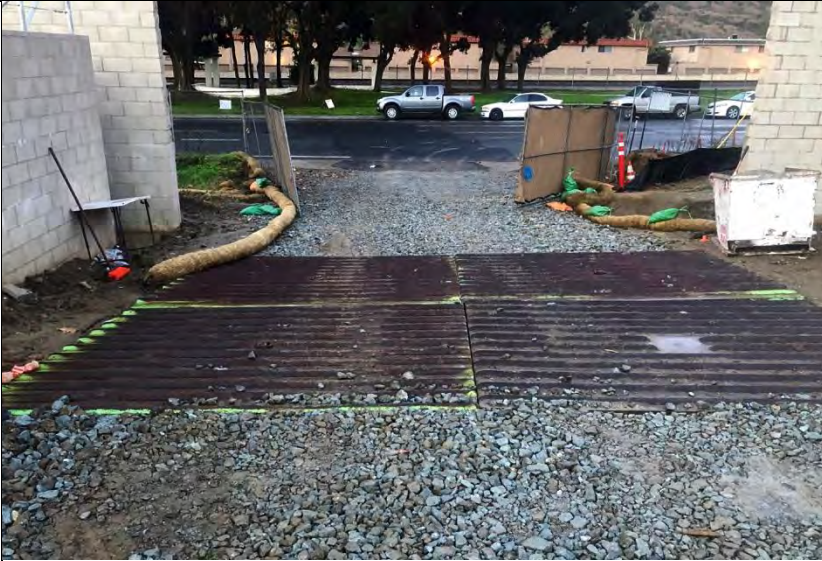
I arrived onsite at San Juan Capistrano Substation at 0645. The crews were using the northwestern entrance to the site; the BMPs at the entrance appeared to be in good condition. However, the site would benefit from additional rock on either side of the rumble plates (Photo 1).

Photo 1 – The northwestern entrance with exit/entry BMPs. Photo facing west.

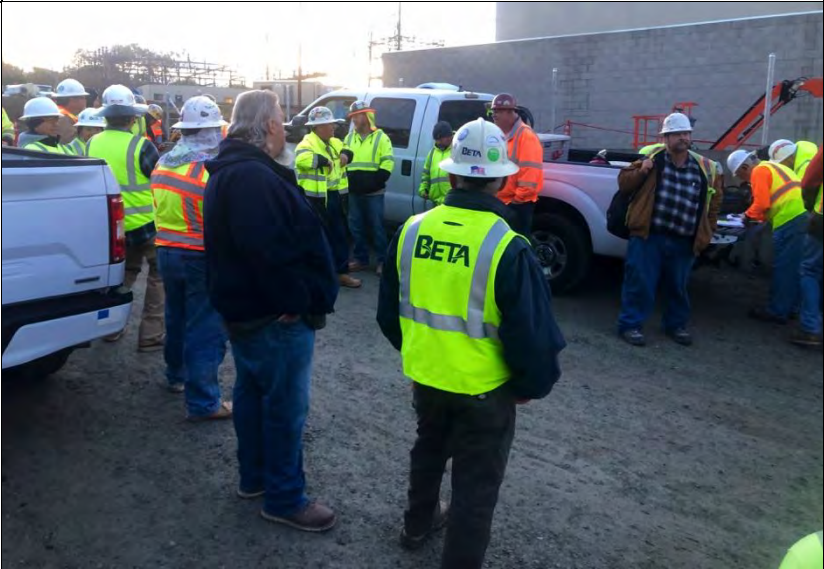
I attended the morning tailboard and introduced myself to the new crew members, explaining my role on the project (Photo 2).

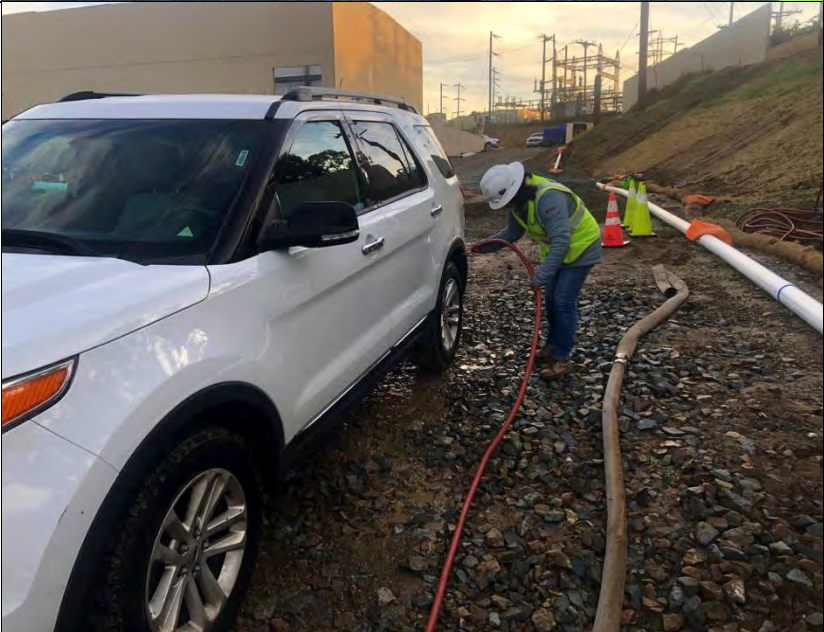
The substation site received approximately 0.25 inches of rain overnight. I did not notice any runoff issues, but the substation site was quite muddy. Some vehicle tires required washing before exiting the substation site (Photo 3). Road base had been added on the access road to the trailers along the north side of the substation site, which helps to keep the mud onsite.

A worker in a white hard hat and high-visibility vest is using a high-pressure red hose to clean the tires of a white SUV. The SUV is parked on a gravel surface. In the background, there are construction materials, a concrete wall, and a hillside with some utility structures under a clear sky.	Photo 3 – Vehicle tires being washed before heading offsite. Photo facing east.

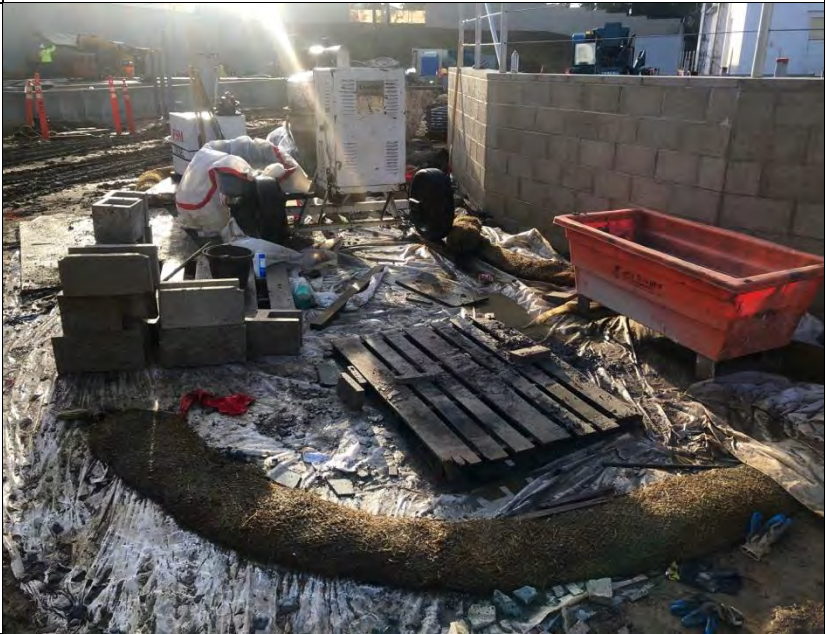
The brick installation on the northern wall was complete and a crew has been tasked with cleaning the mortar mixing area (Photo 6).

Photo 6 – Mortar mixing station being cleaned after completion of brick work on the northern boundary wall. Photo facing south.
01/17/20	San Juan Capistrano Substation

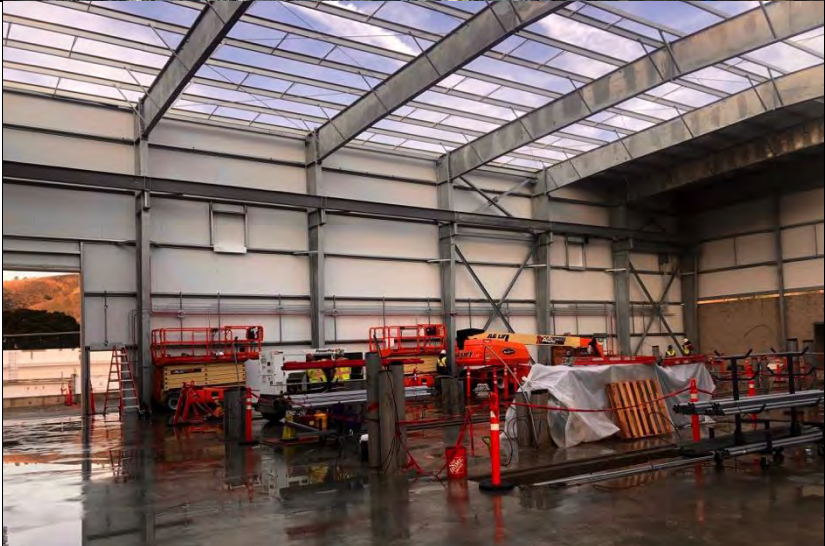
Photo 7 – Inside the 138-kV GIS building. Photo facing west.

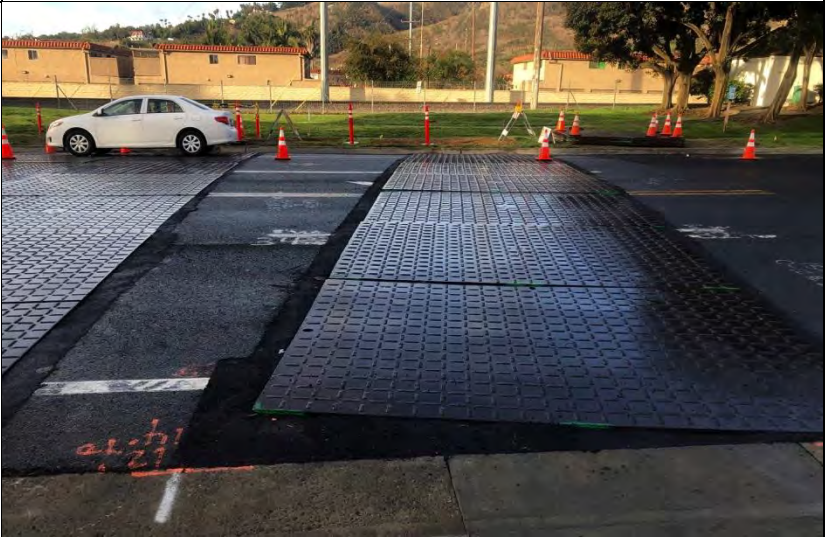
Photo 13 –Excavated trenches across Camino Capistrano covered with metal plates. Photo facing west.

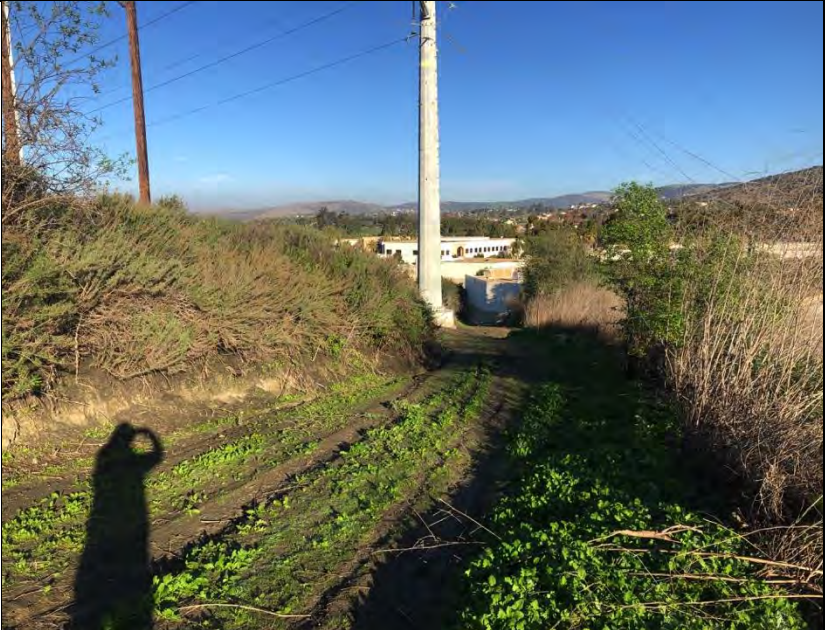
Photo 1 – Access road to tower location #38 where work will begin shortly. Photo facing north.

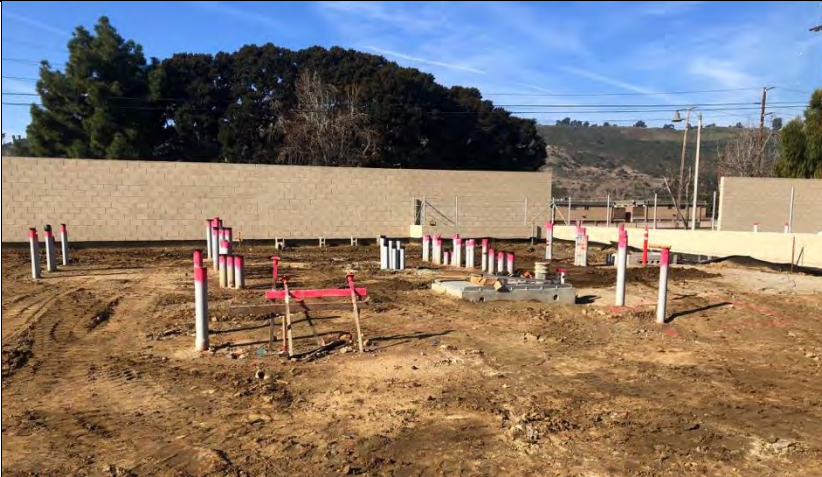
Photo 4 – Work within the switch rack area. Photo facing west.
01/23/20	San Juan Capistrano Substation

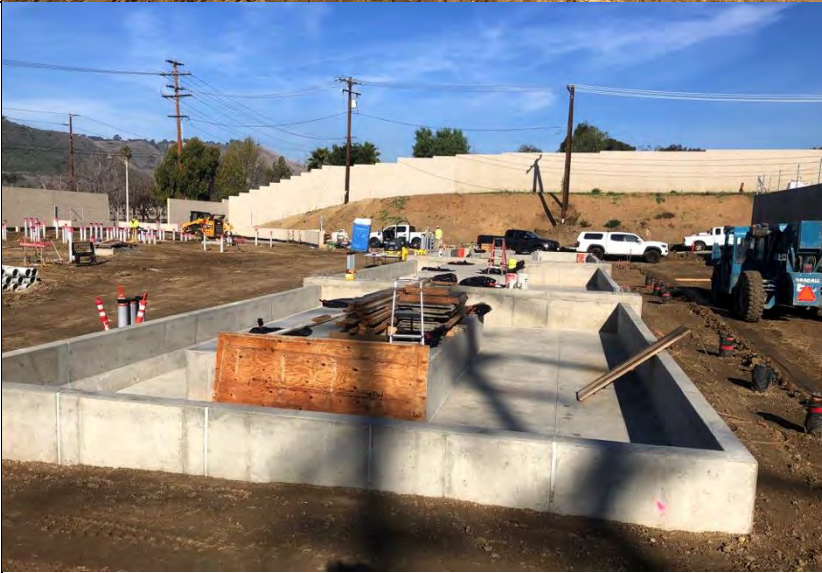
Photo 5 – Work around the transformer foundations. Photo facing north.
01/23/20	San Juan Capistrano Substation

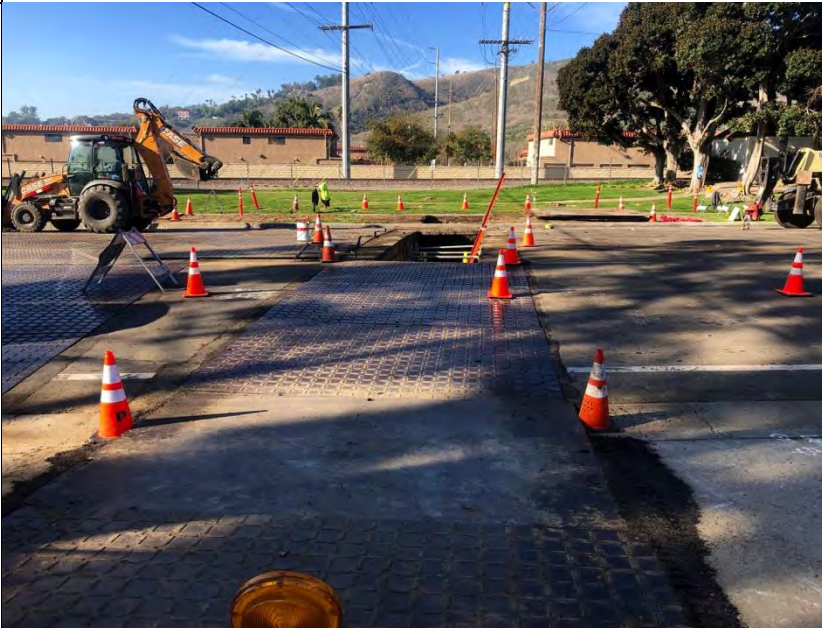
Photo 6 – Excavated trench across Camino Capistrano covered with metal plates, with pouring expected to commence the day of the site visit. Photo facing west.

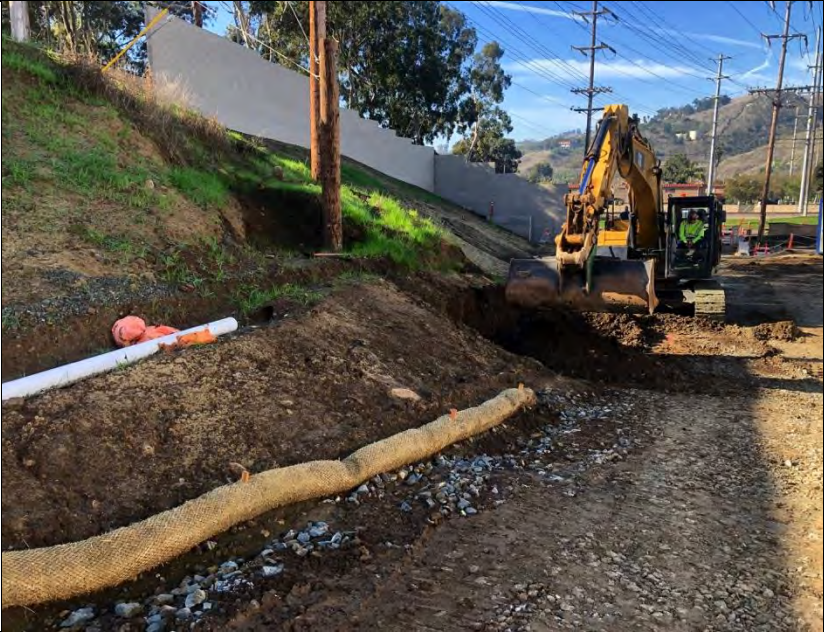
Photo 9 – Conduit trenching along the southern side of the project site. Photo facing west.
01/23/20	San Juan Capistrano Substation

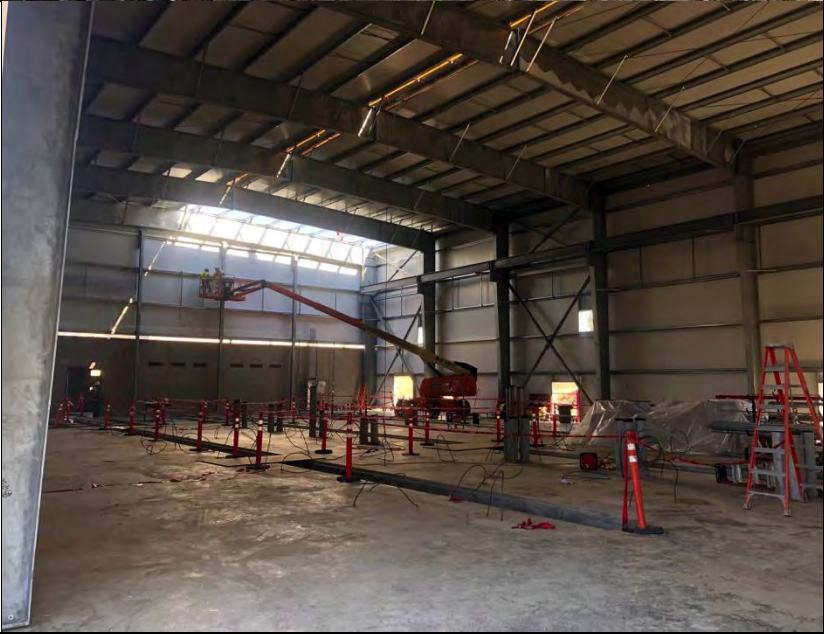
Photo 10 – Work inside the 138-kV GIS building.

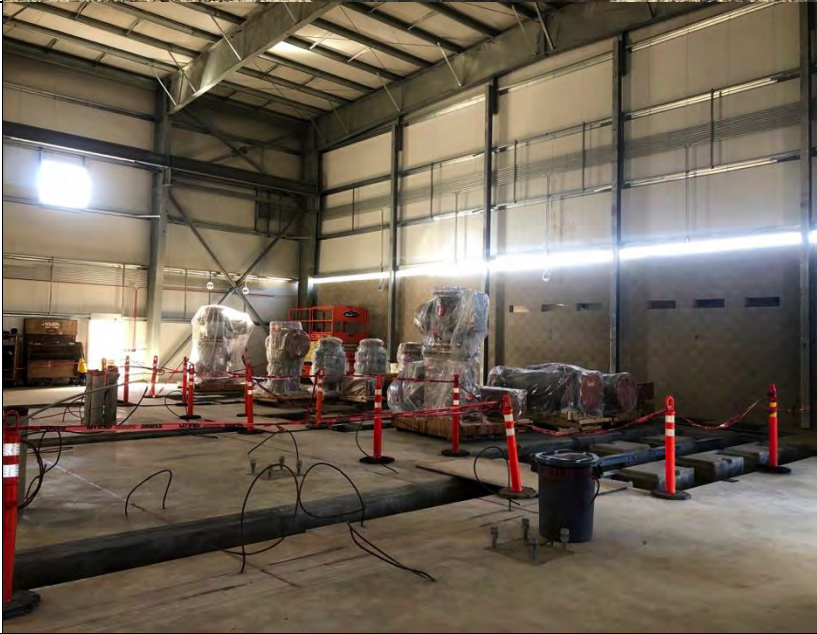
The interior of a large industrial building under construction. The space is filled with equipment, including large metal cabinets and various tools. Safety barriers and orange traffic cones are placed around the work area. The ceiling is high with exposed steel beams and lighting fixtures.	Photo 8 – Work inside the 138-kV GIS building.

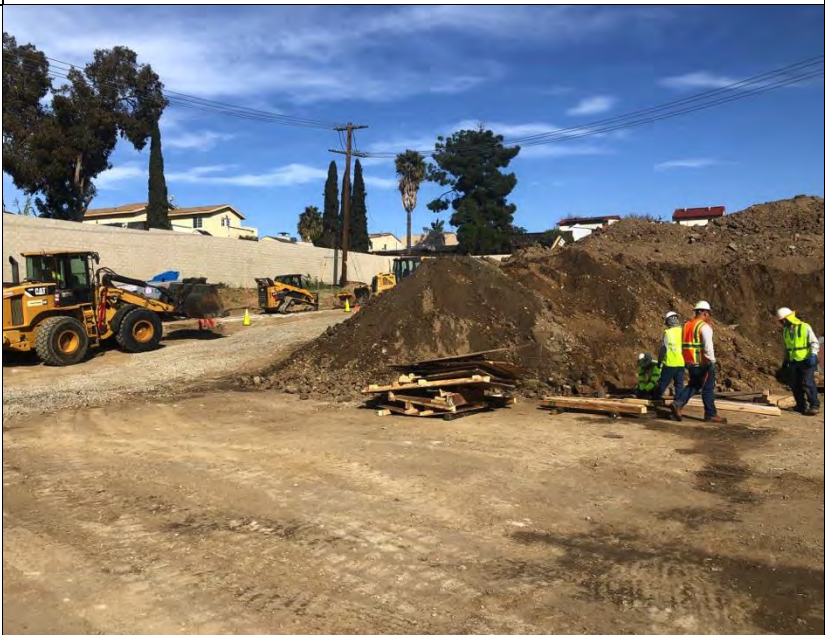
Photo 9 – Soil stockpile area. Photo facing northeast.
01/29/20	San Juan Capistrano Substation

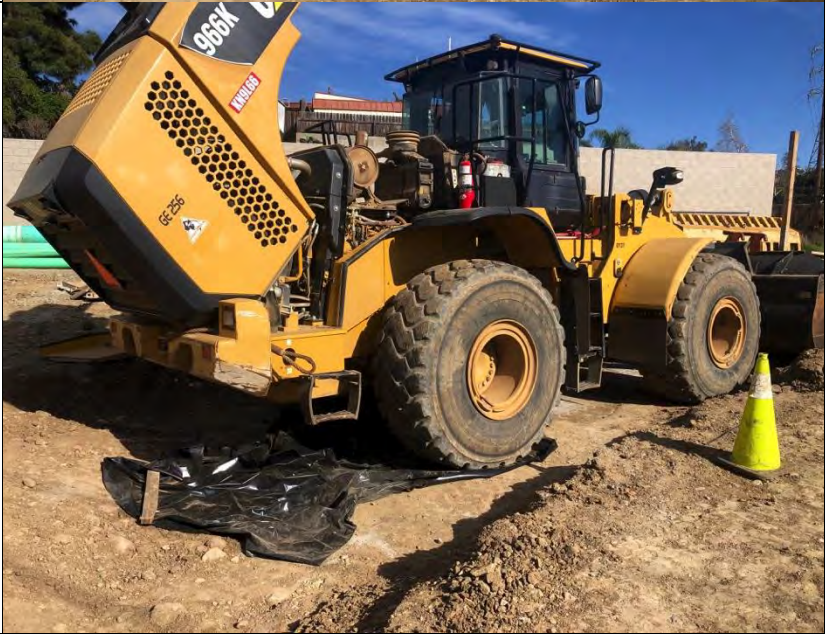
Equipment that was being repaired had plastic sheeting under it (Photo 10). In general, crews were maintaining adequate secondary containment under engines.

Photo 10 – Secondary containment under equipment. Photo facing east.

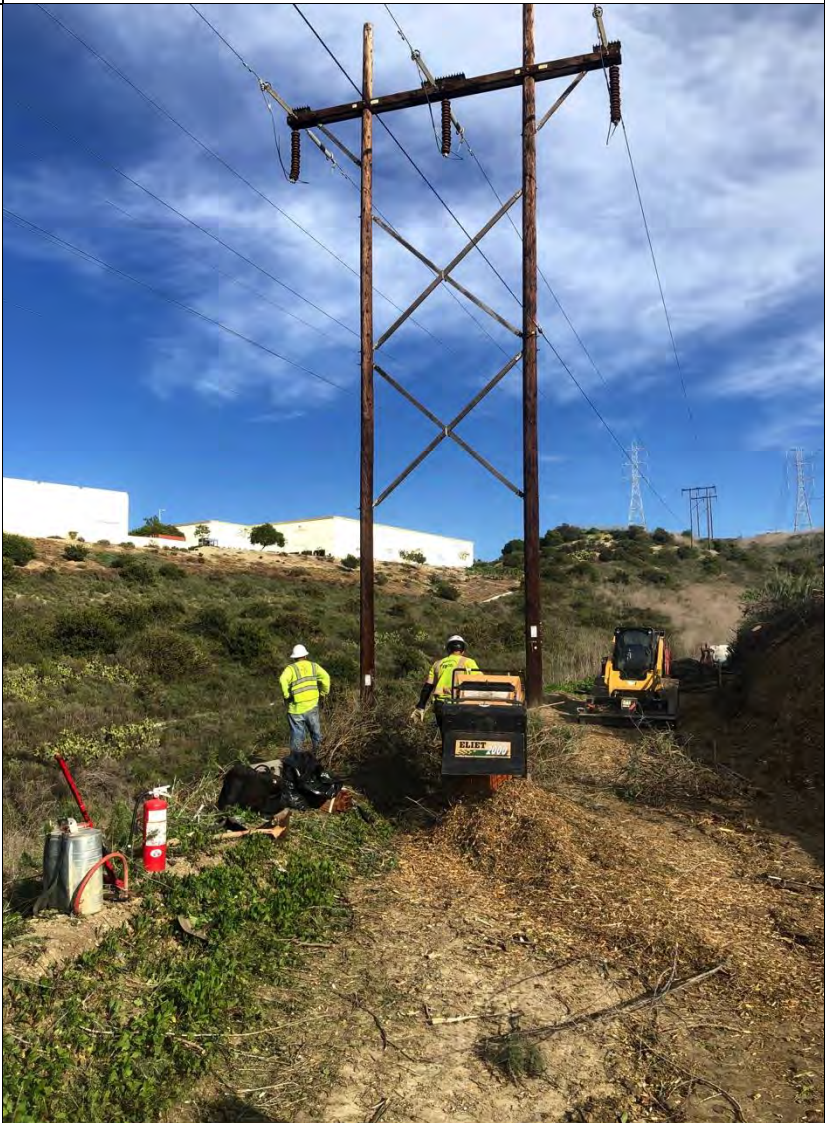
Photo 14 – Vegetation clearing at transmission line tower location #39. Photo facing east.
